APPENDIX B: National Register Forms

**National Register of Historic Places
Registration Form**

historic name Gray, George Edward, House

Gray, George Edward, House Sussex County, Delaware

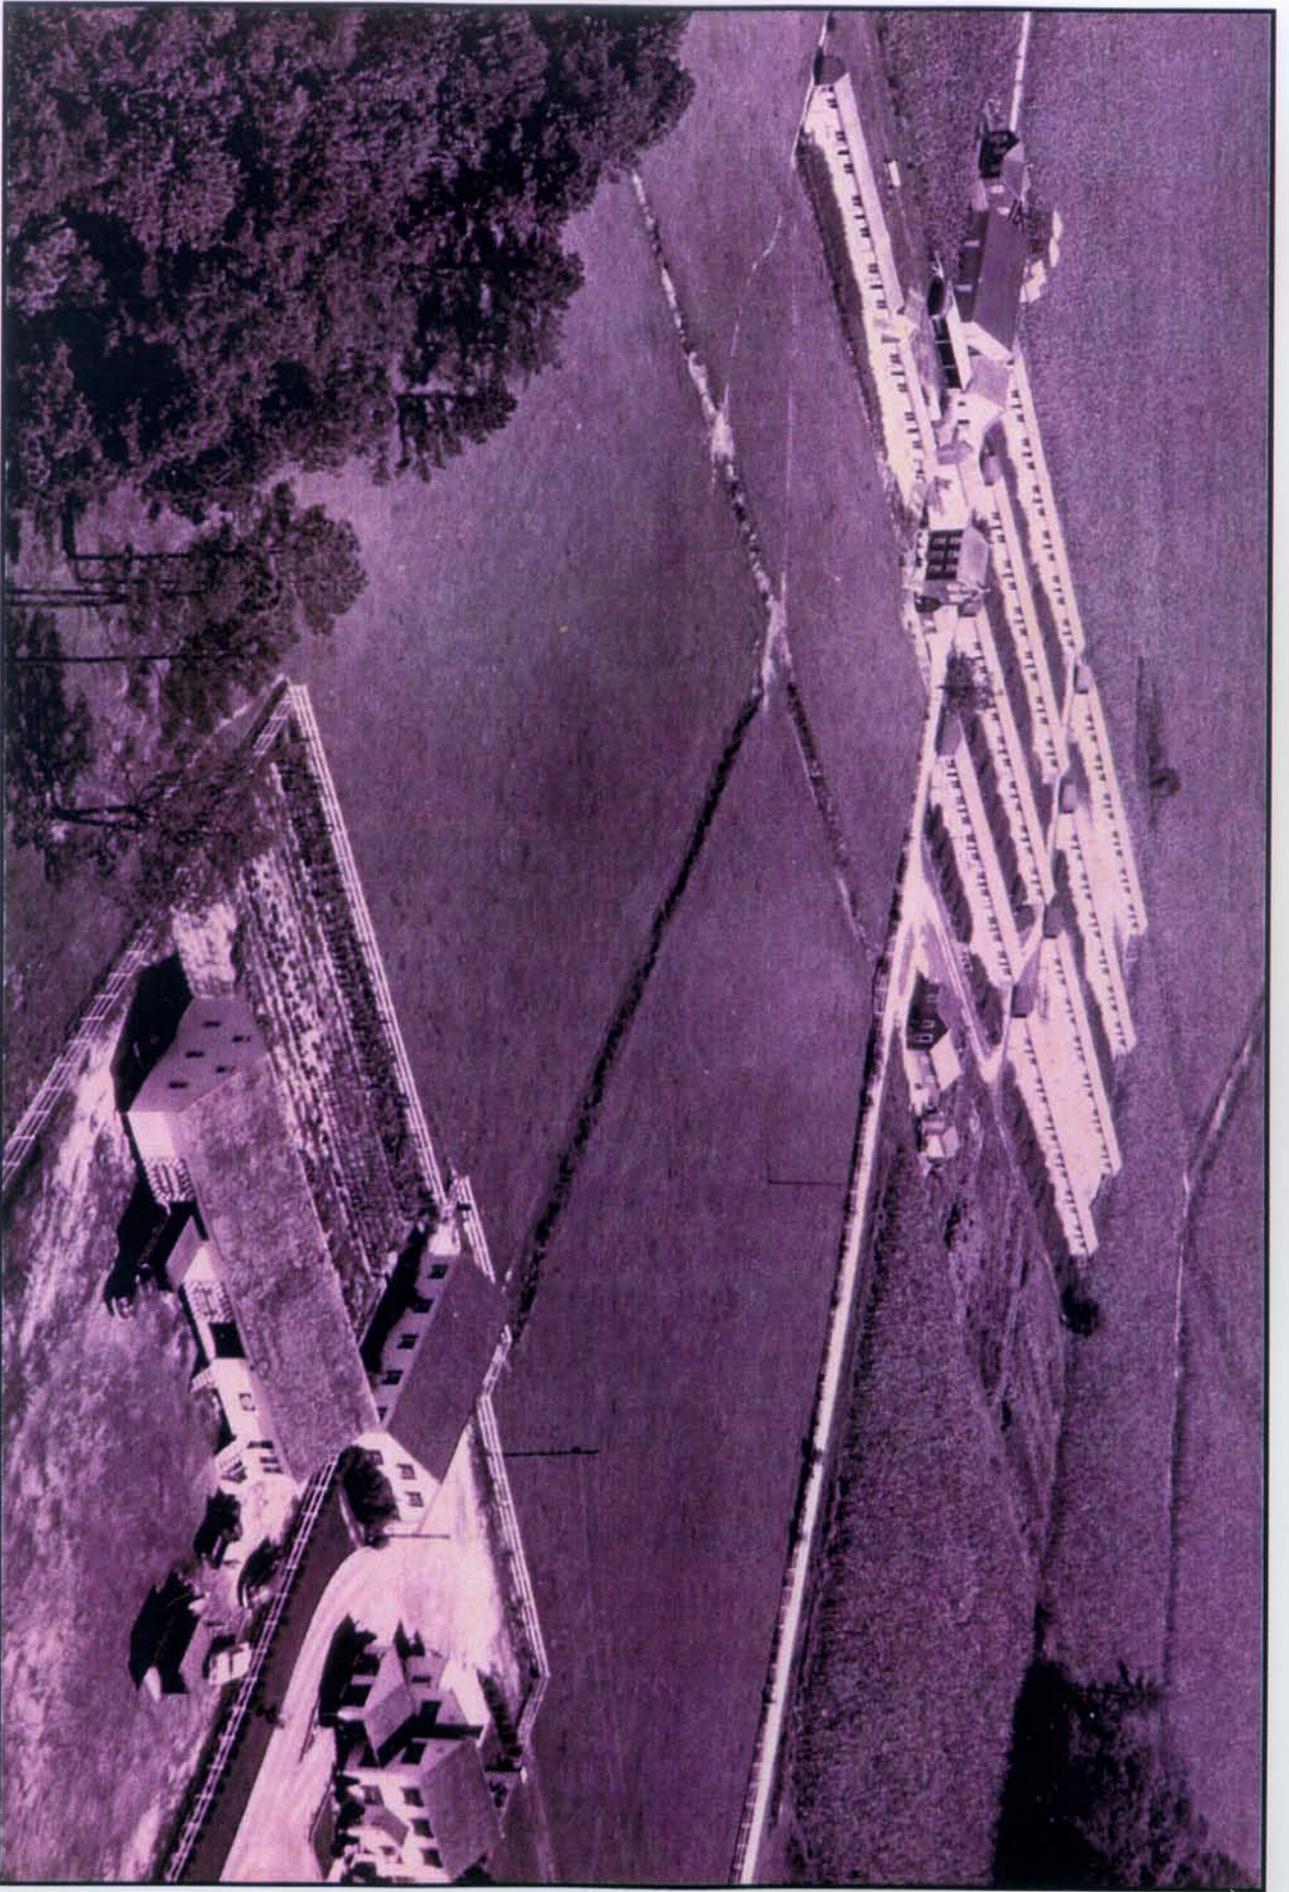
Plate 2

George Edward Gray House (S-8148)

Note chicken houses (now demolished)

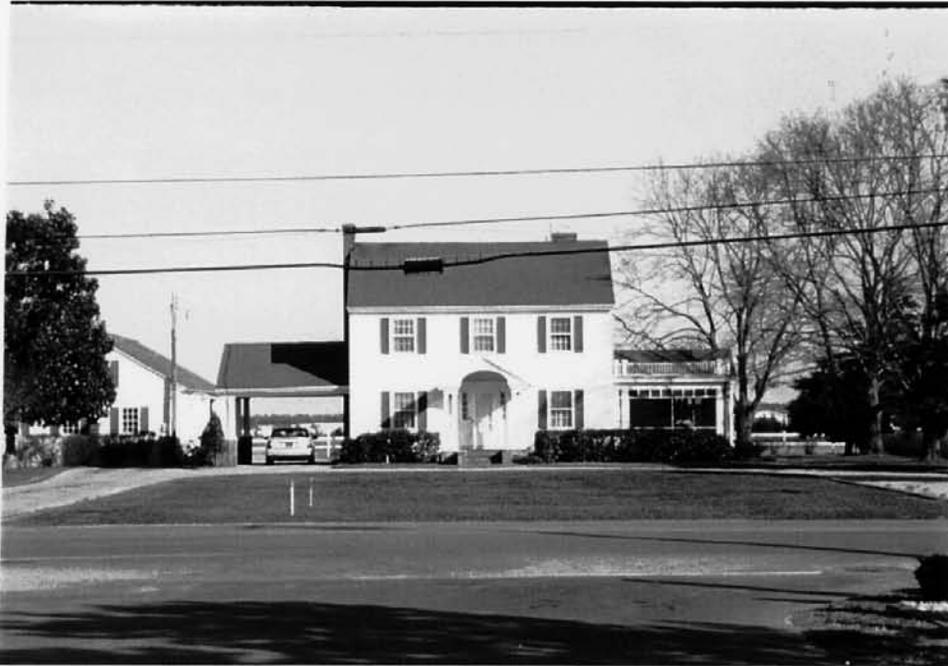
Photo 1: Elevation view, front (south) façade, looking north from opposing side of Route 54, near Salty Way (tax parcel 5-33-12-92).

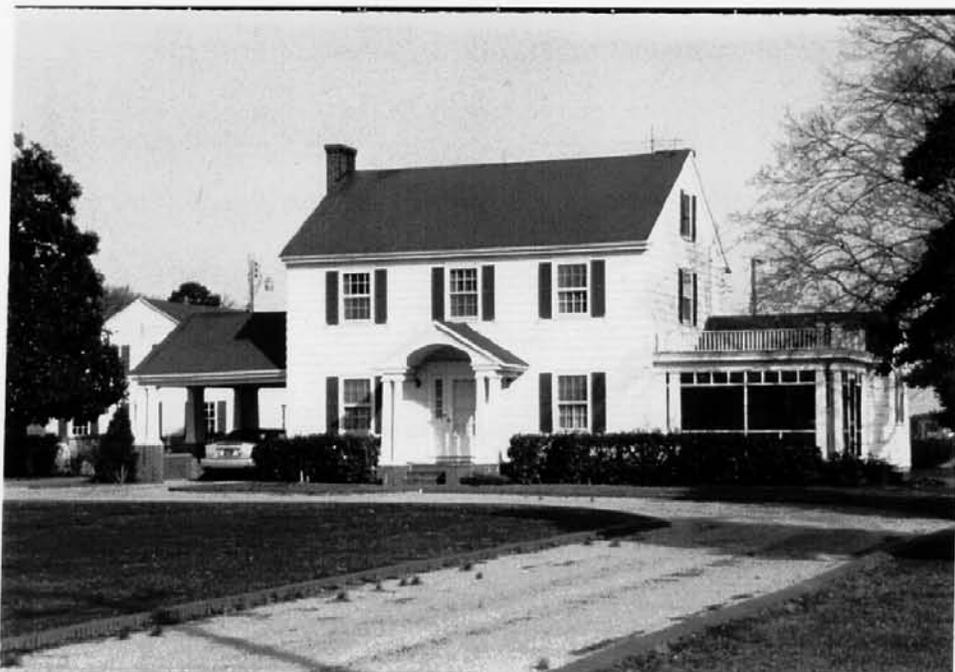
Photo 2: Lateral view from driveway, front (south) façade and side (east) façade, looking northwesterly (tax parcel 5-33-12-92).

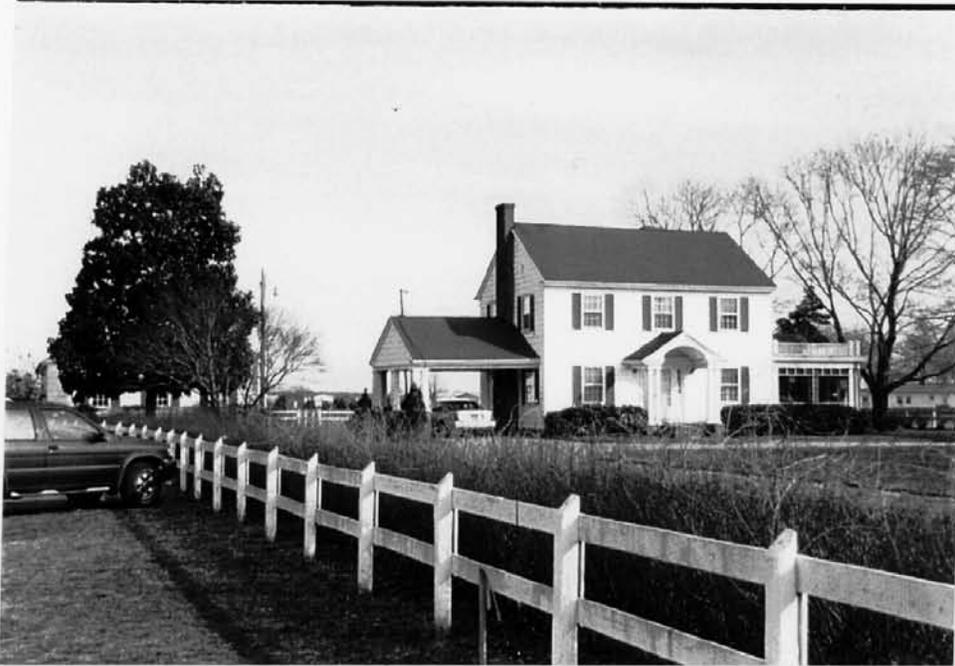
Photo 3: Lateral view, front (south) façade and side (west) façade porte-cochere, looking northeast from driveway (tax parcel 5-33-12-92). The proposed National Register boundary follows along the fence line seen here.

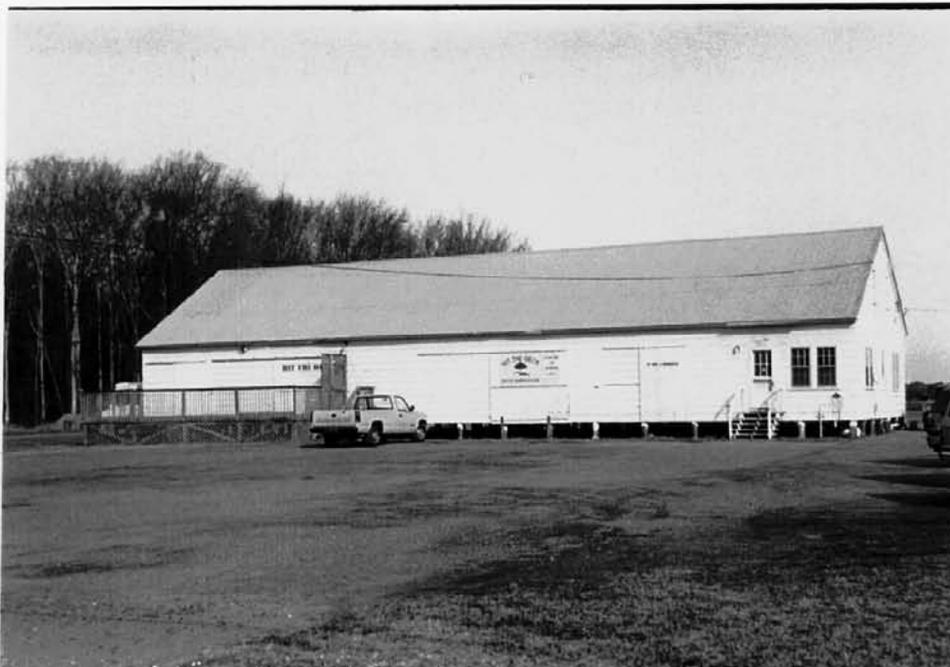
Photo 5: Former feed warehouse (now "Hit the Deck" and Shady Park Office), located west of the main dwelling. Front (south) and side (east) façade, looking north from parking lot (located on tax parcel 5-33-12-92.03).

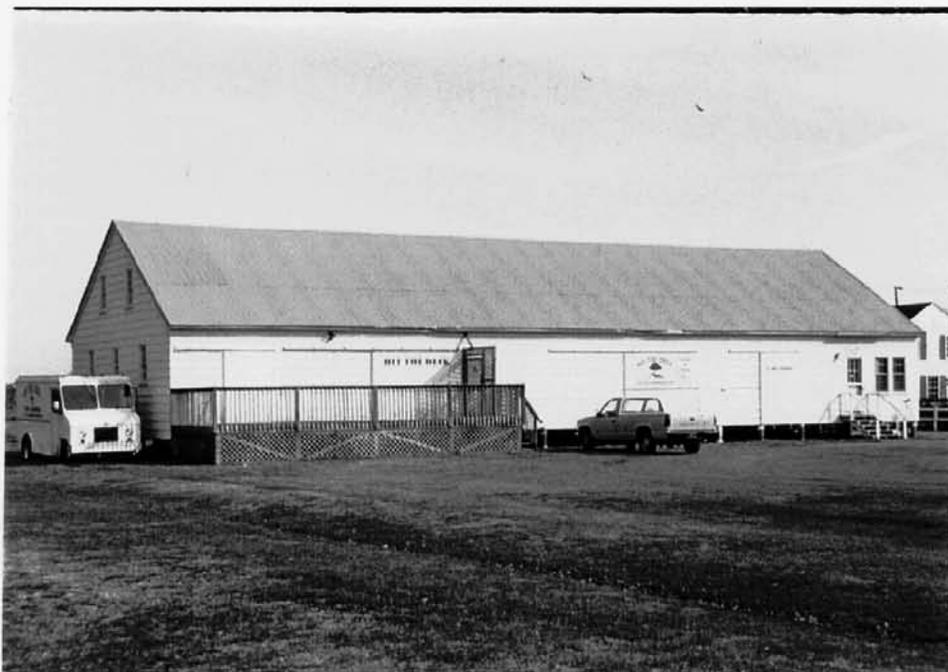
Photo 6: Former feed house, located west of the main dwelling, looking northeast from gravel parking lot at front (south) and side (west) façades (tax parcel 5-33-12-92.03).

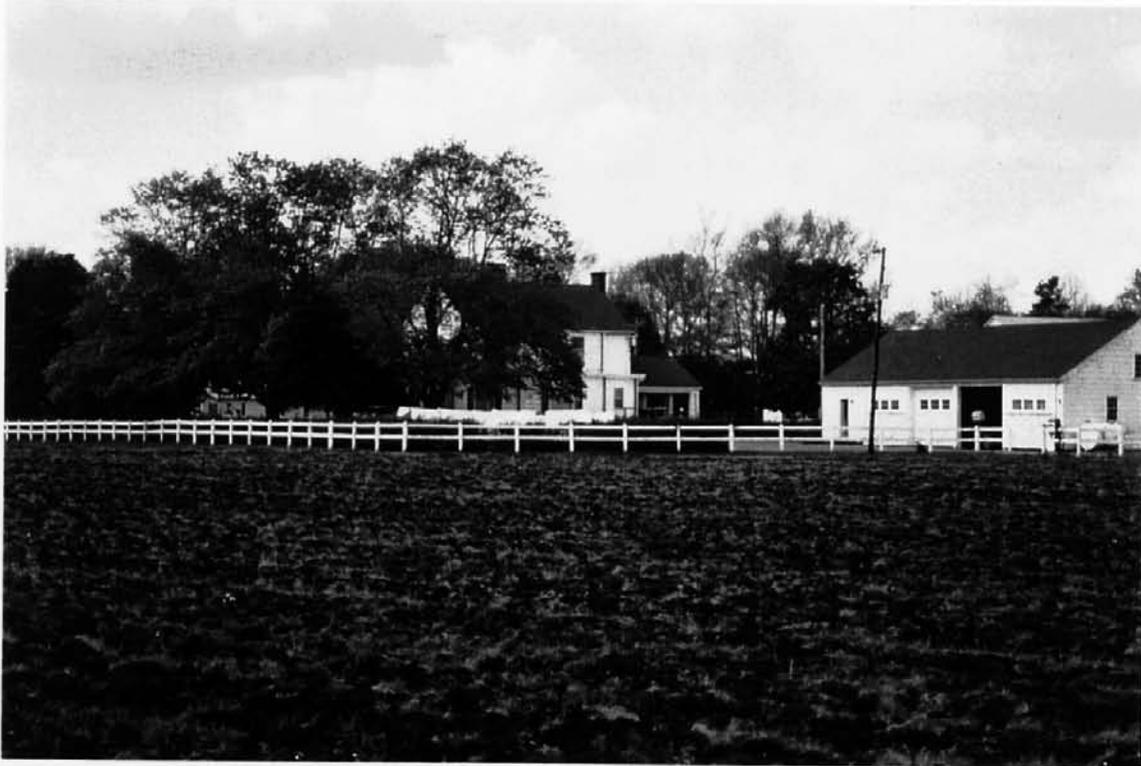
Photo 7: Rear of main Colonial Revival dwelling and side façade of garage, taken from Gray's Lane, looking southwesterly (tax parcel 5-33-12-92). The proposed National Register boundary follows along the south side of the dirt access road to the north of the dwelling.

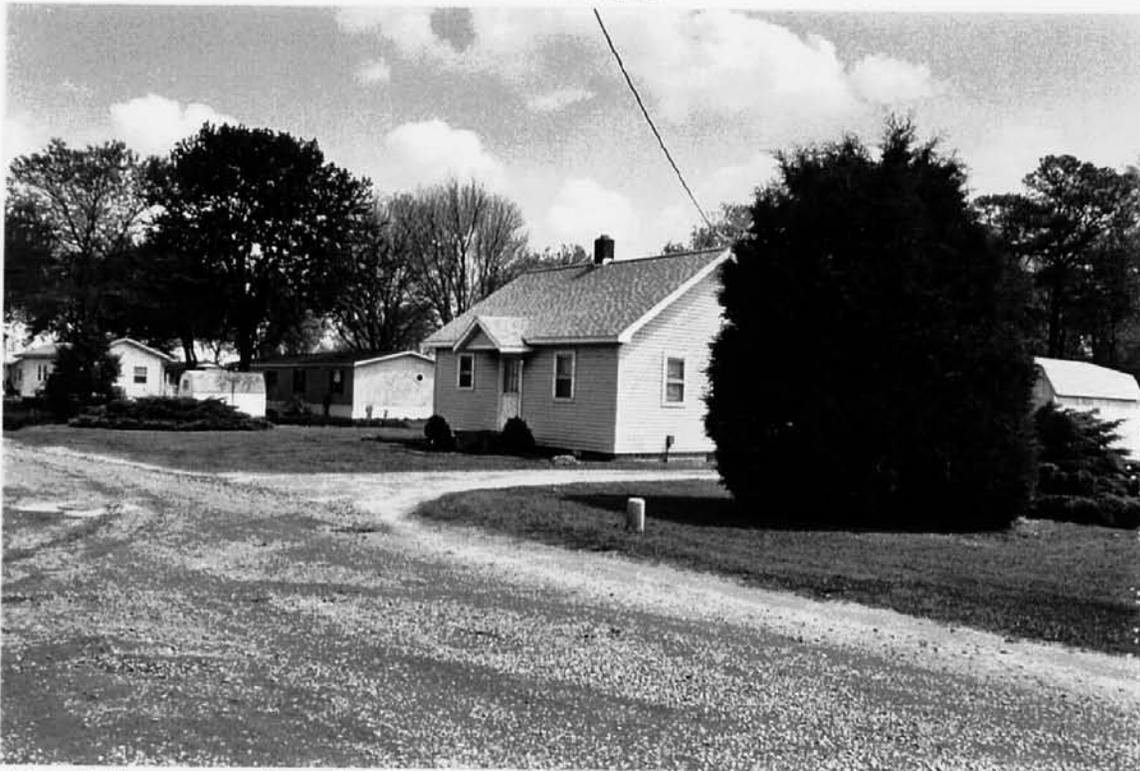
Photo 8: Guest cottage (located on tax parcel 5-33-12-92, east of Gray's Lane), looking northeast. The mobile homes seen in the background (Shady Park) are located on a different tax parcel.

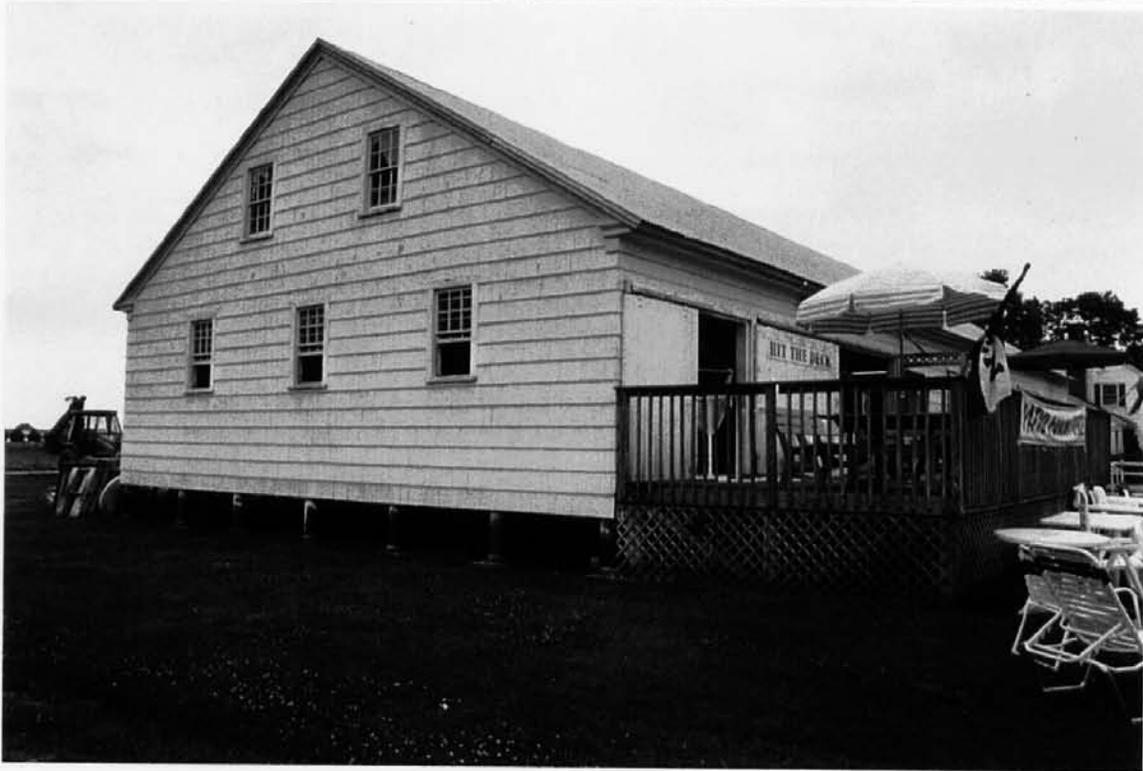
Photo 11: Looking northeast at the side (west) façade of the former feed warehouse (located on tax parcel 5-33-12-92.03).

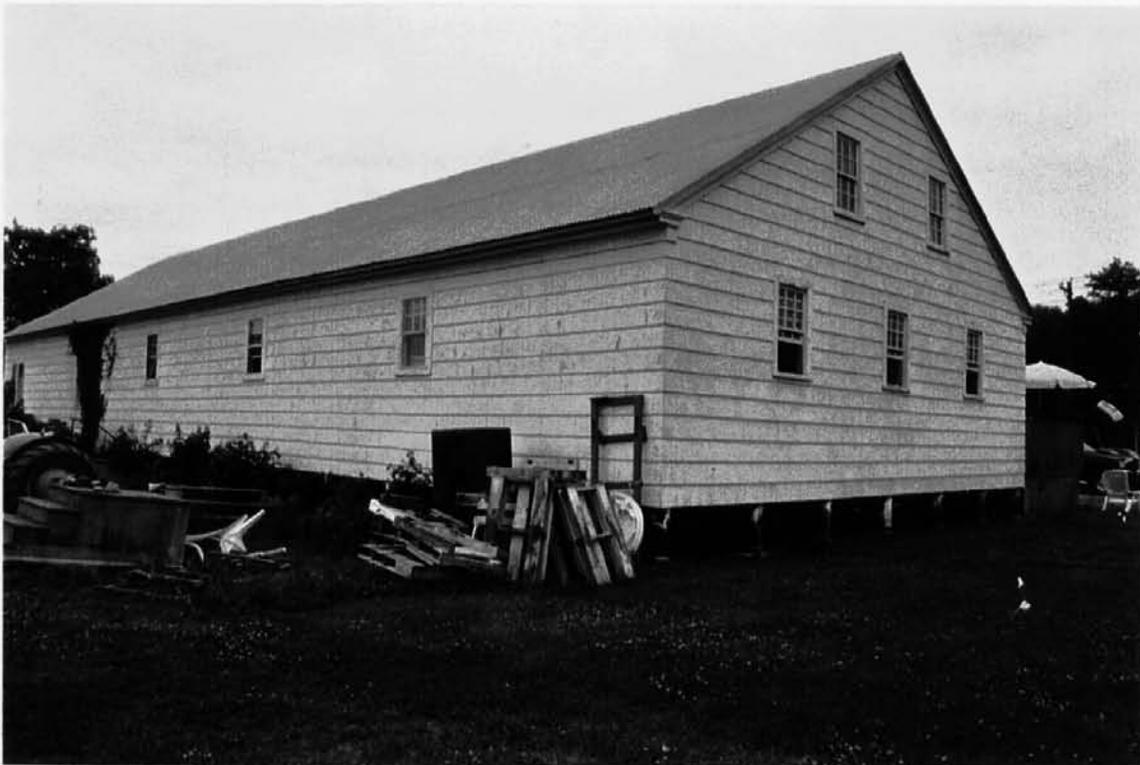
Photo 12: Looking southeast at the rear (north) and side (west) facades of the former feed warehouse (located on tax parcel 5-33-12-92.03).

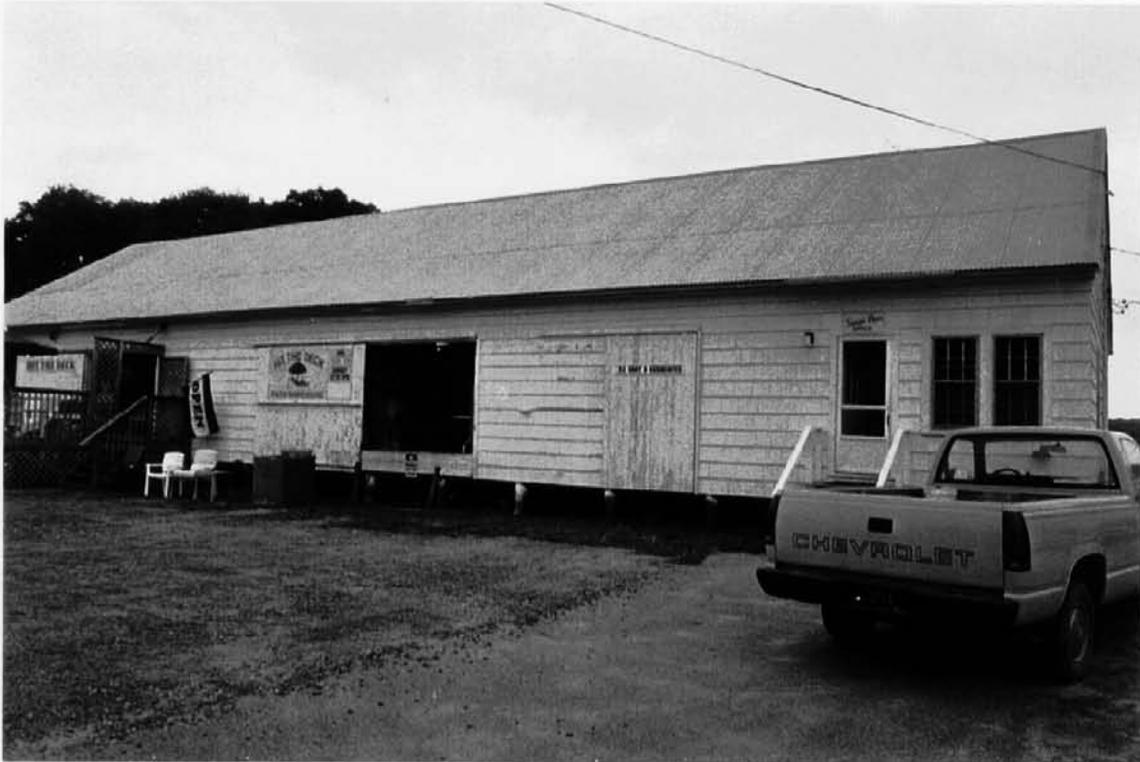
Photo 13: Looking north at the front (south) façade of the former feed warehouse (detail), located on tax parcel 5-33-12-92.03, west of the Colonial Revival dwelling.

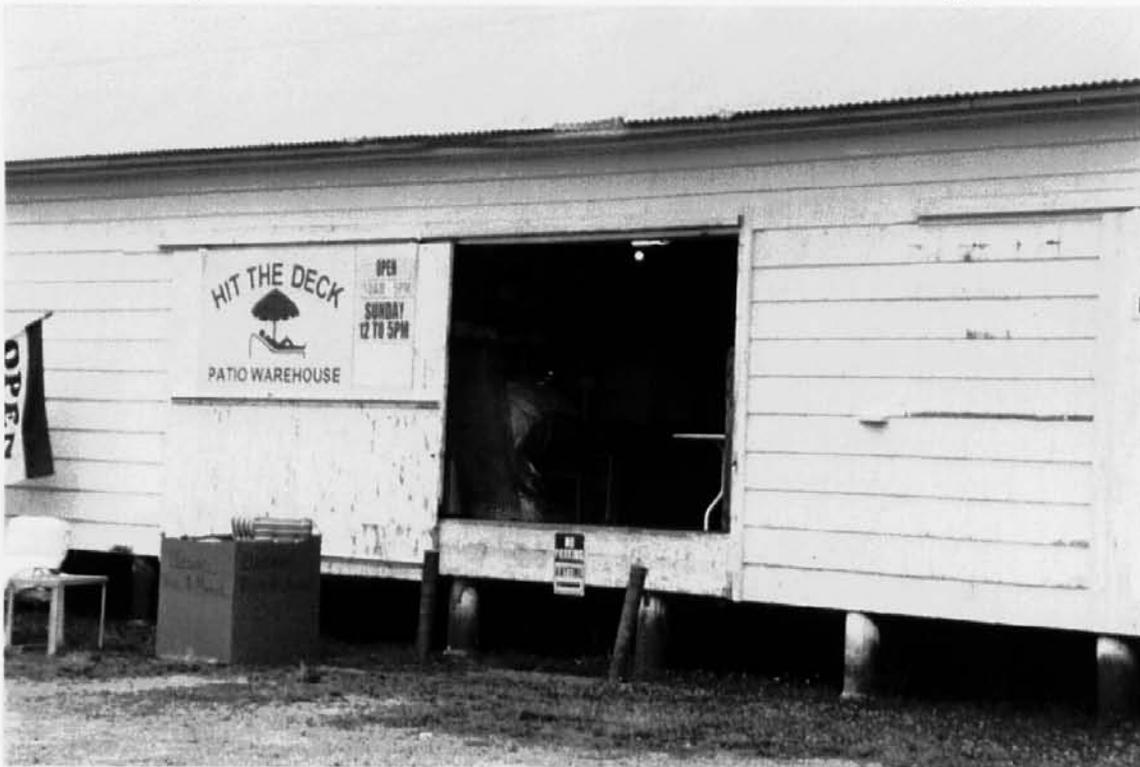
Photo 14: Looking north at sliding door on front (south) façade of the former feed warehouse, located on tax parcel 5-33-12-92.03.

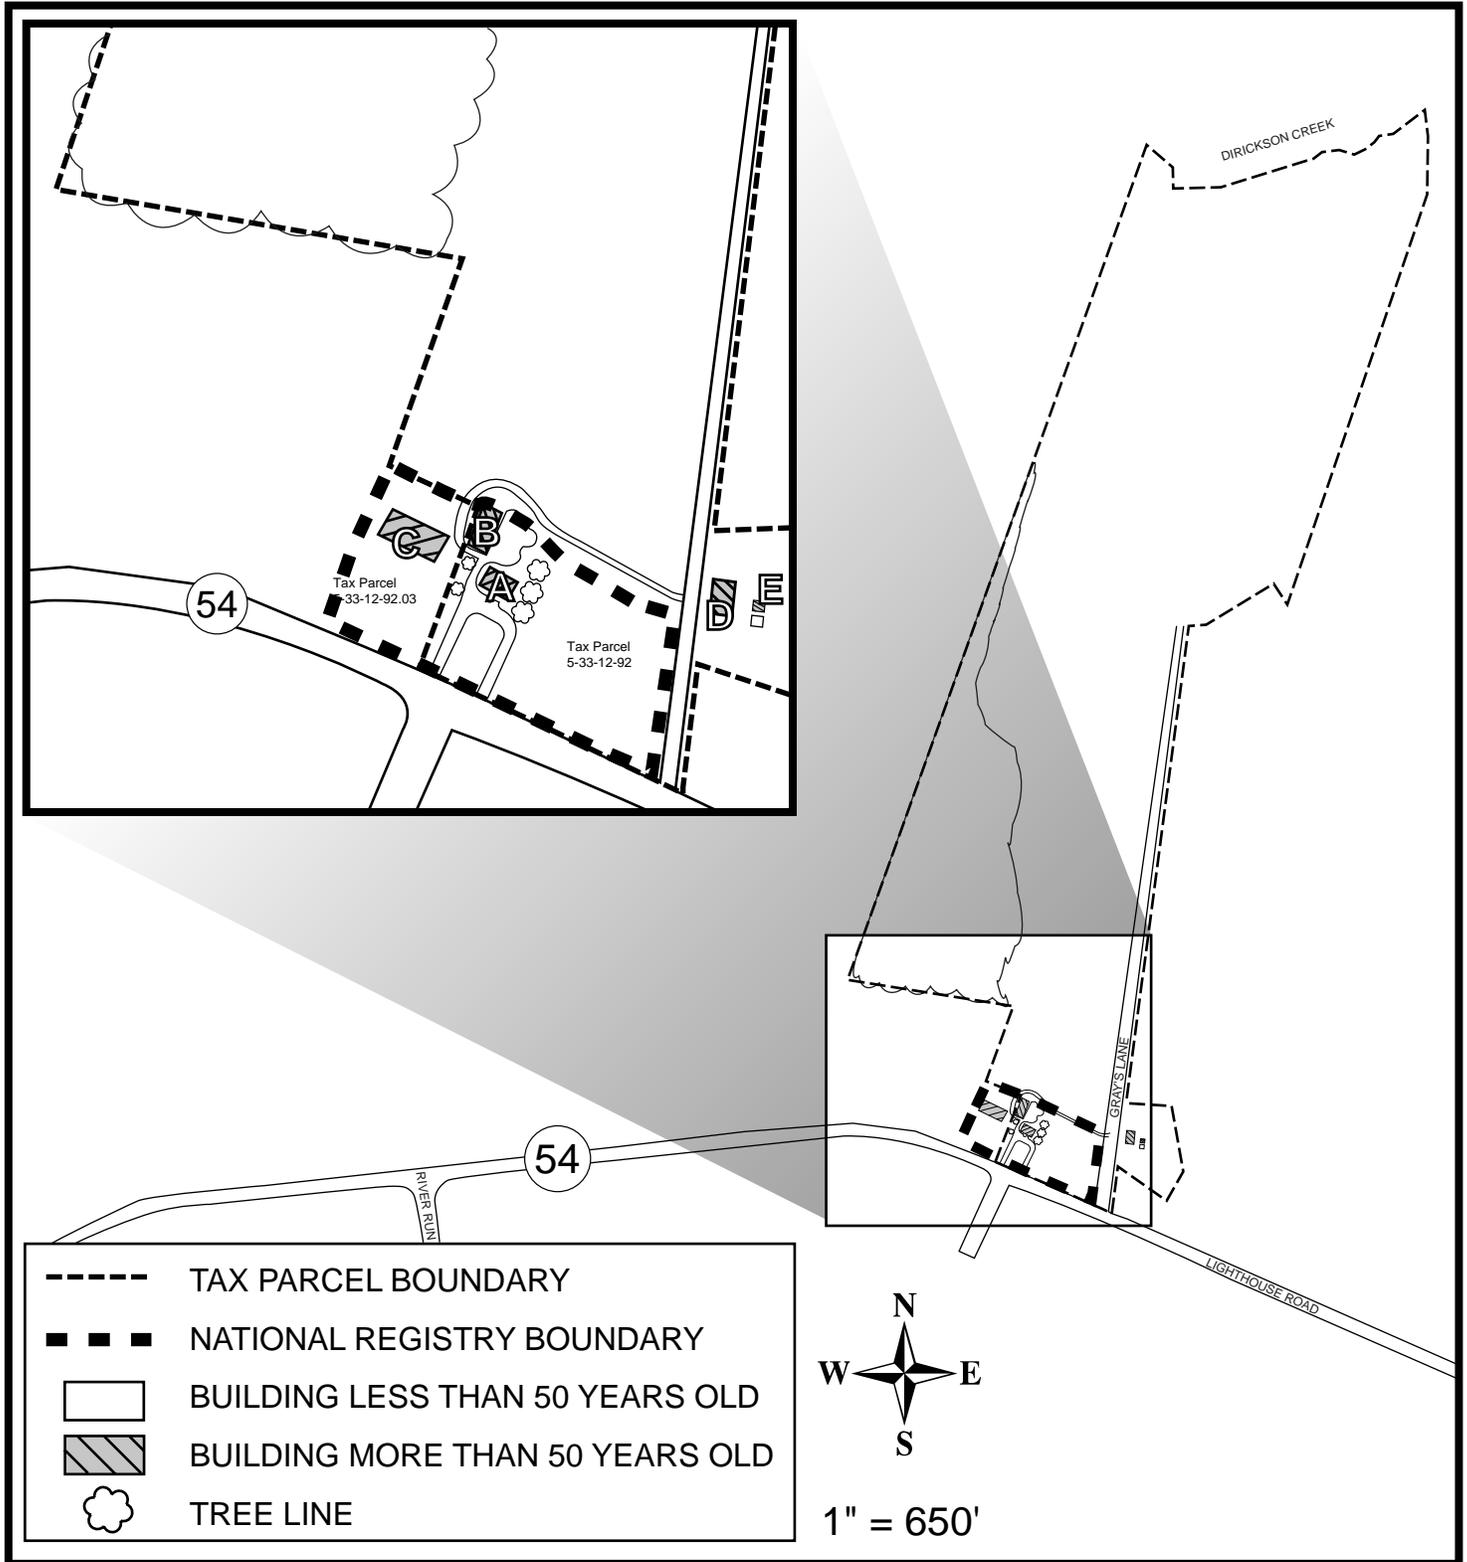
- KEY:
- A: c.1942 Colonial Revival Building
 - B: c.1942 garage
 - C: c.1945 feed warehouse
 - D: c.1946 Guest Cottage
 - E: sheds/outbuildings

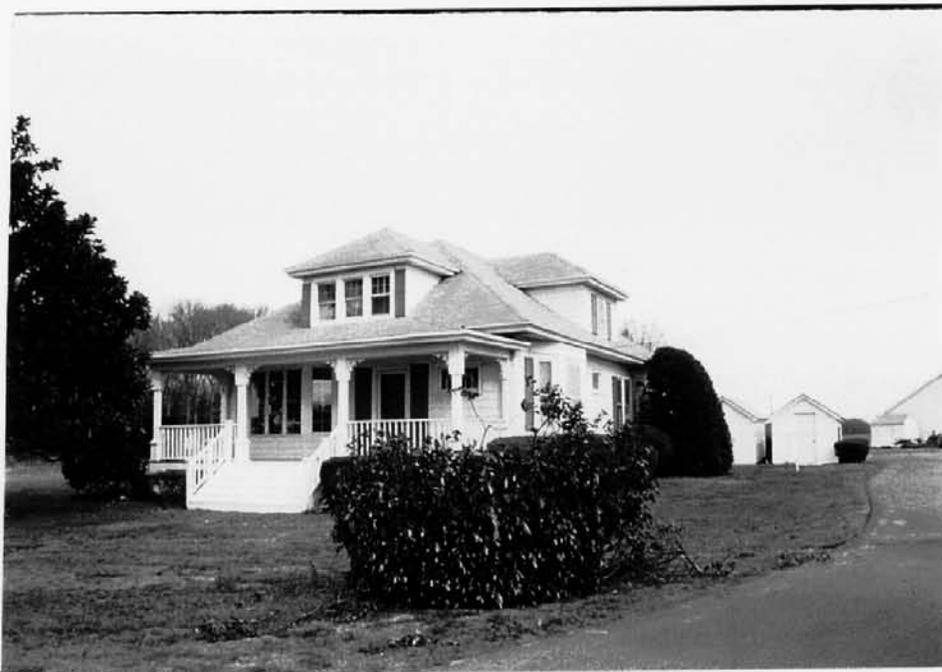
Photo 1: Lateral view, front (south) and side (east) façade (outbuilding seen in right foreground), taken from paved driveway, looking northwest (tax parcel 5-33-20-2).

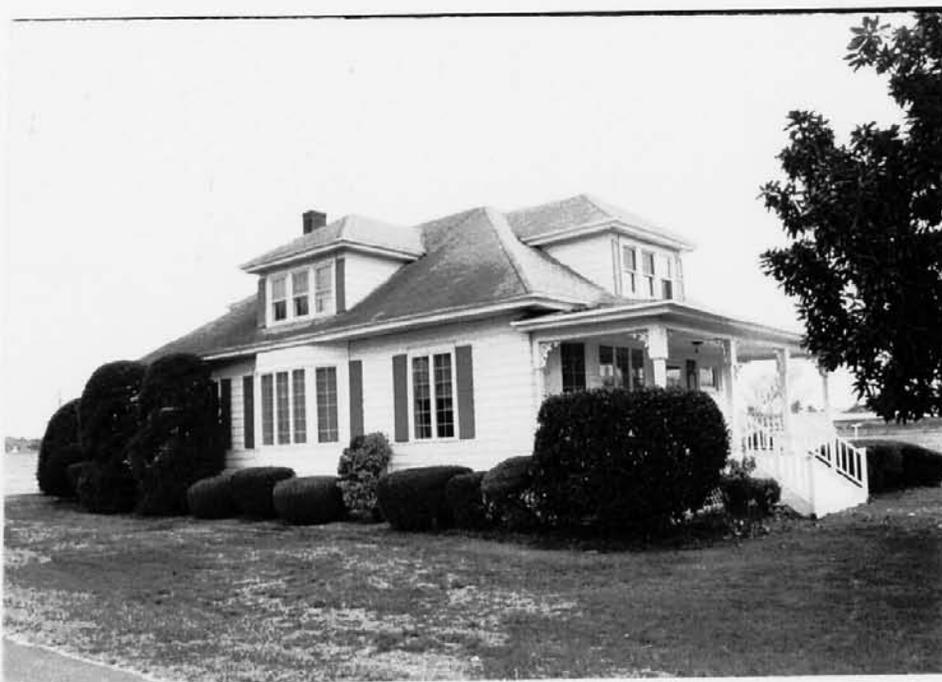
Photo 2: Lateral view of front (south) and side (west) facades. Taken from side yard, looking northeast (tax parcel 5-33-20-2).

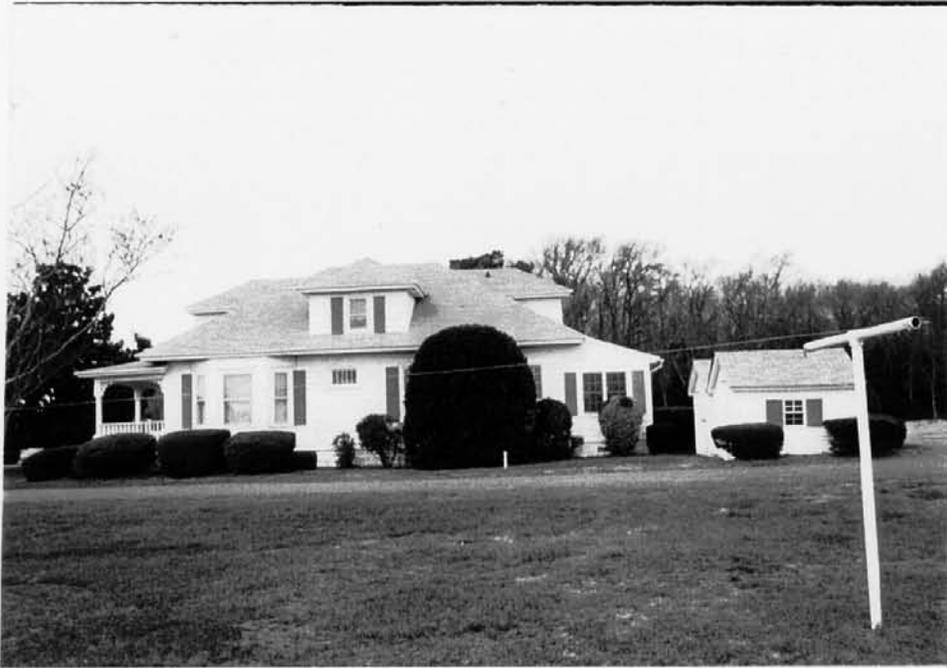
Photo 3: Elevation view of side (west) façade and outbuildings. Looking west from side yard (tax parcel 5-33-20-2).

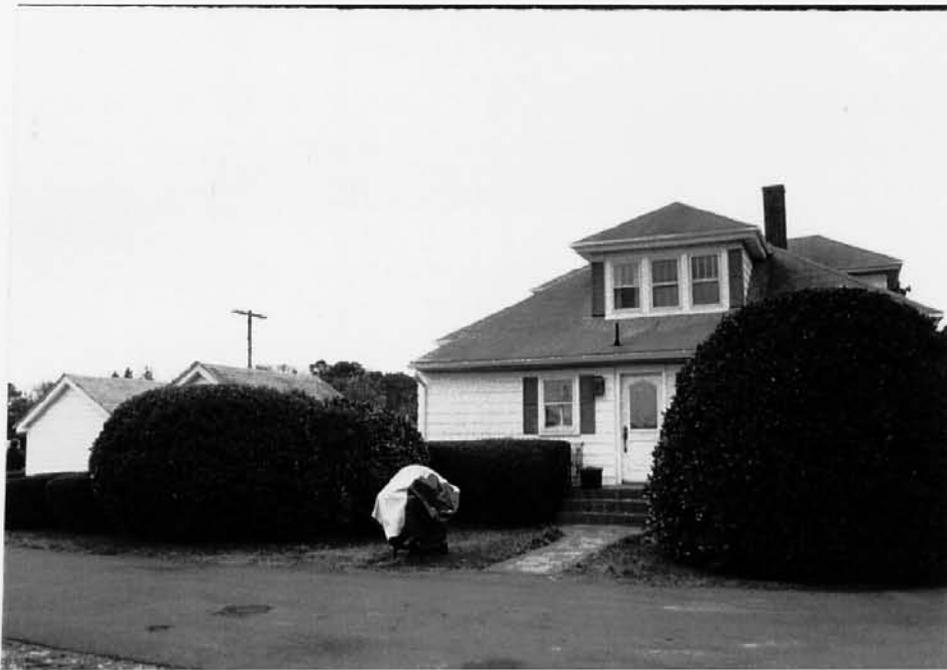
Photo 4: Elevation view of rear (north) façade. Gable peaks of outbuilding seen to left (tax parcel 5-33-20-2).

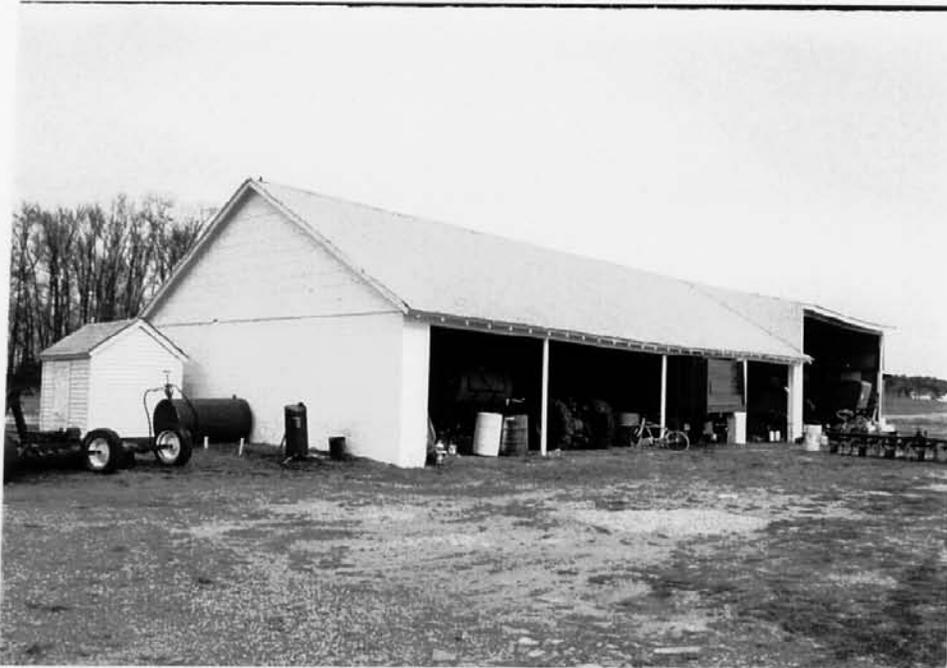
Photo 5: Farm equipment garage and outbuilding, located northeast of the dwelling. Looking north from driveway (tax parcel 5-33-19-25).

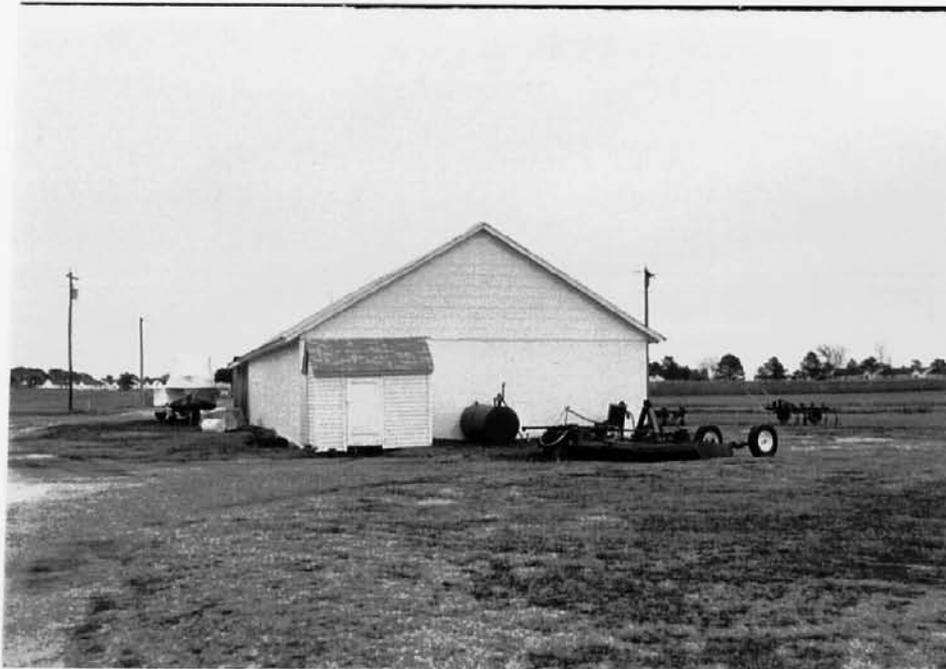
Photo 6: Farm equipment shed and outbuilding, looking east from driveway. These structures are located northeast of the dwelling (tax parcel 5-33-19-25).

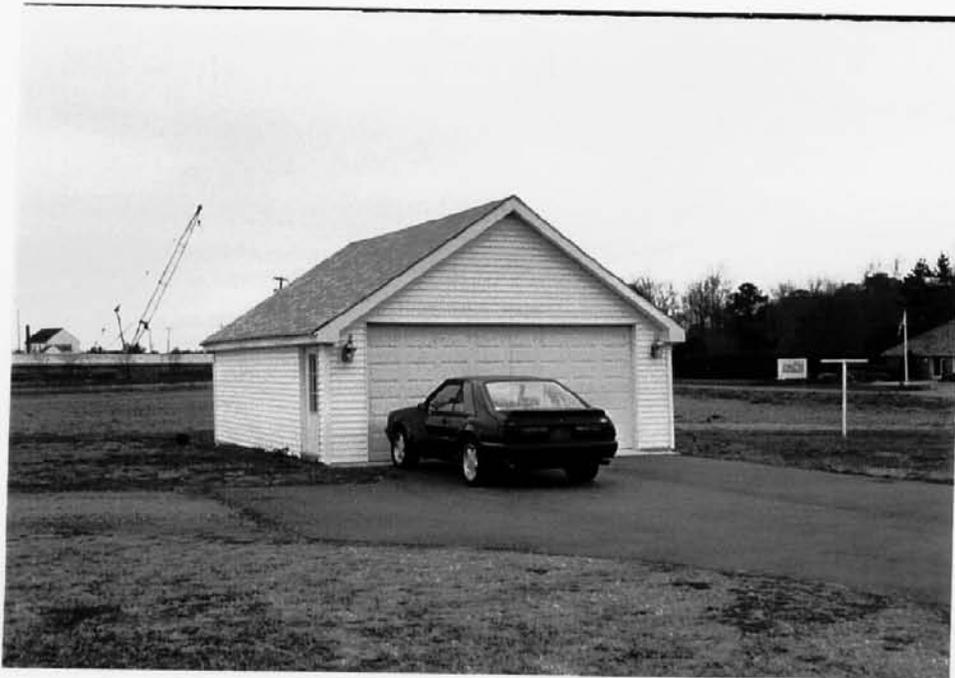
Photo 7: Modern vehicular garage, located northeast of the dwelling, looking east (tax parcel 5-33-20-2).

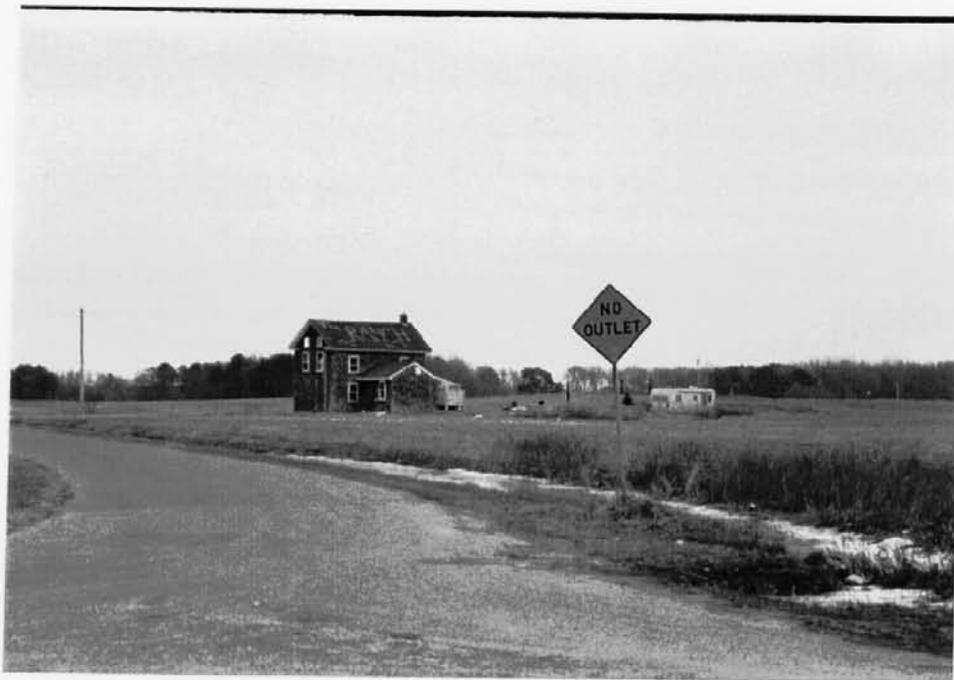
East of Bayville Road (County Road 58B) is an abandoned two and one-half story, c. 1880 I-house known as “The Ranch.” This dwelling is three bays by two bays in width, and has a brick foundation, cedar wood shake exterior, one-over-one double-hung windows, an interior ridge brick chimney, and an asphalt-shingle, side gable roof. The front (north) façade features a central paneled entry, and single two-over-two double-hung windows on the first and second floors. On the rear (south) façade, there is a one story, one bay by one bay ell-addition with an asphalt-shingle, gable roof addition. This dwelling likely once functioned as the main dwelling for the entire Adkins Farm complex, but today it is in need of repair and remains unoccupied.

Photo 8: "The Ranch," looking northeast from Bayville Road, side (west) and rear (south) facades (tax parcel 5-33-19-25). This abandoned dwelling is located across Bayville Road, northeast of the bungalow dwelling.

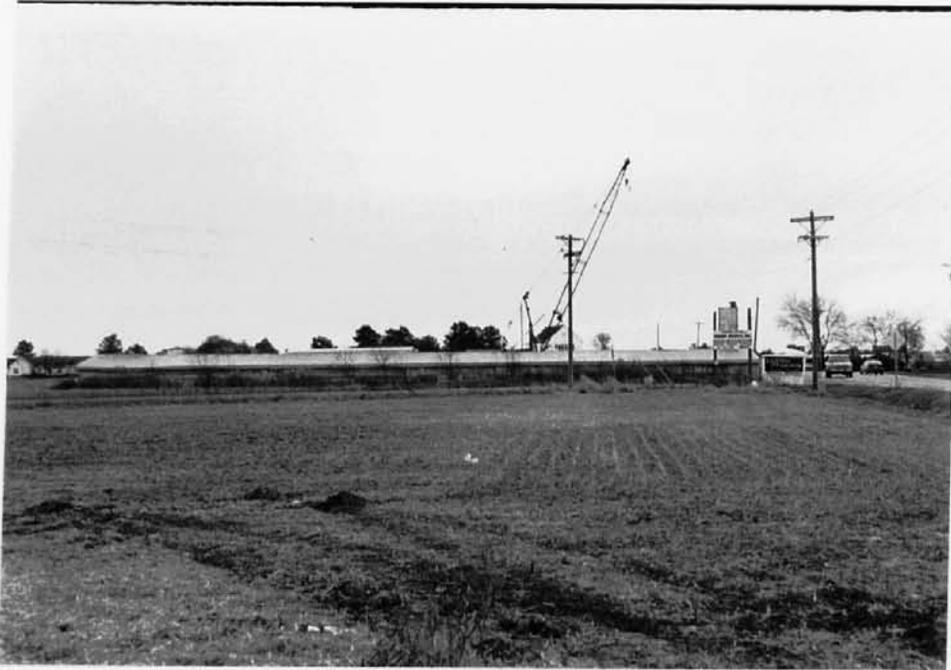
chicken house has not been in use in many years, and is so deteriorated in places that the metal structural supports are failing. Based on physical evidence and photographic aerial mapping from 1962, several additional chicken houses were once located east of this extant broiler house; these structures were either burned or deteriorated.

Photo 9: Abandoned mid-twentieth century chicken houses, looking southeast near Bayville Road (tax parcel 5-33-20-02).

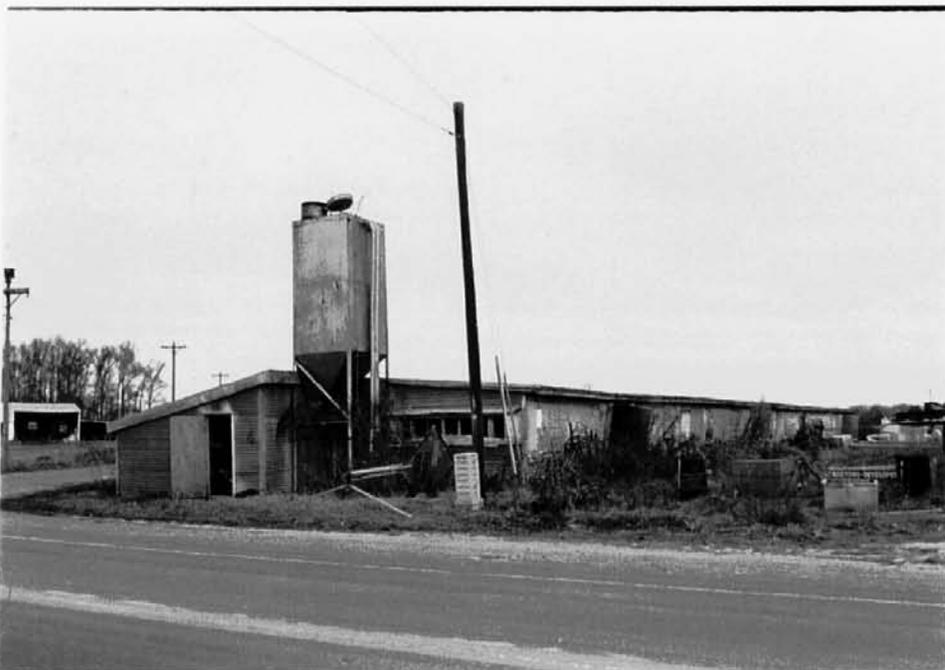
Photo 10: Abandoned mid-twentieth century chicken houses, looking northwest across Route 54 (tax parcel 5-33-20-02).

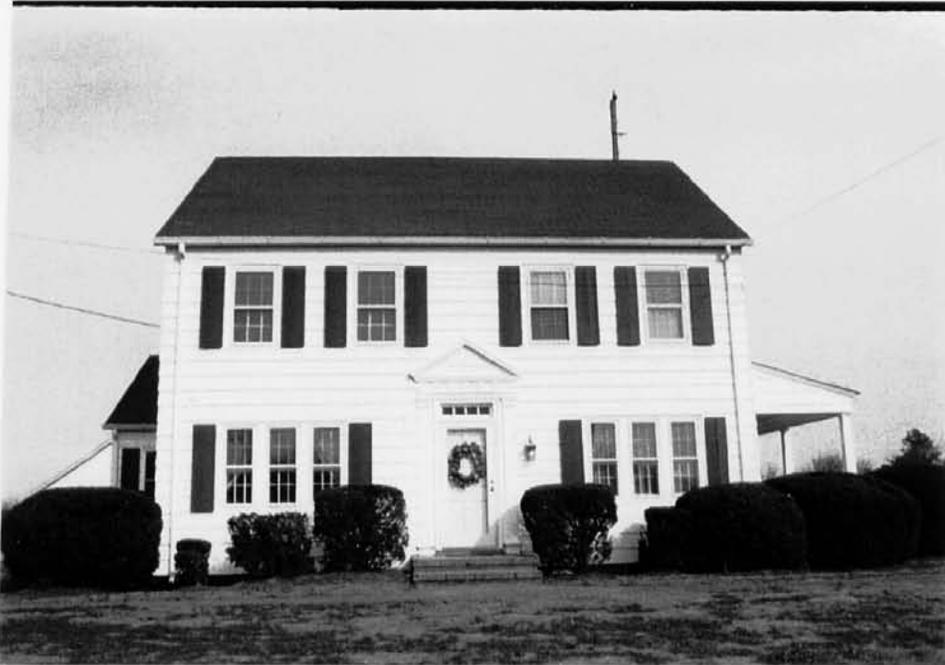
Photo 11: Elevation view, looking north at front (south) façade (tax parcel 5-33-20-03).

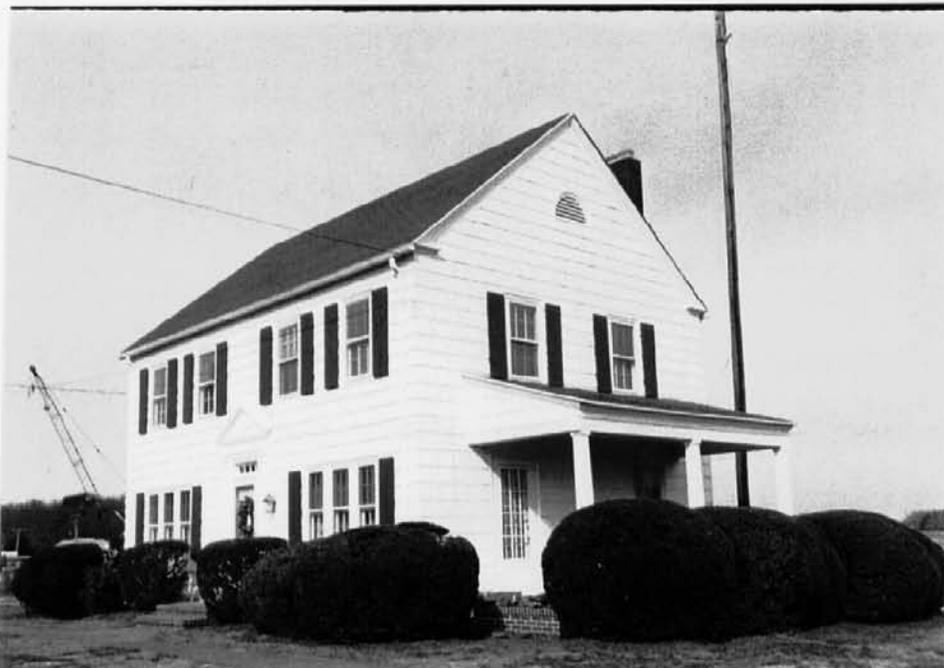
Photo 12: Lateral view of front (south) and side (east) facades, looking northwest from driveway (tax parcel 5-33-20-03).

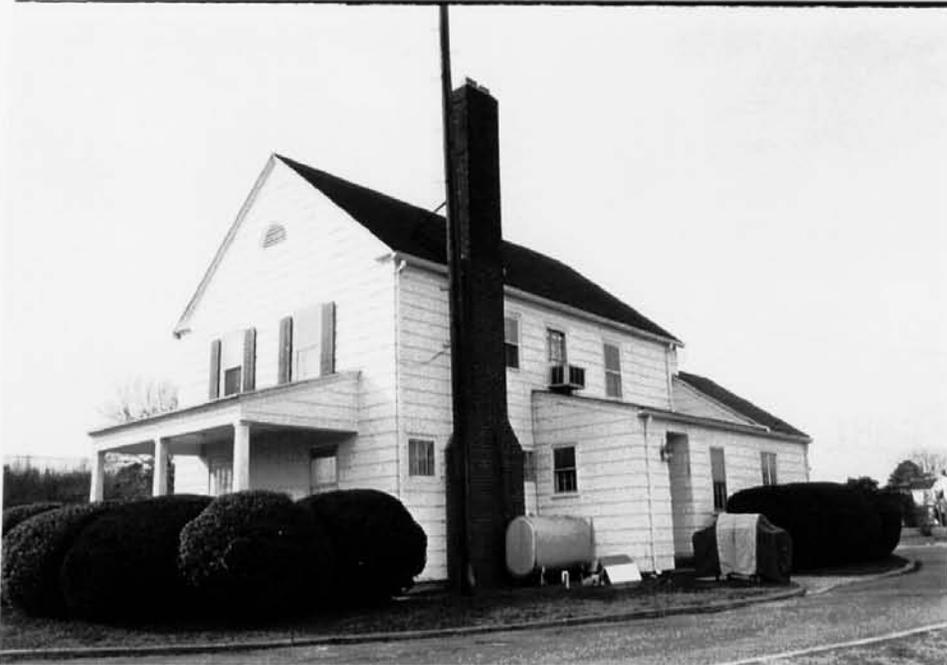
Photo 13: Lateral view of side (east) and rear (north) facades, taken north of driveway (tax parcel 5-33-20-03).
