APPENDIX B: National Register Forms

**National Register of Historic Places
Registration Form**

historic name Gray, George Edward, House

Gray, George Edward, House Sussex County, Delaware

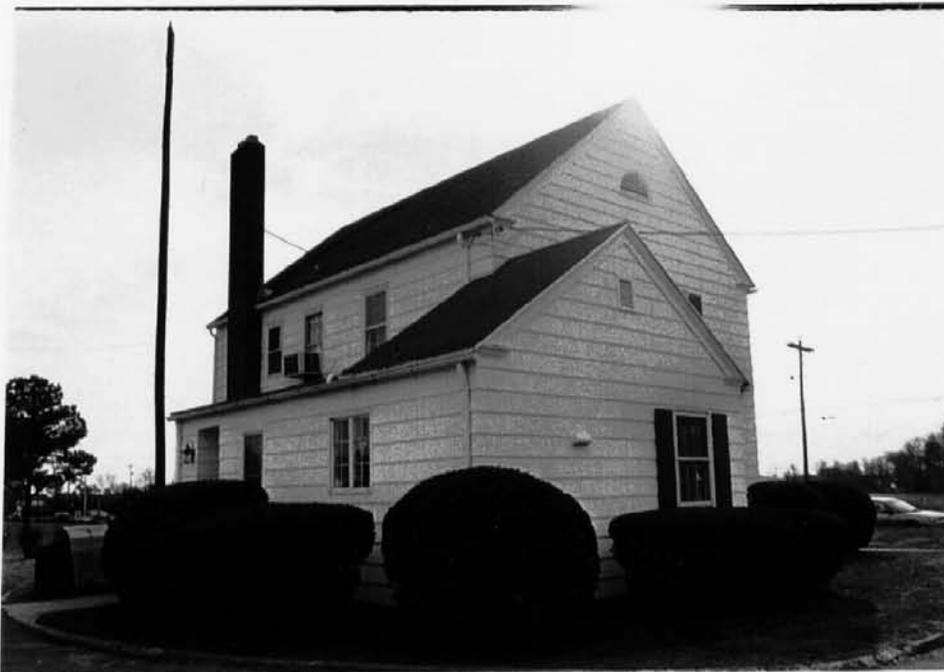
Photo 14: Lateral view of rear (north) and side (west) facades, looking southeast from driveway (tax parcel 5-33-20-03).

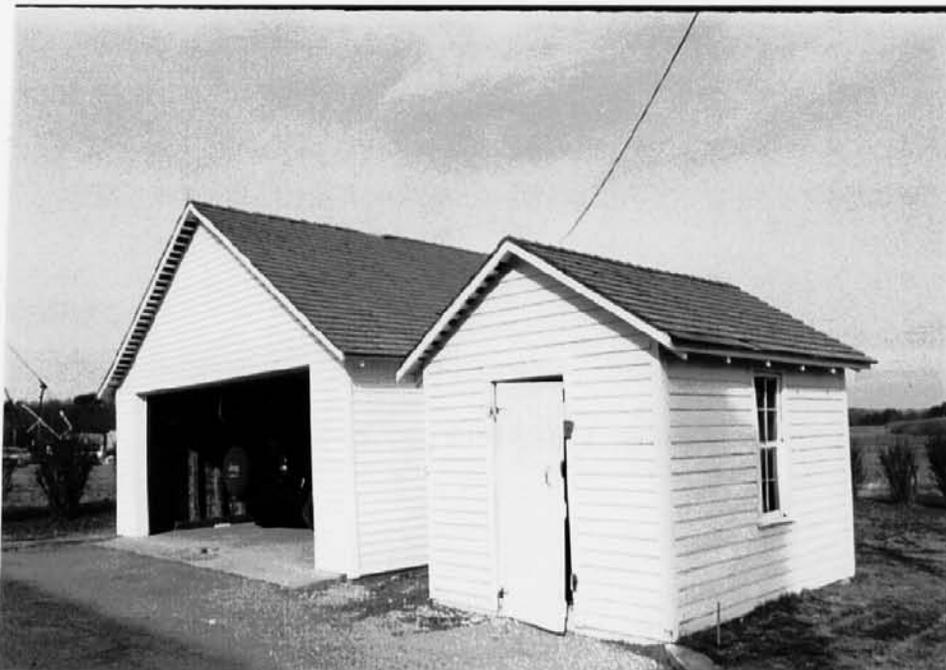
Photo 16: Lateral view of garage and shed, located northwest of the dwelling. Looking northwest from driveway (tax parcel 5-33-20-03).

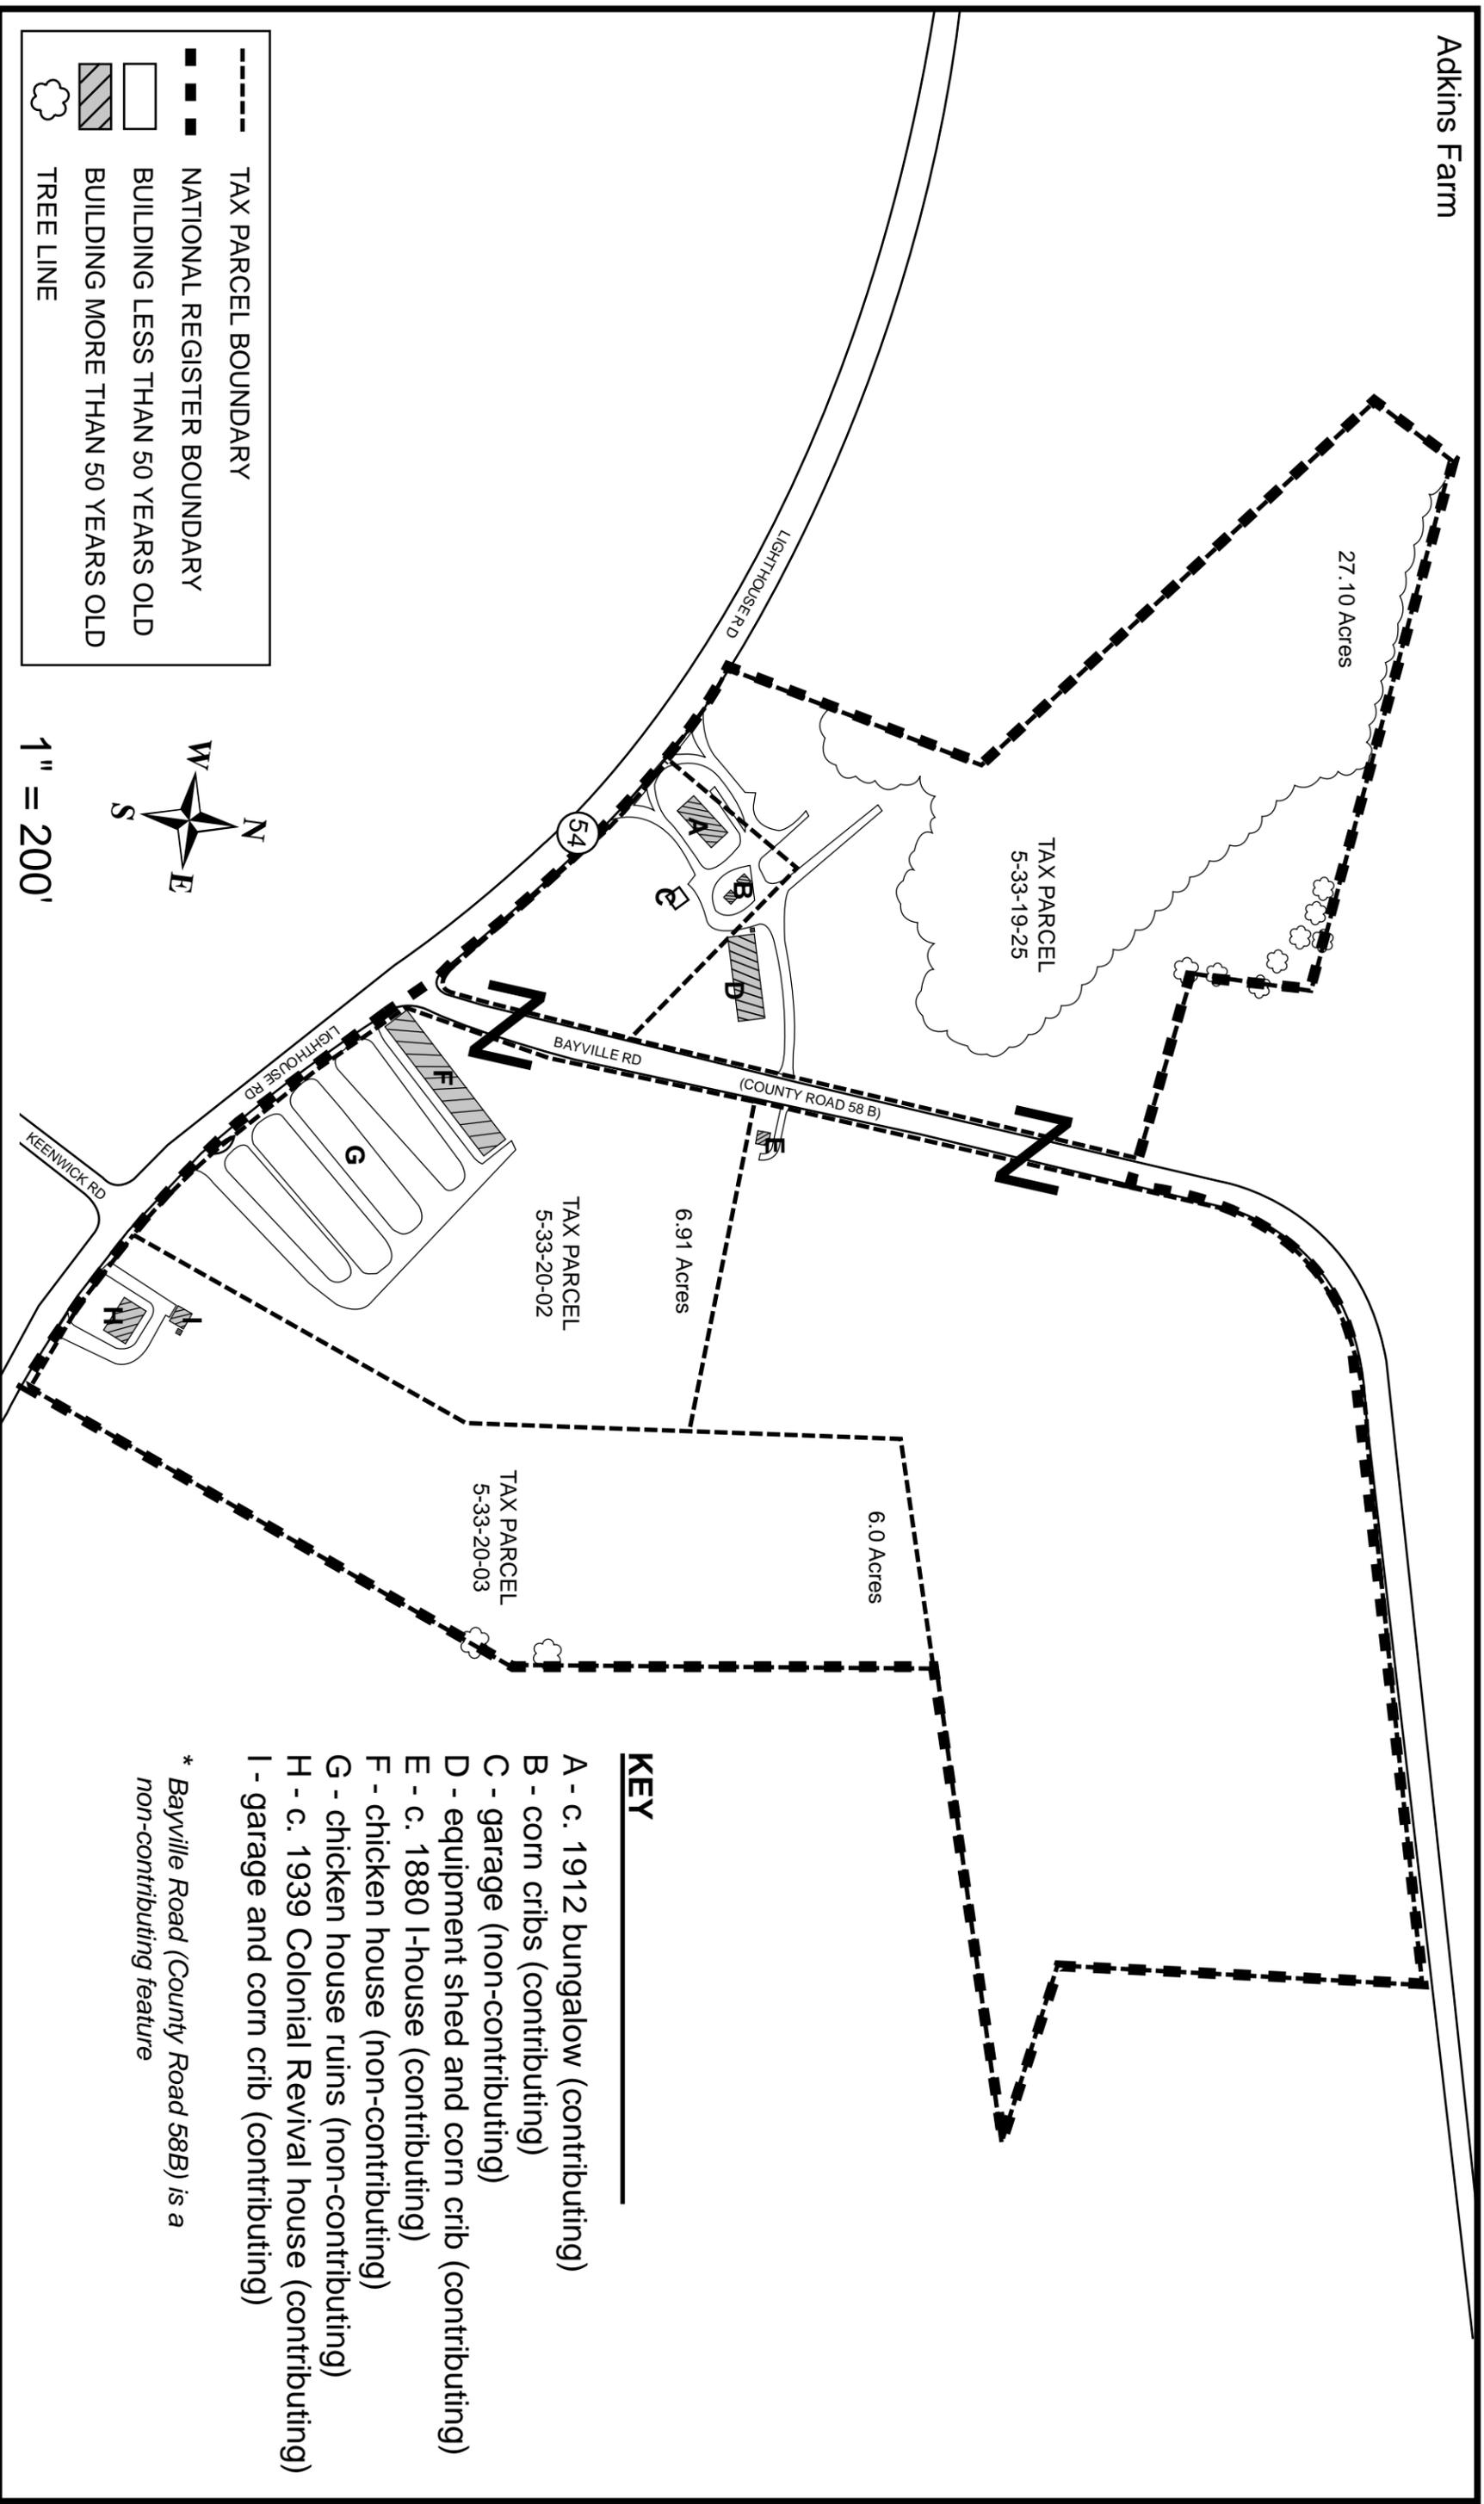
- A - c. 1912 bungalow (contributing)
- B - corn cribs (contributing)
- C - garage (non-contributing)
- D - equipment shed and corn crib (contributing)
- E - c. 1880 I-house (contributing)
- F - chicken house (non-contributing)
- G - chicken house ruins (non-contributing)
- H - c. 1939 Colonial Revival house (contributing)
- I - garage and corn crib (contributing)
