## 4.0 RESULTS

### 4.1 Geomorphology and Lithic Resources

DELAWARE DEPARTMENT OF TRANSPORTATION	
U.S.13/U.S.13A/ROAD 46 INTERSECTION IMPROVEMENTS SEAFORD HUNDRED SUSSEX COUNTY	
SOIL PROFILES AUGER BORINGS 1 AND 2	
FIGURE - 7	<b>SKELLY AND LOY, INC.</b> CONSULTANTS IN ENVIRONMENT - ENERGY ENGINEERING - PLANNING

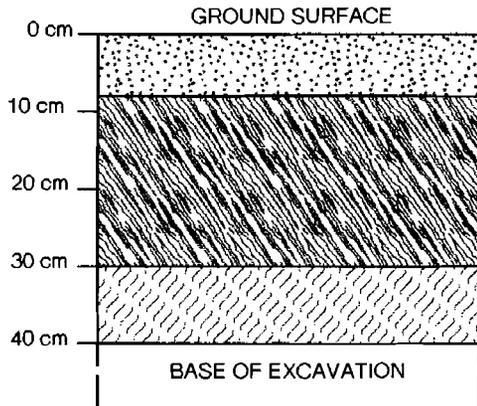
## SOIL PROFILE AUGER BORING 1

A 10YR 4/2 Dark grayish brown sandy loam.

E 10YR 5/3 Brown loamy sand.

Bw 7.5YR 5/3 Brown sandy loam.

Three stratigraphic profiles of excavations within the proposed Connector Road Test Area are described in detail as follows. Auger Borings 1 and 2 are comprised of a moderately well developed soil profile which is very high in sand content (Figure 7). The surface horizon (A) in Auger Boring 1 is shallow, being only 8.0 cm (3.2 in) thick and underlain by a deep and highly weathered E horizon. Underlying the E horizon is a dense and brittle Pleistocene subsoil (Bw)

which could not be deeply penetrated by the soil auger due to its compactness. The surface A horizon in Auger Boring 2 is thicker (25.0 cm, or 9.8 in) than that in Auger Boring 1 and is underlain by a thin remnant of the E horizon. The A horizon in Auger Boring 2 has been plowed, incorporating the majority of the underlying E horizon into a mixed plow layer. The dense and compacted Pleistocene subsoil (Bw) is also encountered below the E horizon in Auger Boring 2. Auger Boring 3 is a mixed fill layer overlying the compacted and dense Pleistocene subsoil (Bw) (Figure 8). No remnants of the intact original surface (A or E horizons) is encountered within this profile. This area was excavated in the past, possibly during the construction of the trucking facility which is located to the east, and fill was redistributed over the graded surface. Localized areas of natural soils, plowed soils, or disturbed soils occur across the proposed connector road test area without obvious differences in surface conditions.

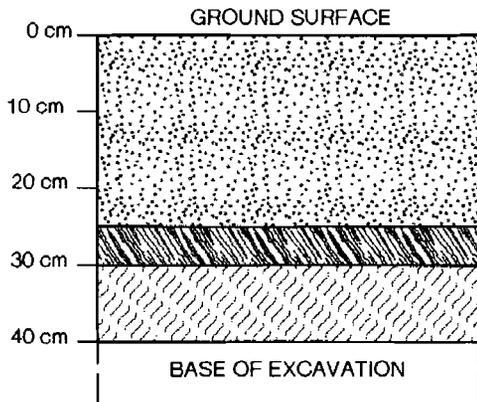
## SOIL PROFILE AUGER BORING 2

Ap 10YR 5/2 Grayish brown sandy loam.

E 10YR 6/3 Pale brown loamy sand.

Bw 7.5YR 5/3 Brown sandy loam.

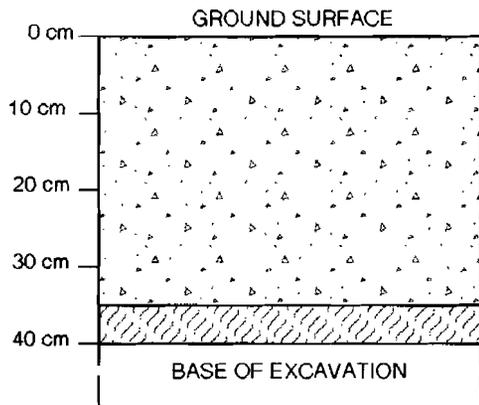
# SOIL PROFILE AUGER BORING 3

**MIXED FILL** 10YR 5/3 Brown and 10YR 6/3 Pale brown loamy sand, mixed with fine gravels.

**Bw** 7.5YR 5/3 Brown sandy loam.

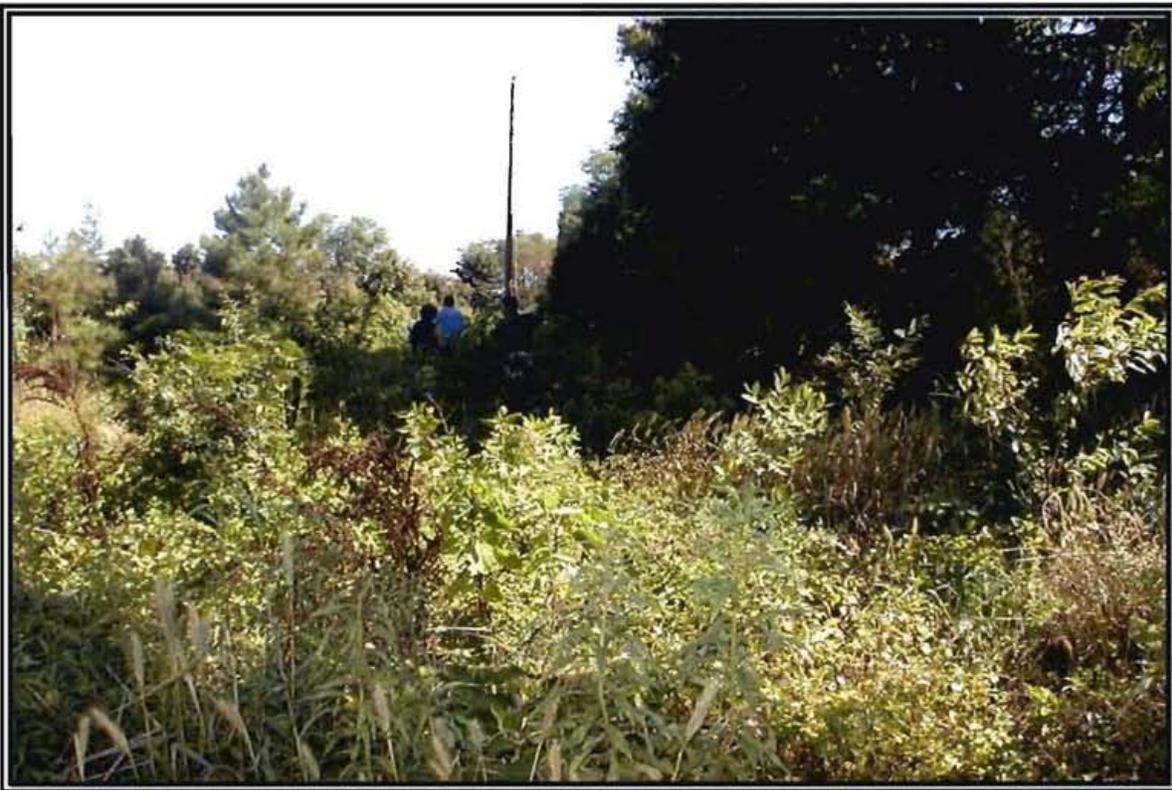
*Photograph 2. General view of middle portion of Connector Road Test Area, facing north.*

contain archaeological remains. This Connector Road Test Area measures approximately 19.1 m (62.5 ft) wide and 251.5 m (825.0 ft) long and is located west of and parallel to current U.S. 13A between Dolby Road and Road 46. Currently, the test area is wooded with heavy undergrowth, including opportunistic species (Photographs 1, 2, and 3). Ground surface visibility was poor (<1%) due to the heavy vegetation. Thirteen STPs were excavated at 15.0 m (49.2 ft) intervals along a single transect within the test area.

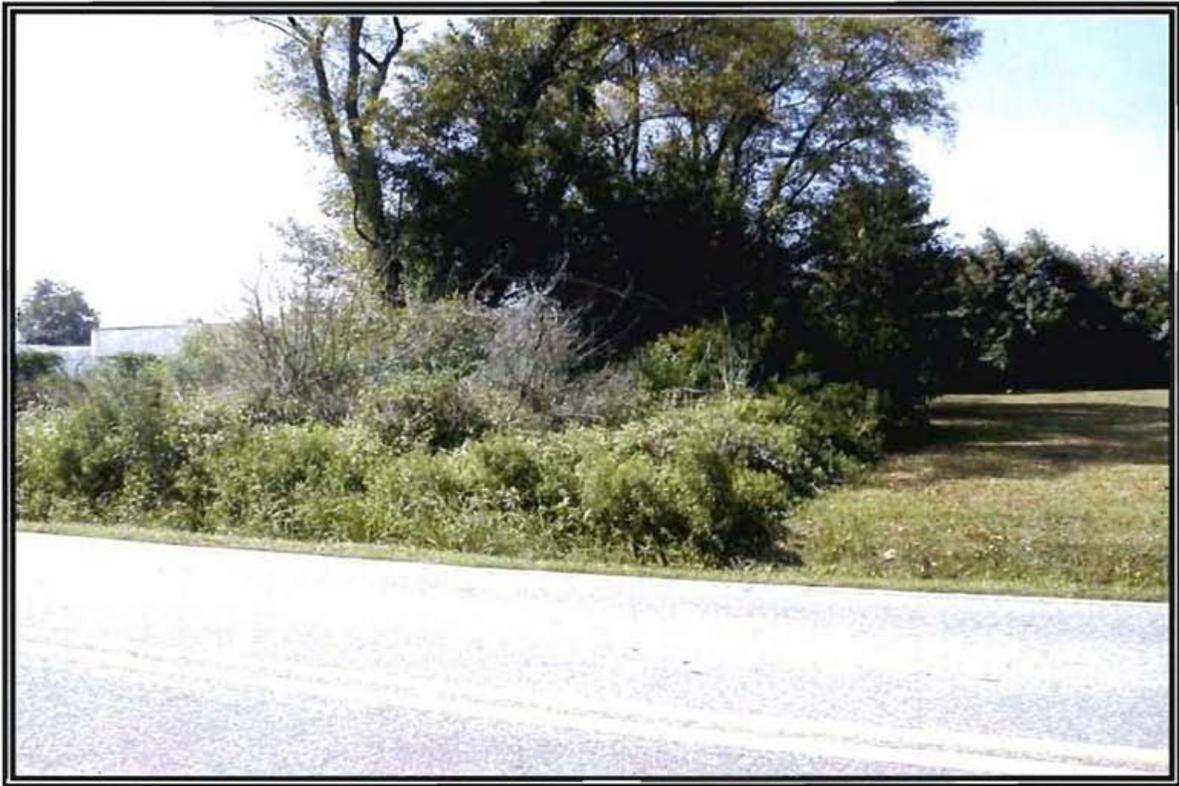
*Photograph 3. General view of north end of Connector Road Test Area, facing south.*

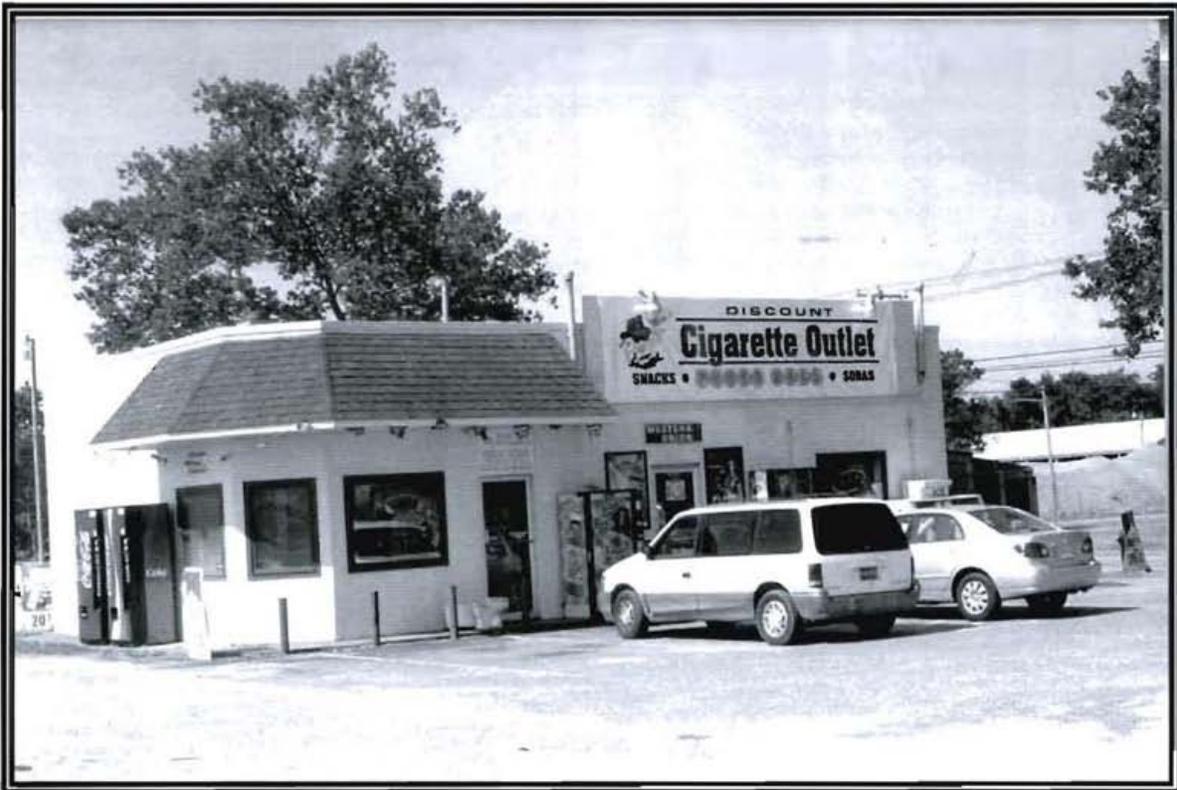
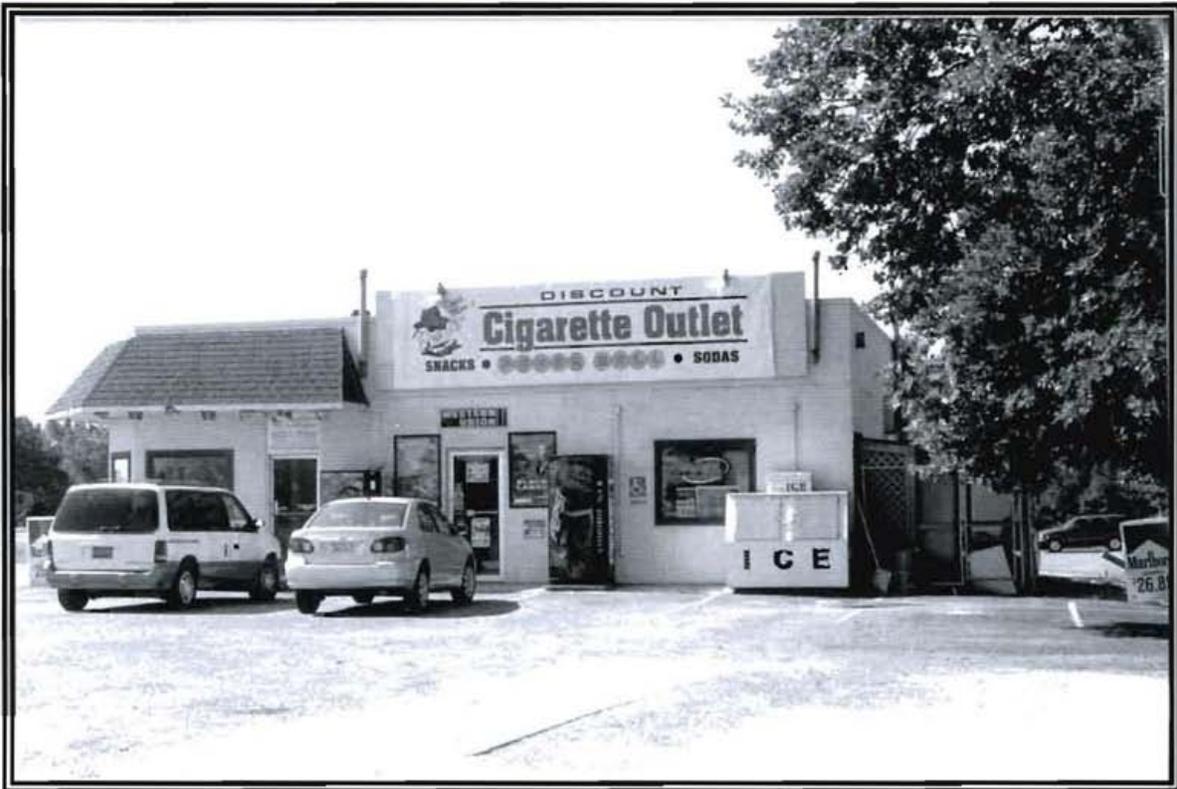
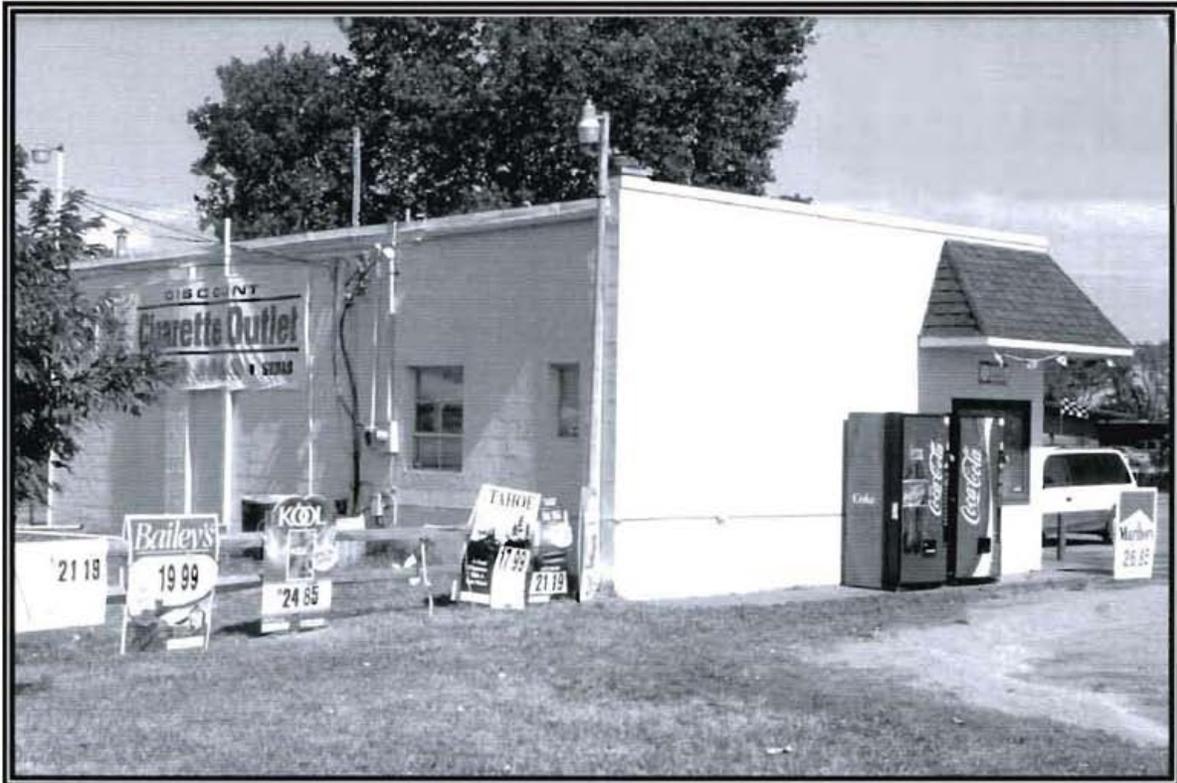
*Photograph 4. Service Station (S-10139), west side of U.S. Route 13, facade and east side, facing southwest.*

*Photograph 5. Service Station (S-10139), west side of U.S. Route 13, facade and west side, facing southeast.*

*Photograph 6. Service Station (S-10139), west side of U.S. Route 13, east side and rear, facing northwest.*

S-10139, a former Service Station (Photographs 4, 5, and 6) located on the west side of U.S. 13, between that highway and U.S. 13A, dates to ca. 1955. The construction date is based on historic as-built plans and maps. As-built plans for the widening of U.S. 13A in 1946 and the construction of U.S. 13 from 1952 do not show the building (Delaware State Highway Department 1946, 1952). A building at the location of the service station does, however, appear on the 1955 Seaford, Delaware quadrangle map (USGS 1955). The facade of the building is also oriented toward U.S. 13, further indication that its construction date coincides with or post-dates U.S. 13 construction.

S-10139, the Service Station on the West Side of U.S. Route 13, does not meet any of the NRHP Criteria for Evaluation. It was built as a result of the 1952 U.S. 13 upgrade. It is not tied to the formative years of highway development in Delaware, nor is it an early example of a service station. When it was built *ca.* 1955, there were hundreds, if not thousands, of similar service stations in Delaware. Therefore, it is not eligible under Criterion A. There is no evidence it was associated with an important person; therefore, it is not eligible under Criterion B. The service station does not embody the distinctive characteristics of a type, period, and method of construction. The concrete block building was constructed in 1955. Its design -- office on one end and service bays on the other -- was used with great frequency since the 1920s, and was ubiquitous by the mid-1950s. Moreover, the building has lost character-defining elements. The garage bays have been converted into retail space, and the exterior apertures have been in-filled with concrete block and glass. The original door has been moved, and a second door has been added to the facade. The design of the office has changed also, with a window where the corner entrance used to be. Additionally, the windows are replacements, and a pent-like roof now shelters the former office. The cumulative changes compromise the integrity of the building. The building also does not

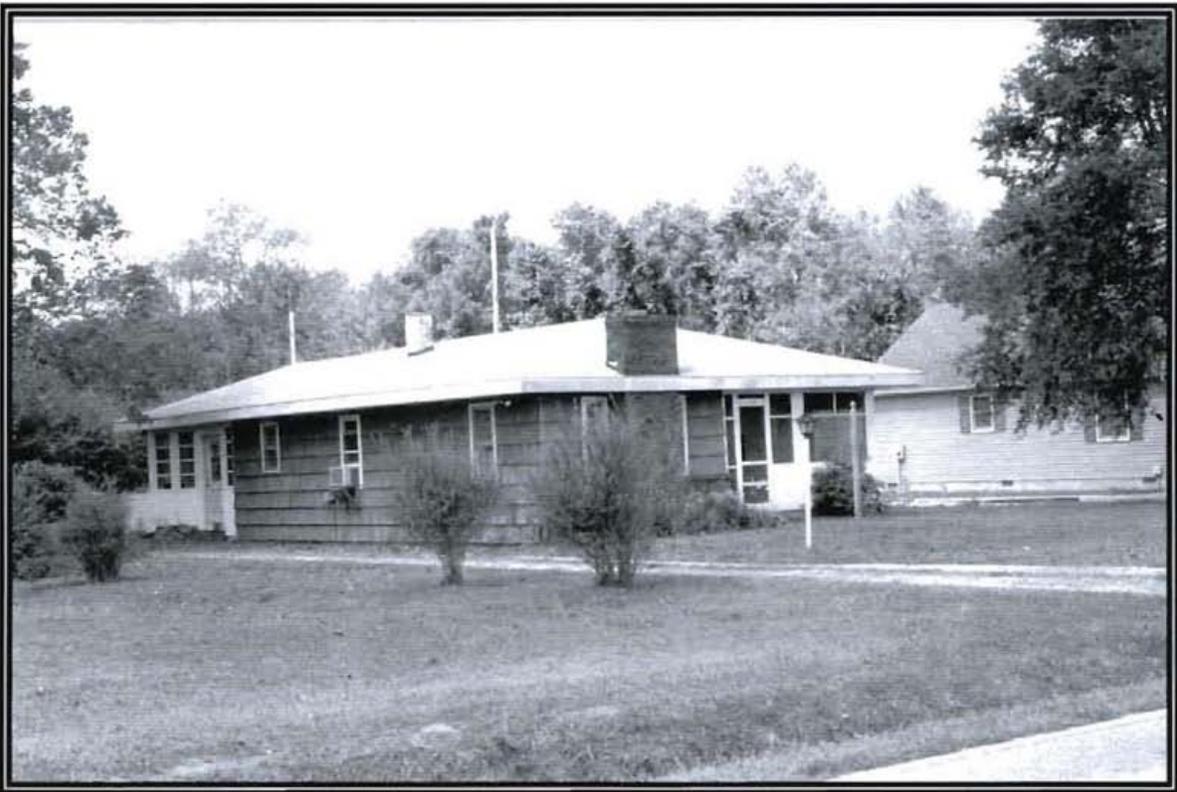
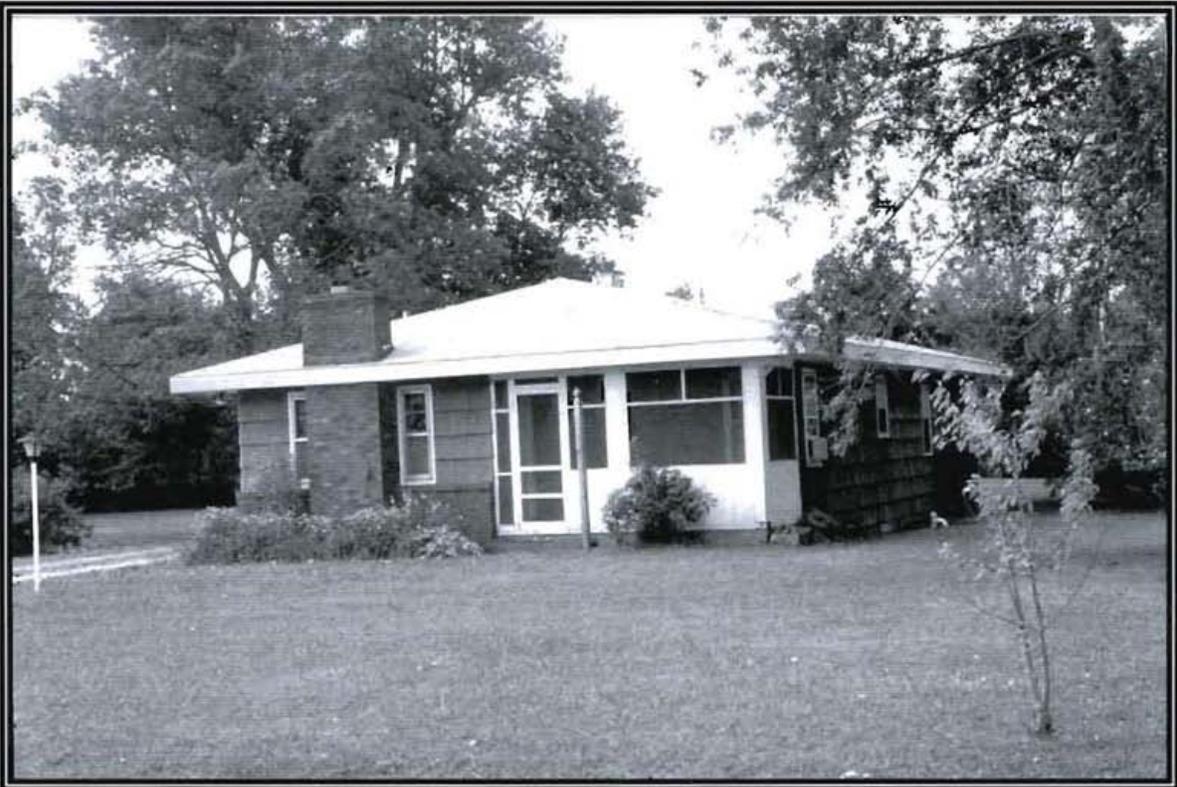
*Photograph 7. Dwelling, 9010 Elks Road (S-10140), facade and east side, facing southwest.*

*Photograph 8. Dwelling, 9010 Elks Road (S-10140), facade and west side, facing southeast.*

S-10140, a dwelling at 9010 Elks Road, is a single-story, three-bay wide frame house (Photographs 7 and 8). It is constructed in a common vernacular style used with great frequency during much of the twentieth century. Based on Sussex County Tax Assessment records, historic maps, and architectural style, the construction date of the house is estimated at *ca.* 1940.

The house is built on a concrete foundation. The walls are finished with shake siding. The hipped roof has wide overhanging eaves, a design characteristic of both the Craftsman and Ranch styles, but the vernacular house cannot be characterized as either. The facade features a wide brick chimney flanked by two narrow, two-over-two windows and a two-bay wide wood and screen porch. A partial width back porch is also located at the rear of the house. Other windows on the house are also two-over-two sash of more conventional dimensions. There is also a frame outbuilding on the property (Photograph 9).

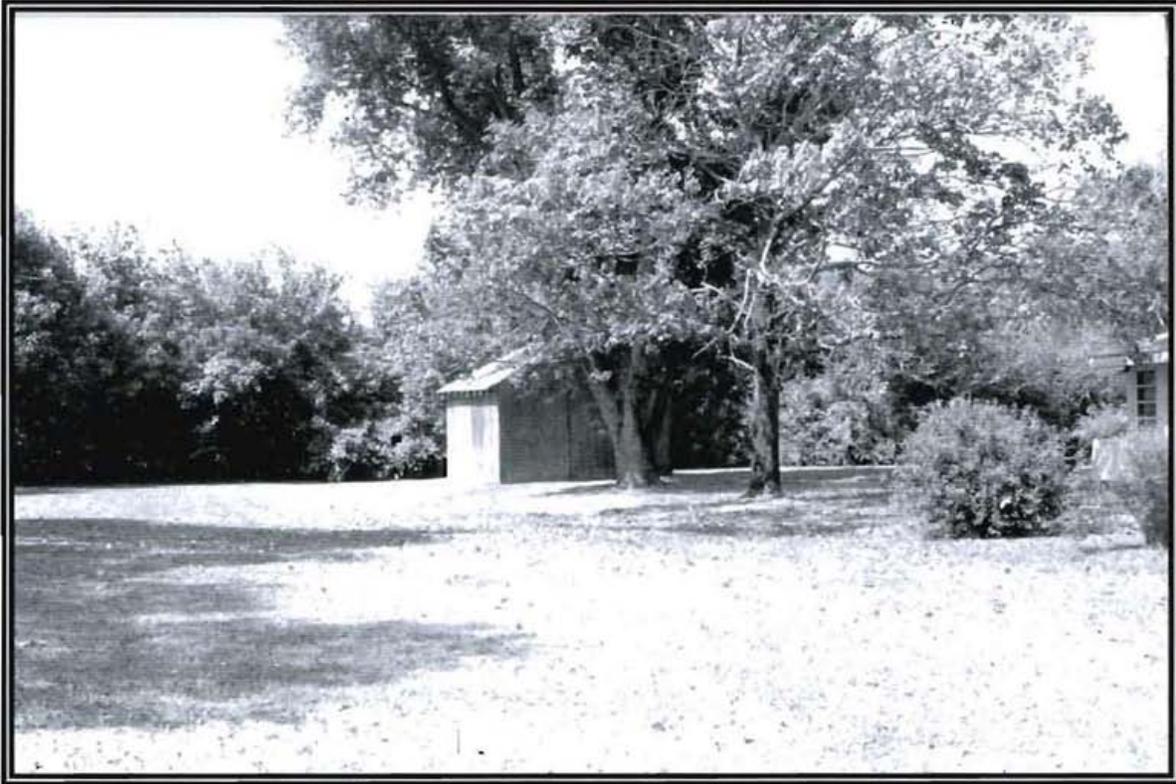
*Photograph 9. Outbuilding on the property of Dwelling, 9010 Elks Road (S-10139), facade and east side, facing southwest.*
