**CRS No. N06190**

**Name: Governor Benjamin T. Biggs Farm;  
S.C. Biggs (Hopkins) House  
Tax Parcel: 1105700219**

CULTURAL RESOURCE SURVEY  
SURVEY UPDATE FORM

**CRS No. N06191**

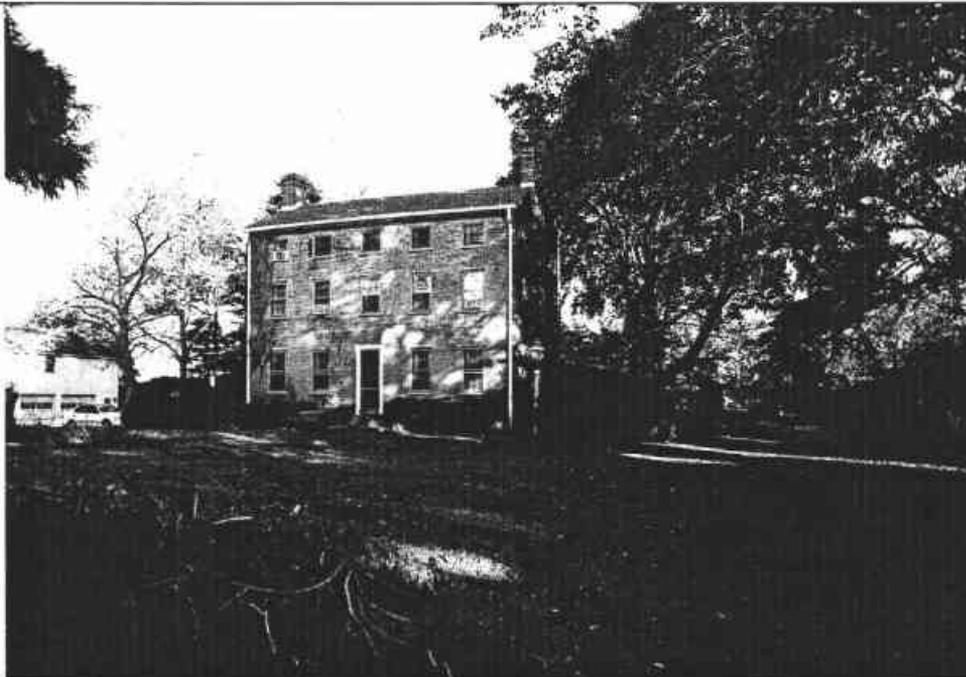
N06190. Photograph 1: Dwelling, east and south elevations, view to northwest.

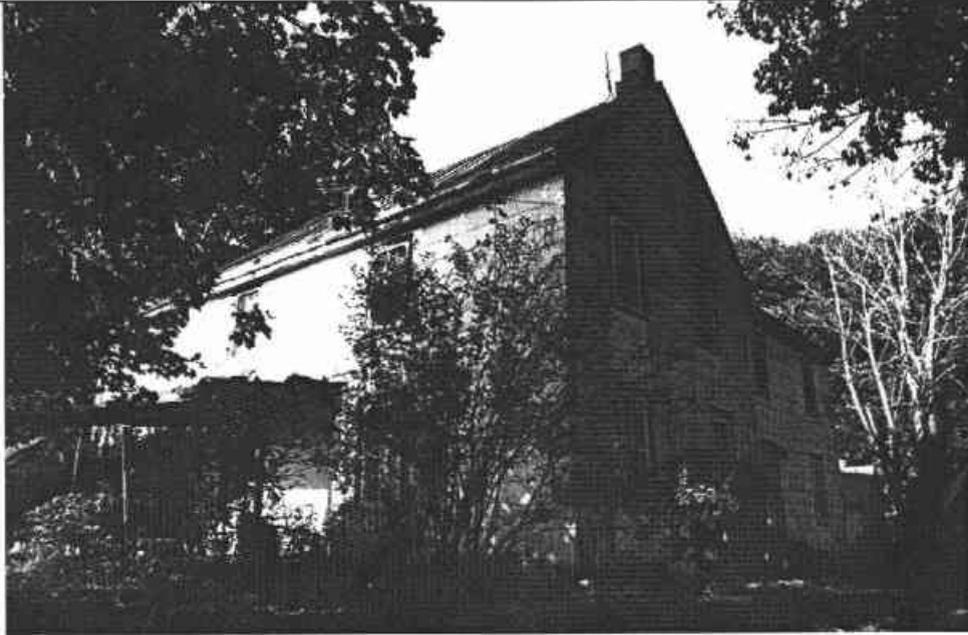
N06191. Photograph 1: Dwelling, north and east elevations, view to southwest. Note deterioration of front porch.

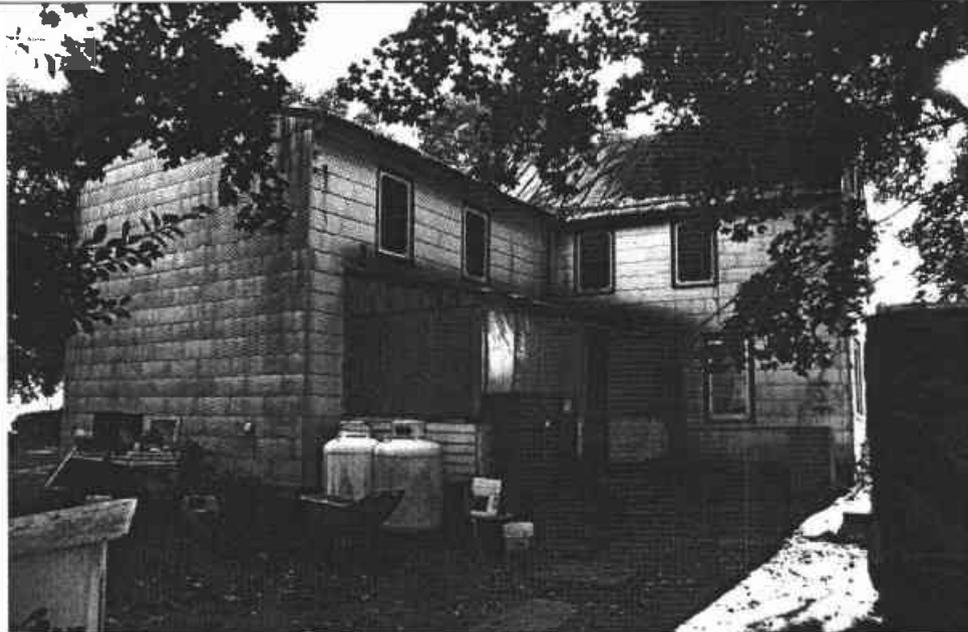
N06191. Photograph 2: Dwelling, west and south elevation, view to northeast. Note asbestos shingles and enclosed side porch.

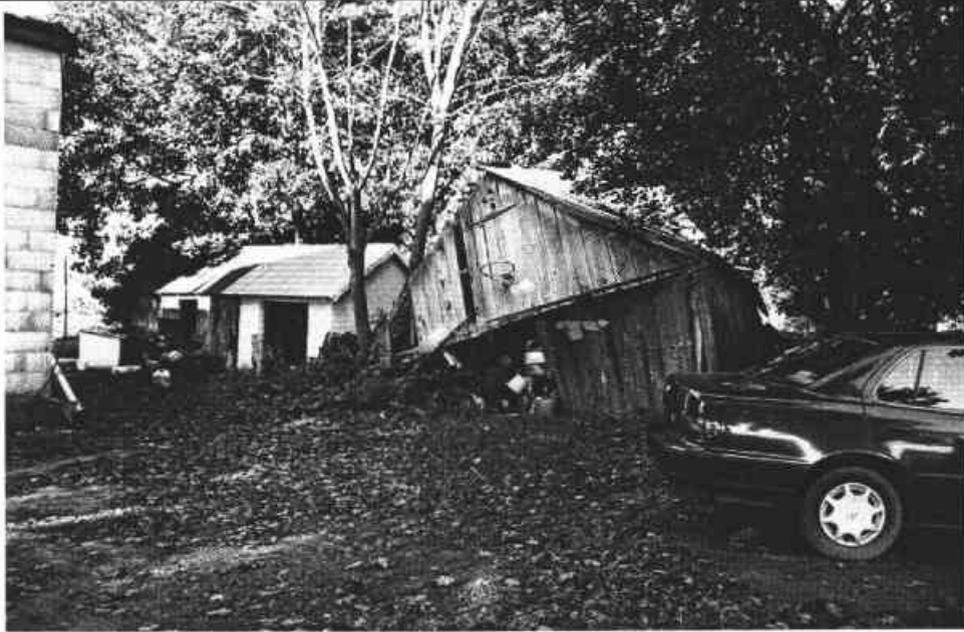
N06191. Photograph 3: Garage, east and north elevations, view to southwest. Note deteriorated condition.

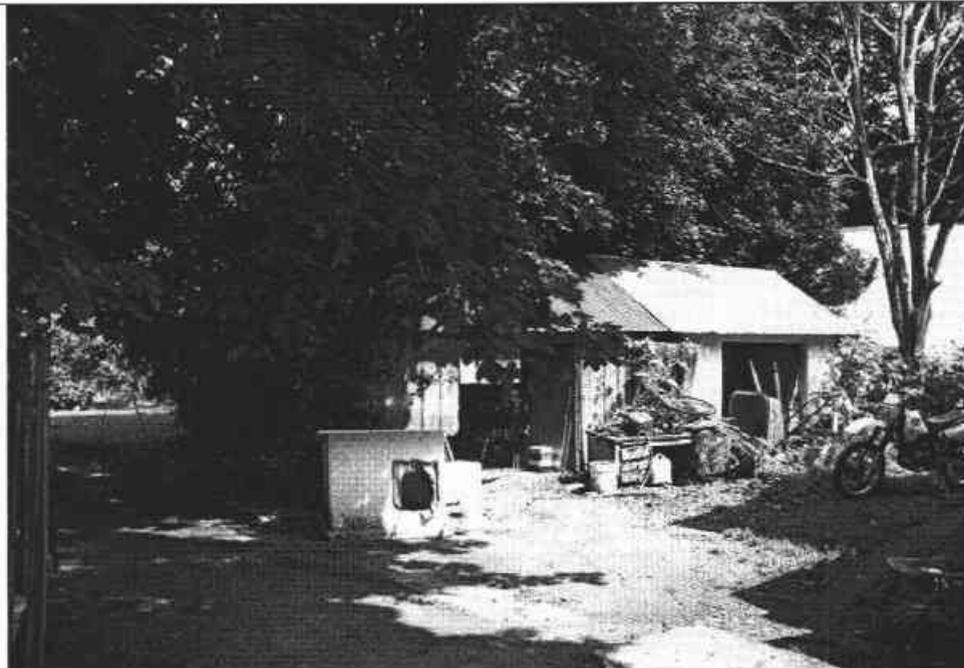
N06191. Photograph 4: Summer kitchen, east elevation, view to northwest. Note the large openings added to the front and the corrugated metal that now covers the roof.

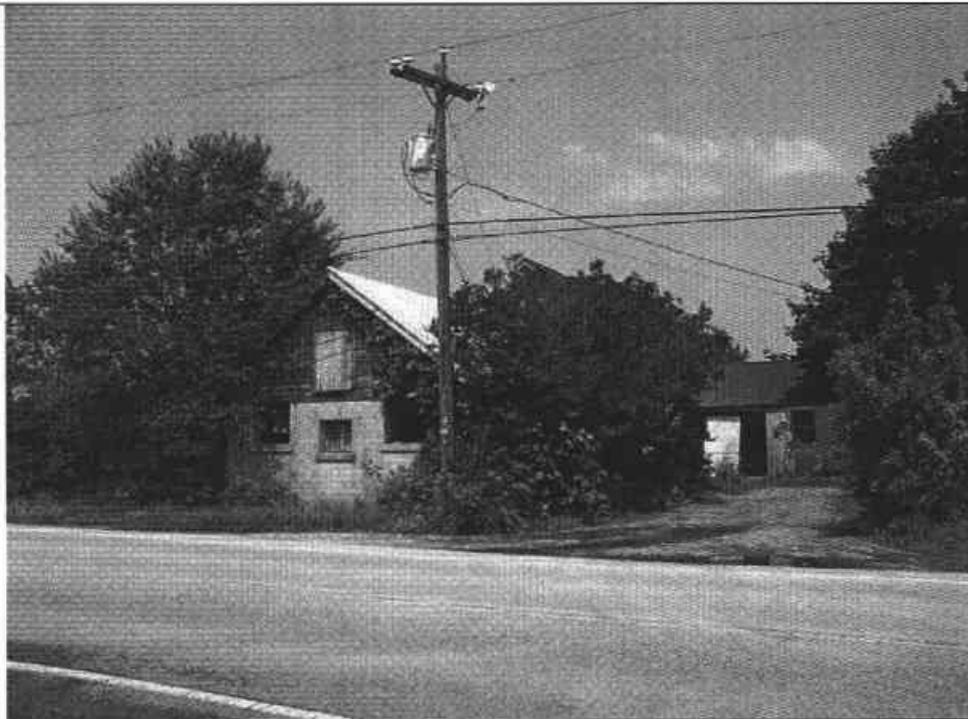
N06191. Photograph 5: Granary/dairy barn and milkhouse, east elevation, view to southwest. Note deteriorated condition and severe vegetation overgrowth.

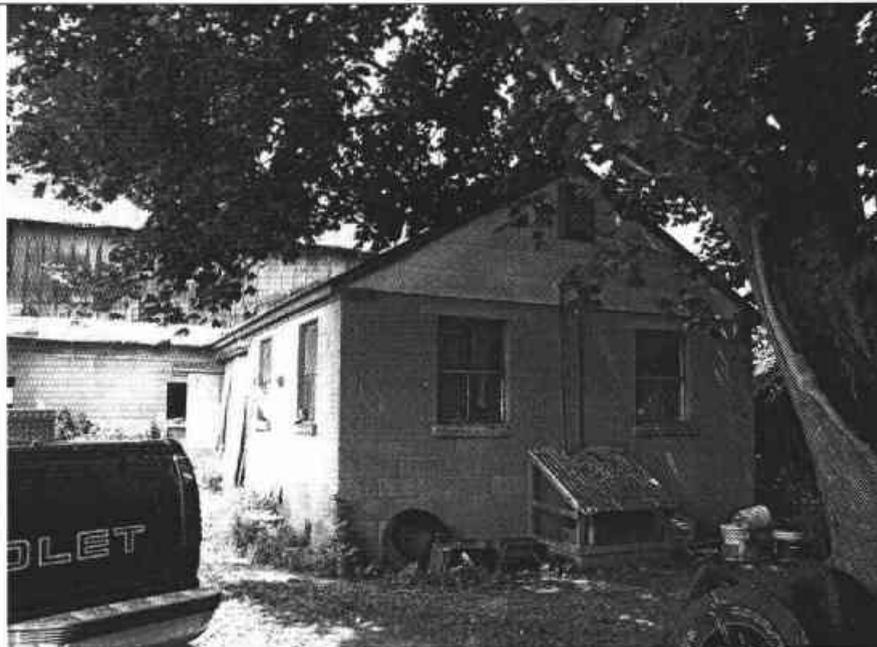
N06191. Photograph 6: Milkhouse, north and east elevations, view to southwest. The milkhouse is attached directly to the north elevation of the granary/dairy barn.

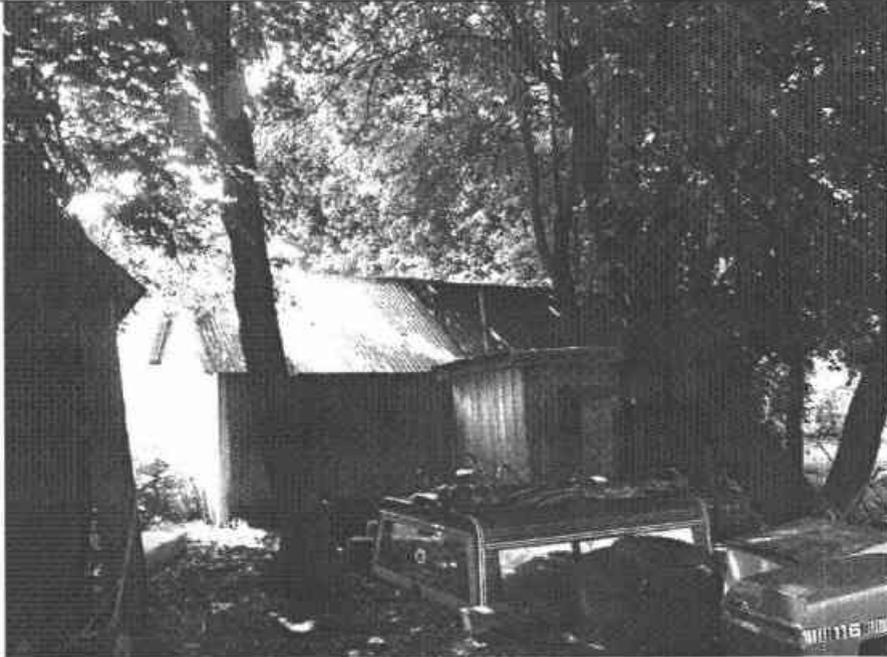
N06191. Photograph 7: Privy #2, west and north elevations, view to southeast. Note west and north elevations of summer kitchen in background and southwest corner of privy #1 in foreground.

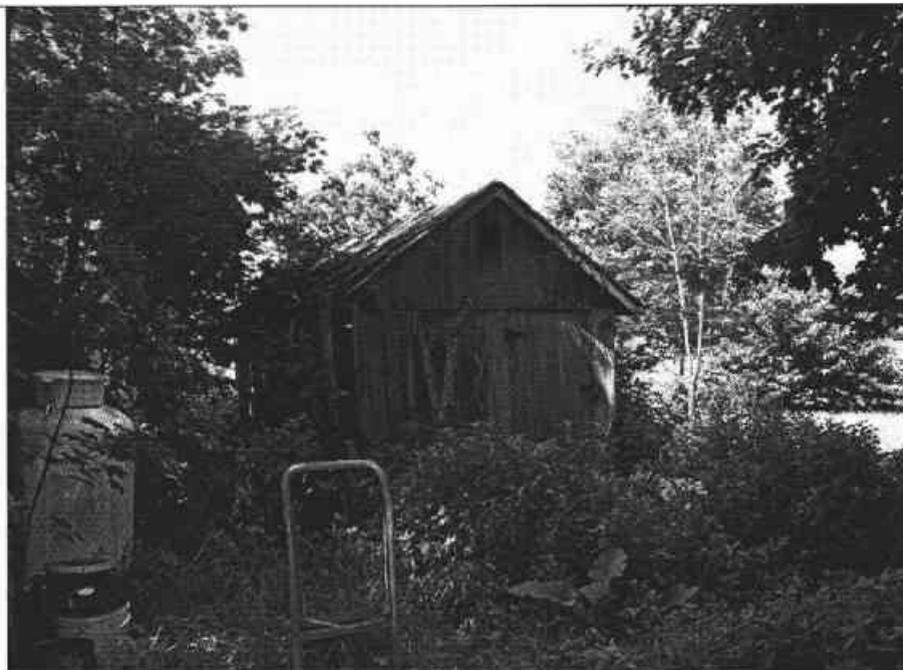
N06191. Photograph 8: Shed, east and south elevations, view to northwest. Note deteriorated condition and vegetation overgrowth.

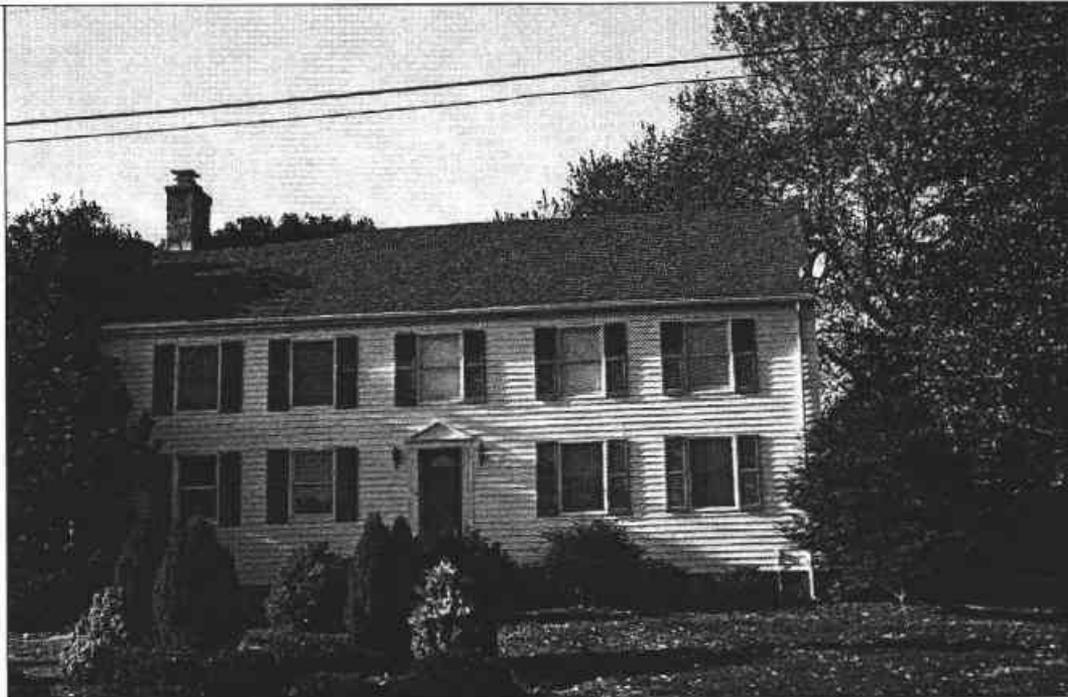
N06320. Photograph 1: Dwelling, south elevation, view to north. Note door surround and landscaped lawn.

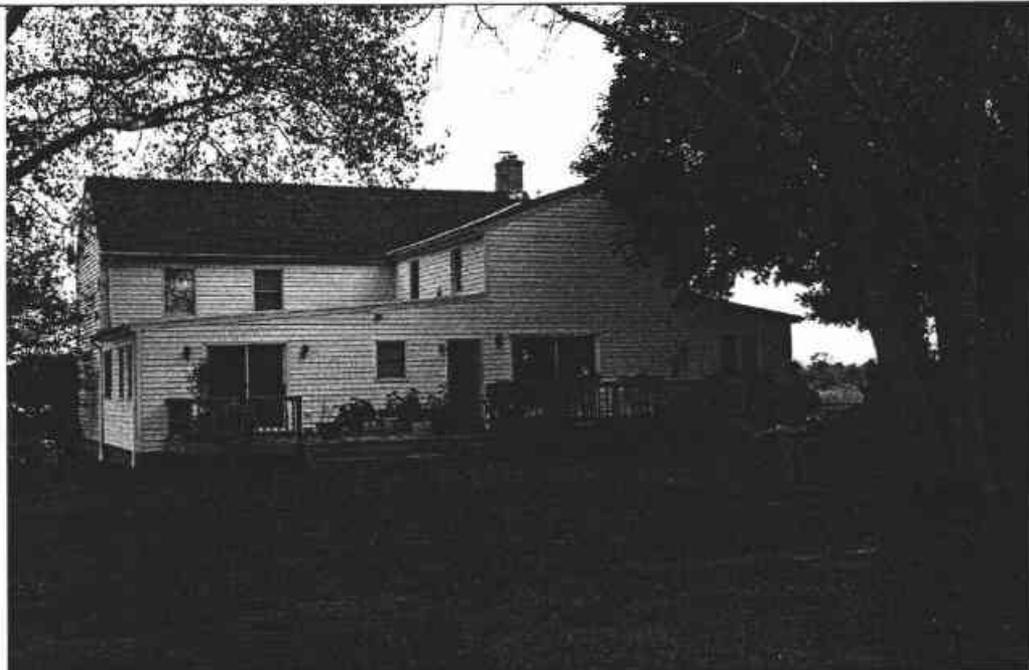
N06320. Photograph 2: Dwelling, north and east elevations, view to south. Note additions to rear ell and the modern deck that extends the length of the northern elevation.

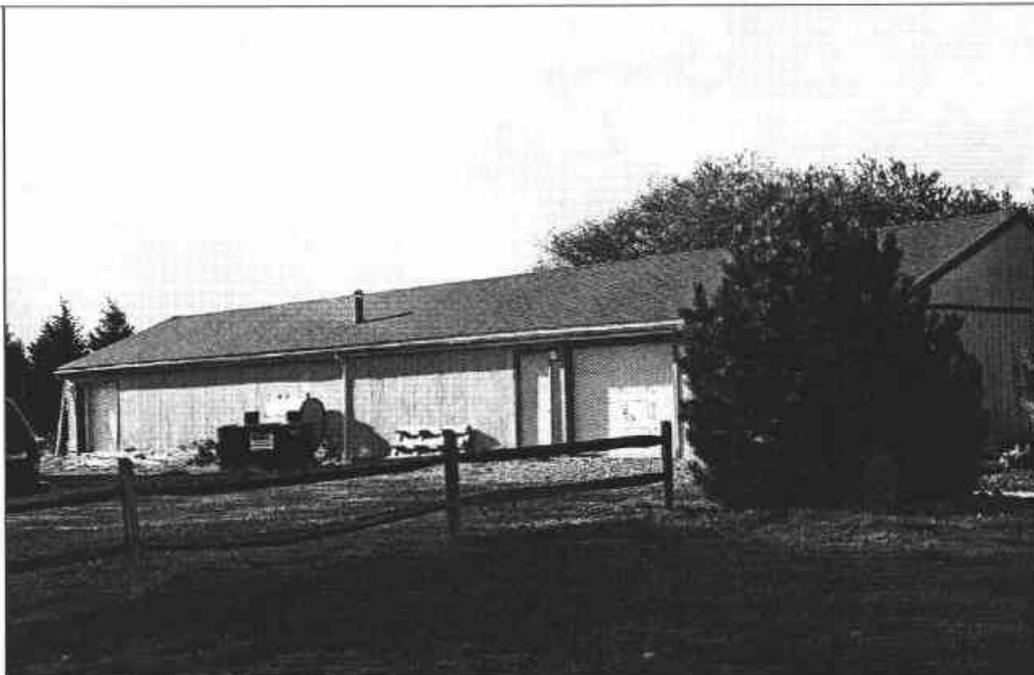
**N06320. Photograph 3: Machine shop, north and west elevations, view to southeast.**

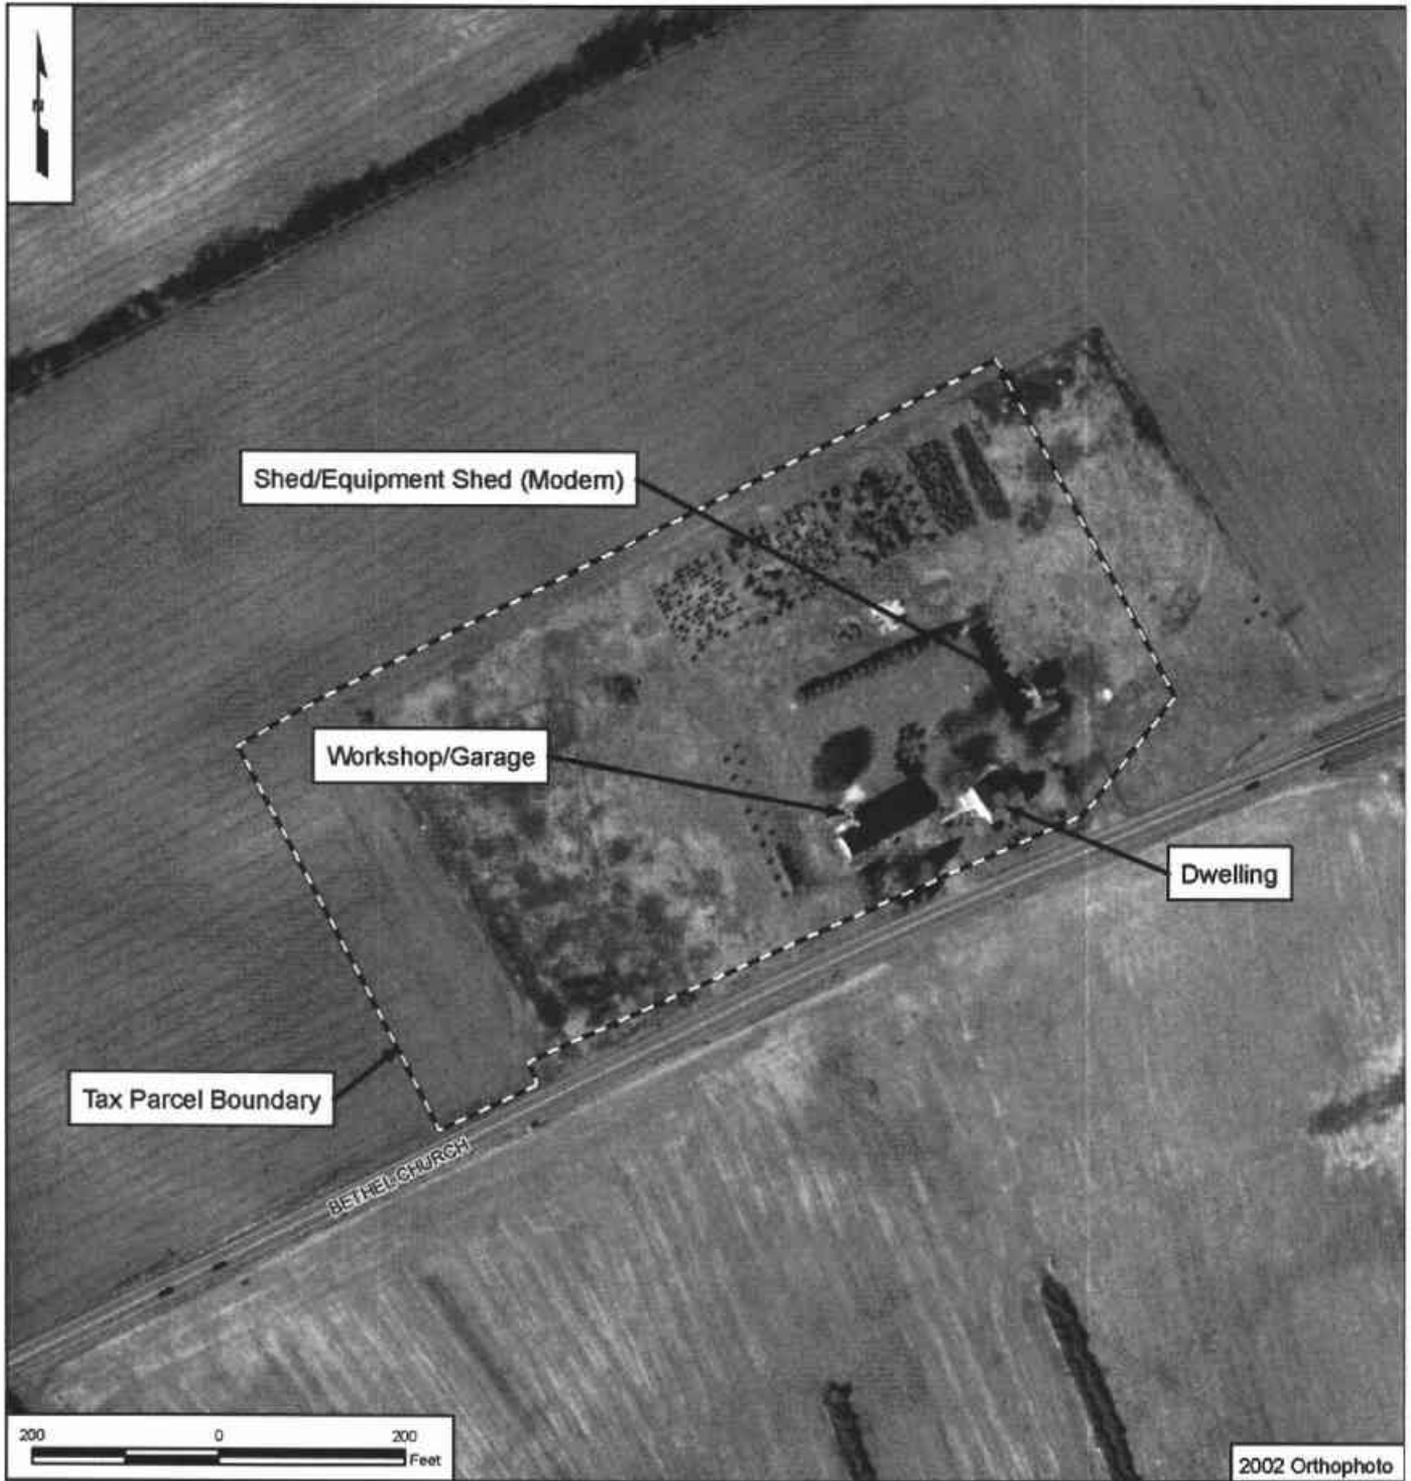
4. SITE PLAN:

1. HISTORIC NAME/FUNCTION: Dwelling Complex, 4531 Summit Bridge Rd
2. ADDRESS/LOCATION: East side of Summit Bridge Rd, 765' South of Boyds Corner Rd
3. CURRENT CONDITION: excellent  good  fair  poor  demolished
4. INTEGRITY: Dwelling and outbuildings demolished in July 2005 as part of intersection improvements at Mt. Pleasant.
5. SETTING INTEGRITY: Located along east side of Summit Bridge Rd (U.S. 301). Cleared lot, only a few trees remain.

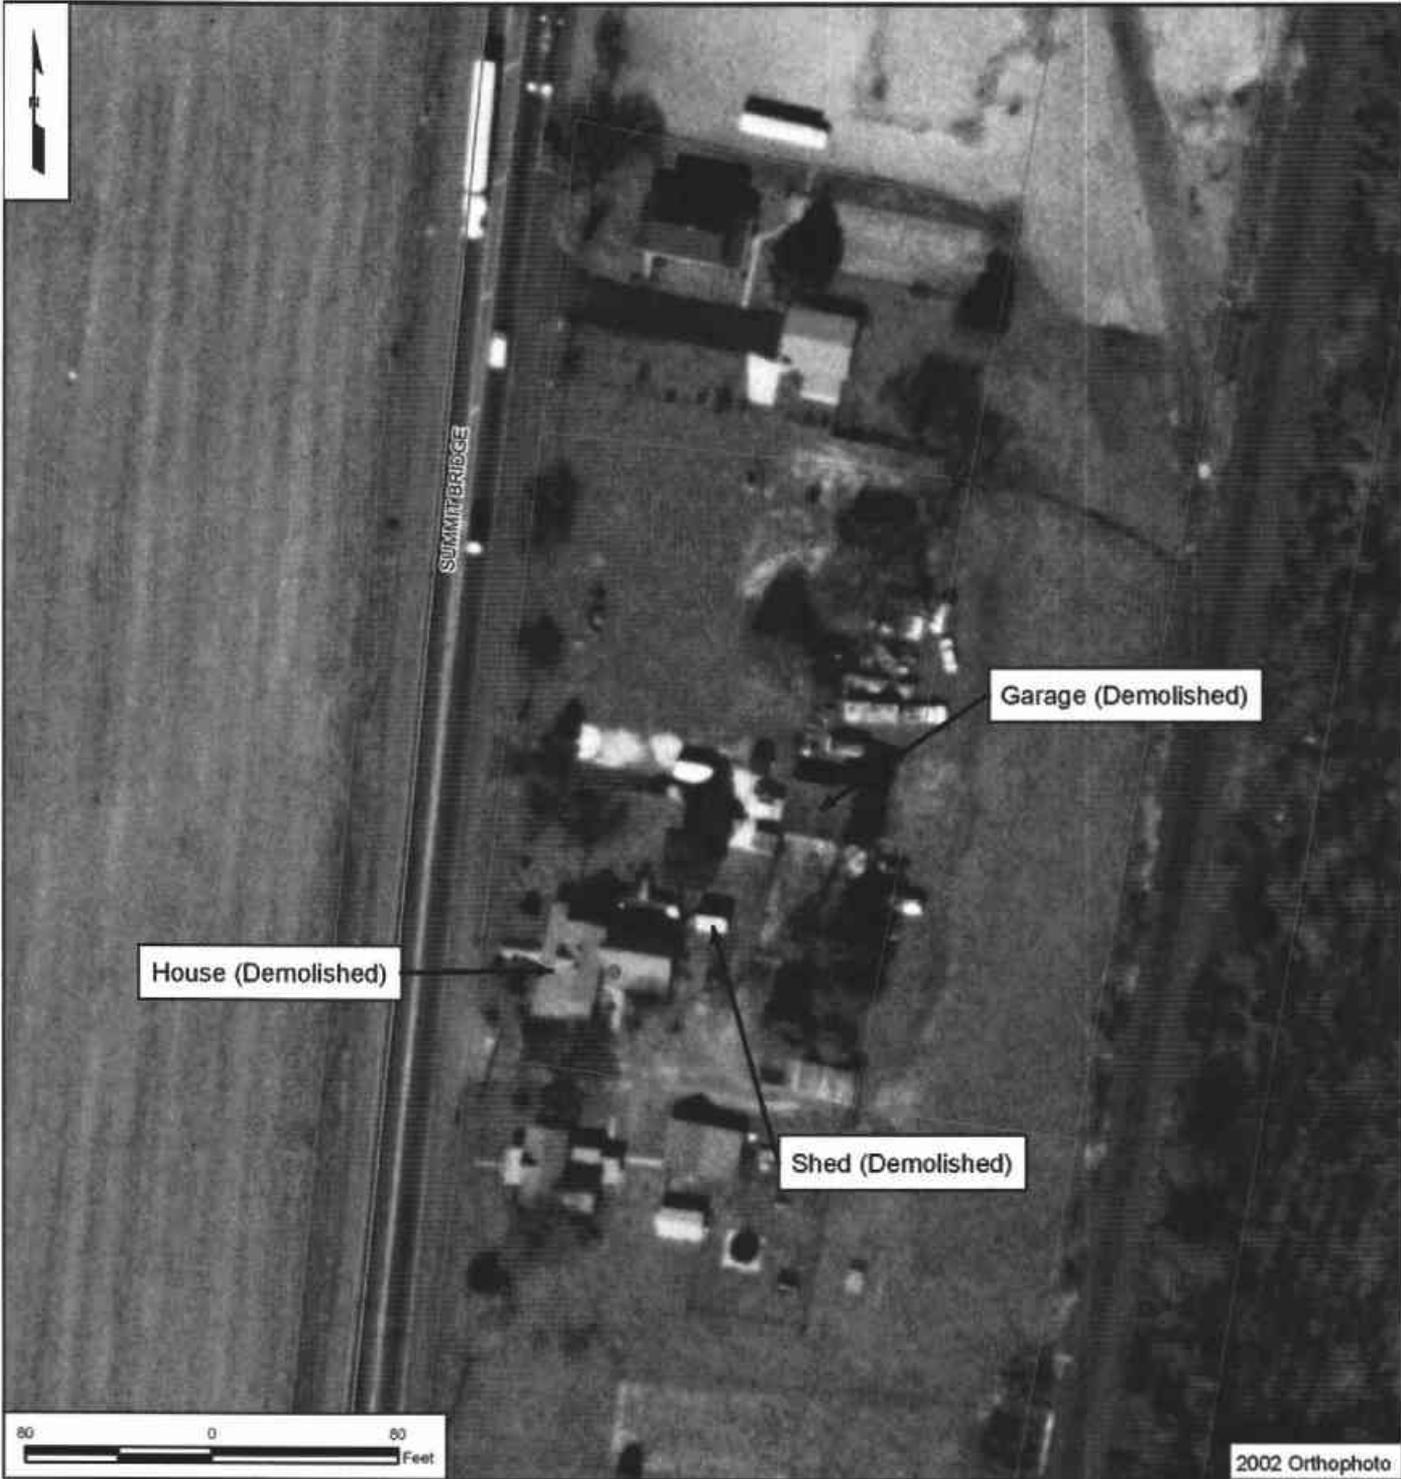
4. SITE PLAN:

1. HISTORIC NAME/FUNCTION: Dwelling, 4535 Summit Bridge Rd
2. ADDRESS/LOCATION: East side of Summit Bridge Rd, 875' South of Boyds Corner Rd
3. CURRENT CONDITION: excellent  good  fair  poor  demolished
4. INTEGRITY: Dwelling and outbuildings demolished in July 2005 as part of intersection improvements at Mt. Pleasant.
5. SETTING INTEGRITY: Located along east side of Summit Bridge Rd (U.S. 301). Cleared lot, only a few trees remain.

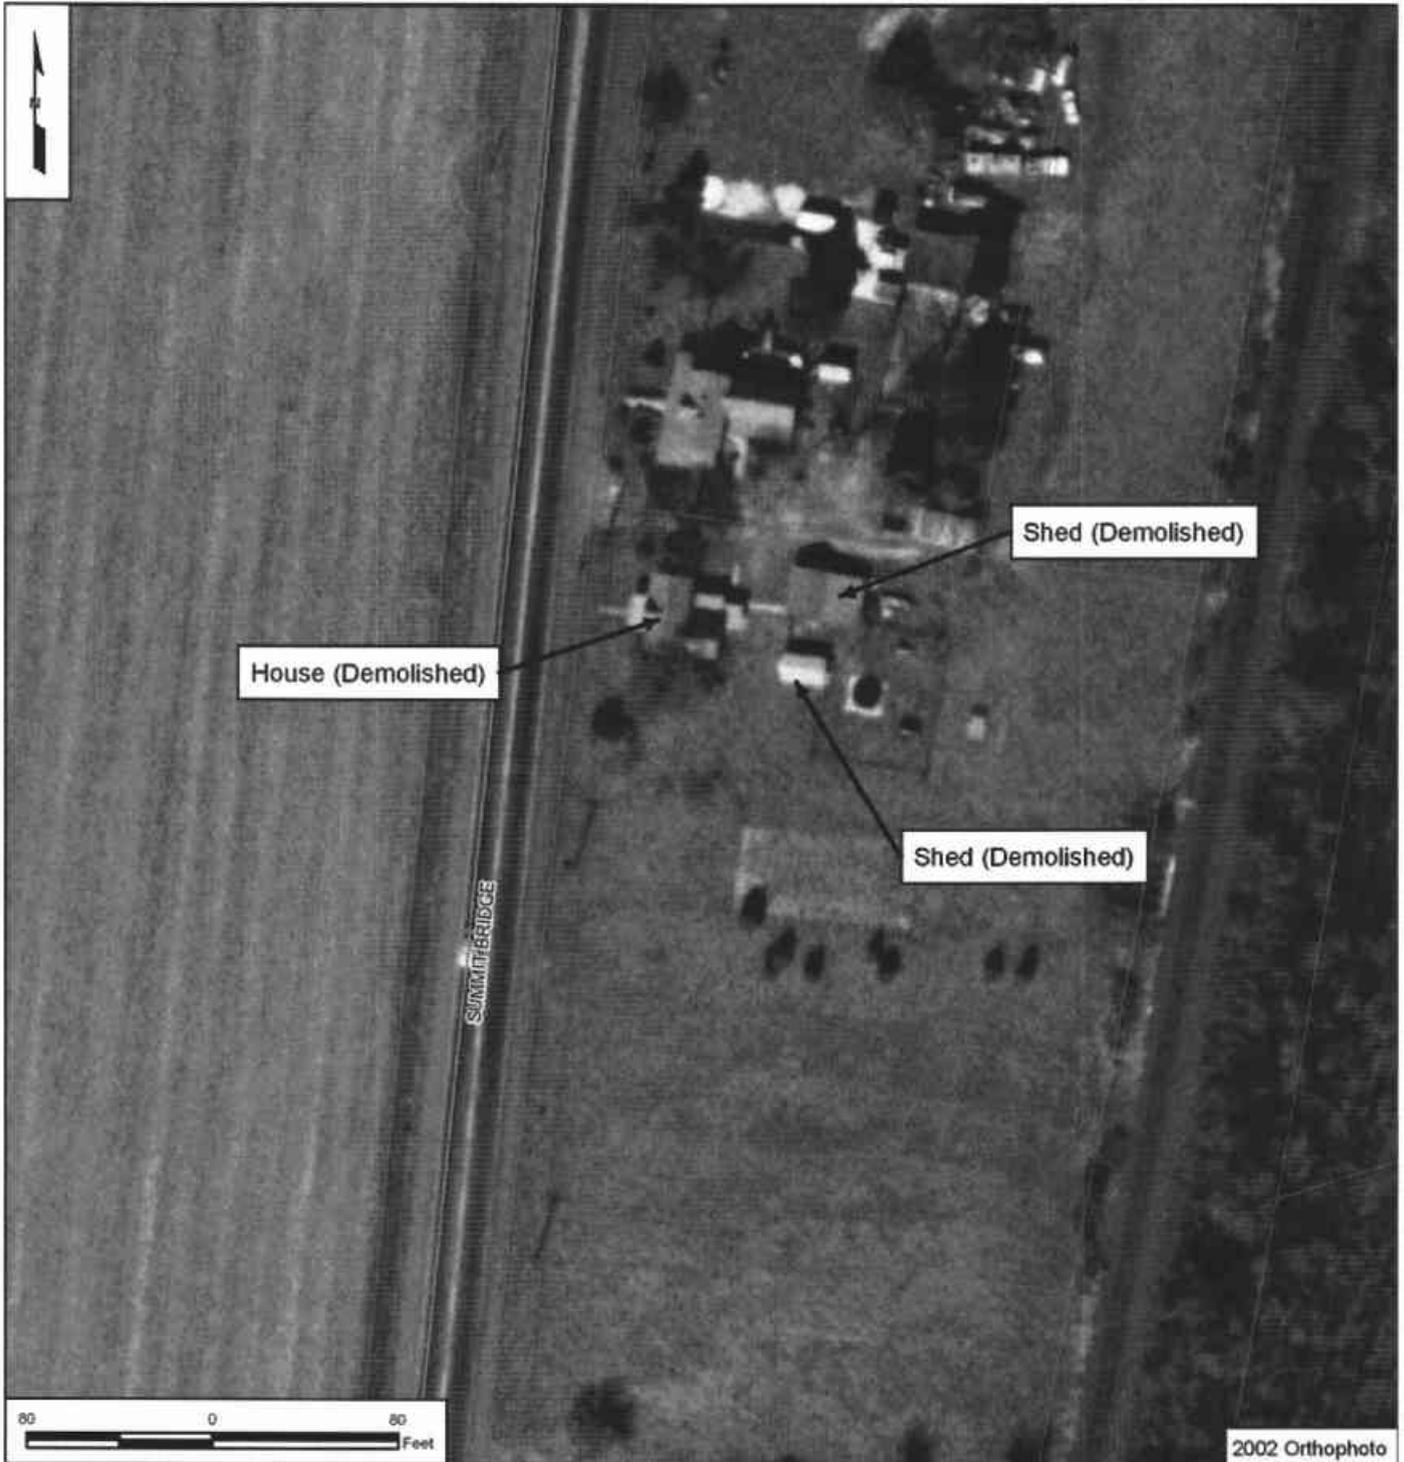
4. SITE PLAN:

1. HISTORIC NAME/FUNCTION: Dwelling, 4519 Summit Bridge Rd
2. ADDRESS/LOCATION: East side of Summit Bridge Rd, 500' South of Boyds Corner Rd
3. CURRENT CONDITION: excellent  good  fair  poor  demolished
4. INTEGRITY: Dwelling and shed identified in previous survey demolished in July 2005 as part of intersection improvements at Mt. Pleasant.
5. SETTING INTEGRITY: Located along east side of Summit Bridge Rd (U.S. 301). Cleared lot, only a few trees remain.

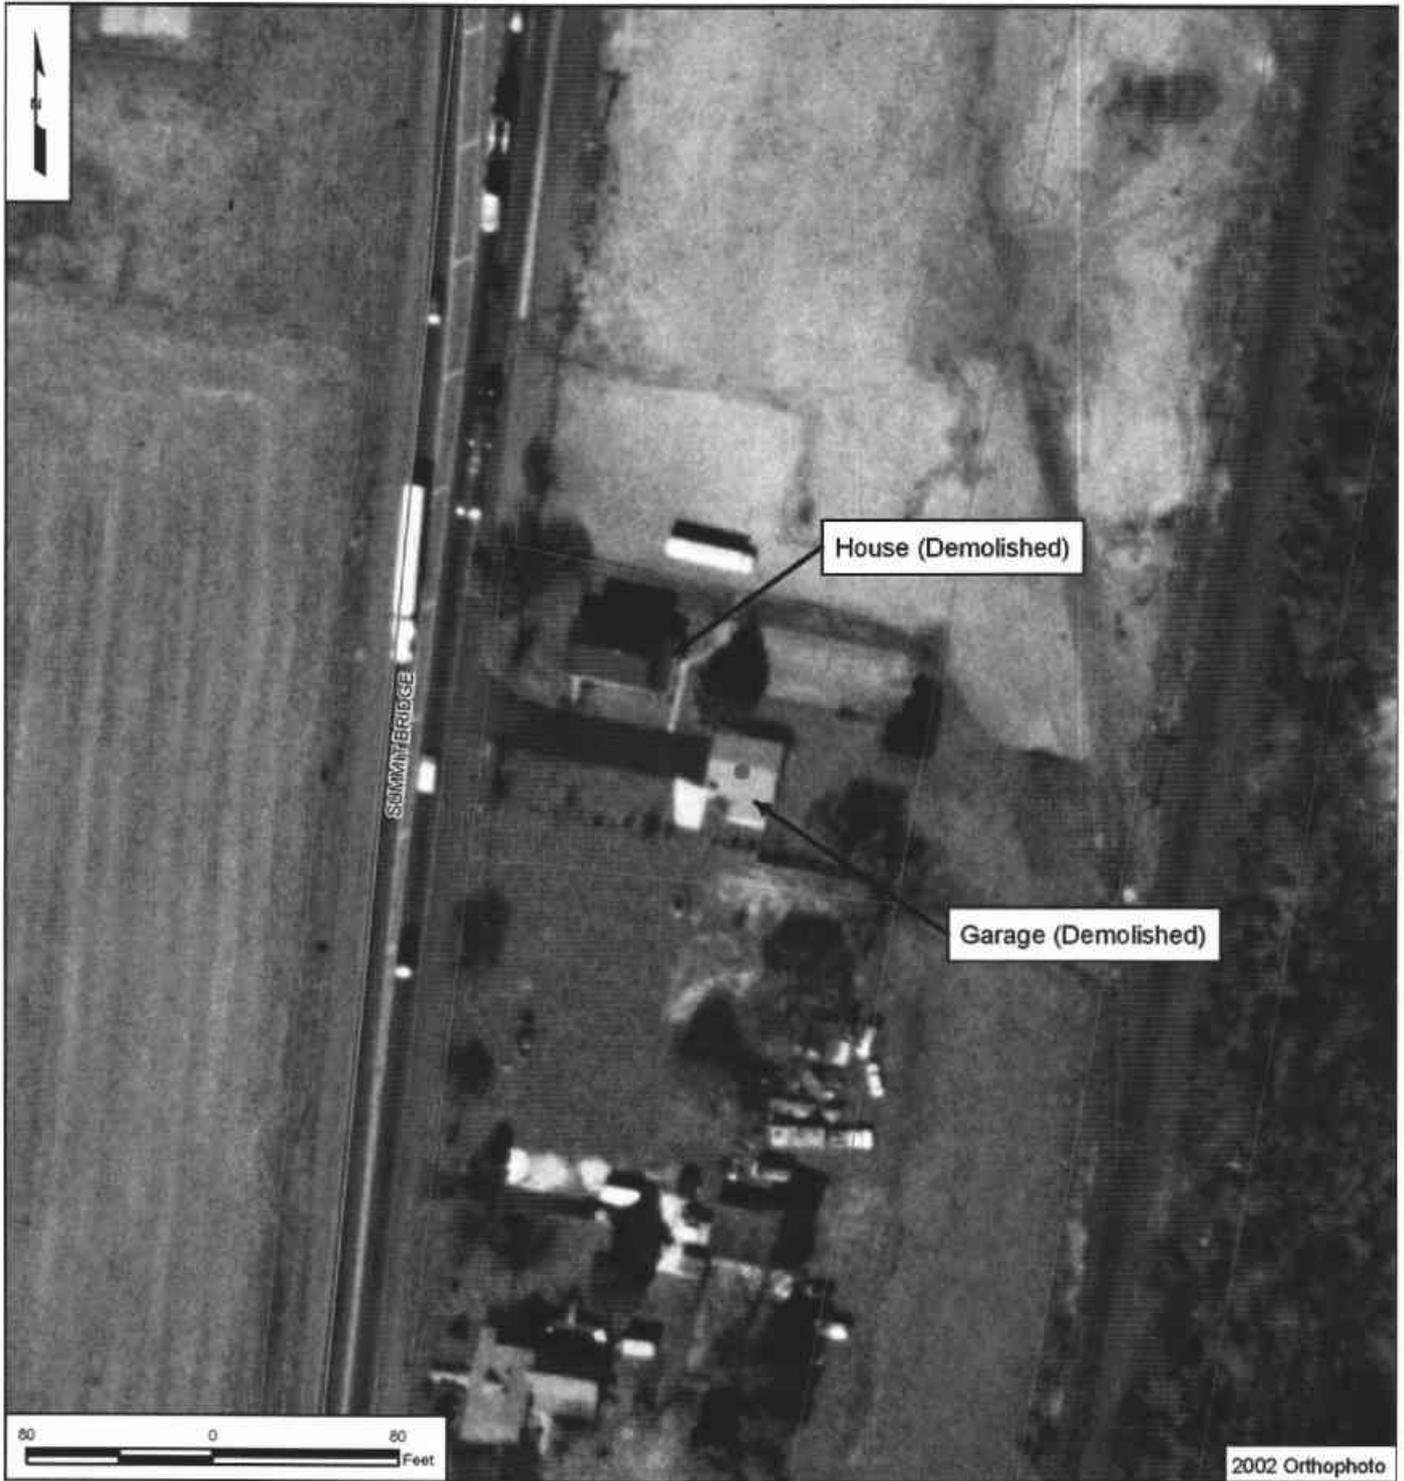
4. SITE PLAN:

1. HISTORIC NAME/FUNCTION: Crothers' Granary
2. ADDRESS/LOCATION: SE Corner of Summit Bridge Road and Boyds Corner Rd
3. CURRENT CONDITION: excellent  good  fair  poor  demolished
4. INTEGRITY: Granary demolished.

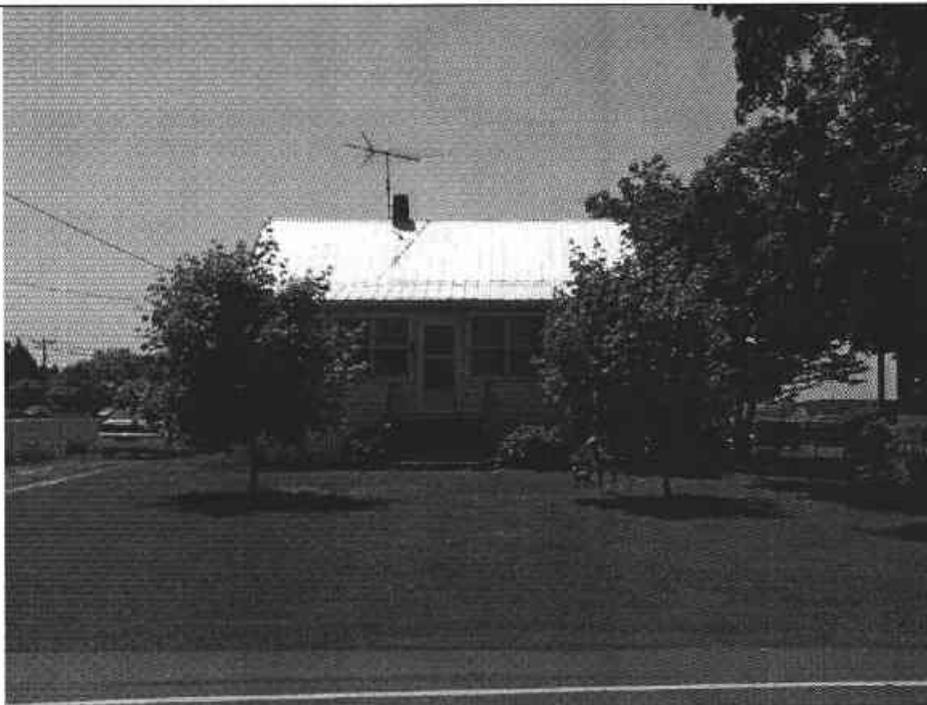
N12018. Photograph 1: Dwelling, north elevation, view to south. This bungalow, a common property type found throughout the U.S. 301 study area, is clad in aluminum siding and the front porch has been enclosed.

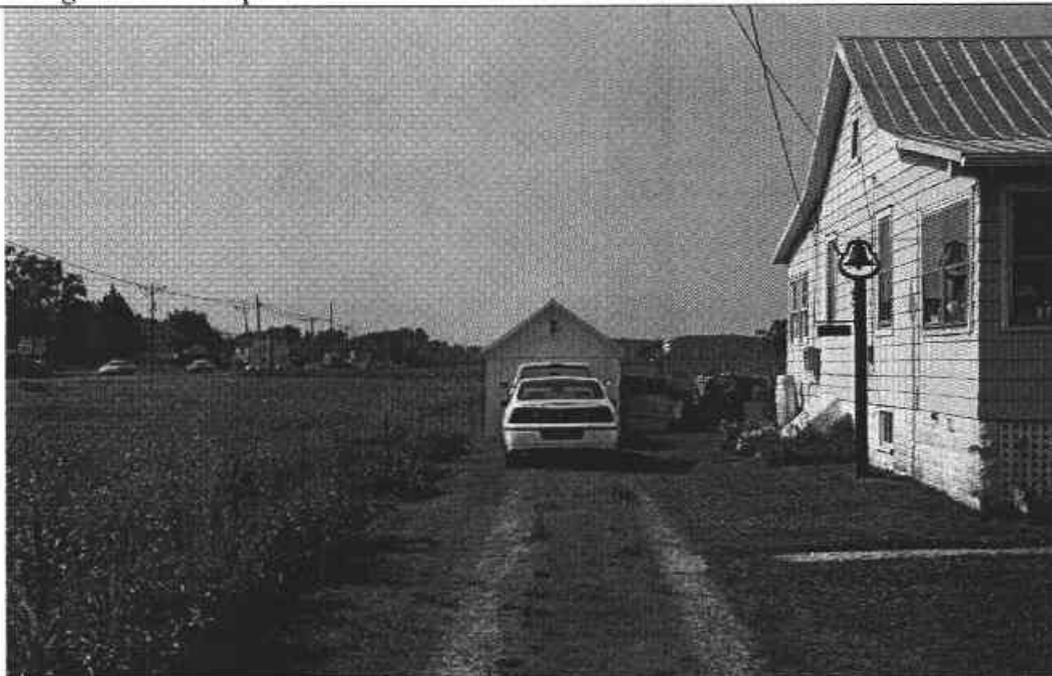
N12018. Photograph 2: Dwelling, east elevation, and garage, north elevation, view to south. Note enclosed porch and different window types lighting the dwelling's interior. Also note vacant lot and heavy traffic on Summit Bridge Road (U.S. 301)..

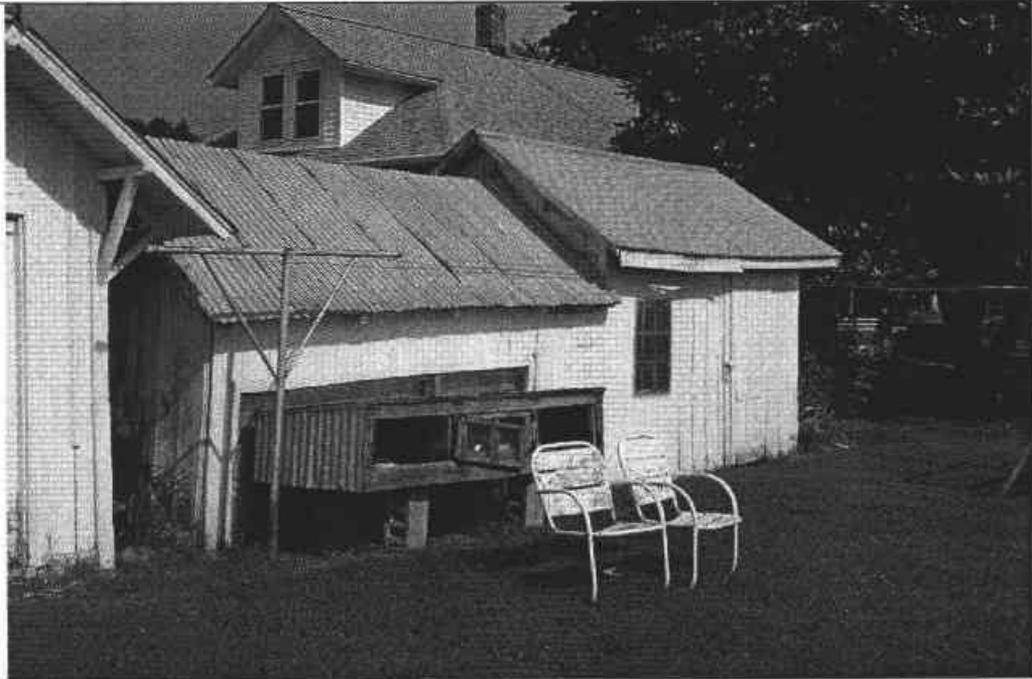
N12018. Photograph 3: Chicken house/shed, east elevation, view to west. This domestic outbuilding is representative of other early-twentieth-century buildings on the property. A tool shed is visible on the left side of the photograph.

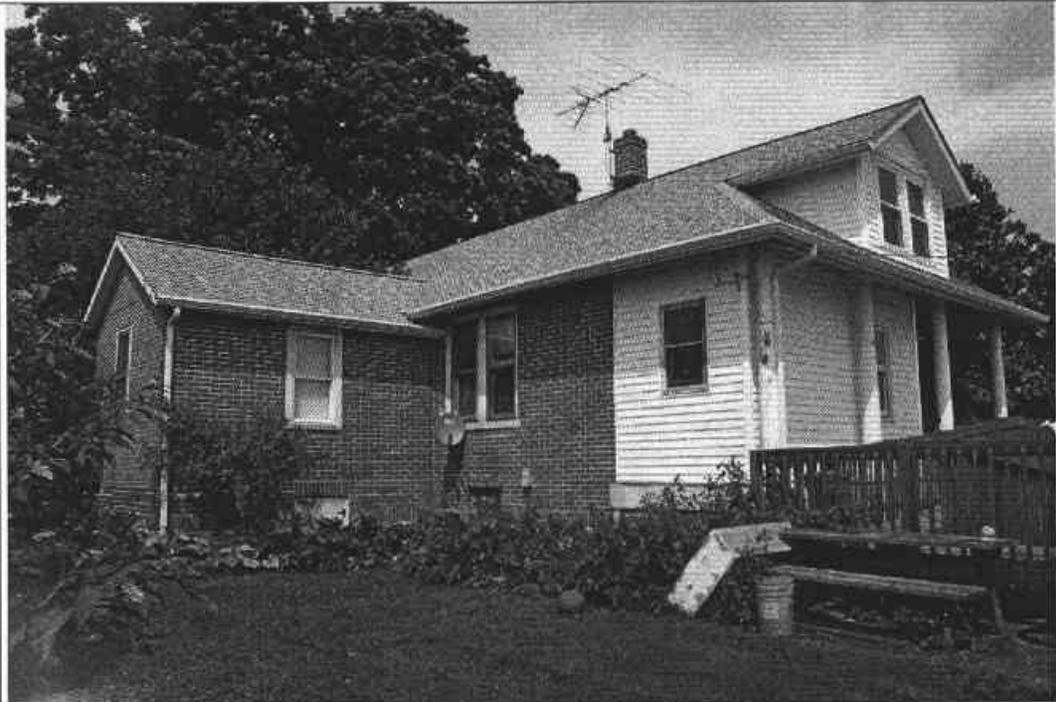
N12019. Photograph 1: Edward T. Pleasanton House, south and west elevations, view to northeast. Note *circa*-1990 rear addition and handicap accessible ramp.

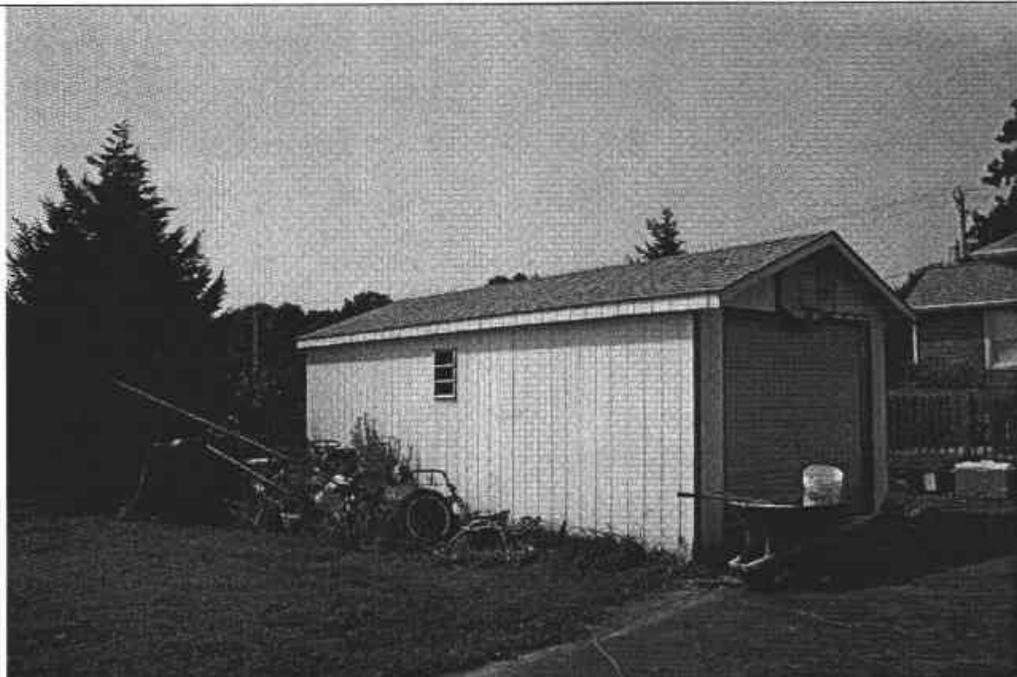
N12019. Photograph 2: Edward T. Pleasanton House, garage, south and east elevations, view to northwest. Note the overall condition of the garage, which has improved since the 1988 survey.

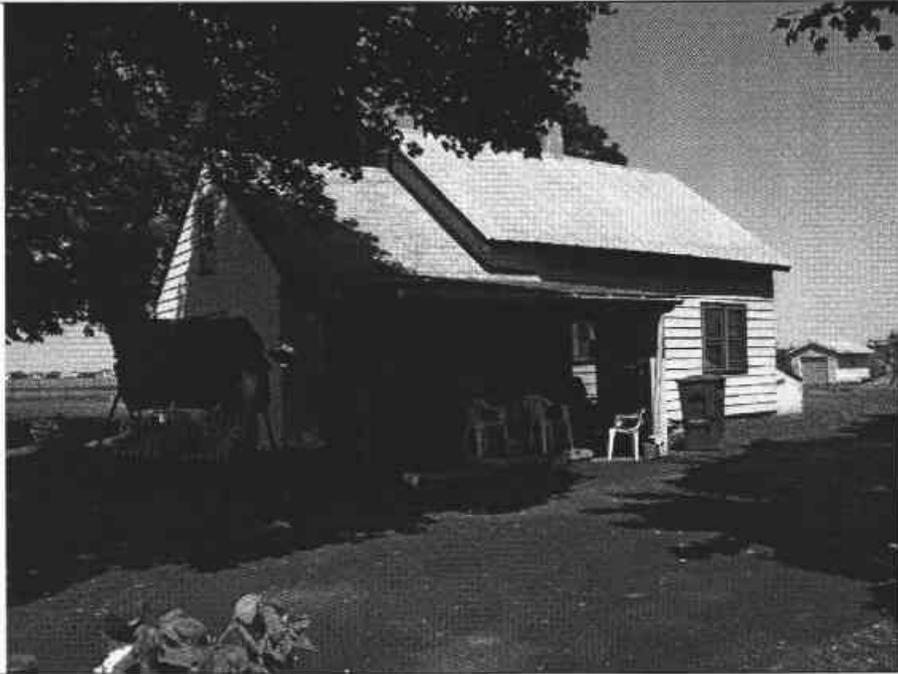
N12020. Photograph 1: Overview of former school from Churchtown Road. Note later addition to south elevation which altered integrity of form and paired replacement windows which altered integrity of fenestration.

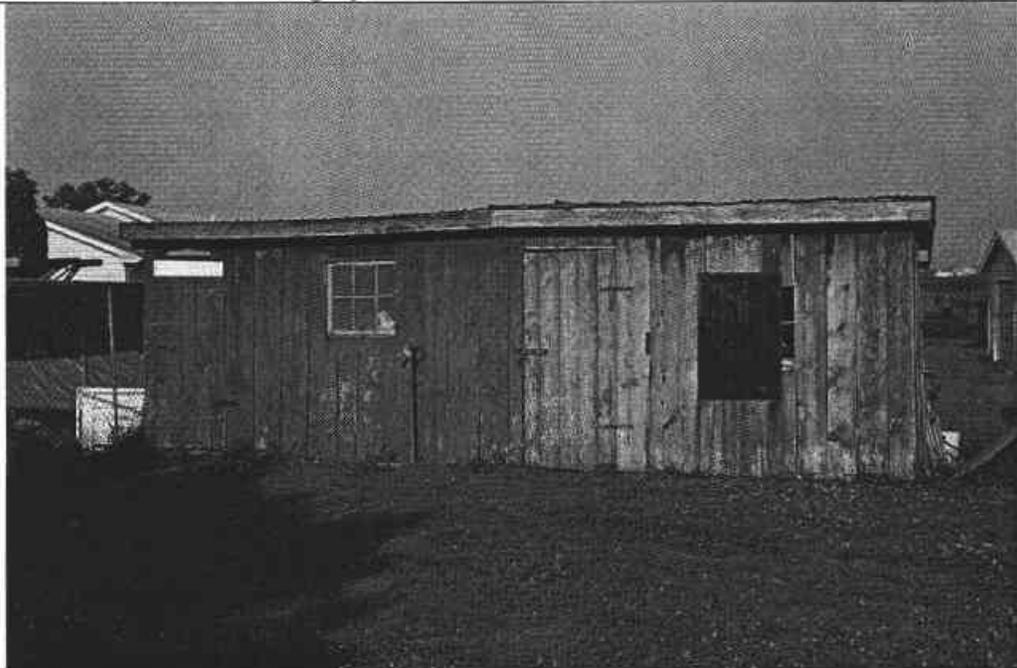
N12020. Photograph 2: Chicken house, east elevation, view to west. Note the fenestration pattern has been altered by the plywood covered window.
