**CRS No. N12636**

**Name: State Bridge Number 383**

CULTURAL RESOURCE SURVEY  
SURVEY UPDATE FORM

**CULTURAL RESOURCE SURVEY  
MAP FORM**

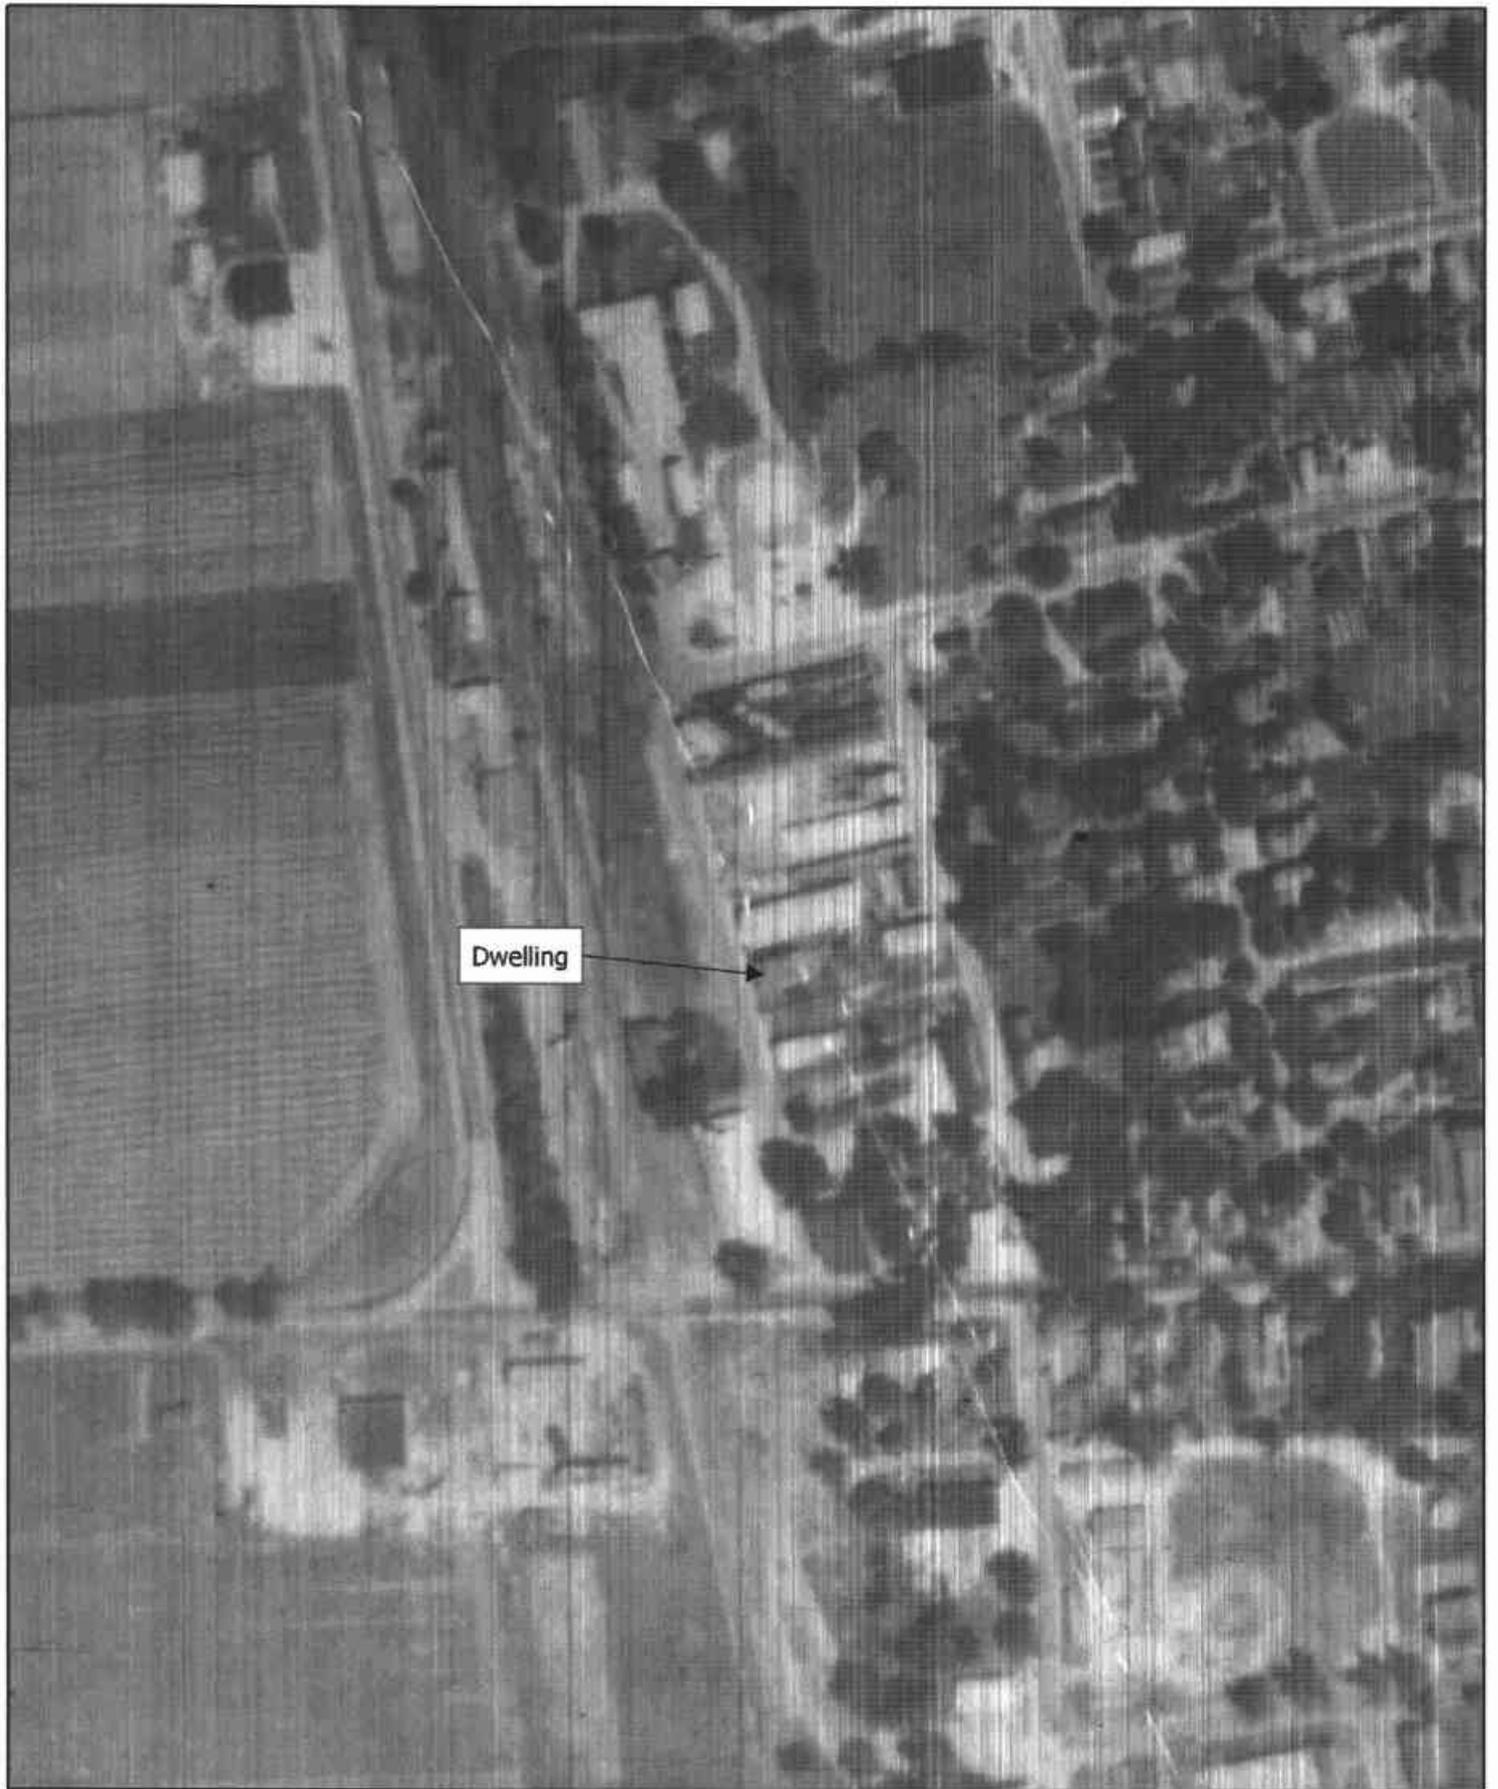
**U.S. 301 Project Development**  
**1962 Aerial**  
Dwelling, 11 Wood Street - CRS No. N12717

1. HISTORIC NAME/FUNCTION: Dwelling, 11 Wood St
2. ADDRESS/LOCATION: 11 Wood St
3. CURRENT CONDITION: excellent  good  fair  poor  demolished
4. INTEGRITY: Building has been demolished.

5. SETTING INTEGRITY: Replaced by a modern building. Numerous modern buildings are located in the vicinity of the former dwelling.

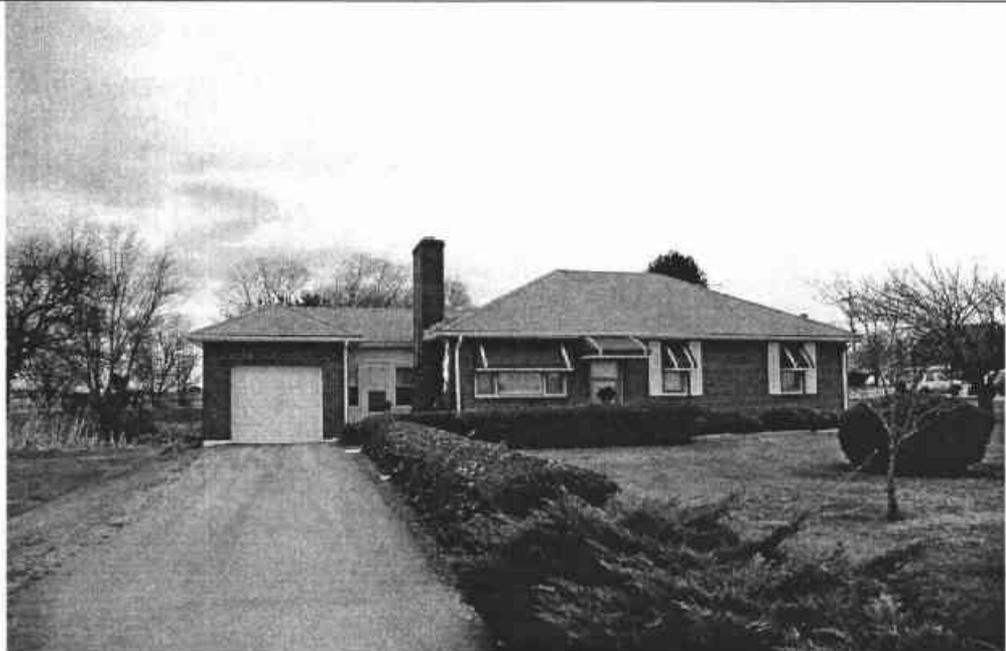
**CRS No. N12740**

N12740. Photograph 1: Dwelling, 2110 South DuPont Highway, west elevation, view looking east. Note the hipped roof and original aluminum awnings.

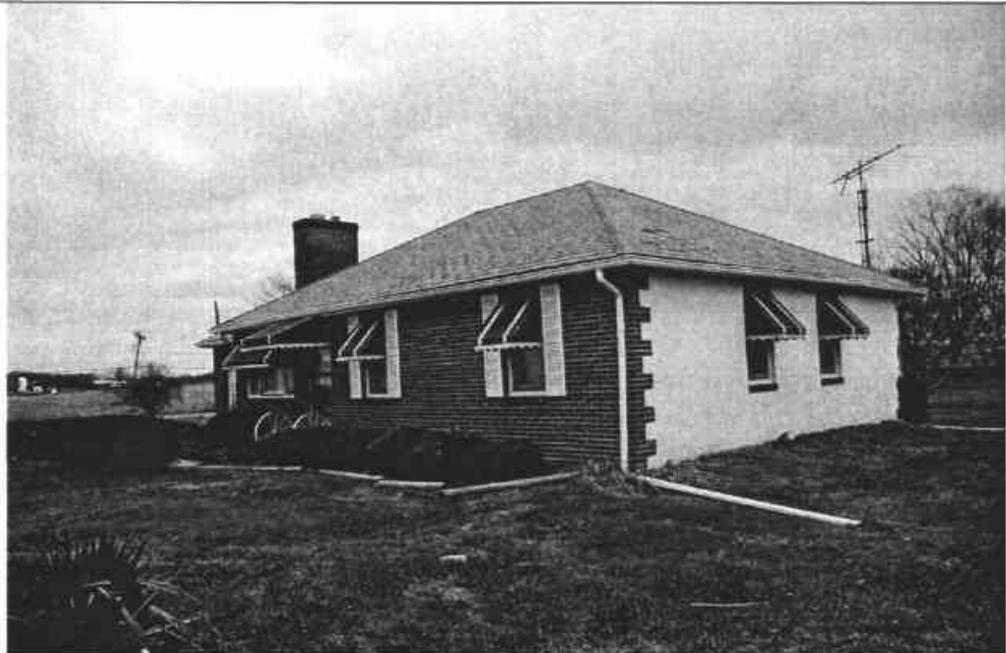
**CRS No. N12740**

N12740. Photograph 2: Dwelling, 2110 South DuPont Highway, south and west elevations, view looking northeast. Note the coining, original aluminum awnings, as well as the stucco-clad south elevation.

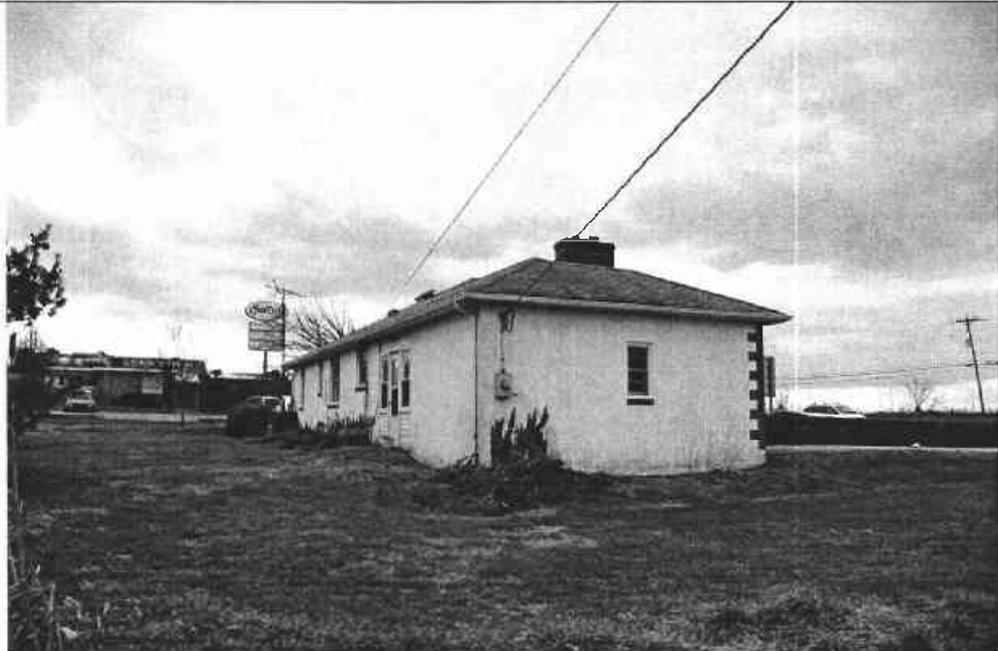
**CRS No. N12740**

N12740. Photograph 3: Dwelling, 2110 South DuPont Highway, north and east elevations, view looking southwest. Note the lack of awnings.

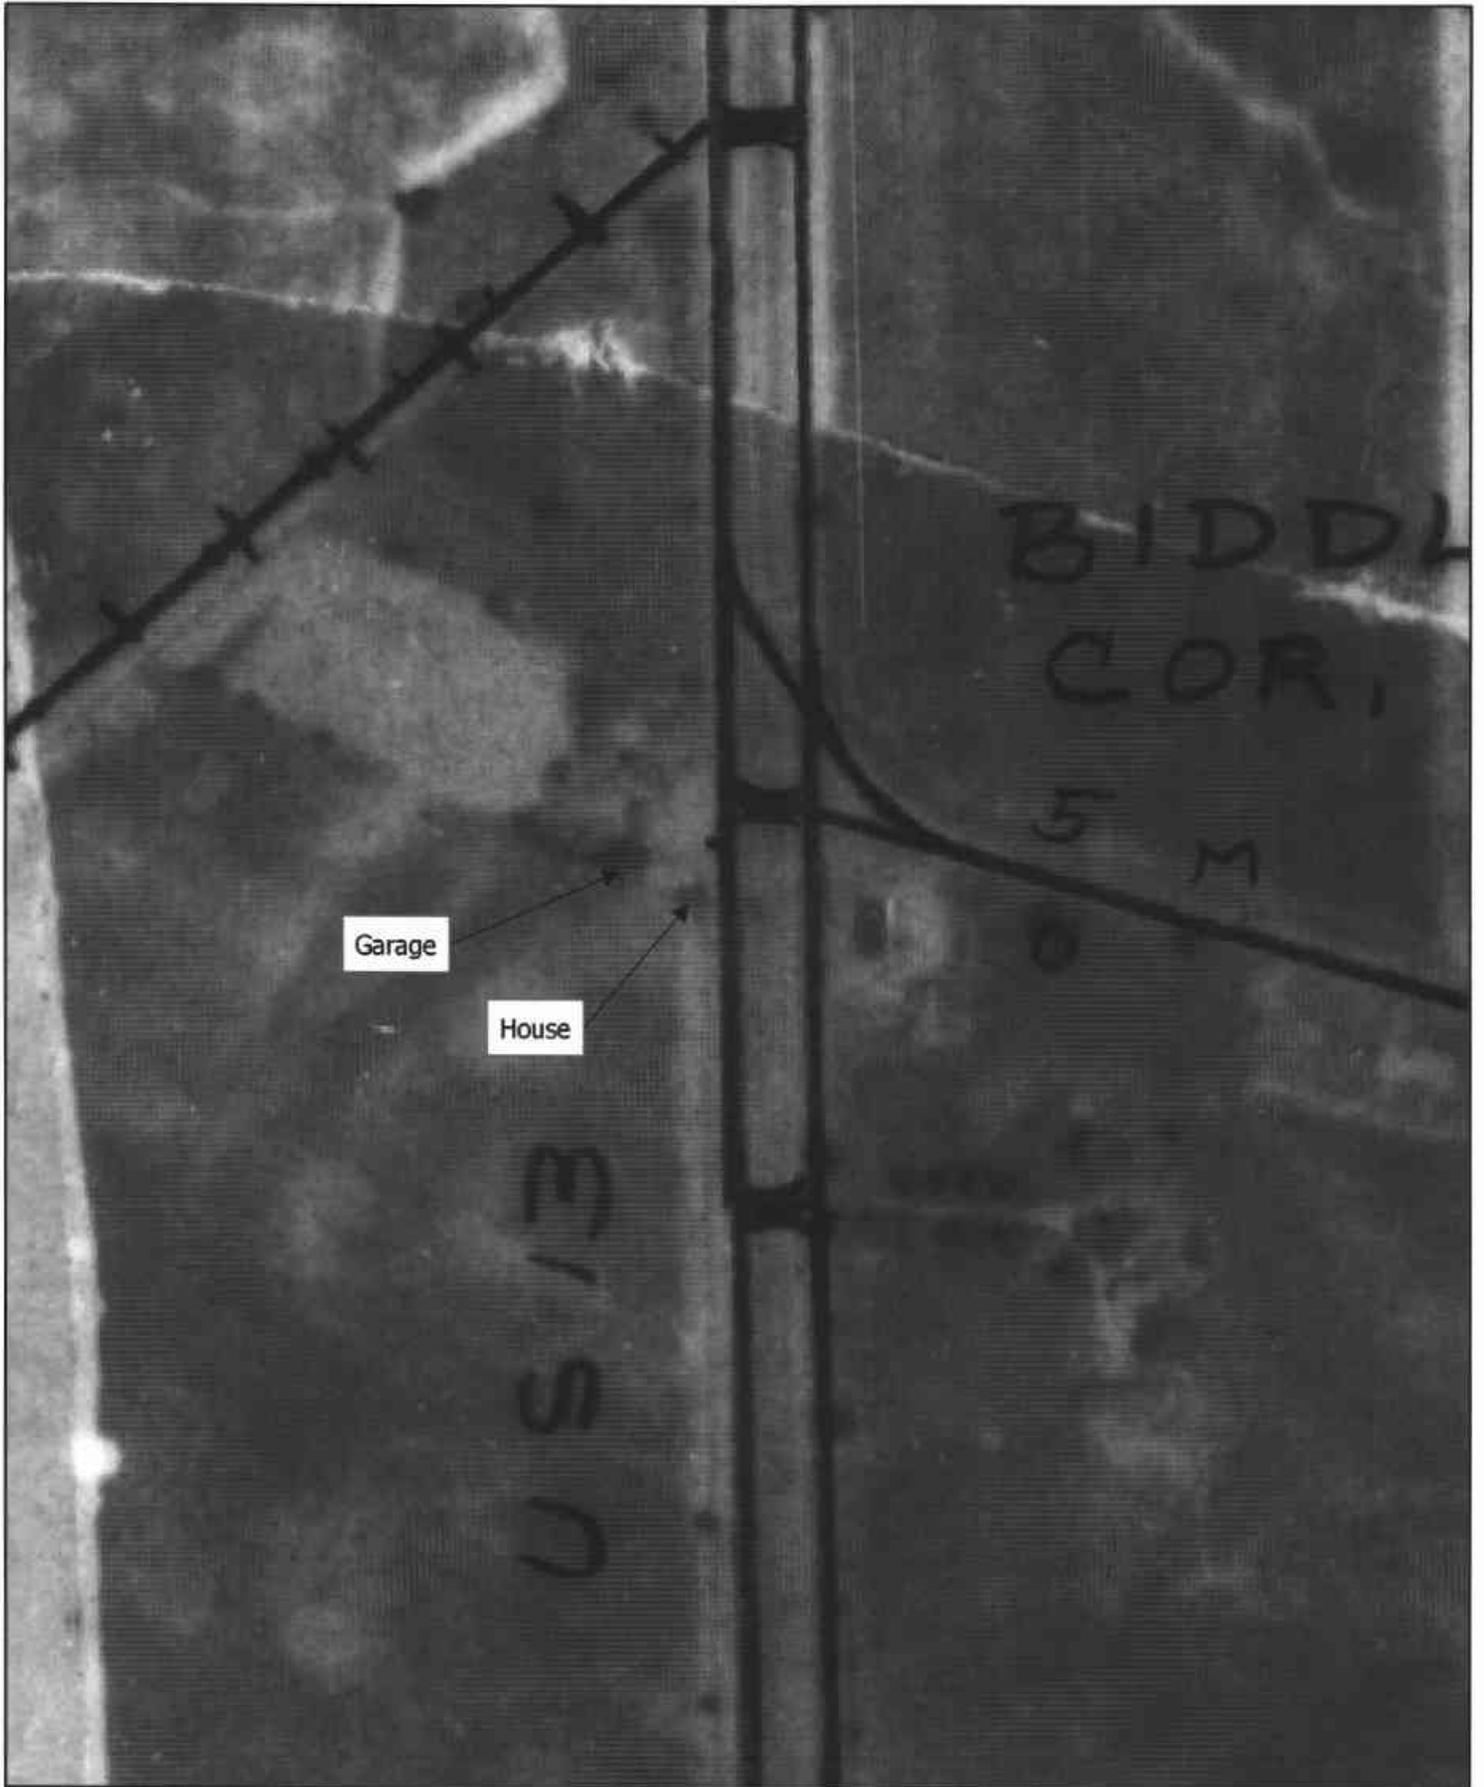
### U.S. 301 Project Development 1962 Aerial

Dwelling, 2101 S. Dupont Highway - CRS No. N12741

1. HISTORIC NAME/FUNCTION: Dwelling, 2101 S Dupont Highway
2. ADDRESS/LOCATION: West side of US 13, at intersection of Biddles Corner Rd
3. CURRENT CONDITION: excellent  good  fair  poor  demolished
4. INTEGRITY: Demolished as part of construction of Biddles Corner Toll Plaza.
5. SETTING INTEGRITY: Property flanked by U.S. 13 and SR 1. Toll plaza to north.

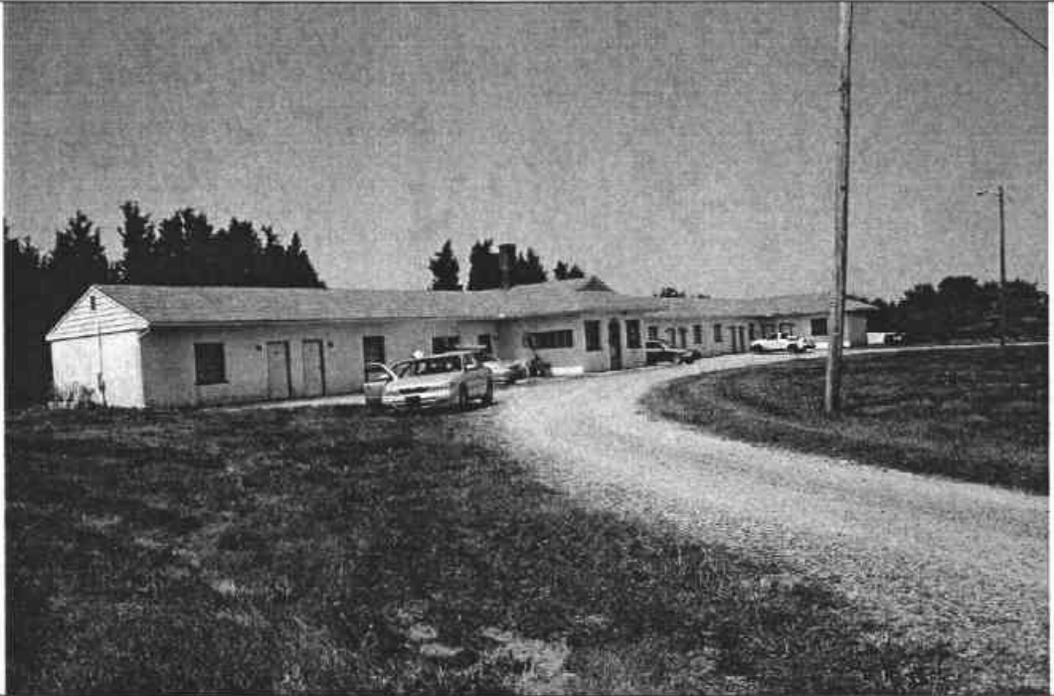
**CRS No. N012742**

N012742. Photograph 1: South and east elevations of Parkway Motel, looking northwest, with office area near the center of photograph and later addition in the foreground.

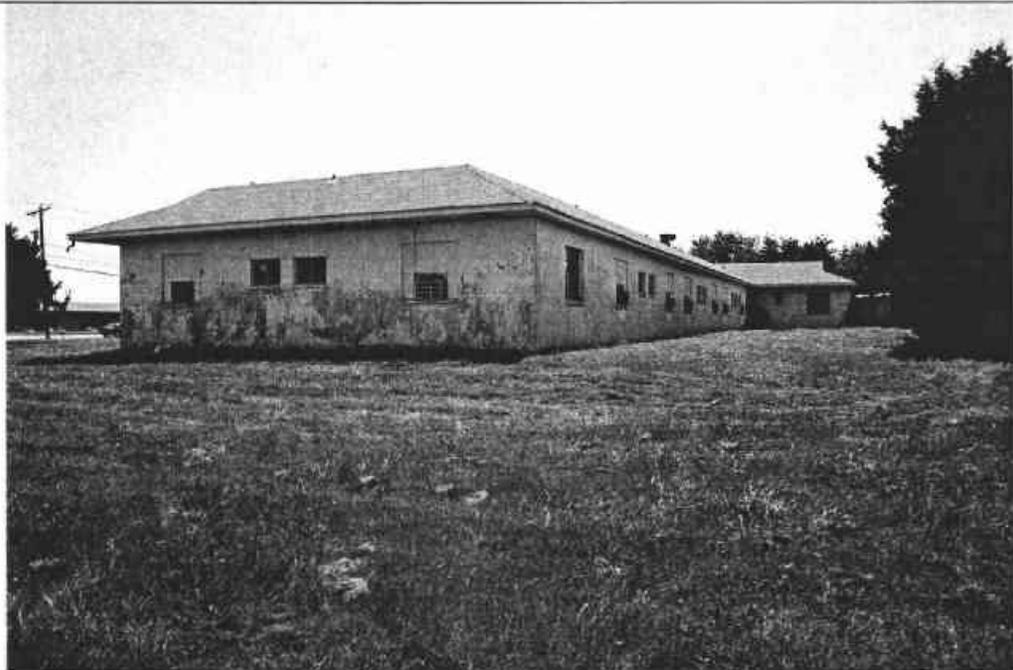
N012742. Photograph 2: North and west elevations of Parkway Motel, looking southeast. Note filled-in windows.

1. HISTORIC NAME/FUNCTION: Parkway Motel
2. ADDRESS/LOCATION: 2397 S. Dupont Highway
3. CURRENT CONDITION: excellent  good  fair  poor  demolished
4. INTEGRITY: The paint is now peeling from the building's cladding.
5. SETTING INTEGRITY: The motel is still in its original location, retains its original roadway signage, which is currently in poor condition.

The motel appears to be in the same condition as during the previous survey which was completed in 1991. The building is in fair to poor condition.

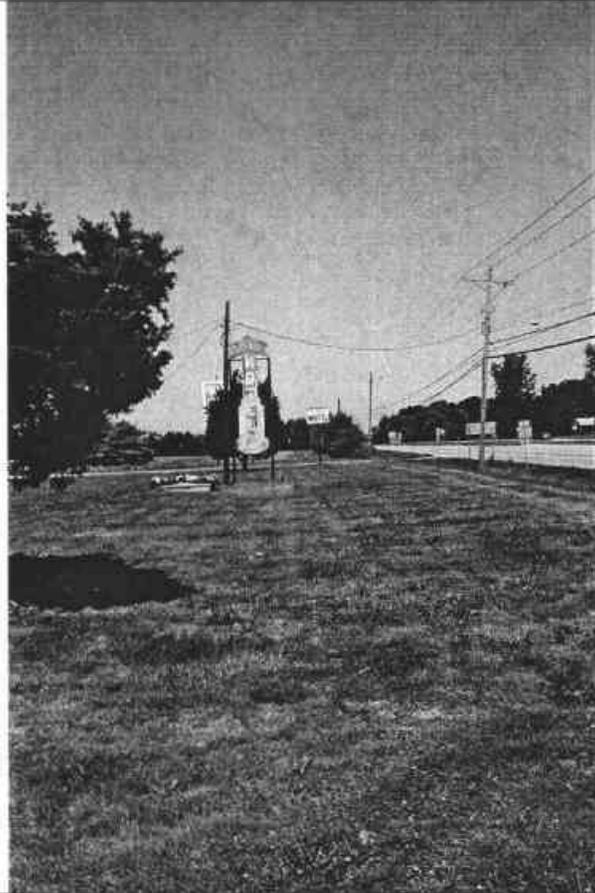
**CRS No. N012742**

This property is located on the west side of South DuPont Highway at the Village of Boyd's Corner, between Odessa and the C & D Canal. The resource is located on a strip of land along the highway; there are several small, mid-twentieth-century residences across the road from the property, and a modern strip mall to the southeast. The property consists of a one-story motel with an office near the center of the building; there are approximately 10 motel units. The building is constructed with concrete blocks that are covered with stucco. Some windows have been replaced and others have been filled in; some of the doors have also been replaced. Originally a U-shaped building, one-story wing was added on the south end sometime after 1962. Overall, the motel is in fair-to-poor condition. In front of the circular driveway there are two signs bearing the name of the business. The earlier of these is a neon sign dating to ca. 1952. The other is a plain commercial sign erected ca. 1970. The neon sign is in poor condition and is nearly illegible.

N012742. Photograph 3: Overview of grounds showing older neon sign and later sign behind it, view looking north.

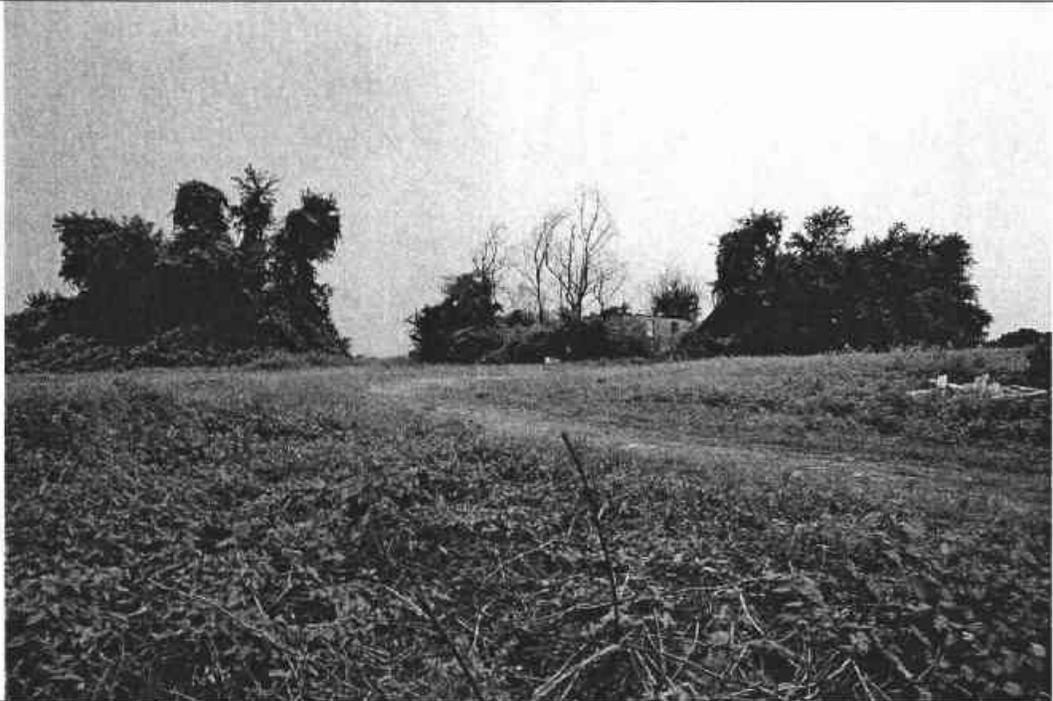
CRS No. N12754

N12754. Photograph 1: J.H. Sutton Agricultural Complex, overview, view looking southwest. Note the clusters of trees where buildings likely once stood.

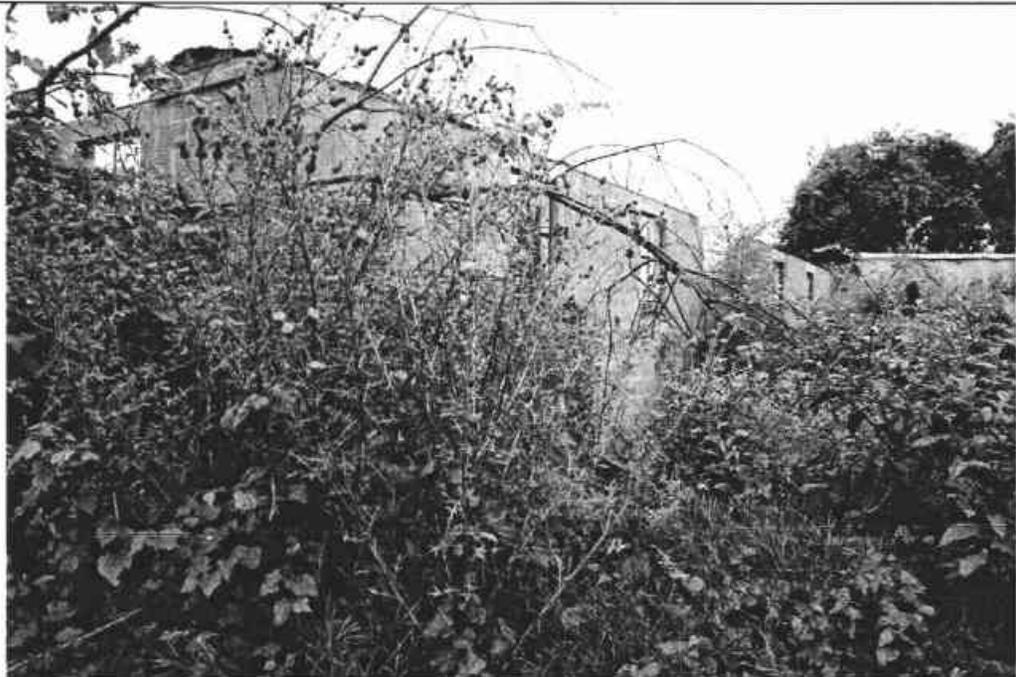
This former farmstead is located on the south side of Lorewood Grove Road. Today all that remains of the dairy barn (ca. 1930) is its concrete block foundation, due to a lightning fire that destroyed the remainder of the building. The granary (ca. 1880) has collapsed, exposing its wood frame structural system. No other details of the building remain. One shed (ca. 1940) was also identified although the structure was heavily overgrown. The buildings are accessed by a gravel and dirt drive. The buildings are all overgrown, not accessible, and barely visible. The buildings are surrounded by cultivated fields.

N12754. Photograph 2: Dairy barn, north and east elevations, view looking southwest. The concrete block first story is the only thing that remains of dairy barn following a post-1991 fire.

1. HISTORIC NAME/FUNCTION: J.H. Sutton Agricultural Complex (Beers 1868)
2. ADDRESS/LOCATION: 1370 Lorewood Grove Rd
3. CURRENT CONDITION: excellent  good  fair  poor  demolished
4. INTEGRITY: Dairy barn destroyed by fire since previous survey. Granary has collapsed. One shed partially visible.
5. SETTING INTEGRITY: Fields are still farmed. Buildings are accessed by a dirt path and are hidden by overgrowth.

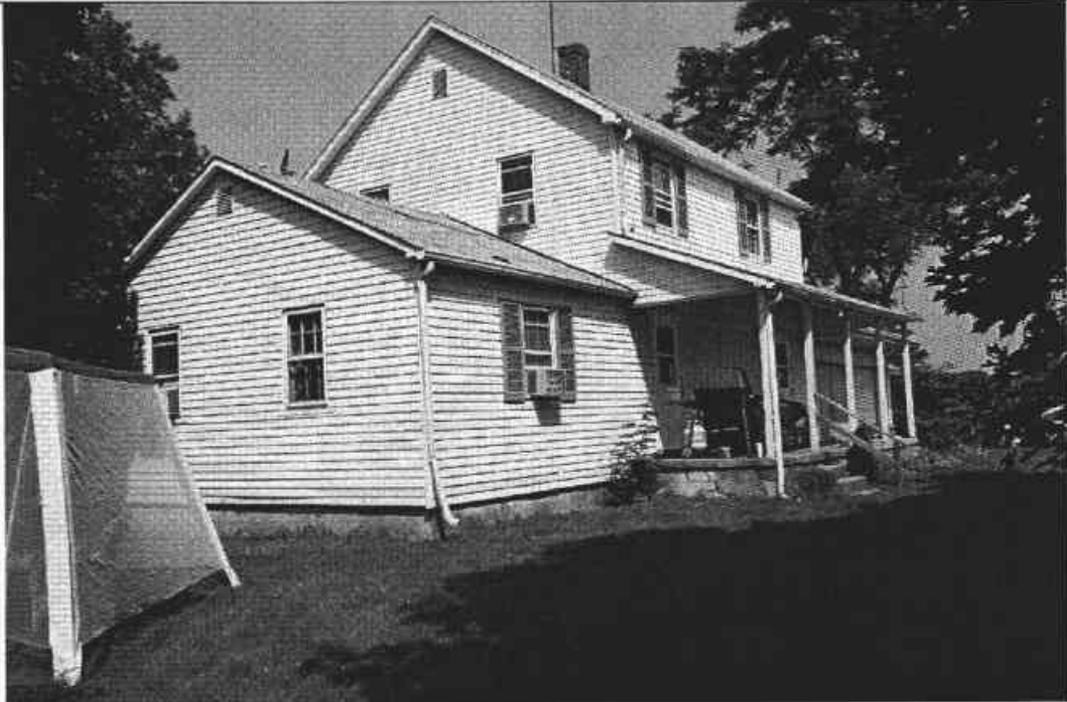
CRS No. N012758

N012758. Photograph 1. Joy Run Farm. Overview of house, looking southwest, showing north and east elevations. Note two-bay garage addition in foreground of photograph.

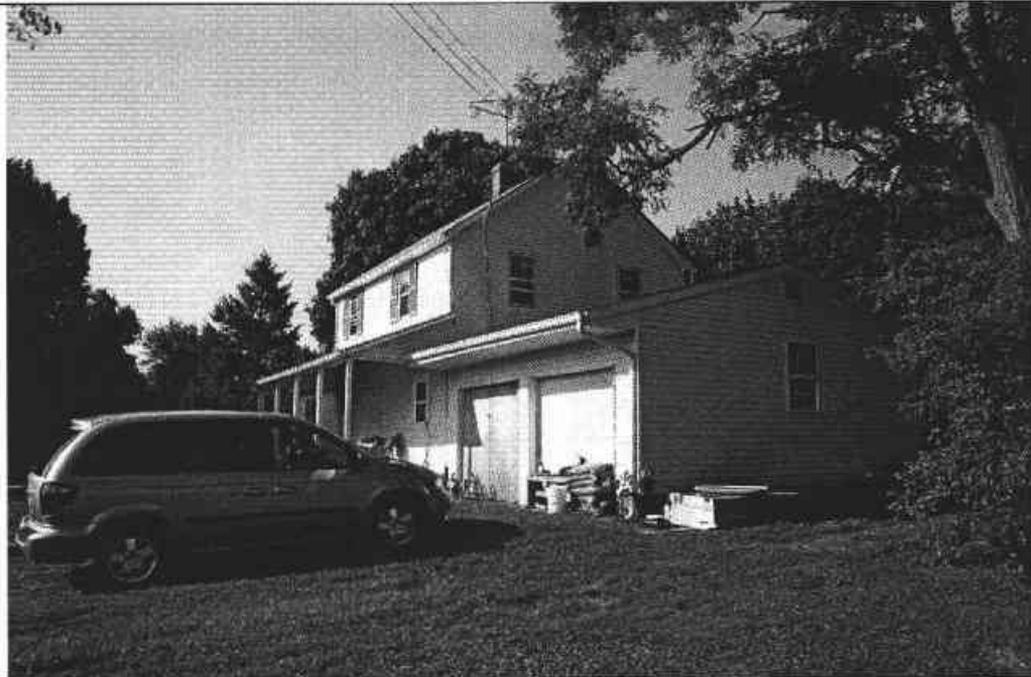
N012758. Photograph 2. Joy Run Farm. Overview of house, looking northeast, showing south and east elevations. Note addition to house in foreground of photograph.

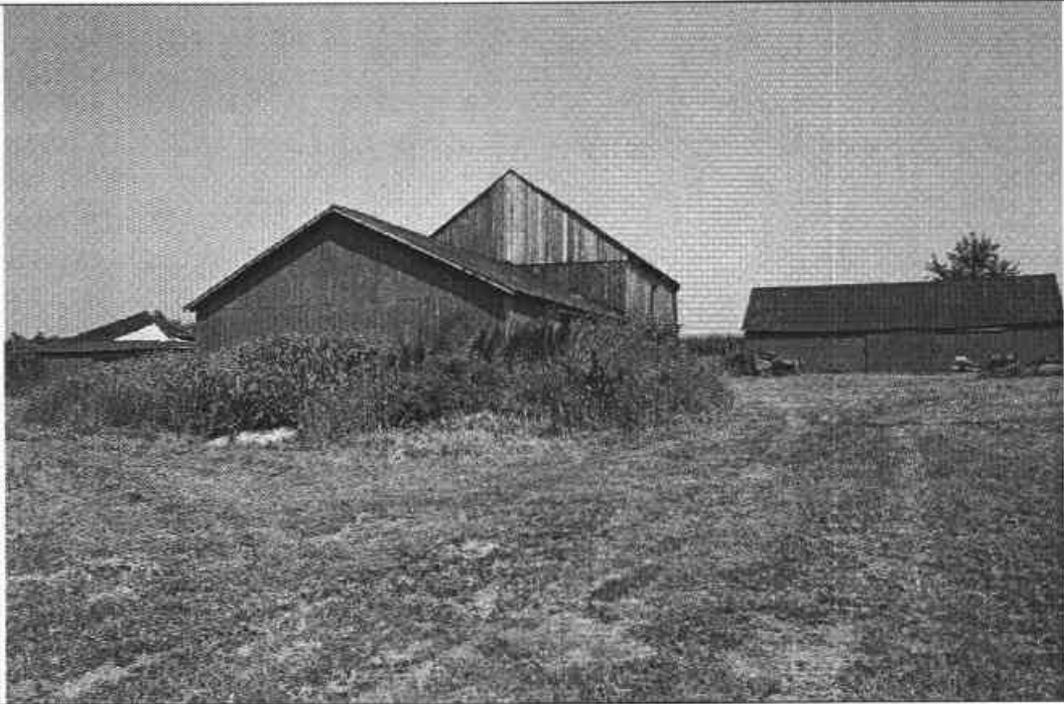
CRS No. N012758

N012758. Photograph 3. Joy Run Farm. Overview of barn and implement shed, looking north. Note addition to barn in foreground.

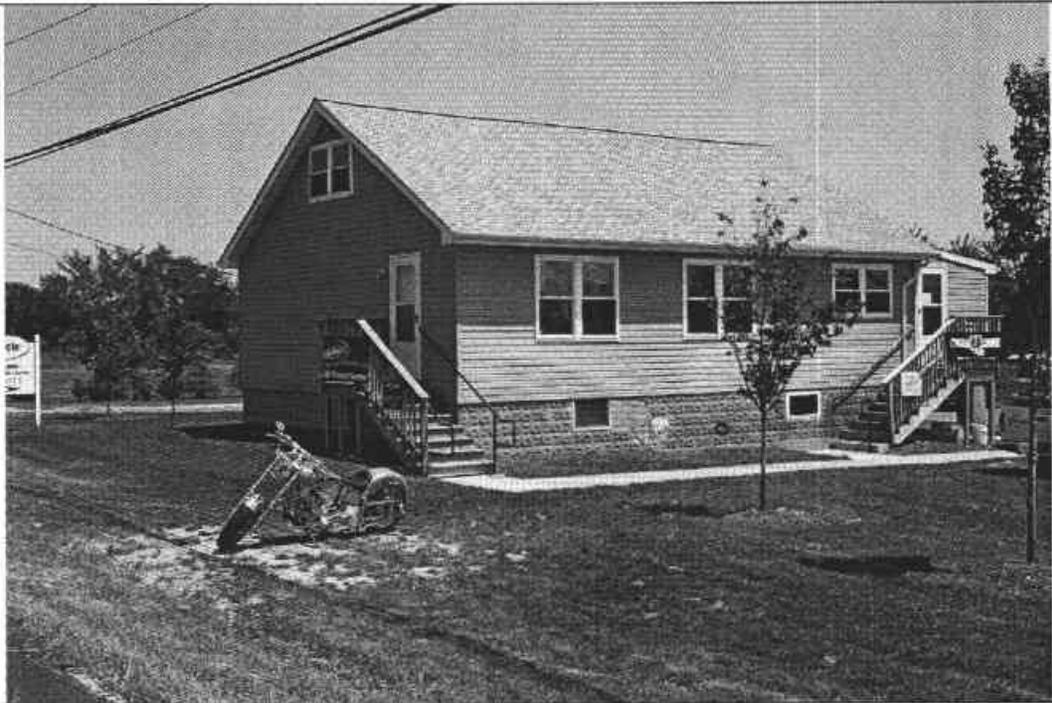
CRS No. N13309

N13309. Photograph 1: Dwelling, west and south elevations, view looking northeast. Note replacement windows, vinyl cladding and the new pedestrian entry on the façade.

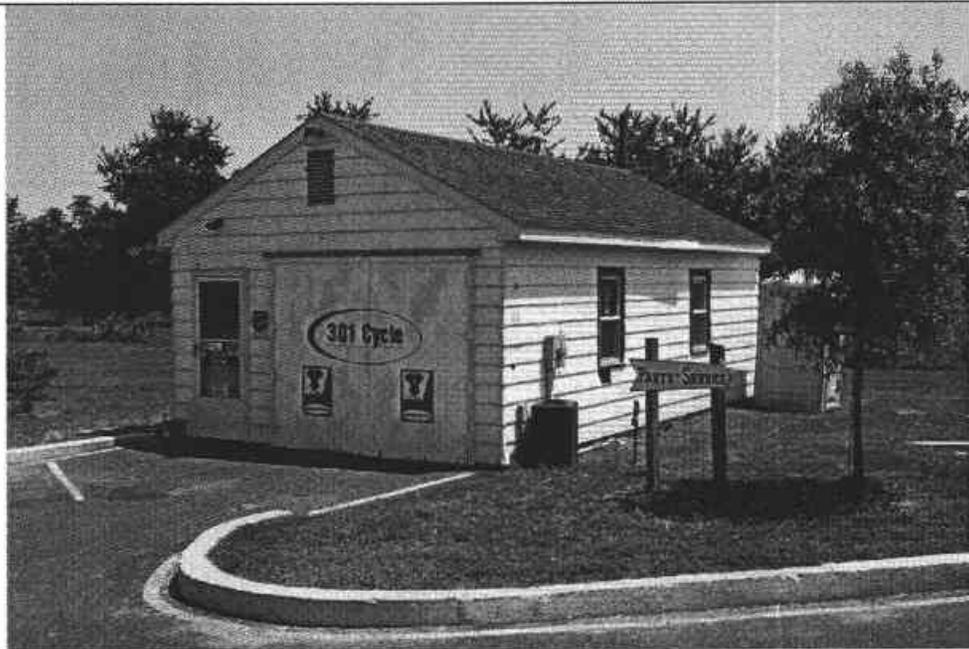
N13309. Photograph 1: Garage, west and south elevations, view looking northeast. Note replacement windows and the hinged, double flush doors on the west elevation.
