**CRS No. N14341**

Address: 4200 Summit Bridge Road

Name: Summit Aviation

U.S. 301 Project Development

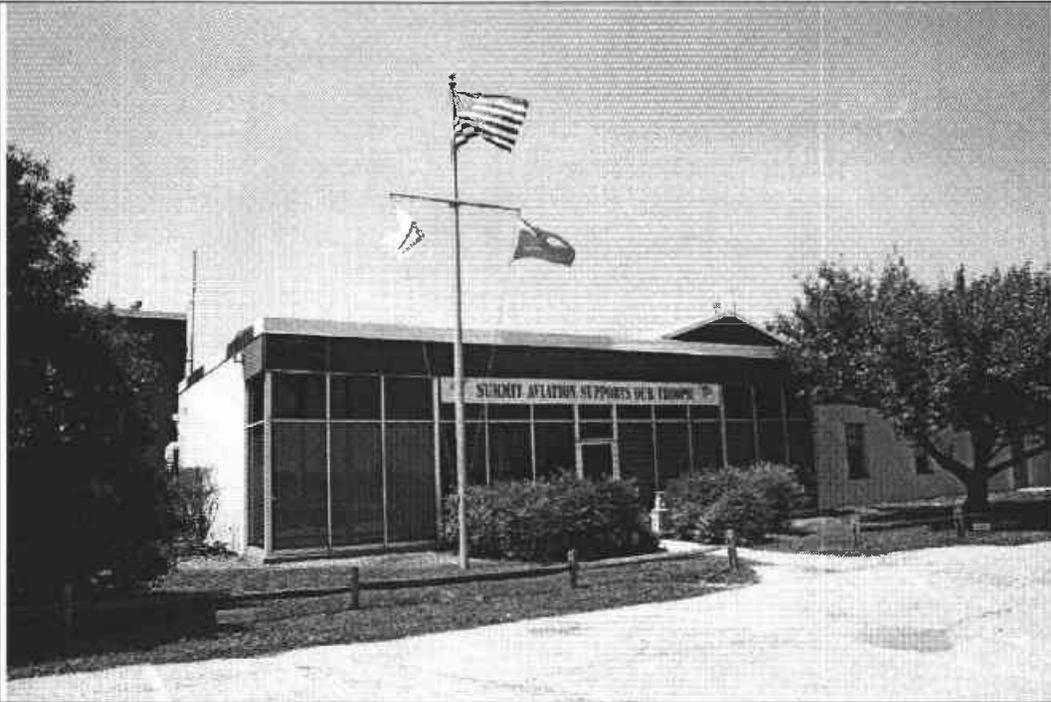
N14341. Photograph 1. Summit Aviation, overview of main office/reception area, view northwest, showing east elevation.

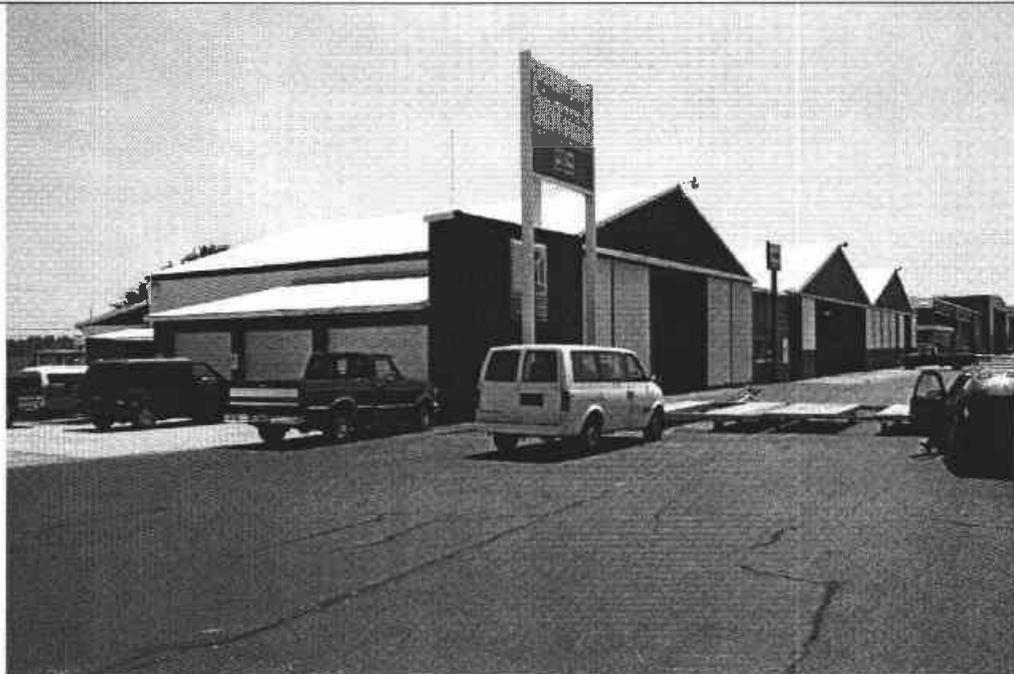
N14341. Photograph 2. Summit Aviation, view of hangar complex, looking southeast from inside airfield area; all these hangars in the photograph are now interconnected.

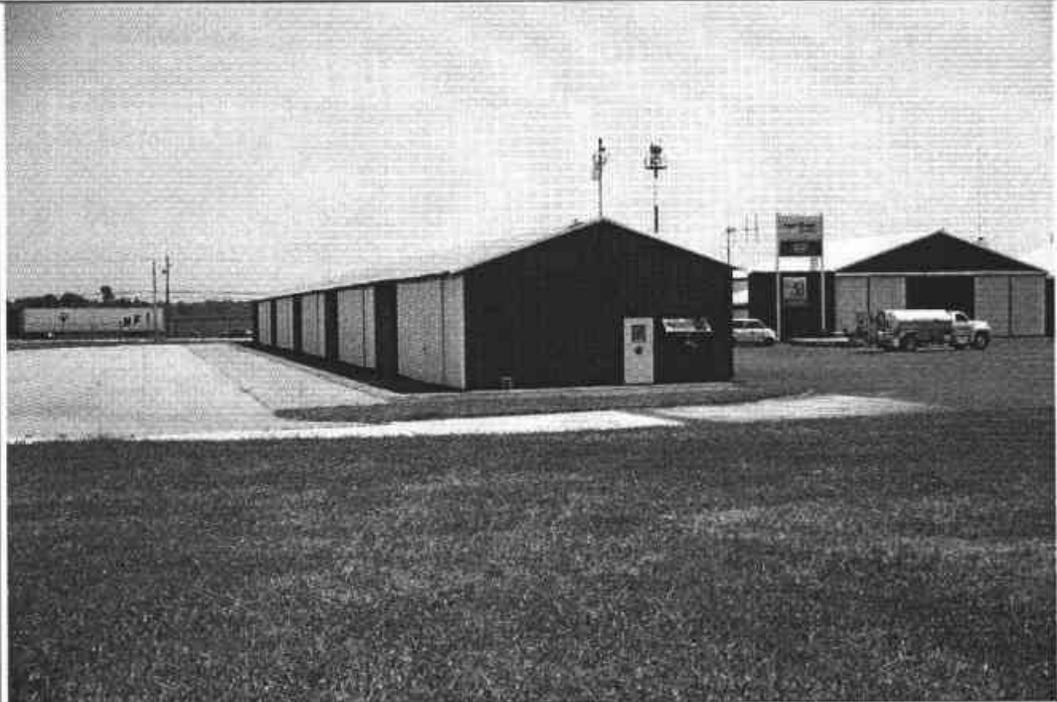
N14341. Photograph 3. Summit Aviation, view of storage hangar, looking east, showing north and west elevations.

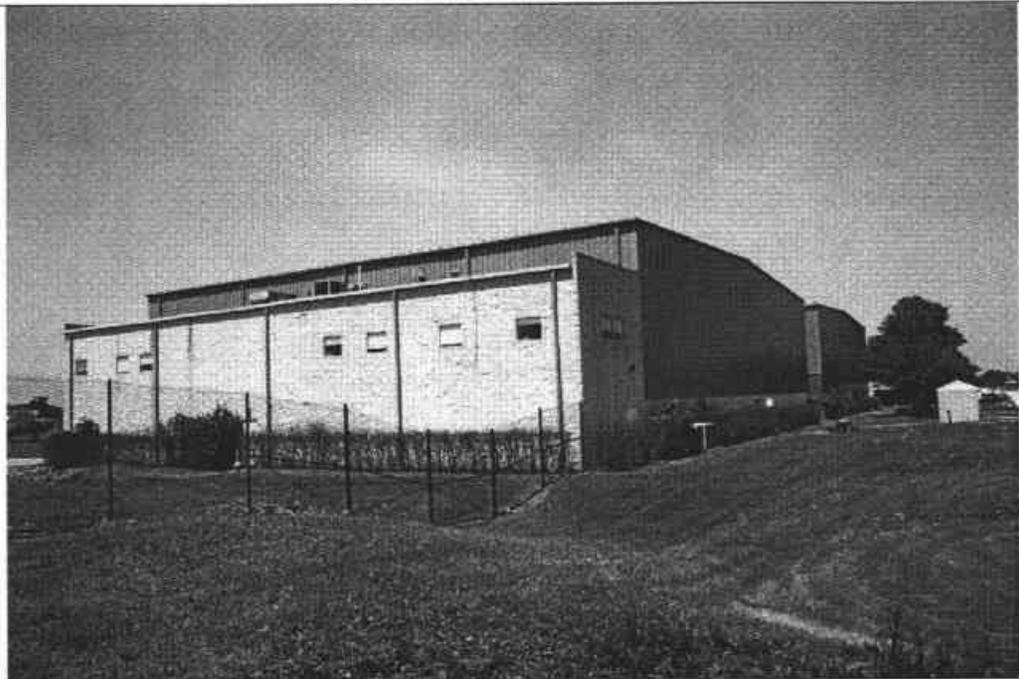
N14341. Photograph 4. Summit Aviation, view of modern hangar additions, showing south and east elevations, looking northwest.

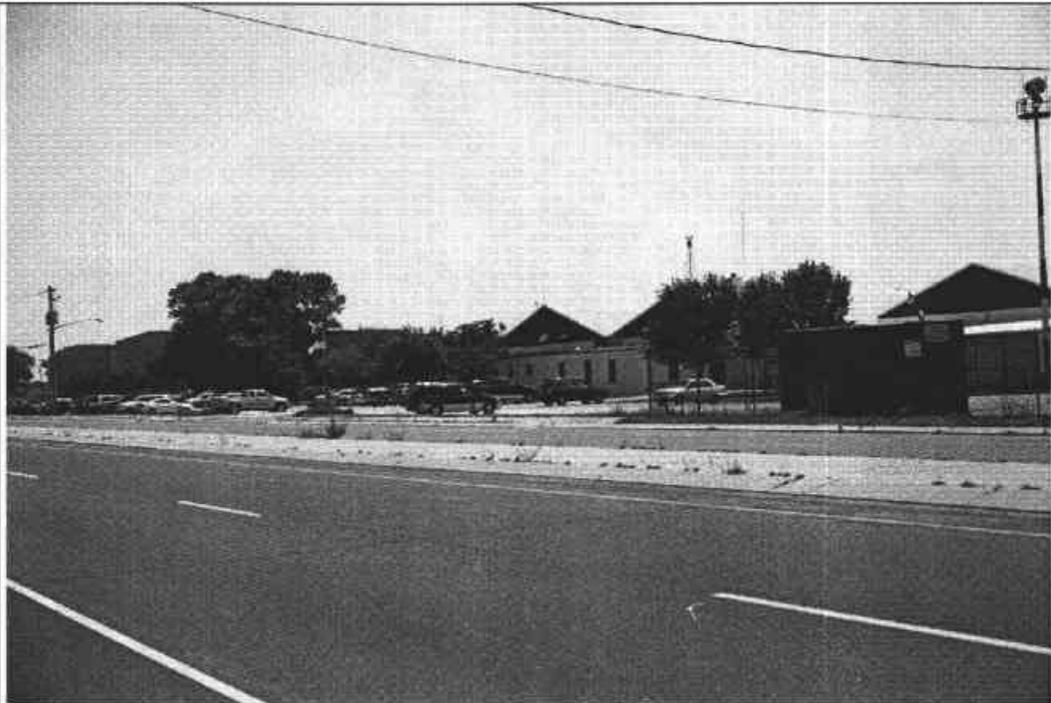
N14341. Photograph 5. Summit Aviation, overview of complex looking southwest.

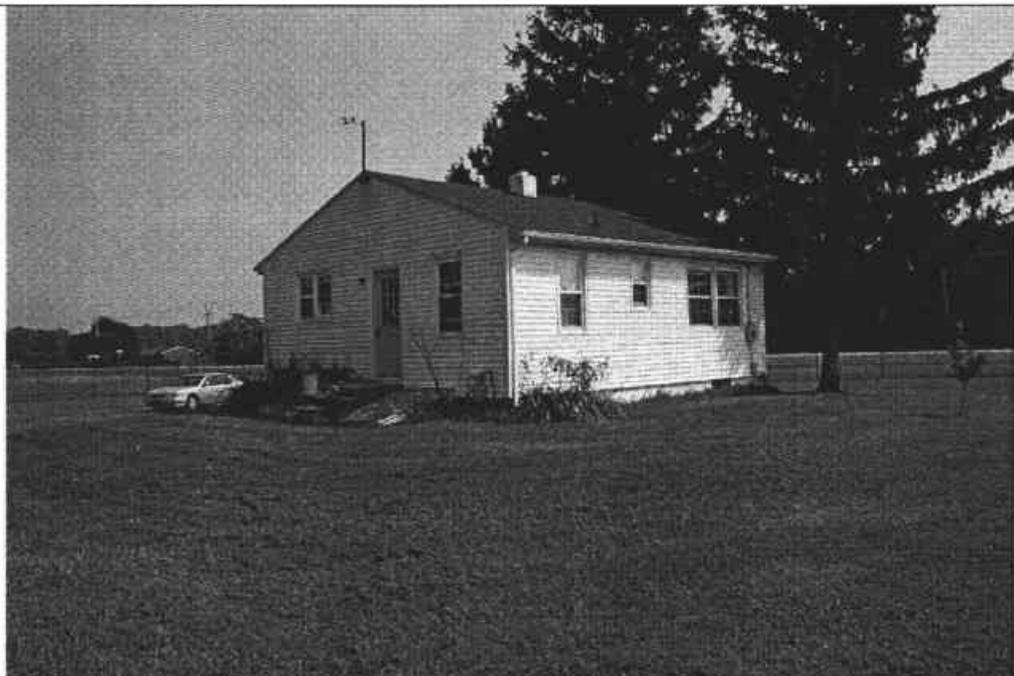
N14341. Photograph 6. Summit Aviation, view of residence on airport property, looking northwest, showing south and east elevations.

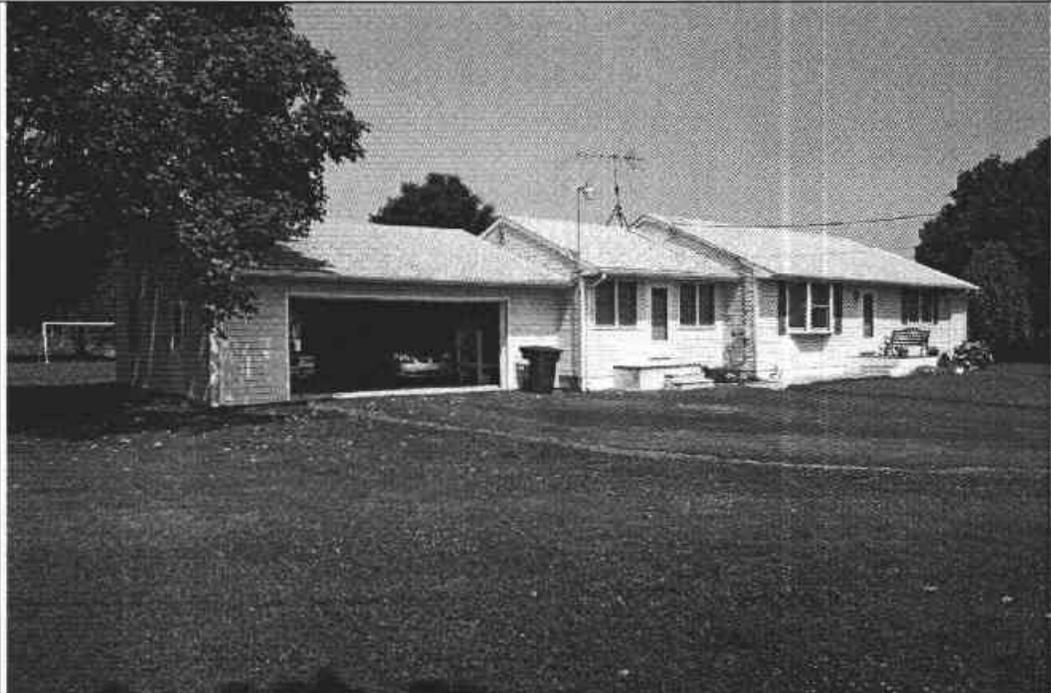
N14342. Photograph 1: Carroll House, view of east and south elevations, looking northwest, showing residence with added garage on the south elevation.

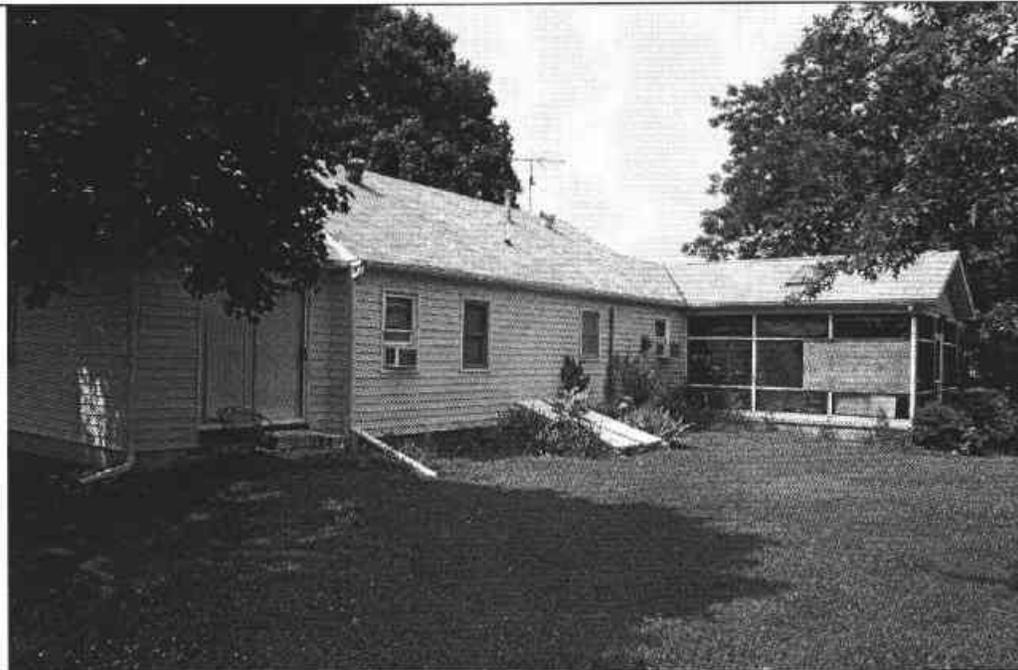
N14343, Photograph 2: 464 Ratledge Road house, showing south and east elevations, looking northwest. Note modern replacement door near foreground.

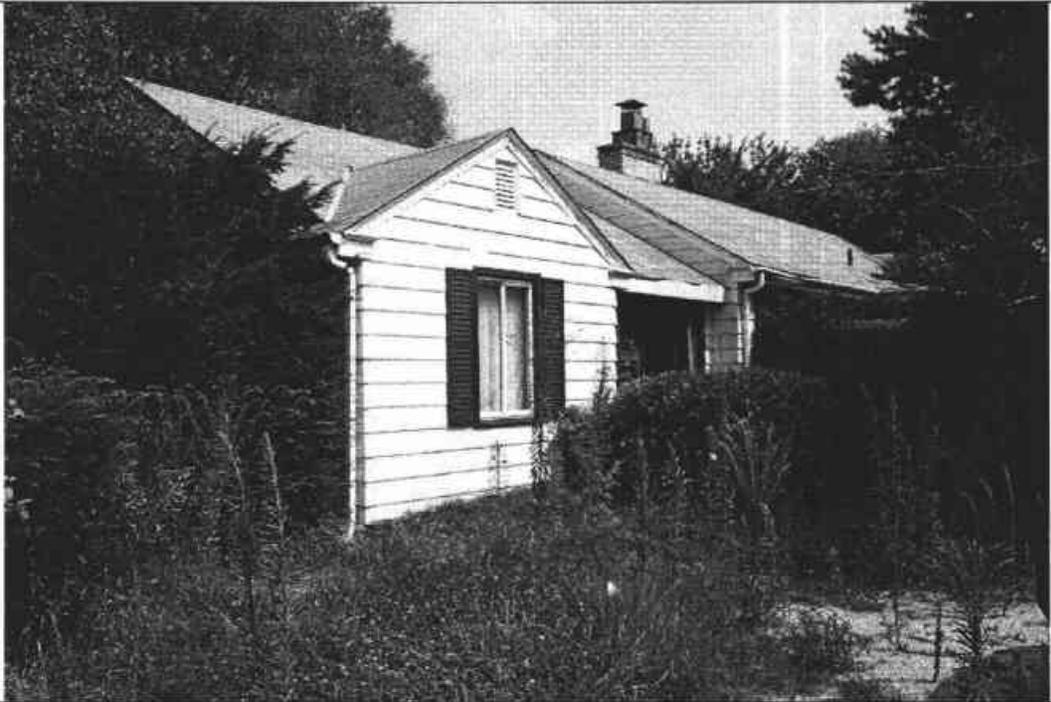
N14344. Photograph 1: Phillip and Nancy Eaton House, west and south elevations, view to southeast. Note replacement windows and overgrown landscaping.

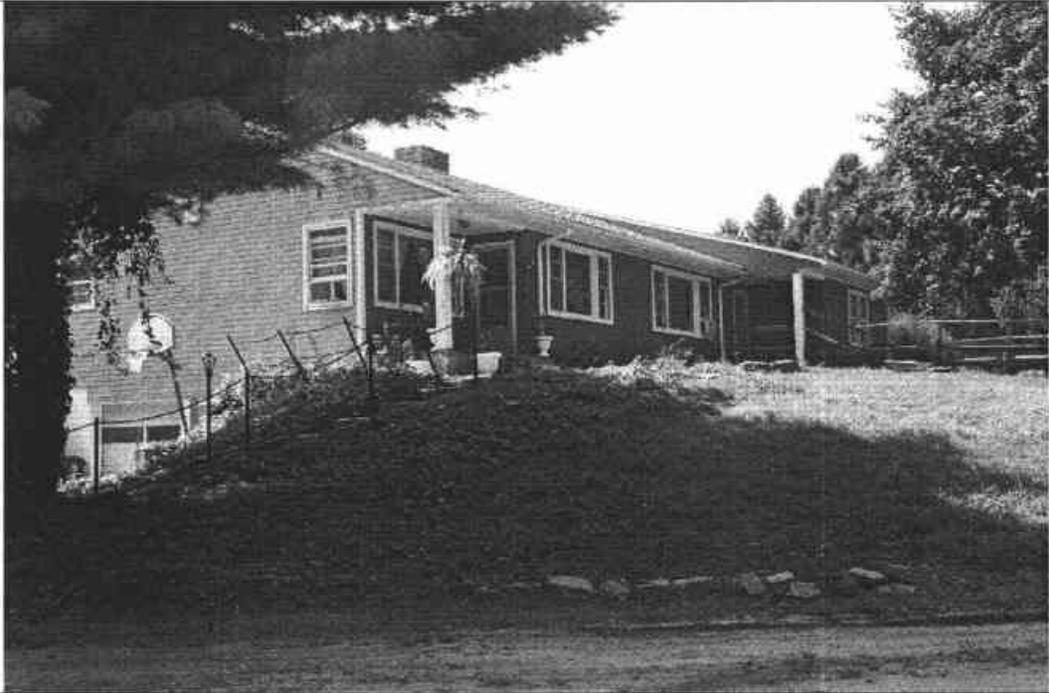
N14346. Photograph 1: Delmarva House 1, north and east elevations looking southwest. Note the three identical window bays on the north elevation and the garage entrance on the east elevation.

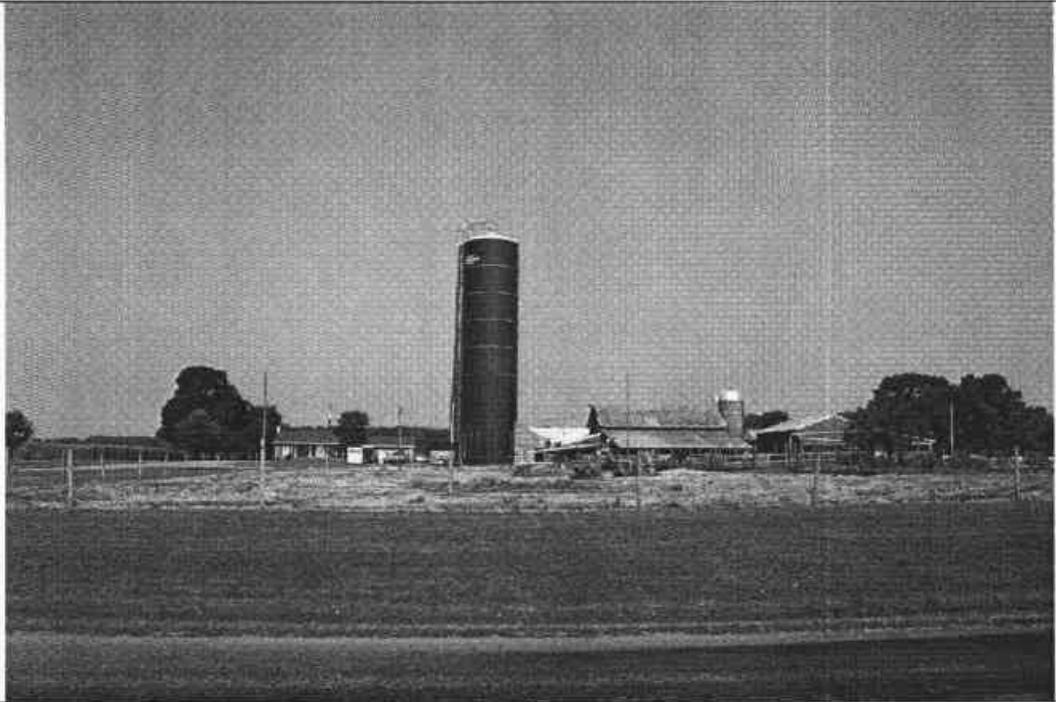
N14348. Photograph 1: Overview of farmstead, looking west. Note modern dwelling to the left, modern silos in foreground, and dairy barn with additions to the right.

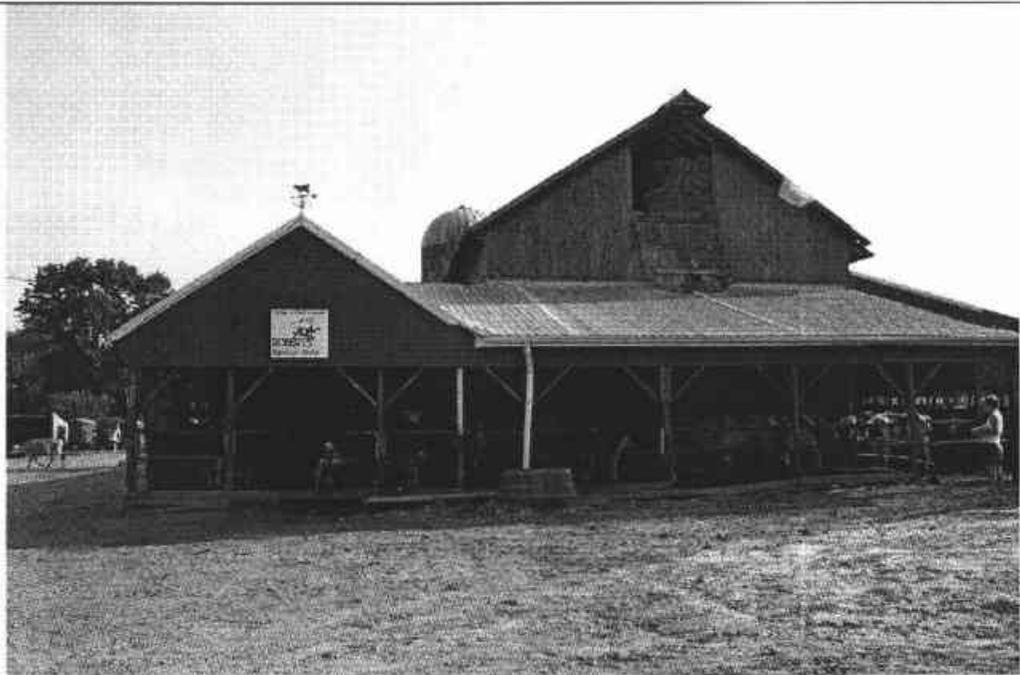
N14348. Photograph 2: Dairy barn, south elevation, looking north. Note modern additions to west and south elevations.

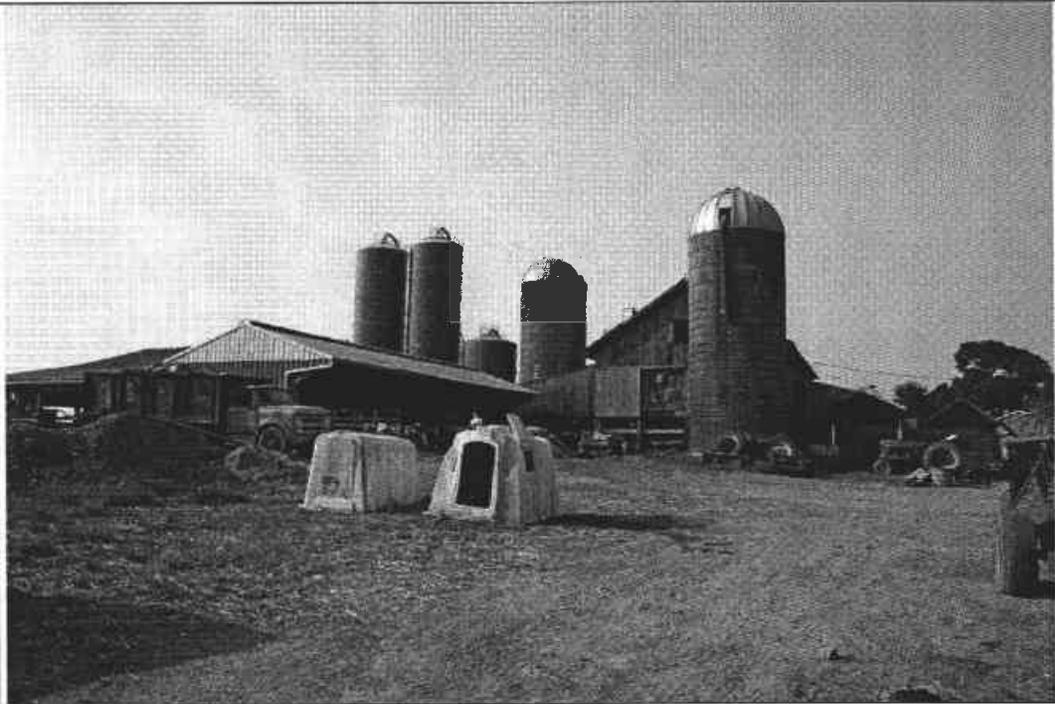
N14348. Photograph 3: Dairy barn, north elevation, looking south. Note modern heifer barn and cowshed additions to left.

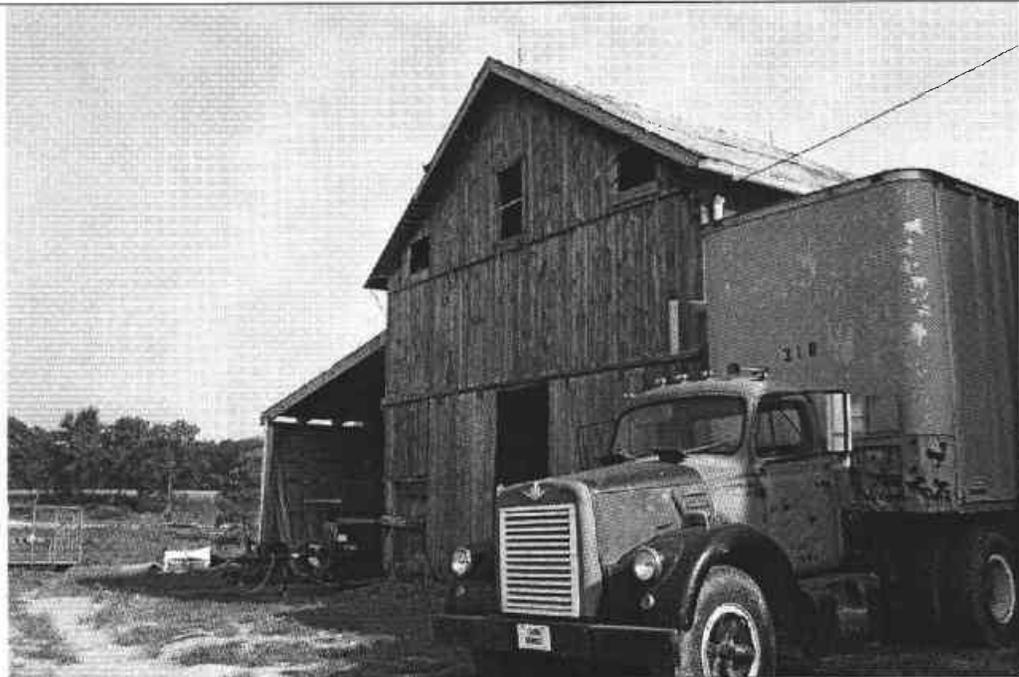
N14348. Photograph 4: Cornerrib/granary, south and east elevations, looking northwest. Note pole shed addition to west elevation to the left.

To be individually eligible, a farm building must be a rare, unique, or well-preserved example of a barn, house, or outbuilding. Although the corncrib/granary is extant, it has experienced a significant number of alterations (i.e., pole shed addition to west elevation and loss of cribbing at side walls); better preserved examples of this outbuilding type, such as the corncrib/granary at Cochran Grange (CRS No. N00118), remain in the study area. The garage and sheds are not rare examples of their types and are in fair-to-poor condition. Additionally, the sheds appear to have been relocated from a former location on the farm. The barn has experienced a number of modern updates (i.e., cowsheds, heifer barn, and modern milk house) and does not appear to be individually eligible. Therefore, the individual buildings that make up the farm complex are not eligible under Criterion C due to loss of integrity. Although the property was historically

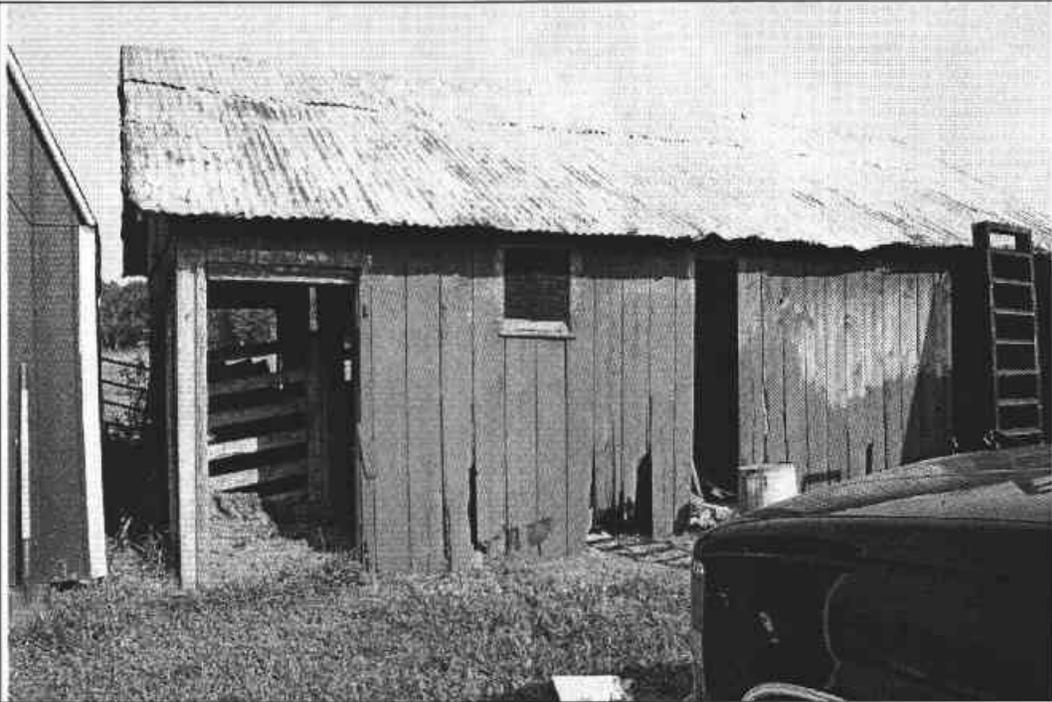
N14348. Photograph 5: Garage, east elevation, looking northwest. Note deteriorated condition of building. A former stable may have been located at the southern end of the building.
