CRS No. N14349

Name: George and Patricia Baker House

CULTURAL RESOURCE SURVEY
PROPERTY IDENTIFICATION FORM

6. PROJECT TITLE/REASON FOR SURVEY (if applicable):
U.S. 301 Project Development

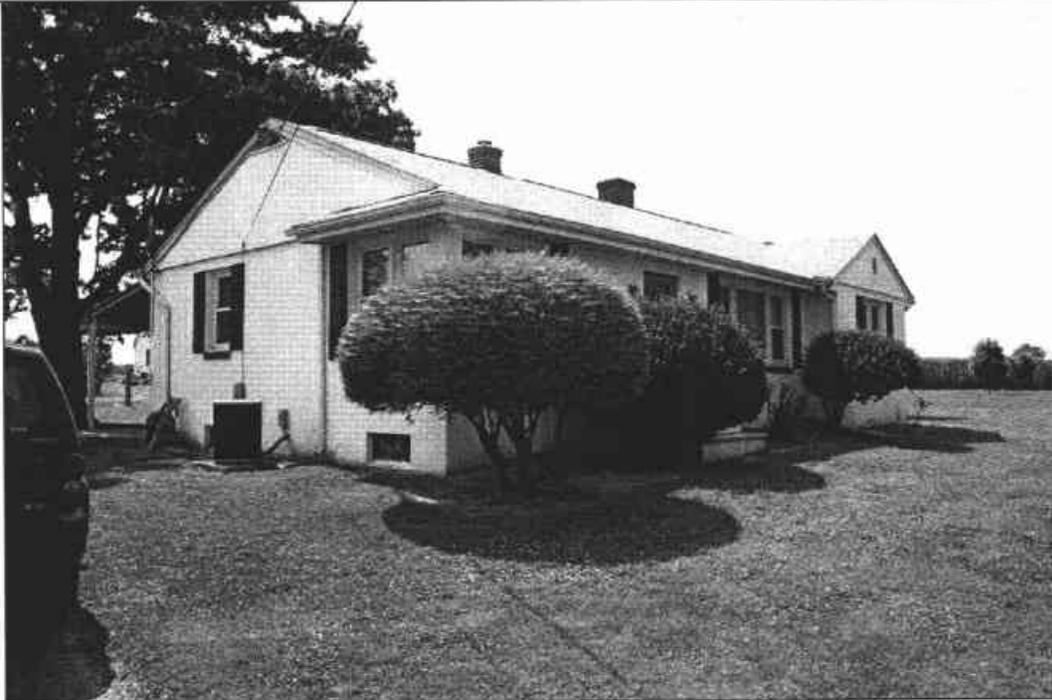
N14349. Photograph 1: George and Patricia Baker House, west and north elevations, looking southeast. Note replacement windows and the side gable Ranch style, a common example in Delaware.

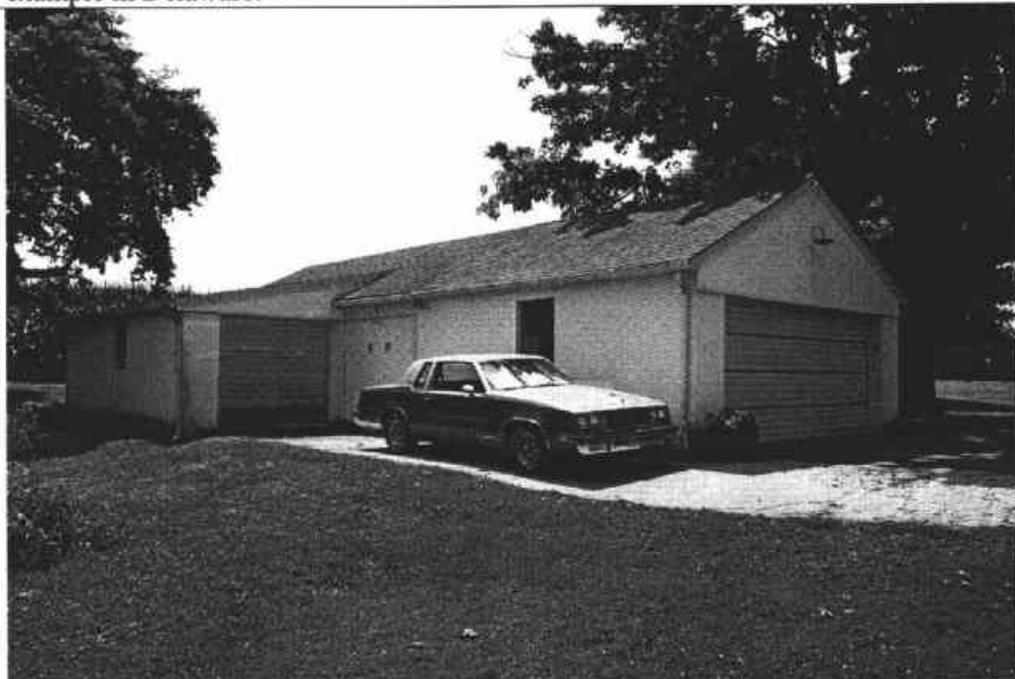
N14349. Photograph 2: Garage, west and north elevations, looking southeast. Note fiberglass garage doors and addition extending from west elevation.

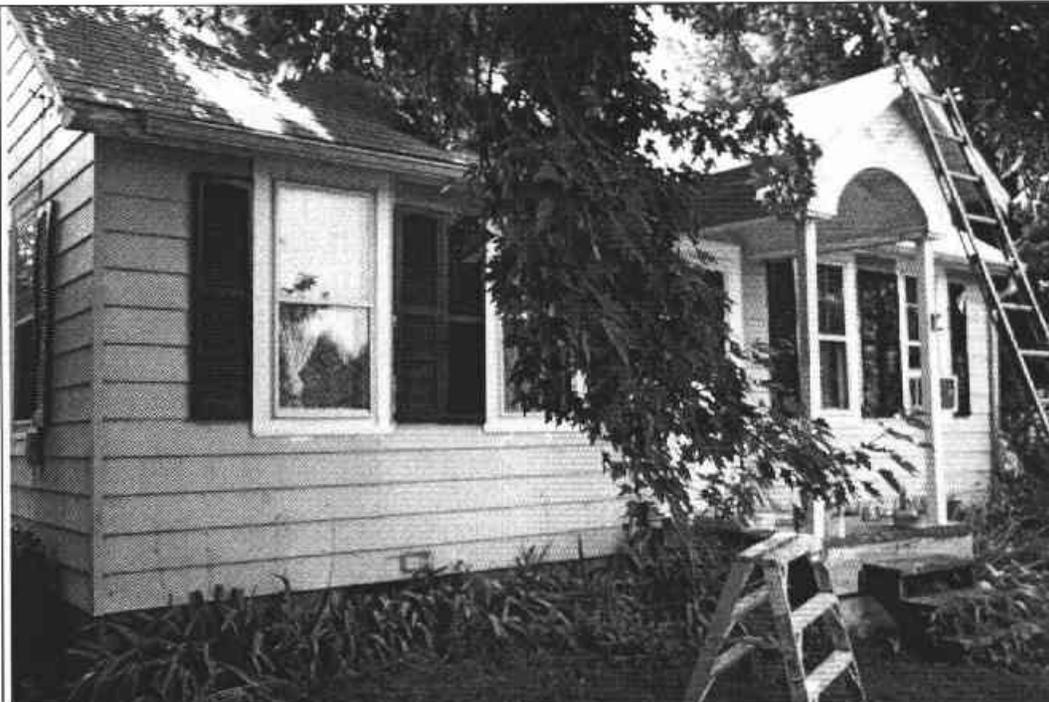
N14350. Photograph 1: Dwelling, west elevation, looking southeast. Note original windows and gable entry.

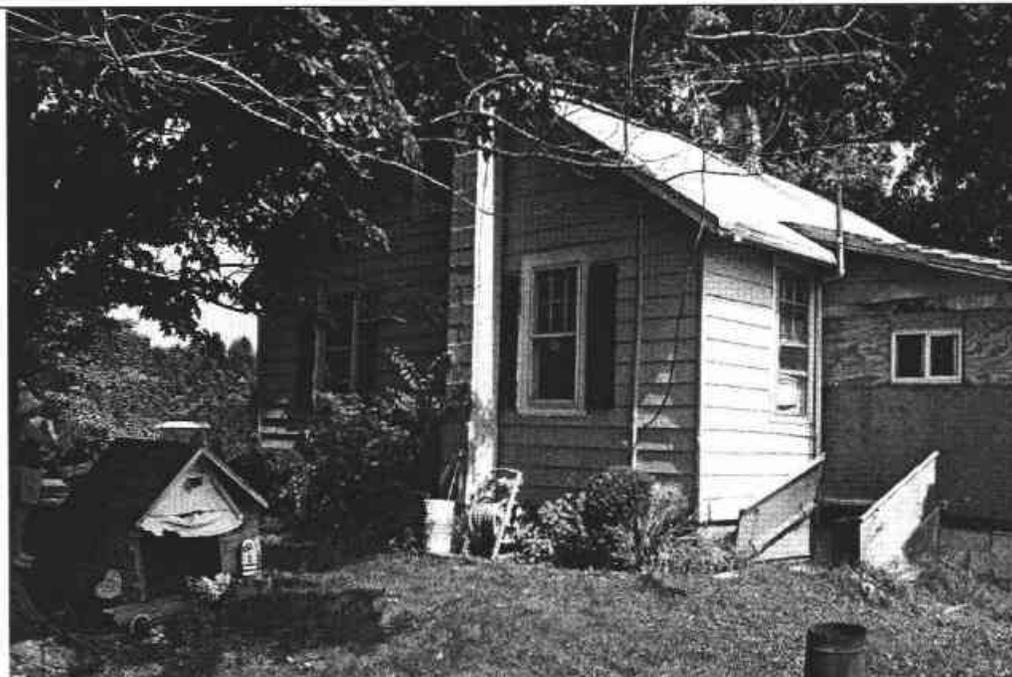
N14350. Photograph 2: Dwelling, south and east elevations, looking northwest. Note addition extending from east elevation and its lack of cladding material.

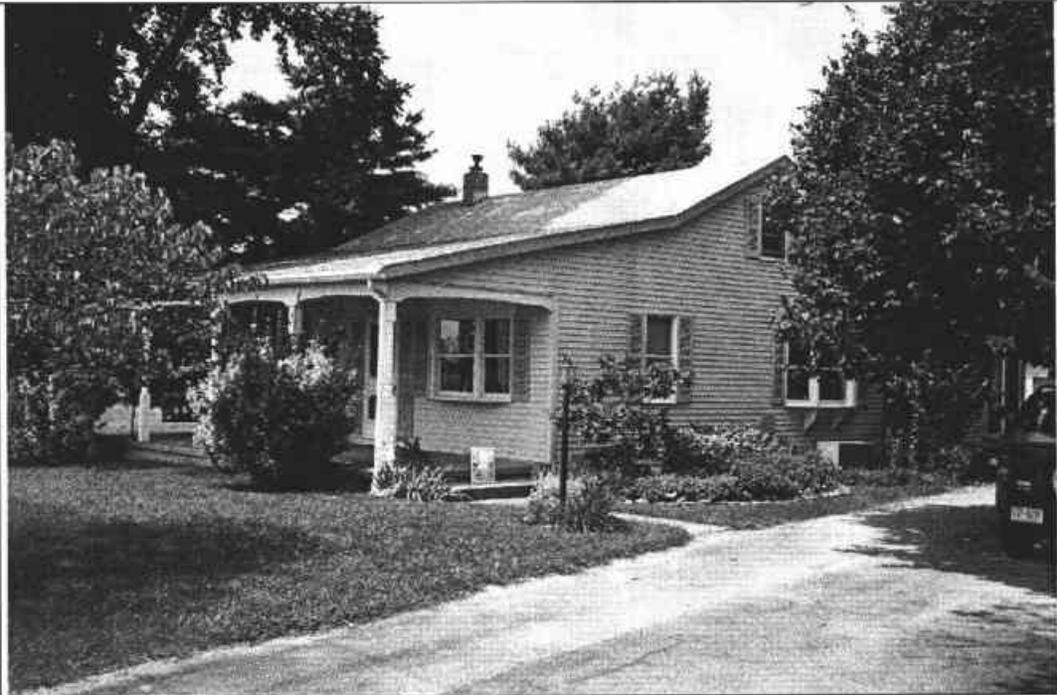
N14351. Photograph 1: Catherine Broadwater House, dwelling, south and east elevations, looking northwest. Note vinyl siding and replacement windows.

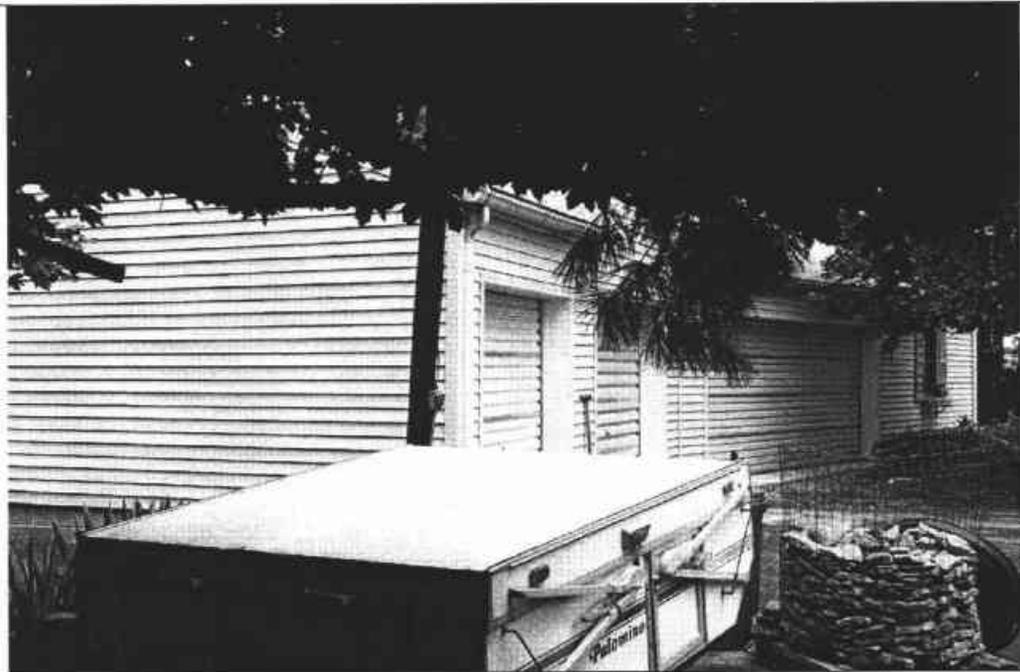
N14351. Photograph 2: Catherine Broadwater House, garage, south elevation, looking east. Note replacement cladding, modern overhead garage doors, and skewed orientation of eastern addition. A mobile pop-up camper is located in the picture's foreground.

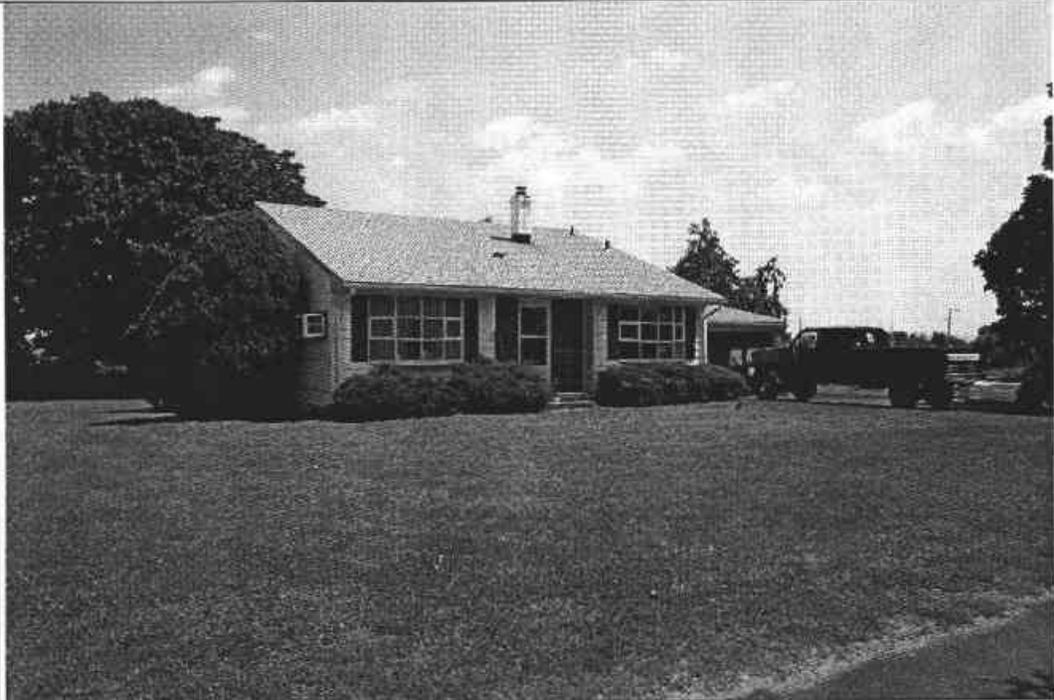
N14352. Photograph 1: George E. and Ivy Thomas House, overview looking east. This dwelling is a representative example of a mid-twentieth-century Minimal Traditional building. Note the attached garage on the south elevation.

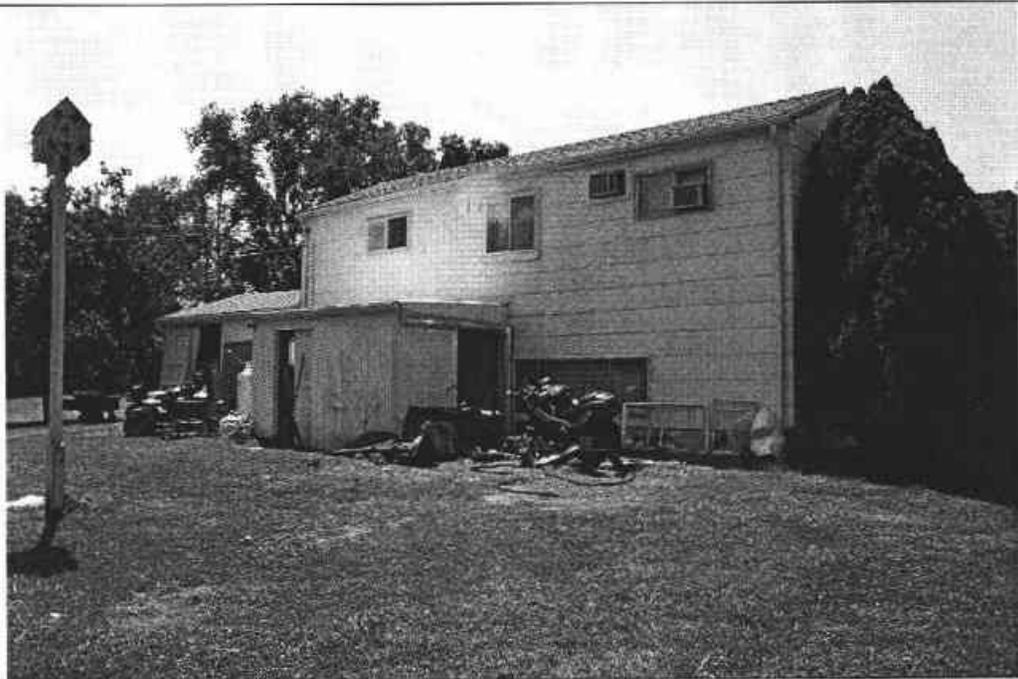
N14352. Photograph 2: Dwelling, rear (east elevation), looking southwest. Note walk-out basement partially hidden by the one-story shed roof addition.

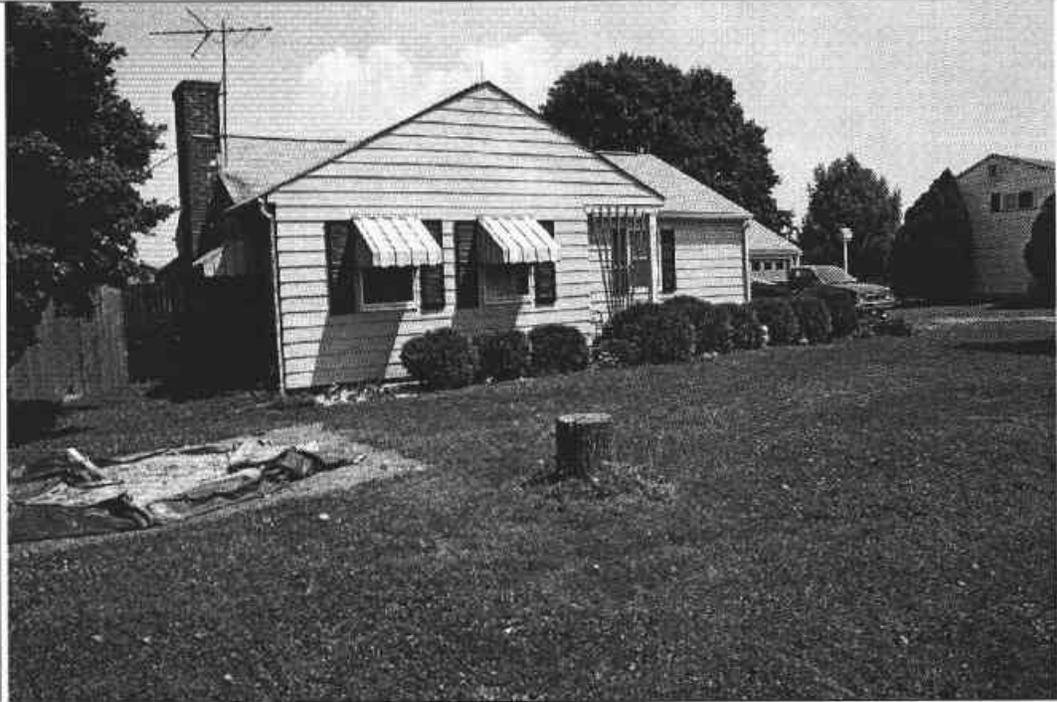
N14353. Photograph 1: Insolo-Robinson House, view of west and north elevations, with detached garage just to the south of the house.

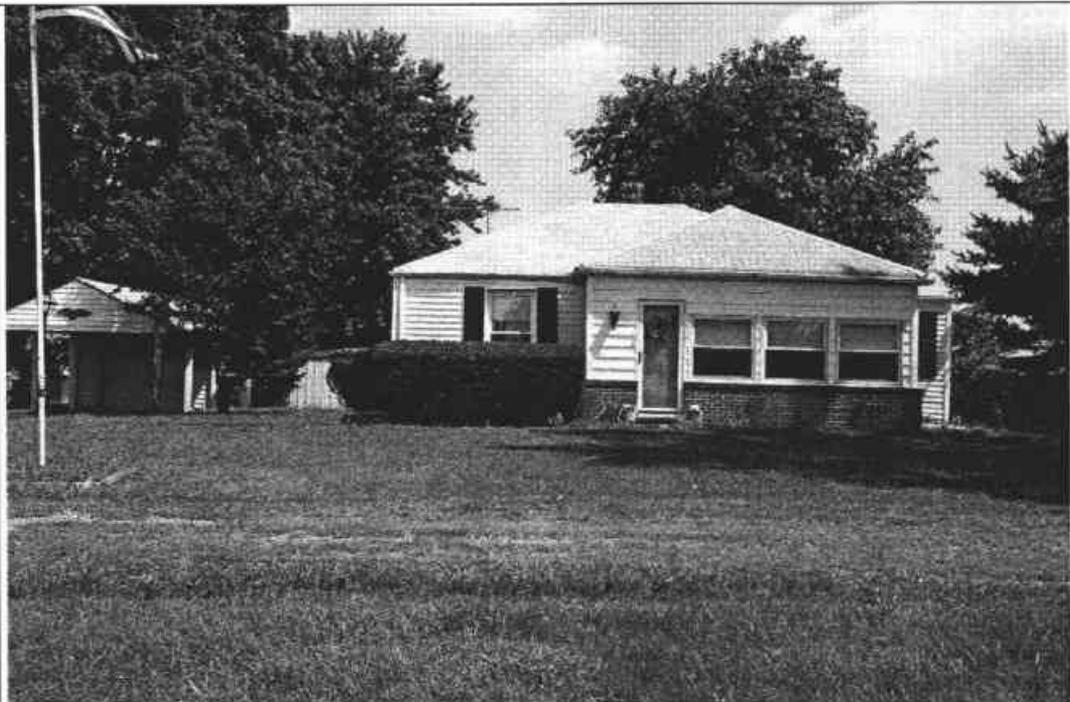
N14354. Photograph 1: Property overview, view looking east. This property is a typical example of a mid-twentieth-century Minimal Traditional dwelling.

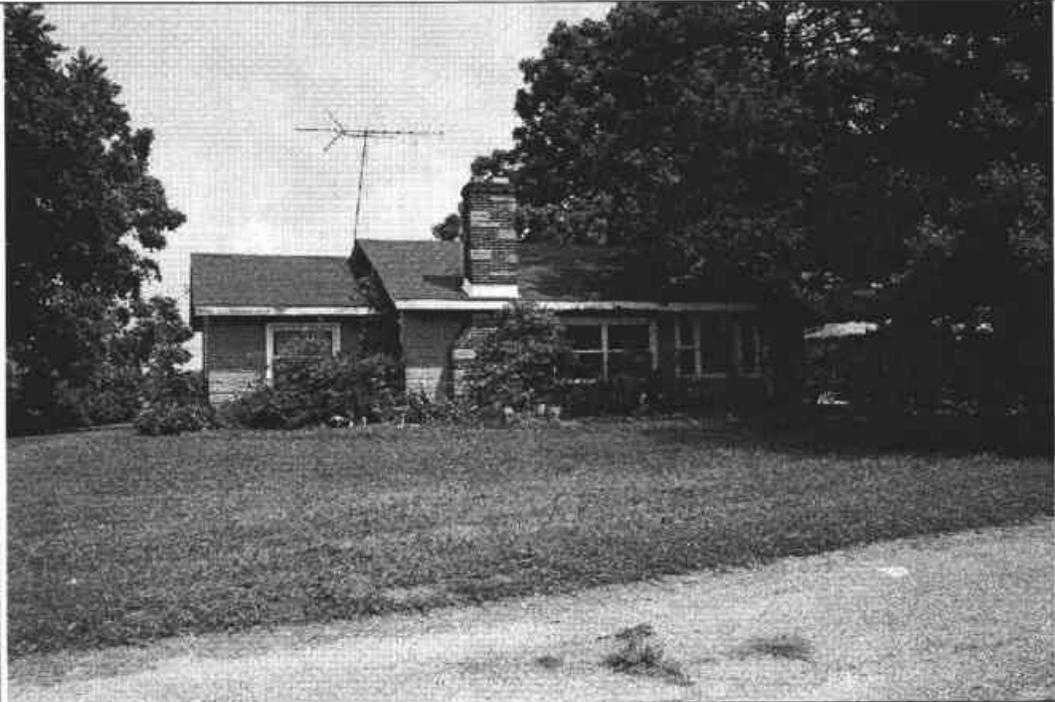
N14355. Photograph 1: Massey-Elston House, view of west elevation, looking east. Note Chicago window, four-pane picture window, and exterior chimney.

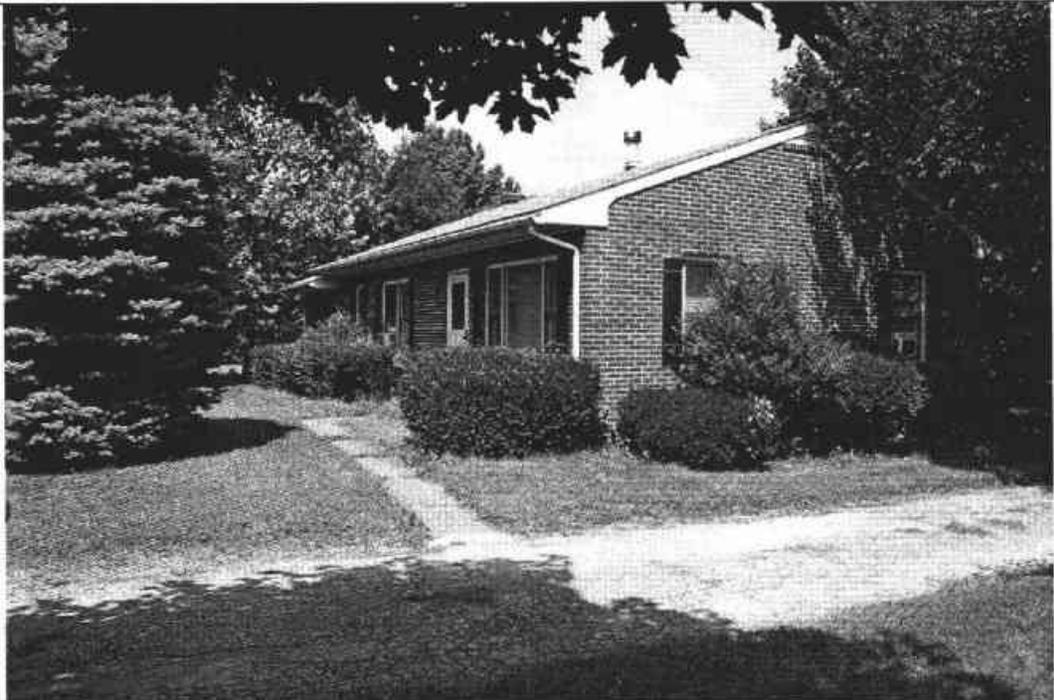
N14356. Photograph 1: Dwelling, west and south elevations, view looking northeast. This property is a representative example of a mid-twentieth-century Ranch dwelling.

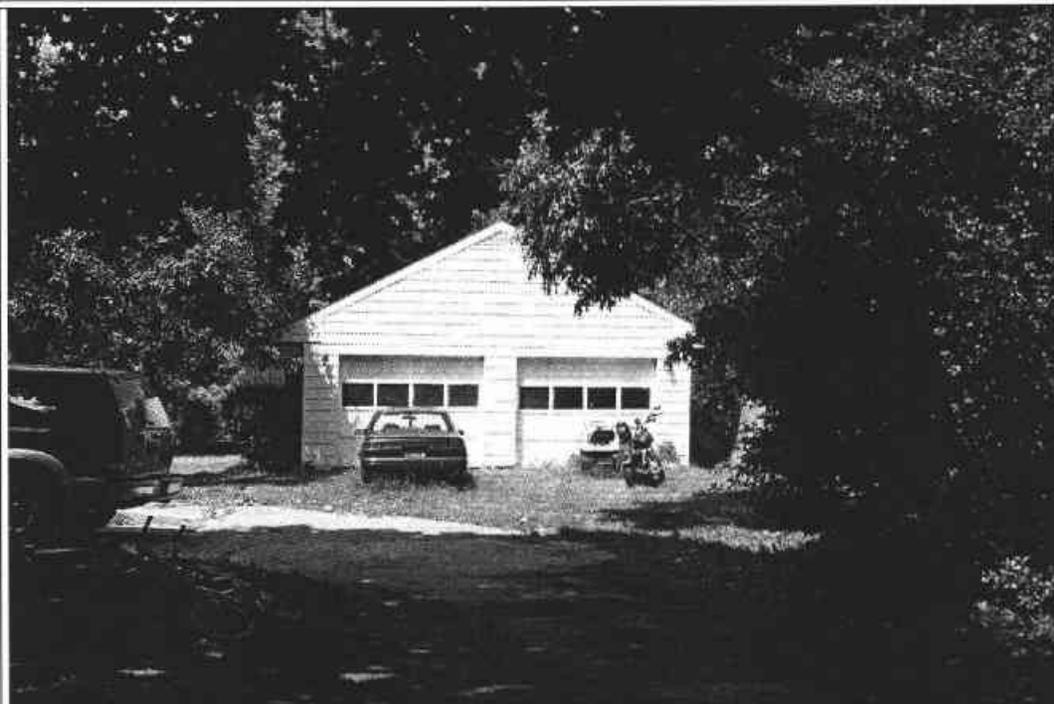
N14356. Photograph 2: Garage, south elevation, view looking north.

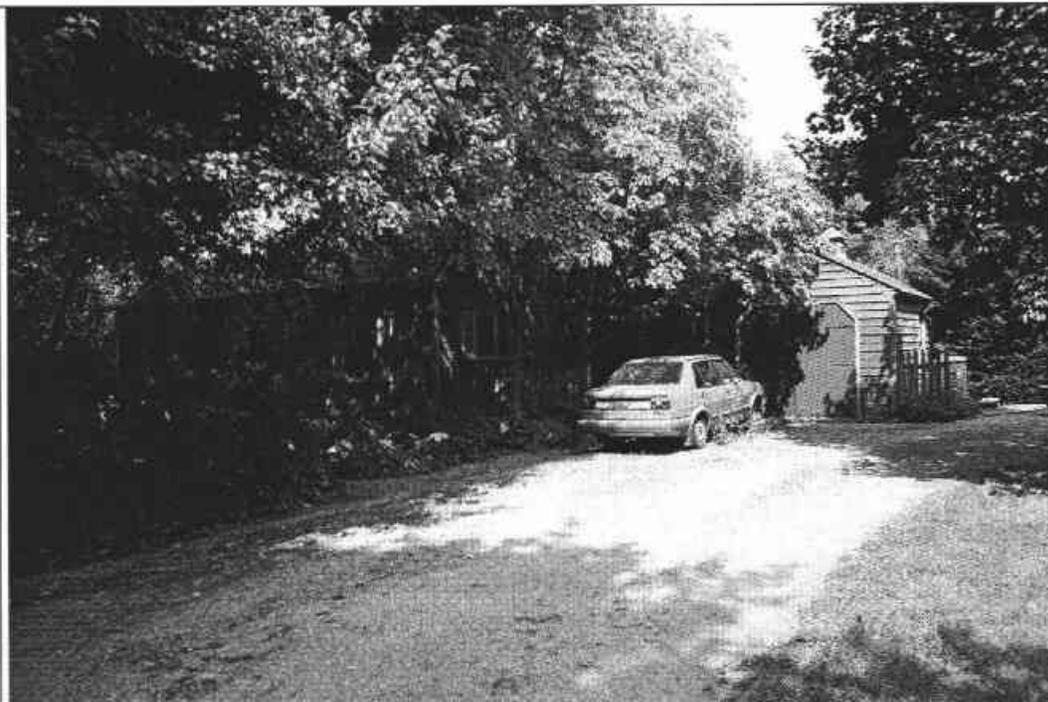
N14357. Photograph 1: Austin and Virginia Foley House, overview looking east, showing façade with attached garage. Note non-operable shutters on windows on house in shadow to left of photograph.

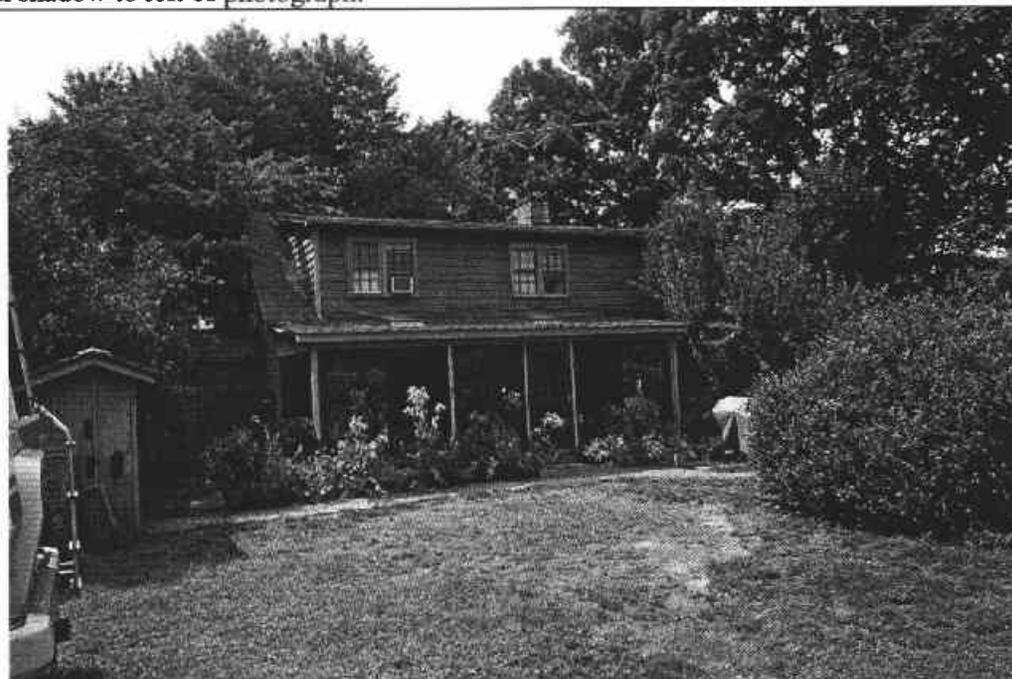
N14357. Photograph 2: Austin and Virginia Foley House, overview looking west, showing rear of house. Note large shed-roof dormer and sun room with large windows on ground floor.

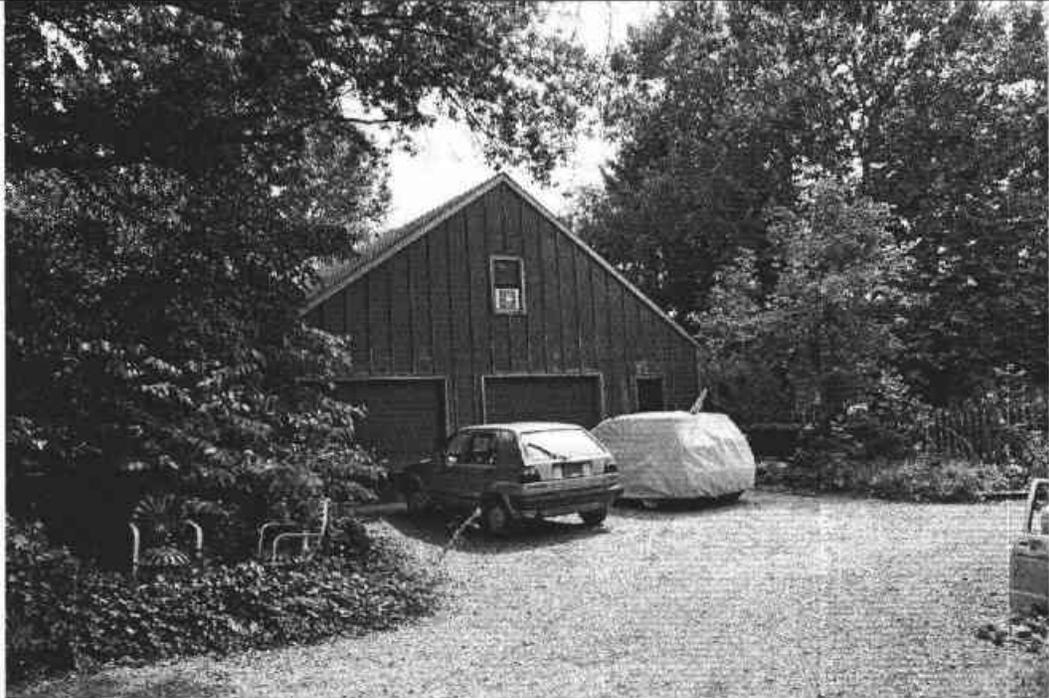
N14357. Photograph 3: Austin and Virginia Foley House, showing large modern garage, looking southeast. There are a variety of other modern outbuildings on this property.
