**CRS No. N14358**

**Name: Asbury Cemetery**

**Address: West side of South DuPont Highway**

**Date of Construction/Major Alteration: ca. 1815; 1928**

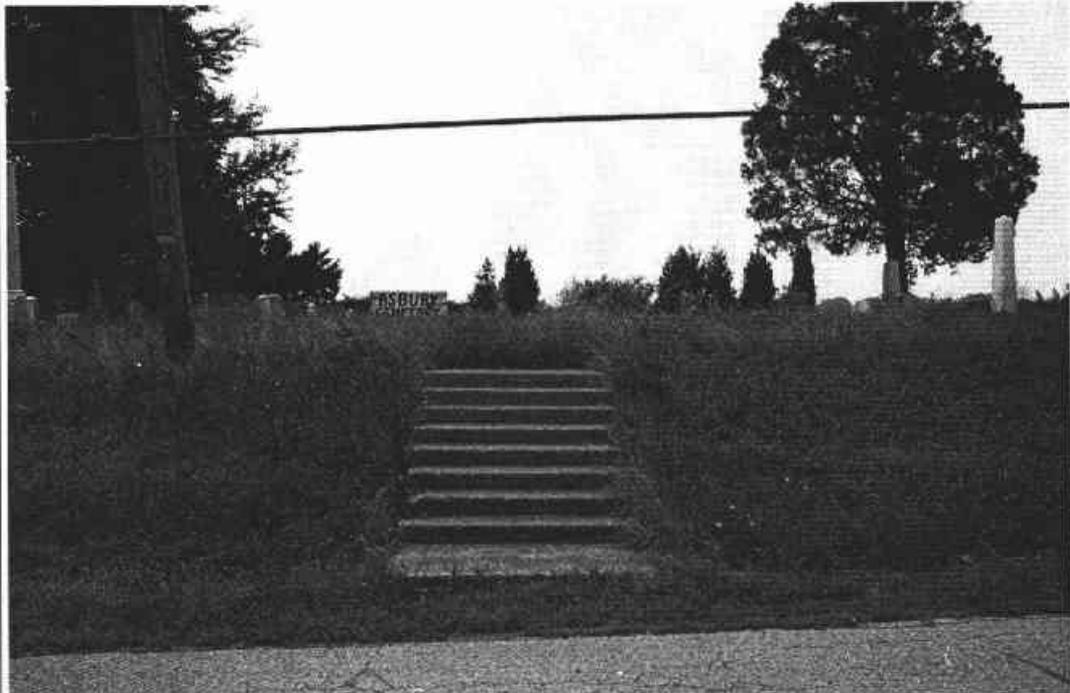
**N14358. Photograph 1. Asbury Cemetery, overview showing stair entrance from road, looking west.**

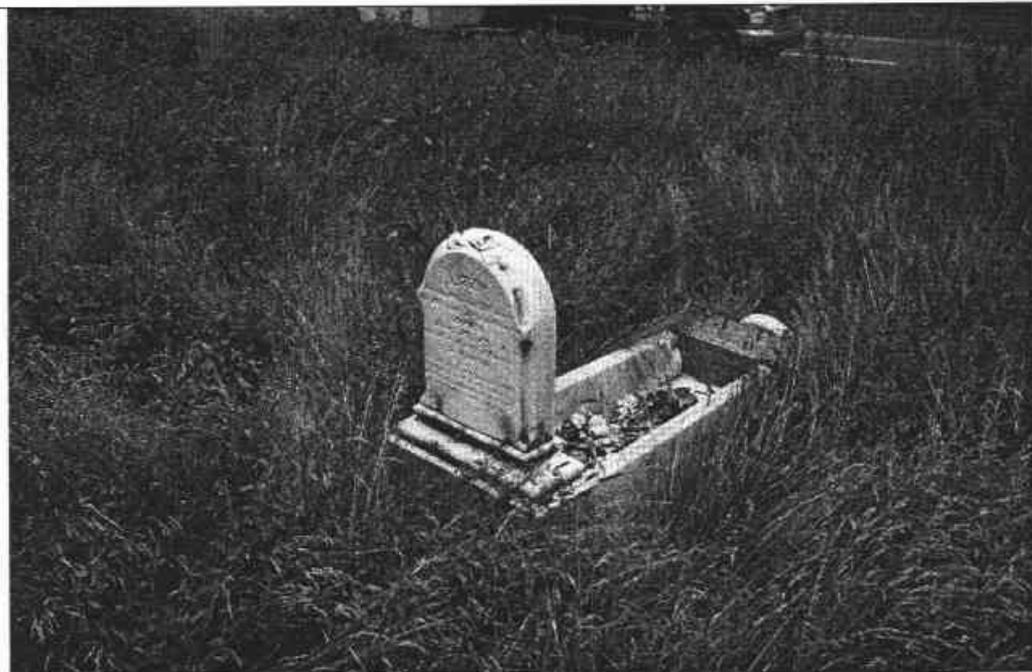
**N14358. Photograph 2. Asbury Cemetery, showing headstone and marker; note proximity of highway with truck in background.**

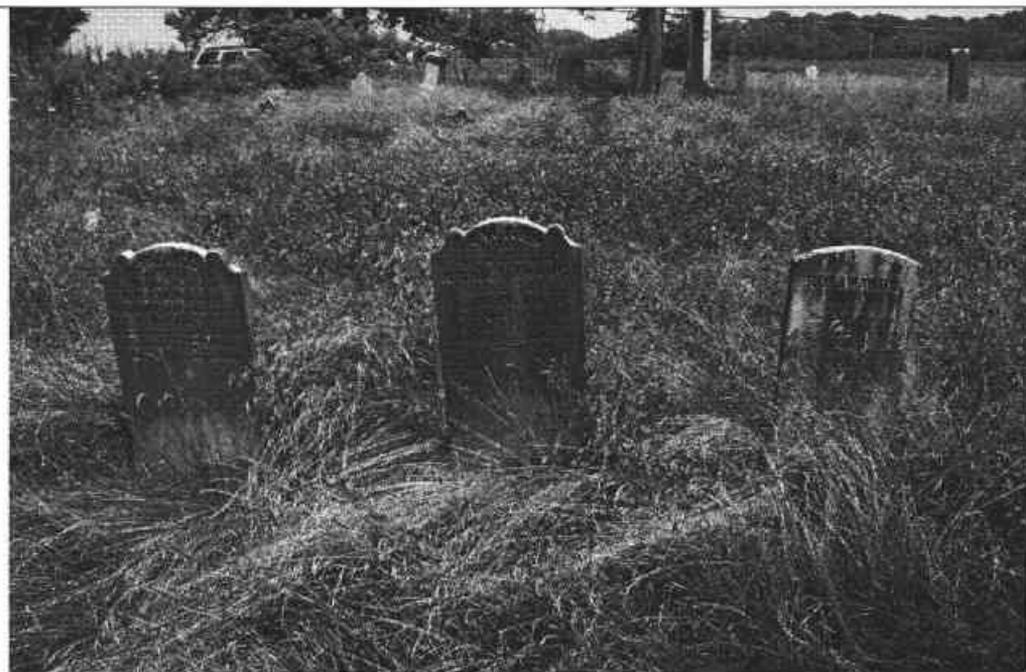
N14358. Photograph 4. Asbury Cemetery, showing typical example of markers located in the western portion of the cemetery, view looking northeast.

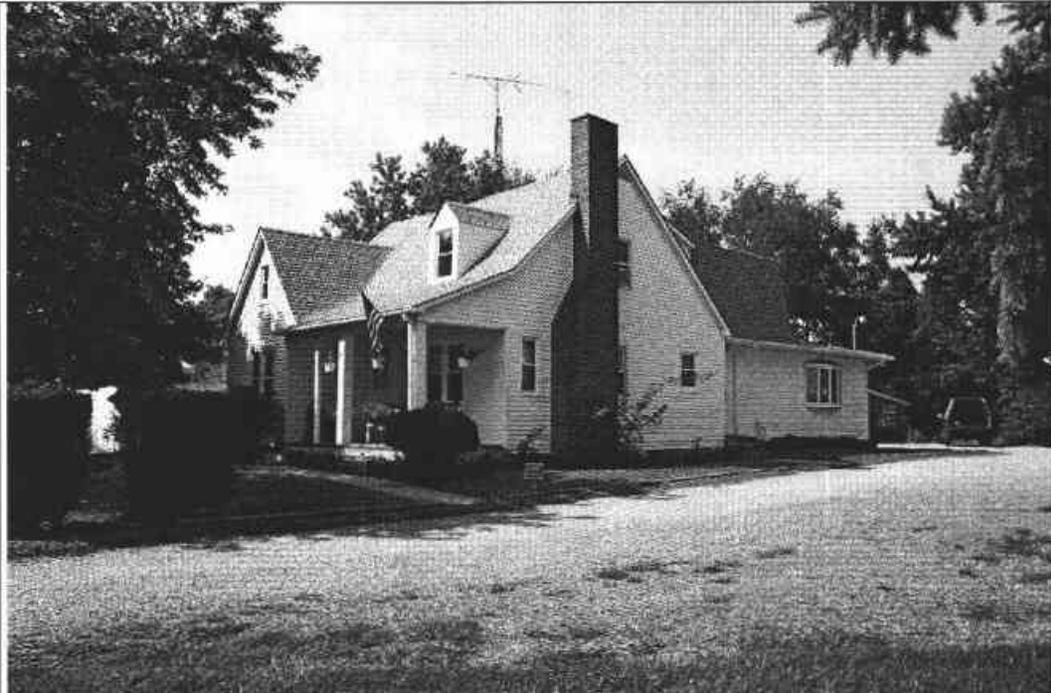
N14359. Photograph 1: William and Mary Hitch House, south and east elevations, view to northwest. Note vinyl siding, replacement windows, and large addition extending from north elevation.

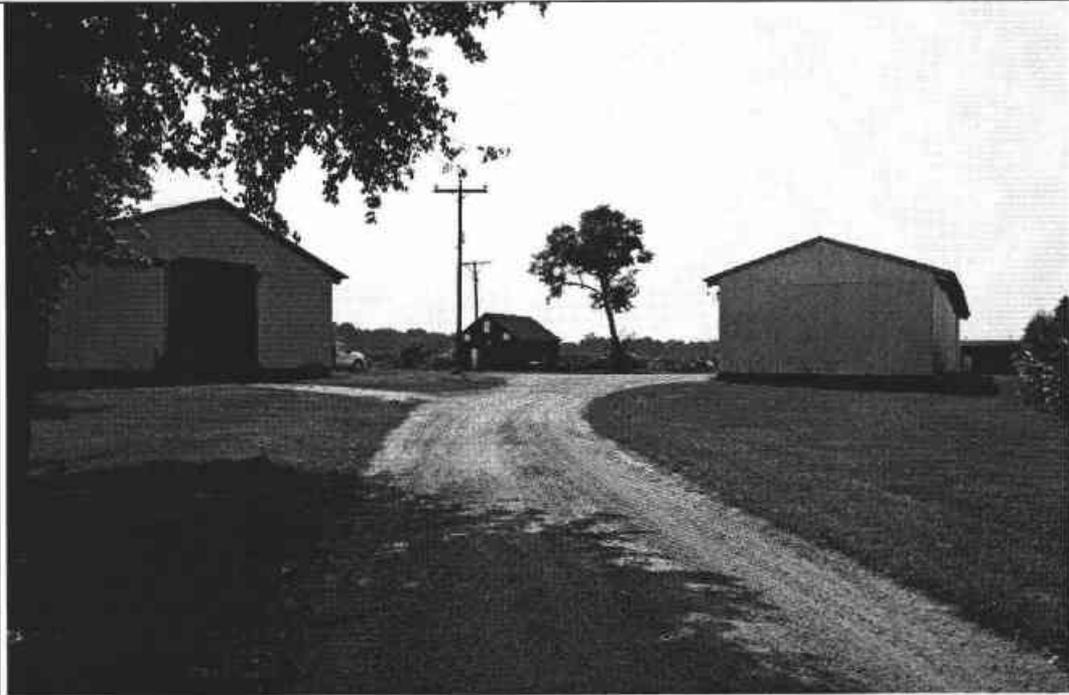
N14360. Photograph 1: Overview of farm complex at end of gravel driveway, view to southwest. Note hay barn to left, equipment shed and corncrib/granary in middle, and equipment shed to right.

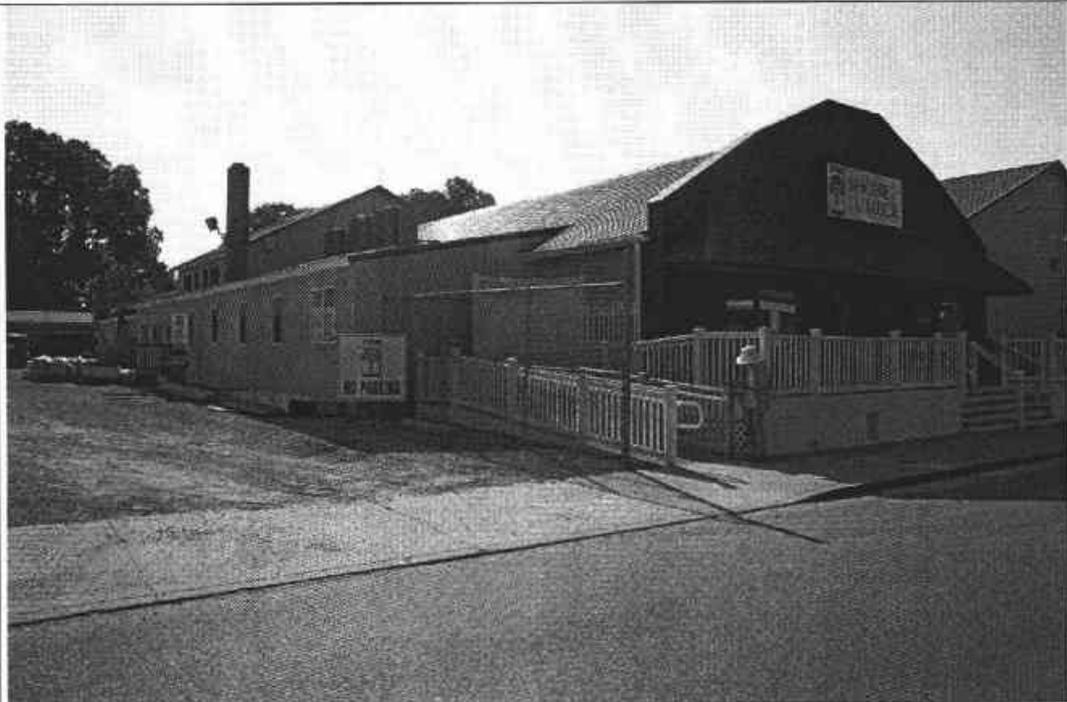
N14361. Photograph 1. Short & Wall Lumber Company, view looking southeast, showing west and north elevations. Note modern pent roof, modern handicap access ramp, modern deck, and replaced windows.

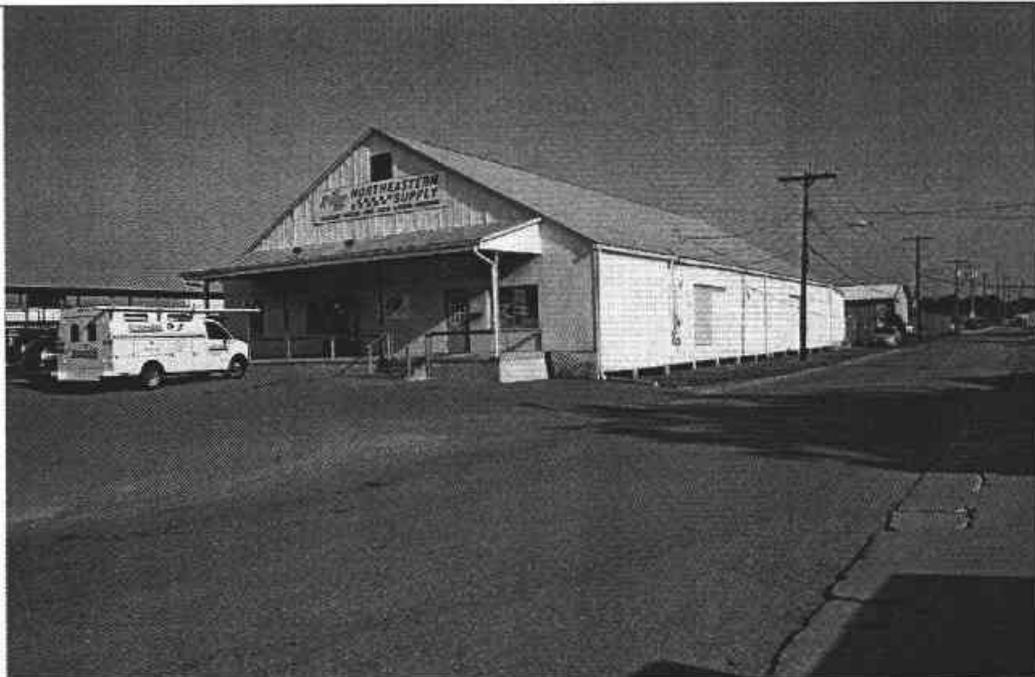
**N14362. Photograph 1. 225 West Main Street, view looking northwest, showing south and east elevations of former fertilizer warehouse, now serving as a retail store (Northeastern Supply). Note replacement deck, and modern/replaced fixed-pane window and pedestrian door, and louvered opening in gable end.**

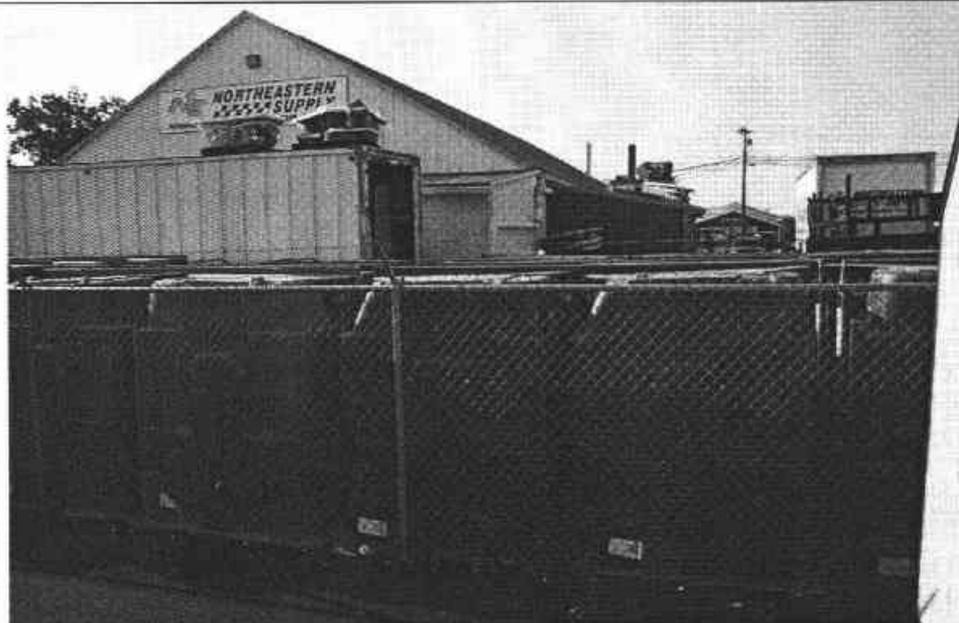
**N14362. Photograph 2. 225 West Main Street, view looking south, showing former fertilizer warehouse, north and partial east elevations. The north and east side the building is used for outside storage; note trailers and hot tubs in foreground.**

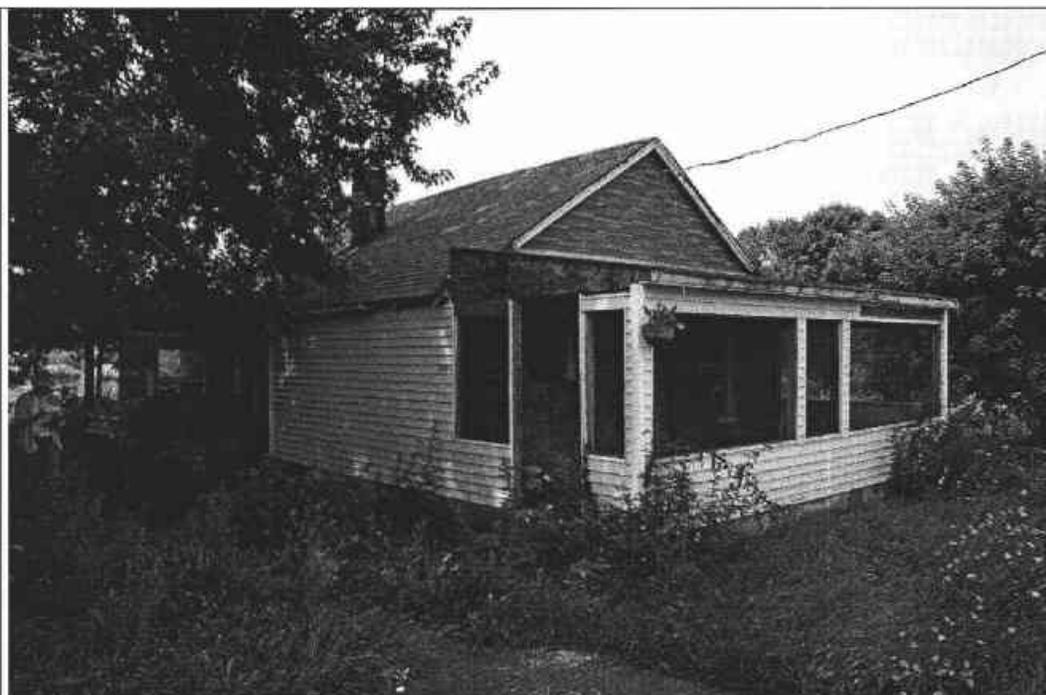
N14363. Photograph 1: Dwelling, north elevation, view to southwest. Note the enclosed front porch and vinyl siding.

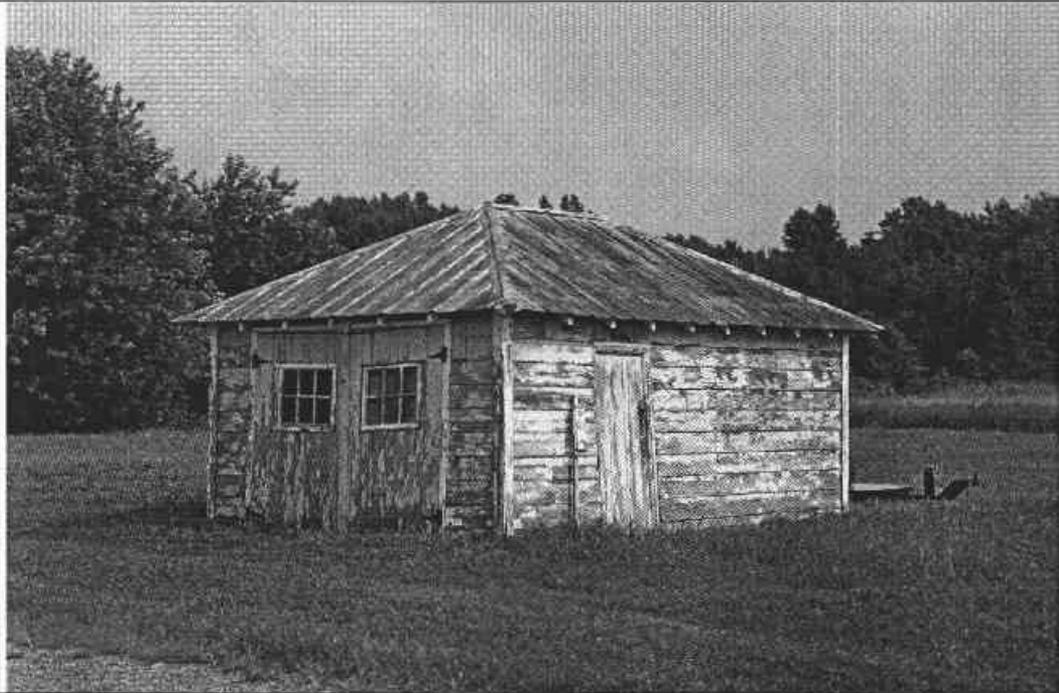
N14364. Photograph 1: Garage, view of north and west elevation. The garage is located behind a modern building. It is unclear if this building is original to the property.

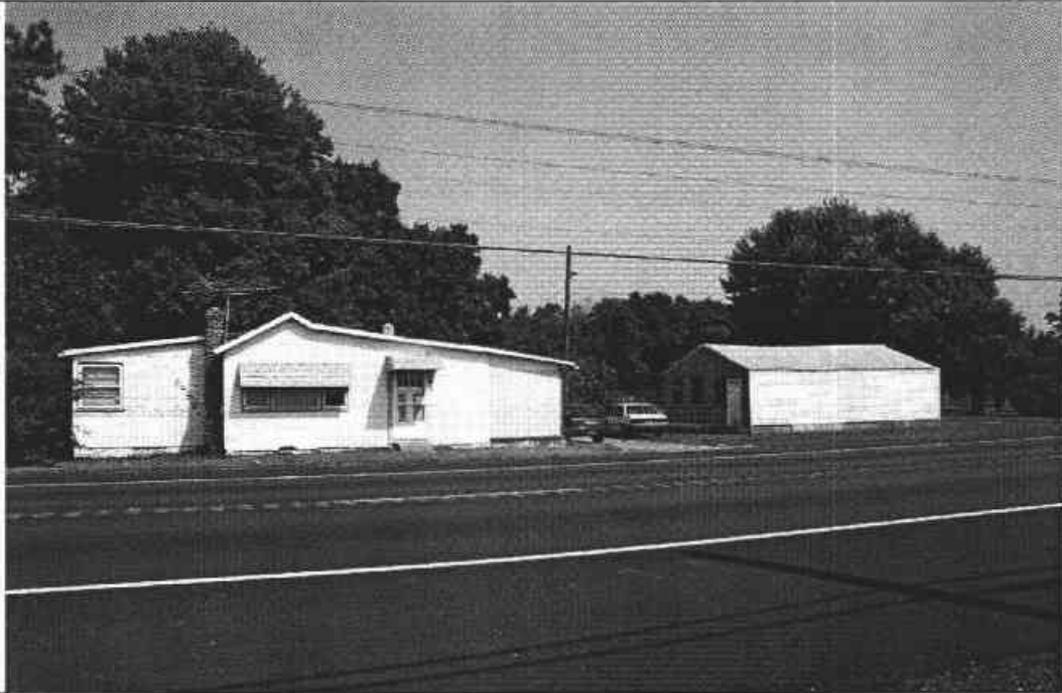
N14365. Photograph 1: Overview photograph, view to southeast. Note the current gable front orientation of the former side gable dwelling as well as the multiple changes to the original gas station.

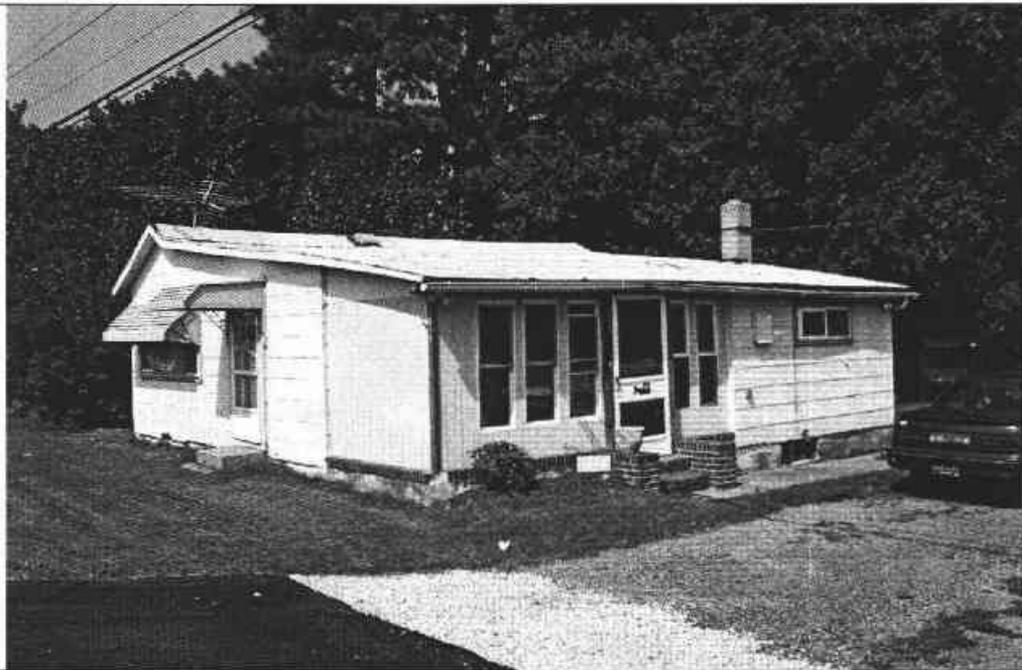
N14365. Photograph 2: Dwelling, west and south elevations, view to northeast. Note the circa-1970 enclosed porch and secondary entrance on the south elevation. .

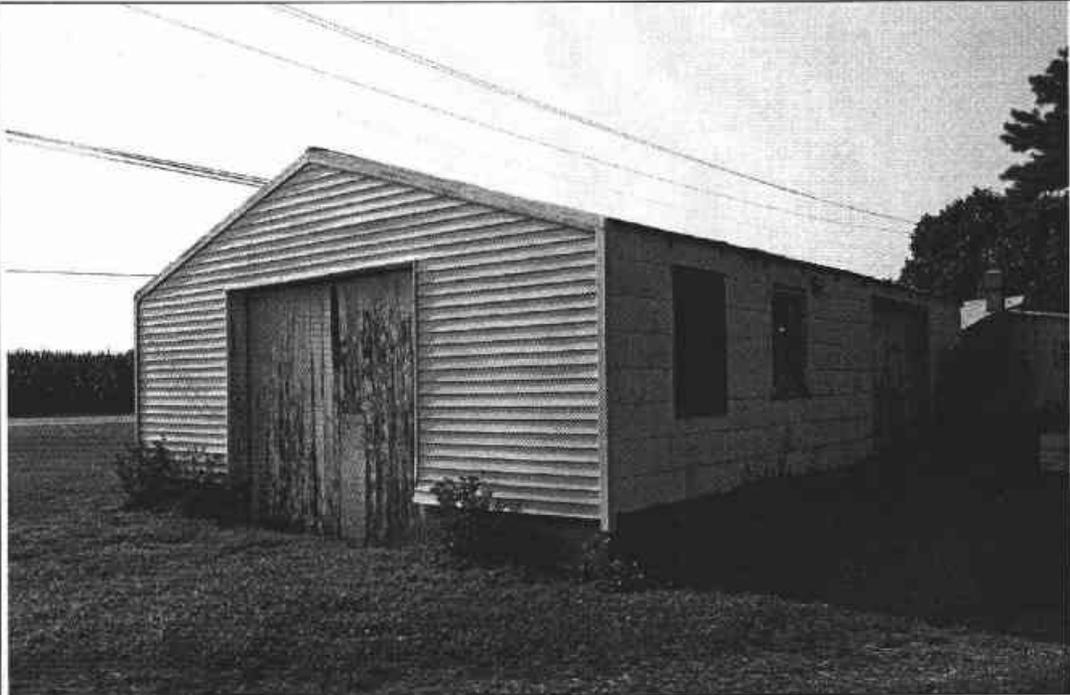
N14365. Photograph 3: Garage, south and east elevations, view to northwest. Note the vehicle openings on each elevation and the replacement vinyl siding on the south elevation.

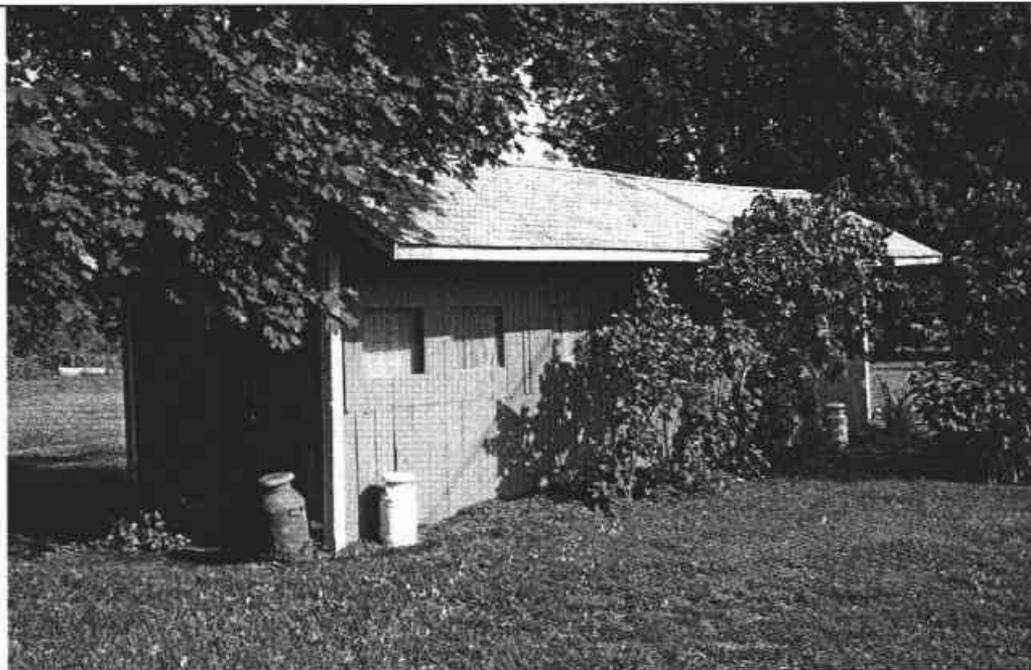
N14365. Photograph 4: Carnival shed, north and west elevations, view to southeast. The shed was likely moved to the property shortly after construction of the dwelling.

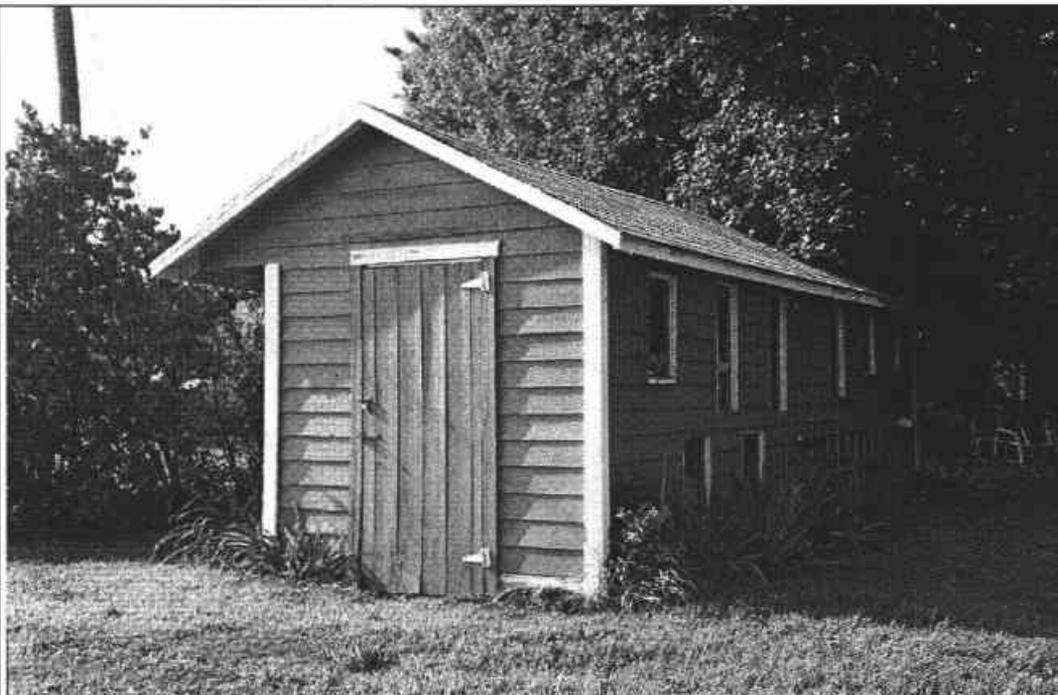
N14365. Photograph 5: Carnival shed, south and east elevations, view to northwest. Note the batten door on the south elevation and the later irregular fenestration on the east elevation.

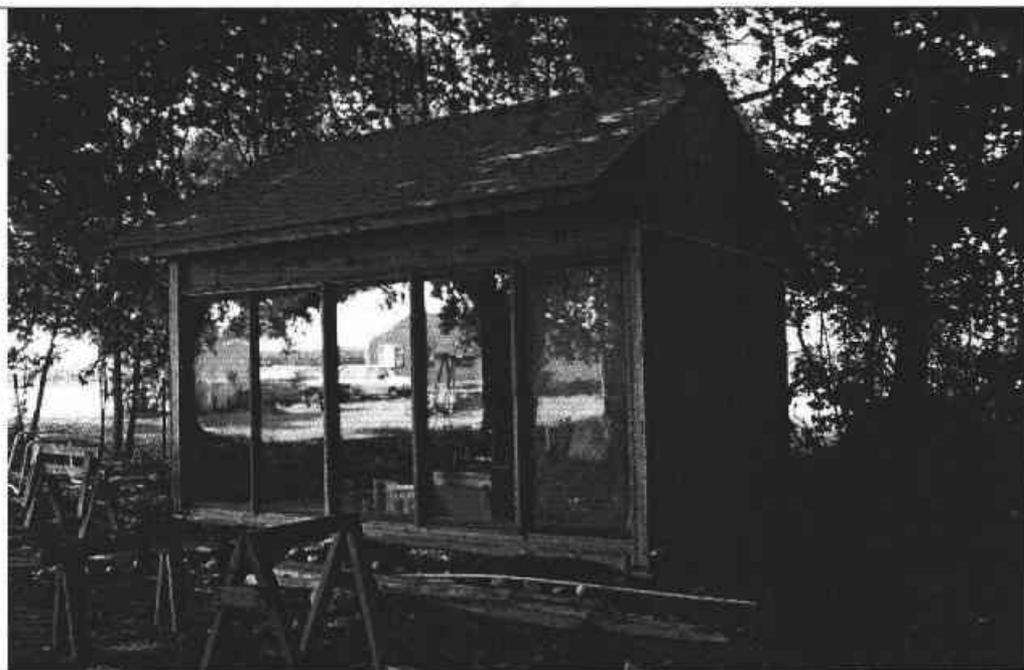
N14365. Photograph 6: Chicken house, south and east elevations, view to northwest. Note the wall of windows that has replaced the original façade. .

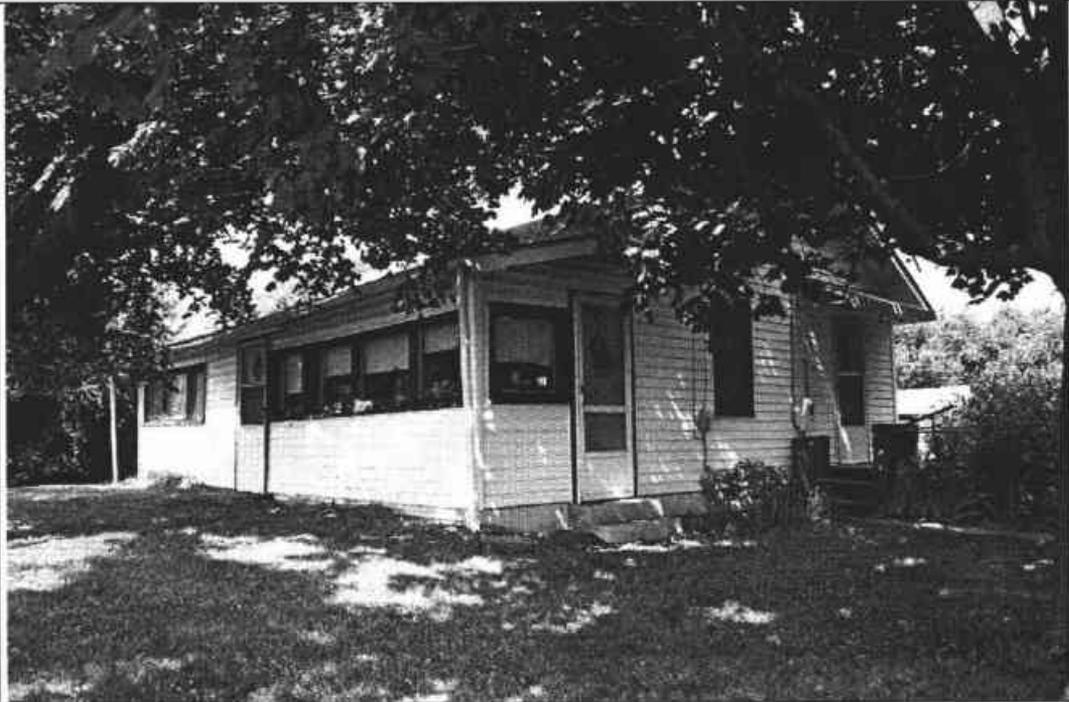
N14366. Photograph 1: Dwelling, north and west elevations, view to southeast. Note the enclosed front porch and modern cladding.

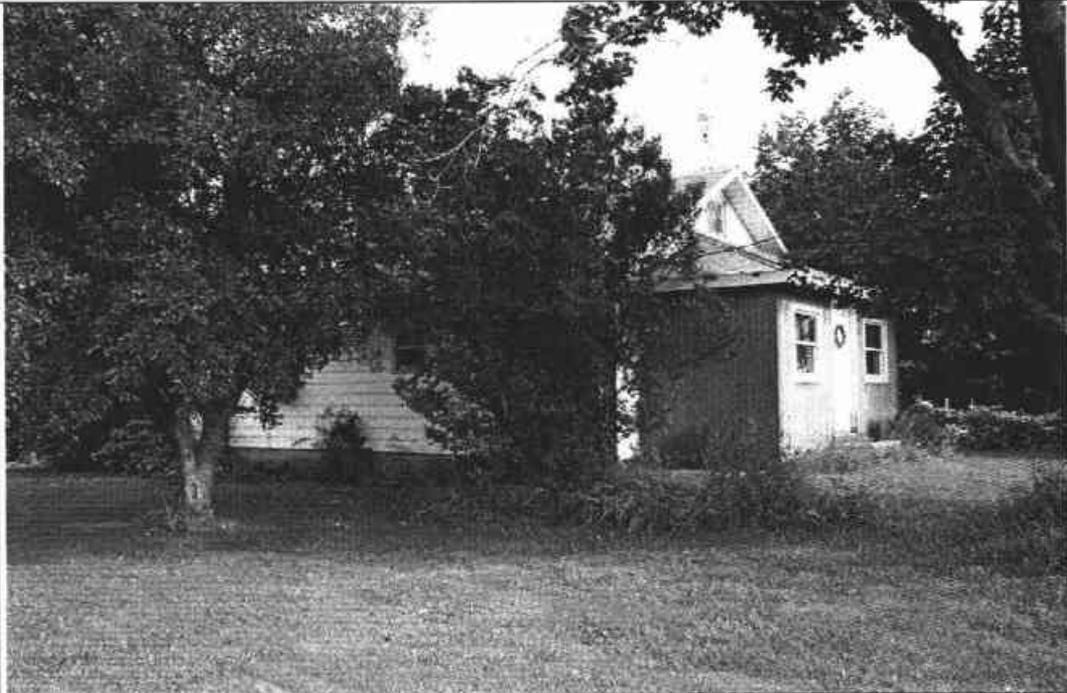
N14367. Photograph 1: Dwelling view of the north and west elevations. Note the modern cladding and the enclosed front porch.

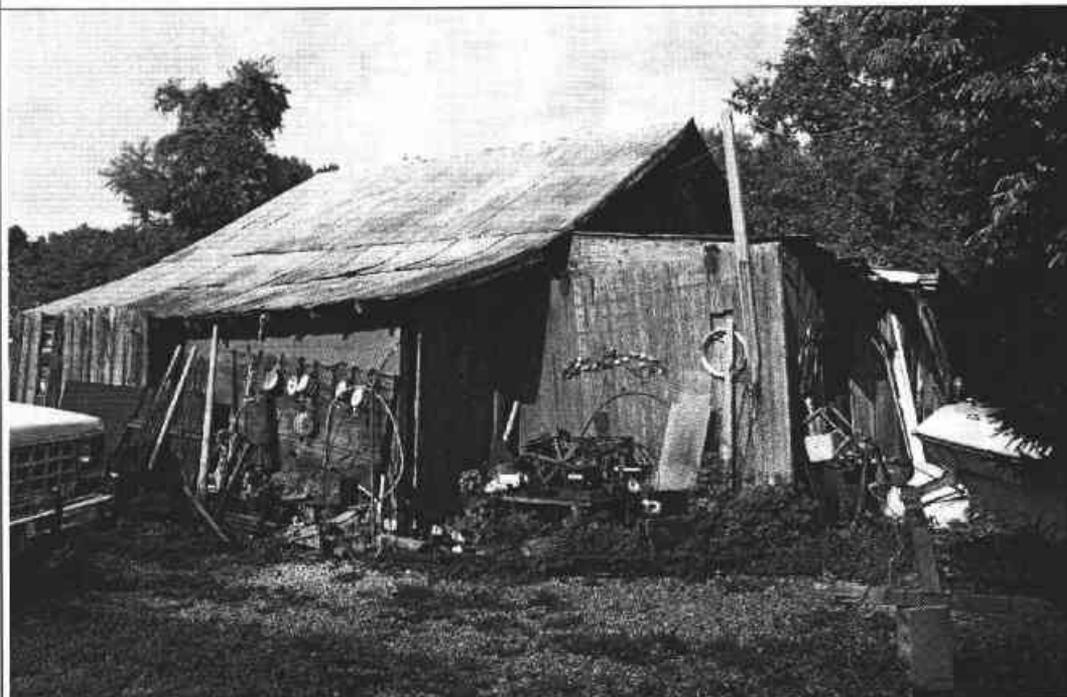
N14367. Photograph 2: Barn view of the north and east elevations. Note the multiple shed roof additions.
