National Register of Historic Places Inventory—Nomination Form

historic Governor Benjamin T. Biggs Farm

Governor B. T. Biggs House (N-5123)
 Saint Georges, Del. Quadrangle
 7.5 minute series
 Scale 1:25,000
 1953, Photorevised 1970

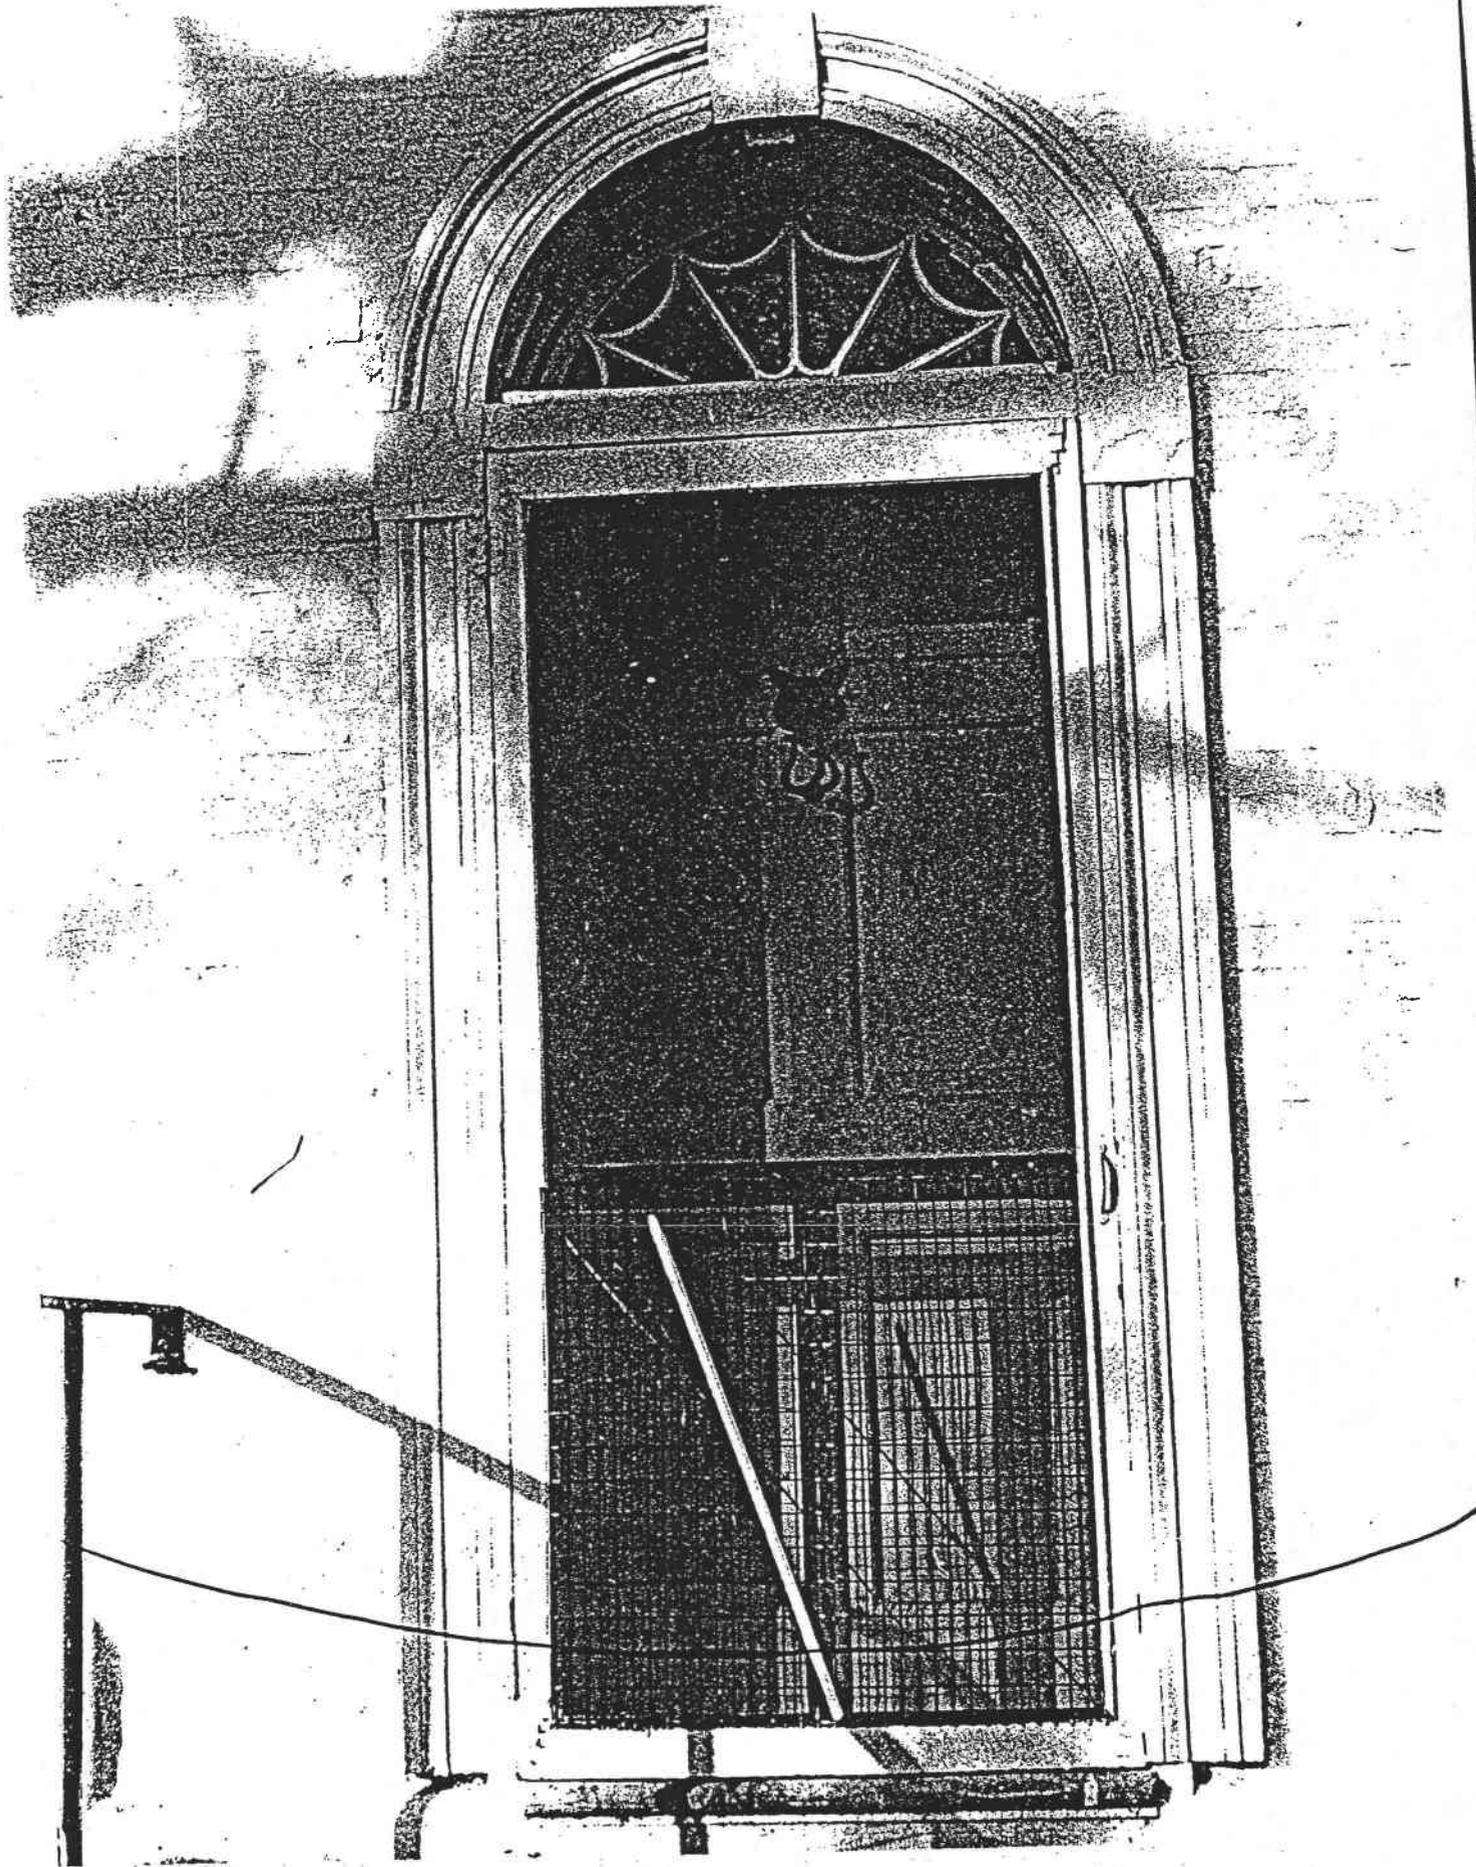
Photo #: 5 of (6)

SOUTH DOOR WAY

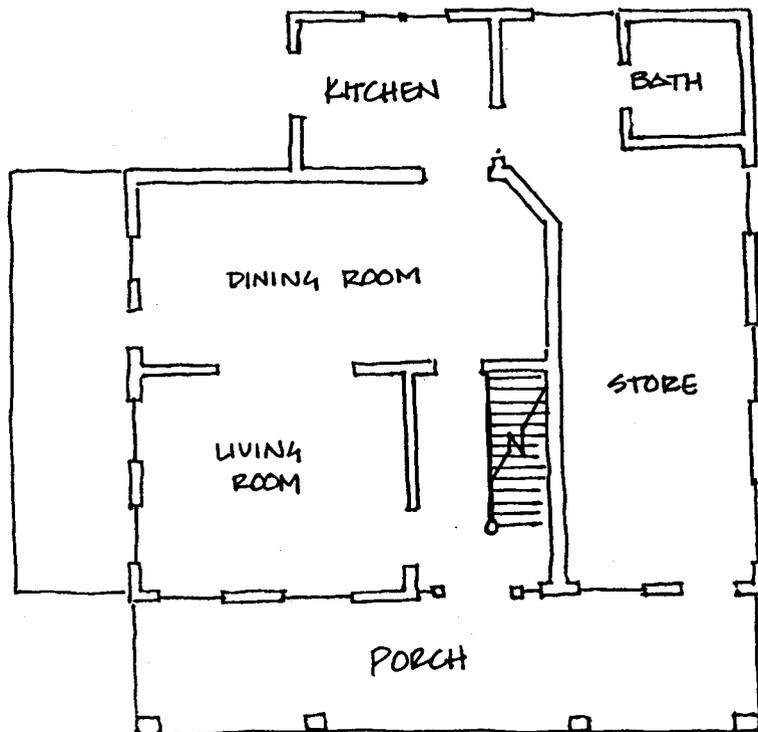
FIRST
FLOOR

ENCLOSED
PORCH
→

The 2-story, rectangular building is constructed of frame and sits on a concrete masonry unit foundation, built at the time of the 1938 relocation. White asbestos shingles cover the original clapboarding. The building's primary facade is divided into four bays and fronted with a wood porch supported on chamfered posts. Recessed beneath the porch is an off-center, nine-light door which accesses the store and a central paneled door with a 3-light transom, sidelights, and a thin lipped lintel which opens to the residence. Thin lipped lintels also trim the windows which are primarily 6/6 double hung, except the shop front windows on the first floor facades, which have simple surrounds. The flat roof is embellished by a cornice now panned in aluminum. There is a single exterior brick chimney centered at the rear of the main volume of the building.

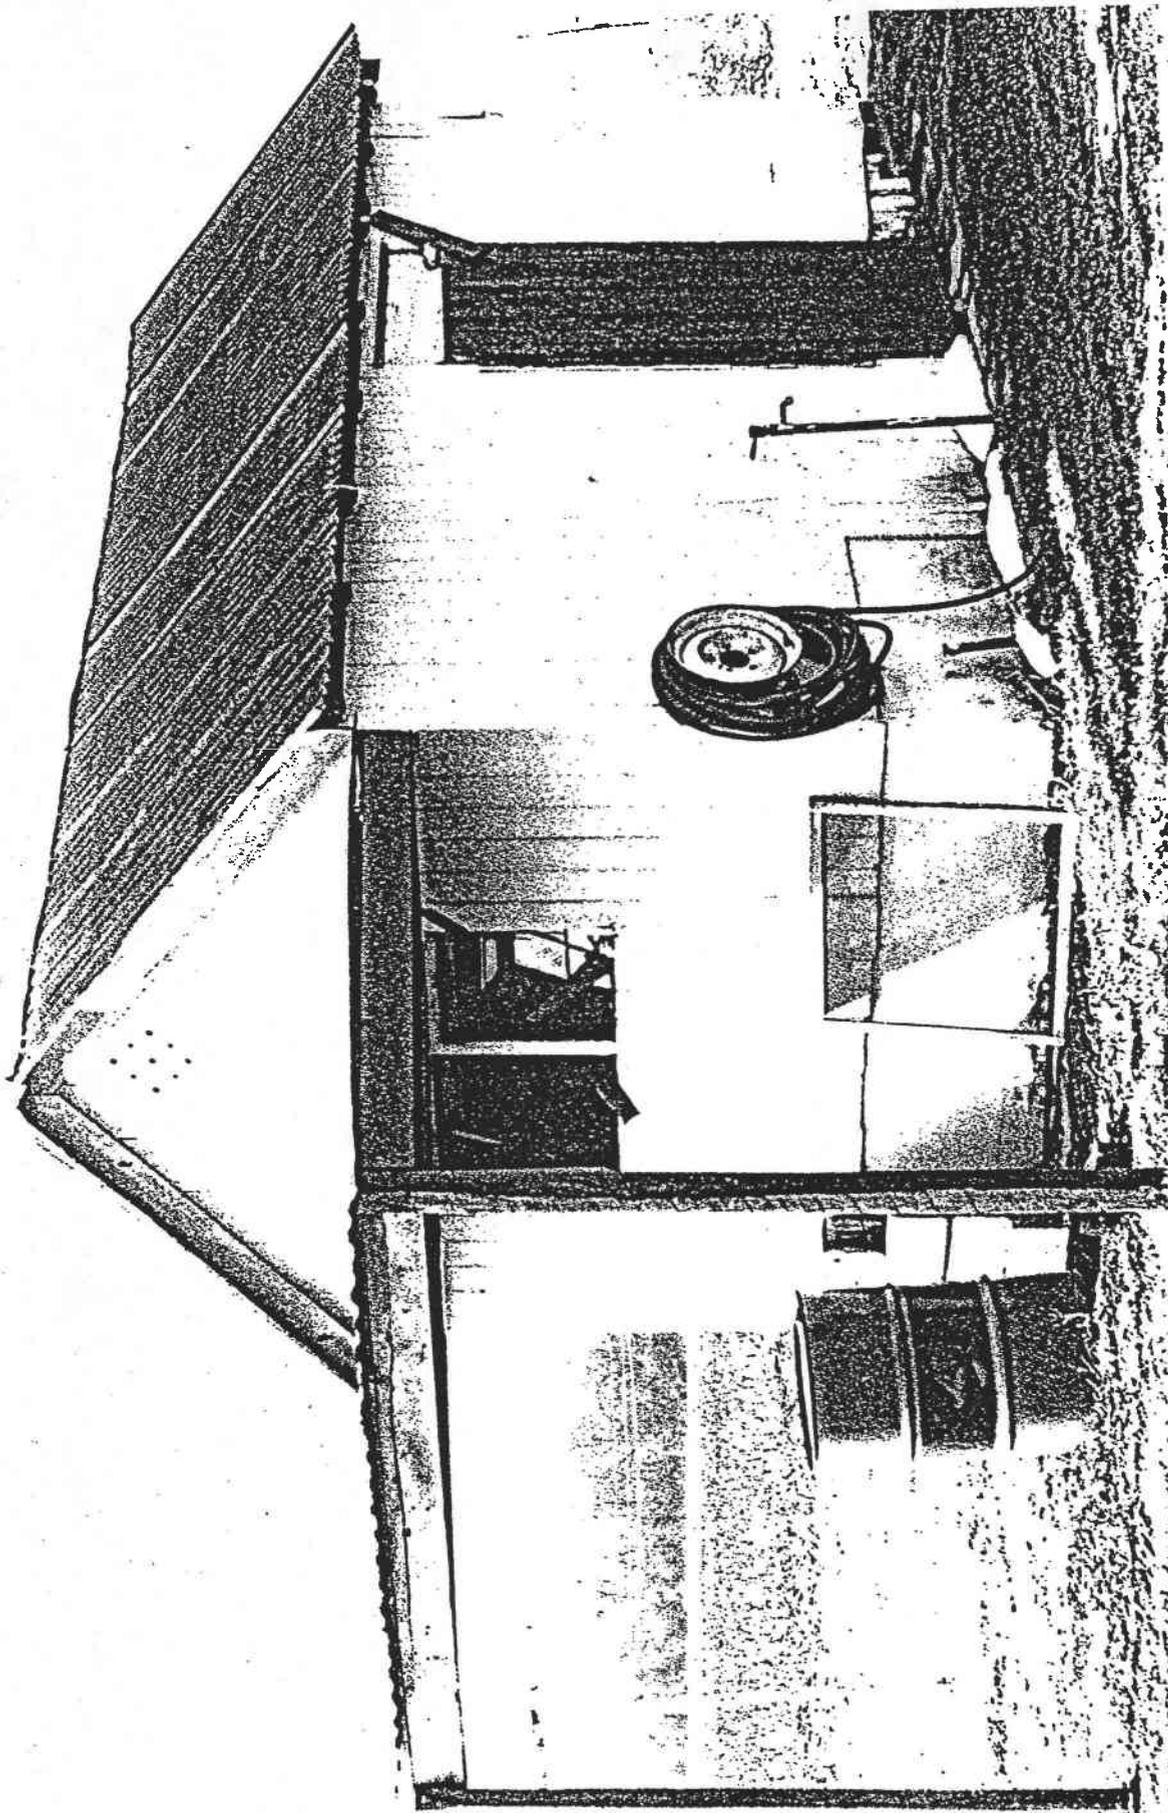
Photo #: 4 of (8)

Old Ford Dairy well house

WELL HOUSE

The property which was once a dairy, still has all the outbuildings relating to that phase of its history. They are all arranged on the north and south sides of a farm-lane running behind the house. Directly behind the house is a small board-and-batten, gable roof structure, possibly a meathouse, on a brick foundation. The doors are hung with strap hinges.
