CHAPTER 1

INTRODUCTION

Purpose and location of the project

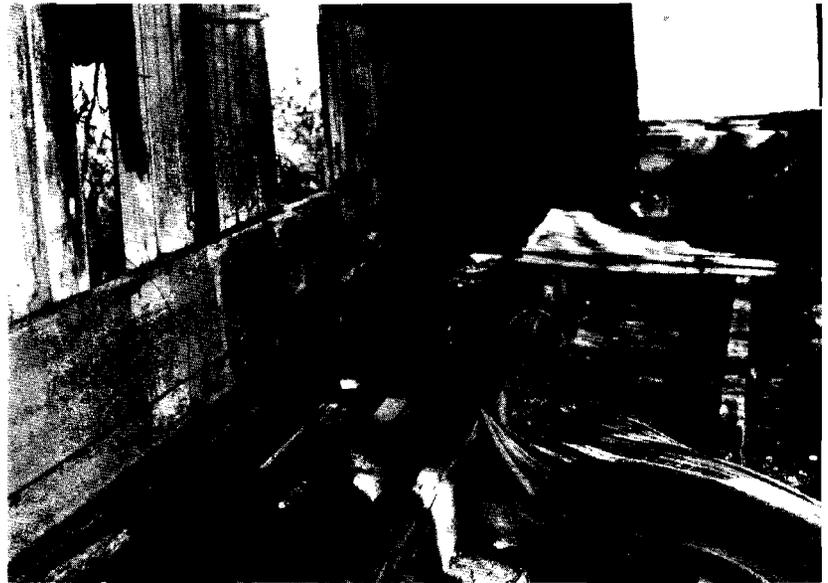
Plate 3 (right, above) Interior of the float house, looking east

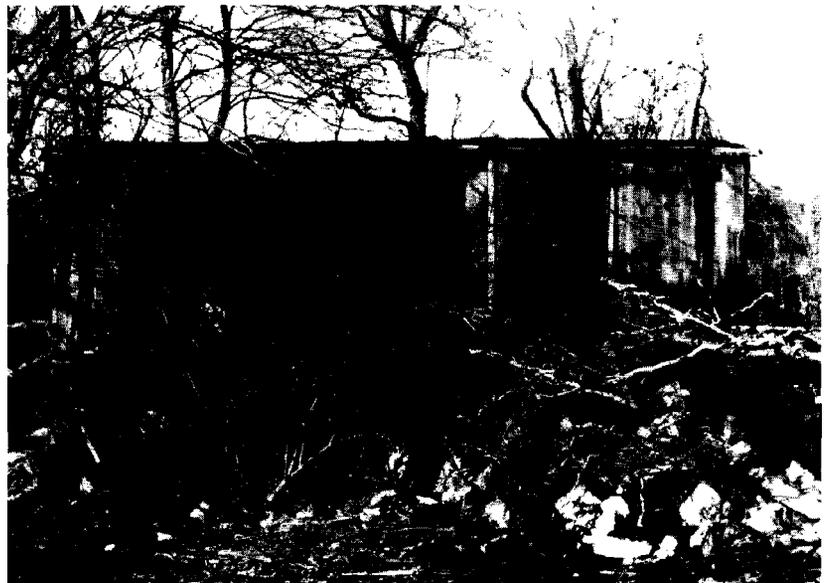
Plate 4 (right, below) View of the float house from the south

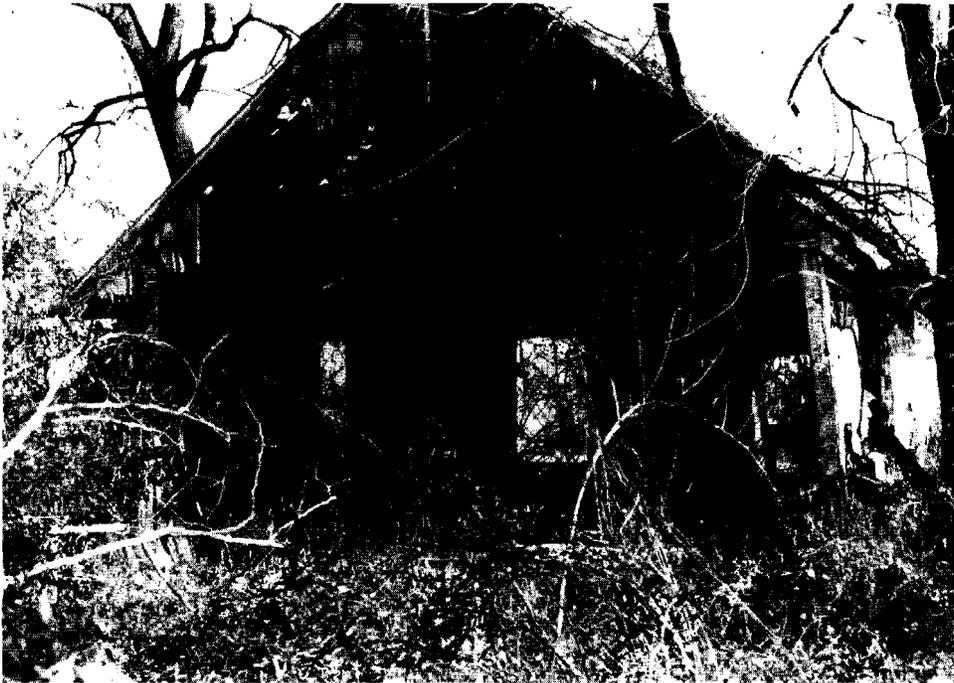
Plate 5 (above) Rear of the ladies' waiting room or scale house building.

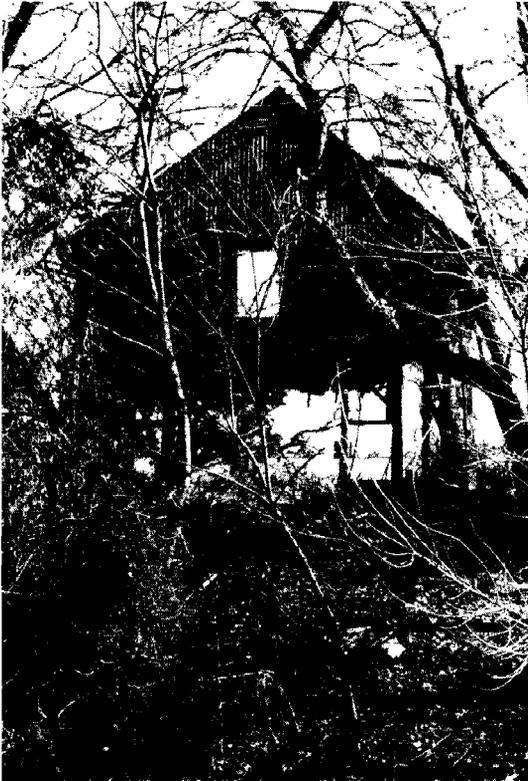
Plate 7 (left) Rear view of the warehouse building now located in the former gravel pit.

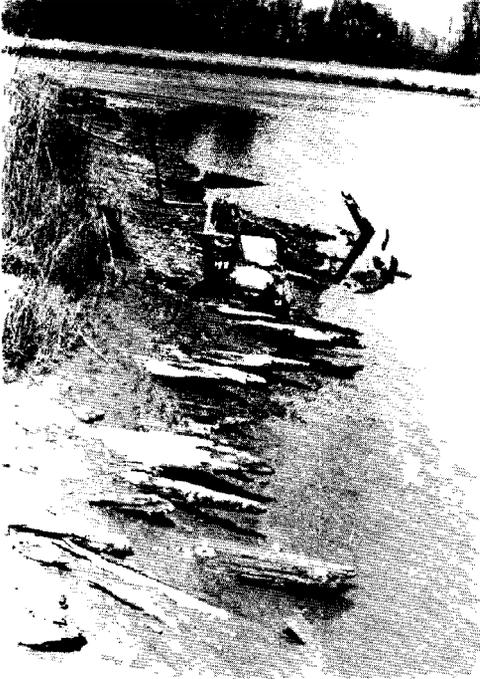
Plate 11 (Left)
View northward along the
St. Jones shore of the Samuel
Mifflin tract, with the timbers
of the granary wharf exposed
at extreme low tide

Other historic structures are visible only at low tide. Near the foot bridge are the pilings on which the existing steamboat company warehouse once stood. Farther north, next to the float house, are two sets of timber pilings that formerly supported wharves for the granaries on the Samuel Mifflin and James Lord tracts (PLATES 11-13). Farther north, near the present mouth of Tidbury Branch, is a vertical planked structure with several compartments that appears to have been a pool or holding tank for live aquatic creatures (PLATE 12).

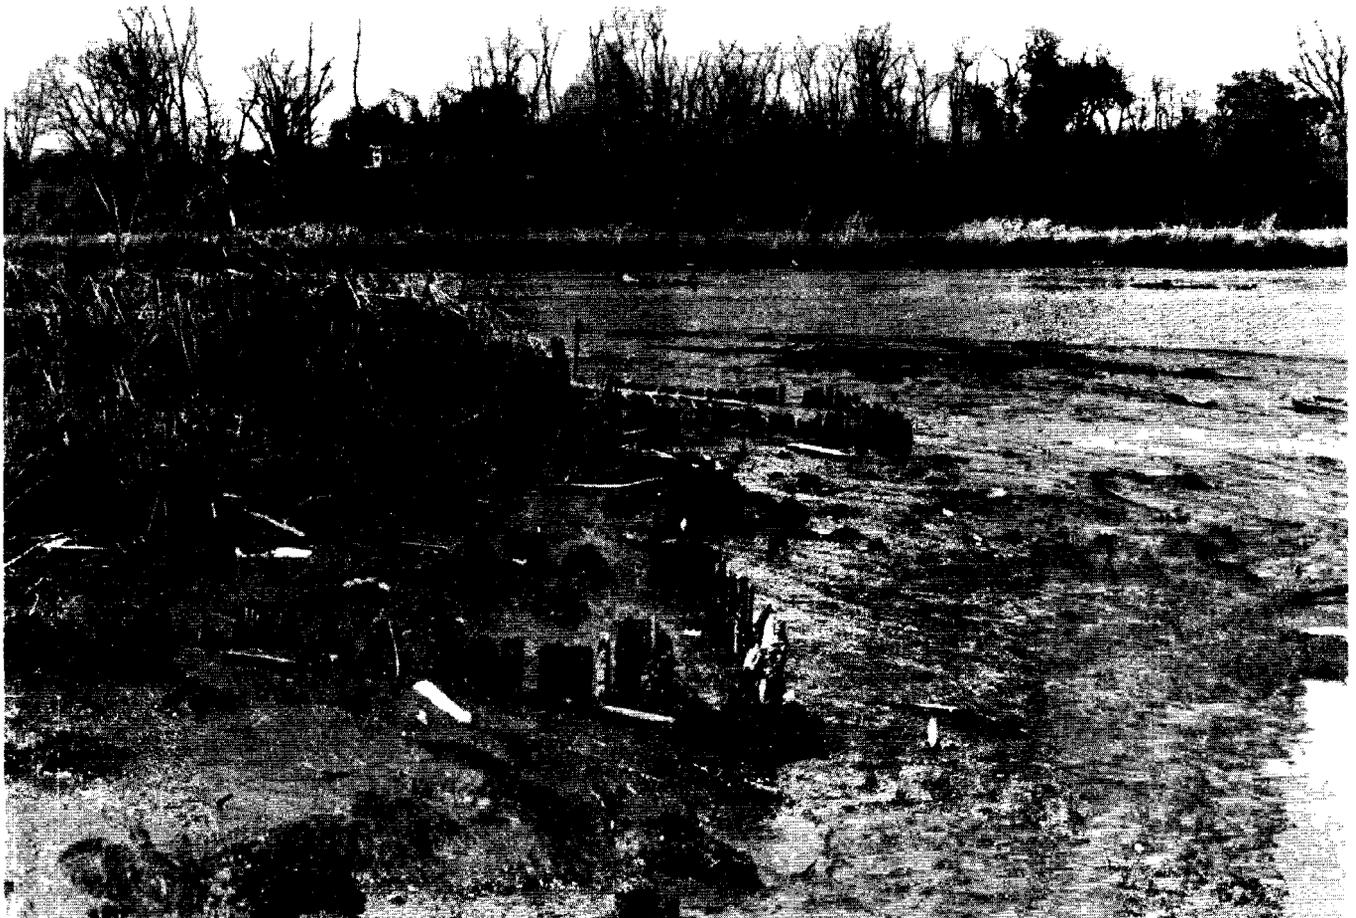
Plate 12 (below) Tank-like structure at
the mouth of Tidbury Branch,
visible in the view from the Samuel
Mifflin wharf, above

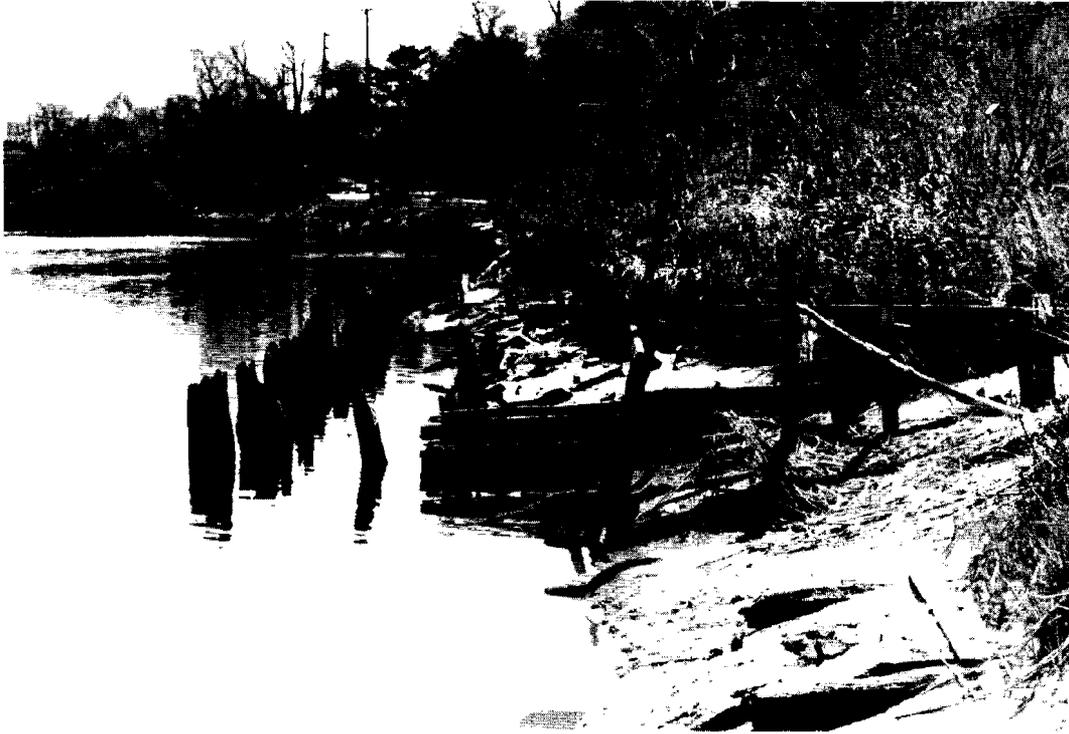
Plate 13 (above) Lord's wharf, later the steamboat company's, from the north

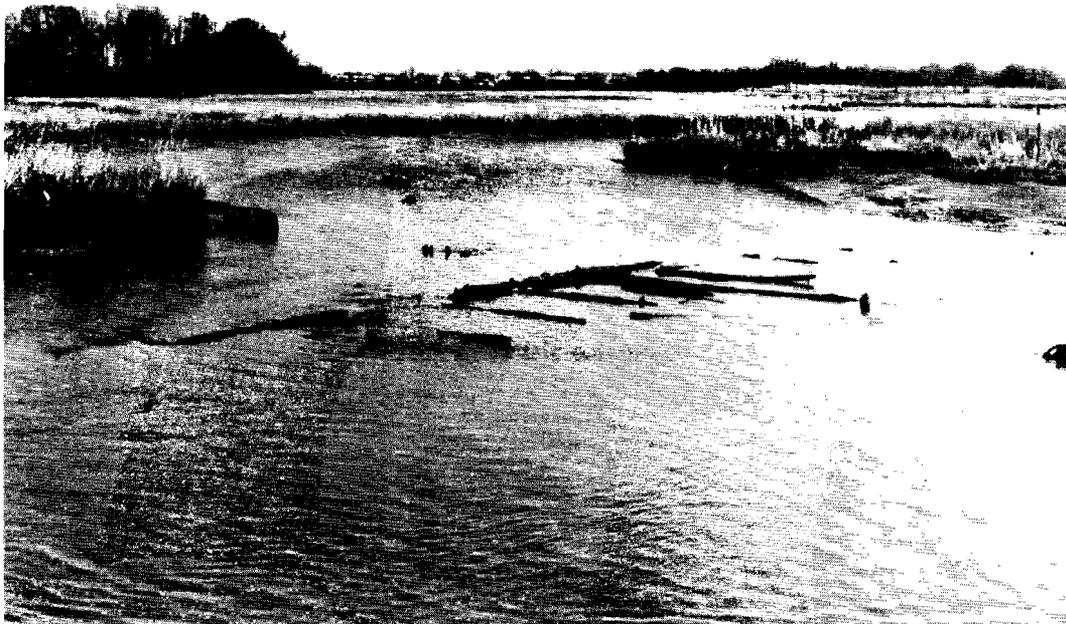
Plate 14 (below) Exposed timber-cribbed earthen structure immediately downstream from the present Tidbury Branch bridge, looking eastward

The present Tidbury Branch bridge (K-5676) has been inserted into the eighteenth-century Hunn dam, now known as the causeway. A short distance downstream from the bridge, a substantial timber and earth fill structure, eighteen feet wide, is exposed at low tide (PLATE 14). This structure lies on the alignment of the eighteenth-century causeway to the "new" landing that later became Lebanon. Local tradition describes this structure as the Hunn nail factory of *circa* 1793. Farther out, next to the old river channel, are several parallel bulkheads built of upright planks
