**W. M. Hawthorn Farmstead National Register
Determination of Eligibility (amended)**

National Register of Historic Places Inventory—Nomination Form

historic W. M. Hawthorn Farmstead (amended), 7NC-E-46

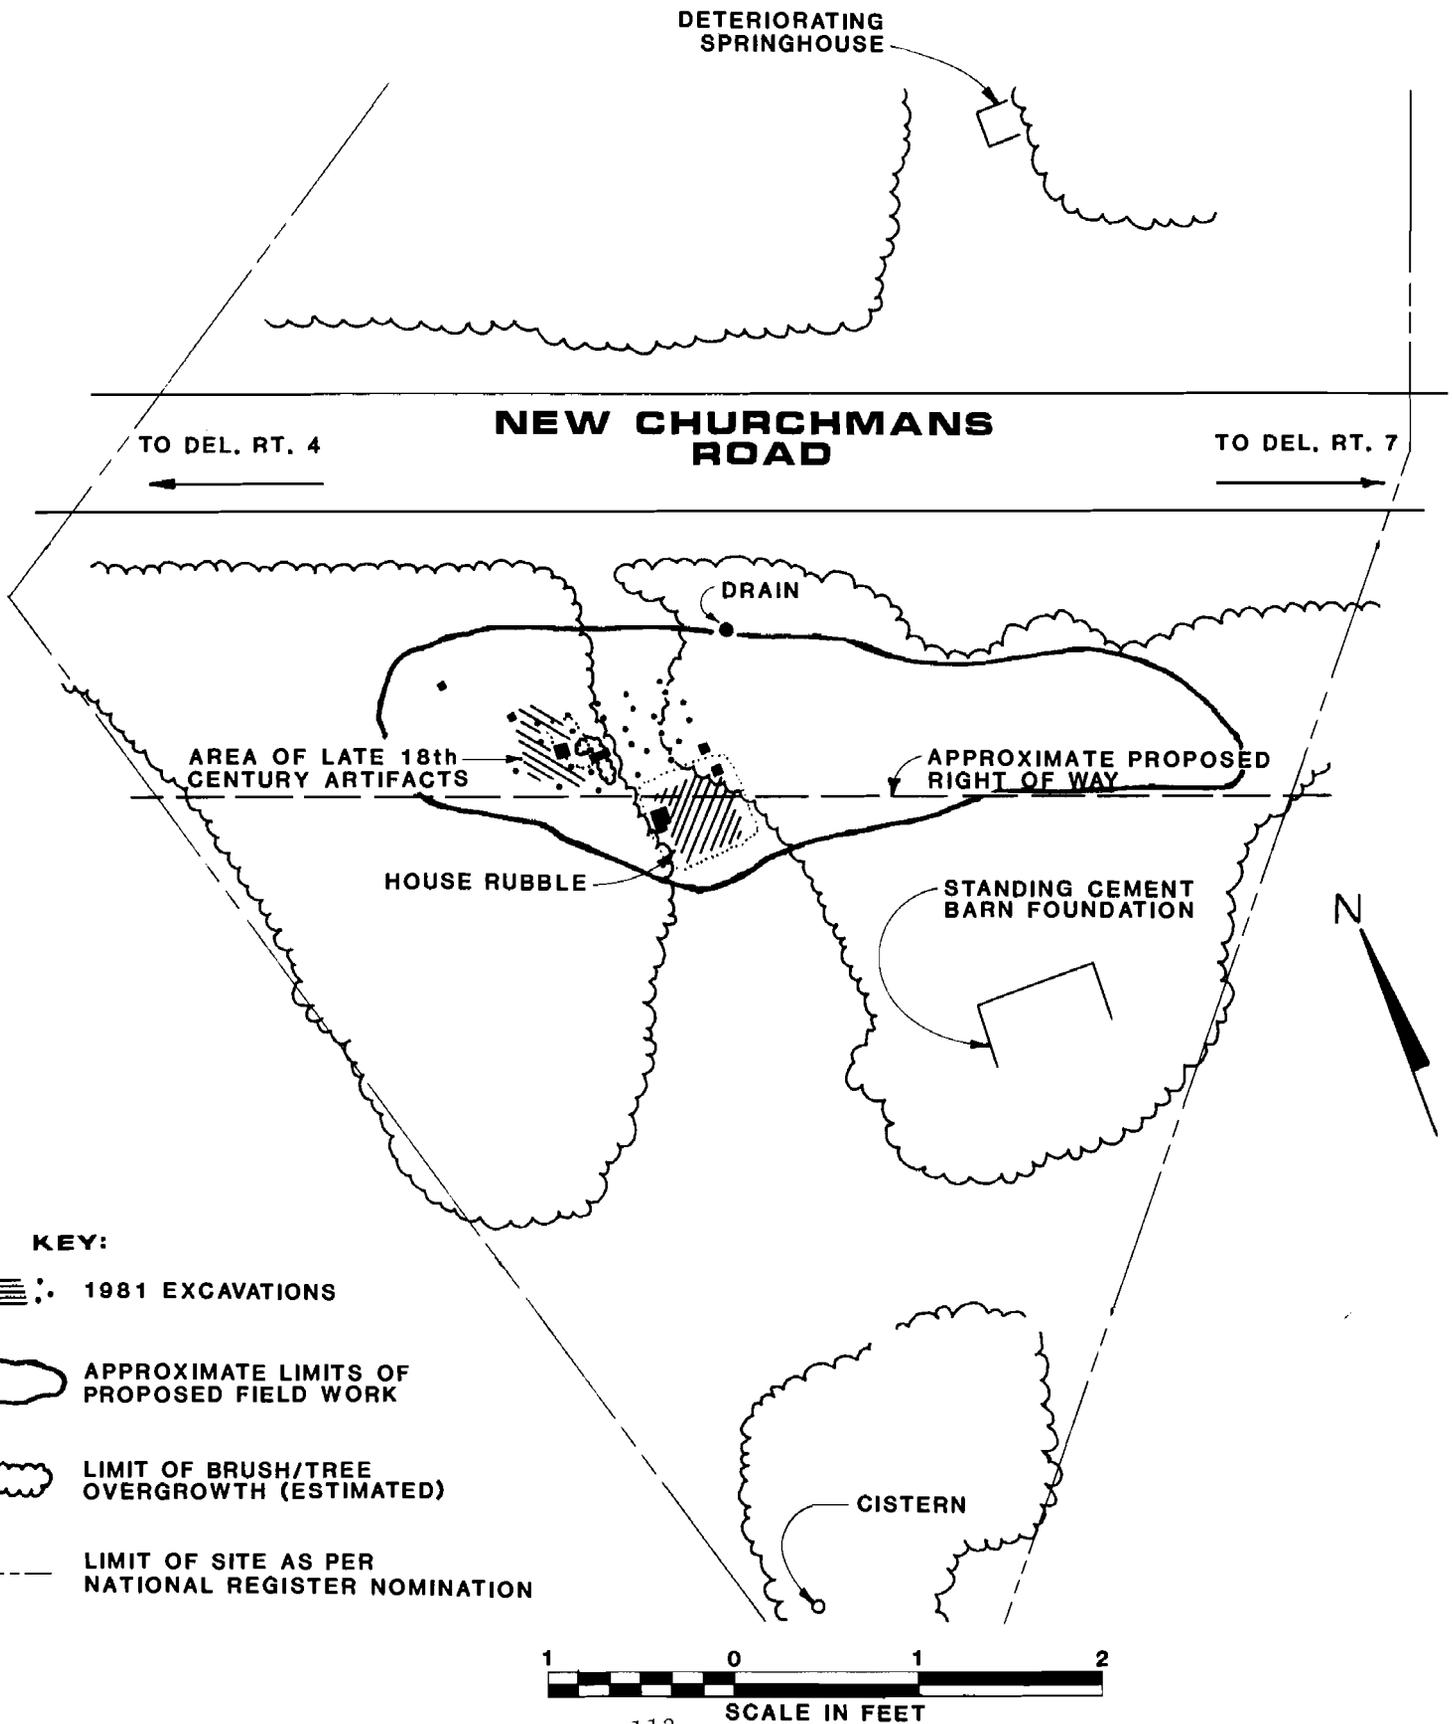
MAP 2 OF NATIONAL REGISTER NOMINATION

LOCATION OF PREHISTORIC COMPONENT
 PROPOSED FOR AMMENDMENT TO THE NATIONAL REGISTER

The site is bounded by agricultural fields on the south side of New Churchmans Road and by a portion of a property line and arbitrarily on the north side of the road as shown on the accompanying map (Amended Figure 2).

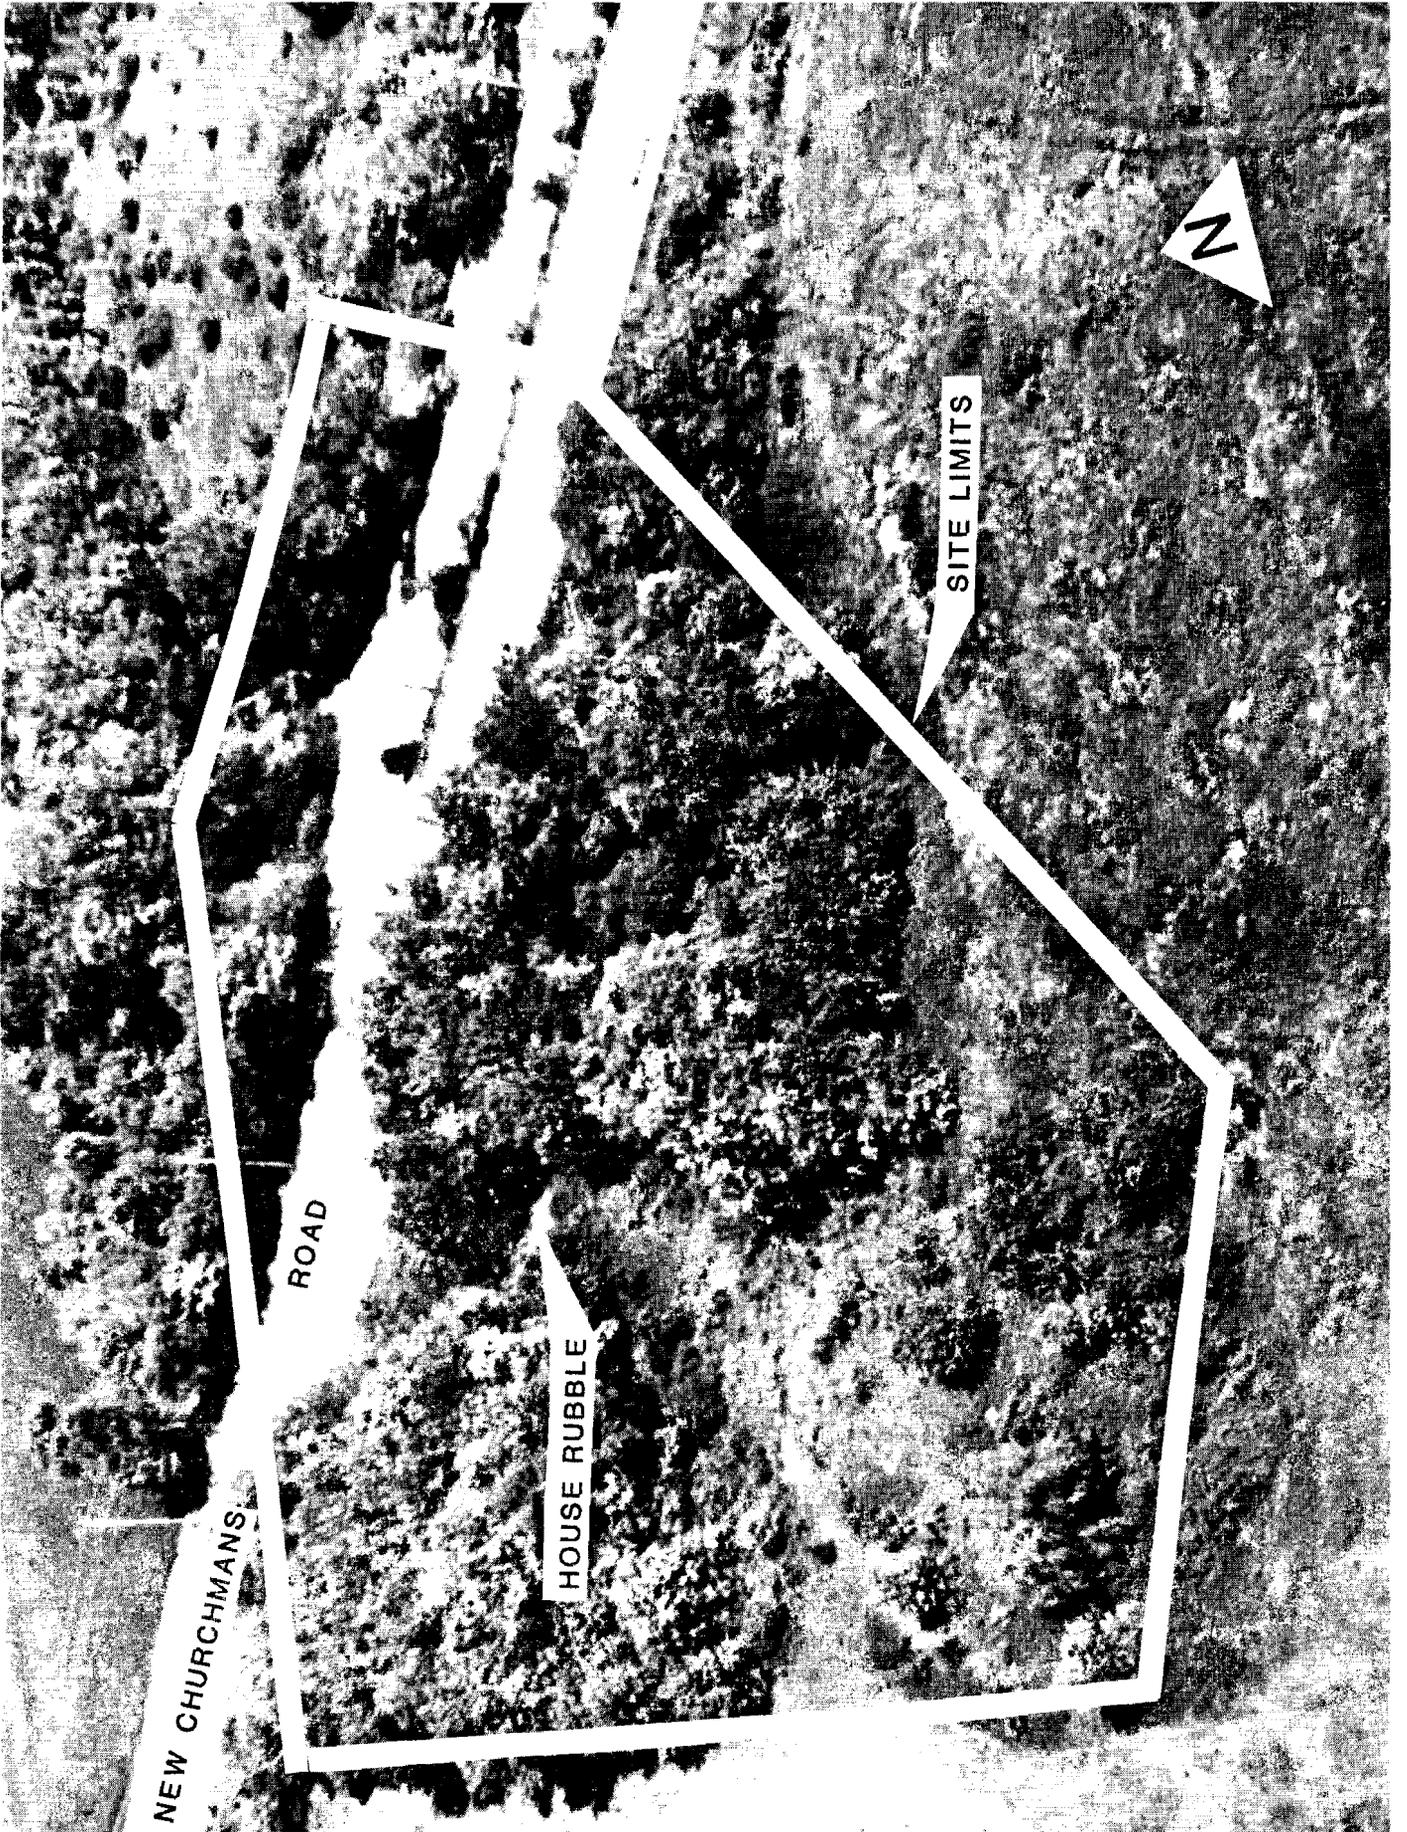
Photograph Number: 1 of 17

Description: aerial view of site, looking north

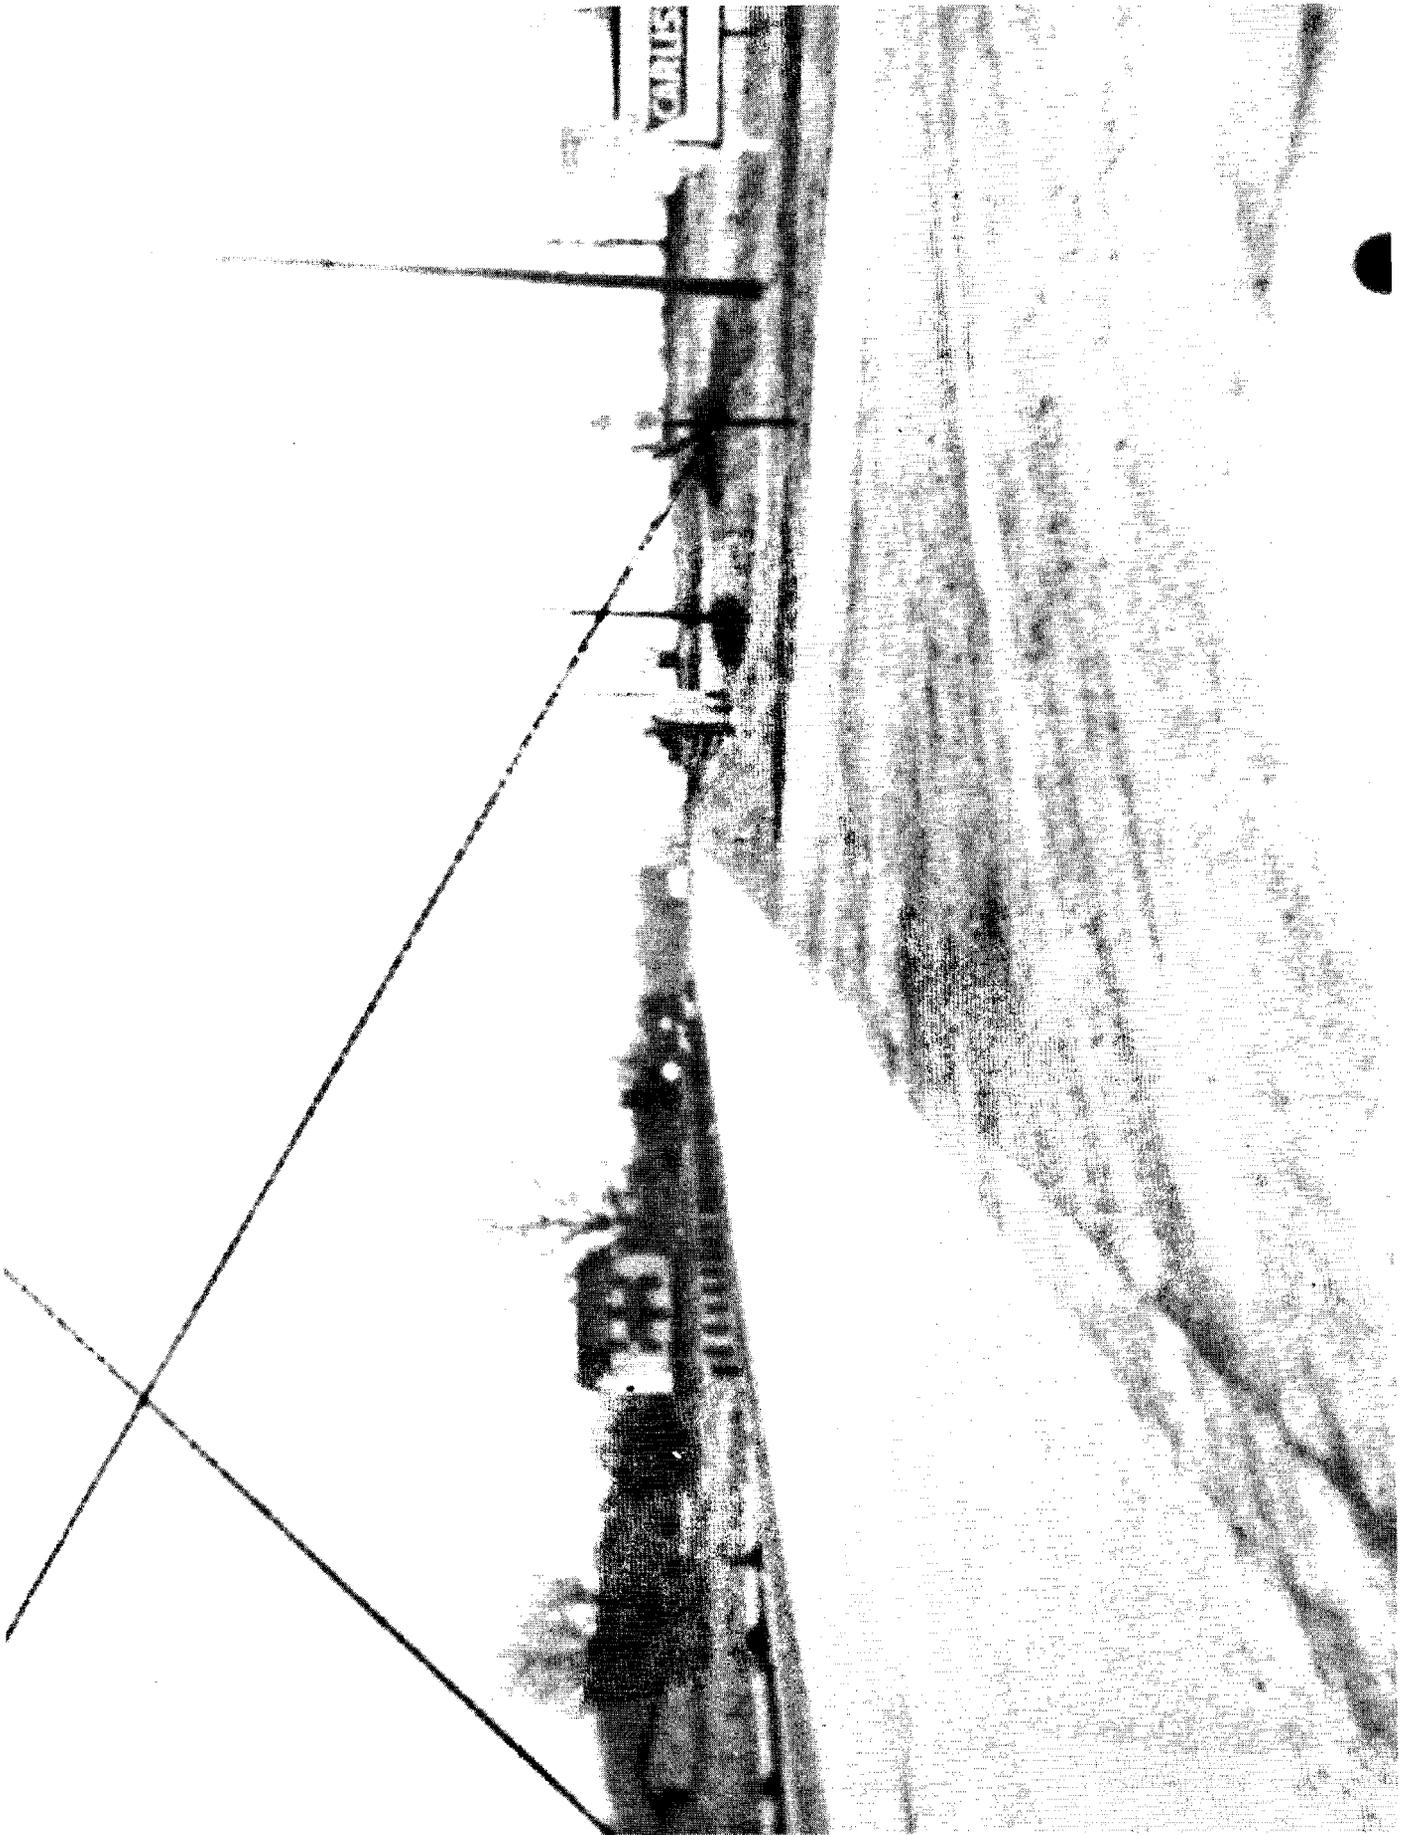
Photograph Number: 2 of 17

A photograph taken of the farmstead circa 1960 (Photo 2) while the house and barn/stable were still standing indicates that the house was of a vernacular architectural style common to the Mid-Atlantic region throughout the 19th century. It appears to be two rooms deep, two rooms wide with a central hallway between them, and two stories high with a low pitched roof, wide front porch, internal gable-end chimneys, and a raised basement. The only disruptions to the site are the minimal disturbance resulting from the overgrowth of vegetation since the end of the site's active occupation (post 1969, see Photo 3), the demolition of the house and deterioration/demolition of out structures, and the 1955 construction of New Churchmans Road which separated the Springhouse from the rest of the site and entailed the demolition of at least a chickenhouse.

Description: view of site prior to demolition of house looking west/northwest
from the intersection of Old Churchmans Road and New Churchmans Road

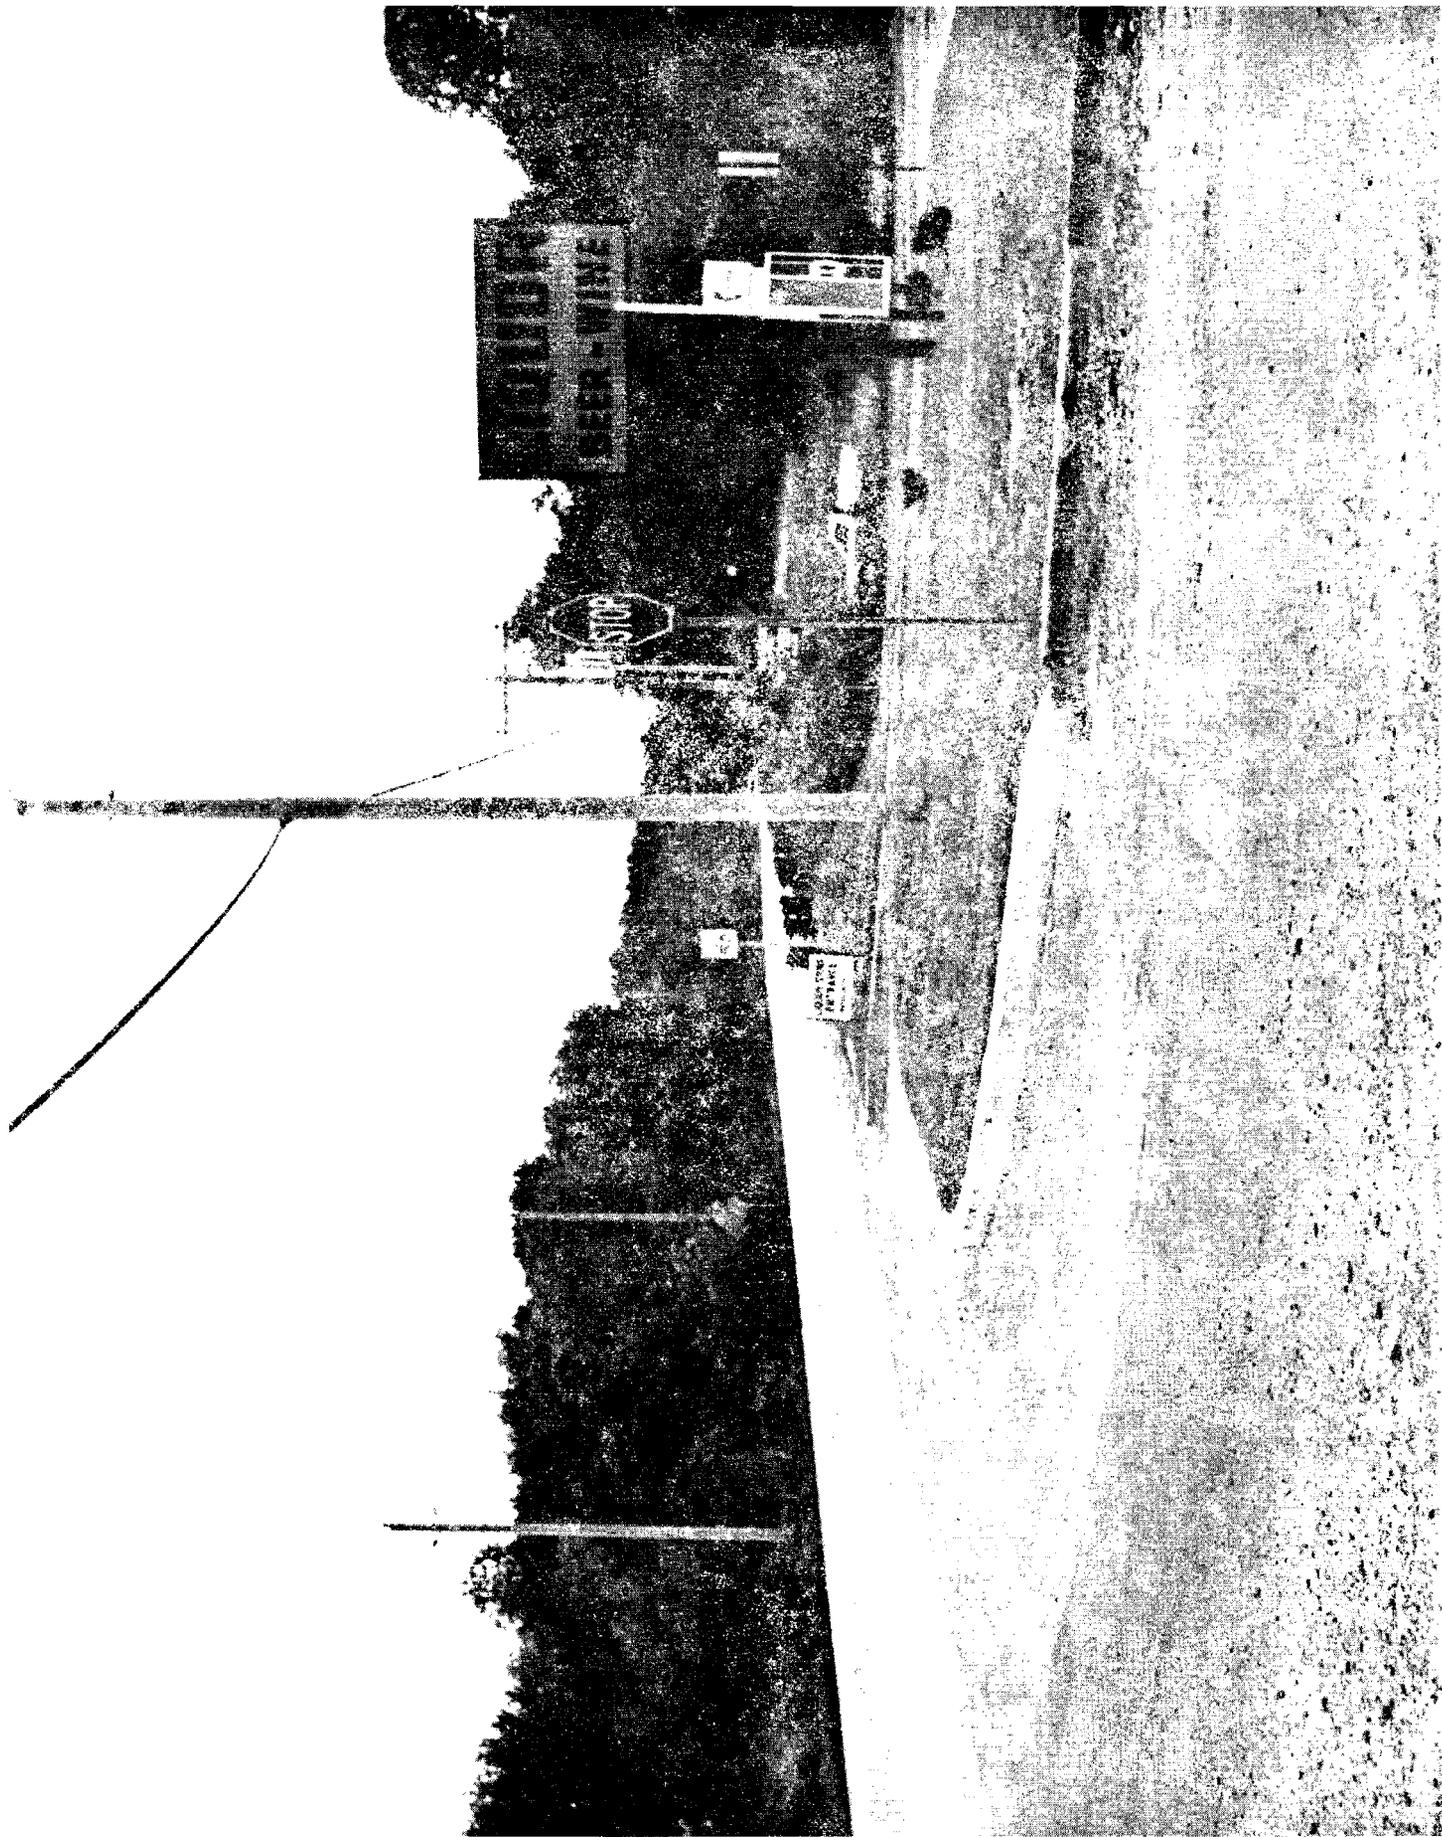
Photograph Number: 3 of 17

Description: view of site's current physical
environment, looking west/northwest from the
intersection of Old Churchmans Road and
New Churchmans Road

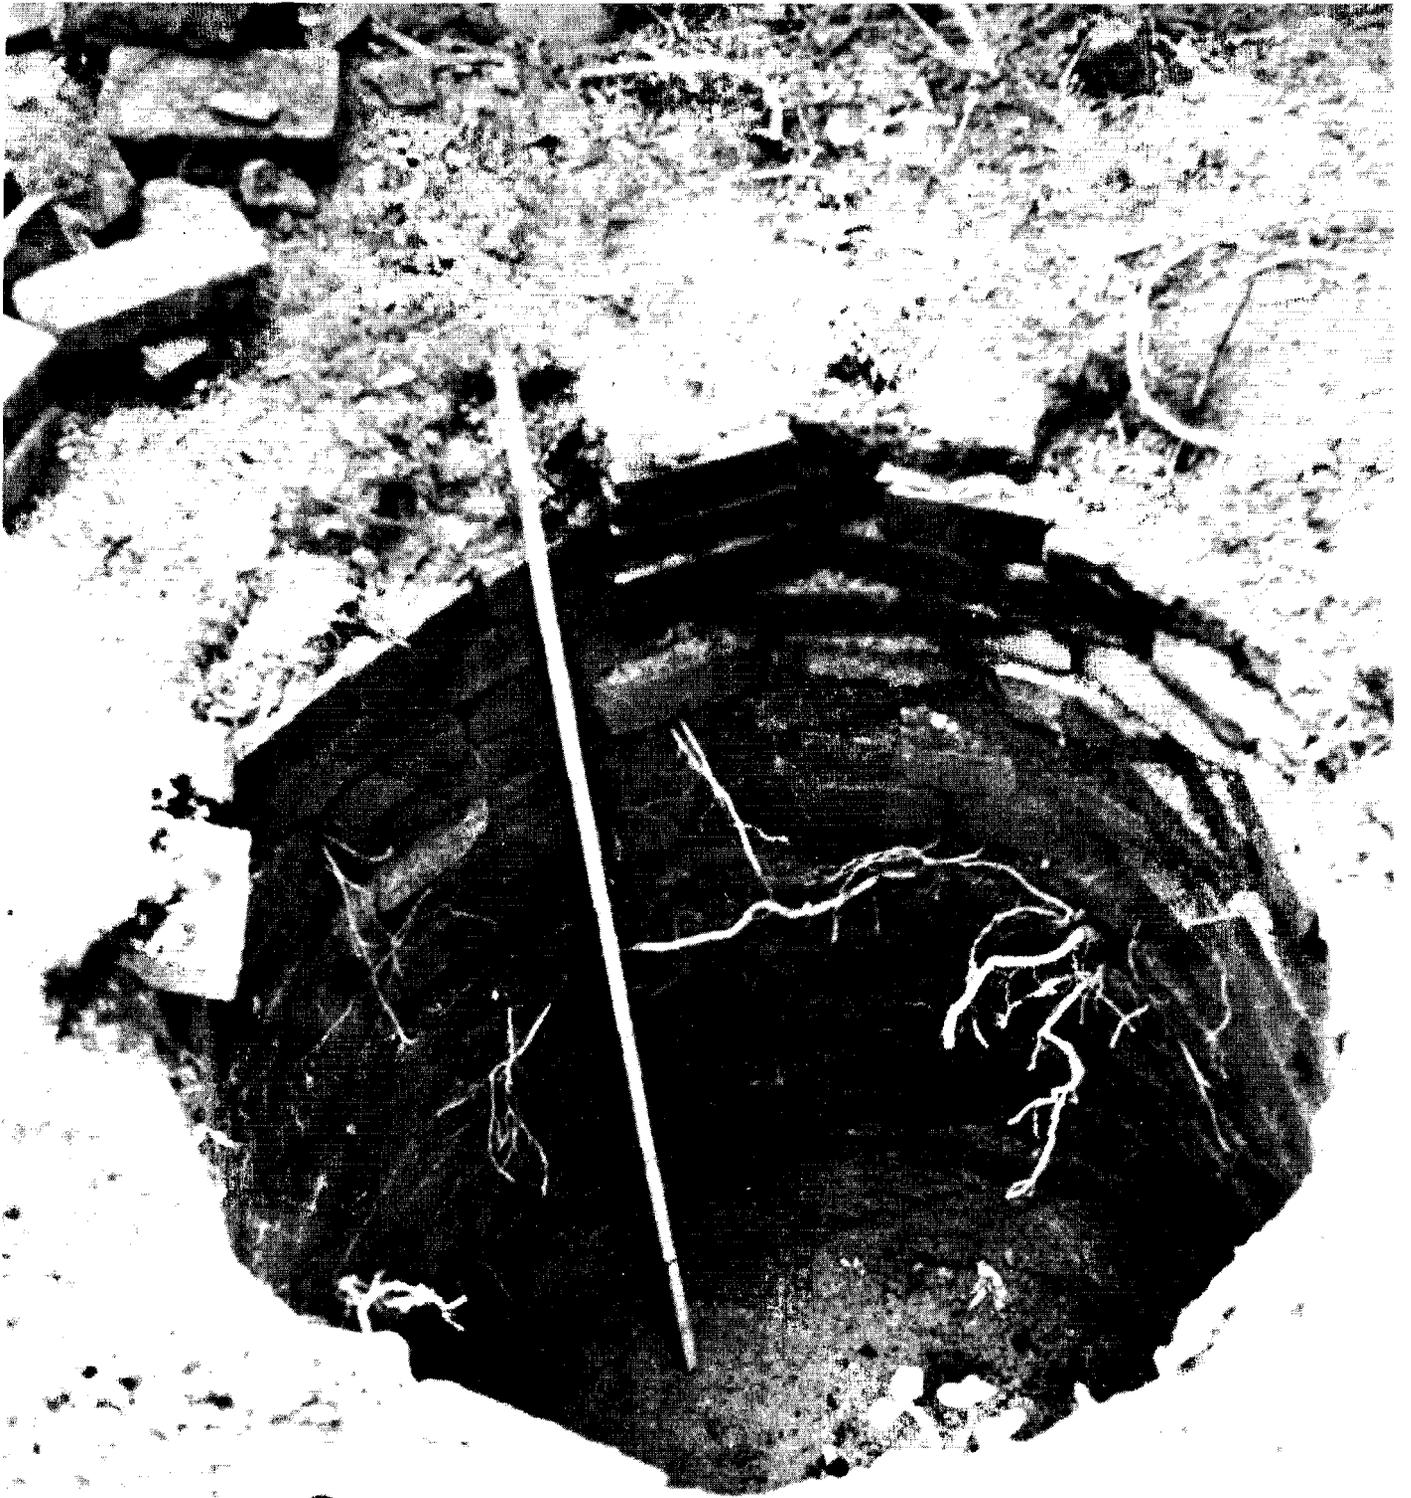
Photograph Number: 5 of 17

Description: Drain feature after excavation,
looking northwest

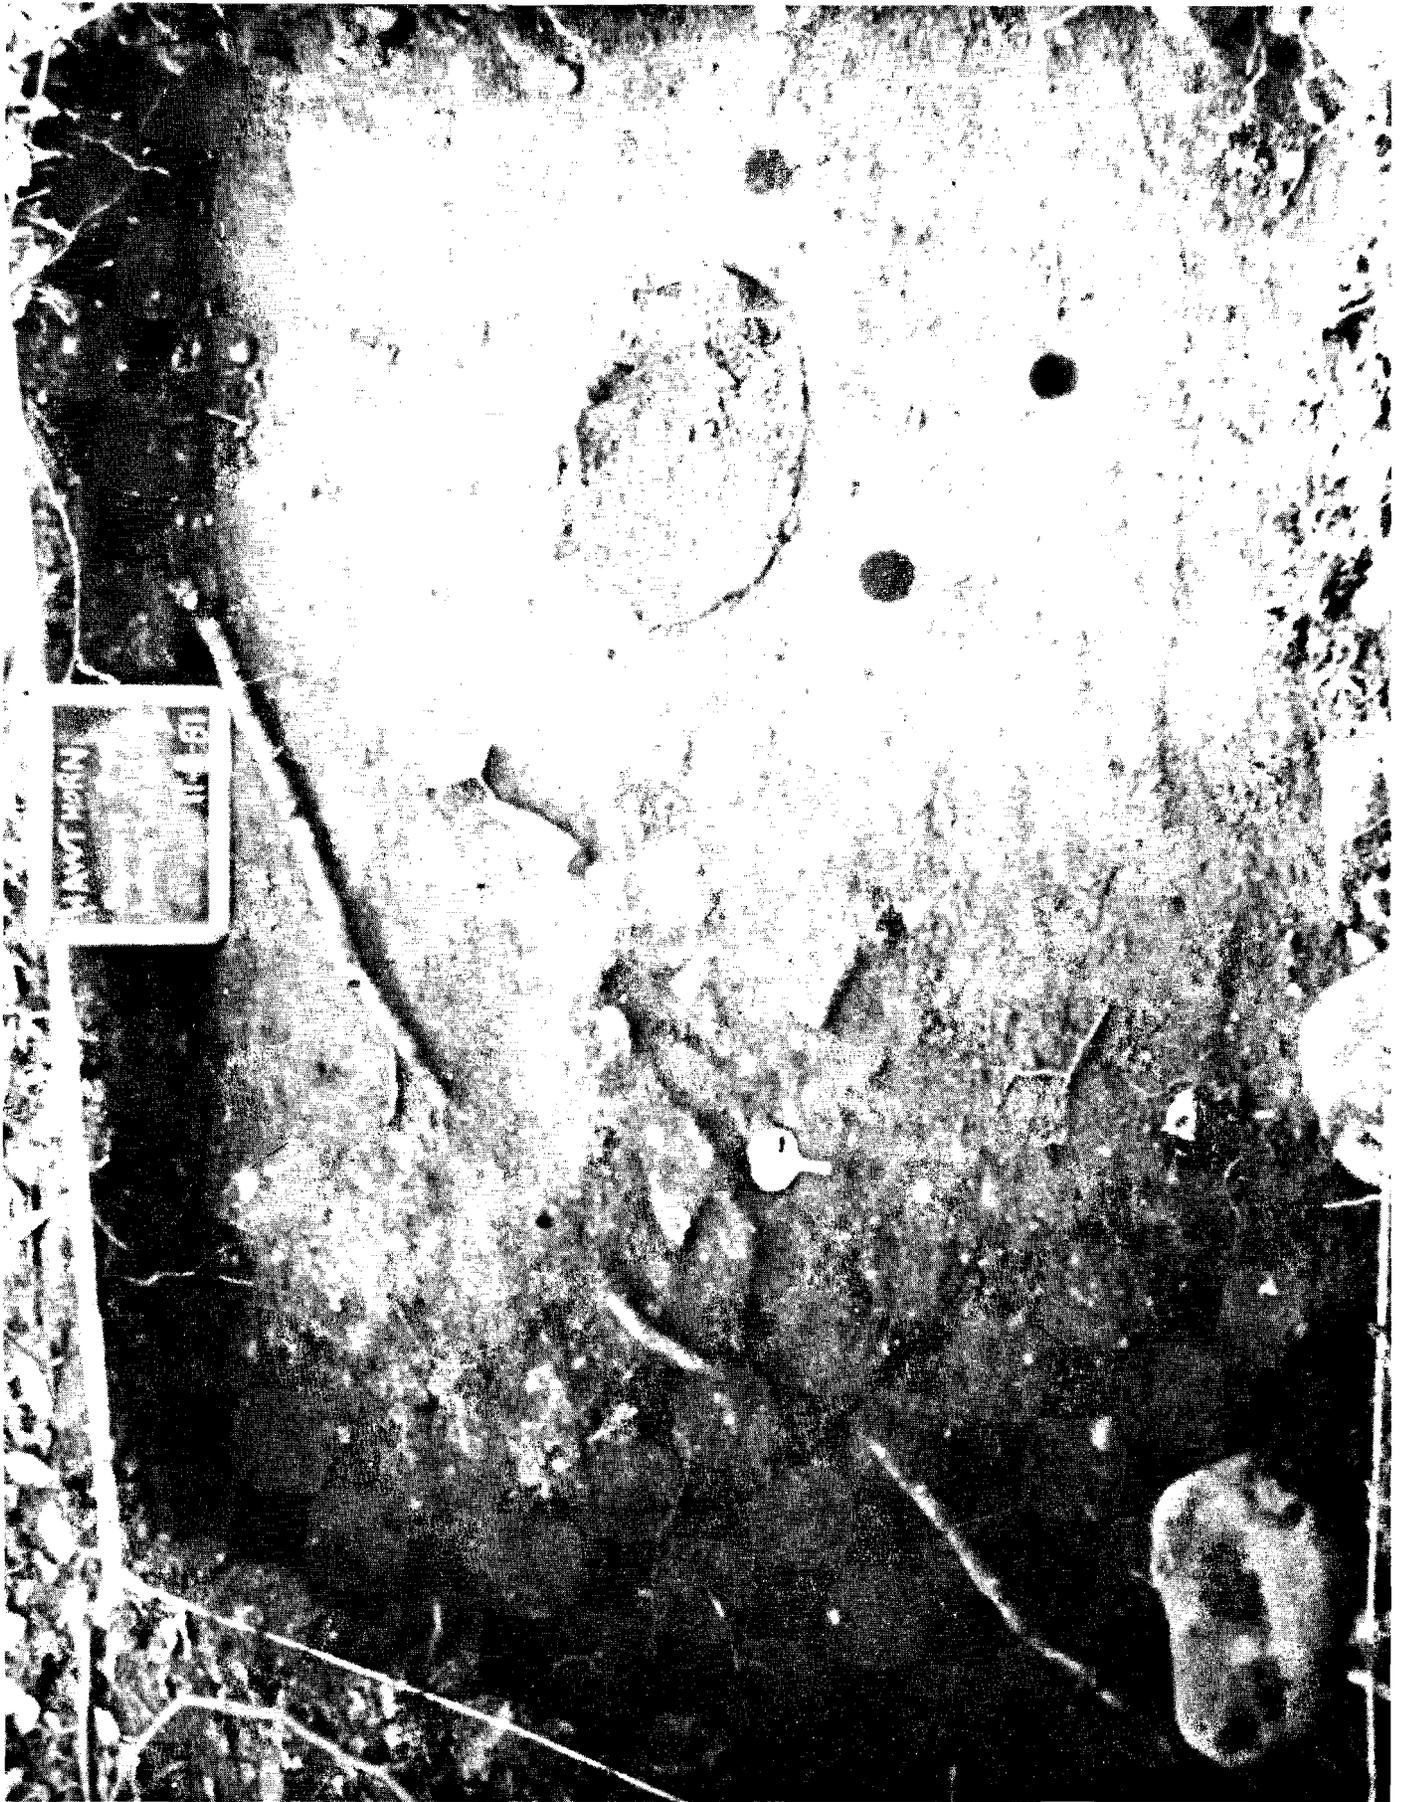
Photograph Number: 9 of 17

Description: Mortar capped feature at end of excavation
(circular capping is outlined from top left to
bottom right; small circle is shovel test
excavation), looking north

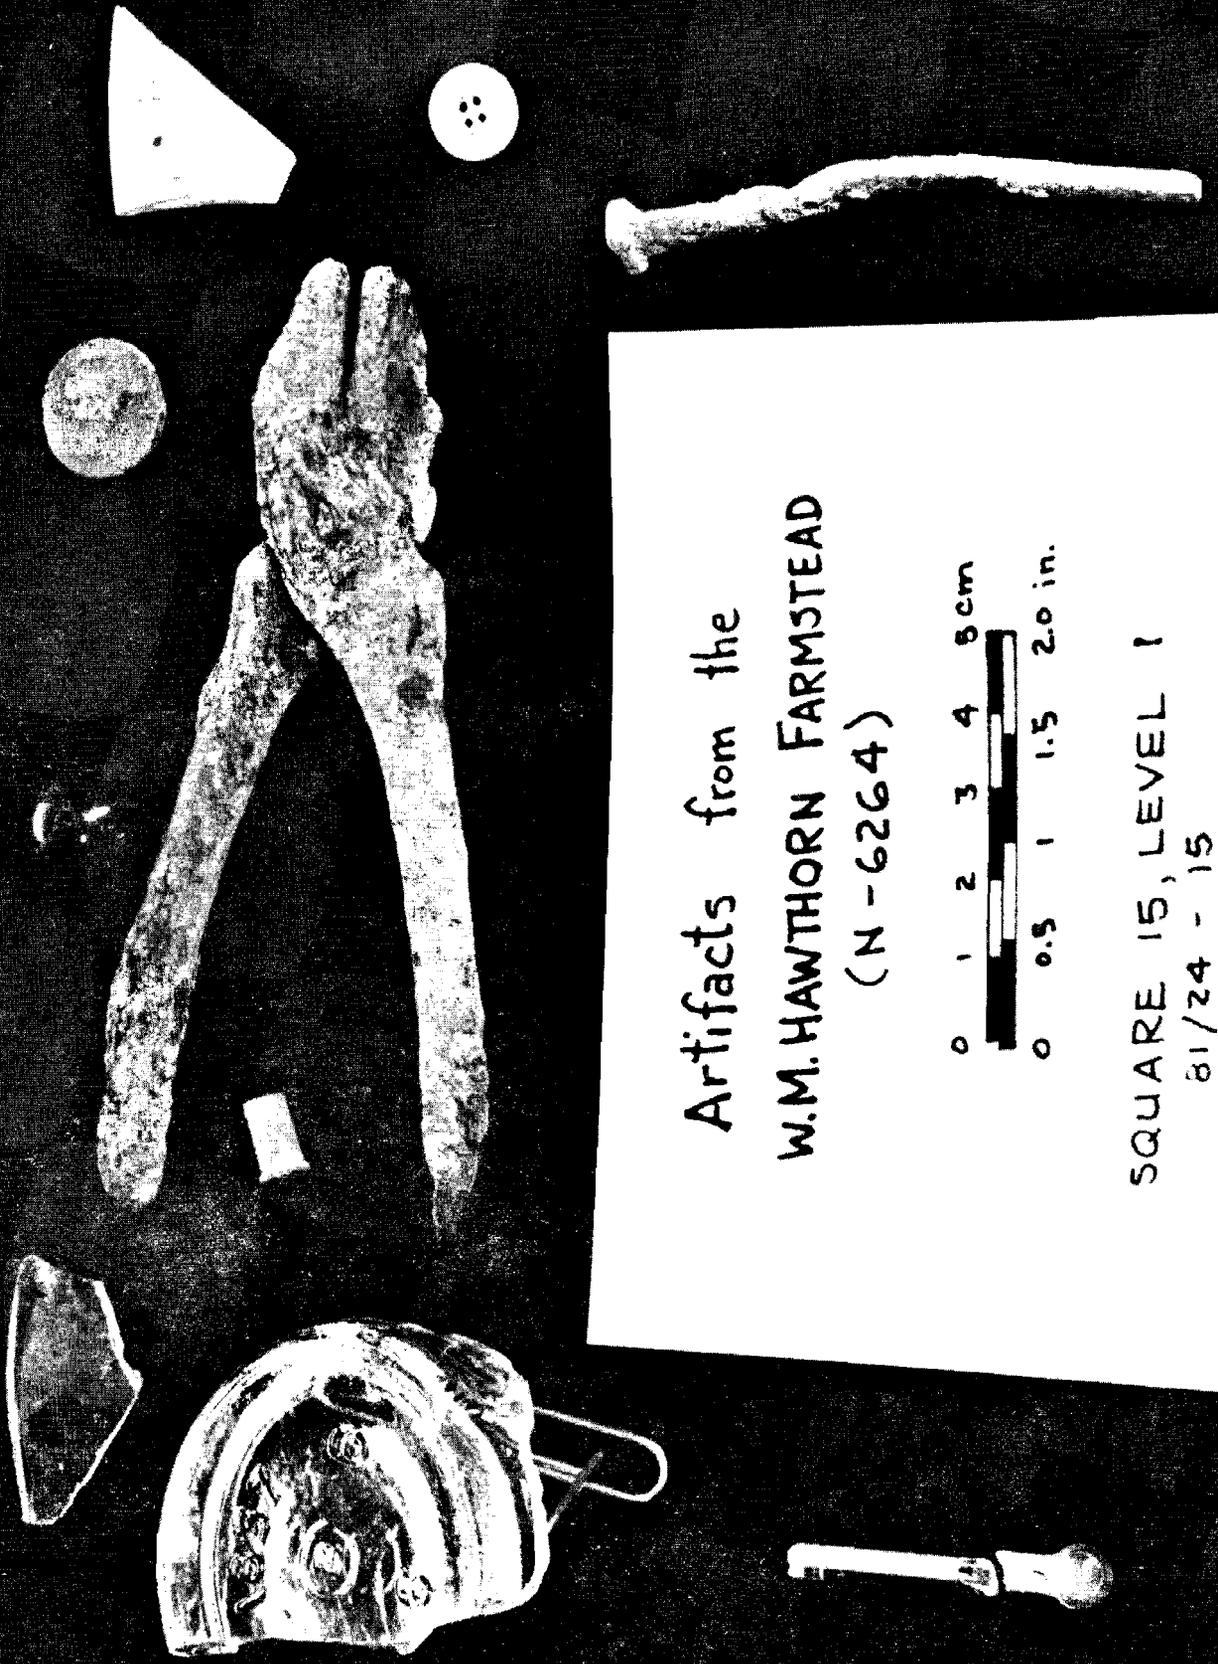
Photograph Number: 12 of 17

Description: 20th century artifacts recovered from
test excavation in house rubble pile (glass,
metal, ceramics, shell button, unreadable coin)

Artifacts from the
W.M. HAWTHORN FARMSTEAD
(N-6264)

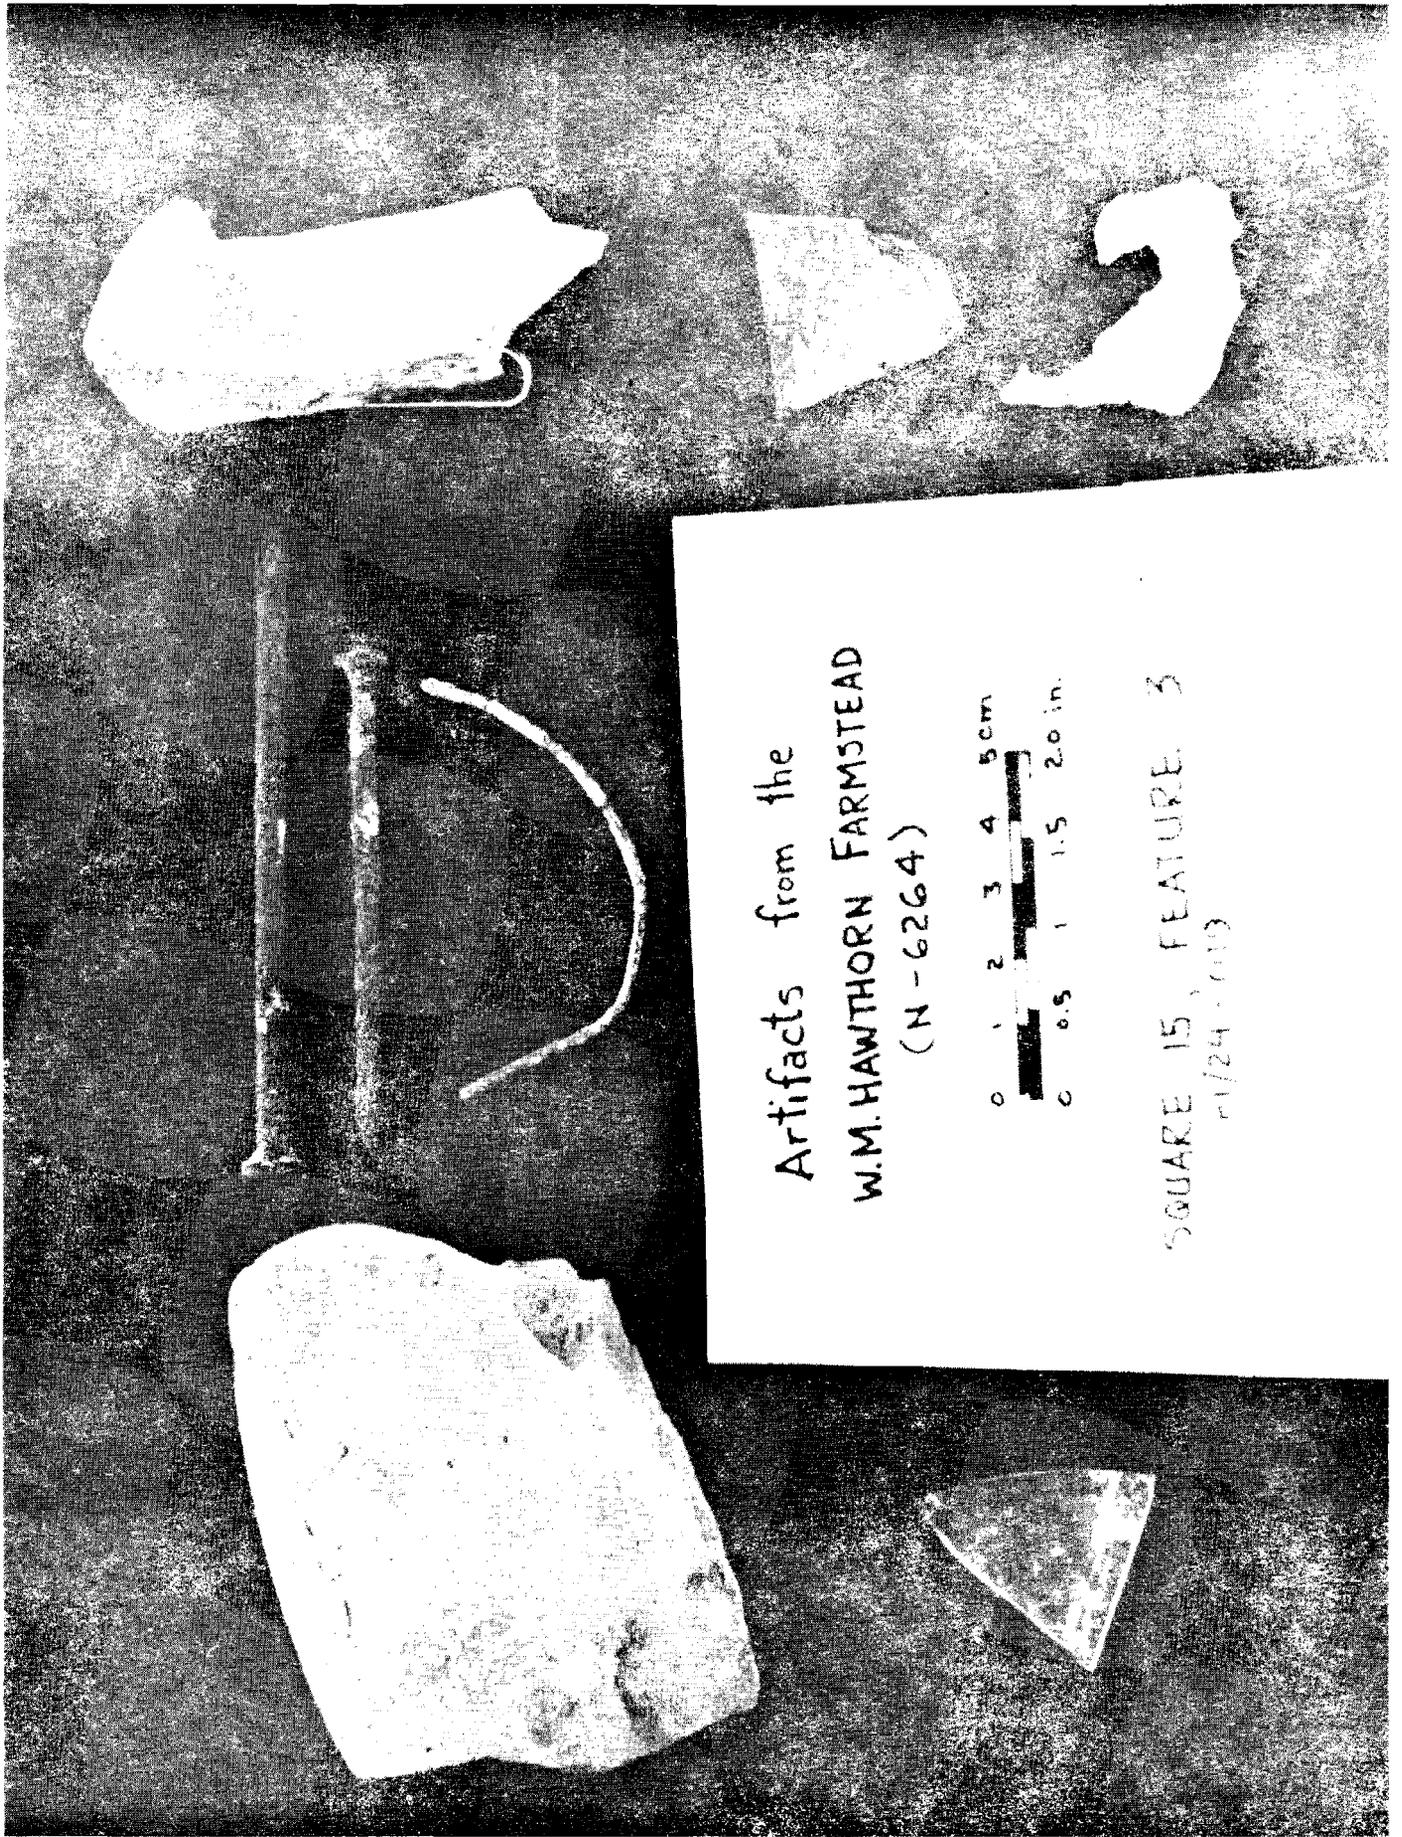
Photograph Number: 13 of 17

Description: late 19th/20th century artifacts
recovered from test excavation in house rubble
pile (glass, ceramics, and metal)

Artifacts from the
W.M. HAWTHORN FARMSTEAD
(N-6264)

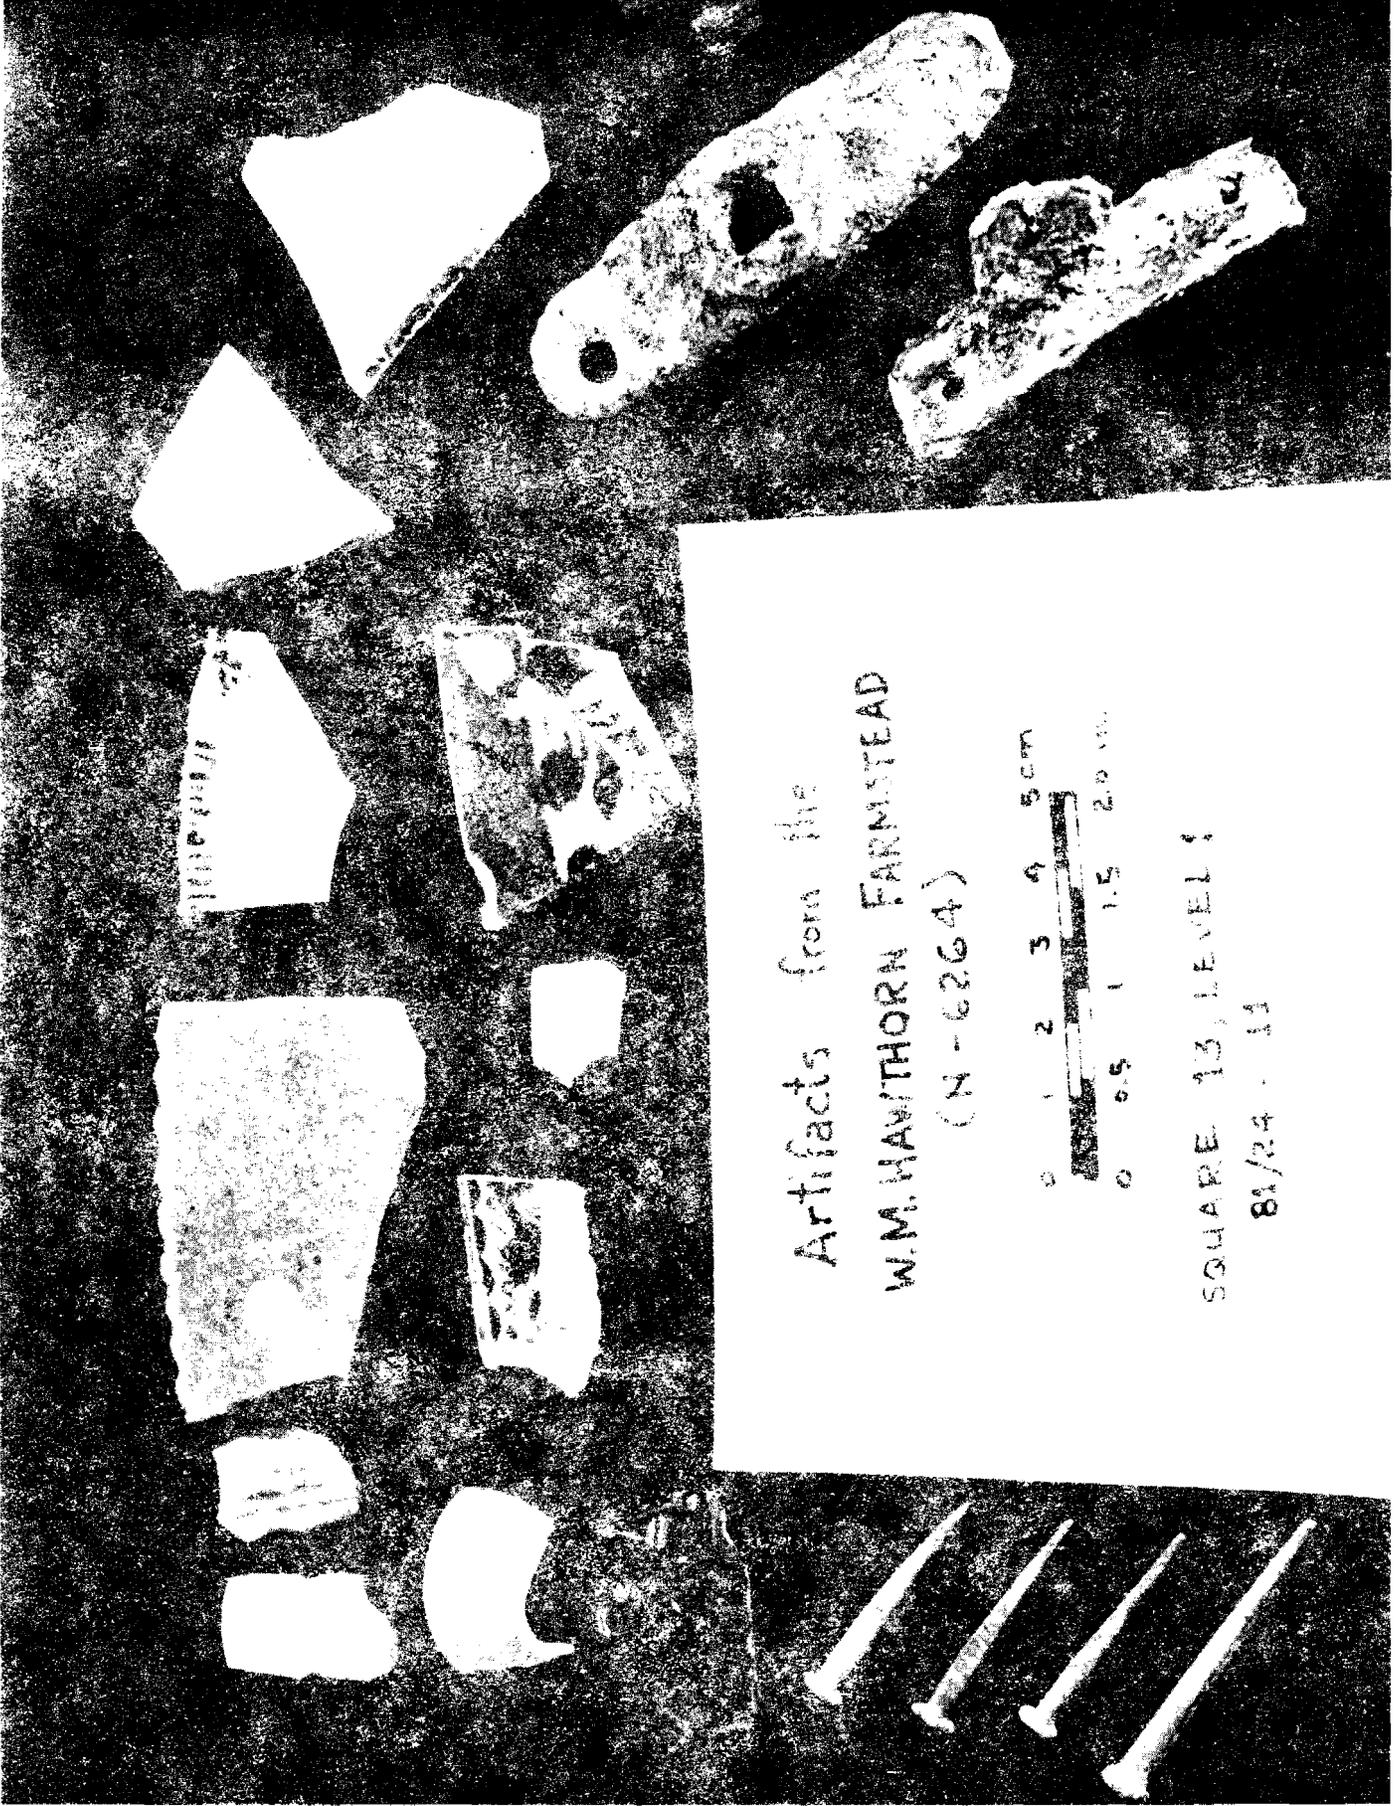
Photograph Number: 14 of 17

Description: late 18th/early 19th century artifacts
recovered from test excavation in lower, level area
northwest of house rubble (nails, bottle glass,
ceramic pipe, ceramic fragments and metal household items)

Artifacts from the
W.M. HAVITHORN FARMSTEAD
(N-6264)
