**W. M. Hawthorn Farmstead National Register
Determination of Eligibility (amended)**

National Register of Historic Places Inventory—Nomination Form

historic W. M. Hawthorn Farmstead (amended), 7NC-E-46

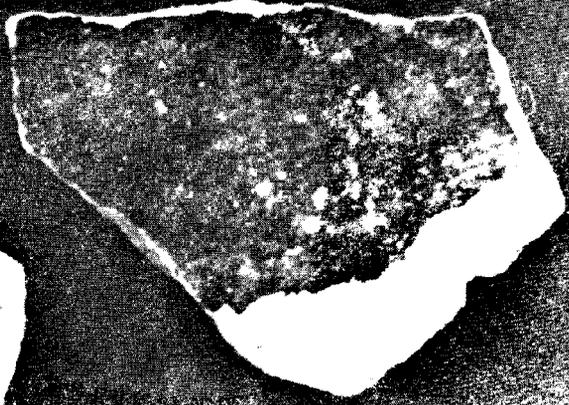
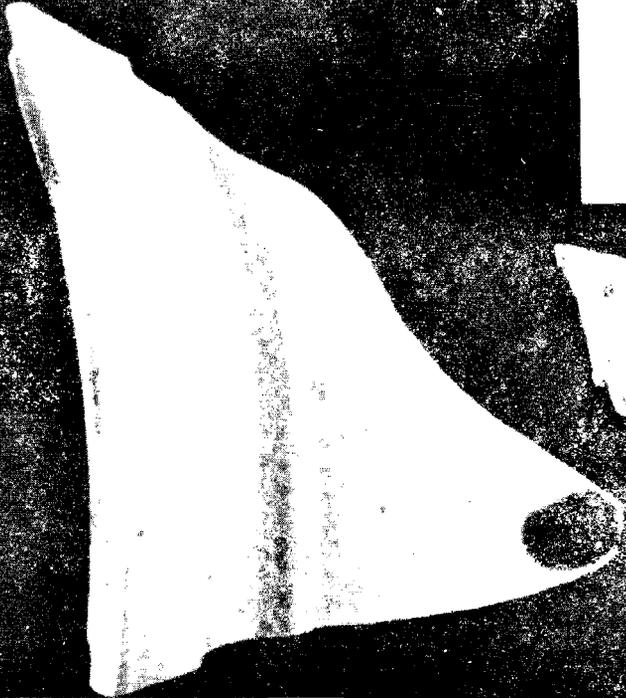
Photograph Number: 15 of 17

Description: late 18th/early 19th century artifacts
recovered from test excavation in lower, level area
northwest of house rubble (ceramics and metal button)

Artifacts from the
 W.M. HAWTHORN FARMSTEAD
 (N. 6264)

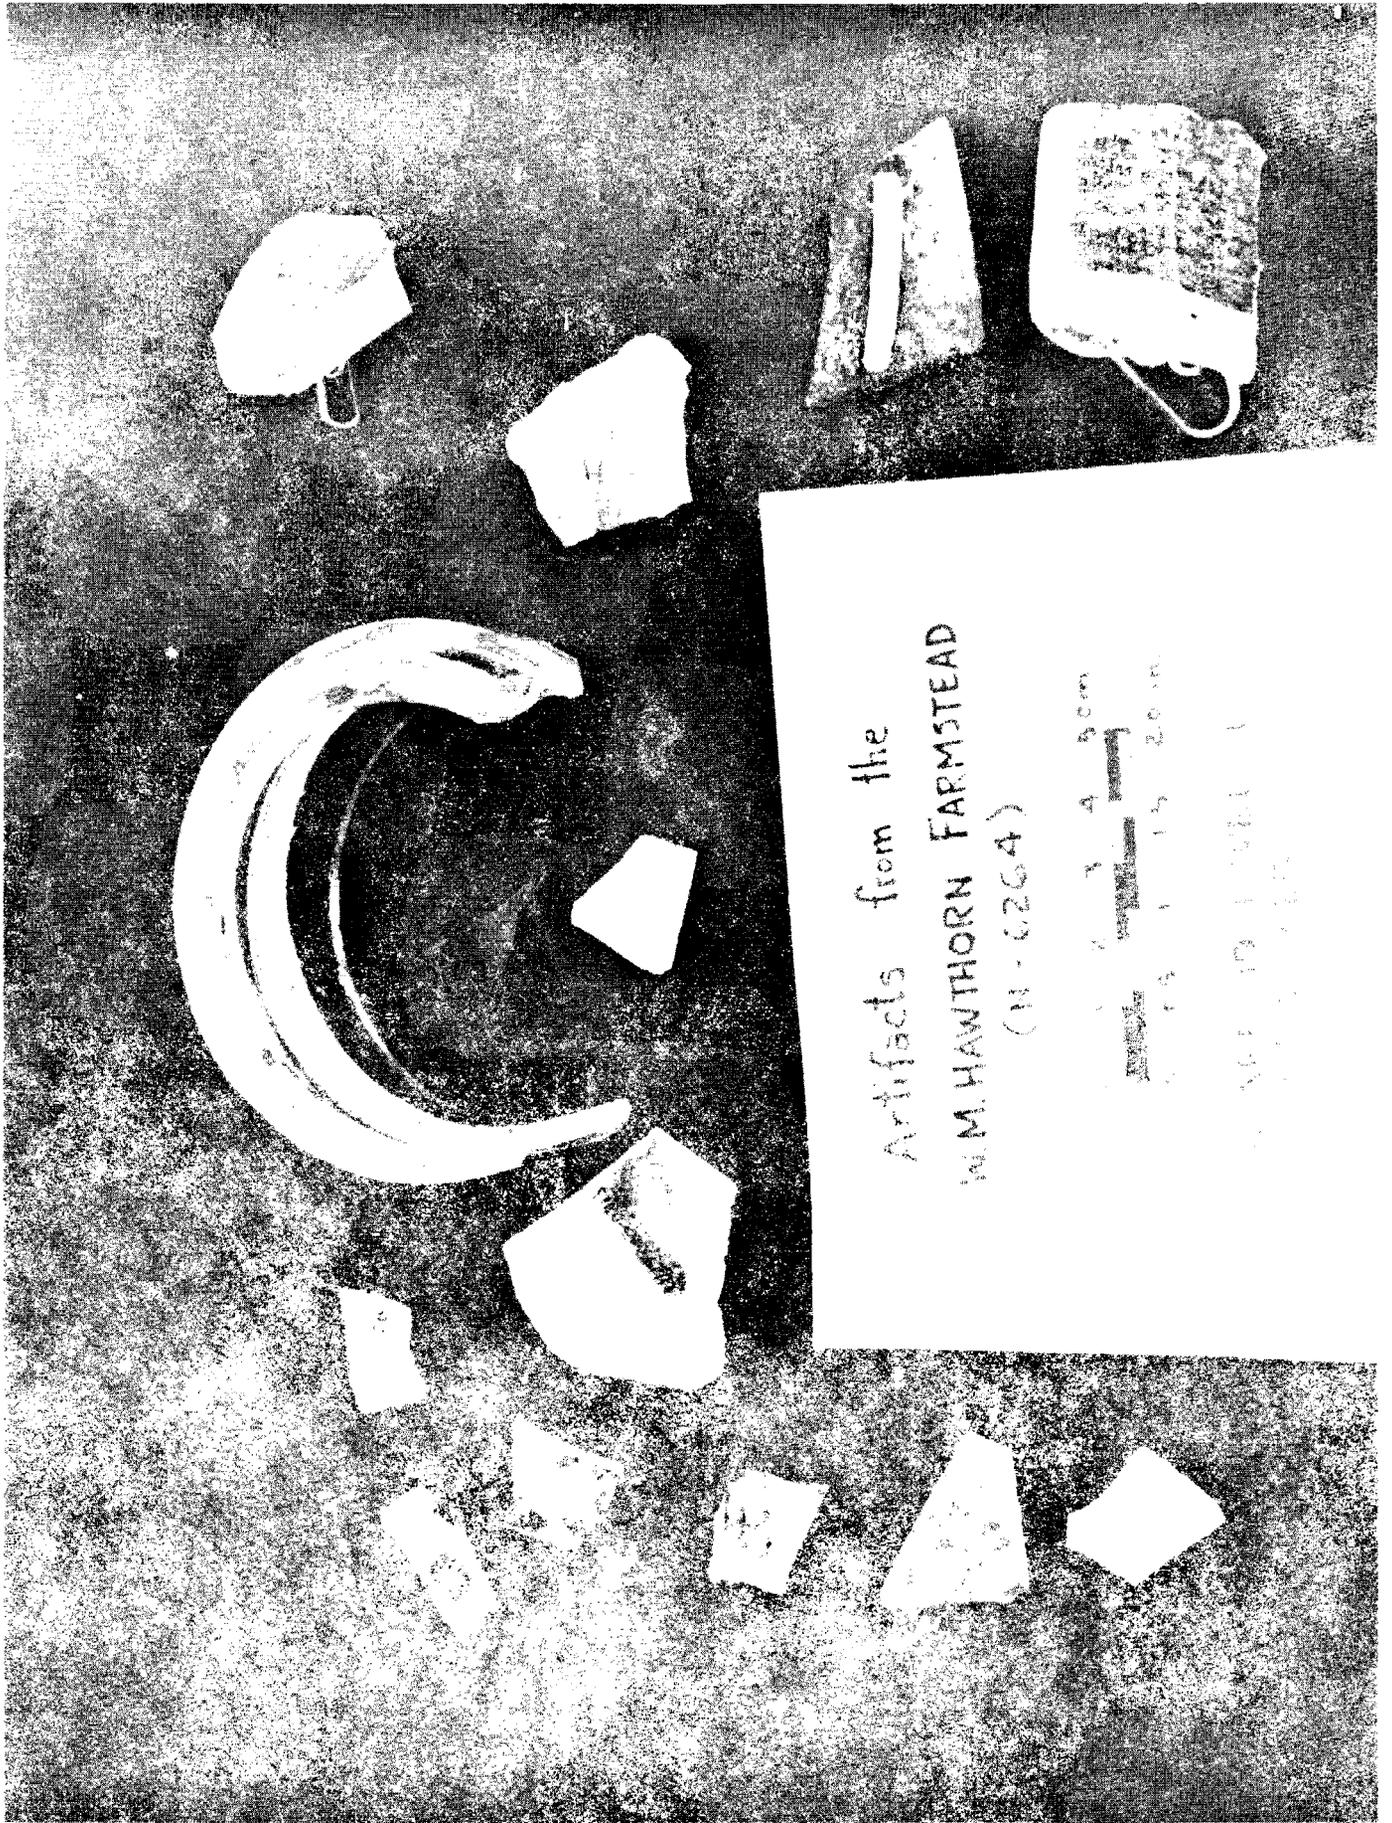
Photograph Number: 16 of 17

Description: late 18th/early 19th century artifacts
recovered from test excavation in lower, level area
northwest of house rubble (glass and ceramic fragments)

Artifacts from the
W.M. HAWTHORN FARMSTEAD
(N-6264)

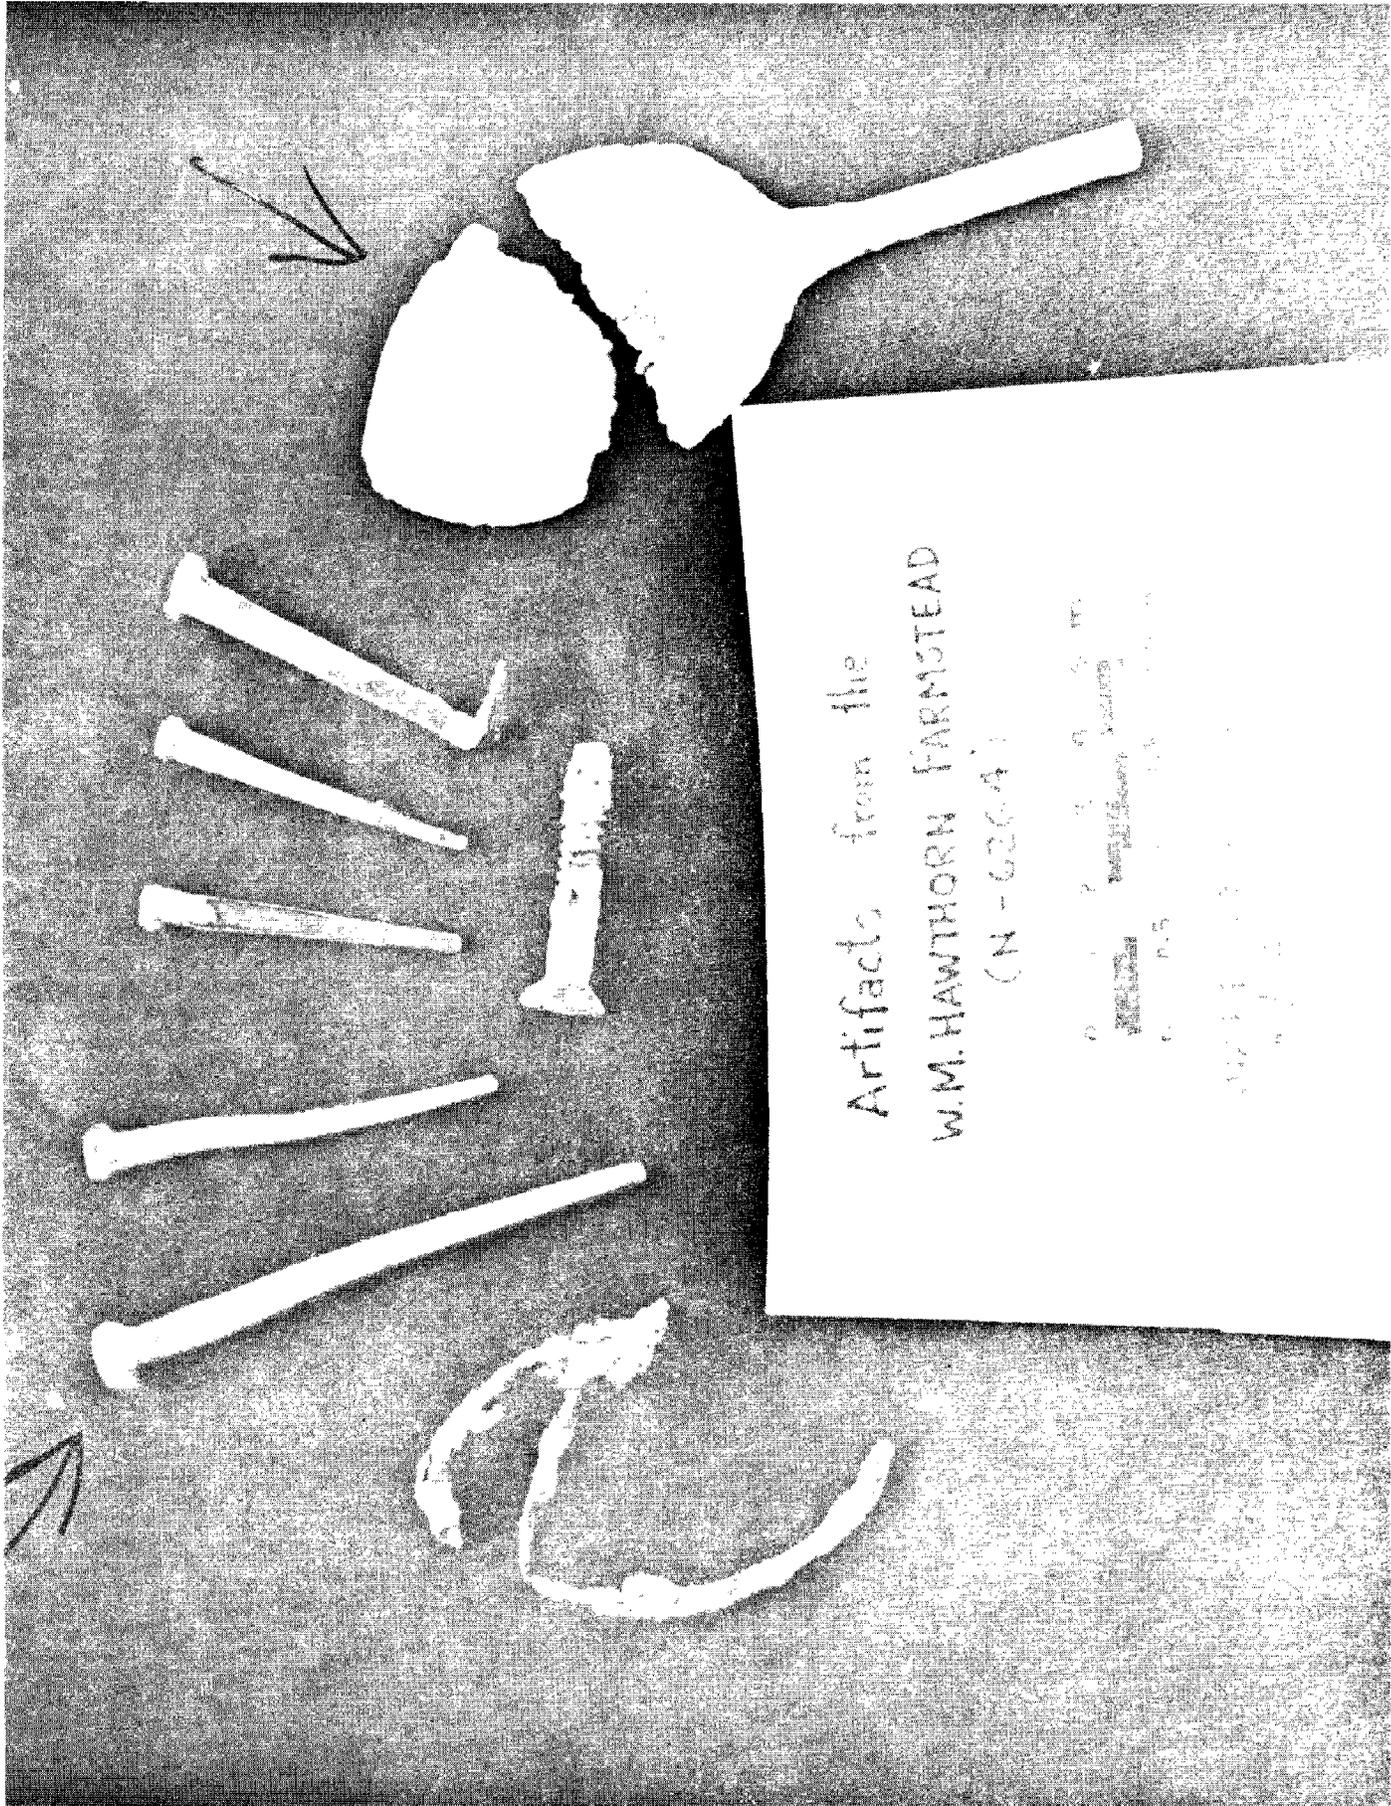
Photograph Number: 17 of 17

Description: late 18th/early 19th century artifacts
recovered from test excavation in lower, level area
northwest of house rubble (metal: Bale seal (?),
nails, screw, pewter spoon)

Artifacts from the
W.M. HAWTHORN FARMSTEAD
(N-6264)

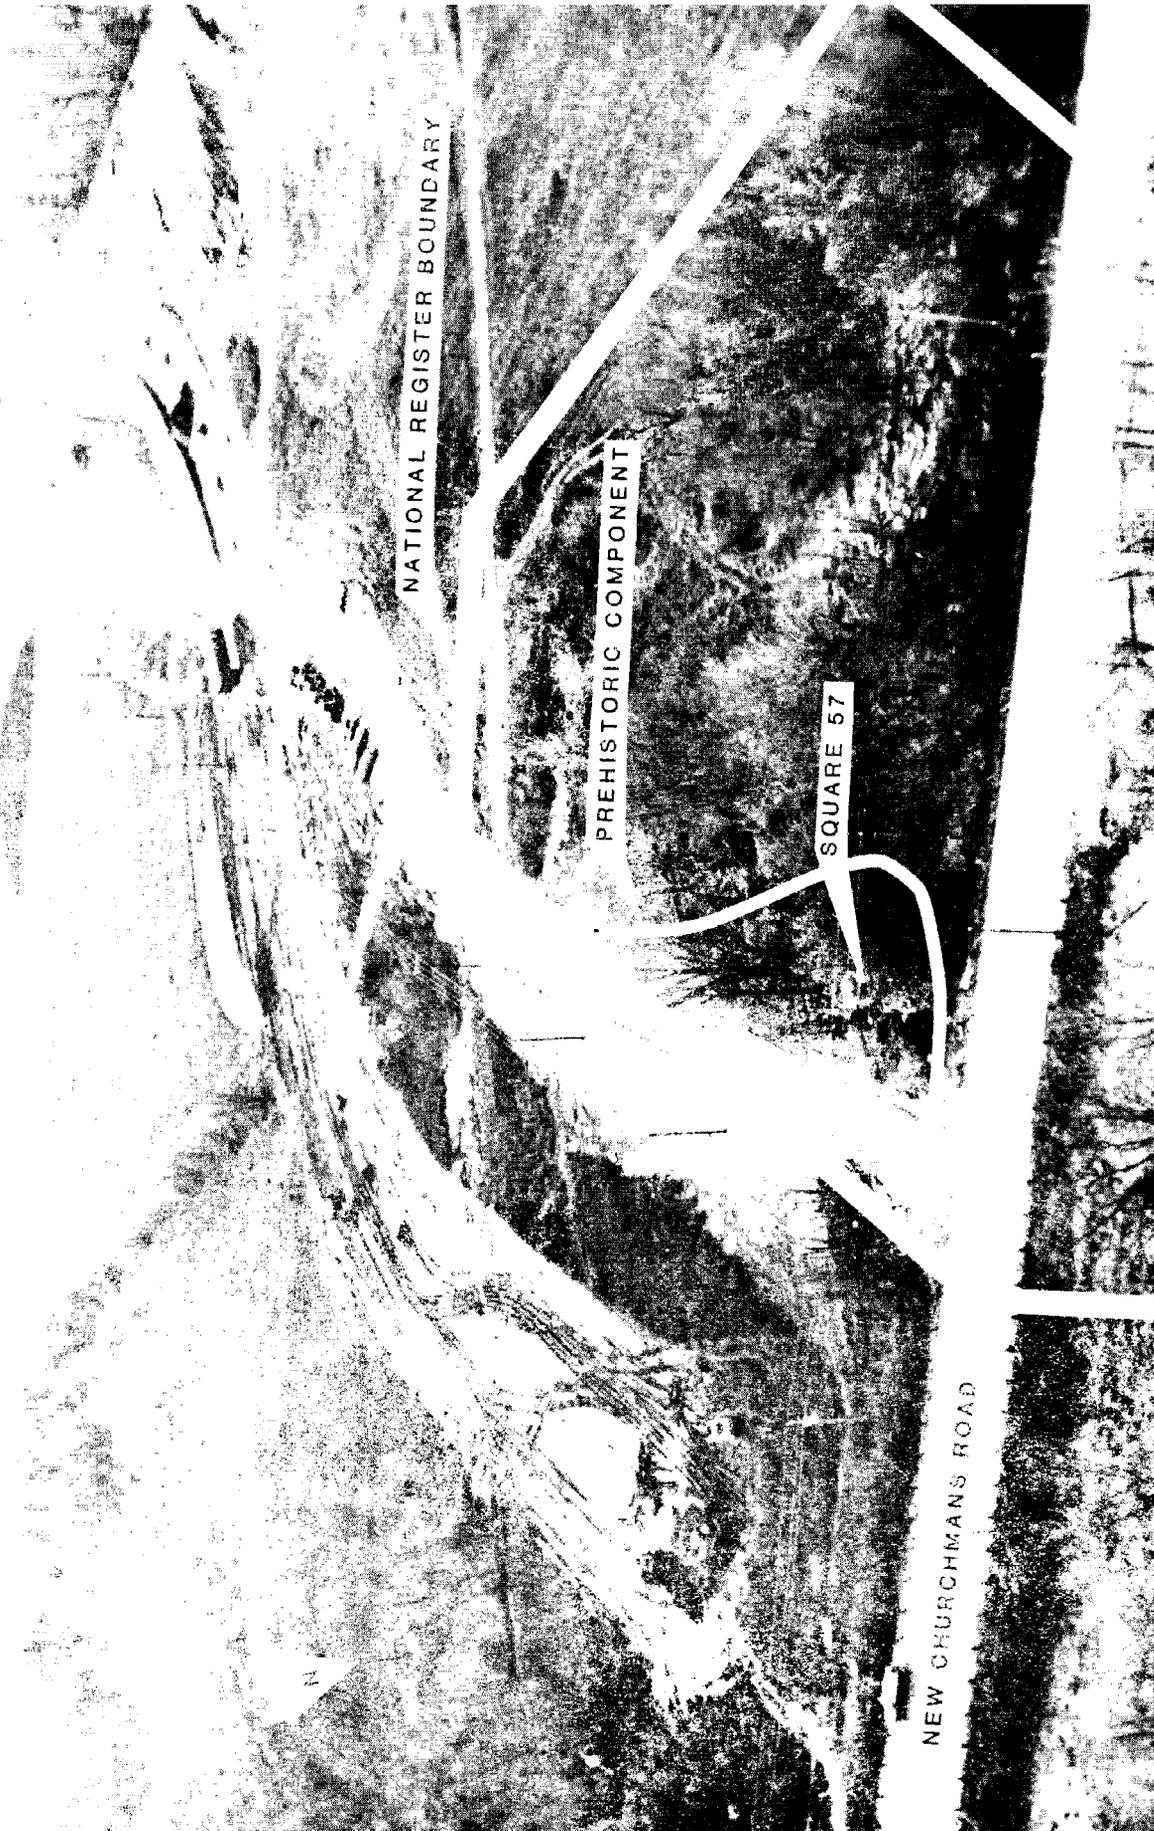
NATIONAL REGISTER BOUNDARY

PREHISTORIC COMPONENT

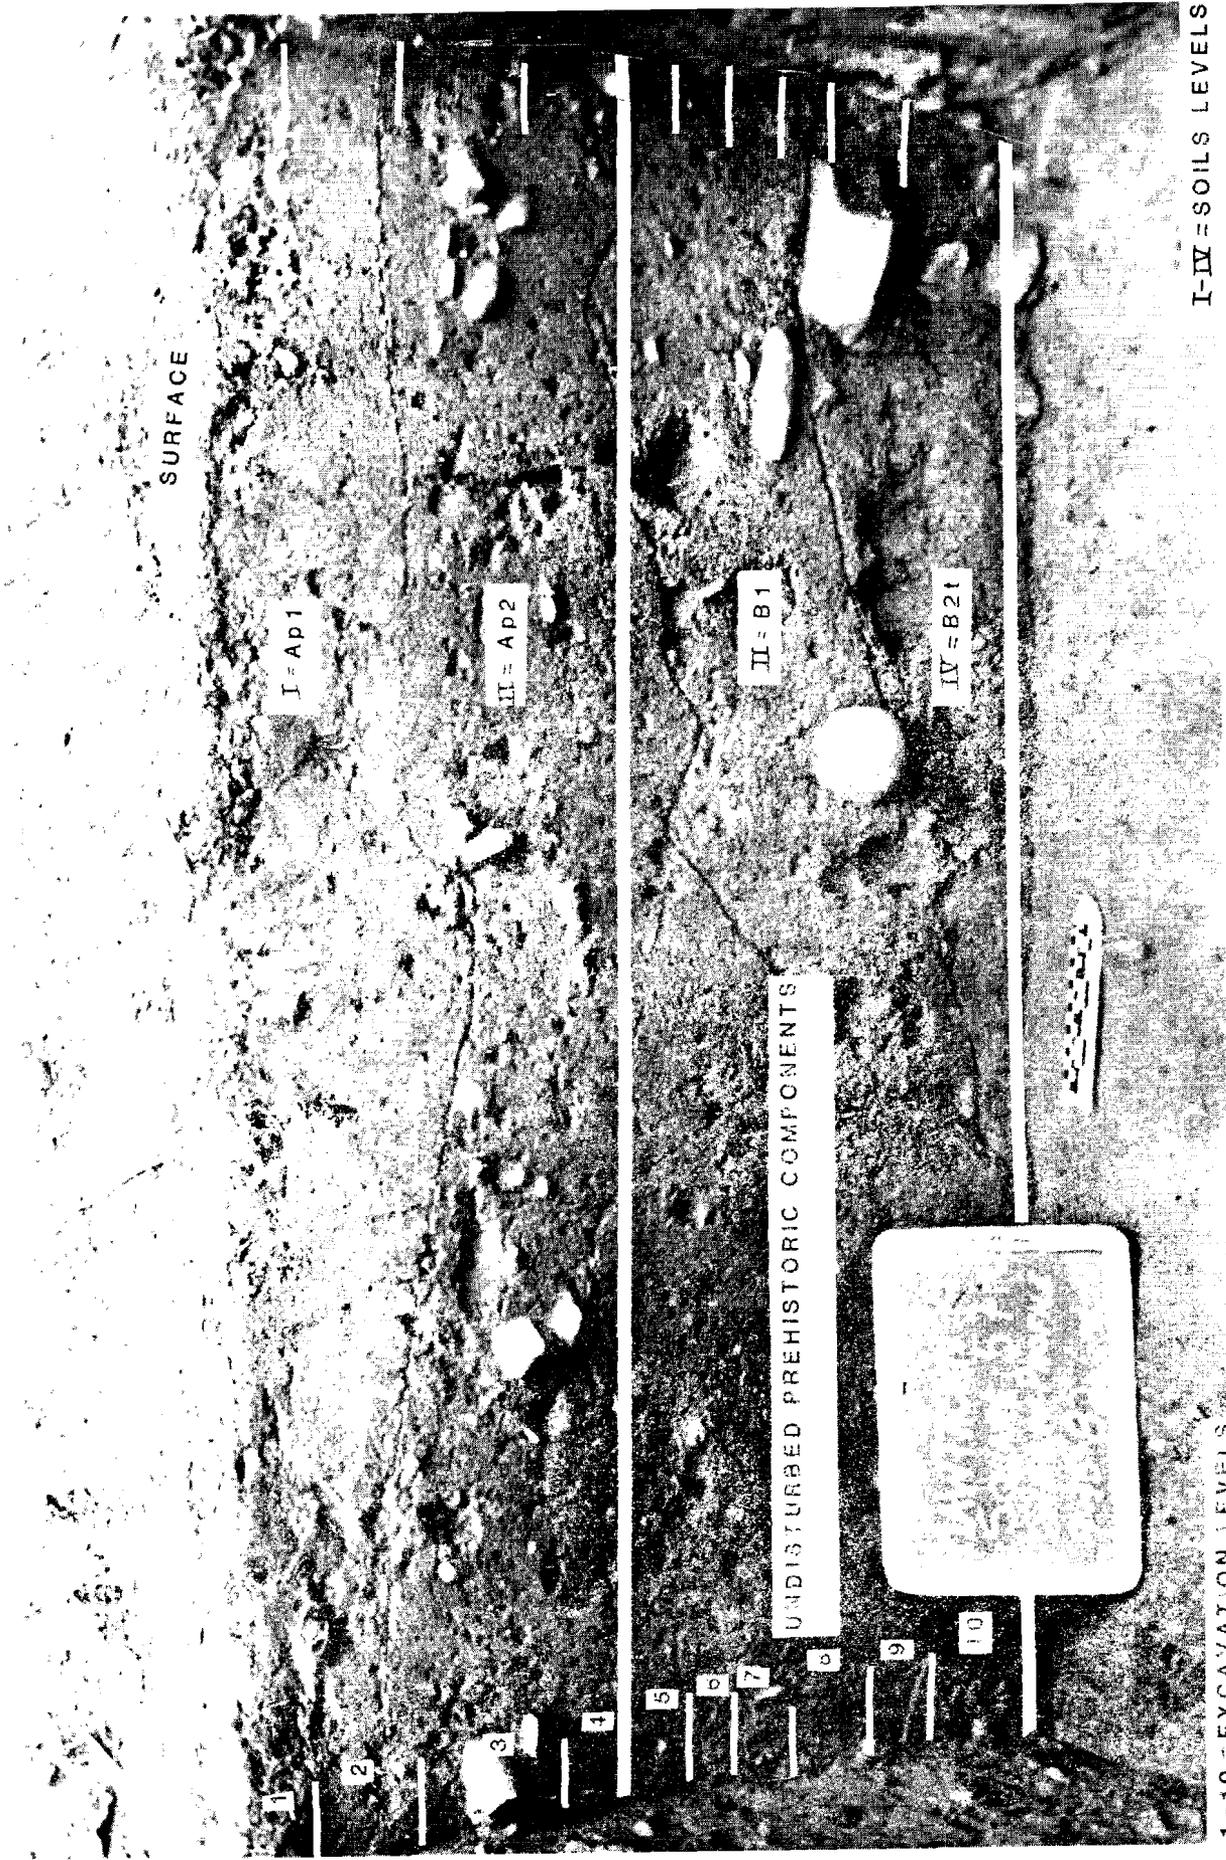
Photograph Number: 19

Description: Square 57, West wall profile

UNDISTURBED PREHISTORIC COMPONENTS

I-IV = SOILS LEVELS

1-10 = EXCAVATION LEVELS

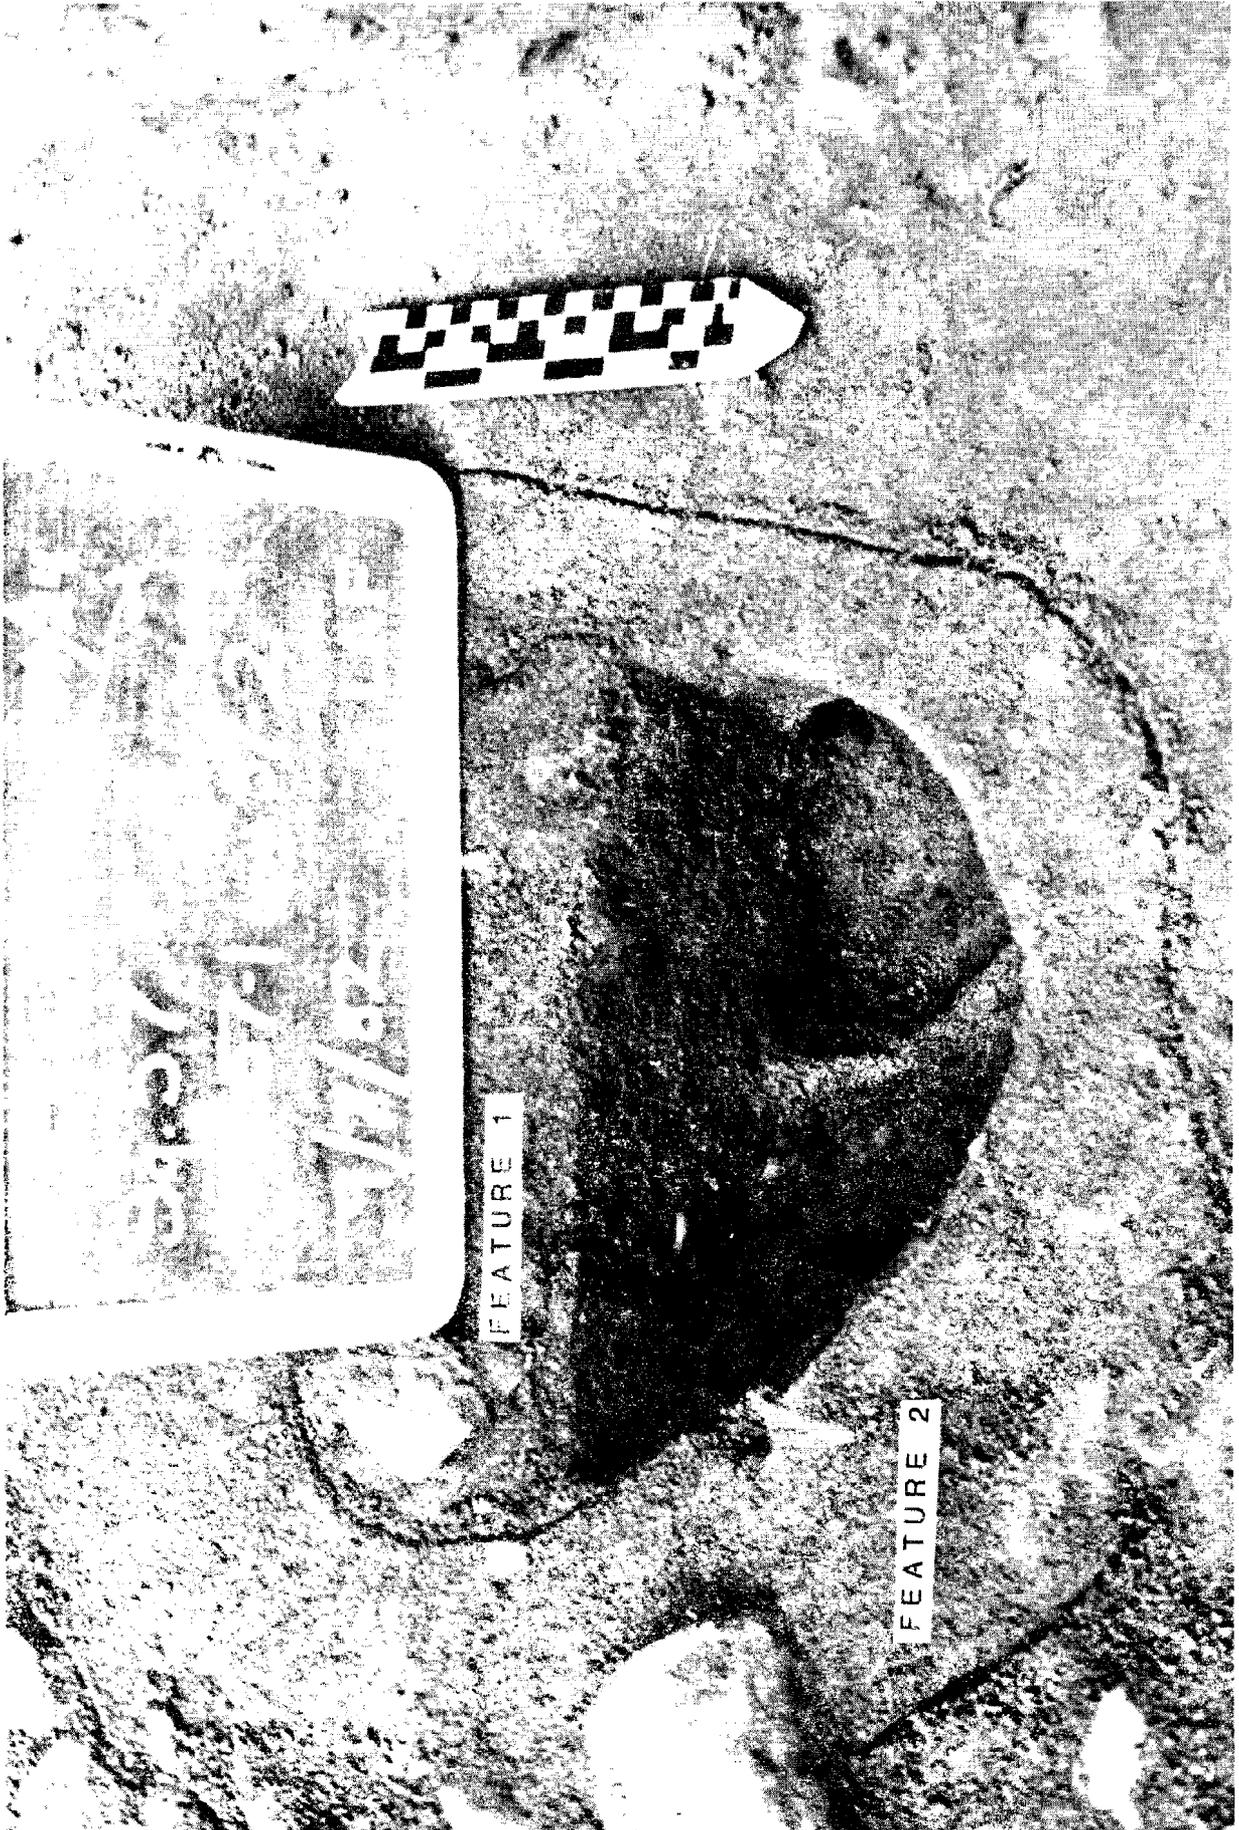
Photograph Number: 20

Description: Feature 1 and Feature 2
