HISTORIC SITE SURVEY

PROPERTY #290
BEAR TRAP DEVELOPMENT
ROAD 268 - BALTIMORE HUNDRED
SUSSEX COUNTY, DELAWARE

**SURVEY REPORT
PROPERTY #290
BEAR TRAP DEVELOPMENT
ROAD 368
BALTIMORE HUNDRED SUSSEX COUNTY
DELAWARE**

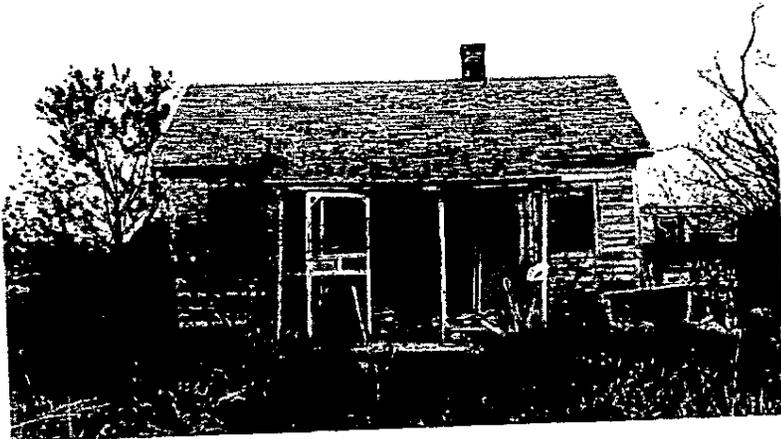
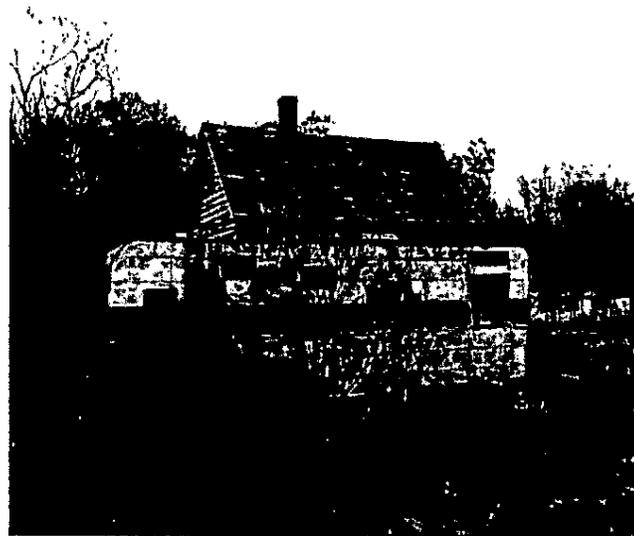
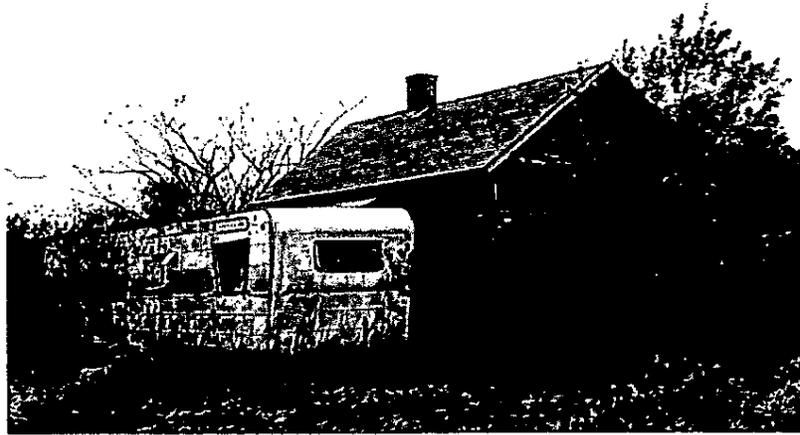
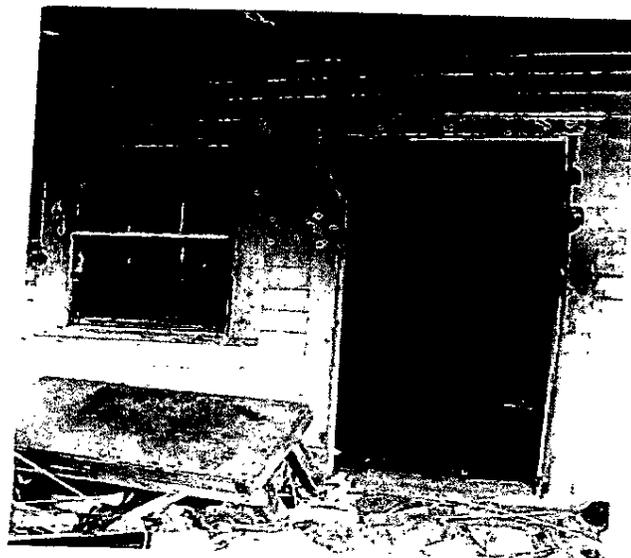
DWELLING

Property #290 consists of a c1940, single-story dwelling, three granaries, an open tractor shed, and three trailers. The three granaries and the open tractor shed would appear to have been constructed at about the same time as the house. The property would appear to have been constructed as a tenant property. The three trailers would appear to have been manufactured in the late 1950s or early 1960s. They were brought to the site to provide additional housing for agricultural workers and to replace the dwelling on the property. None of the buildings are used and all are in very poor repair.

All of the buildings are constructed with wire nails and with machine-sawn lumber. The framing systems of the house, the tractor shed and the granaries are based on accepted construction practice

With regard to the above ground resources at this site, it is recommended that the property be approved to be removed because it is not eligible for listing on the National Register and because there is no compelling reason to conduct additional documentation on a poor example of a mid twentieth-century tenancy when better examples exist in the immediate vicinity. And also because the property will most likely not survive through another winter and hurricane season.

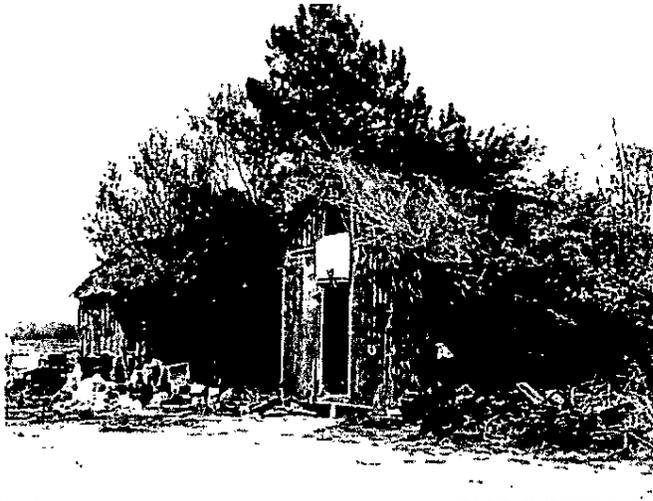
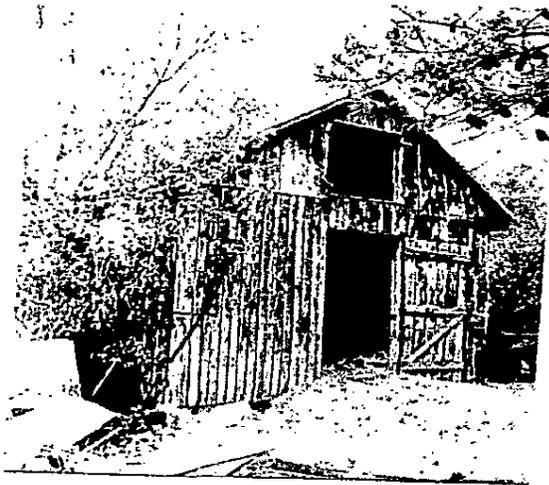
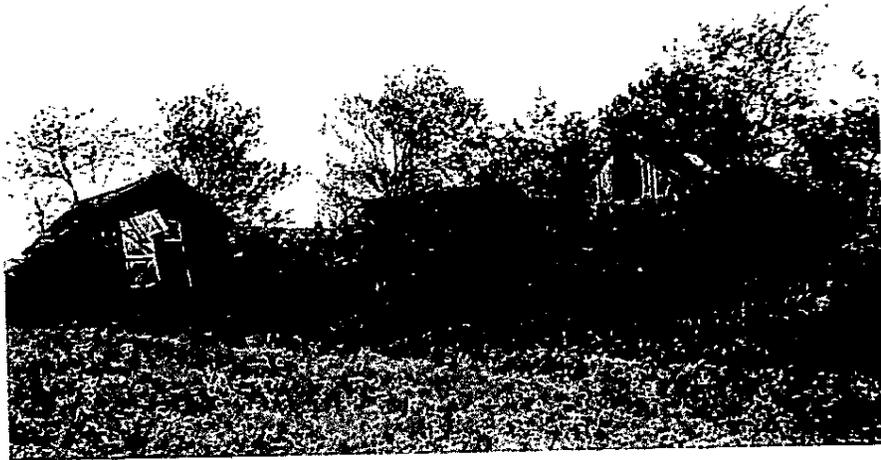
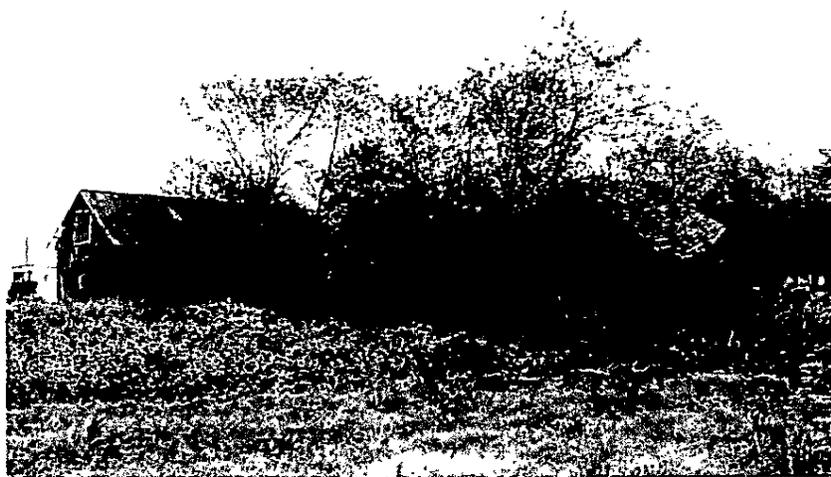
GRANARIES

used during the middle years of the twentieth century. The only exception is that one of the granaries is built on a base that consists of mortise and tenoned joints that relate to another building that was moved to this property or to lumber that was taken from another building when this complex was built. The size of that sill system would appear to have determined the size of the other granaries because they are all the same width and length. None of the other granaries on the site are constructed from reused material.
