This resource was evaluated in association with the federally funded Route 26 Road Improvement Project initiated under Contract 99-112-01 in Fall 1998. The residence is situated on the north side of Route 26 between Club House Road and Old Mill Road. This I-House with Gothic Revival alterations was constructed c. 1870.

Cultural Resource Survey  
Main Building Form

CRS # S-9745  
SPO Map 20-21-07  
Hundred Baltimore  
Quad Bethany Beach  
Zone Coastal  
Acreage 1 acre

1. Address of Property: North side of Route 26 between Club House Road and Old Mill Road (Tax Parcel 1-34-12-155)  
2. Date of Initial Construction: c. 1870  
3. Floor Plan/Style: Compound Plan/I-House  
4. Architect/Builder: n/a  
5. Integrity: Original Site? yes Moved? \_\_\_\_\_  
If moved, when and from where? \_\_\_\_\_  
List major alterations and dates (if known) \_\_\_\_\_

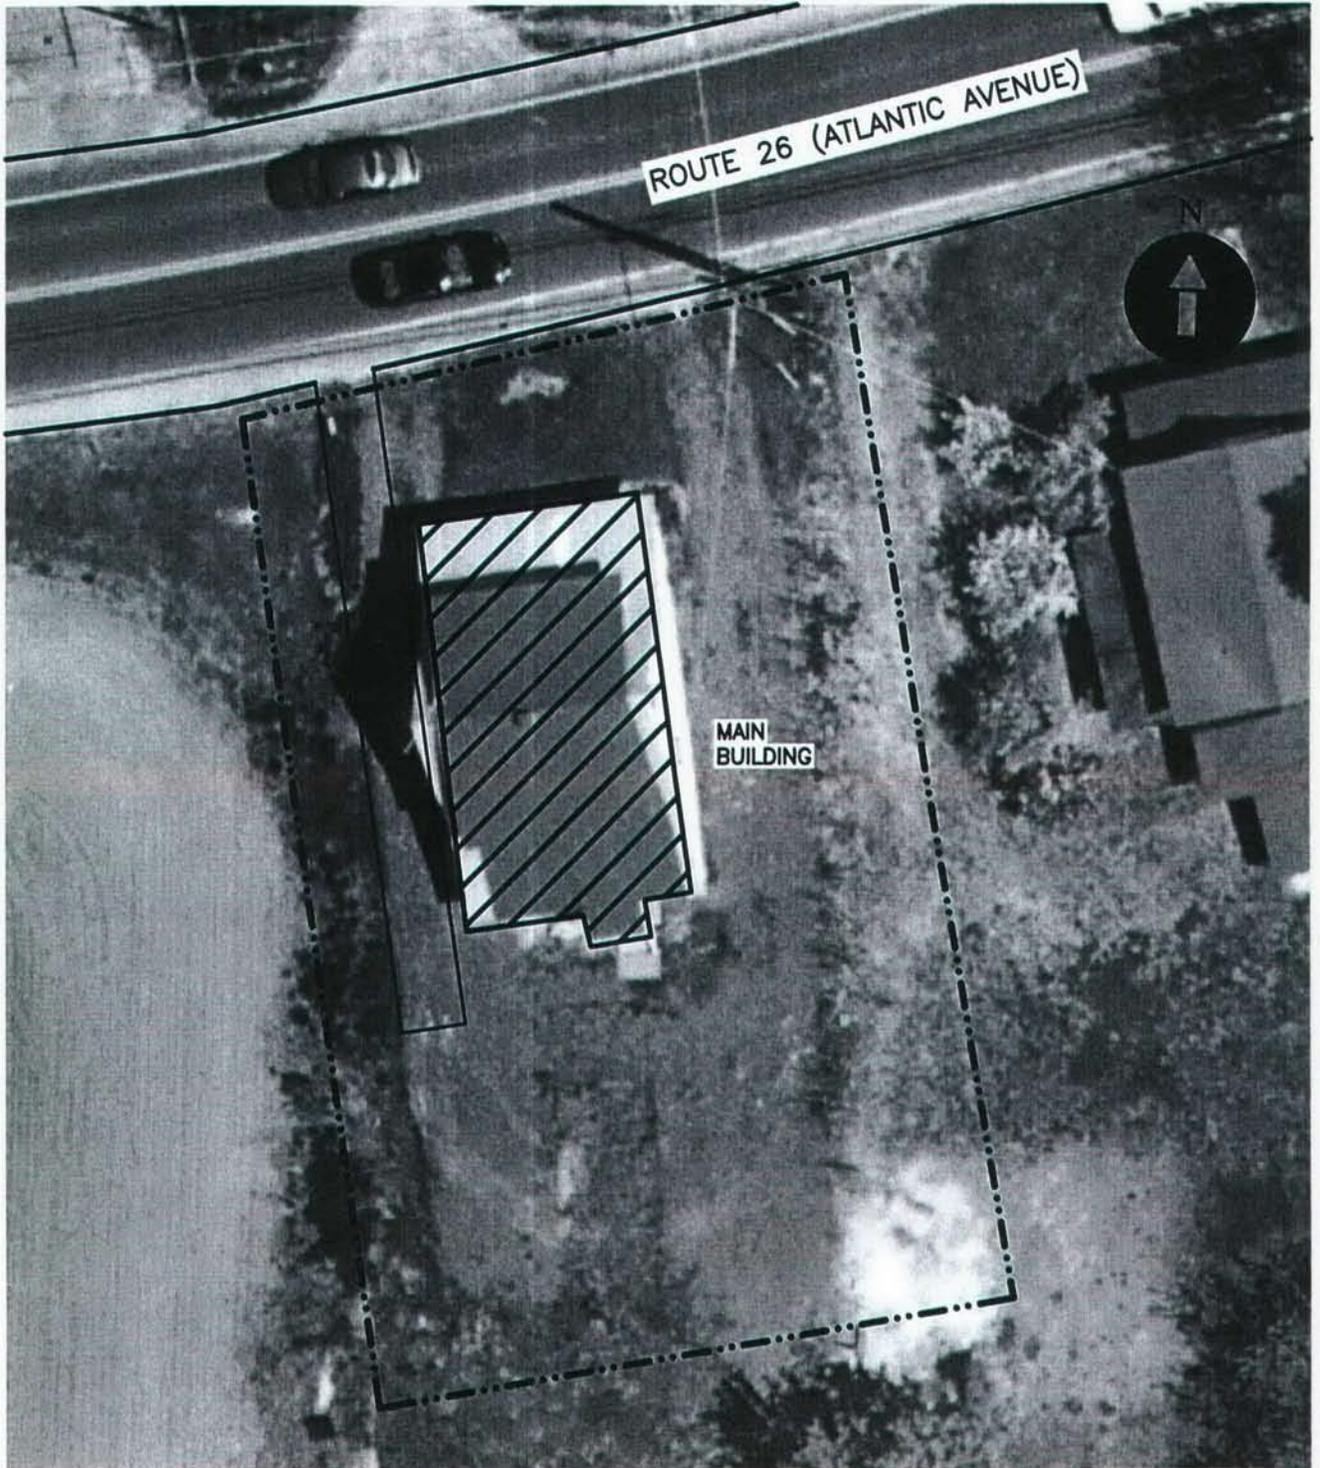
Sketch Plan:

To the south of the main house is a prefabricated tool shed with a double-leaf entrance.
