CRS #: S-9736

Cultural Resource Survey
Related Outbuilding Form

Cultural Resource Survey
Main Building Form

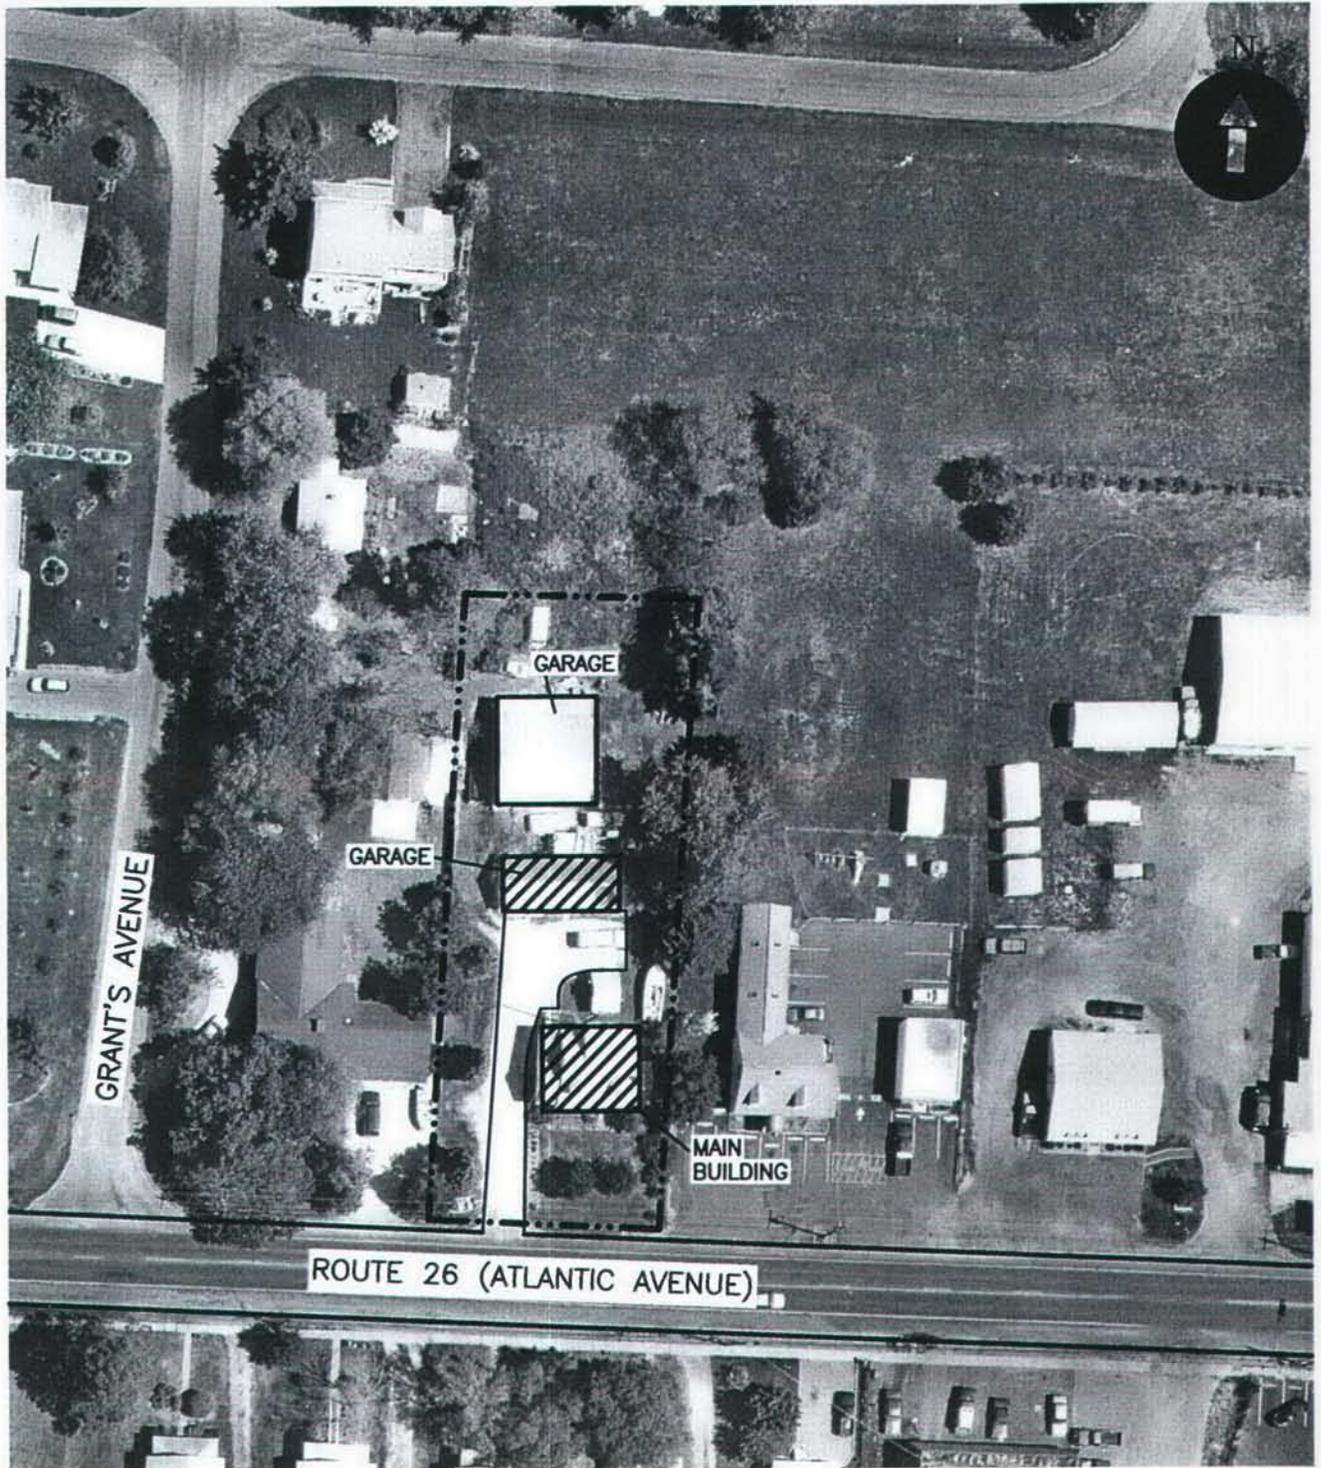
Sketch Plan:

The James and Betty Timmons, Trustees, House (Tax Parcel 1-34-12-290.00) is a two-story, four-bay, wood-clad, Minimal Traditional building with an asphalt-shingle side-gable roof. The main (south) façade features a single-leaf entrance with a paneled aluminum door. To the east of the entrance there is a paired vinyl 1/1 window; to the west there is a single vinyl 1/1 window and a tripartite window with vinyl 1/1 sashes. The roof has two pedimented dormers with wood 6/1 windows. To the west there is a one and one-half story gable roof addition with a sliding window. The west façade features two 1/1 windows. The rear façade has single and paired 1/1 windows and a single-leaf entrance in the addition.

To the north of the main building there is a one-story, two-bay, corrugated metal-clad garage with an asbestos-shingle front-gable roof. The main (west) façade has two vehicular entrances with metal roll-down doors. The south façade has a band on five fixed-light windows.

Also to the north of the main building is another one-story, three-bay, asbestos shingle-clad garage with an asphalt-shingle side-gable roof. The main (south) façade features one vehicular entrance with a paneled wood and glazed roll-down door and two single-leaf pedestrian entrances.

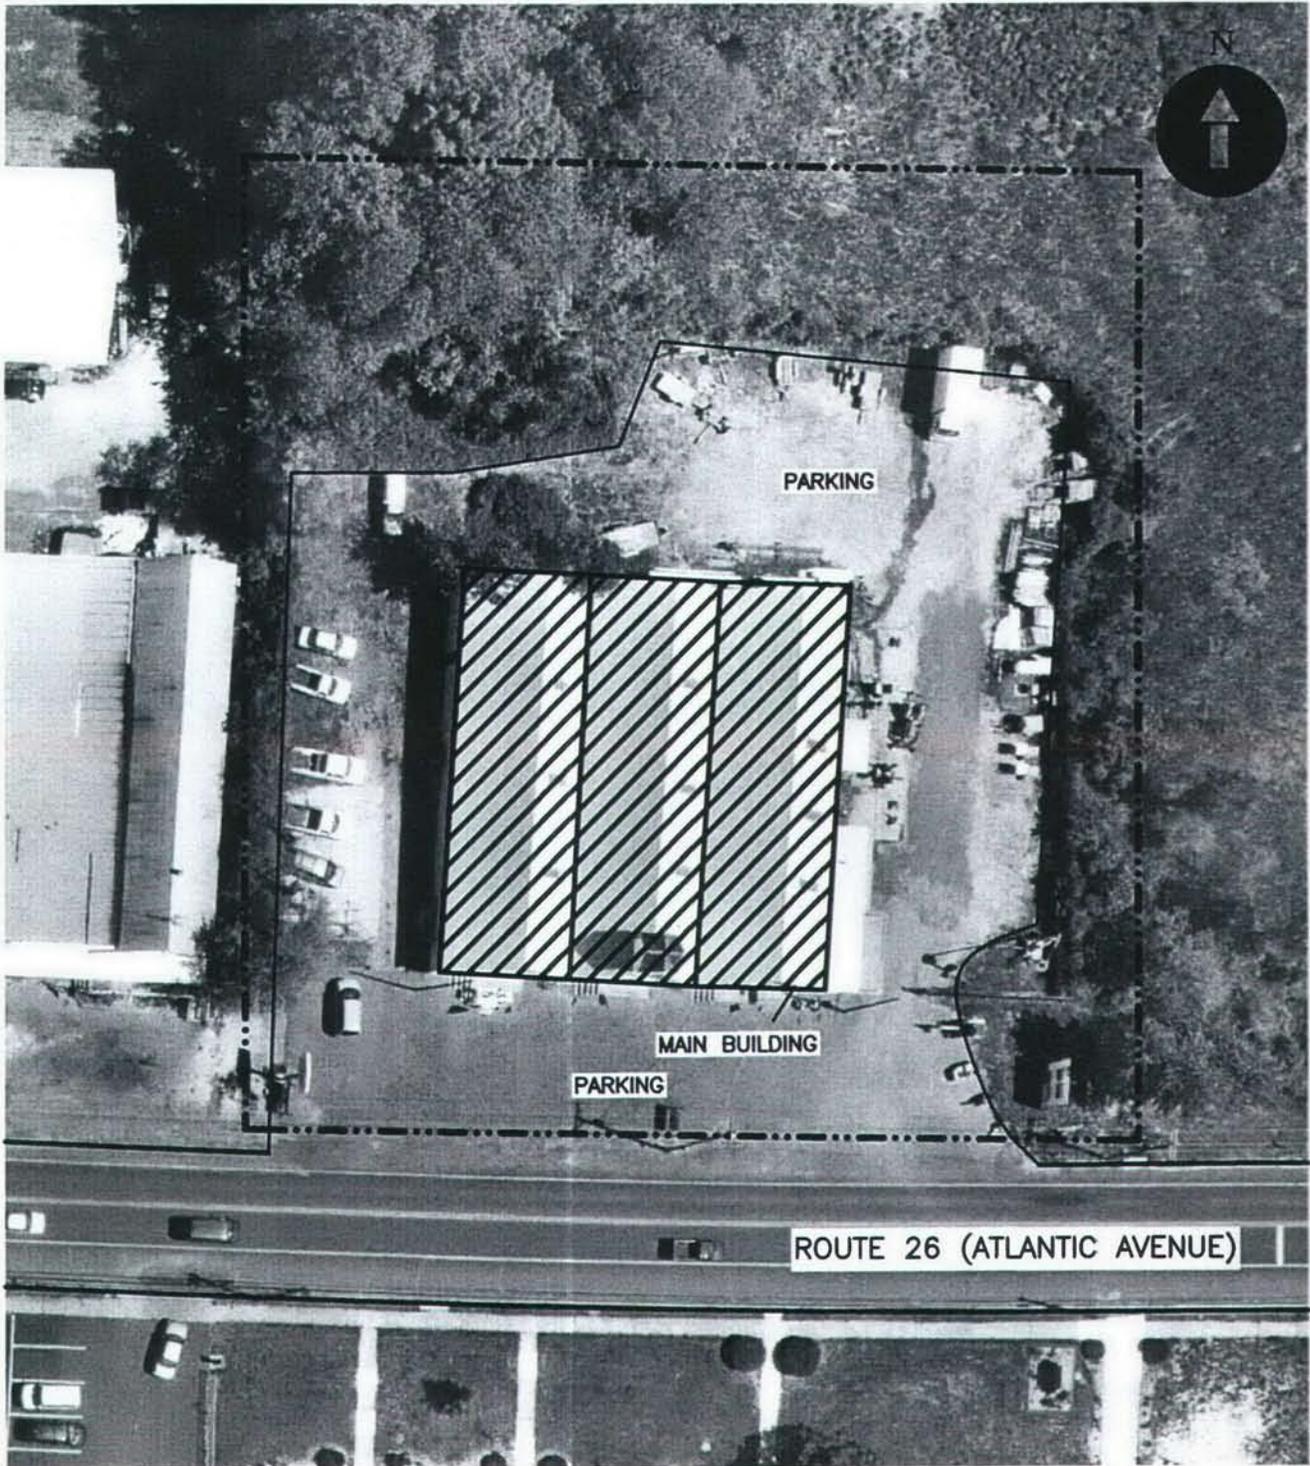
Sketch Plan:

The building on the Rent Equip Property (Tax Parcel 1-34-12-294.00) is a converted grain storage structure that is one and one-half story, three-bays, vinyl clad, with a front gable roof capping each of the three bays. Moving from east to west on the main (south) facade, bay 1 has a single-leaf pedestrian entrance flush with the main facade and a vinyl 1/1 window. To the west of the pedestrian entrance is a converted vehicular entrance that is now a recessed glazed entrance flanked by single-pane fixed sidelights. The east end has a one-story shed roof addition with a paired vinyl 1/1 window on the main (south) facade. Centered in the gable peak is a square opening with a louvered vent. Bay 2 has a converted vehicular entrance that is now a recessed glazed entrance flanked by single-pane fixed sidelights; to the east of the entrance is a square fixed picture window and above the entrance is a square opening with louvered vent. A sliding door may be used to conceal this entrance. A square lantern with a cross-gable roof truncates the gable peak; the peak of the lantern has a four-light oculus whereas its east and west facades have an oculus infilled with louvered vents. Bay 3 has the same entrance as bay 2, also with a sliding door; to the west of the entrance there is a paired vinyl 1/1 window with faux paneled shutters. Above the entrance there is a partially infilled square opening with a small louvered vent. The east facade has a single vinyl 1/1 window, a small fixed square window, and a vehicular entrance with a wood door. The west facade is clad in weatherboard; toward the rear there is a vehicular entrance.

While the location, feeling, and setting have been maintained, other attributes have been compromised. For example, the design has been altered by the addition of stairs to the entrances that have been converted from vehicular use to pedestrian use and the association, while commercial in nature, is not related to agriculture. In addition, the interior has been altered in such a way that it no longer conveys an association with agricultural practices. Each of the sections of the structure house a different commercial enterprise, such as computer learning center and an equipment rental facility. The integrity of materials and workmanship have been compromised or obscured by vinyl siding; vehicular entrances have been converted to pedestrian entrances with glass doors and sidelights. The property is

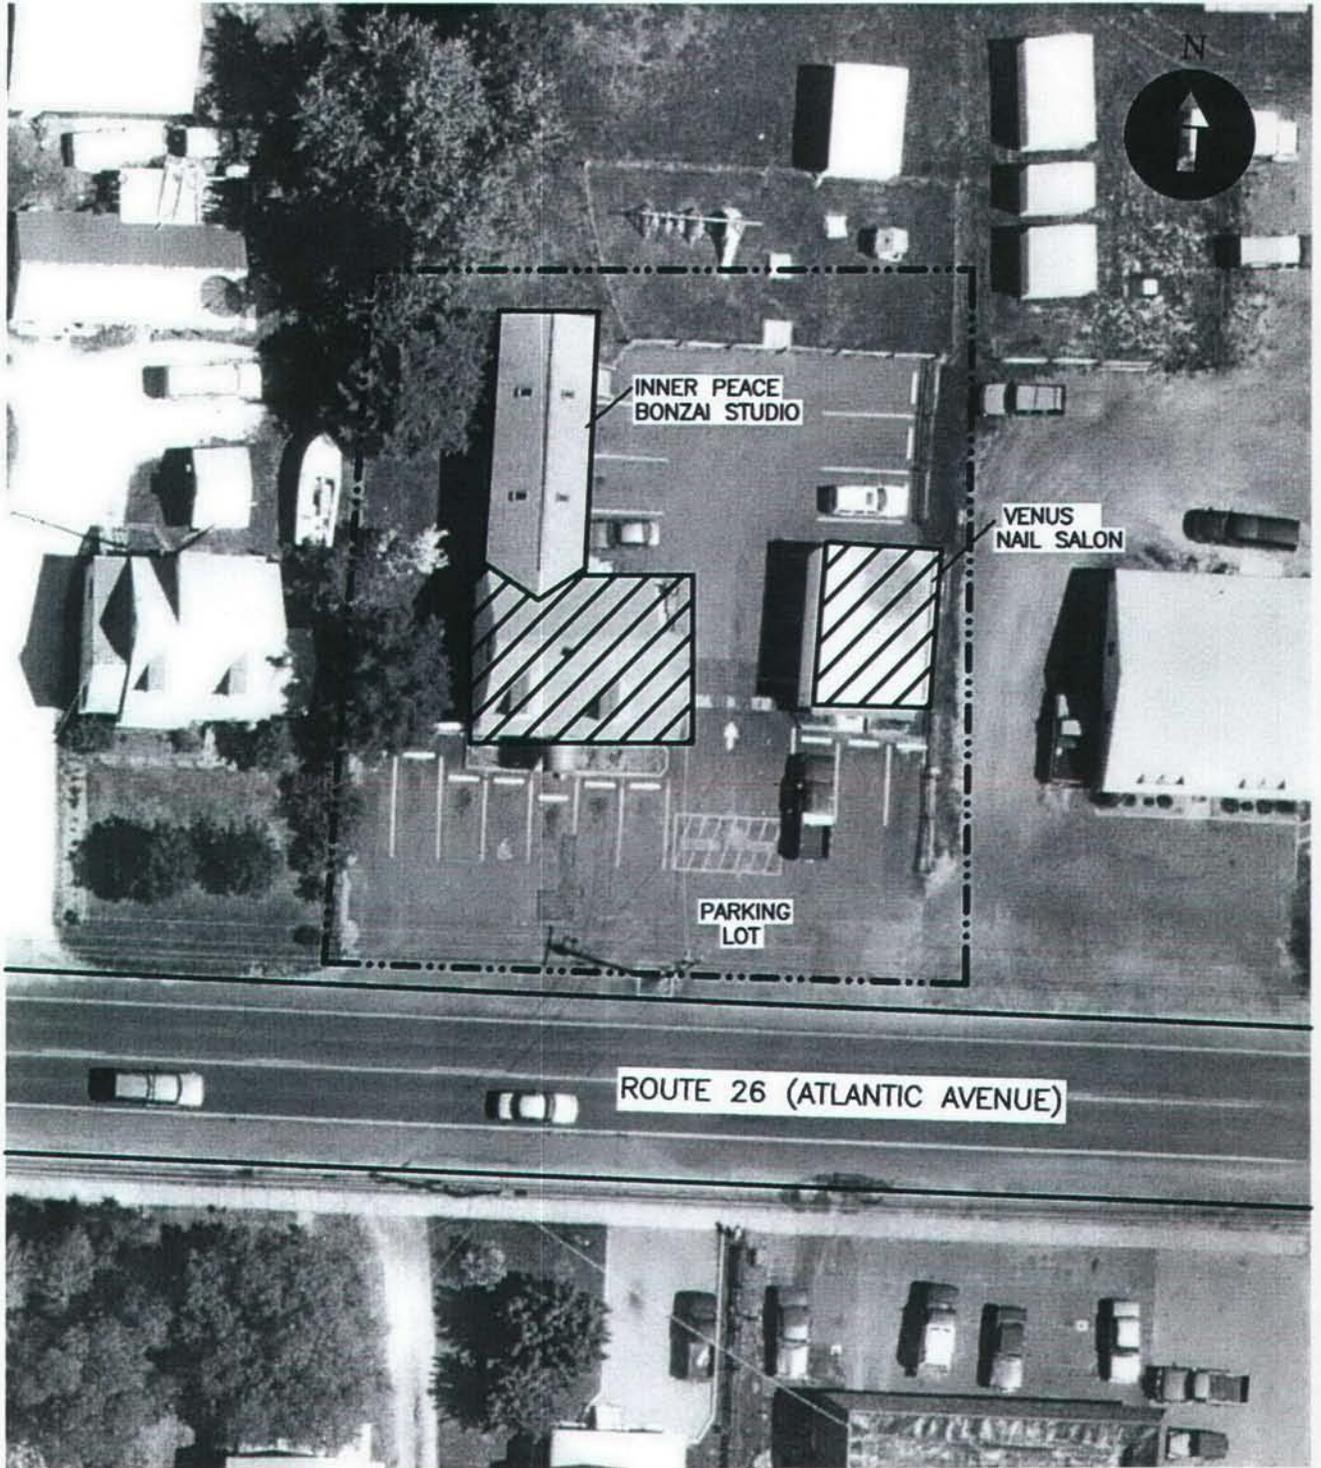
Sketch Plan:

The CFL Enterprises, Inc. Property (Tax Parcel 1-34-12-291.00) has two buildings on its parcel. They both serve commercial uses; Inner Peace Bonsai Studio and a Venus Nail Salon.

The westernmost building is a two-story, three-bay, vinyl shingle-clad Minimal Traditional former residence now commercial entity with an asphalt-shingle side-gable roof. The main (south) façade features a central single-leaf entrance with a glazed door flanked by paired vinyl 1/1 windows with faux louvered shutters. The roof has two pedimented dormers with wood 6/1 windows. The east façade features one large fixed-light picture window set within a one and one-half story asbestos-clad

The easternmost building is a one-story, three-bay, cinderblock commercial building with a flat roof with metal coping. The main (south) façade has a central single-leaf entrance with an aluminum and glazed door flanked by large fixed-light picture windows. A pent eave with wood shake shingles extends across the full façade. The east and west façade have no openings.
