This resource was evaluated in association with the federally funded Route 26 Road Improvement Project initiated under Contract 99-112-01 in Fall 1998. The residence is located on the south side of Route 26 west of Old School Lane. The bungalow style dwelling was constructed c. 1940.

Cultural Resource Survey  
Main Building Form

CRS # S-9730  
SPO Map 20-21-07  
Hundred Baltimore  
Quad Bethany Beach  
Zone Coastal  
Acreage Less than 1 acre

This bridge was evaluated in association with the federally funded Route 26 Road Improvement Project, initiated in Fall 1998 under contract number 99-112-01. This concrete box culvert bridge was constructed c. 1920, undergoing several alterations throughout the early and mid-20th century. This style of bridge with minimal embellishment is a common type not only found in Sussex County, but is also found throughout the state.

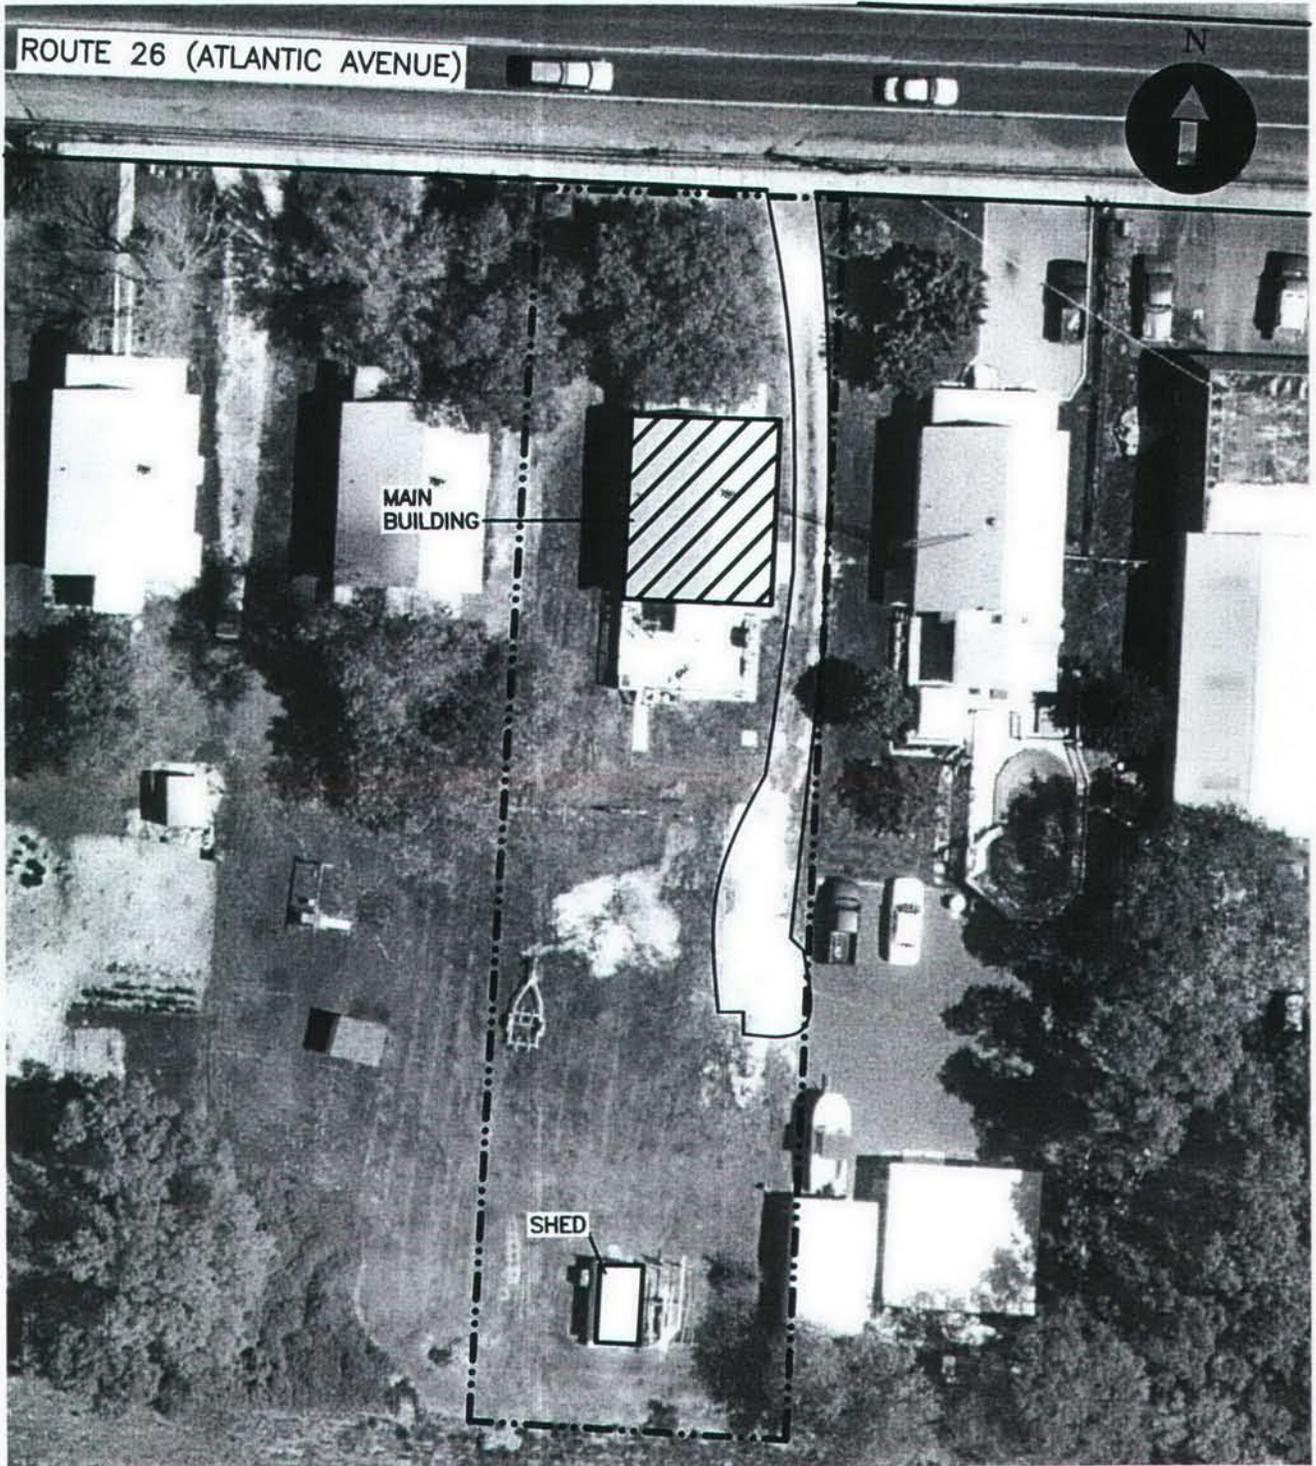
Sketch Plan:

This property has a small prefabricated tool shed to the southeast of the main building.

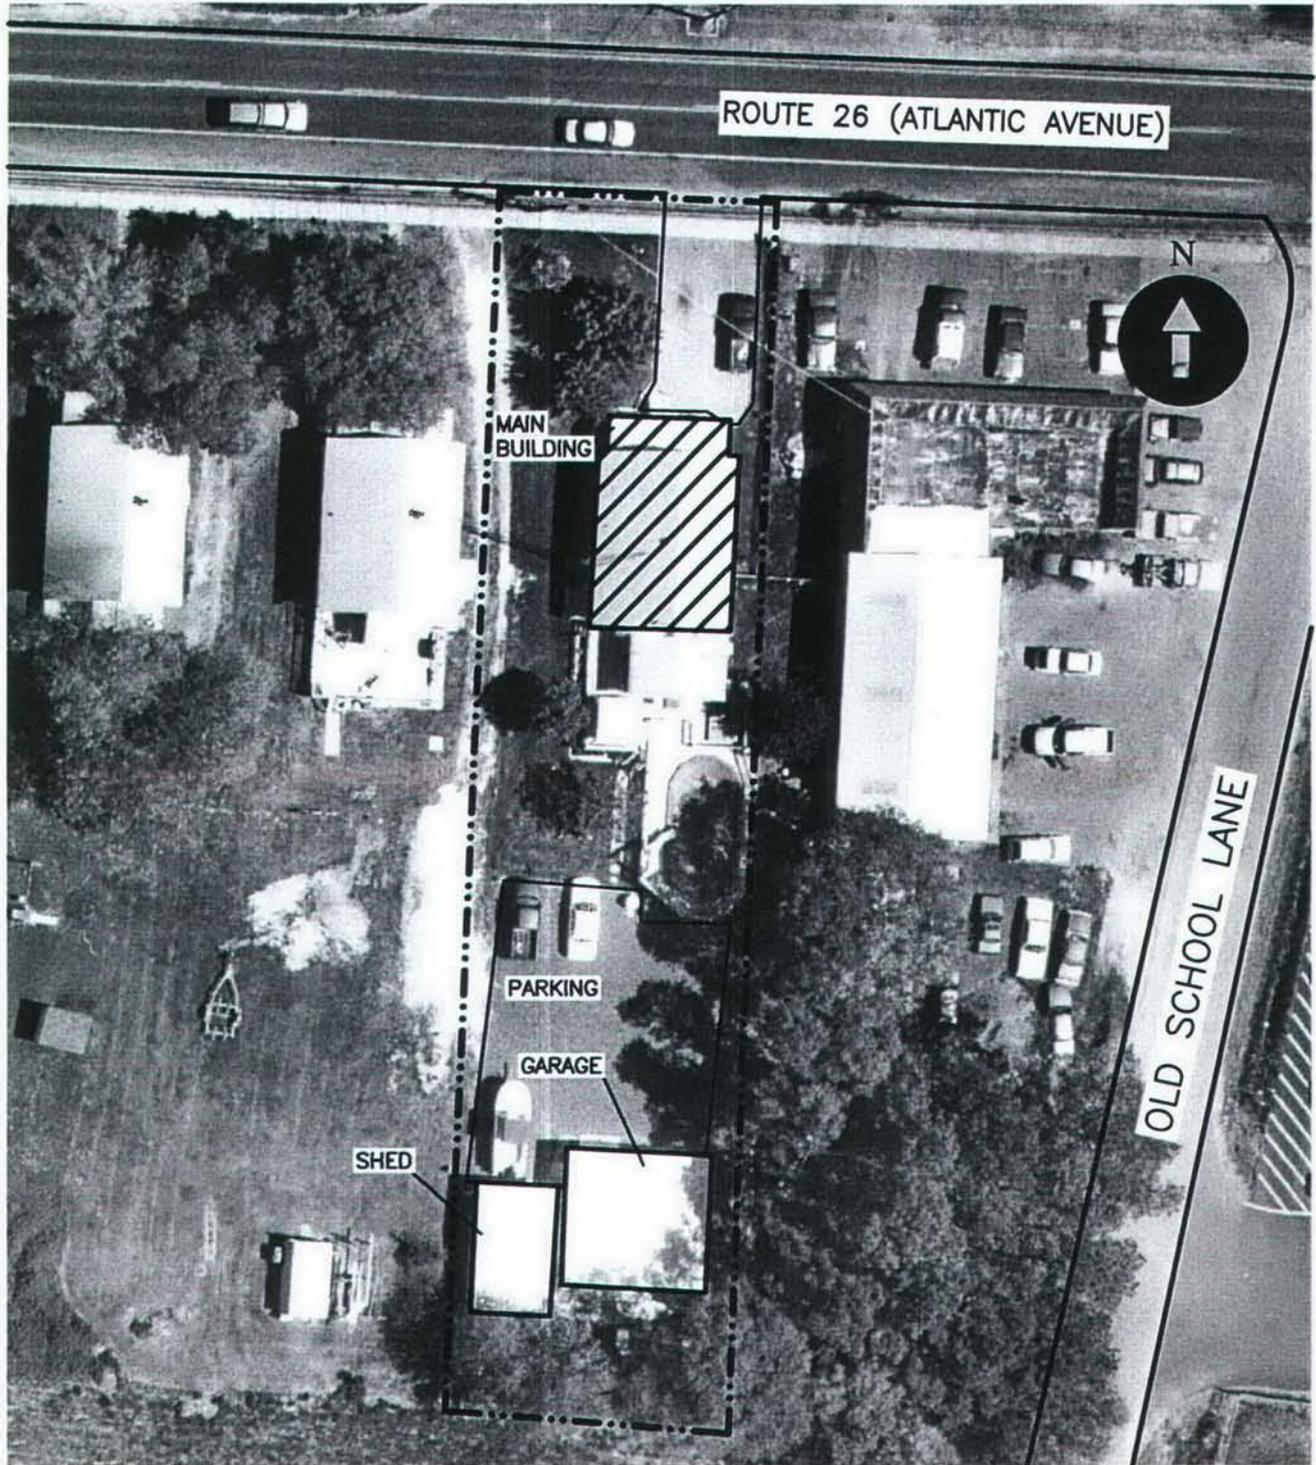
Sketch Plan:

To the southeast of the main building there is a one and one-half-story, three-bay, metal-clad garage with a corrugate metal front-gable roof. The main (south) façade has a central vinyl 1/1 window with faux shutters; to the east there is a single-leaf pedestrian entrance with an aluminum and glazed door whereas to the west there is a single vehicular entrance with a paneled aluminum roll-down door. To the west of the garage is a one-story gable-roof addition with a double-leaf entrance with a sliding door.
