This resource was evaluated in association with the federally funded Route 26 Road Improvement Project, initiated in Fall 1998 under contract 99-112-01.

Cultural Resource Survey
Main Building Form

CRS # S-9728
SPO Map 20-21-02
Hundred Baltimore
Quad Bethany Beach
Zone Coastal
Acreage 2.01 Acres

1. Address of Property: 111 Atlantic Avenue (Tax Parcel 1-34-12-295.00)
2. Date of Initial Construction: Circa 1920
3. Floor Plan/Style: Irregular Commercial/ Former Gasoline Station
4. Architect/Builder: Unknown

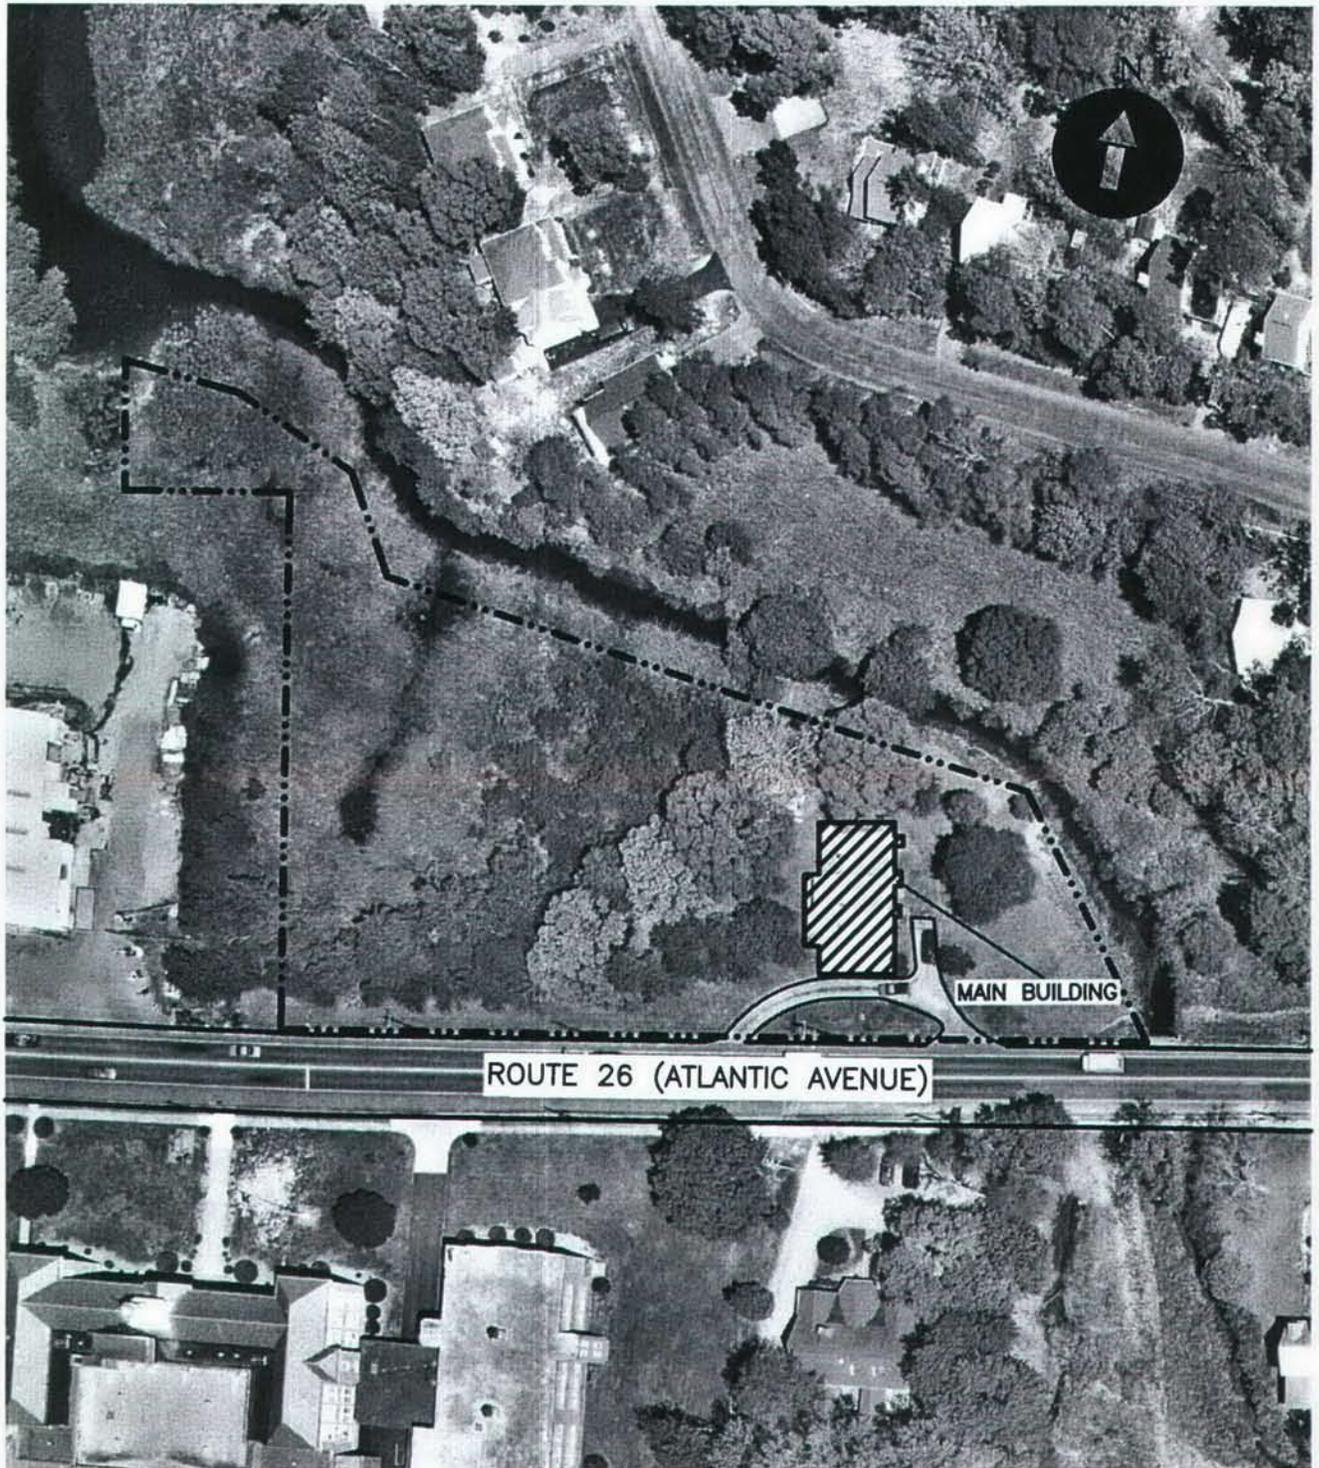
Sketch Plan:

The Donald H. and Suzanne M. Beck Property (Tax Parcel 1-34-12-295.00) is a retail business known as the Coastal Plaza and occupies what was previously a gasoline/automobile service station, built circa 1925. However, the building is heavily altered with recent (2000-2001) additions to the rear and west wall of the building. Except for the large hipped roof drive through on the front façade, the building has lost its original architectural elements as a gasoline/service station. The present owners note that gasoline tanks may still be buried in the front yard of the property.

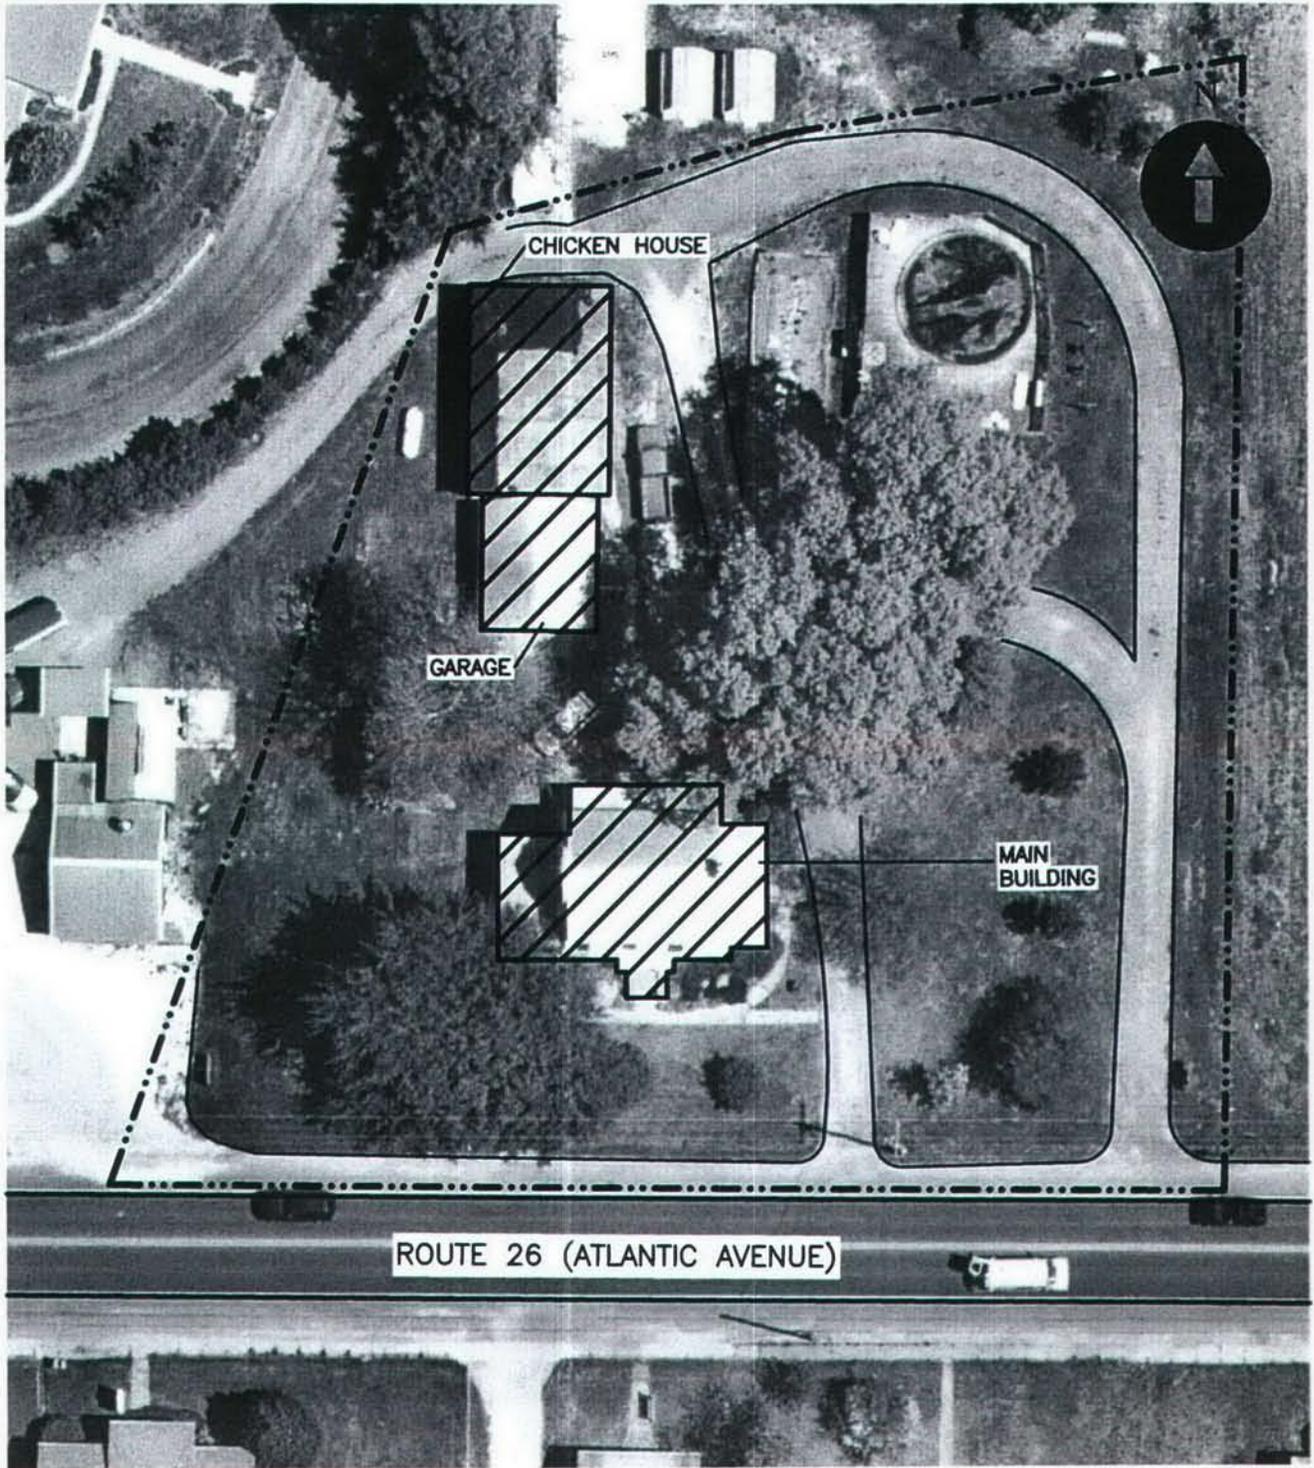
Sketch Plan:

To the rear (north) of the house, in line with the carport/carriage porch, there is a small, two-stall vehicular garage. This vinyl sided, rectangular wood frame building is on a concrete slab foundation and has a steeply pitched front gable roof with asphalt shingles. It uses two metal garage doors that lift up. Centered in the front gable are paired, fixed windows above the garage doors. A double hung sash window with three-over-one lights is located in the east and west walls. Also, there is a wood panel door with three long, rectangular lights in the east wall.

Directly behind (north) of the garage is a rectangular, one story building with a flat roof and overhanging eaves. This building was associated with the property's former farming activities and is the only remaining farm building, probably a poultry house and/or grain shed. There are two wood paneled and glazed entry doors along the east wall. One is off centered and the other is to the extreme left (south). In addition, five irregularly spaced double hung sash windows are located along the east wall of the building. A modern, metal garage door and another sash window are found in the north wall. The wood frame building is covered with aluminum siding and rests on a concrete slab foundation.

Two modern sheds and a trailer situated north of the tax parcel are probably part of the adjacent property and are not included with this evaluation.
