This resource was evaluated in association with the federally funded Route 26 Road Improvement Project initiated under Contract 99-112-01 in Fal 1998. This business is situated on the north side of Route 26, east of Irons Lane. The Gothic Revival style main building was constructed c. 1885, and the corn crib was constructed c. 1925. All of the other outbuildings were built in the late 20th century.

Cultural Resource Survey
Related Outbuilding Form

CRS # S-9771
SPO Map 20-21-07
Hundred Baltimore
Quad Frankford
Zone Cypress Swamp
Acreage 13.80 acres

1. Address of Property: North side of Route 26, east of Irons Lane (1-34-11-171.00)
2. Function: Equipment shed
3. Date: c. 1980
4. Stylistic Features: One-story side-gable wood shed
5. Architect/Builder: Unknown
6. Description:
 - a) Structural System Wood frame

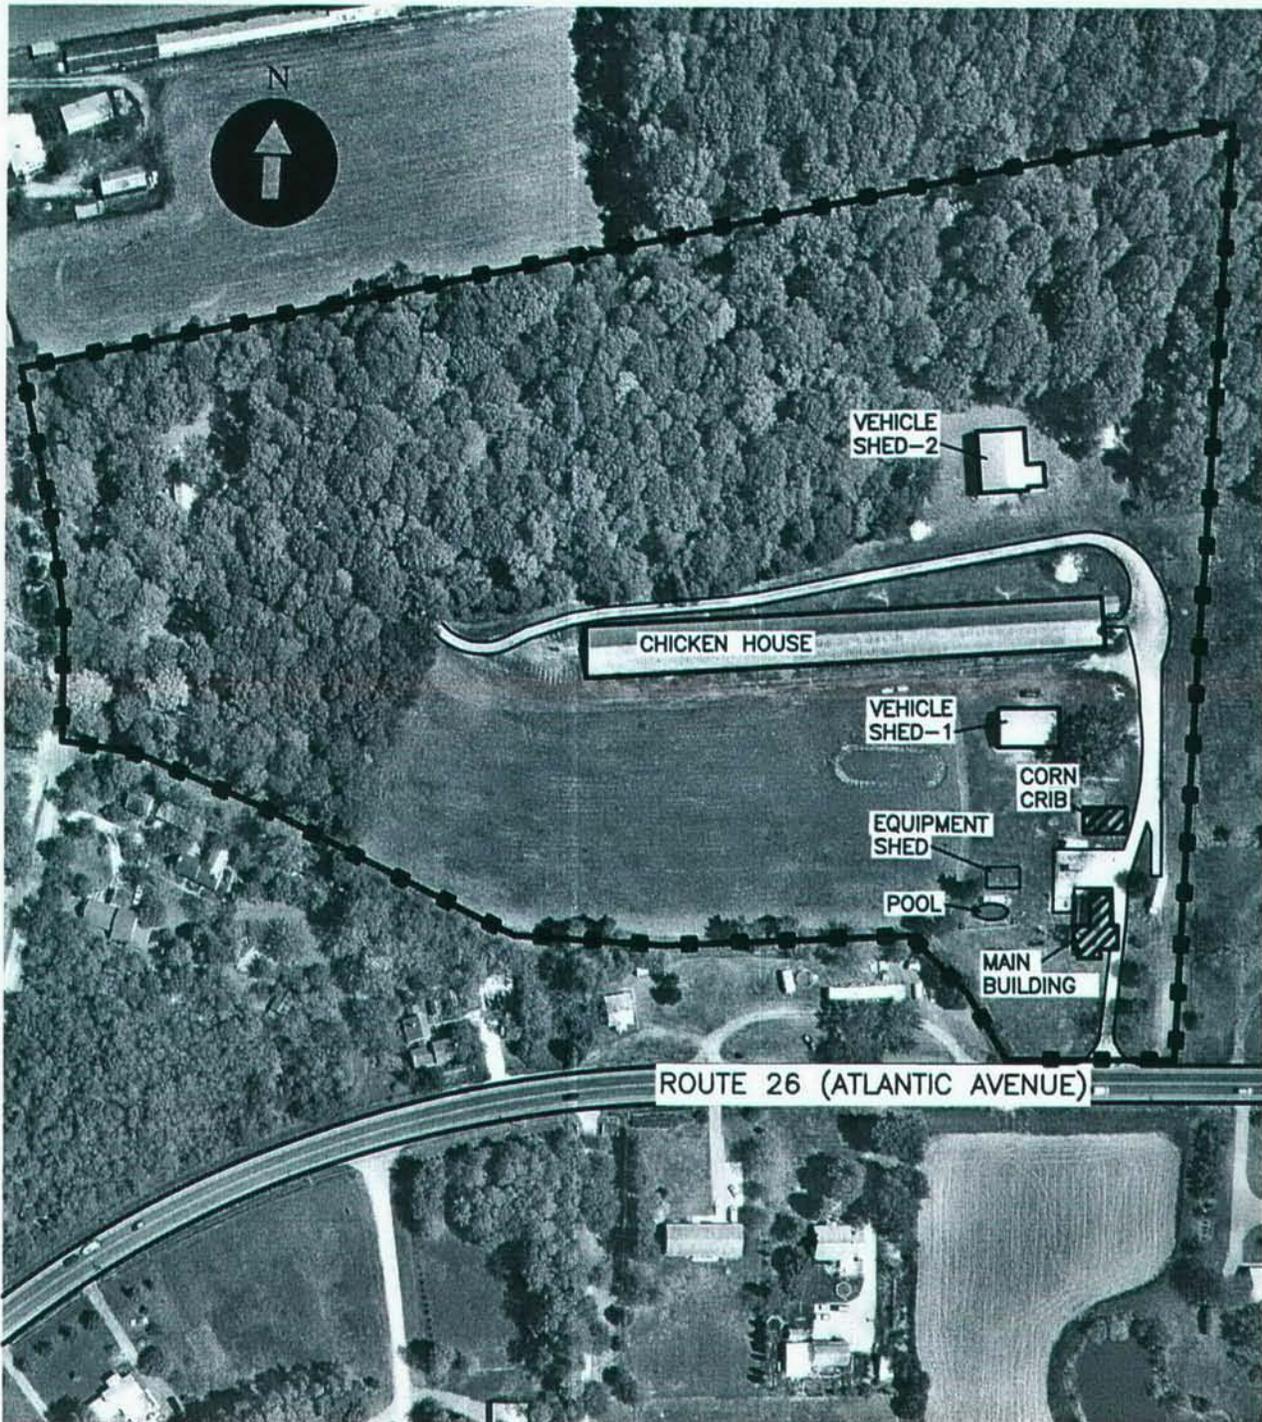
Sketch Plan:

BUILDING 50 YEARS OLD OR OLDER
-

BUILDING LESS THAN 50 YEARS OLD
-

NATIONAL REGISTER BOUNDARY (FOLLOWS TAX PARCEL BOUNDARY)

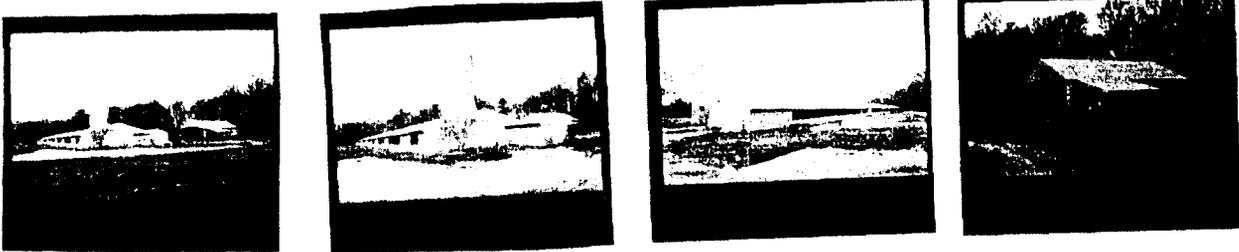
Description (30) Chicken house, facing west; (31) Chicken house, facing NW; (32) Chicken house, facing SW; (33) Outbuilding, facing NW

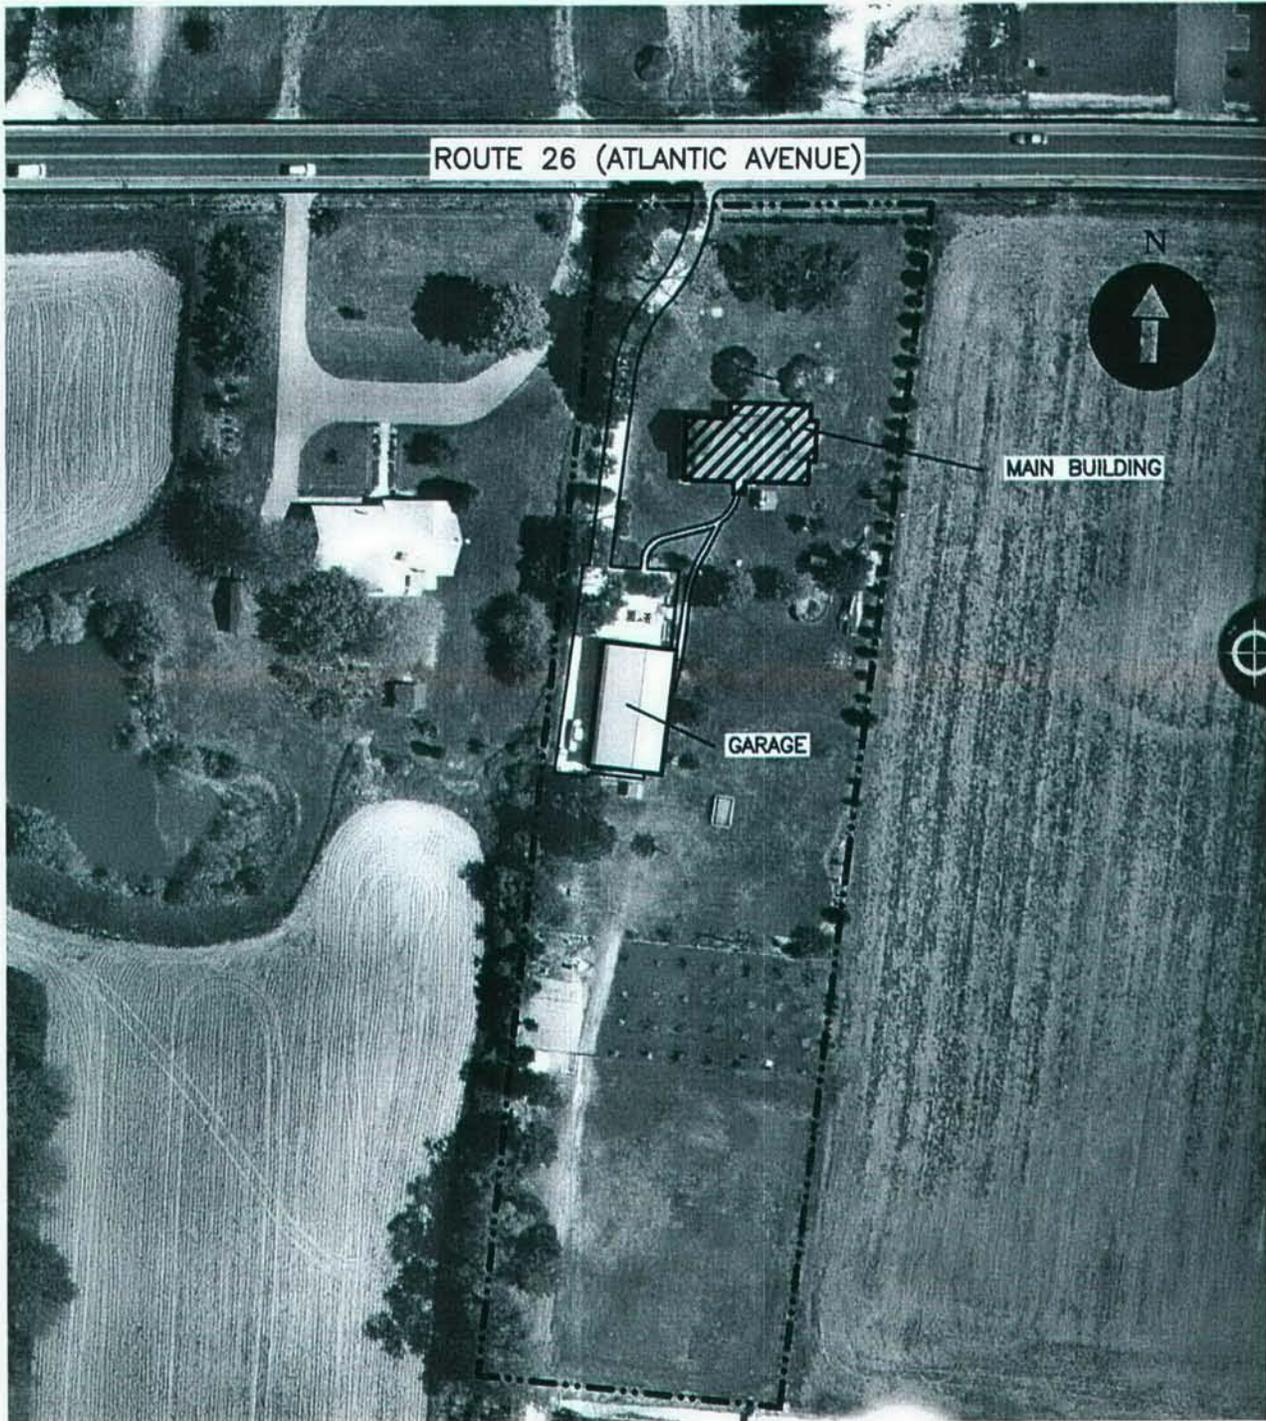
Sketch Plan:

BUILDING 50 YEARS OLD OR OLDER

BUILDING LESS THAN 50 YEARS OLD

TAX PARCEL BOUNDARY
