Cultural Resource Survey
Property Identification Form

1. Name of Property: Stephen D. & Valerie W. Parsons House (Tax Parcel 1-34-12-638.00)
2. Street Location: 45 Atlantic Avenue, Ocean View, DE 19970
3. Owner's Name: Stephen D. & Valerie W. Parsons Tel. #: _____
Address: P.O. Box 246, Dagsboro, DE 19939
4. Type of Resource(s): building: structure: site:
object: district:
5. Surroundings: (check more than one, if necessary)
fallow field: cultivated field: woodland:
scattered buildings: structure: site:
6. Function: original Residence present Residence
7. List Additional Forms Used:
Main Building Form (CRS-2)
Related Outbuilding Form (1) (CRS-3)
8. Surveyor: Dr. Richard Betterly Tel. #: (215) 592-4200
Organization: McCormick, Taylor and Associates, Inc. Date: March 2002
Address: 2001 Market Street, 10th Floor, Philadelphia, PA 19103

Cultural Resource Survey
Main Building Form

1. Address of Property: 45 Atlantic Avenue (Tax Parcel 1-34-12-638.00), Ocean View, DE
2. Date of Initial Construction: Circa 1870
3. Floor Plan/Style: Rectangular/ I-House
4. Architect/Builder: Unknown

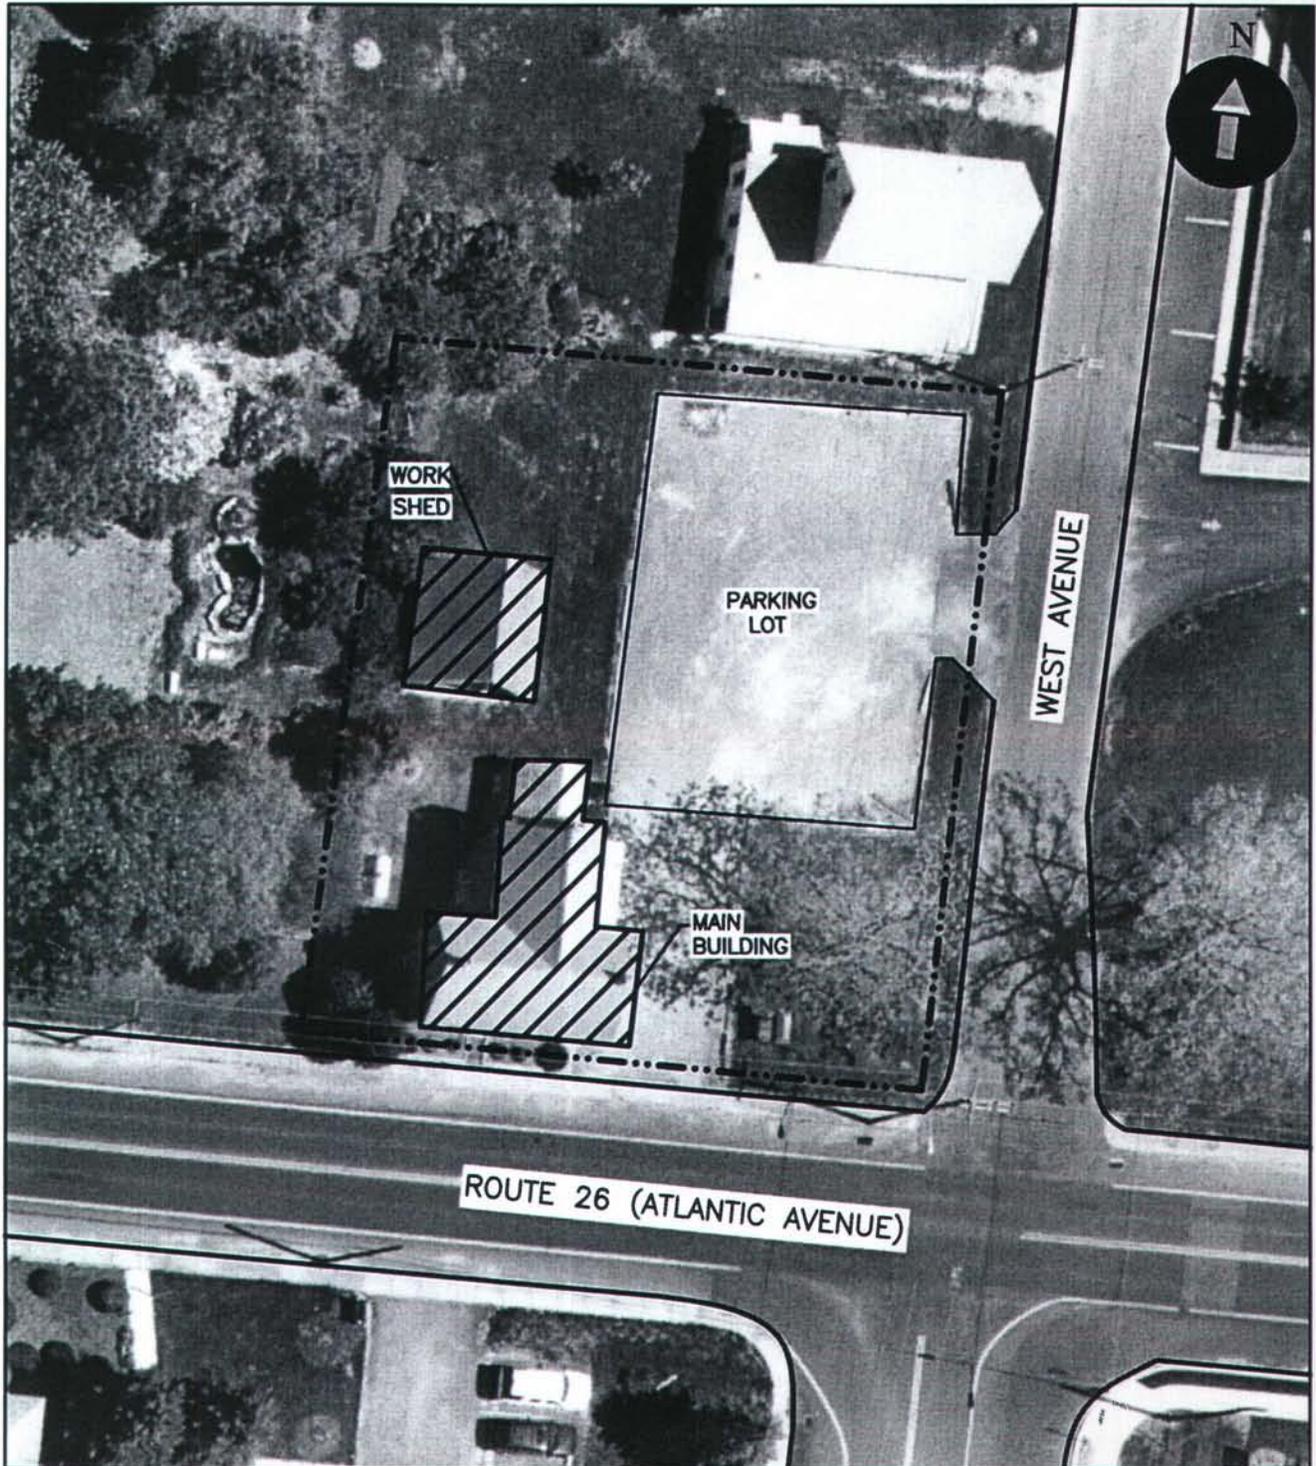
Sketch Plan:

The Stephen D. and Valerie W. Parsons Property (Tax Parcel 1-34-12-639.00) contains a residential building that does not appear on the 1868 Beers map. Two buildings are shown on John West's 1890 map and West made the notation that one was a store. It appears that the current house is one of these two buildings; however, it is not the store, which would have been located closer to the intersection of West and Atlantic Avenues. An open space between the house and West Avenue is the likely location of the store identified on the 1890 map.
