Cultural Resource Survey
Related Outbuilding Form

CRS # S-9709
SPO Map 20-21-07
Hundred Baltimore
Quad Bethany Beach
Zone Coastal
Acreage 0.5 Acres

Cultural Resource Survey
Main Building Form

CRS # S-9708
SPO Map 20-21-07
Hundred Baltimore
Quad Bethany Beach
Zone Coastal
Acreage 2.97 Acres

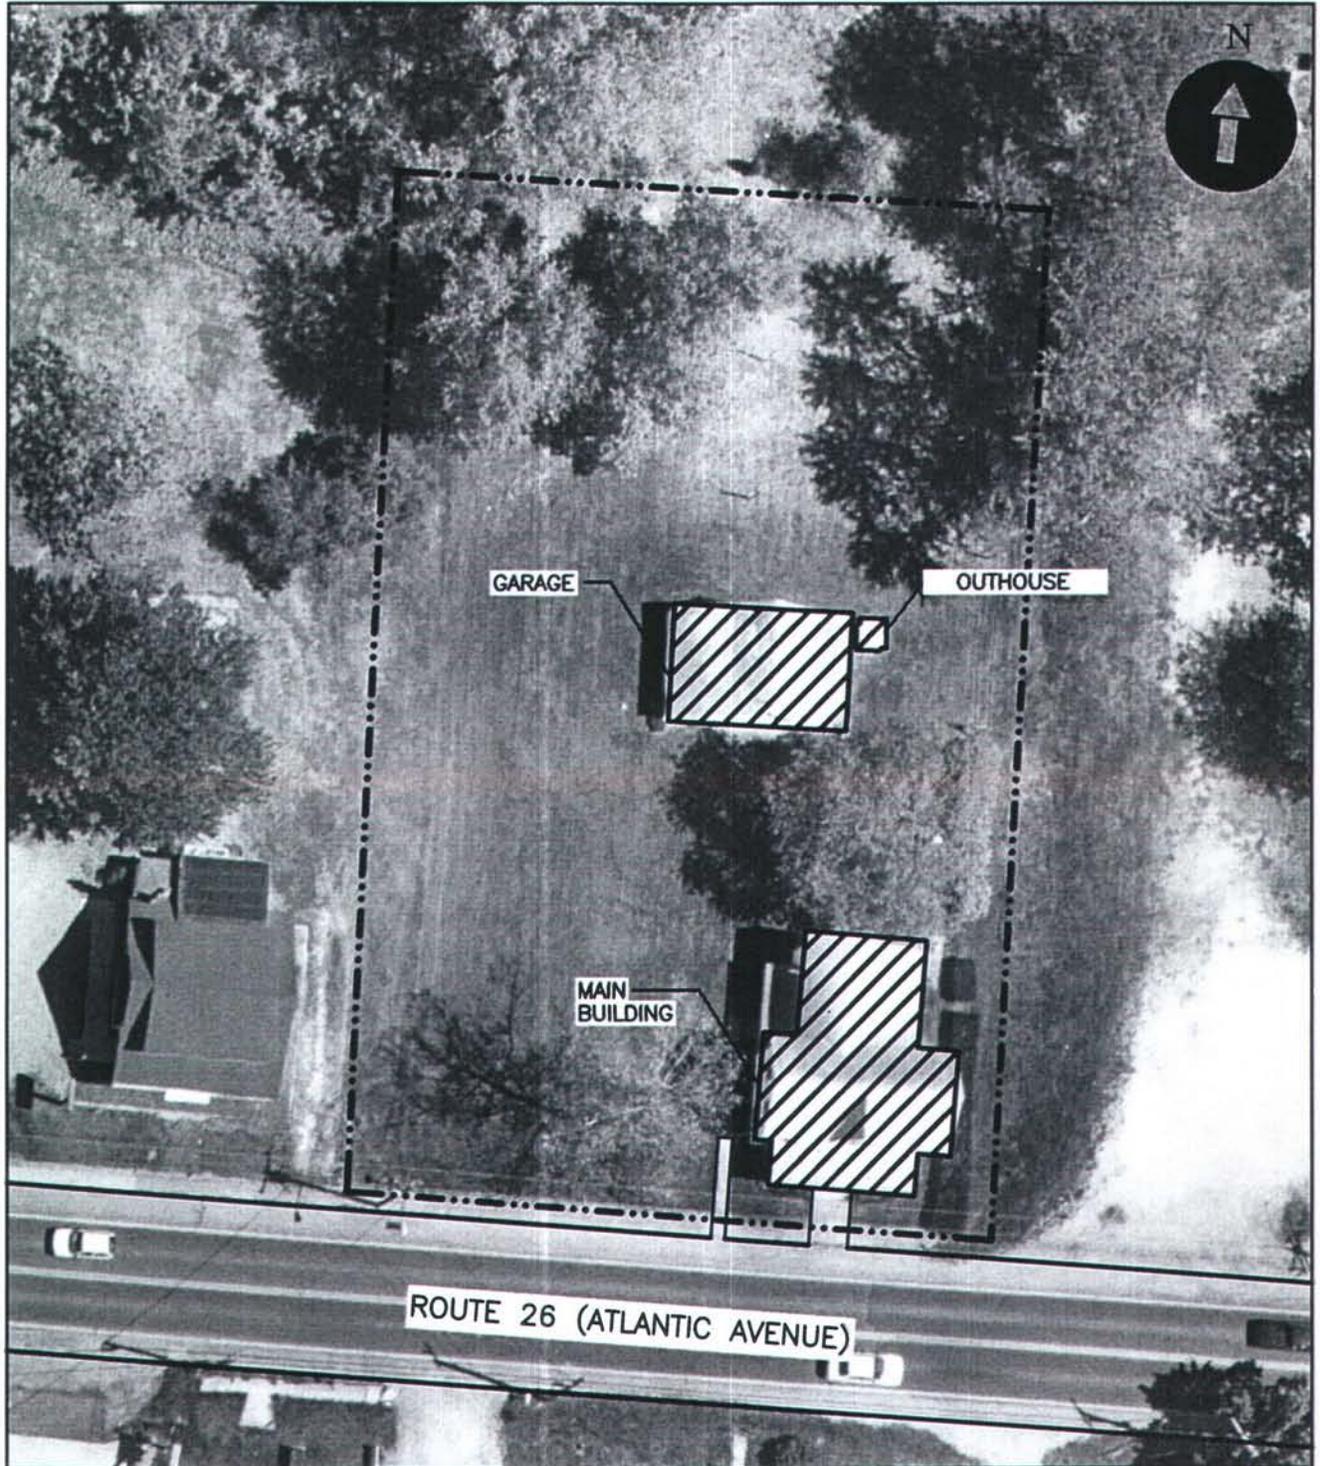
Sketch Plan:

The Rosalind C. Barton House (Tax Parcel 1-34-13-21.00) consists of a main residence, garage/small barn, and outhouse. The main residence is a c. 1880 two-and-a-half story, three-bay cross gable vernacular Gothic Revival house with a brick foundation and vinyl exterior. A single-story enclosed front porch with wood posts and screen windows is located along the façade. The main residence has one-over-one vinyl replacement windows throughout, except at the attic level. A segmental arched one-over-one window is located within the front cross gable. Two chimneys were originally located at the ridge line, but both have since been removed. The main residence includes a two-story frame kitchen ell with two single-story enclosed porches along the east and west side elevations.

The Rosalind C. Barton House is clad in modern vinyl siding, contains one-over-one vinyl replacement windows, and has had both of its brick chimneys removed. As a result, the dwelling's integrity of design, materials and workmanship have been compromised. The historic acreage of this property has likely been sold off over time, and now the dwelling is situated near Route 26 and is no longer being used for agriculture, thereby affecting the integrity of setting, feeling, and association. Although the property retains supporting outbuildings that add to its integrity of setting, these structures and their contribution to the property's integrity are not sufficient to counterbalance the areas of integrity that have been compromised. This property is not associated with an event of importance, nor is it representative of a pattern of events or historic trends (Criterion A). The Rosalind C. Barton House is not affiliated with any persons important to local, state or national history (Criterion B). While this dwelling still possesses the basic outline of a Gothic Revival dwelling, it is not distinctive to a given time period or method of construction, nor is it known to represent the work of a master or architect (Criterion C). Owing to prior ground disturbance, there is little probability that new information will result from any archaeological testing performed in the vicinity of the property (Criterion D).

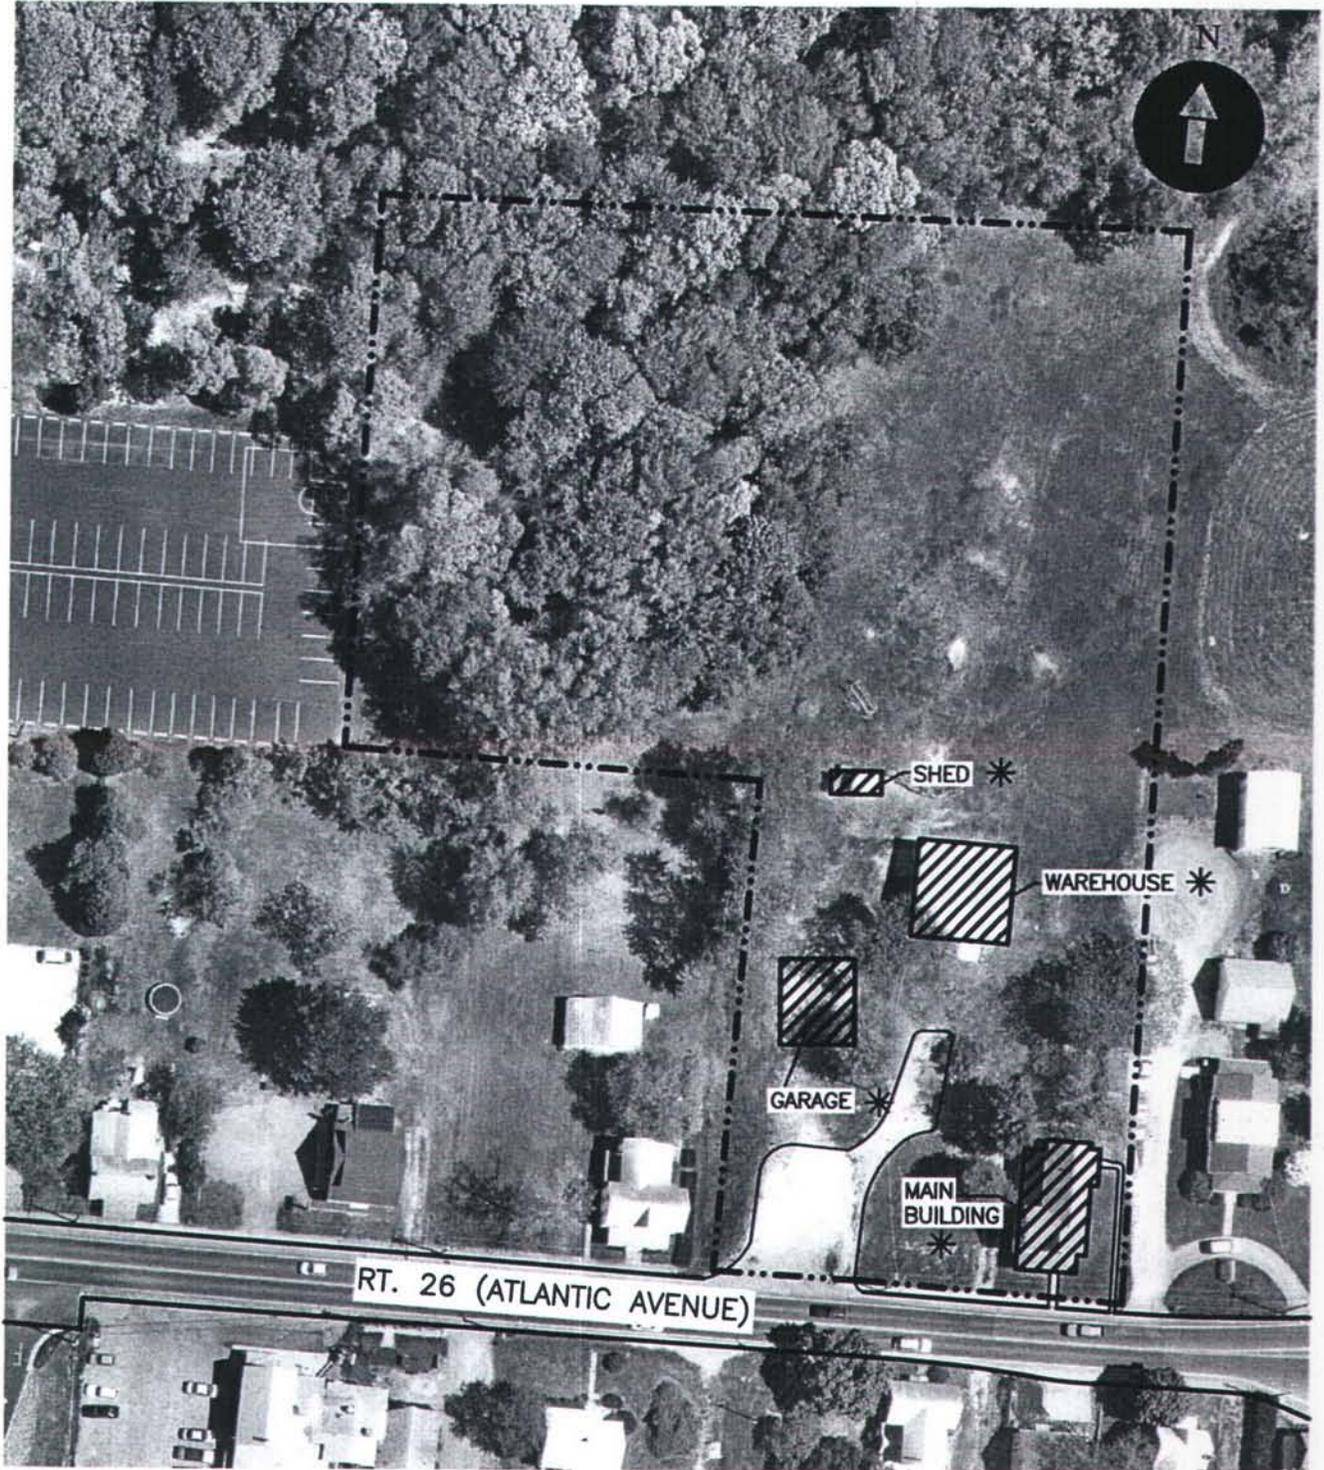
Sketch Plan:

The Joseph C. Rakauskas Property (Tax Parcel 1-34-13-23.00) includes a circa 1890 cross gable vernacular, Gothic Revival style residence with kitchen ell and three associated outbuildings. The two-and-a-half story, three-bay residence has a brick foundation, aluminum siding, and an asphalt shingle roof. The residence has a boxed cornice line with cornice returns in the gable ends and north elevation of the kitchen ell. The windows throughout the residence are predominately one-over-one. The enclosed porch along the façade has a brick foundation and is supported by simple wood posts. The kitchen ell is a two-story addition with a brick foundation, aluminum siding, and an asphalt shingle roof. A single-story hipped roof addition is located along the east elevation. A single-story addition with a shed roof is located on the west elevation of the kitchen ell. A brick chimney is located along the ridgeline in the center of the kitchen ell. A circa 1950 one story, corrugated metal warehouse with concrete block foundation is located to the north of the main residence. Double doors with glazing and wood muntins are found on the south elevation of the warehouse. The circa 1940 garage is to the north east of the residence. The gable front garage has a frame structural system and vertical board siding. The one-and-a-half story garage has an asphalt shingle roof and vertical board door above the garage bay. A single-story shed roof addition is located along the north side of the garage. In the northeast corner of the property is a single-story frame shed dating from circa 1920, formerly used as a granary, with horizontal wood boards and an asphalt shingle covered gable front roof.

* DEMOLISHED PER JULY 2003
FIELD SURVEY

This dwelling does not retain the integrity of setting, feeling, or material. The Joseph C. Raskauskas Property is clad in vinyl siding and contains replacement windows. Although the property retains several outbuildings that reflect an agrarian use, the decreased acreage and surrounding development diminish the property's integrity of setting. This dwelling is not associated with an event of importance, nor is it representative of a pattern of events or historic trends (Criterion A). The Joseph C. Raskauskas Property is not affiliated with any persons important to local, state or national history (Criterion B). Although it exhibits characteristics of the Gothic Revival style, this dwelling is not exemplary of a given time period or method of construction, nor is it known to represent the work of a master architect (Criterion C). Owing to prior ground disturbance, there is little probability that new information will result from any archaeological testing performed in the vicinity of the property (Criterion D).

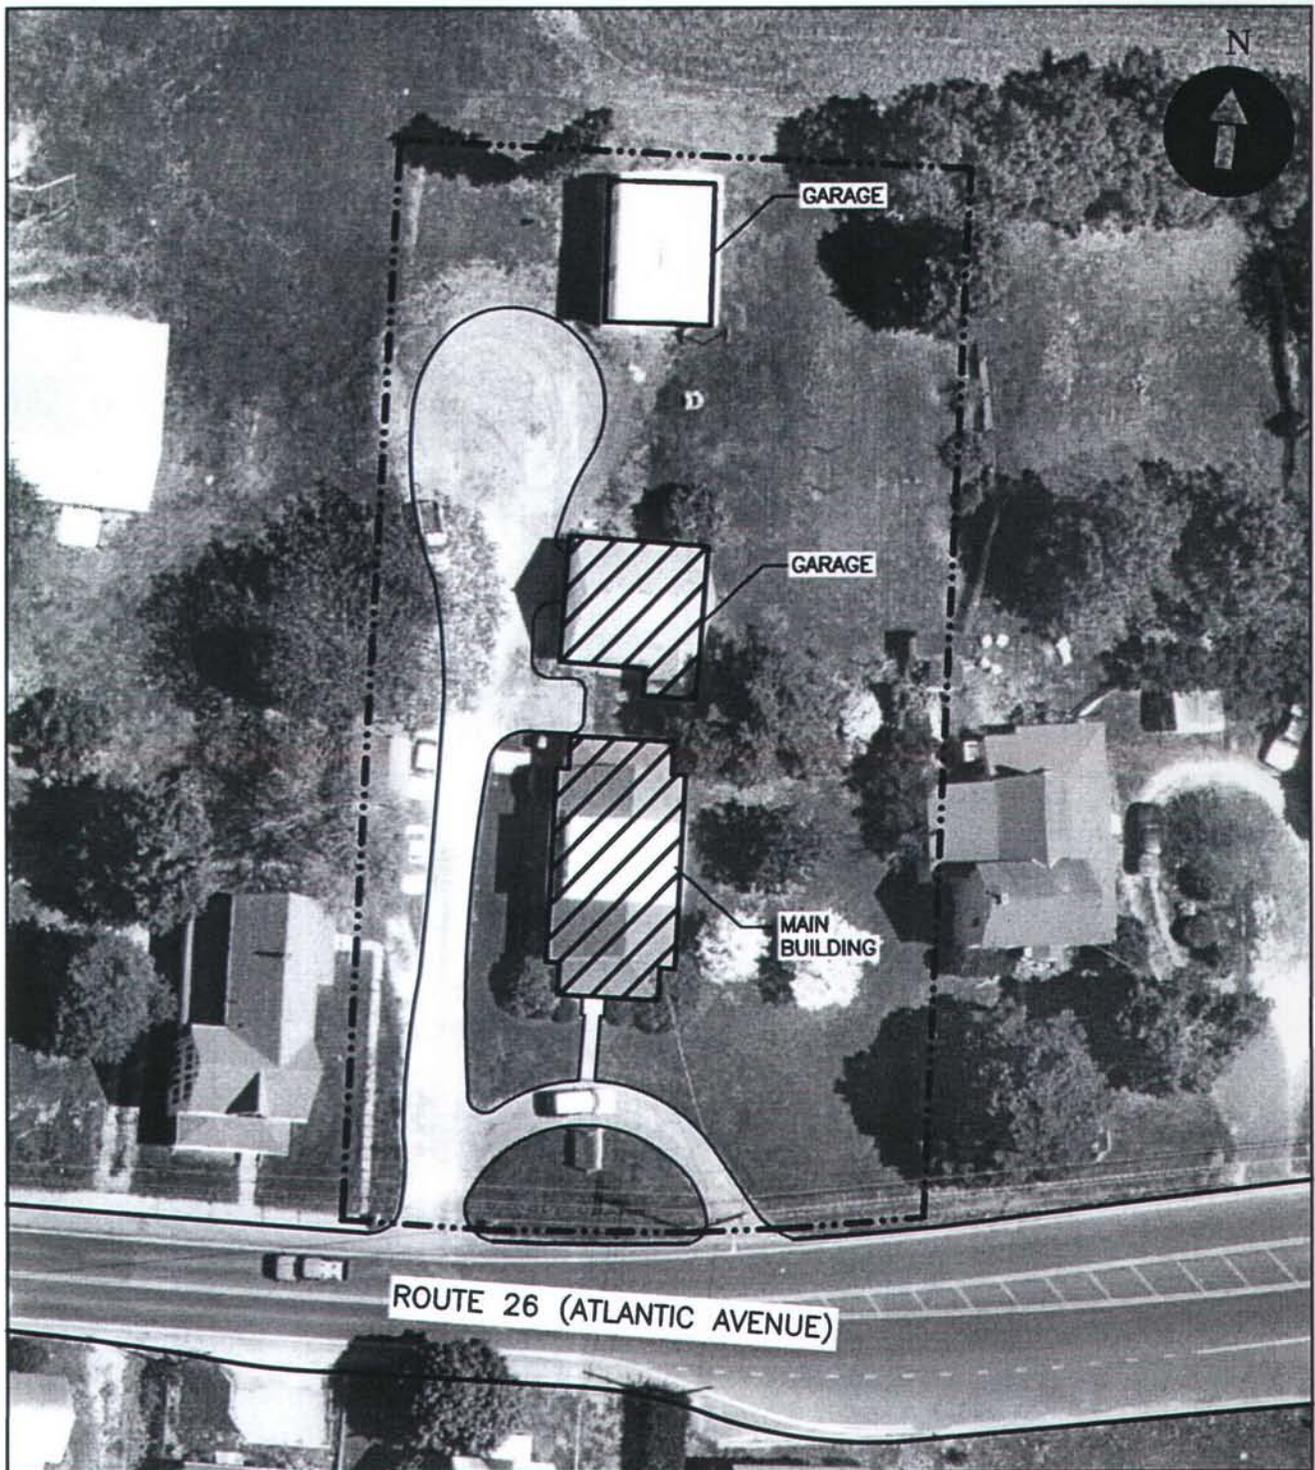
Sketch Plan:

The Gulfstream Development Corporation Property (Tax Parcel 1-34-13-24.00) includes a *circa* 1925 one-and-a-half story, two-bay, gable front Bungalow style building and two associated outbuildings. The residence has a concrete foundation, frame structural system, and asbestos exterior. The gable roof is covered with asphalt shingles and continuous dormers are found along the east and west elevations. Both dormers have asbestos siding and asphalt shingle covered shed roof. The dormers contain ribbon windows with wood trim. One-over-one paired windows are found throughout the building. The enclosed single-story hipped roof porch along the façade has vertical board siding and modern replacement windows. A *circa* 1950 gable front, two-bay garage is located immediately north of the residence. The garage is constructed of concrete block with asbestos siding in the west gable end. The roof is covered with asphalt shingles and has an open cornice with exposed rafters along the north and south elevations. A single-story concrete block wing is located at the southeast

This dwelling does not retain integrity of setting or feeling requisite for eligible bungalows. The Gulf Stream Development Corp. Property is clad in asbestos shingle siding; the porch has been enclosed and contains replacement windows. Whereas the enclosing of a porch does not necessarily detract from the eligibility of a bungalow *per se*, in this case the treatment of the enclosed porch is in such a way that it diminishes the integrity of the bungalow form. The use of modern, paired six-over-six vinyl windows and a modern door on the front façade is uncharacteristic of this property type. This dwelling is not associated with an event of importance, nor is it representative of a pattern of events or historic trends (Criterion A). The Gulf Stream Development Corp. Property is not affiliated with any persons important to local, state or national history (Criterion B). While this dwelling still possesses characteristics of its bungalow style, it is not exemplary of a given time period or method of construction, nor is it known to represent the work of a master architect (Criterion C). Owing to prior ground disturbance, there is little probability that new information will result from any archaeological testing performed in the vicinity of the property (Criterion D).
