CRS #: S-9706

This resource was evaluated in association with the federally funded Route 26 Road Improvement Project, initiated in Fall 1998 under Contract #99-112-01 (SR 26, US 113 to the Assawoman Canal).

Cultural Resource Survey  
Main Building Form

1. Address of Property: 25 Atlantic Avenue (north side), Ocean View, DE (Tax Parcel 1-34-13-25.00)  
2. Date of Initial Construction: Circa 1870  
3. Floor Plan/Style: I-House; Vernacular I-House  
4. Architect/Builder: Unknown

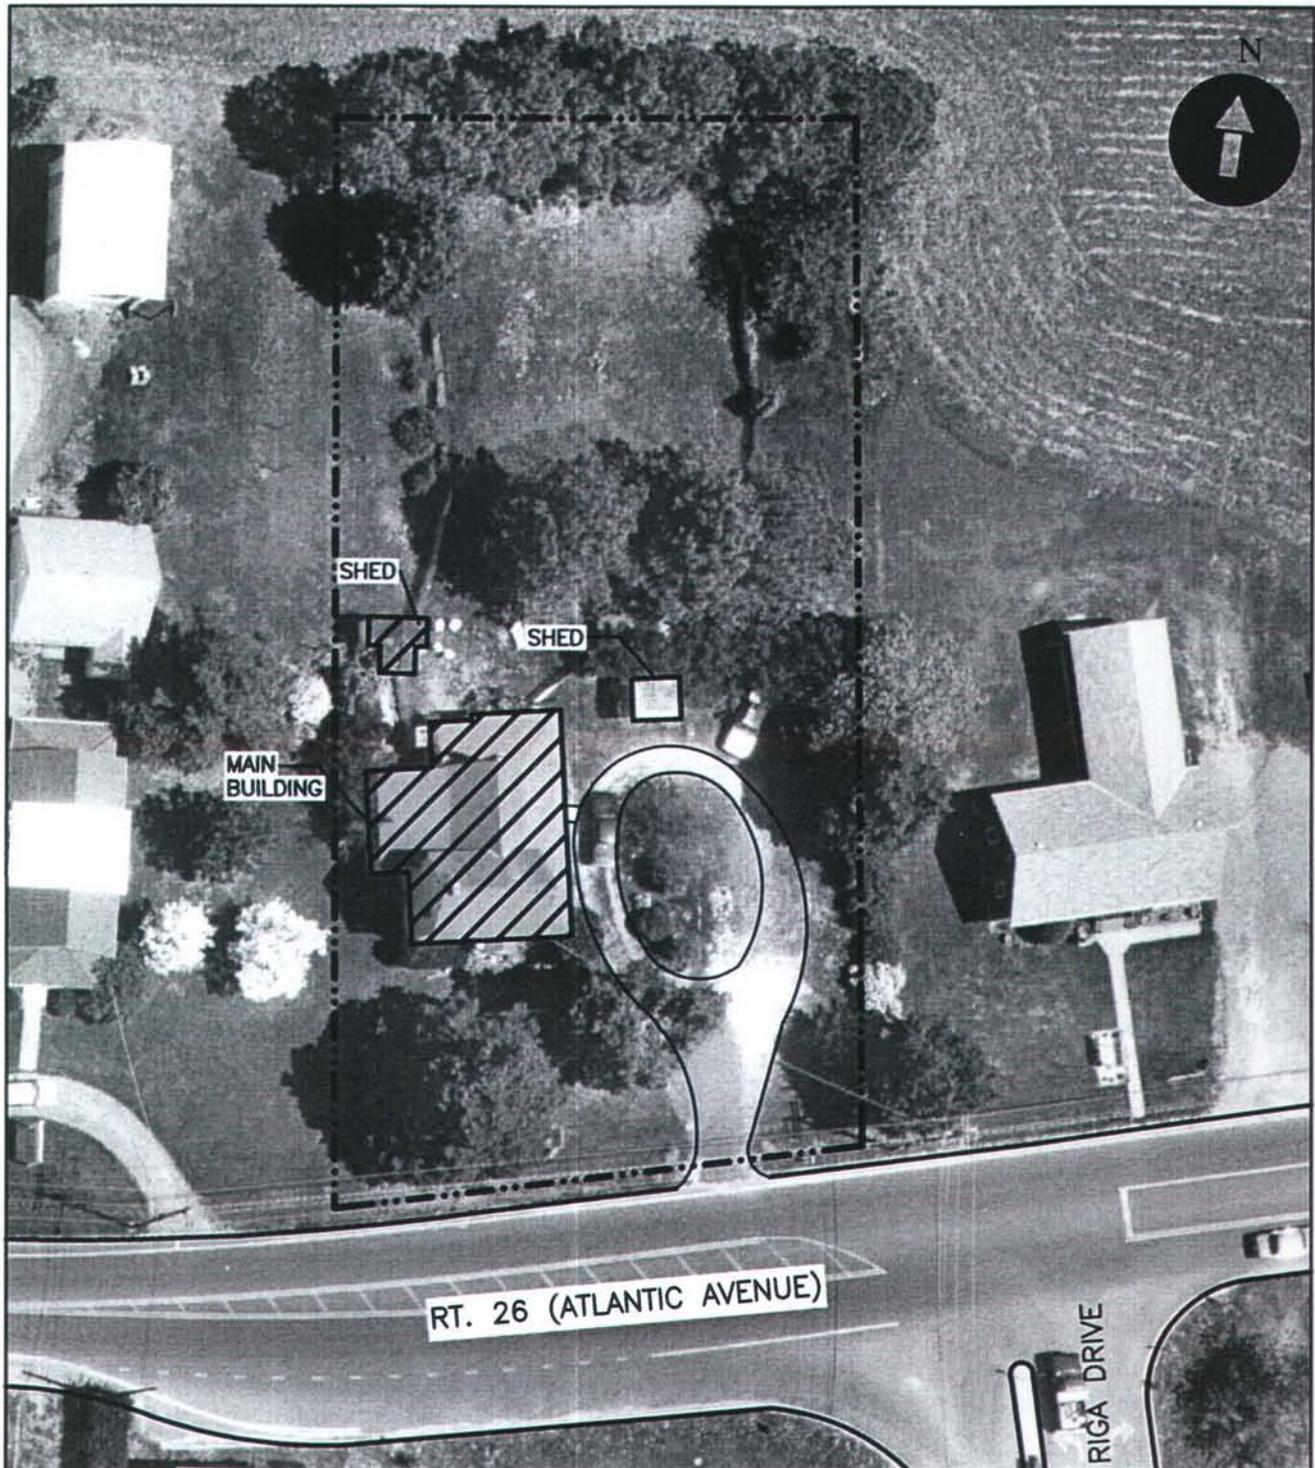
Sketch Plan:

A *circa* 1900 single-story, frame shed is located to the northwest of the residence. The shed has vertical board siding, an asphalt shingle covered gable roof, and concrete foundation. While this shed is currently being used for storage, it may have once have been used as an agricultural building.

A single-story frame shed with vinyl siding is located to the northeast of the residence. The *circa* 1980 prefabricated shed has an asphalt shingle covered flat roof.

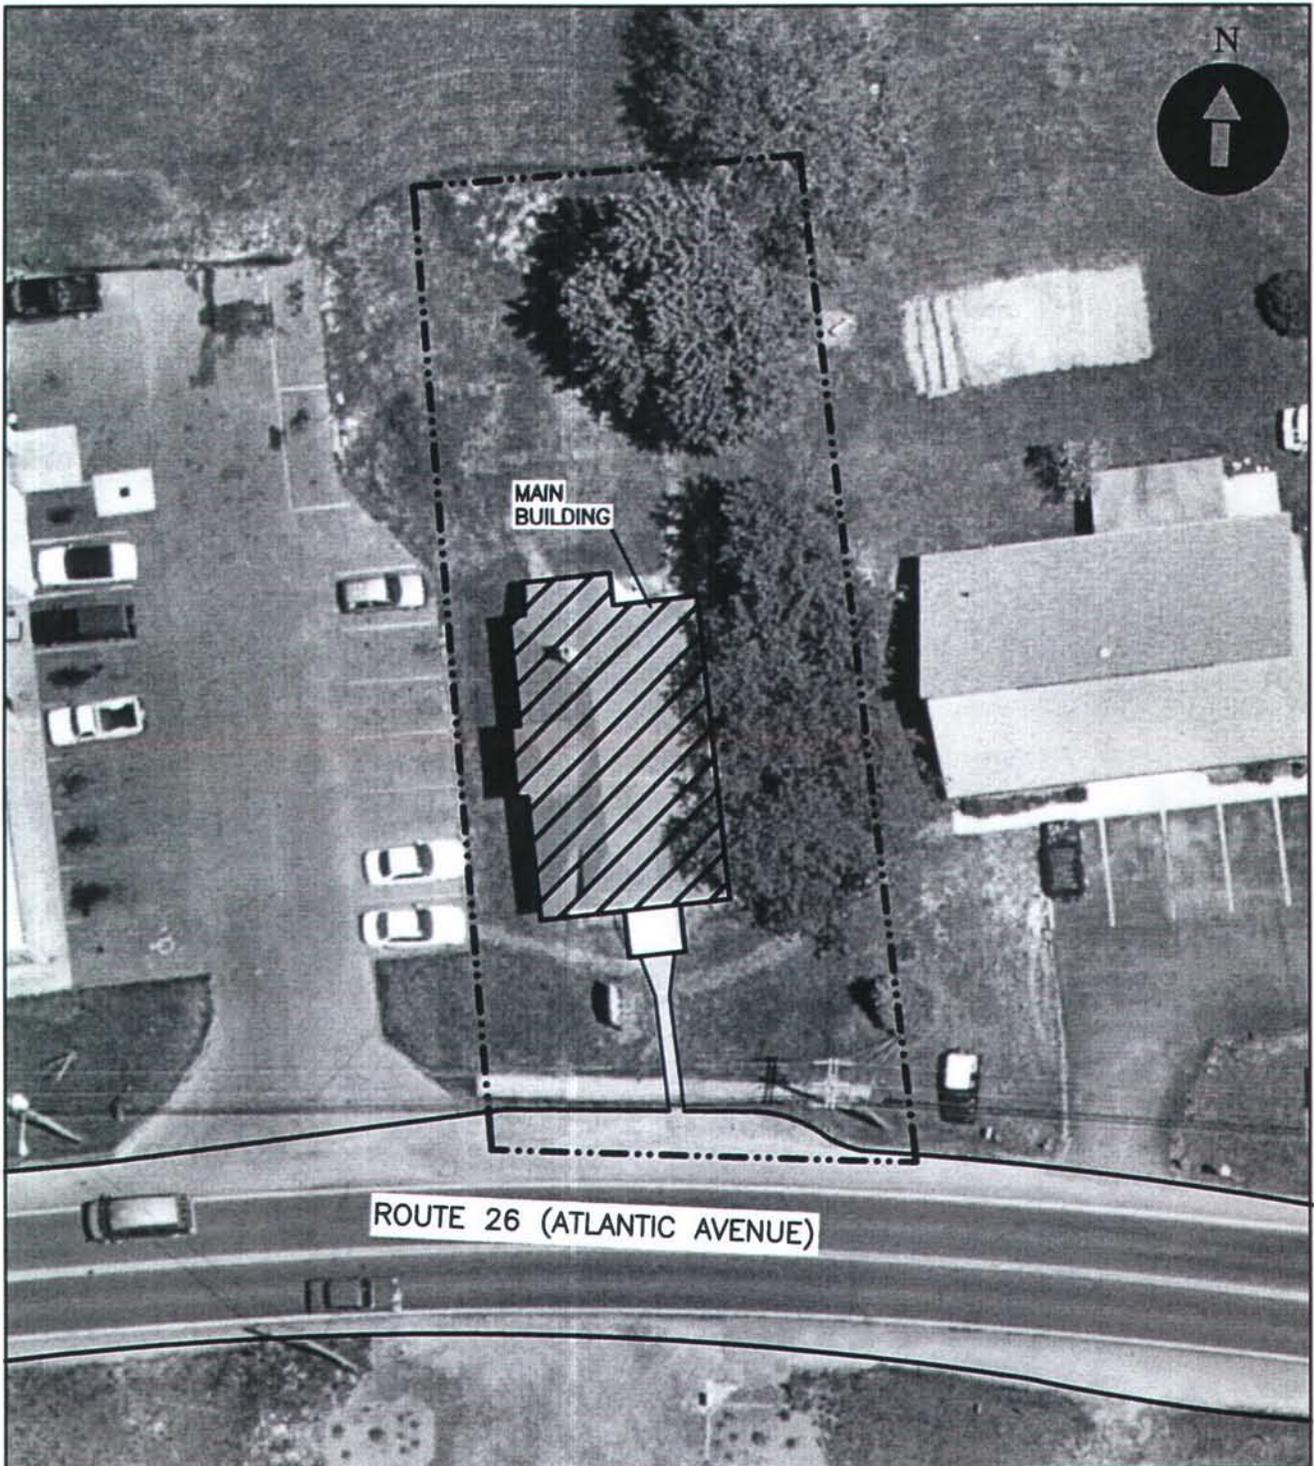
Sketch Plan:

The Sea Dogs Golf Property (Tax Parcel 1-34-13-1094.00) is a c. 1940 Bungalow style, one-and-a-half story, three-bay frame building currently used as a business. The property has a concrete block foundation and frame structural system. The façade includes an enclosed porch on concrete block piers with asbestos siding. Ribbon windows of four-over-one configuration are located along the enclosed porch. The building has a hipped roof with asphalt shingles and three dormers. Hipped roof dormers with paired four light windows are located along the south and west elevations. A continuous shed roof dormer is located along the east elevation and includes two sets of paired windows with four-over-one windows. The majority of windows throughout the building are four-over-one original windows with wood trim. Windows are evenly spaced with paired windows along the east and west elevation of the enclosed porch. Ribbon windows are located along the enclosed porch and bay section on the west elevation. A brick chimney is found on the interior slope of the north elevation.

This dwelling turned business is situated on the north side of Route 26 and is surrounded by modern commercial development including a paved parking lot immediately adjacent to the west, which detracts from the property's integrity of setting.
