This resource was evaluated in association with the federally funded Route 26 Road Improvement Project, initiated in Fall 1998 under contract number 99-112-01.

Cultural Resource Survey
Main Building Form

1. Address of Property: 40 & 42 Atlantic Avenue (Tax Parcel 1-34-13-657.00)
2. Date of Initial Construction: c. 1880
3. Floor Plan/Style: Rectangular/Folk Victorian
4. Architect/Builder: Unknown

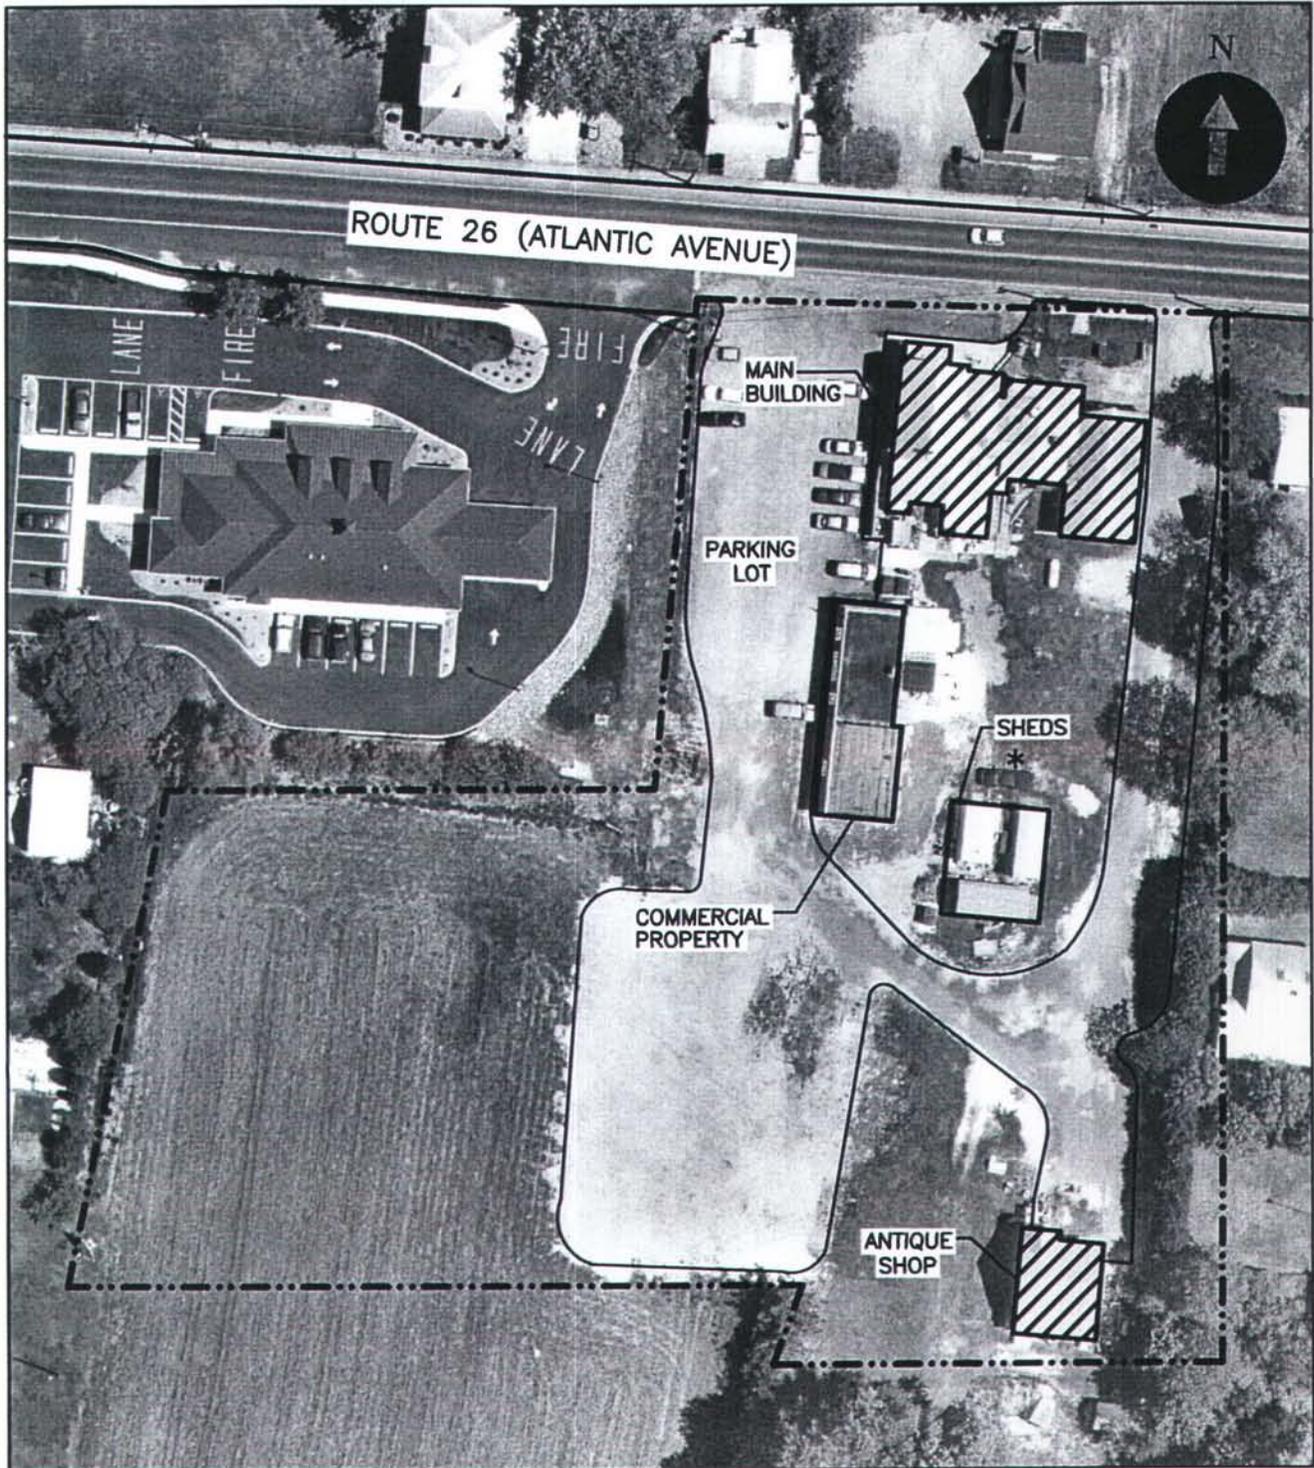
Sketch Plan:

To the rear of the main building and east of the commercial property is a group of four large prefabricated sheds, currently used for storage.

* PER JULY 2003 VISIT, A NEW SHED EXISTS IN THIS LOCATION

BUILDING 50 YEARS OLD OR OLDER

BUILDING LESS THAN 50 YEARS OLD

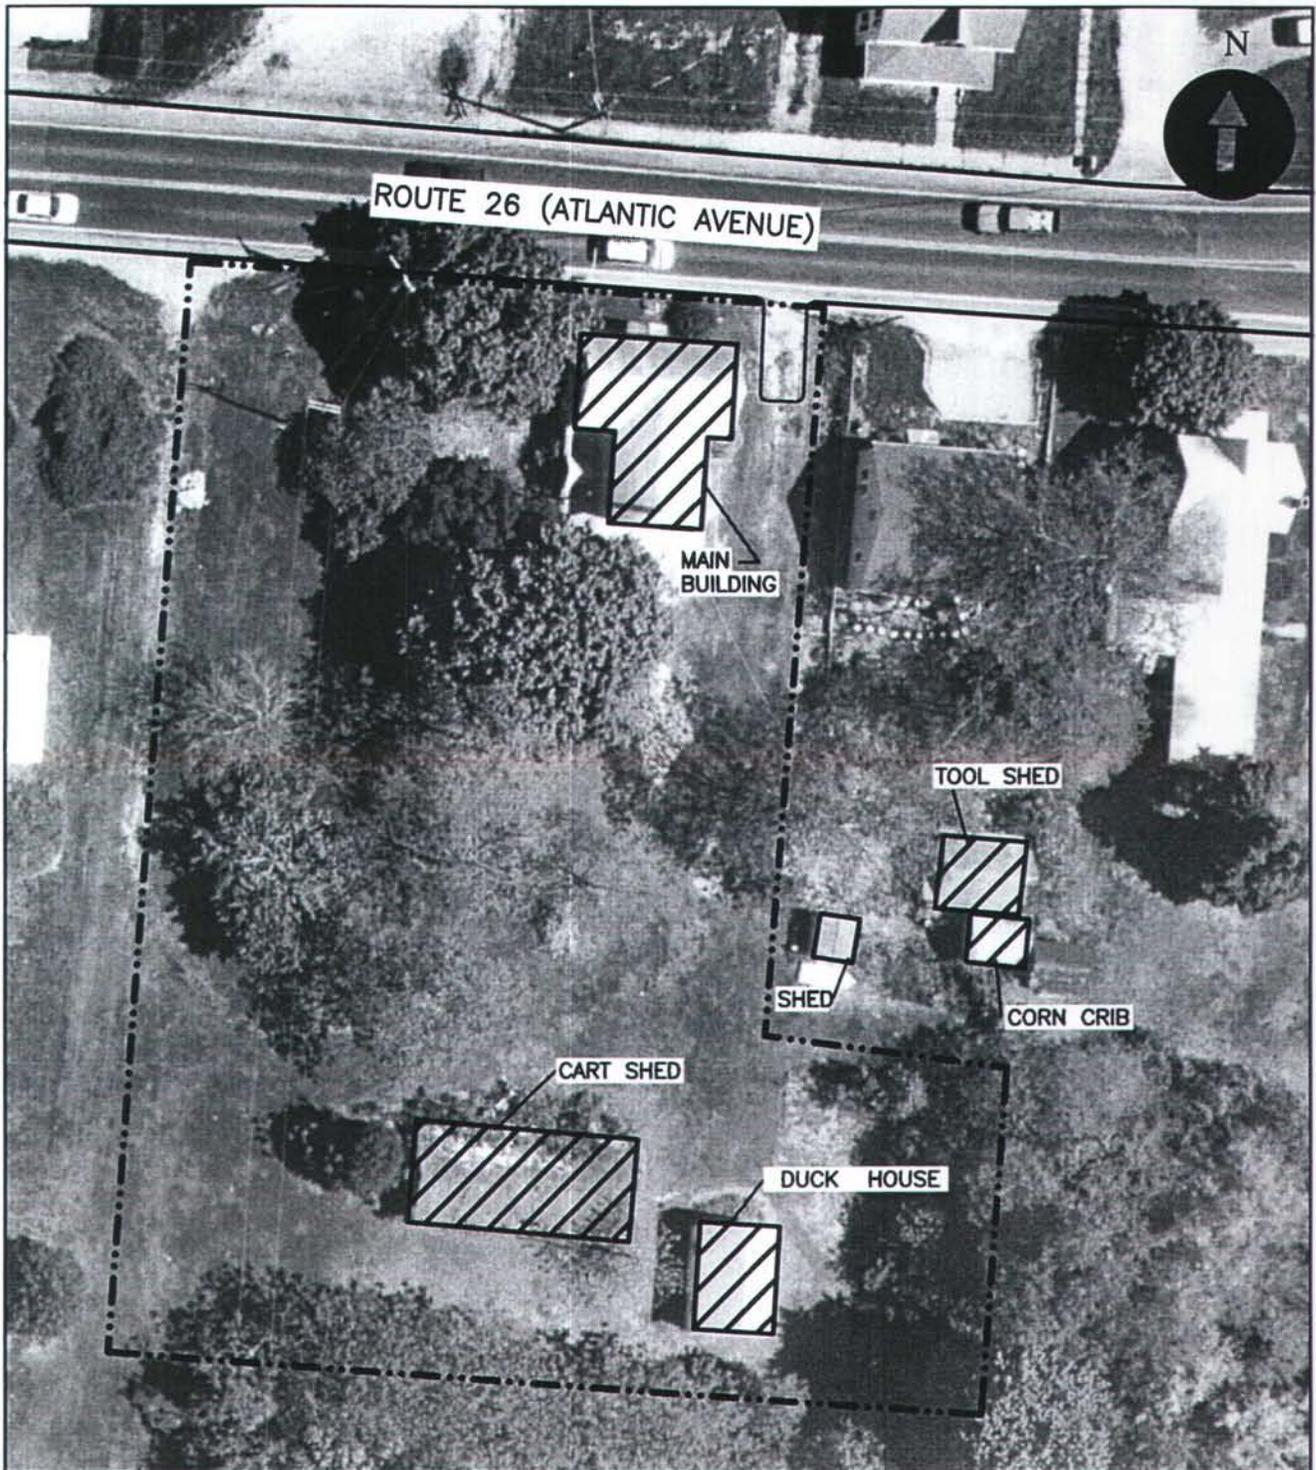
Sketch Plan:

There are five outbuildings located south and southeast of the main house. The first three outbuildings described herein are now situated on the adjacent tax parcel; however, through owner interviews it was determined that these buildings were historically associated with the Evans Property and therefore included with this survey. These three buildings are clustered together near the southeast corner of the house. The first is a late 20th century, gable front tool shed with a low-pitched, asphalt shingle roof. The wood frame building sits on a concrete slab and its walls are covered with corrugated metal. A front entrance (no door) in the north end gable is the only opening for the shed. East of the tool shed there is a 19th century corn crib/grain shed on stone piers. The building's wooden frame is covered with horizontal wood clapboards. A wood plank door is over the entrance in the front gable and the building has a steeply pitched, standing seam metal roof with overhanging eaves and exposed rafters. A window opening (no glass or frame) is in the south side gable wall. Directly to the north of the corn crib/grain shed is the third building in this grouping. This is another wood frame, gable front shed; however, it dates from the early 20th century. It has a concrete foundation with corrugated metal walls and roof. No openings are visible and the front entrance is covered with wood boards.

About 30 yards south of the main house, there are 2 side-gable, rectangular buildings. The first, probably the duck house, has a north/south ridge while the other, a cart-shed, has an east/west ridge.

Similar to a chicken house, the duck house is wood framed with clapboard siding. Two double hung sash windows are located in the front (east) wall, one on each side of the centrally placed doorway with its wood plank door. The early to mid-20th century duck house was built on a concrete slab foundation and uses asphalt shingles for the roof. The cart-shed is a late 19th century wood framed building sitting on stone piers. It has an open front along the south façade. The gable end walls and the back (north) wall are covered with horizontal wood clapboards. The interior is unfinished but separate bays are evident for equipment and machinery storage.
