CULTURAL RESOURCE SURVEY
SURVEY UPDATE FORM

CRS # N05100

1. HISTORIC NAME/FUNCTION: Davidson House (formerly identified as the McMullen House)

2. ADDRESS/LOCATION: 831 S Dupont Highway, Newark, Delaware 19720

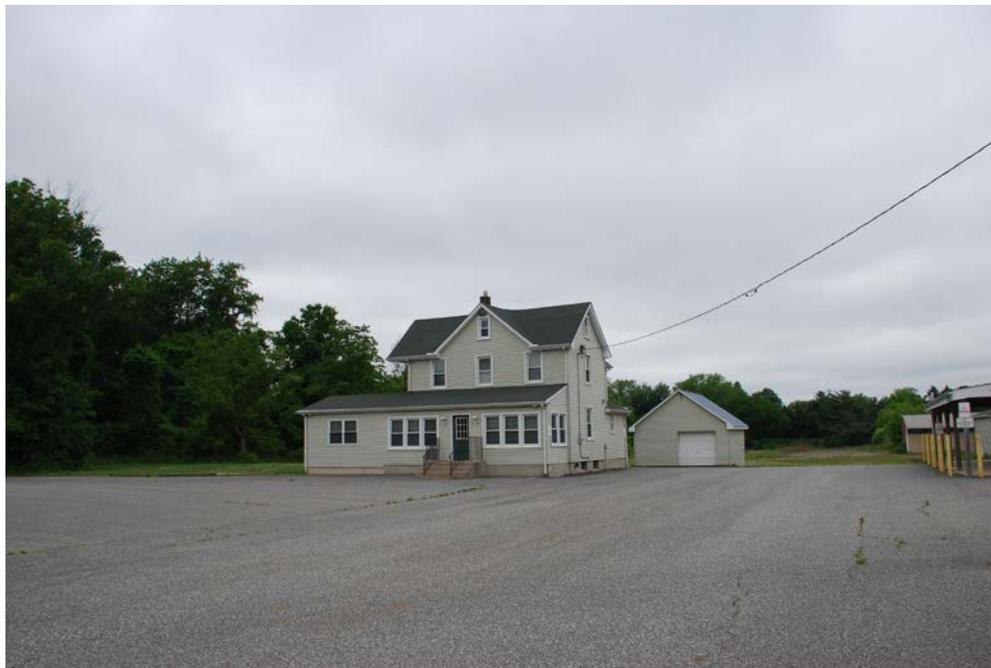
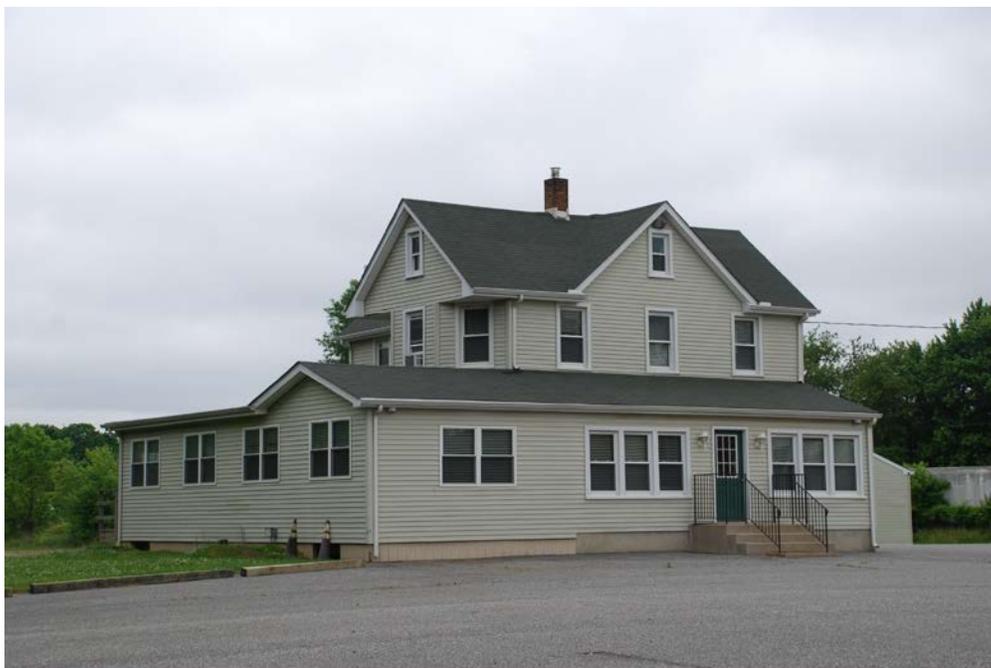
CRS # N05100 Date 5/22/2012 Photo Roll # n/a Surveyor S Groesbeck & P Kuhn

4. INTEGRITY: A one-story addition has been constructed on the southwest elevation since previous survey in 1979. The house has been covered in replacement vinyl siding. The fenestration pattern on the front enclosed porch has changed and the door on the façade has been replaced. The windows have been replaced with 1/1 vinyl-sash.

Description Façade (south elevation) of main building and garage looking north; Southwest corner of main building looking southwest
