CULTURAL RESOURCE SURVEY
PROPERTY IDENTIFICATION FORM

CRS # N08811
SPO Map 08-09-34
Hundred White Clay Creek
Quad Newark East
Other Parcel 903000062

- HISTORIC NAME/FUNCTION: Dwelling, 140 Stanton Christiana Road
- ADDRESS/LOCATION: 140 Stanton Christiana Road, Newark, Delaware 19702
- TOWN/NEAREST TOWN: Christiana vicinity?
- MAIN TYPE OF RESOURCE: building structure site object
landscape district
- MAIN FUNCTION OF PROPERTY: Single Dwelling
- PROJECT TITLE/ REASON FOR SURVEY (if applicable):

CULTURAL RESOURCE SURVEY
MAIN BUILDING FORM

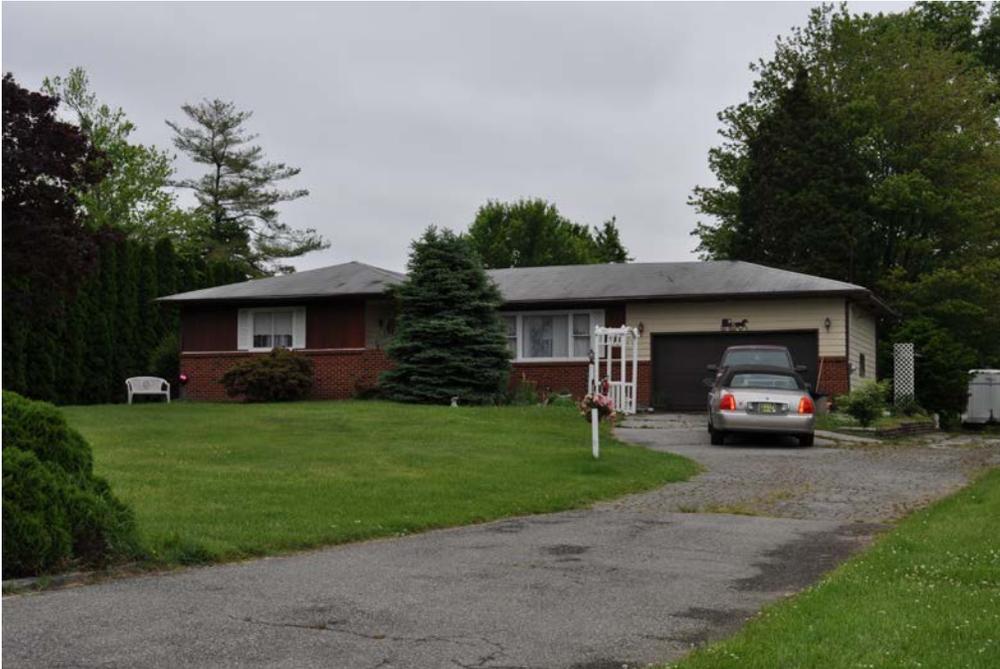
CRS # N08811 Date 5/21/2012 Photo Roll # N/A Surveyor S. Groesbeck
P. Kuhn

- a. Facade: Direction: West
- 1) Bays 3
- 2) Windows 2
- fenestration Paired on north projecting bay, picture window flanked by smaller windows in bay south of main entrance
- type 1-light sliding, 1-light fixed flanked by smaller 1/1 sash, all vinyl replacement
- trim Vinyl trim, continuous rowlock sill
- shutters Fixed vinyl louvered shutters

- 3) **Door(s)** 2
 location South end of projecting bay, attached garage on southern bay
 type single-leaf, metal, paneled roll-up
 trim N/A
- 4) **Porch(es)** Inset Porch with brick wall

Description Main (west) elevation looking northeast
