CULTURAL RESOURCE SURVEY
PROPERTY IDENTIFICATION FORM

CRS # N08814
SPO Map 08-09-33
Hundred New Castle
Quad Newark East
Other Parcel:1003900008

1. HISTORIC NAME/FUNCTION: Pleasant Hill (Beers' 1868)
2. ADDRESS/LOCATION: 300 Grebe Drive, Bear, Delaware 19701
3. TOWN/NEAREST TOWN: Bear vicinity?
4. MAIN TYPE OF RESOURCE: building structure site object
landscape district
5. MAIN FUNCTION OF PROPERTY: Single-family Dwelling
6. PROJECT TITLE/ REASON FOR SURVEY (if applicable):
SR 1 Road Widening

CRS # N08814.001

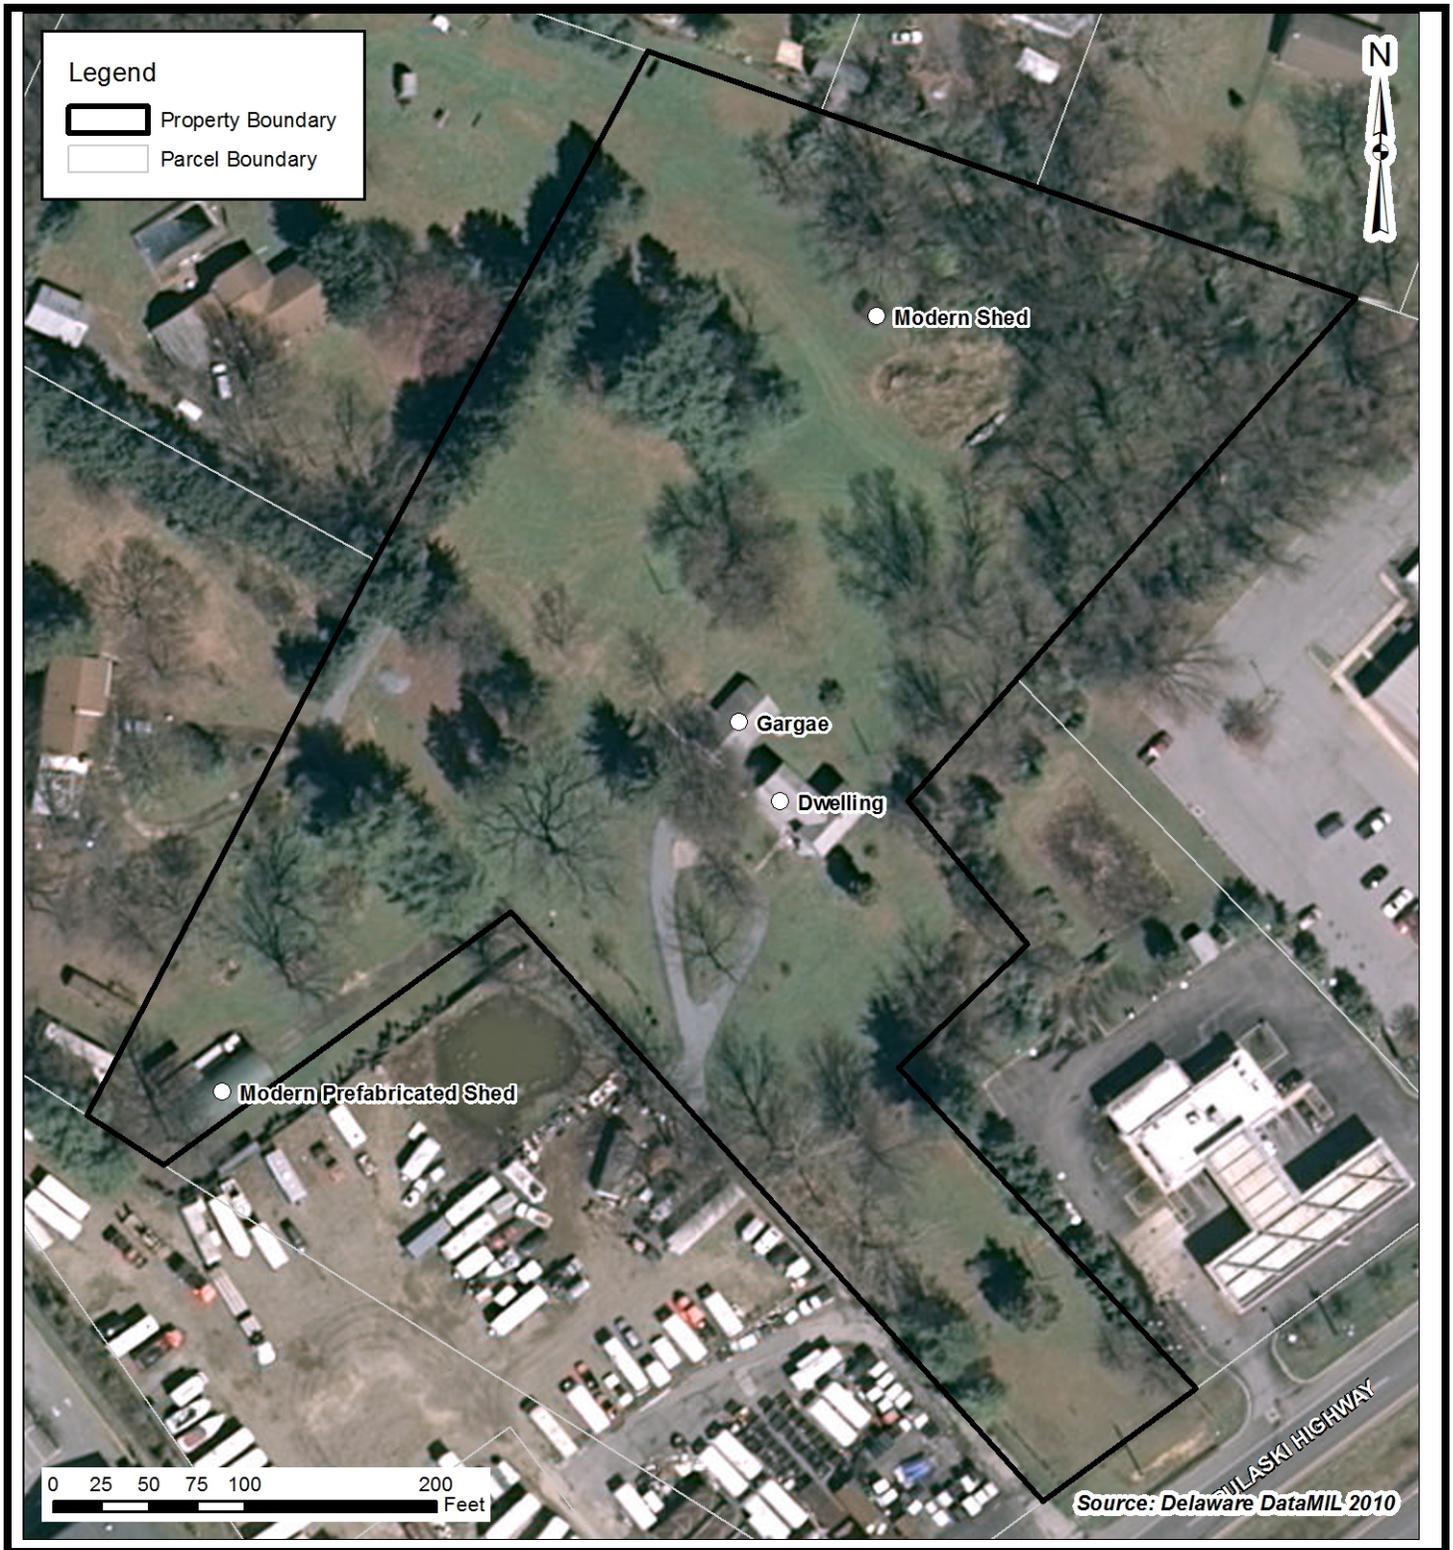
4. SITE PLAN:

In addition to the dwelling (.001) and garage (.002), there is a barrel-roof metal storage building near the southwest corner of the property and a one-story wood frame prefabricated shed. Both date to after 1965 and were not included in the survey.

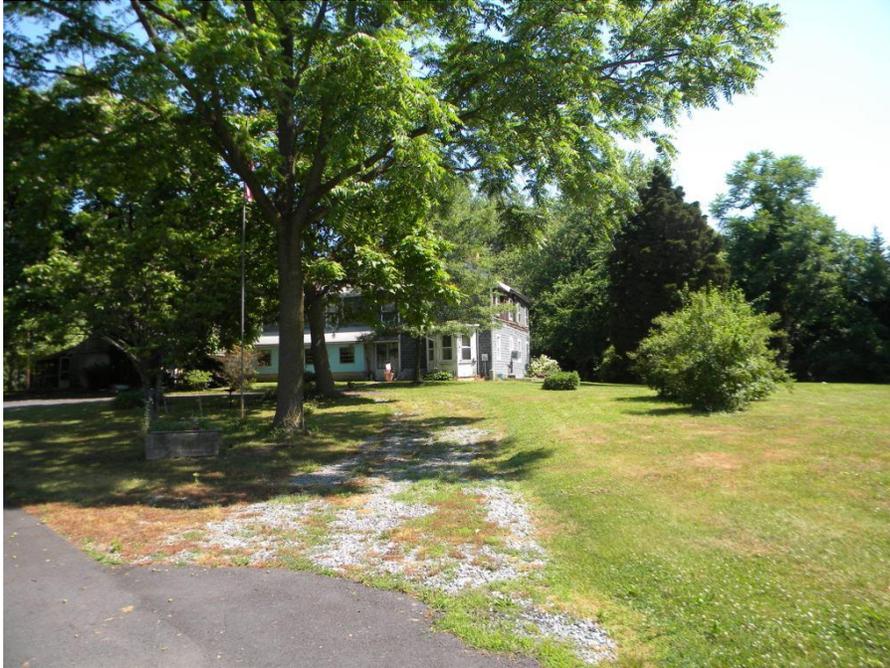
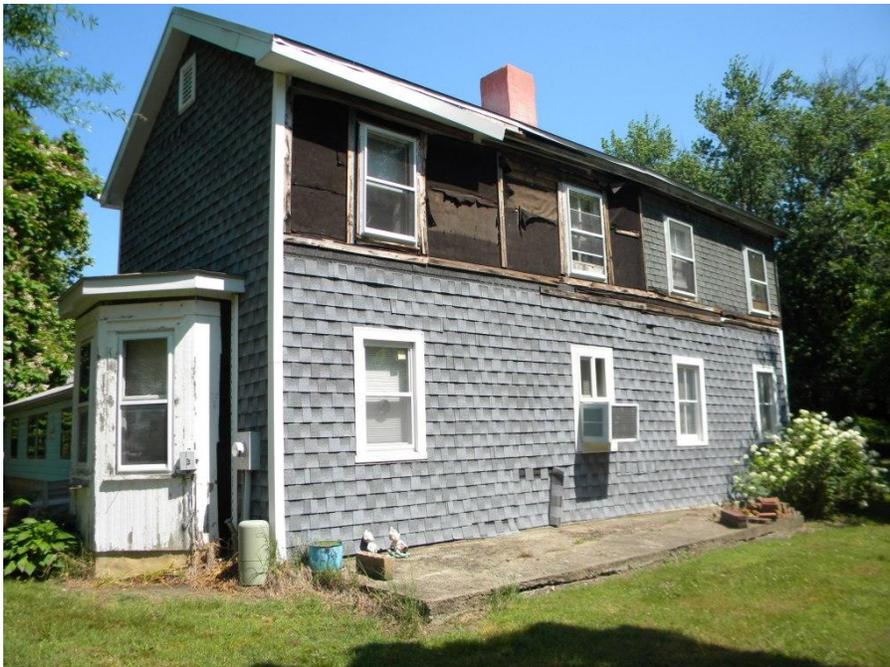
Description Facade (west elevation) of main building (.001) looking northeast; South elevation of main building (.001) looking northeast

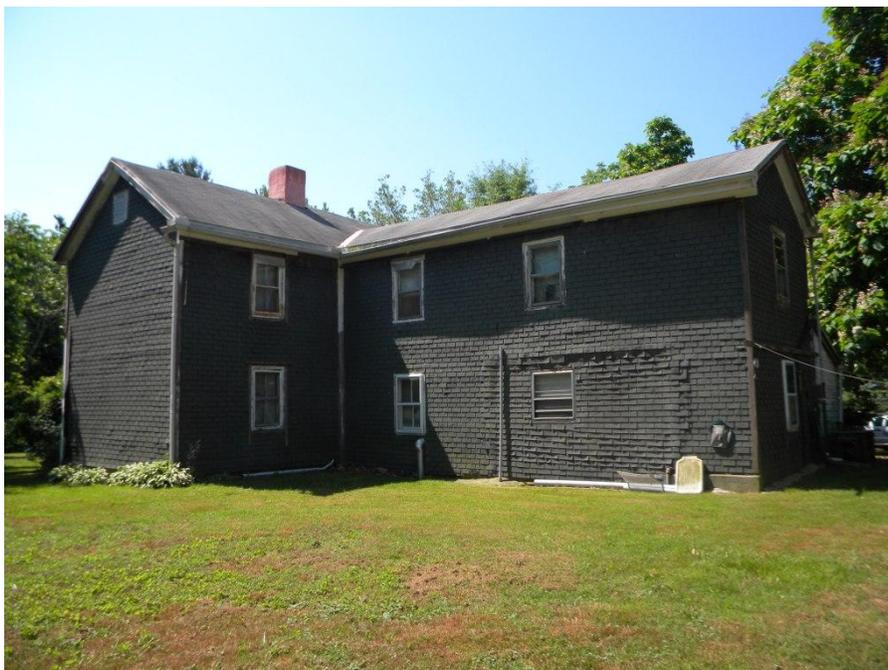
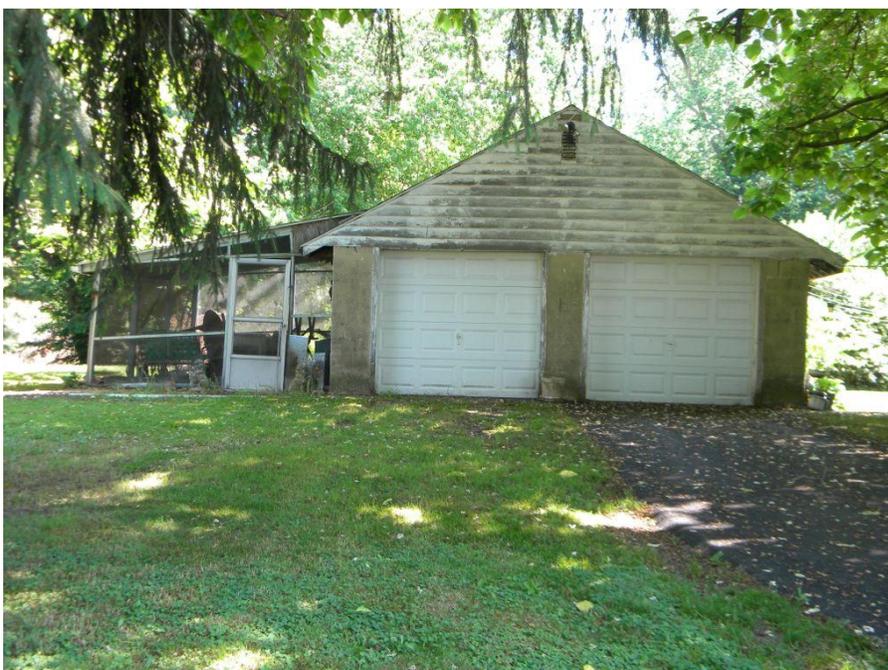
Description East and north elevations of main building (.001) looking southwest; West elevation of garage (.002) looking east
