CULTURAL RESOURCE SURVEY
PROPERTY IDENTIFICATION FORM

1. HISTORIC NAME/FUNCTION: Dwelling, 485 Christiana Rd
2. ADDRESS/LOCATION: 485 Christiana Rd, New Castle, Delaware 19720
3. TOWN/NEAREST TOWN: Christiana vicinity?
4. MAIN TYPE OF RESOURCE: building structure site object
 landscape district
5. MAIN FUNCTION OF PROPERTY: _____
6. PROJECT TITLE/ REASON FOR SURVEY (if applicable):

CULTURAL RESOURCE SURVEY
MAIN BUILDING FORM

CRS # N08816.001

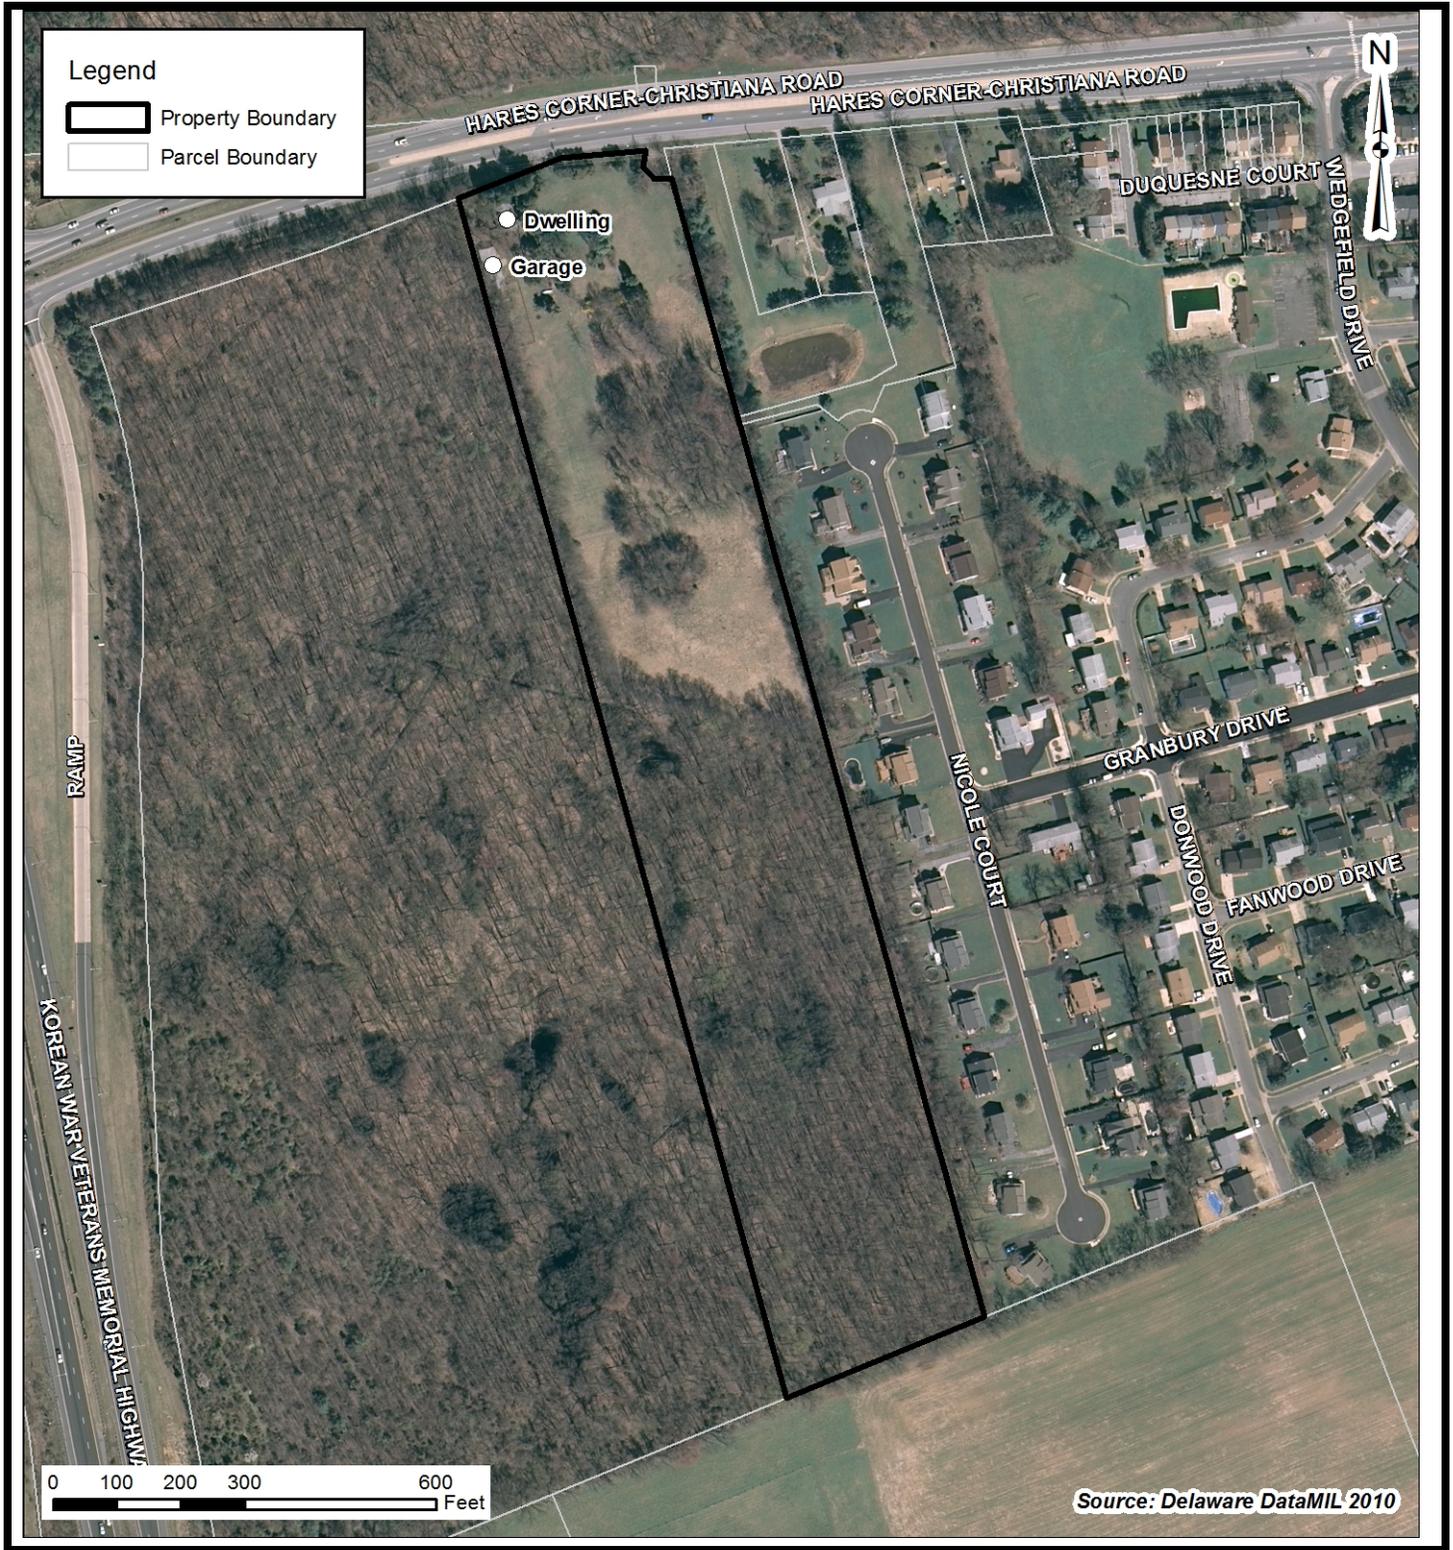
4. SITE PLAN:

10. **LANDSCAPING:** The house sits close to, but elevated above the road, with a few plantings and a chain link fence separating it from the road. A paved driveway runs southwest from Christiana Road, then south along the east side of the house and continues to the secondary structure. The majority of the 15-acre property is covered with trees and mature trees surround the dwelling.

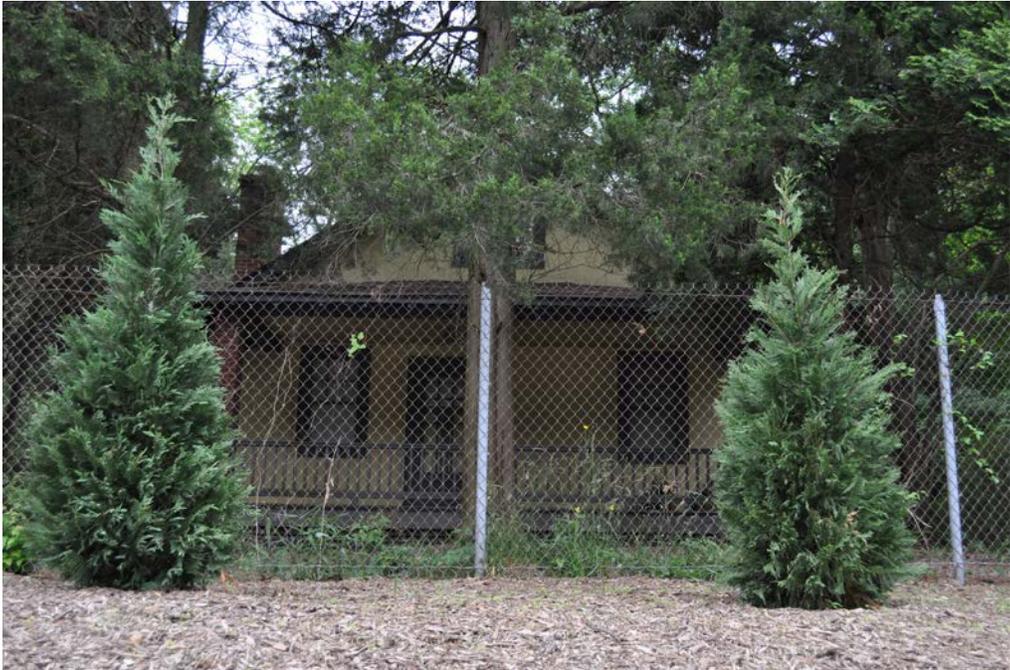
Description Façade (north elevation) of main building looking south; Northeast corner of main building looking southwest

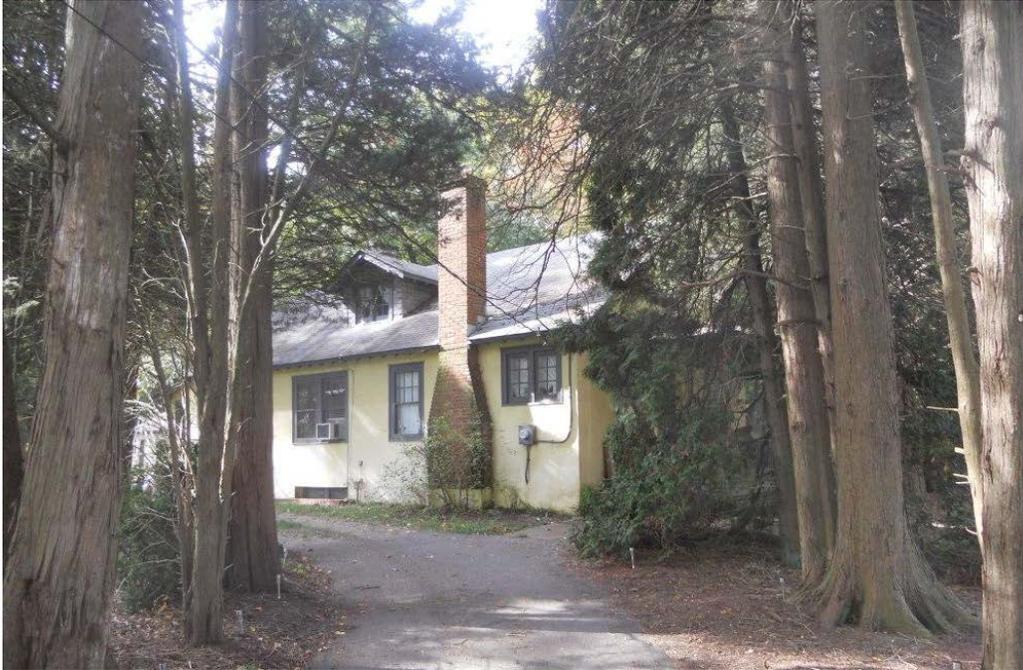
- 1) **Bays** 5
- 2) **Windows** 6
 fenestration 6 light paired N & S, 6/1 center bays 1st story, 6 light paired dormer 1/2 story
 type 6 light paired wood sash, 6/1 double-hung wood sash
 trim N/A
 shutters N/A
- 3) **Door(s)** 1
 location S end of elevation
 type single-leaf wood panel with glazed lights
 trim N/A
- 4) **Porch(es)** N/A

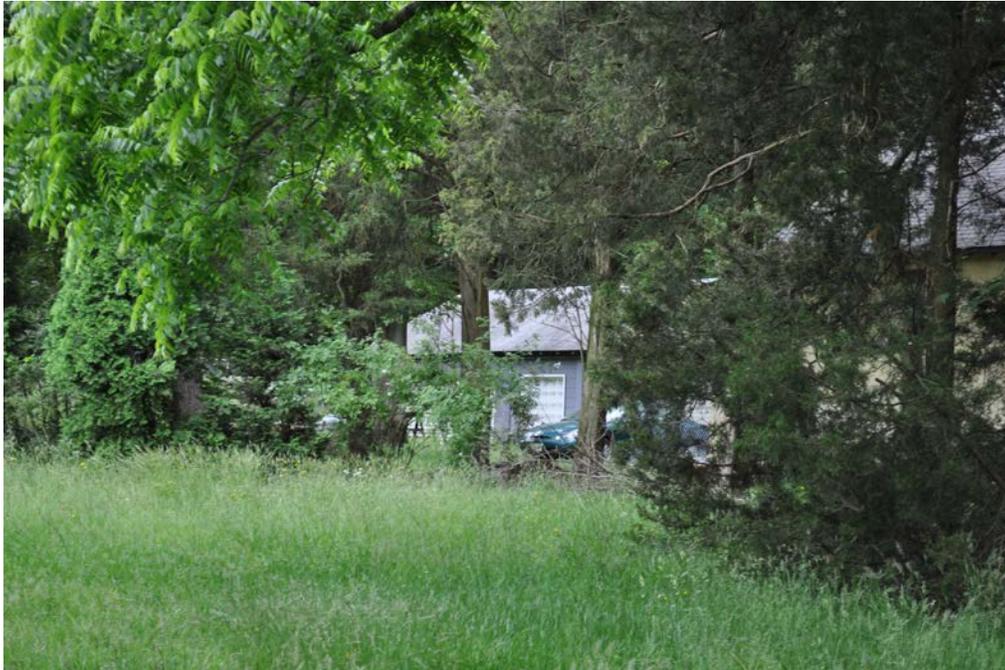
A large gable-front wood frame building, likely a garage, with an asphalt shingle roof and exposed rafter tails is located south of the house. Most of the building was obscured by trees, but it appears to have composite siding and a large multiple-pane window on the north end of its east elevation. Historic aerials show the building on the property by 1951.

Description East elevation of garage looking southwest
