CULTURAL RESOURCE SURVEY  
PROPERTY IDENTIFICATION FORM

1. HISTORIC NAME/FUNCTION: Wagner Property
2. ADDRESS/LOCATION: 1042 S Dupont Highway, New Castle, Delaware, 19702
3. TOWN/NEAREST TOWN: Bear vicinity?
4. MAIN TYPE OF RESOURCE:

building <input checked="" type="checkbox"/>	structure <input type="checkbox"/>	site <input type="checkbox"/>	object <input type="checkbox"/>
landscape <input type="checkbox"/>	district <input type="checkbox"/>		
5. MAIN FUNCTION OF PROPERTY: Dwelling
6. PROJECT TITLE/ REASON FOR SURVEY (if applicable):  
SR 1 Widening

Organization: The Louis Berger Group Date: June 2012

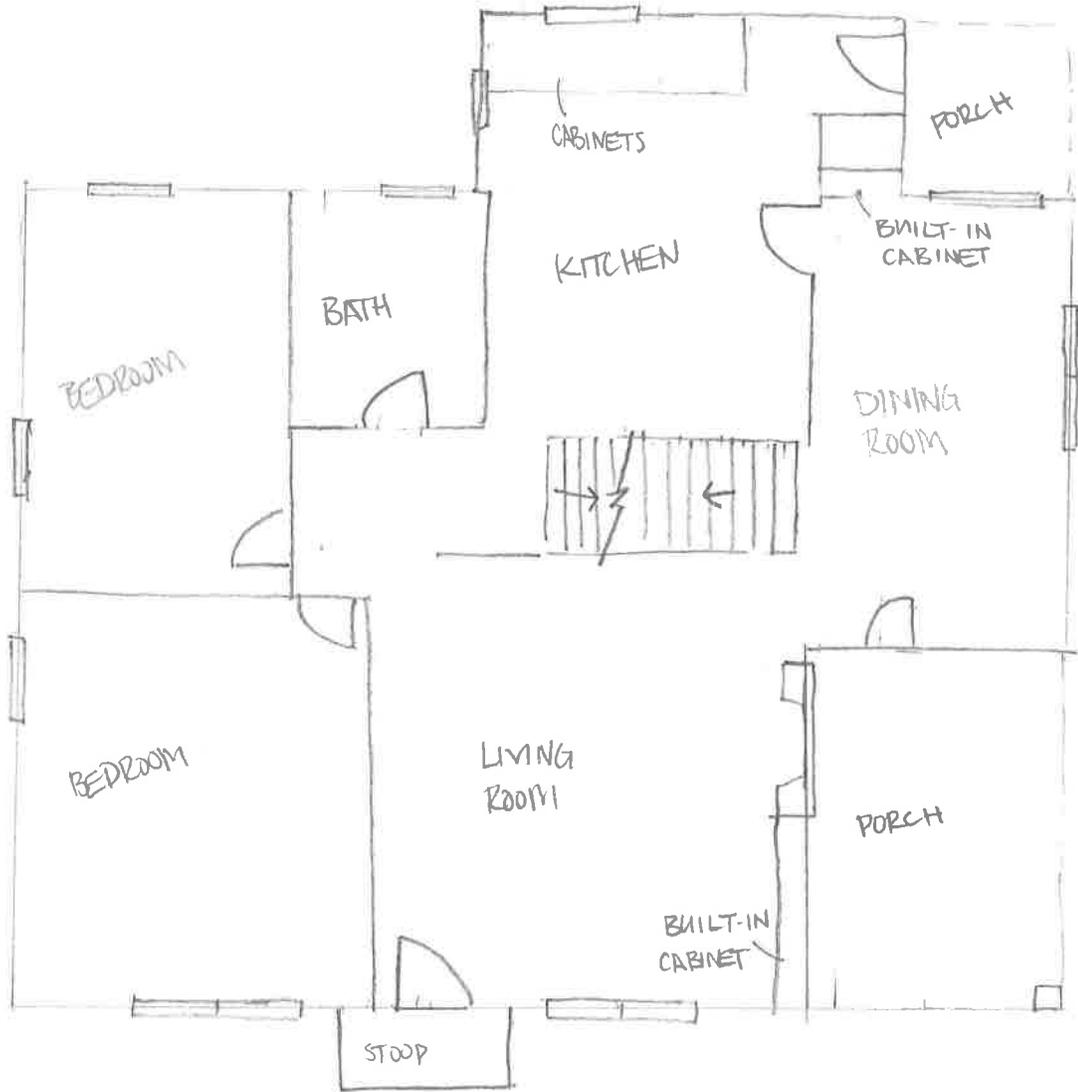
FIRST FLOOR

1042 S DUPONT HIGHWAY

1956 DWELLING

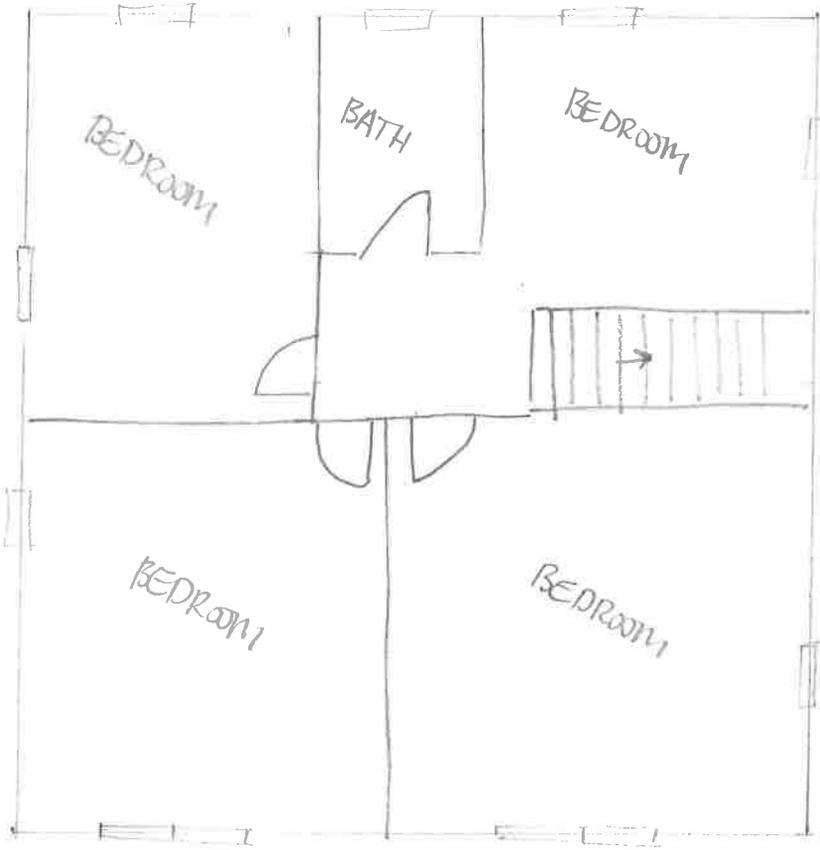
SECOND FLOOR

1042 S DUPONT HIGHWAY

1956 DWELLING

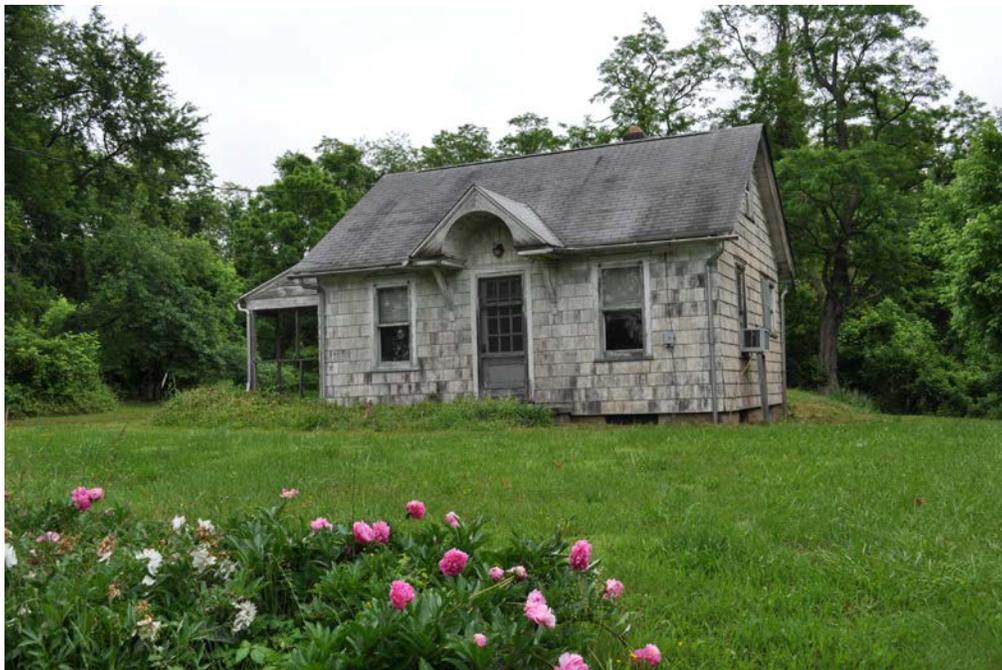
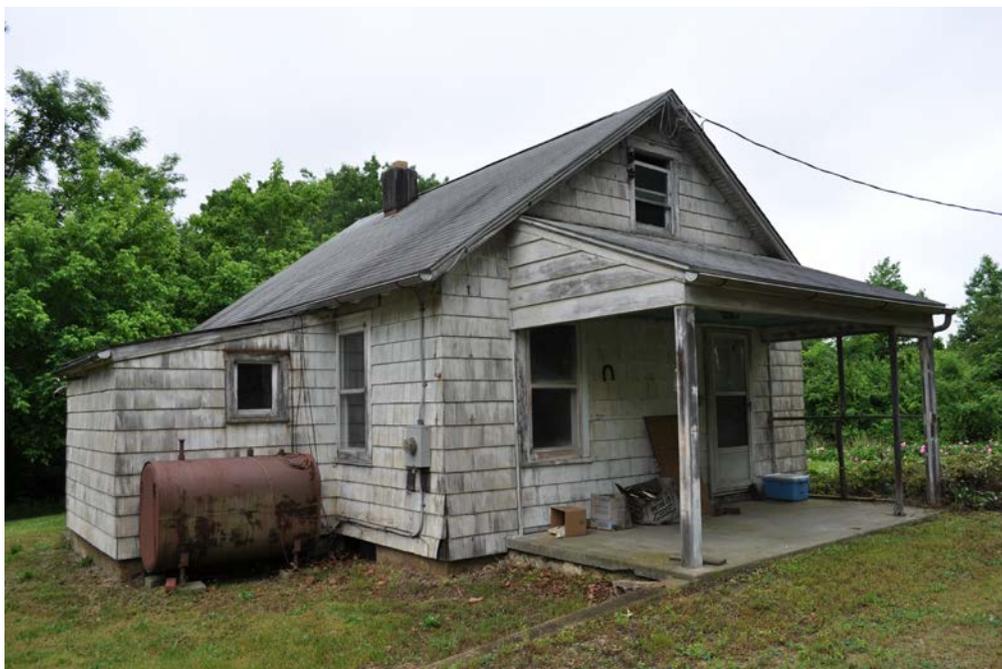
Description     Façade (west elevation) and south elevation of 1940 dwelling (.002) looking northeast; Northeast corner of 1940 dwelling (.002) looking southwest

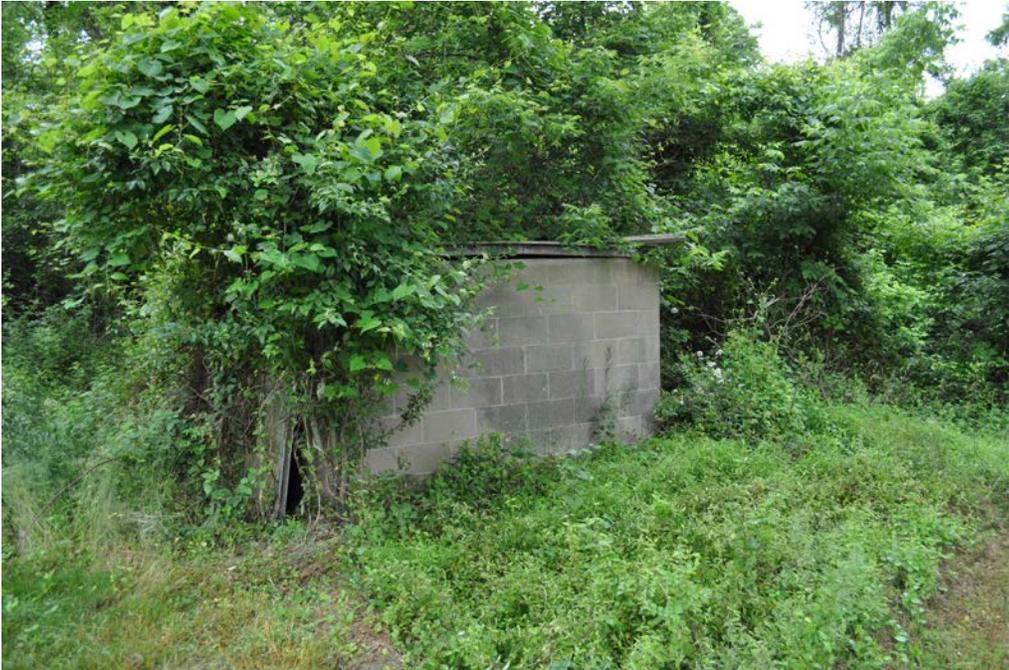
Description Northwest corner of concrete block outbuilding (.005) looking southeast; East elevation of barn (.003) looking west

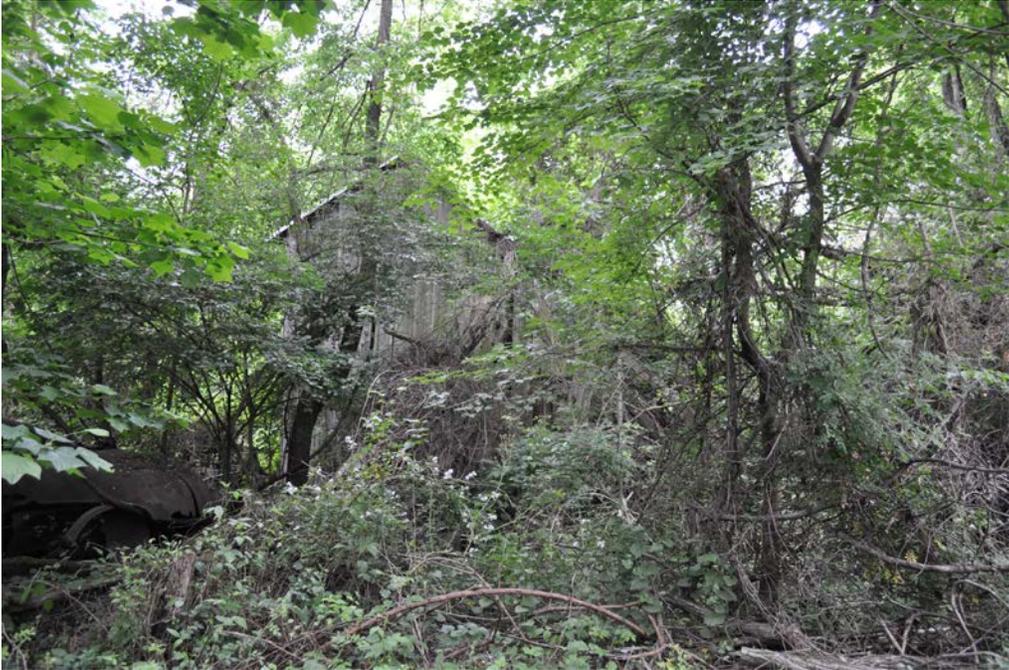
a) Floor plan            The owner indicated that 1<sup>st</sup> story had been used to house cows and the 2<sup>nd</sup> story for chickens. The 2<sup>nd</sup> floor joists were partially collapsed and the building was unsafe to enter.

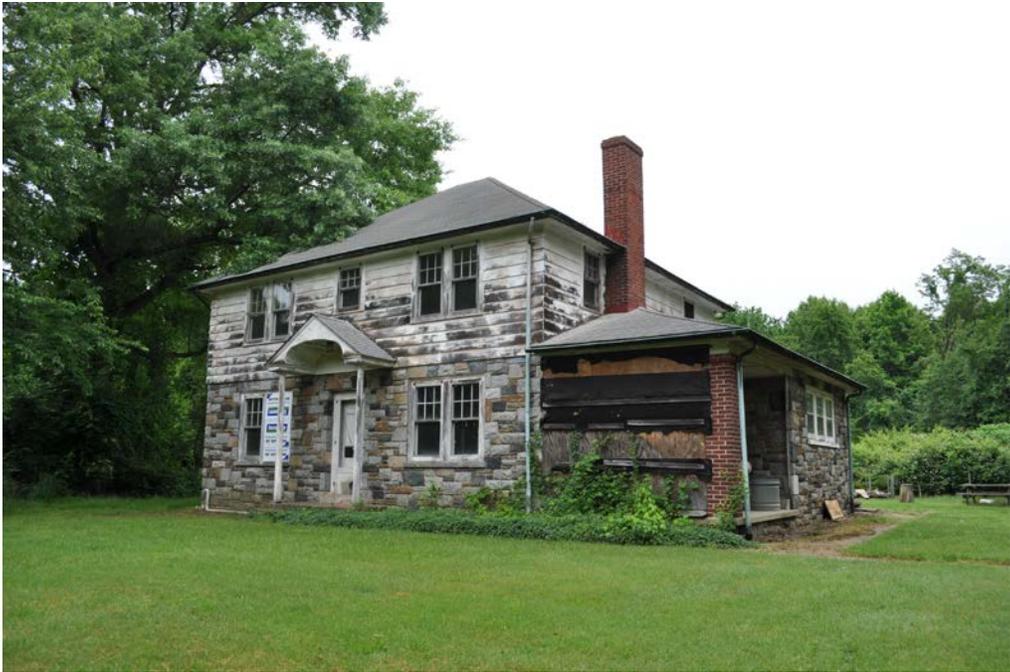
- fenestration N & S ends, 1<sup>st</sup> story, 3 bays second story w/ smaller center window type 6/1 double-hung paired wood sash with center single window on 2<sup>nd</sup> story, one of 1<sup>st</sup> story N opening windows missing

Description Interior of barn (.003) looking west; Façade (west elevation) and south elevation of 1956 dwelling (.001) looking northeast

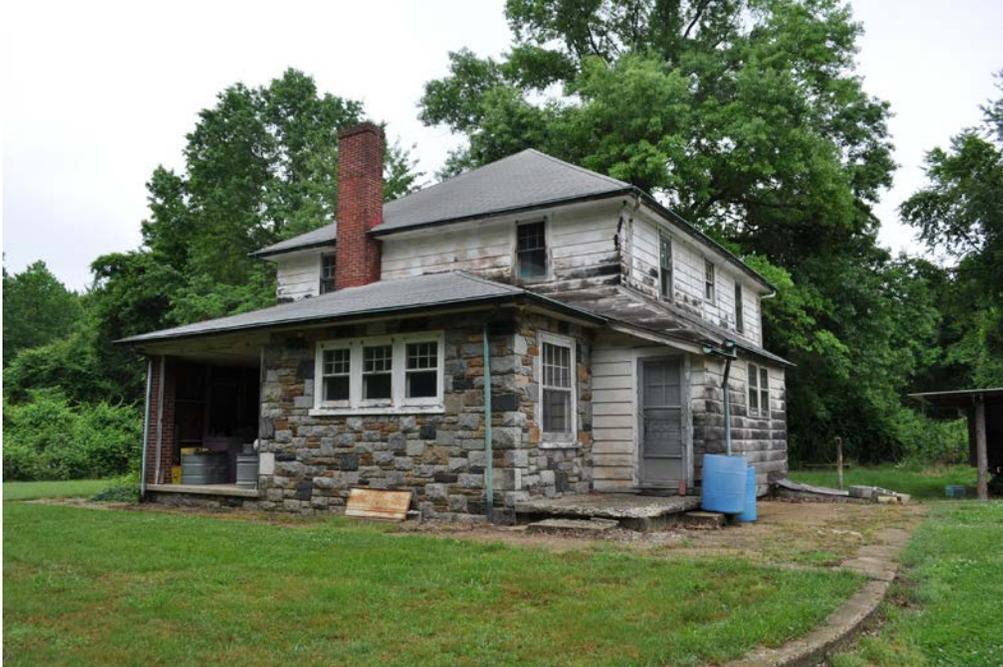
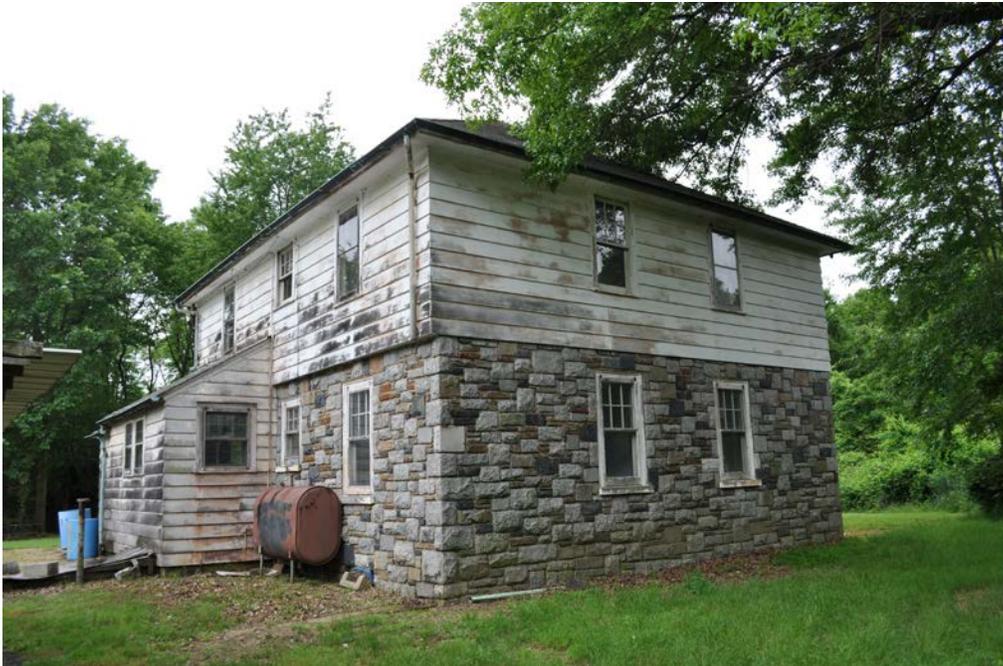
Description Southeast corner of 1956 dwelling (.001) looking northwest; Northeast corner of 1956 dwelling (.001) looking southwest

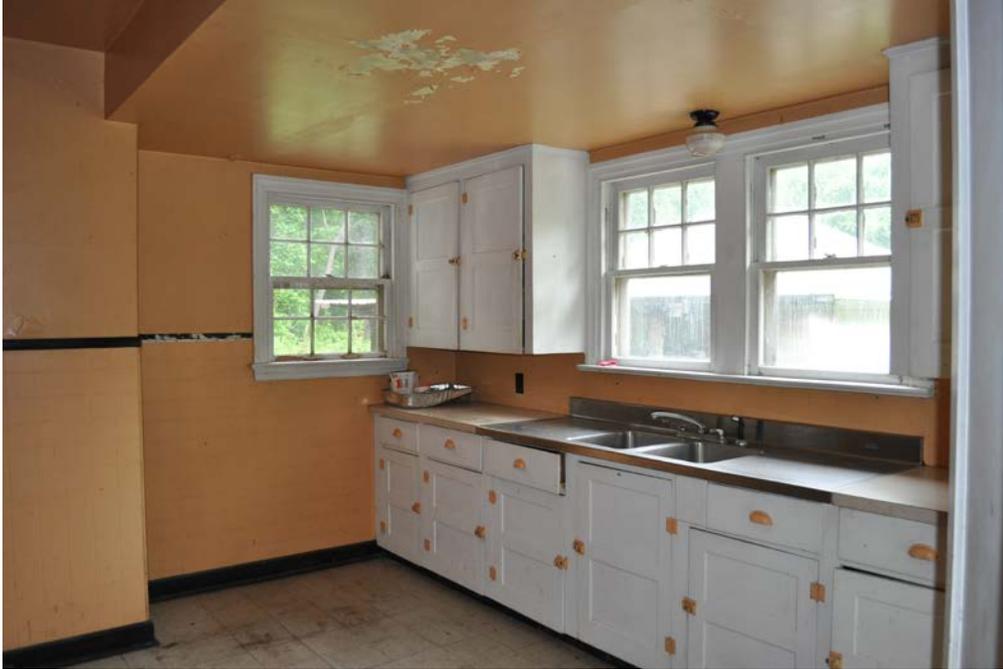
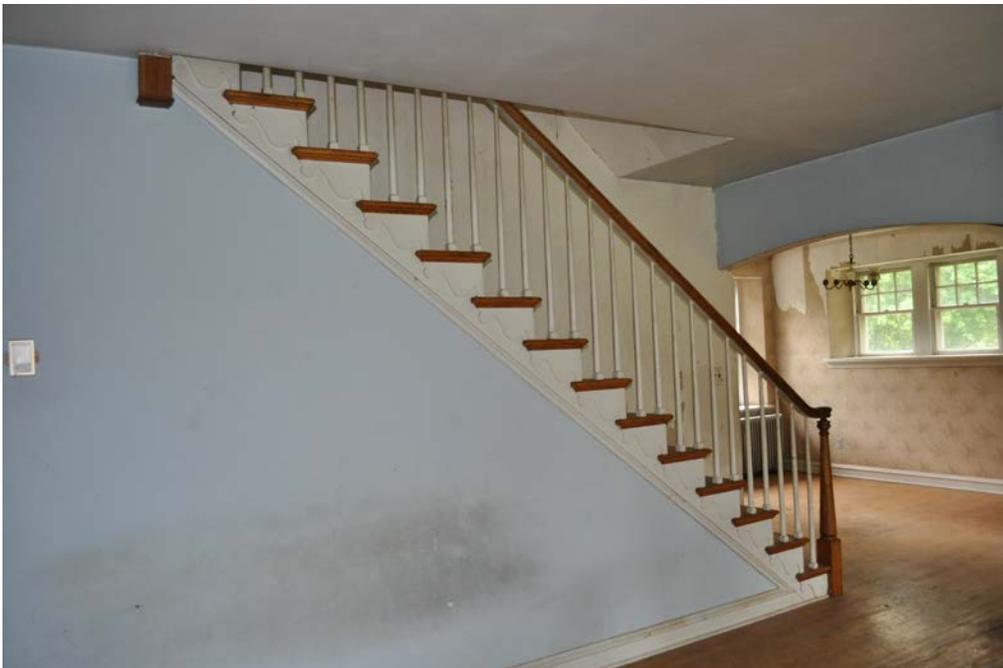
9. **INTERIOR:** built-in cabinets in dining room and living room, fireplace in living room. House has retained almost all original hardware, floors, trim, cabinets, etc.
10. **LANDSCAPING:** The clearing in which house sits is surrounded by mature trees. A low concrete retaining wall/sill defines the yard and runs along unpaved drive.
11. **OTHER COMMENTS:** N/A

Description Kitchen Interior of dwelling (.001); Interior stairs of 1956 dwelling (.001)

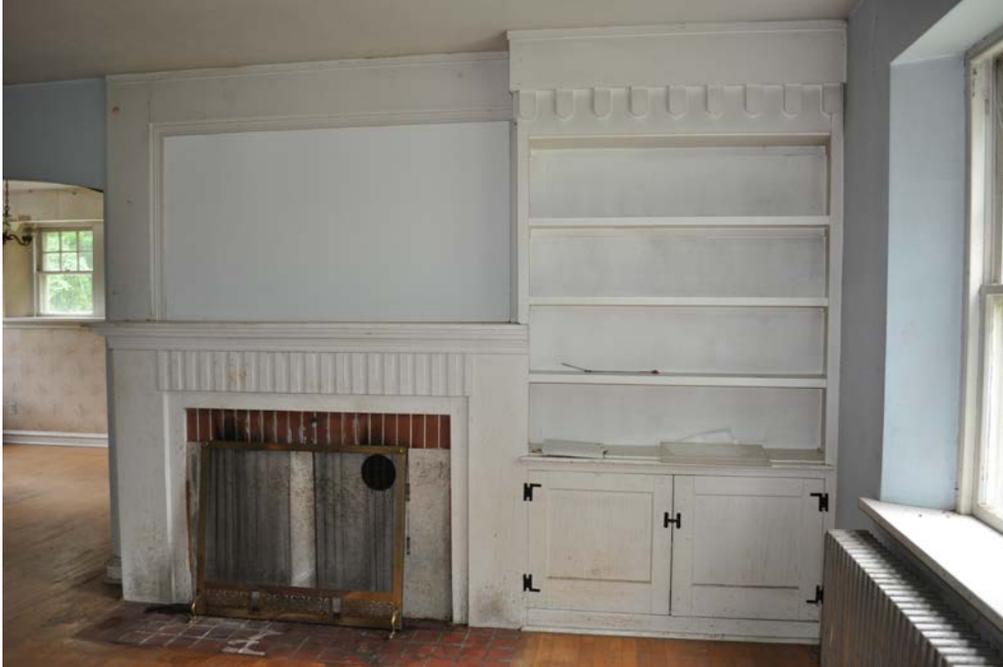
Description Fireplace and built-in cabinets, Interior of 1956 dwelling (.001); Bedroom, Interior of 1956 dwelling (.001)

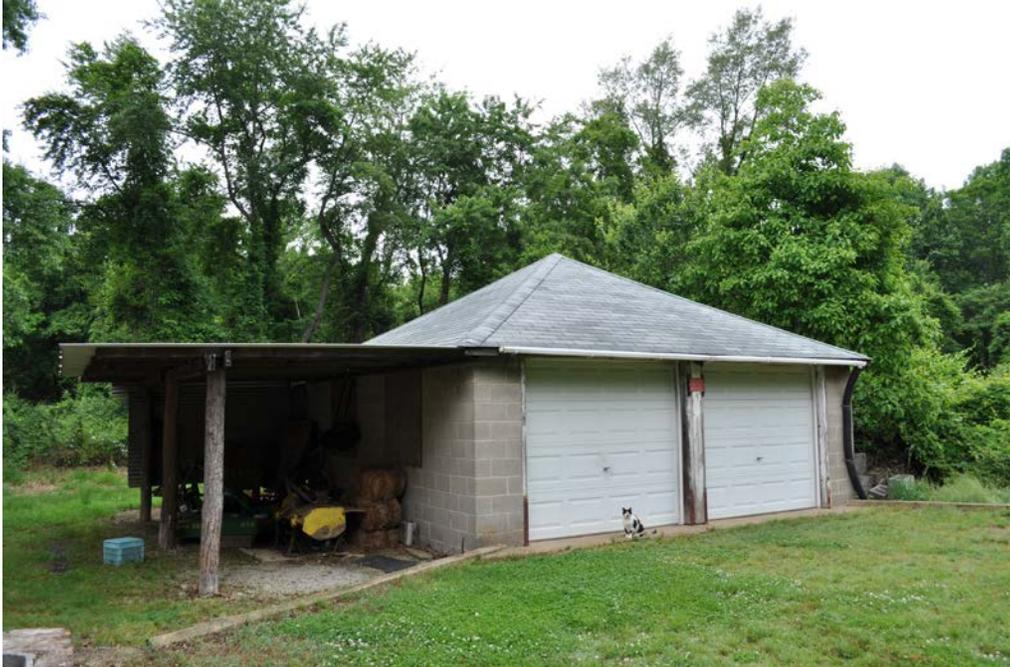
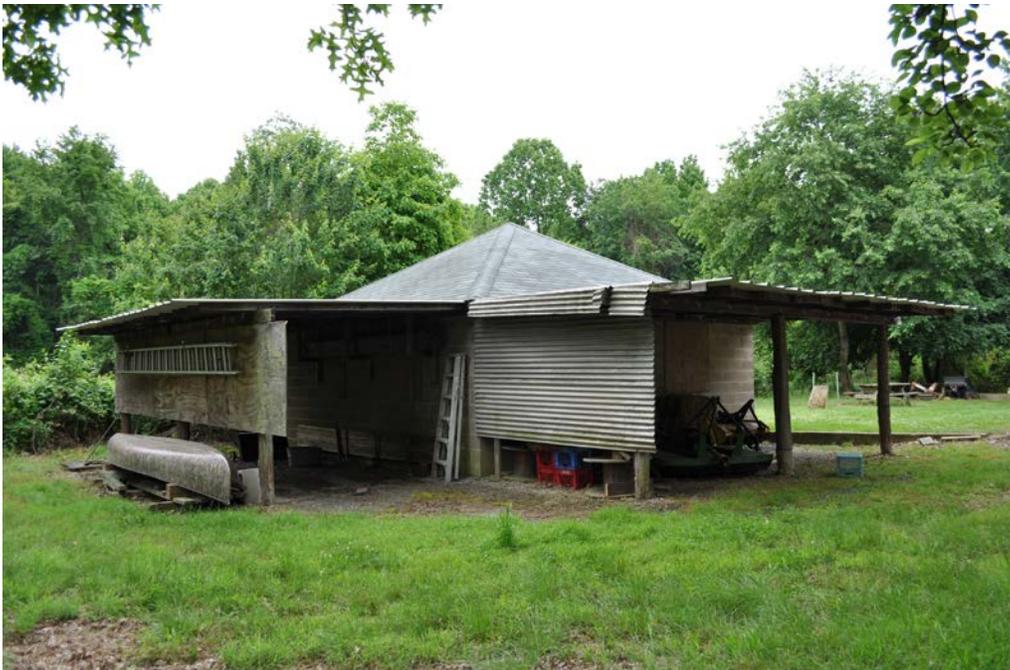
3) door(s): 2 roll-up garage doors with replacement metal doors

- b. Side: direction: West
  - 1) bays: 2
  - 2) windows: 2 window openings have been boarded over
  - 3) door(s): 0
  - 4) other: shed roof open-sided with metal roof and wood post supports

Description Façade (south elevation) and west elevation of garage (.004) looking northeast;  
Northwest corner of garage (.004) looking southeast
