4.0 RESULTS

DELAWARE DEPARTMENT OF TRANSPORTATION

S. R. 26 IMPROVEMENTS
(CLARKSVILLE TO ASSAWOMAN CANAL)
BALTIMORE HUNDRED
SUSSEX COUNTY

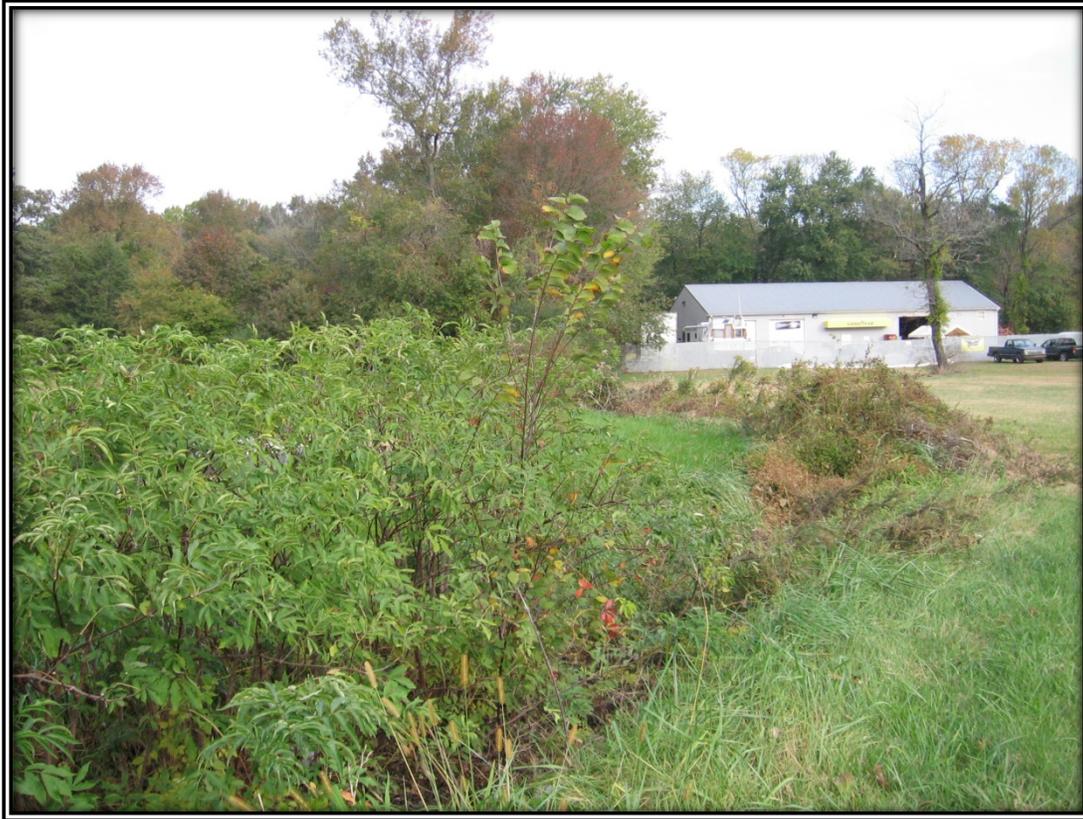
Photograph 1. General view of the grassy portion of the Parking Lot Test Area, facing north.

This test area was tested for the possible presence of archaeological resources (Photographs 1 and 2). Both wooded as well as grassy areas are present in the test area. Some disturbance is present in the test area, especially adjacent to the current St. George's United Methodist Church and a commercial parking lot (see Figure 2:Sheet 1). The excavated test area soils are typical of upland coastal plain sediments. The profile of STP N150 E150, excavated within the central portion of this stormwater management area, is comprised of a dark yellowish brown (10YR 4/4) sandy loam plowzone (Ap horizon) underlain by a yellowish brown (10YR 5/6) sandy loam subsoil (Bw horizon) (Figure 3; Appendix A). Despite the excavation of 19 STPs in the Parking Lot Test Area, no archaeological remains of any type were identified.

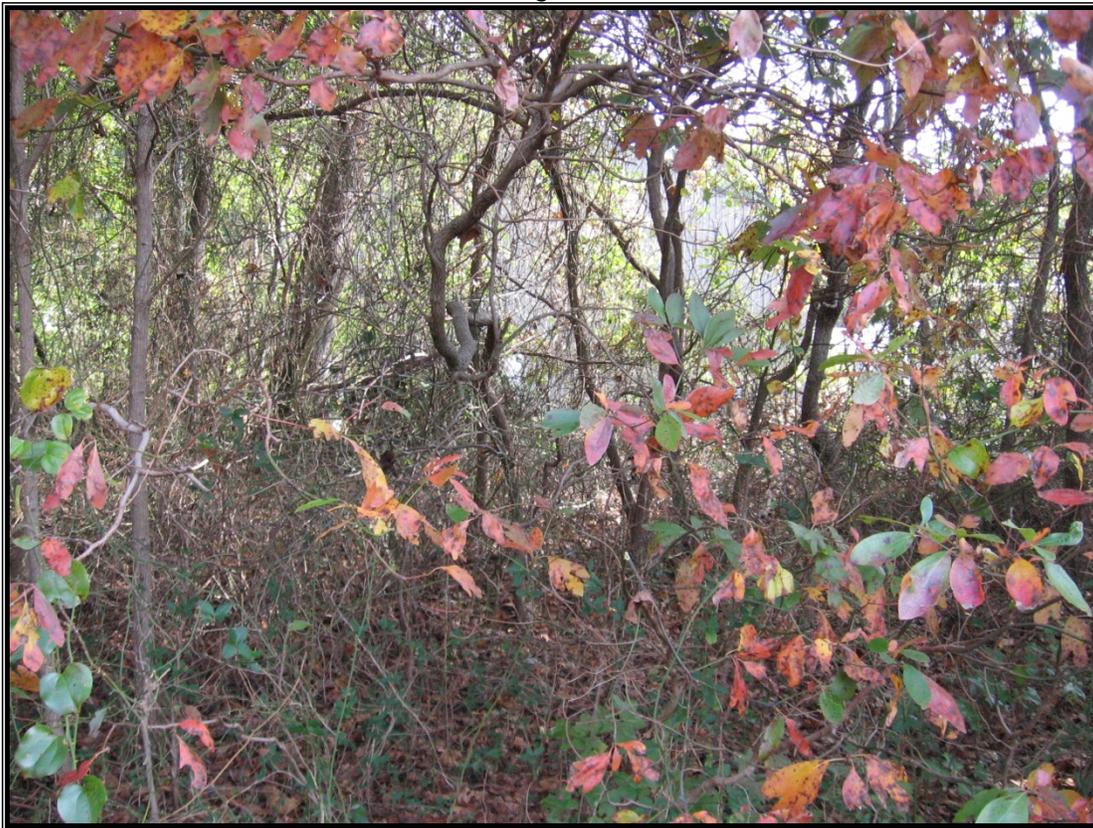
Photograph 2. General view of the wooded portion of the Parking Lot Test Area, facing west.

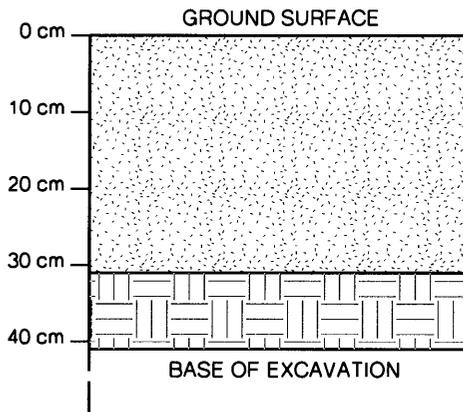
FIGURE - 3

SOIL PROFILE SHOVEL TEST PIT N150 E150 PARKING LOT TEST AREA

Ap 10YR 4/4 Dark yellowish brown sandy loam.

Bw 10YR 5/6 Yellowish brown sandy loam.

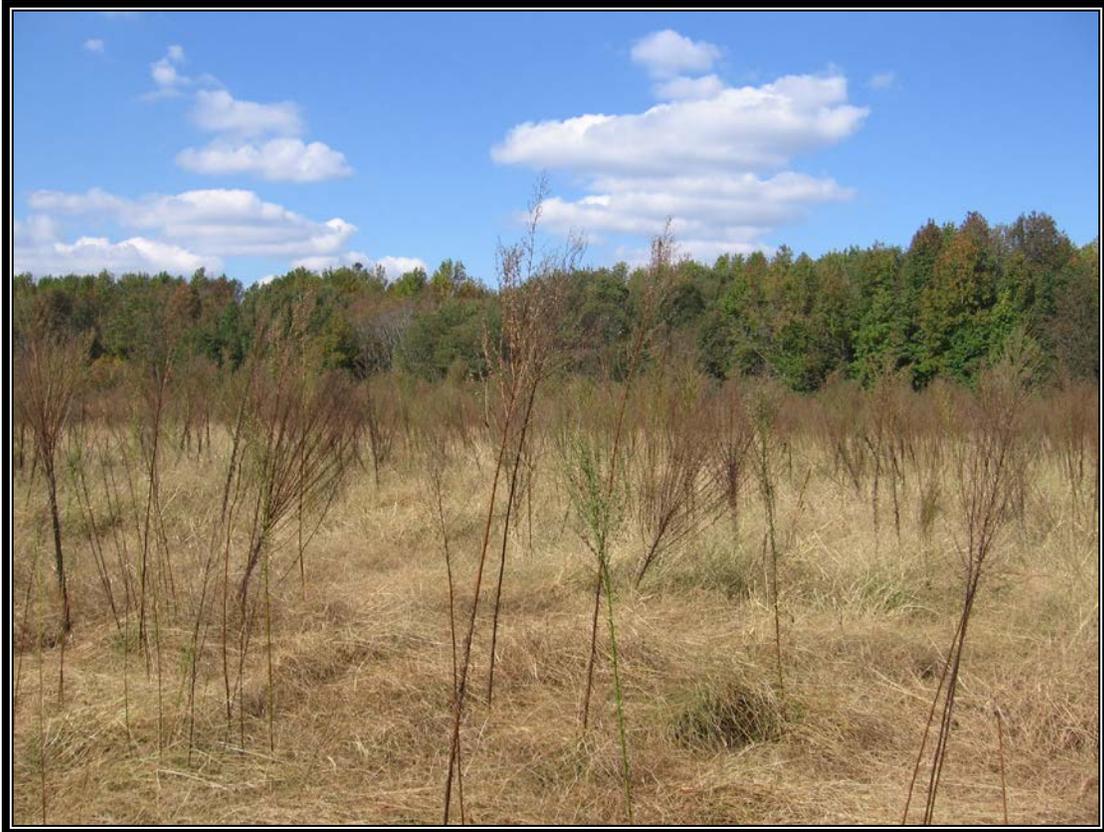
Photograph 3. General view of the grassy portion of the SWM #1 Test Area, facing northwest.

This stormwater management area was tested for the possible presence of archaeological resources (Photograph 3; see Figure 2:Sheet 2). Vegetation present at the time of the survey was tall grasses and other scrub plants. The soils are typical of upland coastal plain sediments, with variations in the degree of internal drainage of the soil profile. Soil drainage is directly dependent on the landscape position, with the poorly drained soils in or near drainage ditches which border the area.

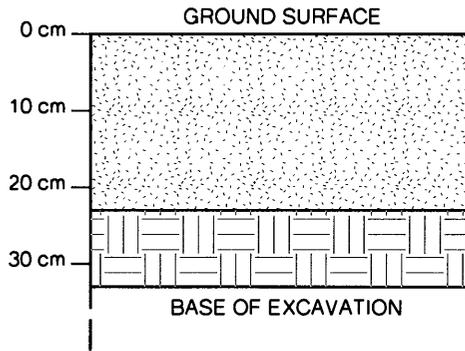
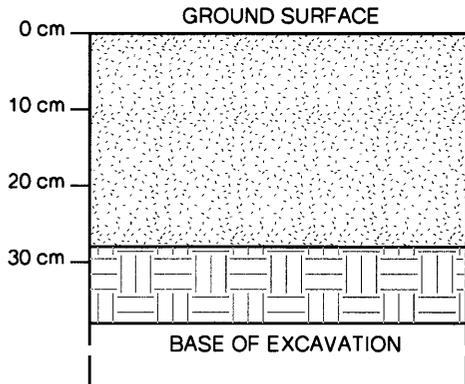
FIGURE - 4

Ap 10YR 4/4 Dark yellowish brown sandy loam.

Bw 10YR 5/6 Yellowish brown sandy loam.

SOIL PROFILES SHOVEL TEST
PITS N240 E195 AND N225 E165
SWM #1 TEST AREA

The profile of STP N240 E195, excavated within the northeast portion of this stormwater management area, is comprised of a dark yellowish brown (10YR 4/4) sandy loam plowzone (Ap horizon) underlain by a yellowish brown (10YR 5/6) sandy loam subsoil (Bw horizon) (Figure 4; Appendix A). The profile of STP N225 E165, excavated within the west-central edge of the test area near a drainage ditch, exhibits the same basic profile (Figure 4; Appendix A). Despite the

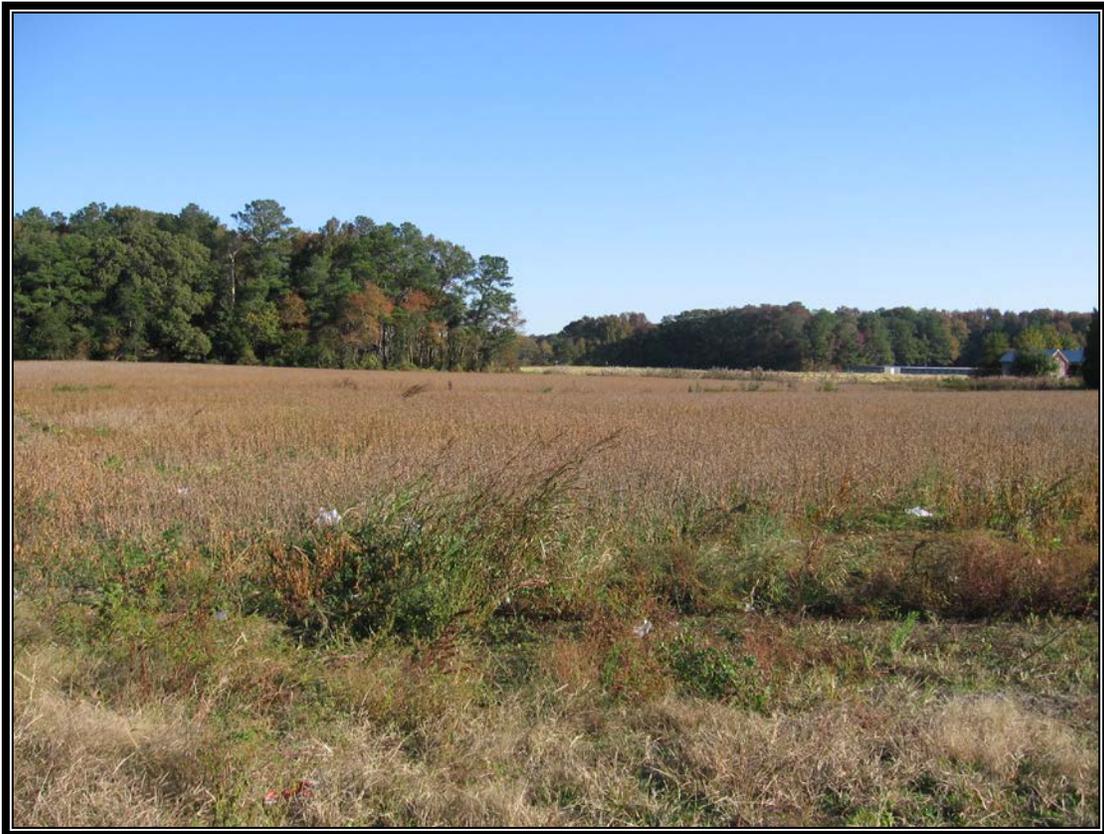
Photograph 4. General view of the soybean field in the SWM #3 Test Area, facing northeast.

This stormwater management area is located in a soybean field and was tested for the possible presence of archaeological resources (Photograph 4). Roadway disturbance and a drainage ditch border the test area (see Figure 2:Sheet 3). The soils are typical of upland coastal plain sediments. The profile of STP N105 E135, excavated within the central portion of this stormwater management area, includes a layer of modern fill comprised of sandy silt loam interspersed with layers of coarse sand, underlain by a dark brown (10YR 3/3) sandy loam plowzone (Ap horizon), underlain by a light gray (10YR 7/1) sandy loam subsoil (Bw horizon) (Figure 5; Appendix A). Obviously, the modern fill has been introduced to the otherwise natural soil profile. The modern fill contains modern trash such as Styrofoam and aluminum foil. Despite the excavation of 20 STPs in the SWM #3 Test Area, no archaeological remains of any type were identified.

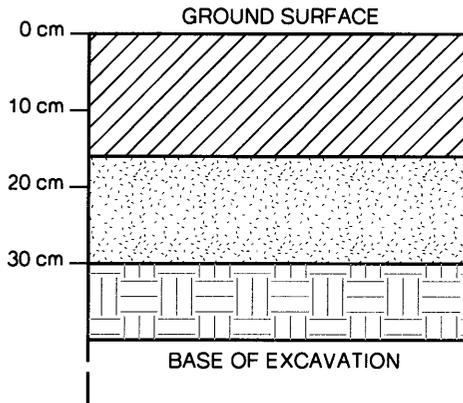
- Modern Fill** Loam mixed with bands of coarse sand and modern trash

- Ap** 10YR 3/3 Dark brown sandy loam.

- Bw** 10YR 7/1 Light gray sandy loam.

DELAWARE DEPARTMENT OF TRANSPORTATION	
S.R. 26 IMPROVEMENTS (CLARKSVILLE TO ASSAWOMAN CANAL) BALTIMORE HUNDRED SUSSEX COUNTY	
SOIL PROFILE SHOVEL TEST PIT N105 E135 SWM #3 TEST AREA	
FIGURE - 5	SKELLY AND LOY, INC. CONSULTANTS IN ENVIRONMENT - ENERGY ENGINEERING - PLANNING

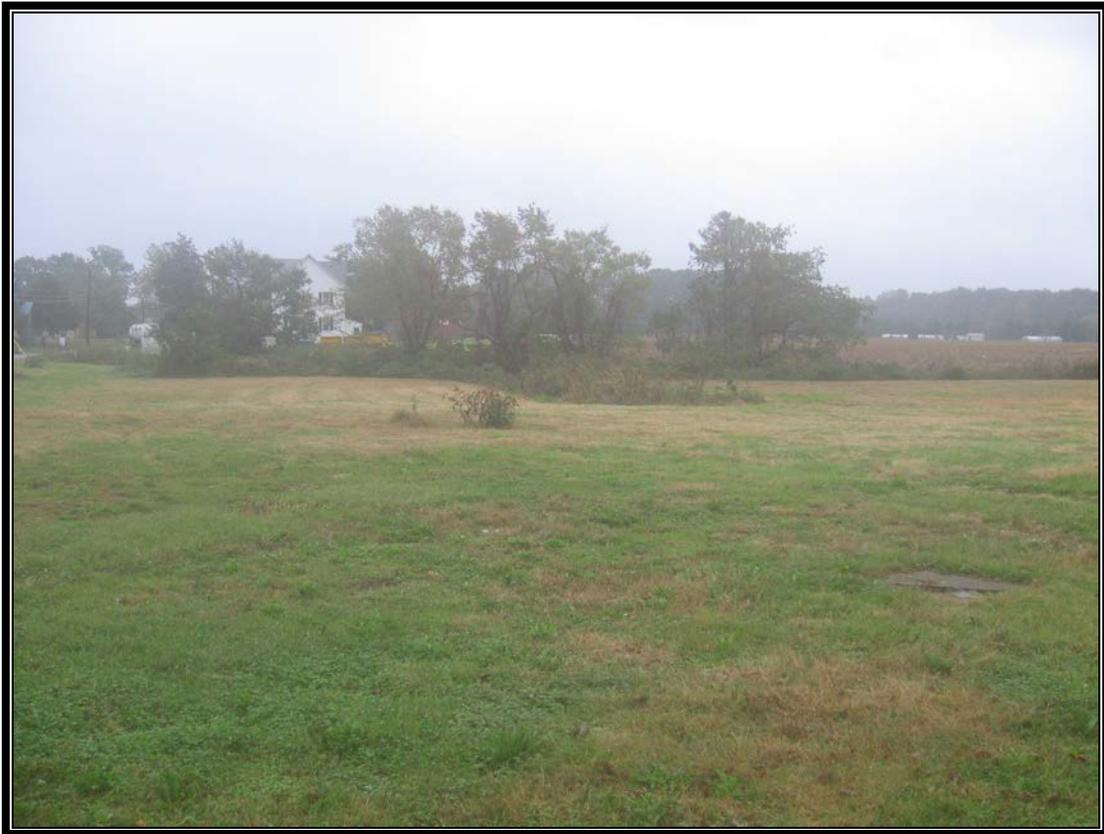
Photograph 5. General view of the grassy portion of the SWM #4 Test Area, facing southeast.

This stormwater management area was tested for the possible presence of archaeological resources (Photographs 5 and 6). Portions of the test area are disturbed or wet. Most of the test area is an agricultural field; however, the northwestern portion exhibits grasses. The soils are typical of upland coastal plain sediments. The profile of STP N165 E165, excavated within the central portion of this stormwater management area, is comprised of a brown (10YR 4/3) sandy loam plowzone (Ap horizon) underlain by a yellowish brown (10YR 5/8) sandy loam subsoil (Bw horizon) (Figure 6; Appendix A). As with other test areas, a few excavated profiles in the SWM #4 Test Area also exhibit redeposited modern fill over the natural soil profile, and a few profiles exhibit hydrated conditions in the lower levels of the Ap horizon. Despite the excavation of 67 STPs in the SWM #4 Test Area, no archaeological remains of any type were identified.

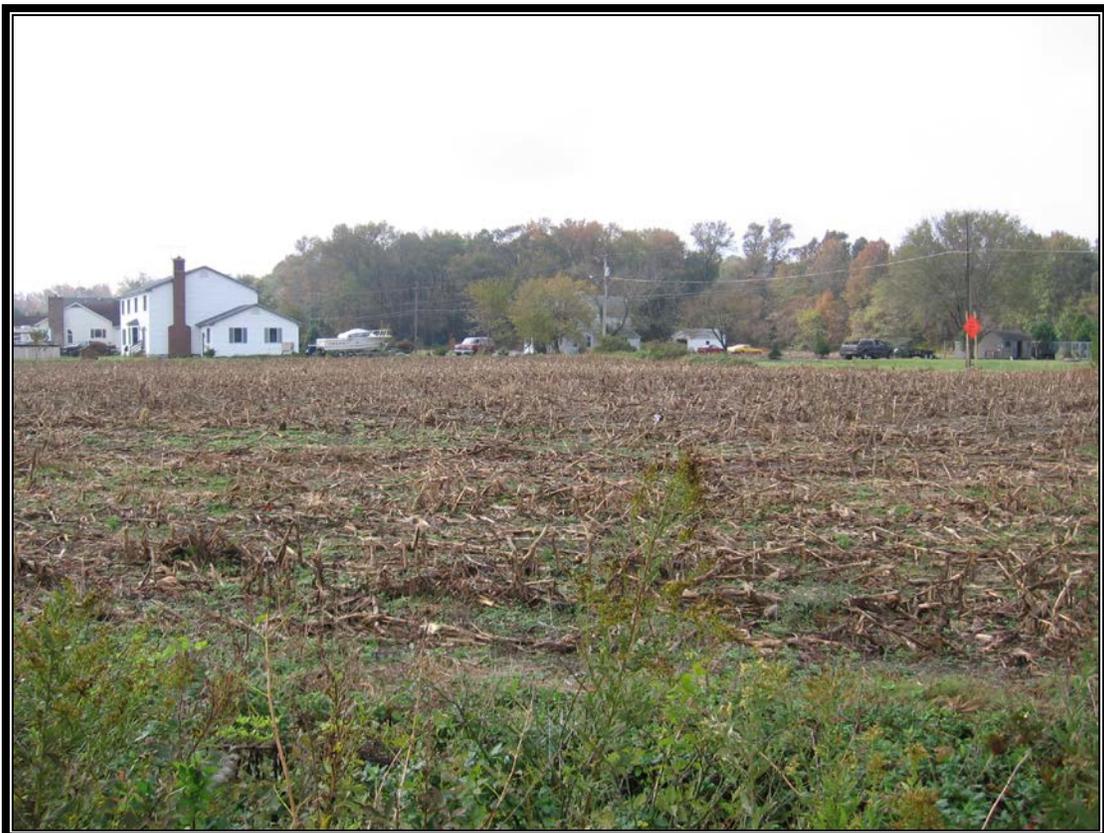
Photograph 6. General view of the agricultural field portion of the SWM #4 Test Area, facing south.

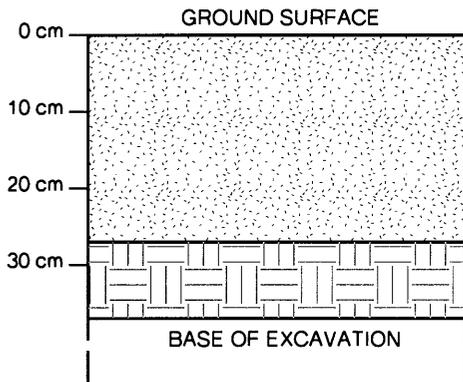
Ap 10YR 4/3 Brown sandy loam.

Bw 10YR 5/8 Yellowish brown sandy loam.

DELAWARE DEPARTMENT OF TRANSPORTATION	
S.R. 26 IMPROVEMENTS (CLARKSVILLE TO ASSAWOMAN CANAL) BALTIMORE HUNDRED SUSSEX COUNTY	
SOIL PROFILE SHOVEL TEST PIT N165 E165 SWM #4 TEST AREA	
FIGURE - 6	SKELLY AND LOY, INC. CONSULTANTS IN ENVIRONMENT - ENERGY ENGINEERING - PLANNING

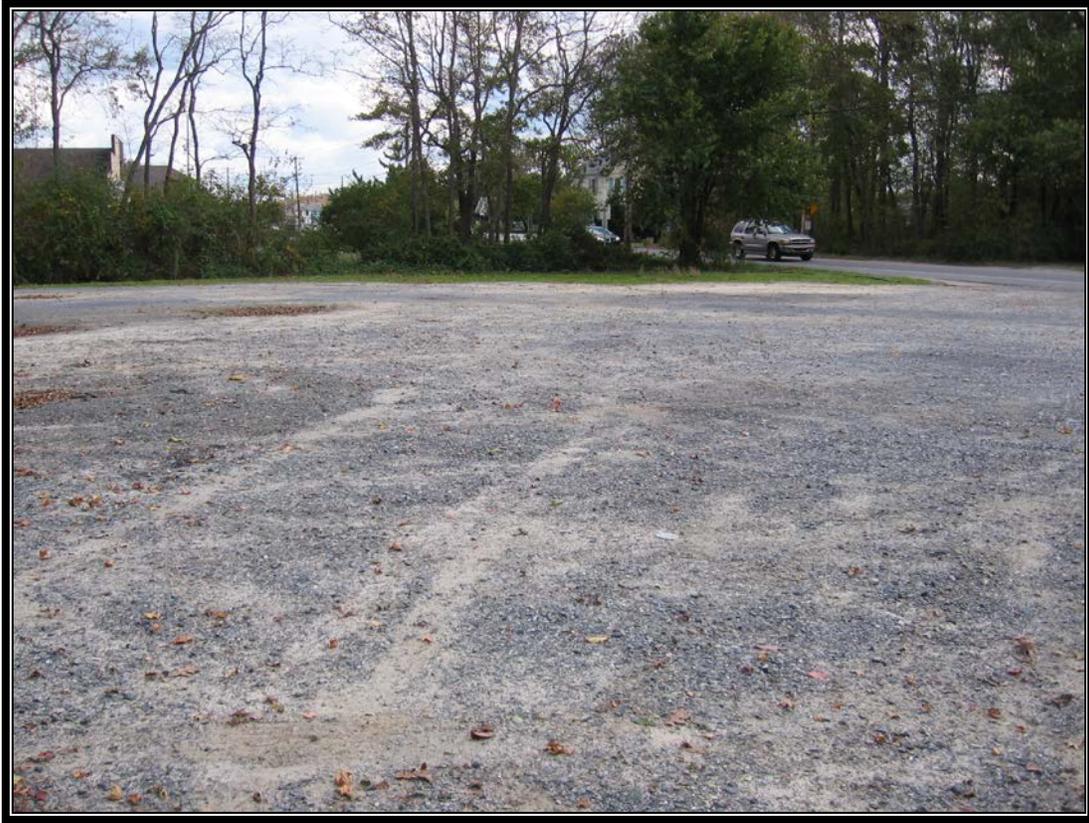
Photograph 7. General view of the disturbed gravel parking lot comprising the SWM #5 Test Area, facing southeast.

This test area is comprised entirely of a graded, compact gravel commercial parking lot; therefore, no STPs were excavated (Photographs 7 and 8).

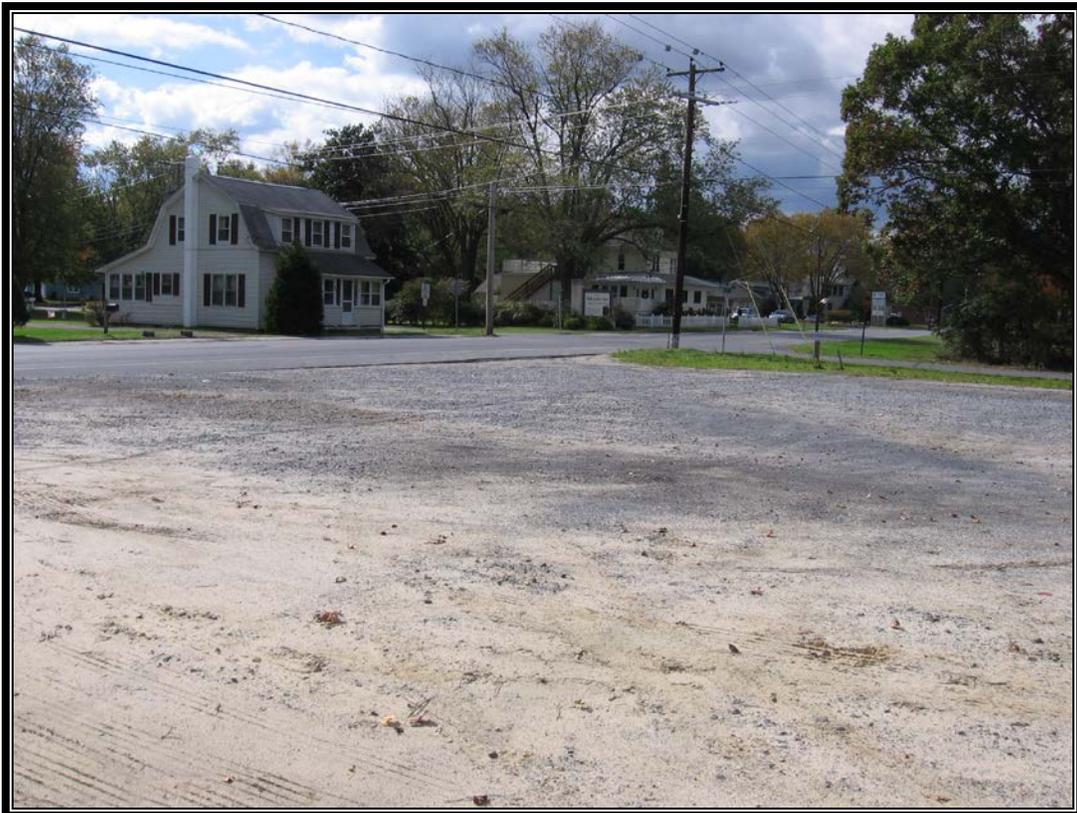
Photograph 8. General view of the disturbed gravel parking lot comprising the SWM #5 Test Area, facing southwest.
