**ARCHITECTURAL RESOURCES SURVEY
BRIDGE 376, STATE ROAD 54 IMPROVEMENTS**

Sussex County, Delaware

The Louis Berger Group, Inc.
East Orange, New Jersey

February 2000

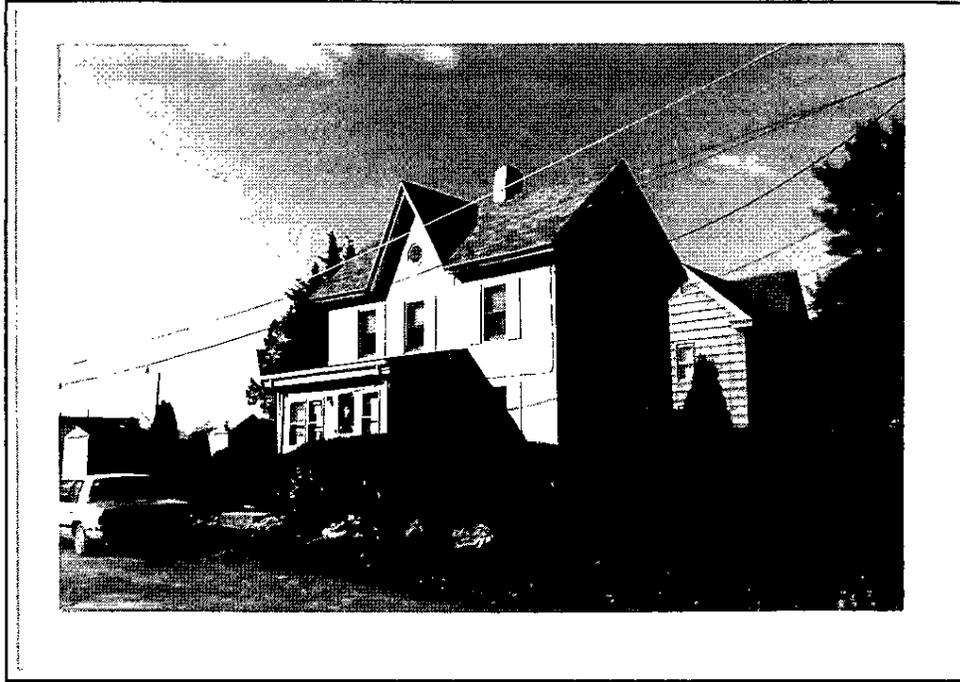
PLATE 1: Wilkerson Property (S-2243), House, Looking West

Description: The Wilkerson Property house stands on a low rise by the northwest corner of Main Street and Park Street, a small side street. It is a two-story, cross-gabled frame structure, clad in asbestos shingle and roofed with asphalt shingle. The concrete-block foundation probably represents a rebuilding of the original foundation, which may have lacked an excavated basement. Built on a single-pile rectangular plan with asymmetrical three-bay fenestration that suggests a hall-parlor interior configuration, the house has received

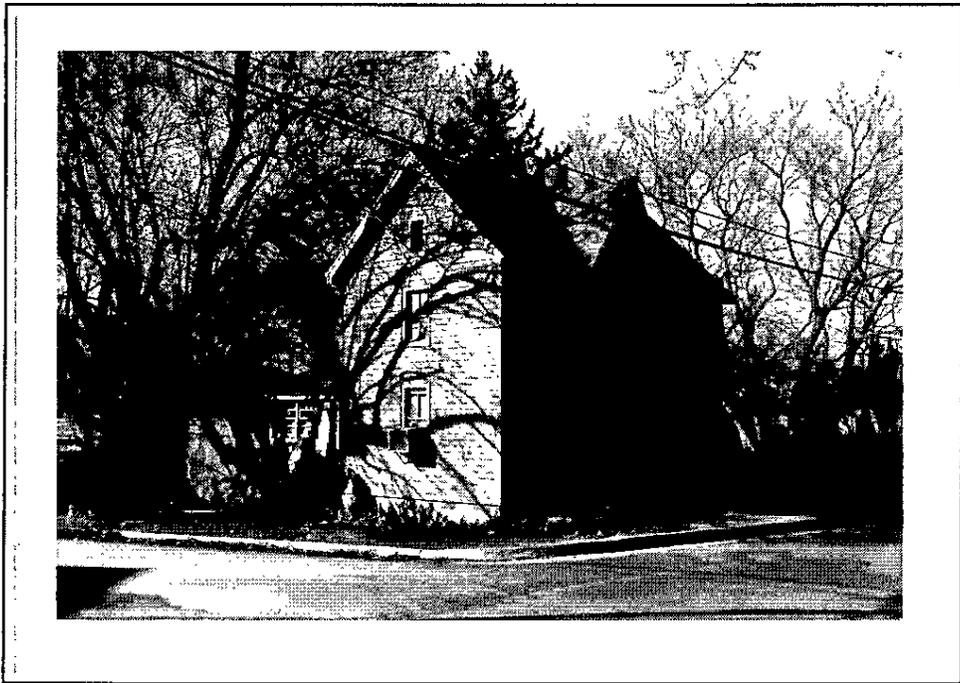
PLATE 2: Wray Property (S-2244), House, Looking West

Description: The house on the Wray Property is located on the northwest corner of Main and Hosier streets, facing east to Main Street. It is a two-story, cross-gabled frame structure set on a foundation of concrete block, clad in vinyl siding, and roofed with asphalt shingle. It is constructed on a T-shaped footprint with the one-story rear ell extending from an off-center position against the two-story main block. The principal or east facade is of three-bay symmetrical design with the entry at the center under the cross gable, indicating a probable center-passage single-pile plan for the main block. The first- and second-story window sash on the main block is of the two-over-two double-hung type and is apparently the original sash. A brick chimney

pierces the roof in an off-center position. The overhanging eaves are trimmed with a plain box cornice. Since the house was first surveyed in 1980, the original brick foundation has been replaced with one of concrete block, the front porch has been taken down, the clapboard has been replaced with vinyl siding, and the porch along the south elevation of the rear ell has been enclosed. There are no surviving outbuildings more than 50 years old on the property.

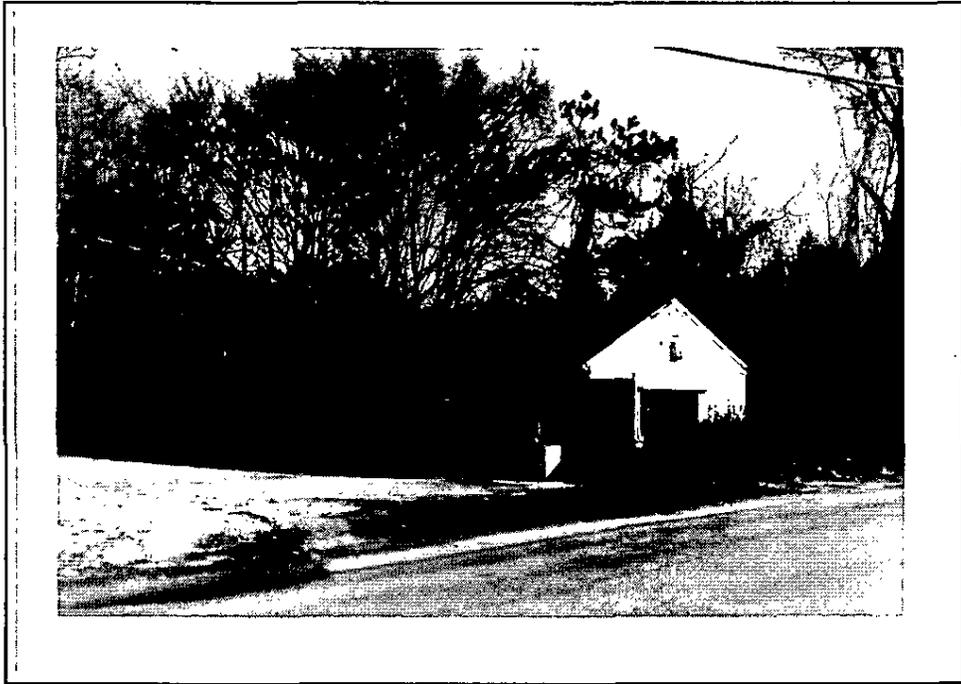
PLATE 3: Selbyville VFC Property (S-2248), Store Building, Looking East

Description: This commercial building is located on the east side of Main Street, standing just to the northeast of Bridge No. 376. It is a one-story, gable-roofed frame structure that is set on a foundation of poured concrete, clad in asbestos shingle, and roofed with asphalt shingle. Divided into two main interior spaces, the front or west portion is about twice the size of the east portion. The building is rectangular in shape with an inset principal entry at the northwest corner. The major window sash consists of three large single-pane display windows, one of these on the west end of the building and two on the north elevation. There are no outbuildings on the property.

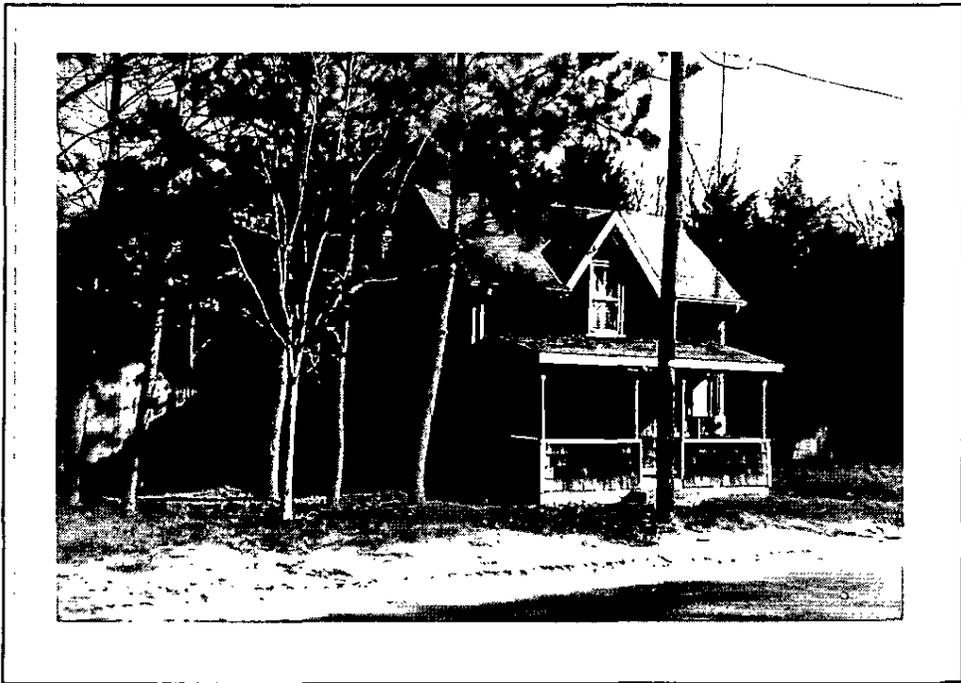
PLATE 4: Difranks Property (S-2249), House, Looking East

is set on a brick foundation, clad in wood shingle, and roofed with asphalt shingle. The original section of the building is constructed in a T-shaped plan with a one-and-a-half-story main block and one-story rear ell. The principal or west facade is of symmetrical three-bay design with the entry at the center under the cross gable. Garret windows are positioned in each of the main block's three gables, with two in the north end gable and one in each of the other gables. The window sash in the original section is of the two-over-two double-hung type. Two brick chimneys rise through the roof, one in an interior end position at the north end of the main block, the other one central to the rear ell. The front porch was rebuilt circa 1940 with a foundation of poured concrete, but retains the four slender turned posts and wooden shirting wall of its earlier design. Other alterations include the addition of a leanto along the south side of the ell, probably dating to the 1920s, judging from the 1932 Sanborn map and the 1980 survey form; recladding of the walls in cypress shingle, also carried out in the 1920s, according to the 1980 survey form; and the addition of a bathroom in a bay projecting from the north side of the ell, at some date between 1932 and 1958, judging from Sanborn maps (see Figures 3 and 4). There are no surviving outbuildings more than 50 years old on the property.

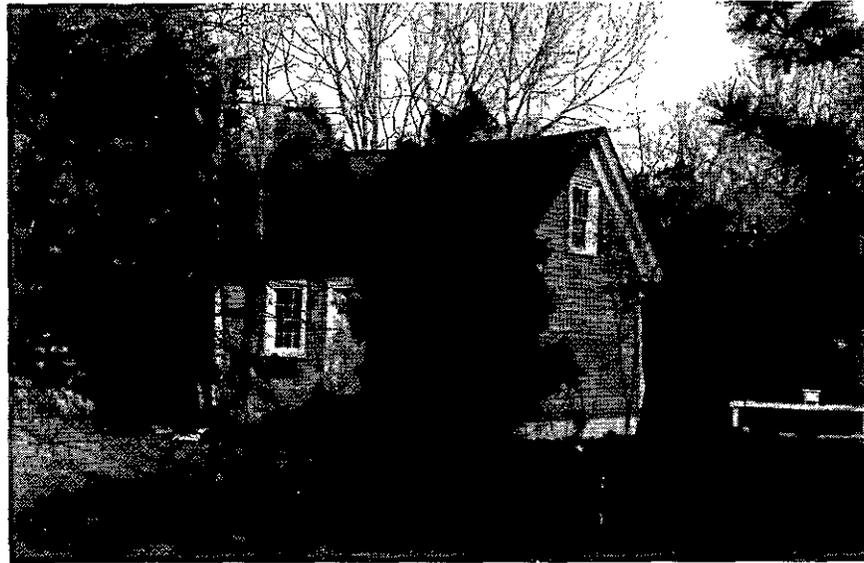
PLATE 5: Lynch Property, Lemuel Brasure House (S-2314), Looking North

The 1871 Lemuel Brasure House (S-2314) is a small, rectangular, gable-roofed frame dwelling, just one room in plan and one story in height, set on a new foundation of concrete block that is faced with brick on the front or west facade. The house is clad in weatherboard, probably partially the original board, and roofed with asphalt shingle. The symmetrical principal facade has a center entry, fitted with a rail-and-stile door with four panels, flanked by two windows. On the rear or east facade there is only one window, on the north side of the centrally positioned entry. The gable-end windows are at the garret level, two in the north end and one in the south end. All the window sash is of the six-over-six double-hung type. The cornice for the overhanging eaves consists of a plain board soffit trimmed with a simple molding.

twice, has had its foundation replaced with modern materials, and has had its chimney taken down, it still retains its form and evidently most of its original fabric, as does the kitchen building. Hence the Brasure House and its freestanding kitchen demonstrate the integrity of design, materials, and workmanship necessary to represent their historic significance. The moving episodes have both taken place within the half-acre parcel; in fact, the last move returned the house to a position approximating its original relationship to the street, so the house's integrity of location is therefore adequate.

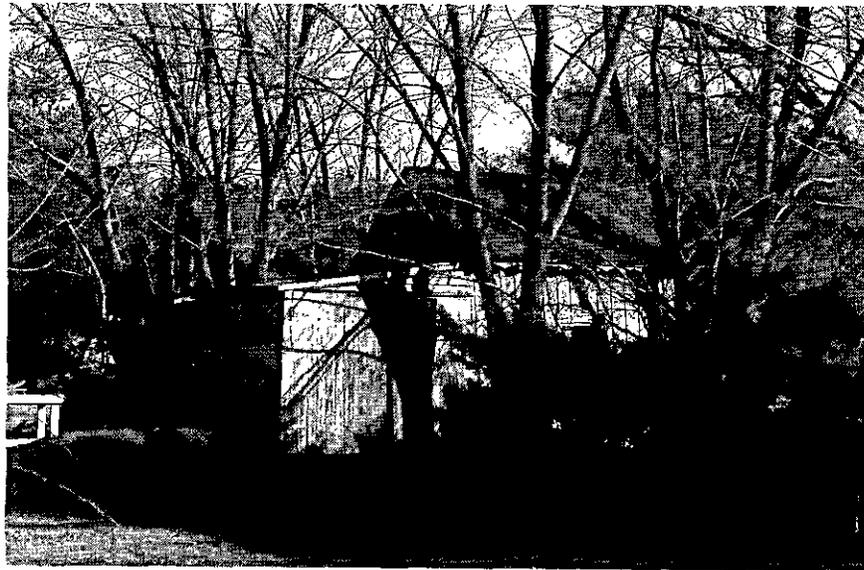
PLATE 6: Lynch Property, Lemuel Brasure House (S-2314), Kitchen Building, Looking East

Description: The Lynch Property is located on the east side of Main Street and just north of the intersection with Hosier Street. Three buildings are located on the parcel: the original Lemuel Brasure House (S-2314), built in 1871; a kitchen building, evidently constructed at the same date or soon afterward to provide additional space for domestic work; and the larger Edward L. Brasure House (S-2250), built in 1913 to replace the older house as the family's main dwelling. The lot is of rectangular shape, 115 feet by 193 feet, with the shorter dimension fronting on Main Street. The 1913 Edward Brasure House is situated on the southwest corner of the lot, standing in the position originally occupied by the 1871 house. When the larger house was built, the original house was moved about 100 feet to the rear, so that the 1913 house, the kitchen building (which evidently has always remained in its original auxiliary position), and the 1871 house were positioned in a line extending from the front of the lot straight back toward the rear. At some date since 1980, however, the 1871 house was moved again in the process of restoration; hence today the 1871 house is situated approximately 60 feet northeast of the 1913 house and set back about 50 feet from the street. The kitchen building stands about 30 feet behind the 1913 house.

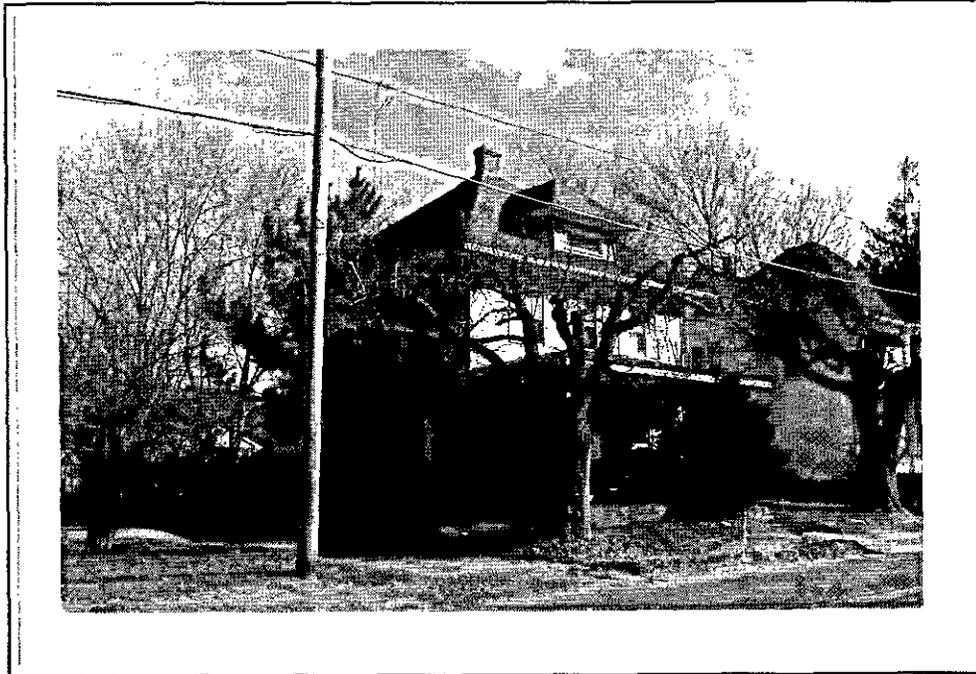
PLATE 7: Lynch Property, Edward L. Brasure House (S-2250), Looking East

The Edward L. Brasure House (S-2250) of 1913 is a two-and-a-half-story frame four-square house, with the square shape and pyramidal roof that are emblematic of that type. It is set on a foundation of rockface concrete block, clad in vinyl siding, and roofed with asphalt shingle. The principal or west facade has two bays on the first floor and three on the second, with the principal entry to the south and a bay window to the north. A two-story bay window structure is situated toward the east end of the north facade. The first- and second-story window sash is of the one-over-one double-hung type. A hip-roofed dormer is set on the front roof slope, fitted with a five-light transom window. A brick chimney pierces the peak of the roof. The widely overhanging eaves are without adornment. The hip-roofed porch is evidently of the original wooden construction, but its original railing has been removed along with the wire screening and supporting uprights that were present when the house was surveyed in 1979. According to the 1932 Sanborn map, the one-story leanto that extends across the rear of the house had been built by that date.

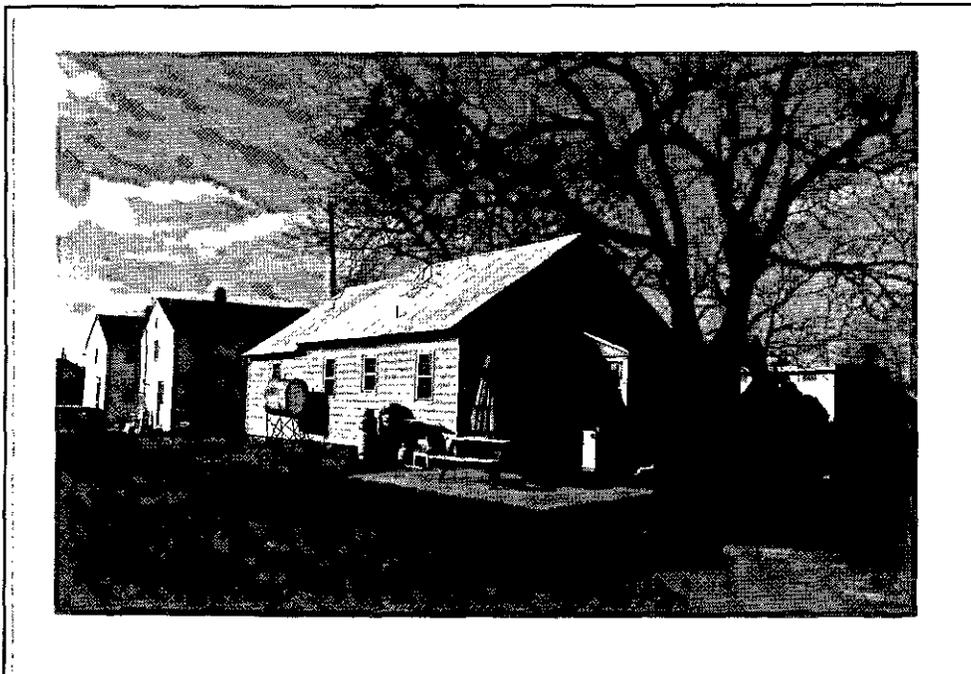
PLATE 8: Pepper Rental Property (S-9203), House, Looking West

Description: The Pepper Rental Property house is situated on the south side of Park Street, standing about 150 feet west of Main Street. The house is a one-story, gable-roofed frame structure that is set on a foundation of concrete block, clad in composition board, and roofed with standing-seam metal. The original section faces north toward Park Street, its three-bay facade organized symmetrically with the principal entry in the center. A concrete stoop serves as a front porch. An addition of unknown date extends to the west, also one story in height but with a roof lower than that of the original section. A shed-roofed enclosed side porch is set against the east end of the house. A brick chimney rises through the roof ridge in an internal position situated toward the east end. The window sash is of the six-over-six double-hung type, except for those on the north or principal facade, which are larger and of eight-over-eight double-hung design. There are no outbuildings on the property. In terms of style, the original section of the house represents a simple cottage rendition of the Minimal Traditional style, a common form for small houses in the eastern United States from the late 1930s through the early 1950s.

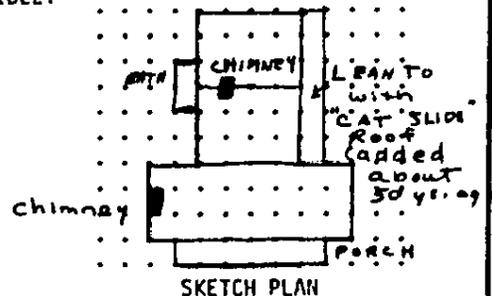
3. CONDITION: good _____ deteriorated _____
 remarks: In process of being renovated
4. INTEGRITY: a) original site b) moved _____
 c) if moved, when and from where _____

d) list major alterations and dates (if known) Lean to porch added to south side about 50 yrs ago; bath room added to north wall; cypress shingled walls over rough heart of pine siding added about 50 yrs ago; front porch screened about 40 yrs ago; unknown three layers of shingles on roof

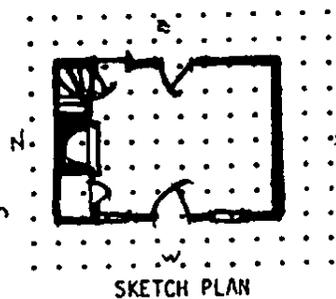
Chimney has been removed and lower half of N. end filled in with clapboards different from upper half indicating an exposed - base brick chimney.

two windows on N. end upstairs 3/4
one window on S. end upstairs 1/6
