4.0 RESULTS

4.1 Stormwater Management Swale 1

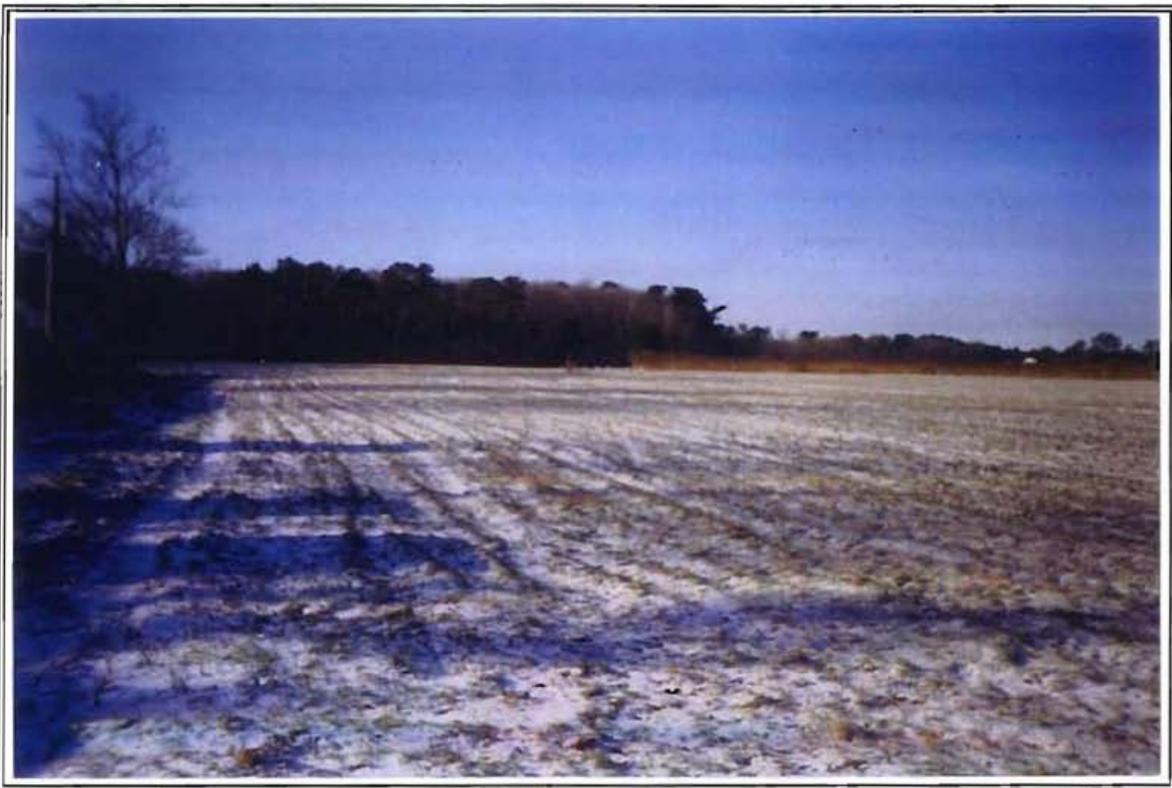
Photograph 1. View of Stormwater Management Swale 1 proposed location, facing west.

Stormwater Management Swale 1 is the easternmost of the two proposed swales. It begins on the south side of existing S.R. 54 approximately 45.7 m (150.0 ft) west of the intersection of Bayville Road with S.R. 54, and trends in a southwest direction for approximately 201.2 m (660.0 ft) (see Figure 2). The proposed swale location is an open agricultural field, and a ditch, which will be enlarged, already exists in the location (Photographs 1 and 2).

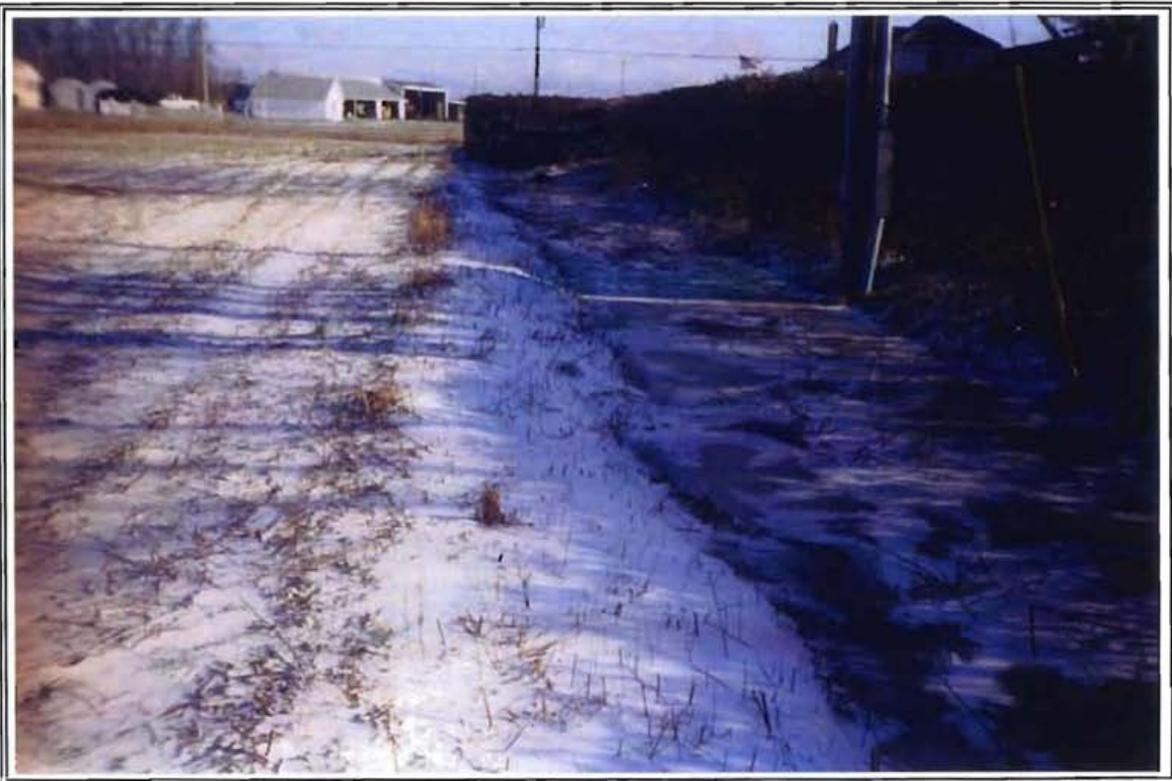
Photograph 2. View of Stormwater Management Swale 1 proposed location, facing south.

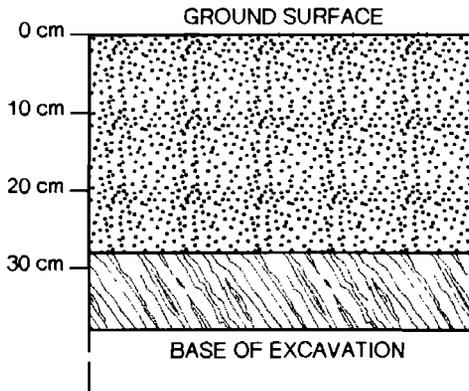
SOIL PROFILE SHOVEL TEST PIT 1-2

Ap 10YR 3/3 Dark brown sandy loam.

Bw 10YR 5/4 Yellowish brown sandy loam.

A total of 13 STPs was excavated along the existing ditch within the proposed location of Stormwater Management Swale 1. The excavated STP profiles exhibited two natural strata and some hydrated soils, implying some drainage restrictions (Figure 3). No archaeological remains of any type were identified during the Phase I survey within the proposed Stormwater Management Swale 1 location.

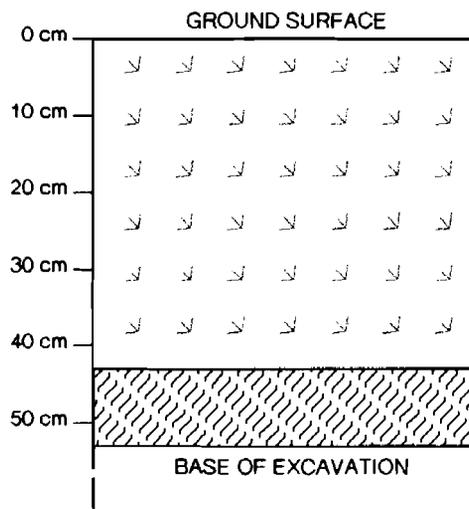
SOIL PROFILE SHOVEL TEST PIT 1-11

Ap 10YR 3/3 Dark brown loam.

Bw 10YR 5/1 Gray sandy loam, with common
10YR 5/4 Yellowish brown mottles.

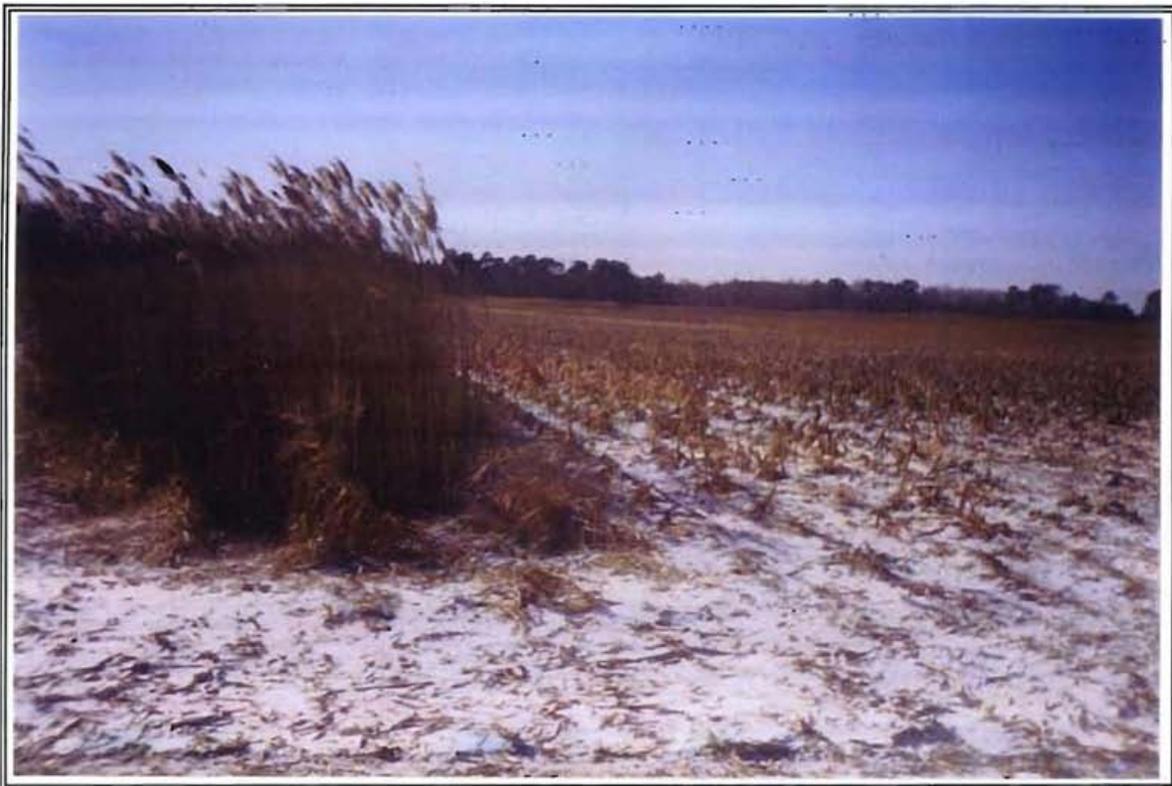
Photograph 3. View of Stormwater Management Swale 2 proposed location, facing north.

Stormwater Management Swale 2 is located west of the Stormwater Management Swale 1 location. Stormwater Management Swale 2 begins on the south side of existing S.R. 54 approximately 128.0 m (420.0 ft) east of the intersection of Laws Point Drive with S.R. 54, and trends in a southwest direction for approximately 420.0 m (1,378.0 ft) (see Figure 2). The proposed swale location is an agricultural field once planted in corn, and a ditch, which will be enlarged, already exists in the location (Photographs 3, 4, and 5).

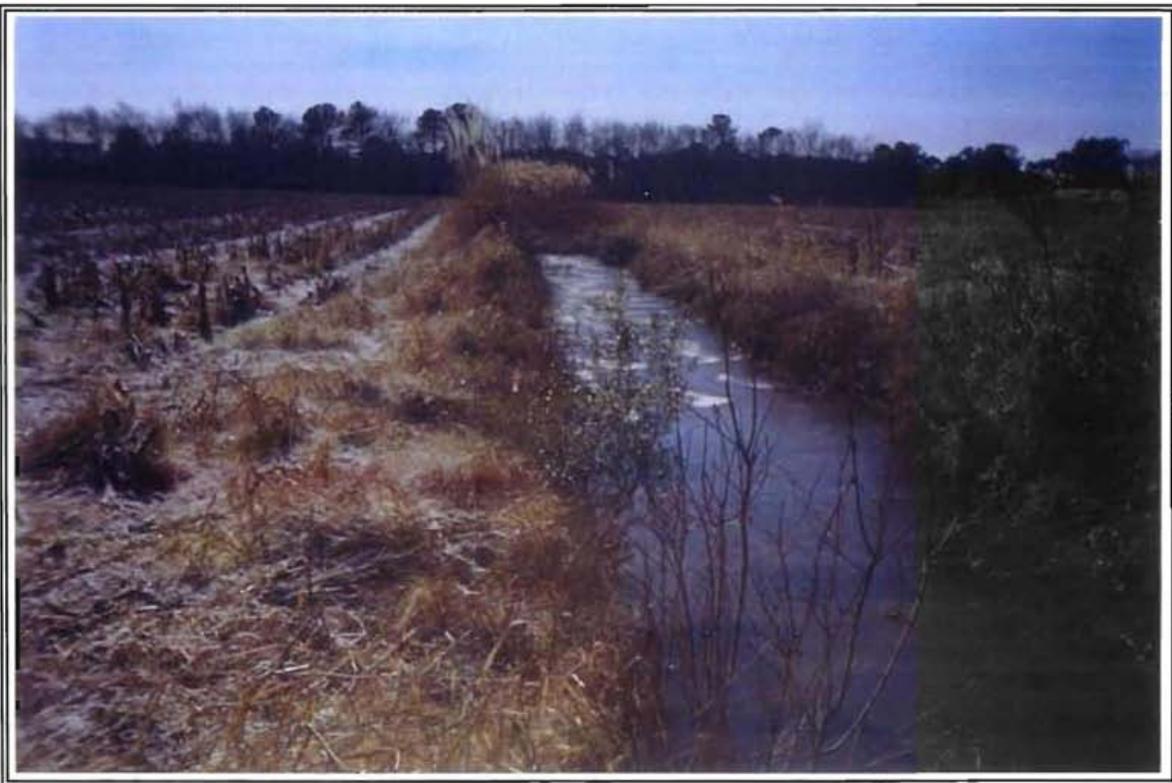
Photograph 4. View of Stormwater Management Swale 2 proposed location, facing north.

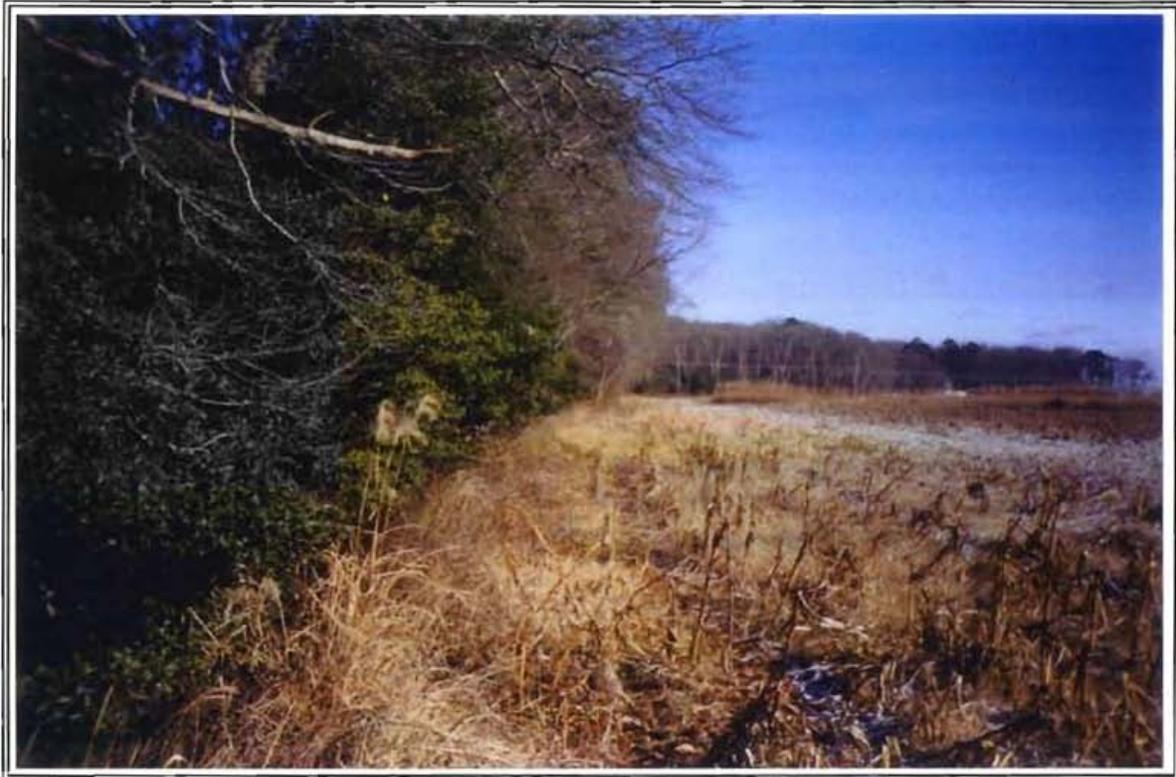
Photograph 5. View of Stormwater Management Swale 2 proposed location along tree line, facing south.

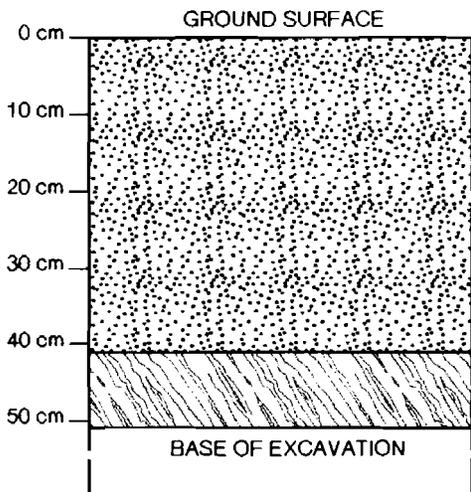
SOIL PROFILE SHOVEL TEST PIT 2-5

Ap 10YR 3/2 Very dark grayish brown sandy loam.

Bw 10YR 5/4 Yellowish brown sandy loam.

A total of 28 STPs was excavated along the existing ditch within the proposed location of Stormwater Management Swale 2. The excavated STP profiles exhibited two natural strata and some hydrated soils, implying some drainage restrictions (Figure 4). No archaeological remains of any type were identified during the Phase I survey within the proposed Stormwater Management Swale 2 location.

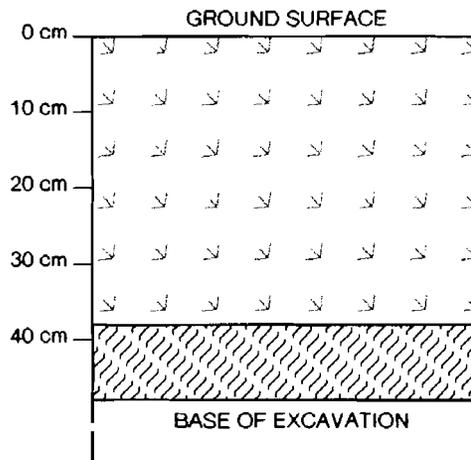
SOIL PROFILE SHOVEL TEST PIT 2-27

Ap 10YR 3/2 Very dark grayish brown sandy loam.

Bw 10YR 5/1 Gray sandy loam.
