IV. RESULTS

HISTORIC ARCHITECTURE

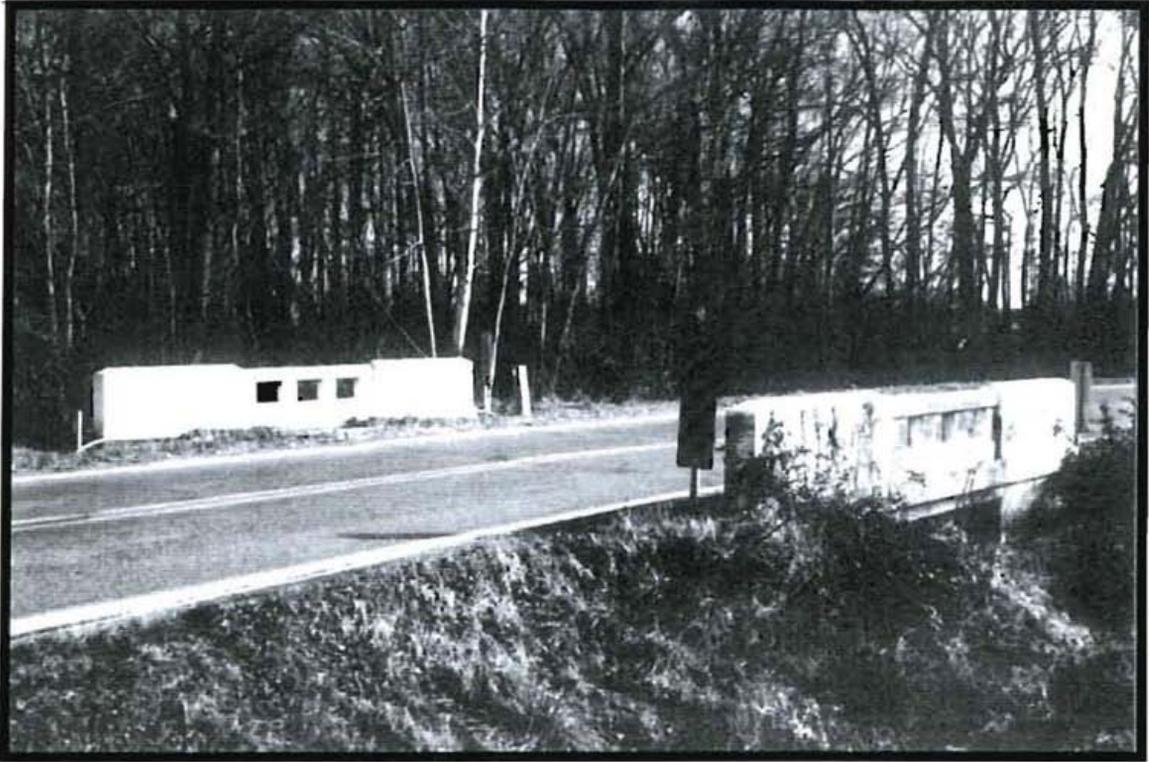
Plate 1 Bridge 447A, View Looking Southeast

Bridge 447A was identified by an imprint of its designated number located on the northwest corner of the west wing wall. The bridge carries Fleming's Landing Road (State Route 9, formerly Road 449) across a shallow tributary of Cedar Swamp (Plate 1). The bridge, constructed in 1934 or 1935, is a single span reinforced concrete slab structure supported on concrete abutments with nearly parallel wing walls. The bridge is 23 feet in length, with a span of 8 feet, 4 inches, and an overall height of about 9 feet. The stream that the bridge spans is confined in a gravel base culvert with sloping sides, which obscure the bridge's concrete abutments. The bridge is 30 feet wide at the northern end and 32 feet at the southern end to accommodate a curve in the road, setting the two sides of the bridge slightly out of parallel alignment.

The bridge span is marked by a balustrade with three rectangular openings between plain squared concrete balusters beneath a flat top rail. The wing walls flanking the balustrade are 7 feet, 4 inches each in length with chamfered top corners and one inset diamond each on the exterior walls. Currently painted white, Bridge 447A was designed to handle a 20-ton truckload

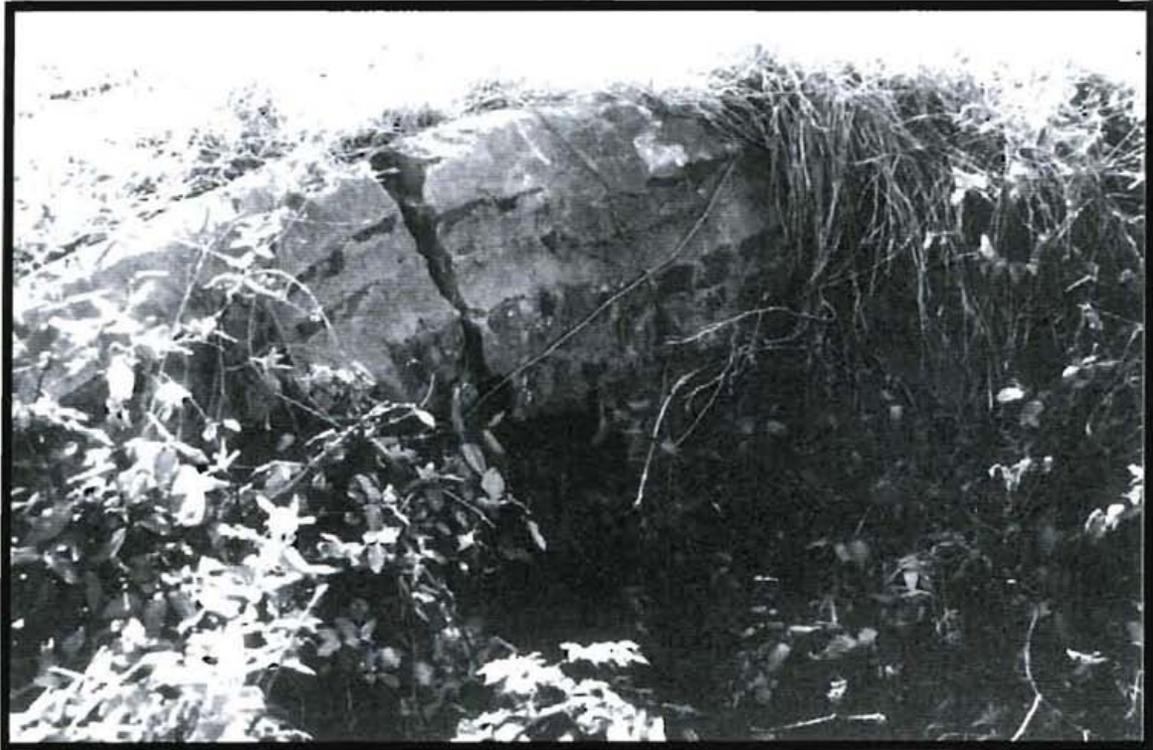
Plate 2 Brick Culvert, View Looking North

The bottom of the culvert was inaccessible, but appears to be of poured concrete. The culvert's arch, which supports the gravel driveway, is constructed of brick roughly pointed with a cement mortar (Plate 2). The inferiority of the construction indicates that a trained mason probably did not build the culvert. Again, the property owner more likely built the culvert to ease transit from Fleming's Landing Road over a drainage ditch to the main house and outbuildings.

The brick culvert is a utilitarian structure likely constructed by the homeowner whose driveway it conveys over a drainage ditch. The construction date is difficult to determine due to the culvert's utilitarian nature and lack of identifiable style or construction technique; its condition and materials, however, indicate that the culvert was probably constructed between 1930 and 1945. The culvert, located just south of the intersection of Fleming's Landing Road and Taylor's Bridge Road, carries a driveway over a drainage ditch—as mentioned above—that parallels Fleming's Landing Road (see Figure 2).

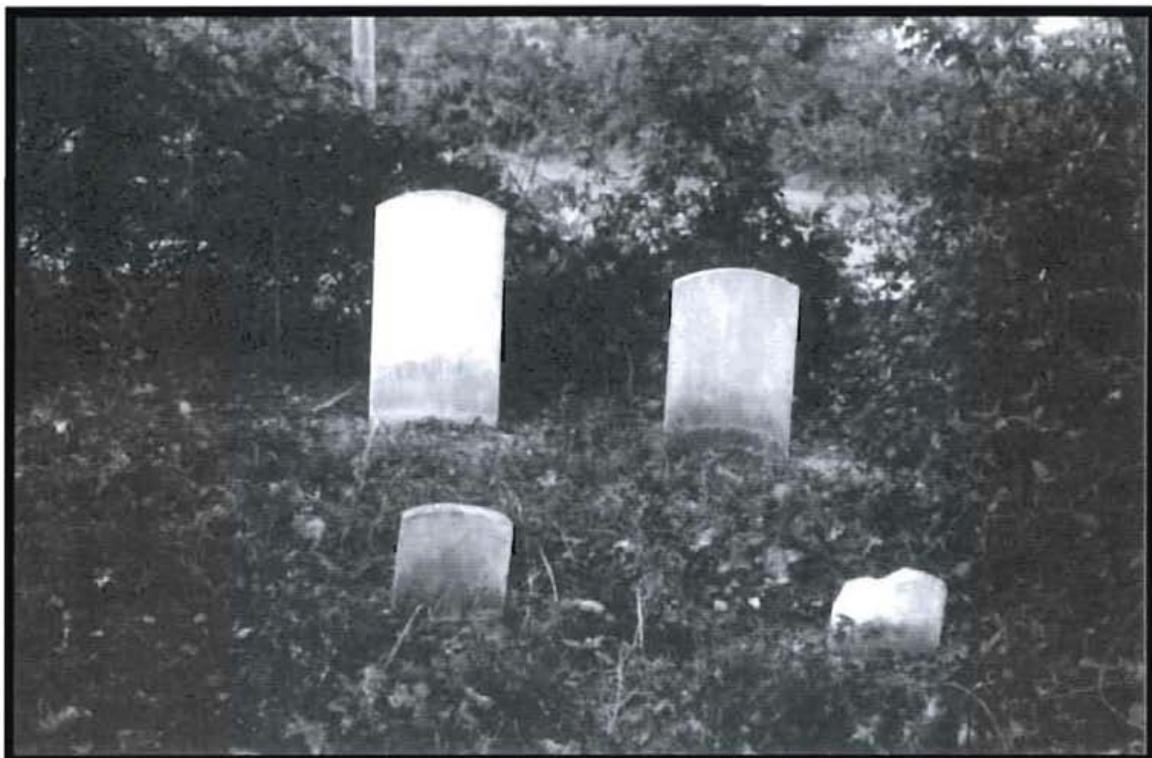
Plate 3 Section I, Head and Footstones of Jeremiah and Judith "Cales"

Section I – East Area. Section I is located directly across State Route 9 from Section H. Two head and footstones belonging to Jeremiah Cales (d.1879) and Judith Cales (d. 1868), previously identified, are located six meters off the edge of the road and approximately 50 meters south of the Bridge 447A (Plate 3) (Figure 9). The area, which is very heavily overgrown, was cleared of under brush; no other grave features were identified in close proximity to those already found. The inscription on the first tombstone reads, “Our Mother – Judith Cales – Died November 19th, 1868 – Aged 69 Years” (Plate 4). The second is inscribed, “Our Father-Jeremiah Cales – Died October 18th, 1879 – Aged 76 Years” (Plate 5).

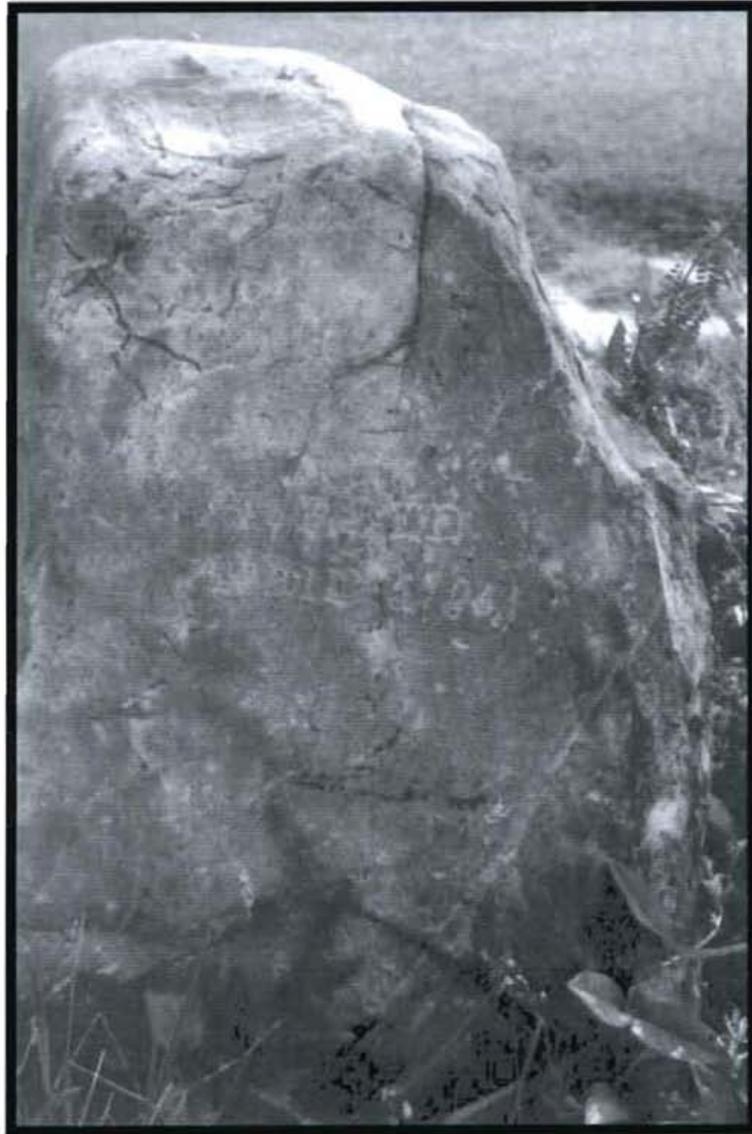
Plate 7 Section J, Property Marker, View Looking East
(the Stone Reads: "A. Reed April 5 1861")

Section J – Southeast. The southeast corner of this intersection is the location of a historic stone property marker (Figure 10). The marker is engraved on two sides: the west facing side reads “A. REED APRIL 5, 1861” (Plate 7), and the north side is engraved, “F. COOPER” (Plate 8). The property marker was recorded with black-and-white photographs and rubbings.
