**S-11910. Dwelling, 17991 Redden Road**  
**(PIN: 135-6.00-20.00)**  
**(Detail Map #5)**

**S-11911. Dwelling, 18953 Redden Road  
(PIN: 135-6.00-15.00)  
(Detail Map #5)**

**S-11912. Dwelling, south side of Redden Road  
(PIN: 135-6.00-10.00)  
(Detail Map #5)**

**S-12177. Appenzellar Tract, U.S. 113**  
**(PIN: 230-19.00-32.00 and 230-19.00-104.00)**  
**(Detail Map #1)**

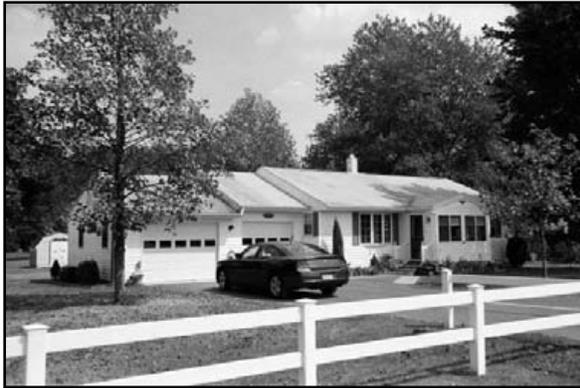
S-11910

The c. 1960, one-story, side-gabled dwelling (.001) faces west. The façade measures five bays wide, and sidewalls three bays deep. A small, gabled enclosed entry extends from the center of the façade, sheltering the main entrance. A secondary entrance is located within another centralized enclosure that extends from the rear. Casement and six-over-six, double-hung vinyl sash windows pierce all sides of the house, lighting the interior. One addition extends from the northern end of the dwelling, a gabled, one-car garage. The house rests on a concrete-block foundation. Its exterior walls are clad in vinyl, and the rooftops are sheathed in asphalt. A concrete-block chimney rises from the center, interior of the roof ridge.

main building (.001) façade and north side, view to SE

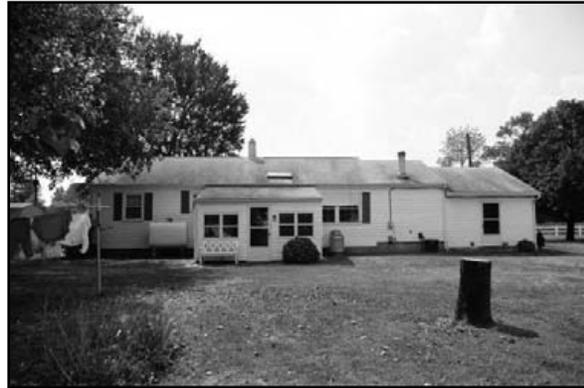
main building (.001) rear, view to W

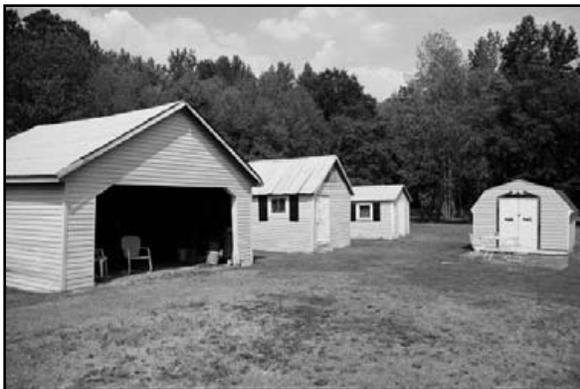
Northeast of the house stands three, wood-framed, mid-twentieth-century, one-story outbuildings: a garage, workshop, and shed. The garage (.002) is clad in vinyl and sheltered by a gabled-front roof covered in asphalt. Its façade features a single, large-bay opening. The workshop (.003) is also clad in vinyl and is sheltered by a gabled-front roof sheathed in corrugated metal. A modern, fiberglass door pierces the façade, and replacement bays pierce the sidewalls. Lastly is the shed (.004). Like the other two buildings, it too is completely clad in vinyl and is sheltered by a gabled-front roof covered in metal. A plain wood door pierces the façade, and fixed, wood-framed windows pierce the sidewalls and rear. Though not confirmed, these outbuildings are believed either to have been moved to their present locations or, to be the remnants of a former farm property (a former farmhouse stands on the adjacent property). It does not appear that they are visible on the 1937 or 1962 aerial photographs, but the resolution of neither image is adequate to be certain.

left to right: garage (.002), shed/workshop (.003), shed (.004), and modern shed, view to NE

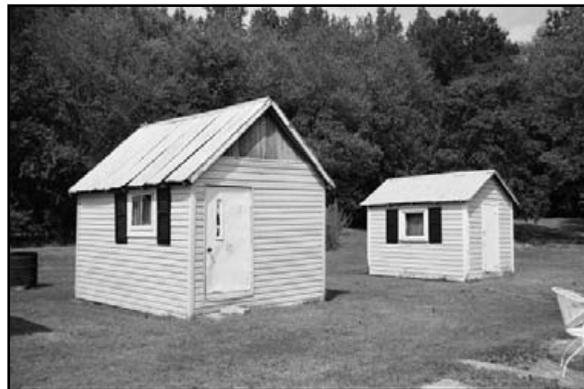
left to right: shed/workshop (.003) and shed (.004), view to NE

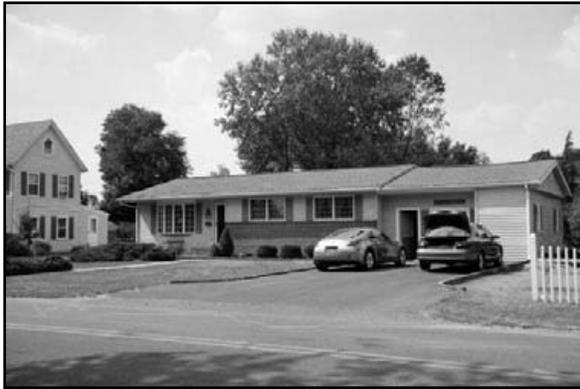
**S-11911**

The c. 1960, one-story, side-gabled dwelling faces south. The main entrance is off-center, toward the west end of the façade, sheltered by a slightly inset entry with brick stoop. A secondary entrance is located toward the eastern end of the façade within a suspected addition or former garage. Centered along the rear wall is yet a third entrance into the house. Replacement casement and six-over-six, double-hung vinyl sash windows appear on all sides of the house, lighting the interior. A large gabled addition extends from the northwest corner of the rear wall featuring a shed-roofed screened porch across its east wall. A modern, open, wood deck further extends east from the porch. The house rests on a concrete-block foundation and is clad in both vinyl and brick veneer. The gabled rooftops are sheathed in asphalt. Two brick chimneys rise from the home, one center, interior of the rear roof slope, and one from the exterior of the addition's gabled-end.

main building (.001) façade and east side,  
view to NW

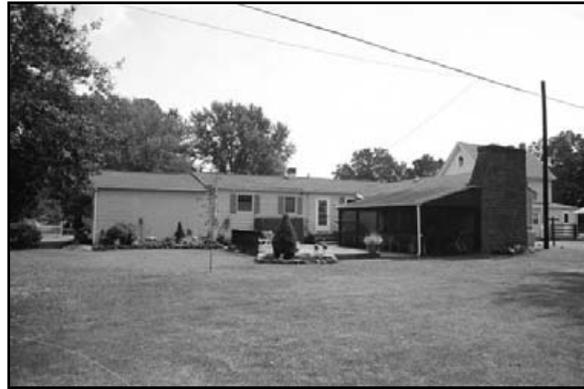
main building (.001) rear, view to SW

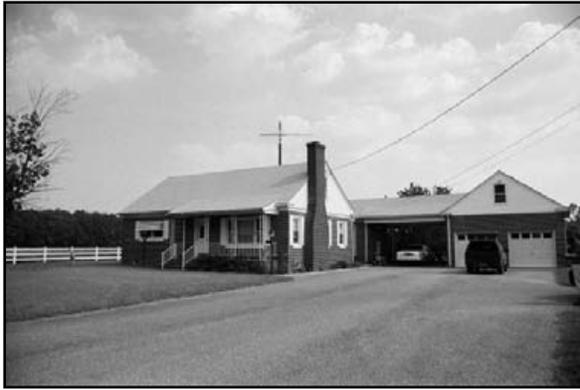
S-11912

The c. 1940s, one-and-one-half-story brick dwelling faces north. The façade features a centralized main entrance sheltered by a slightly inset porch, supported and trimmed by iron railing. Two secondary entrances also exist, one within the rear gabled ell, and one within a rear patio area along the west side of the house. A combination of four-over-four wood-sash and six-over-six vinyl-sash, double-hung windows light the interior. Vinyl, non-functional shutters flank each opening. Additions include a gabled hyphen, which extends west from the rear gabled ell and attaches to the property's two-car, gabled-front garage (.002). All architectural elements of the garage (style, massing, materials) match those of the house. Overall, the house is believed to rest on a concrete-block foundation covered by brick veneer, same as that covering the exterior walls. The side-gabled roof is sheathed in asphalt, and features boxed cornices and two brick chimneys. One chimney rises from the center of the exterior of the west gabled end of the main block of the house, and the other from the center of the exterior of the rear of the garage.

main building (.001) façade and west side, view to SE

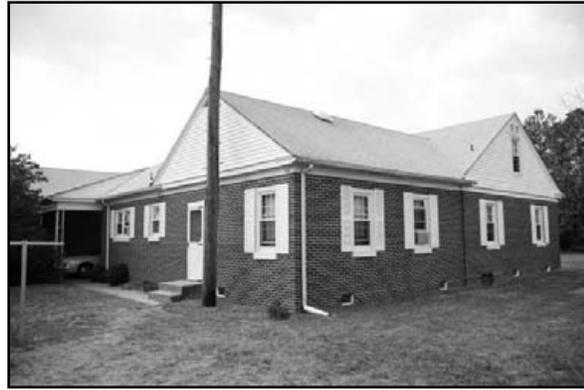
main building (.001) rear and east side, view to NW

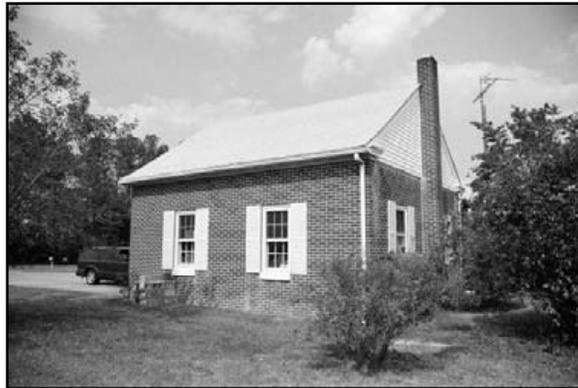
main building (.001), attached garage rear and west side, view to NE

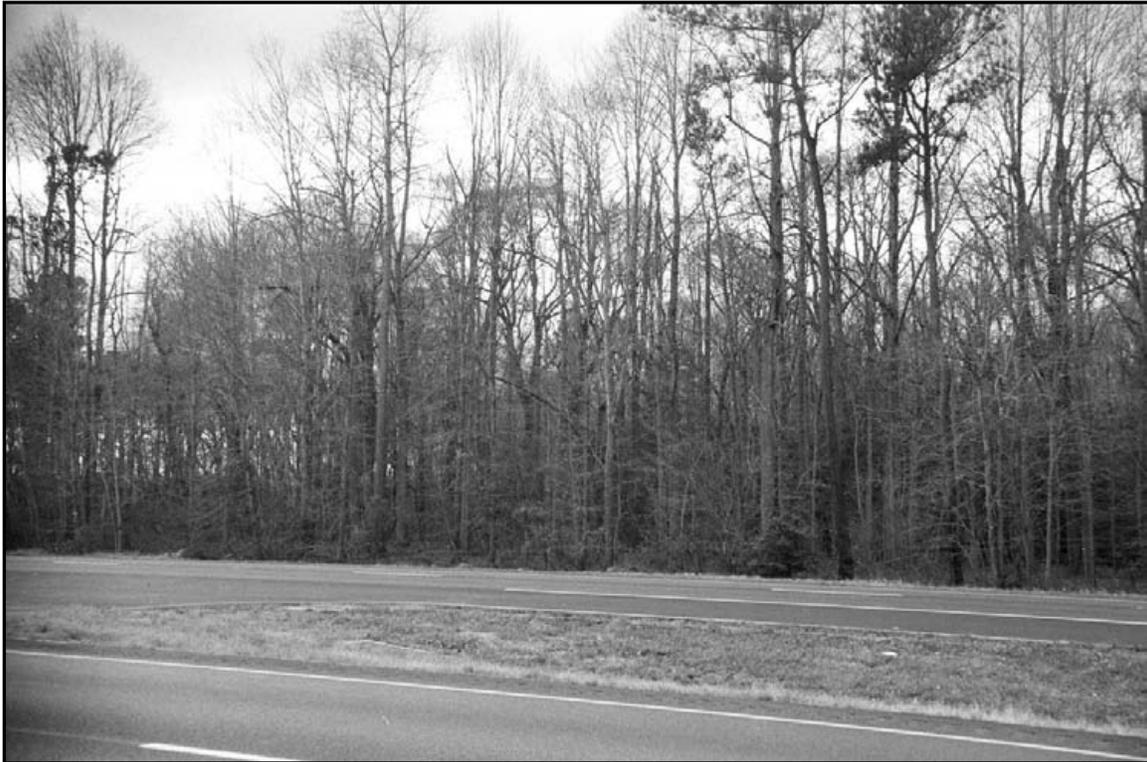
S-12177

Stand #2 (49.1 acres) is located west of U.S. 113 and south of Staytonville Road. The stand contains scattered loblolly and Virginia pine but is primarily upland red and white oak species, hickory, yellow-poplar, maple and gum. The stand was established in 1910. A small portion of this stand adjacent to U.S. 113 appears to have been part of the original Appenzellar Tract, acquired by the state in 1928. The remainder of the stand was purchased in 1968 from Harry Frankel.

Appenzellar Tract, Stand 2, mostly deciduous hardwoods on the west side of U.S. 113, view to W

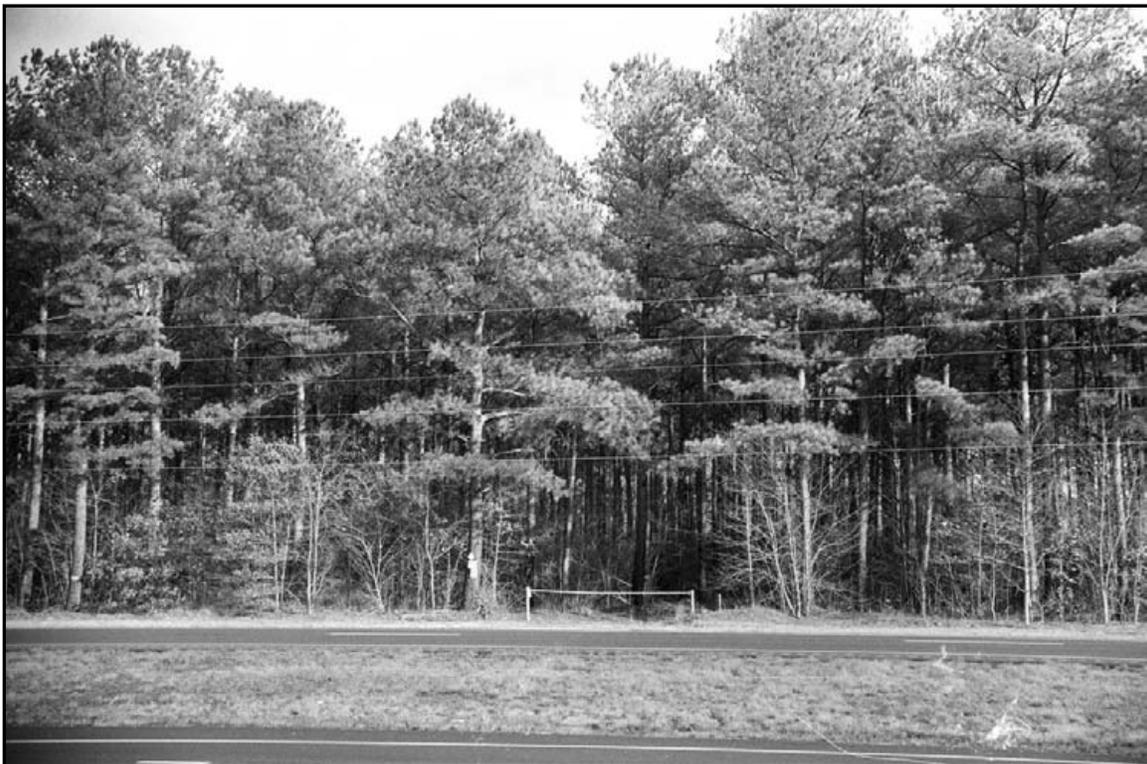
Stand #5 (16.2 acres) is a loblolly pine demonstration site consisting of two sites separated by a stream corridor. The southern portion of the stand was part of the original Appenzellar Tract, acquired by the state in 1928, while the northern portion of the stand was acquired after 1957. The stand of trees was established in 1968.

Appenzellar Tract, Stand 5, a loblolly pine demonstration site on the east side of U.S. 113, view to E

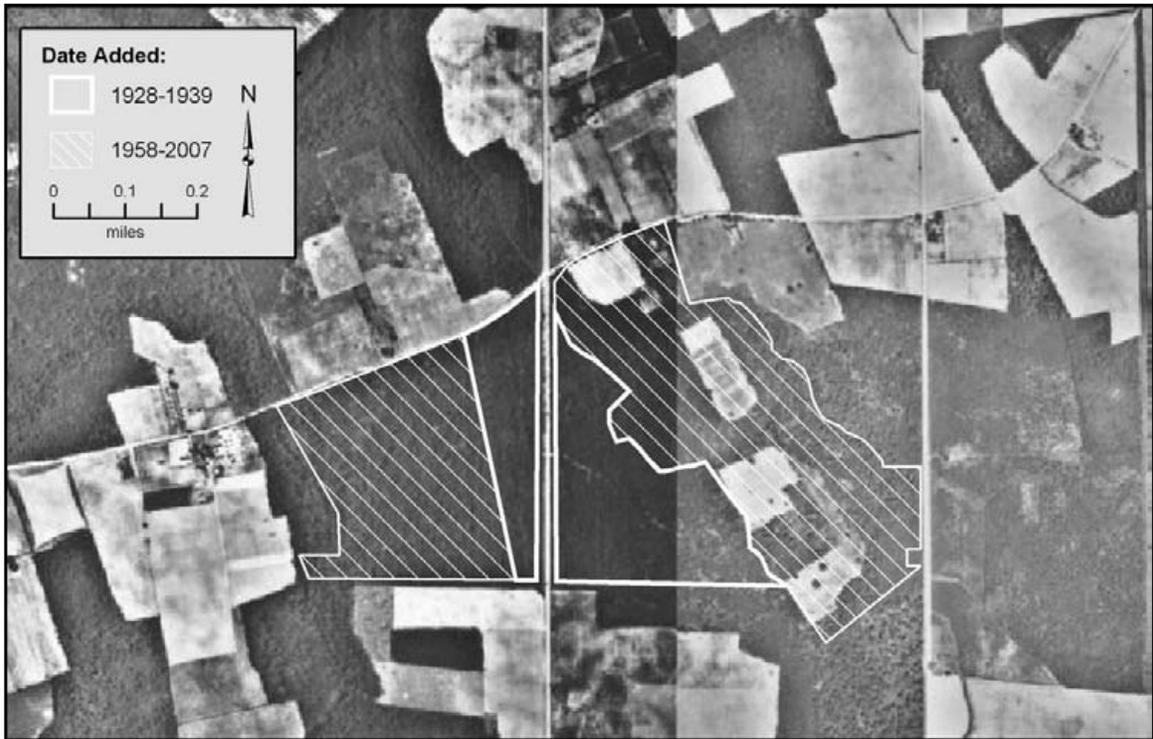
(1937 aerial)

Several structures once stood on the Appenzellar Tract, as can be seen on aerial photographs and on a 1967 survey of the Frankel Tract (see graphics, below). The 1937 aerial photograph shows dense forest on either side of U.S. 113 with no apparent buildings close to the road. Further to the east are open fields and a possible farmstead on the south side of Fleatown Road, in an area of the Appenzellar Tract acquired after 1957. The 1962 aerial photograph shows chicken houses on the west side of U.S. 113, at the southern edge of the tract. These are also shown on the 1967 Frankel survey, which includes a dwelling adjacent to the chicken houses as well as a building at the corner of the DuPont Highway and Staytonville Road. With the possible exception of the latter, these buildings were not associated with the forest. None of the buildings is extant.
