S-00150. McColley's Chapel, McColley's Chapel Road
(PIN: 135-5.00-44.00)
(Detail Map #5)

**S-03180. Compton-Pennell Farm, North Side, Maple Branch Road
(PIN: 135-3.00-5.00)
(Detail Map #4)**

**S-03181. Joseph Robbins House, 15127 Old State Road
(PIN: 135-3.00-26.00)
(Detail Map #4)**

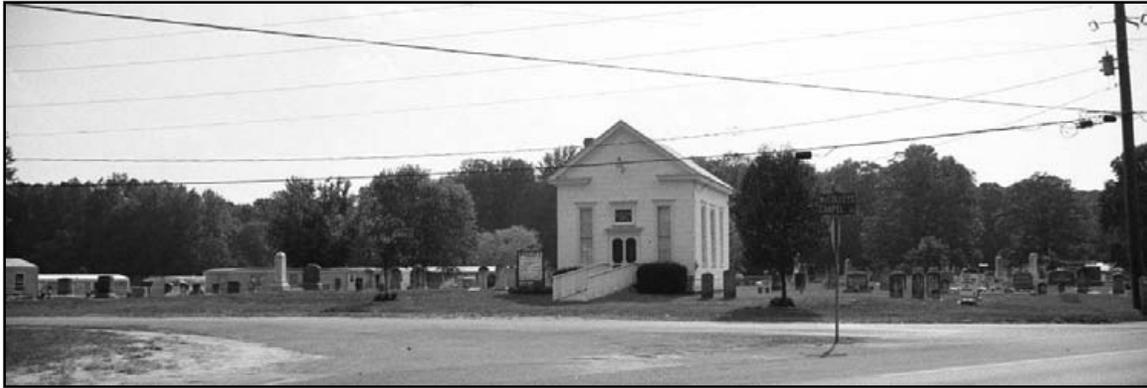
S-00150

The one-story, wood-framed, c. 1898 gabled-end chapel (.001) stands slightly back from the roadway facing east-northeast. A small gabled ell, which houses the chancel, extends from the center of the rear wall. The rectangular-shaped building measures three bays wide by four bays deep with all openings framed in plain, wood-framed cap trim. The east façade features a modern handicap ramp trimmed in iron railing in front of a centralized double-door entry, topped by wood-framed signage. Large, narrow double-hung, four-over-four wood-framed windows flank the entrance. The sidewalls of the main block are pierced by double-hung, six-over-six wood-framed windows, and the sides of the ell by double-hung, one-over-one openings. The entire exterior of the building is clad in asbestos shingles, and the gabled roof in sanding-seam metal. Plain-boxed cornices trim the roofline, and are particularly highlighted in the front and rear walls with gabled returns. A brick chimney rises from the exterior of the south sidewall.

chapel (.001), façade and north side, and cemetery (.002), view to SSW

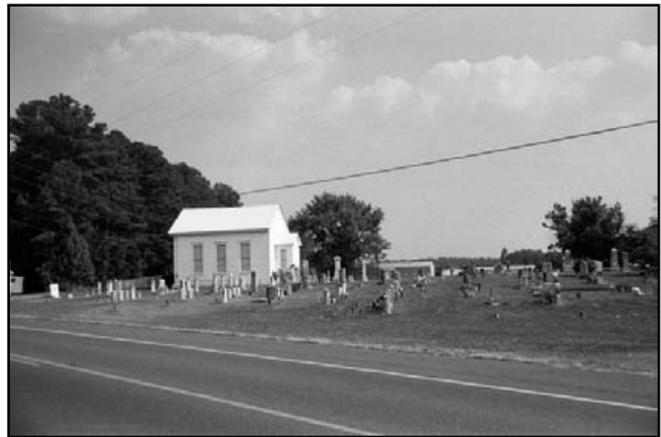
chapel (.001), rear and south side, and cemetery (.002), view to NNE

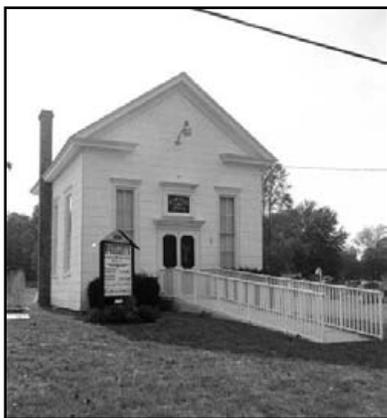
chapel (.001), rear and north side, and cemetery (.002), view to S

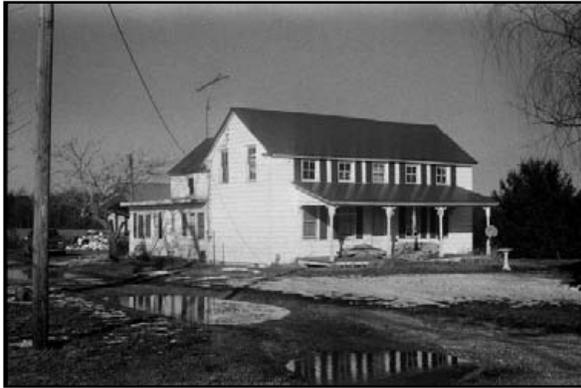
The main block of the c. 1900 house is a low, two-story, five bay, wood-framed I-house. A shed porch shelters the first story openings on the south façade. This three-bay porch has turned posts and sawn brackets. The main entry is placed in the center of the façade wall and is flanked by paired two-over-two, double-hung sash windows. Shorter two-over-two, double-hung sash windows are placed in the second story of the façade. The gable ends of the original block are fenestrated with two-over-two, double-hung sash windows. A gabled two-story ell projects from the center of the rear wall of the house and may have been part of its original construction. This ell is flanked on its east and west sides by single-story shallow shed-roofed additions. These additions are primarily fenestrated with one-over-one, double-hung sash replacement windows. The house has a concrete foundation and is sheathed in aluminum siding.

main building (.001) façade and west side, view to NE

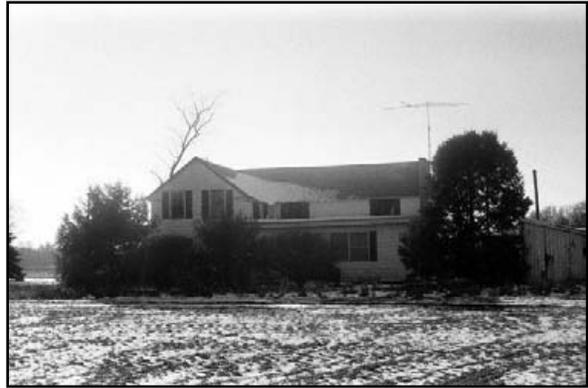
main building (.001) rear, view to SW

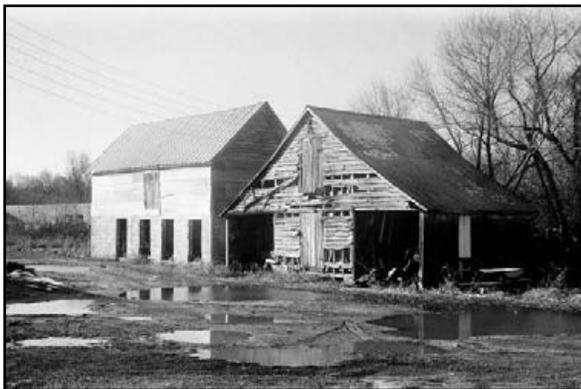
The gabled and shed roofed, c. 1900 wood-framed equipment barn (.002) is oriented with its front gable facing south. The front gable is flanked by two open shed-roofed equipment bays. The south gable is pierced by vertical board, side-hinged doors in the ground floor and loft level. The remaining walls are blank. The building sits on a brick and concrete-block foundation, is sheathed in horizontal wood siding, and has a roof sheathed in metal. It is in poor condition with pieces of the siding missing and wall framing exposed.

The c. 1940 gabled-roof barn (.003) is sited with its roof ridge oriented east-west. This wood-framed outbuilding is two stories in height. The front wall has four door openings, lacking doors in its ground floor, and a side-hinged, vertical board door placed in its second-story wall. The gable end walls are blank while two door openings are placed in its rear wall. Its lower walls are exposed concrete block while its upper walls are sheathed in corrugated metal sheet and clapboard.

barn (.003) and equipment barn (.002), view to NW

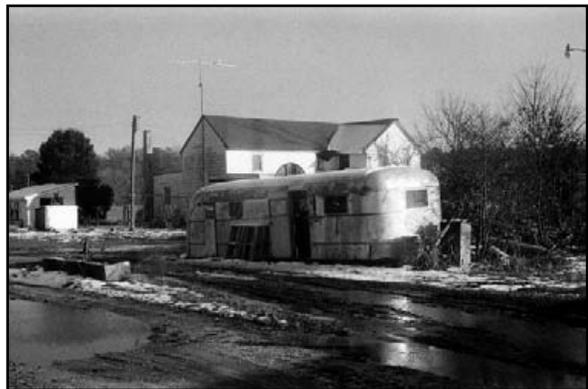
The c. 1950 trailer (.004), an example of the streamlined “Airstream” type, measures approximately 22 feet in length, 6 feet 6 inches in height, and 6 feet in width. Two doors are placed in one wall, while the remaining walls are fenestrated with awning windows. The trailer is clad in sheet metal.

trailer (.004), view to SE

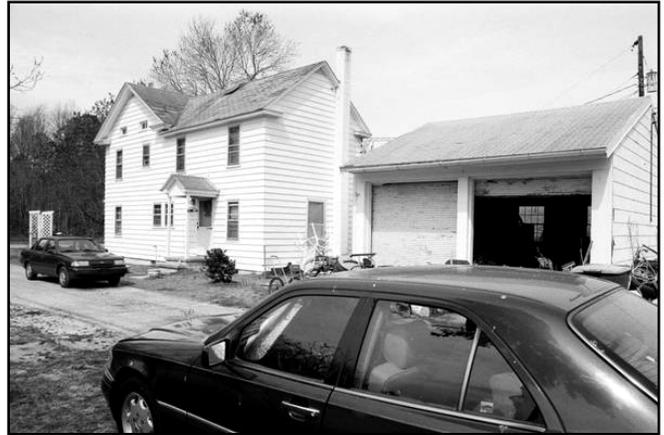
left to right: main building (.001) rear and south side and garage (.002), view to NW

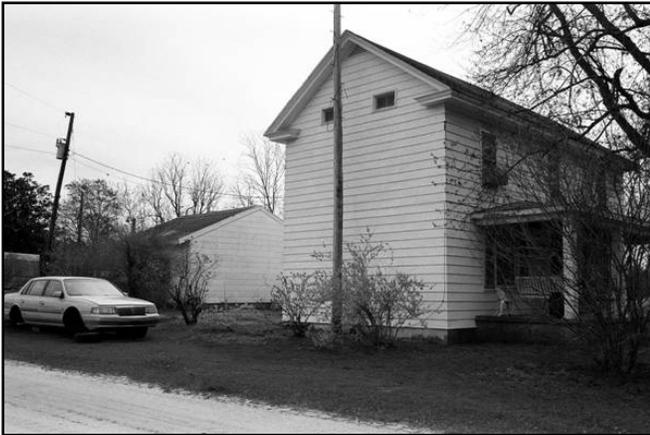
The first outbuilding, a c. 1950, wood-framed, side-gabled, two-car garage (.002) is placed east of the house. Its south façade wall is marked by two corrugated metal, roll-down, garage doors. The two gable-end walls are blank, while the rear wall is marked by two, eight-over-eight, double-hung sash windows. The garage sits on a concrete-block foundation, its walls are sheathed in cement-asbestos siding over the original clapboards, and its roof is sheathed in asphalt shingles.

left to right: garage (.002) and main building (.001) façade and north side, view to SE

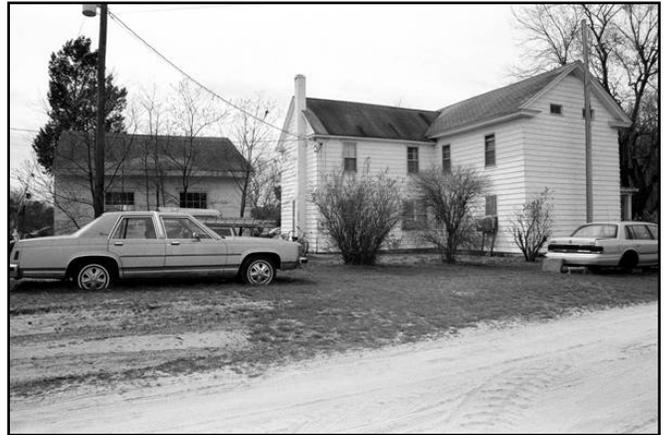
left to right: garage (.002) and main building (.001) rear and north side, view to SW

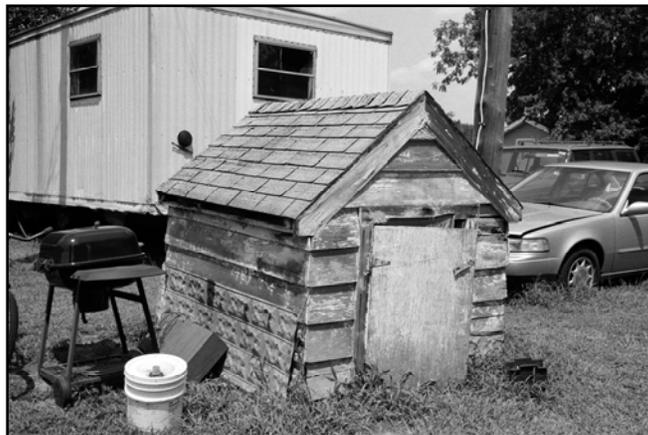
A small well house (.003) is placed east of the garage and south of a modern trailer. This c. 1950, gabled front building is marked by a replacement plywood door and metal cladding over the original vertical board siding. The door is placed in the south wall. The remaining walls are blank.

well house (.003), view to NE

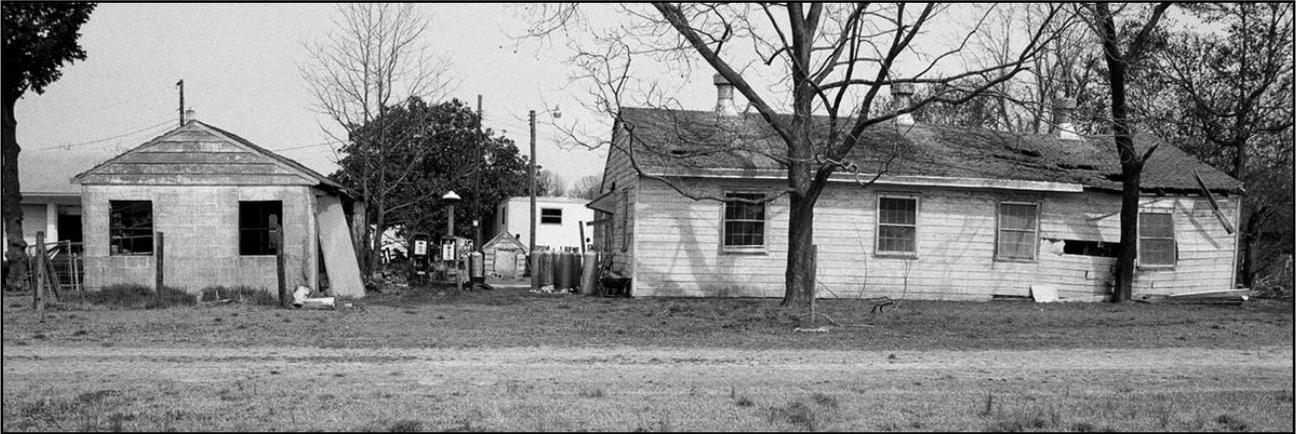
A wood-framed, c. 1950 equipment shed (.004) is placed south of the garage and south of the driveway. This gabled front structure is constructed of concrete block with the gable peaks sheathed in horizontal wood siding. The walls are deteriorated with the doors missing. The north façade has a central wood and glass garage door with 8 lights and 24 panels. The west wall has a two-over-two, double-hung sash window, and a southwest side, one-light, three-panel, broken door. The east wall has a central corrugated metal sliding door, while the south wall is marked by two, four-light metal sash windows. The structure sits on a concrete-block foundation.

left to right: equipment shed (.004) and workshop (.005), view to N

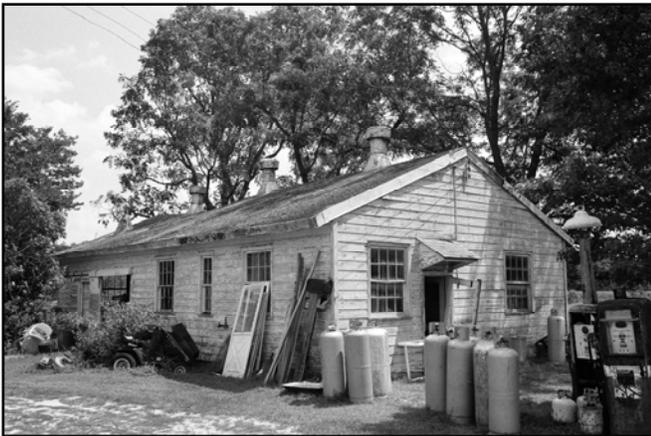
A c. 1950, side-gabled, wood-framed workshop (.005) is placed east of the equipment shed. The three metal ventilators that rise from the roof ridge are similar to those found on many local hatcheries, but the configuration of the interior of the building, with its open rafters and exposed roof braces suggests that it never functioned as a hatchery. The hatcheries previously recorded within the study area tend to be built of concrete block and have finished interiors, most likely to keep the chicks warm and clean. The north façade of the workshop has a five-panel wood door

inserted in a former sliding door opening and a sliding metal door. Three windows, eight-over-eight and four-over-four, double-hung sash are placed in that wall. The gable ends are fenestrated with two, eight-over-eight, double-hung sash windows, while a two-panel, one-light, broken wood door is placed in the west wall. The rear wall is fenestrated with four eight-over-double, hung-sash windows. The walls are sheathed in clapboard. The rear wall conveys the level of deterioration of this outbuilding with missing clapboards and partially buckled framing. The building has an asphalt shingle roof.

workshop (.005), view to SE

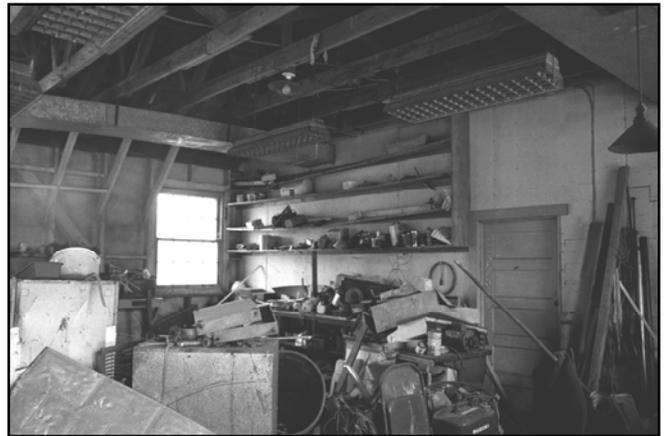
interior of workshop (.005), view to S

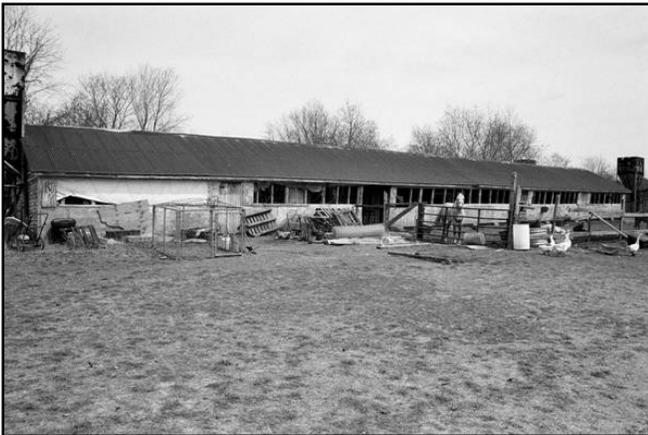
A c. 1950, single-story, side-gabled, wood-framed chicken house (.006) is placed east of the workshop. This building is placed on concrete-block piers, is sheathed in horizontal wood siding, and plywood, and has a roof sheathed in corrugated metal. Four plain wood batten doors are placed across the south façade wall. Between them, continuous screened openings extend the length of the wall. The east gable end has a plain wood door, while the north wall has three plywood and screened doors, and eight hatches. The latter presumably allowed chickens access to the yard. Its roof is sheathed in corrugated metal.

chicken house (.006), view to NE

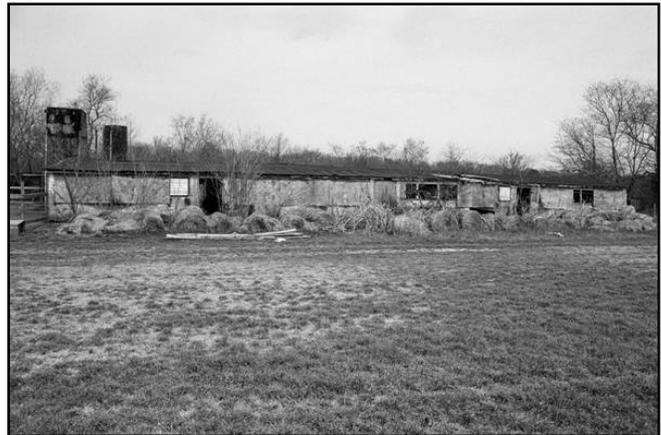
A second chicken house (.007), probably erected c. 1960, is placed east of the first. It sits on a concrete-block foundation, is sheathed in horizontal wood siding and plywood panels, and has a roof sheathed in corrugated metal. Its north wall contains three door openings with missing doors and four screened openings. The end wall contains double plywood doors placed in the center of the wall, while the rear wall contains two door openings with doors missing, and screened openings.

chicken house (.007), view to N

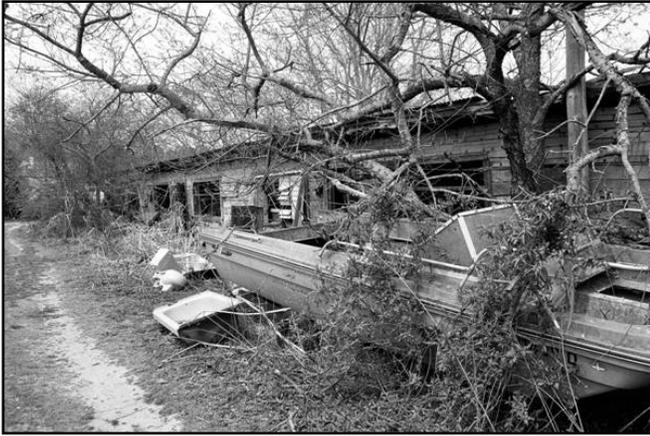
A third chicken house (.008) is placed across the driveway from .006. This c. 1960 house, set on concrete-block piers, has a shed roof and walls sheathed in asphalt and bricktex. Its roof is sheathed in corrugated metal. The south façade wall contains 22 screened openings and 11 batten doors. The west end wall contains a central door opening, now boarded over, while the opposite end wall is blank. The rear wall contains six door openings with missing doors.

chicken house (.008), view to W

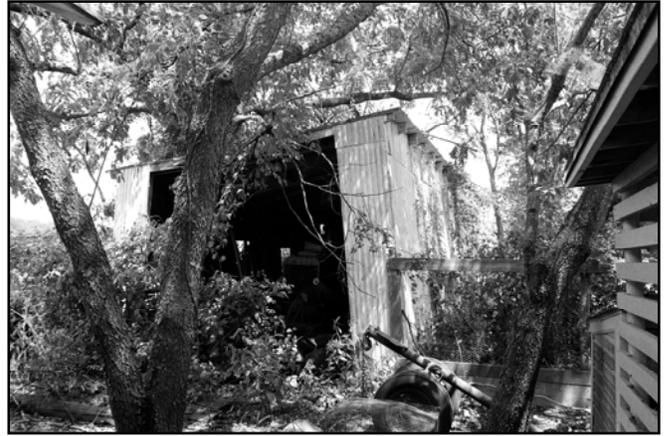
An early 1960s metal-clad shed (.009) is placed north of .008. This structure sits on a concrete-block foundation and has a shed roof clad in corrugated metal. The west wall has a door opening with a missing door, while the north wall has a missing window. The rear wall has a door opening with a missing door.

shed (.009), view to NE

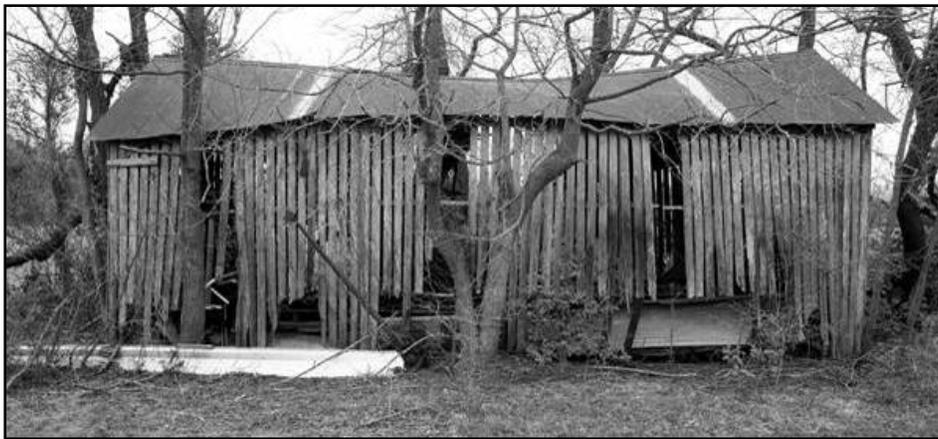
The final outbuilding, a corn crib (.010) is located east of .007. Constructed in c. 1950, the collapsing structure is rectangular and single pen in form with wood slat sides. It sits on concrete-block footers and has a door on its west wall.

corn crib (.010), view to S
