CULTURAL RESOURCE SURVEY
PROPERTY IDENTIFICATION FORM

CRS # S-11911
SPO Map 12-13-11
Hundred Georgetown
Quad Georgetown
Other _____

1. HISTORIC NAME/FUNCTION: Dwelling
2. ADDRESS/LOCATION: 18953 Redden Road
3. TOWN/NEAREST TOWN: Georgetown vicinity?
4. MAIN TYPE OF RESOURCE: building landscape structure district site object
5. MAIN FUNCTION OF PROPERTY: domestic
6. PROJECT TITLE/ REASON FOR SURVEY (if applicable):

1. HISTORIC NAME/FUNCTION: Appenzellar Tract
2. ADDRESS/LOCATION: east and west sides, U.S. 113, approx. 1 mile north of Ellendale crossroad
3. TOWN/NEAREST TOWN: Ellendale vicinity?
4. MAIN TYPE OF RESOURCE:

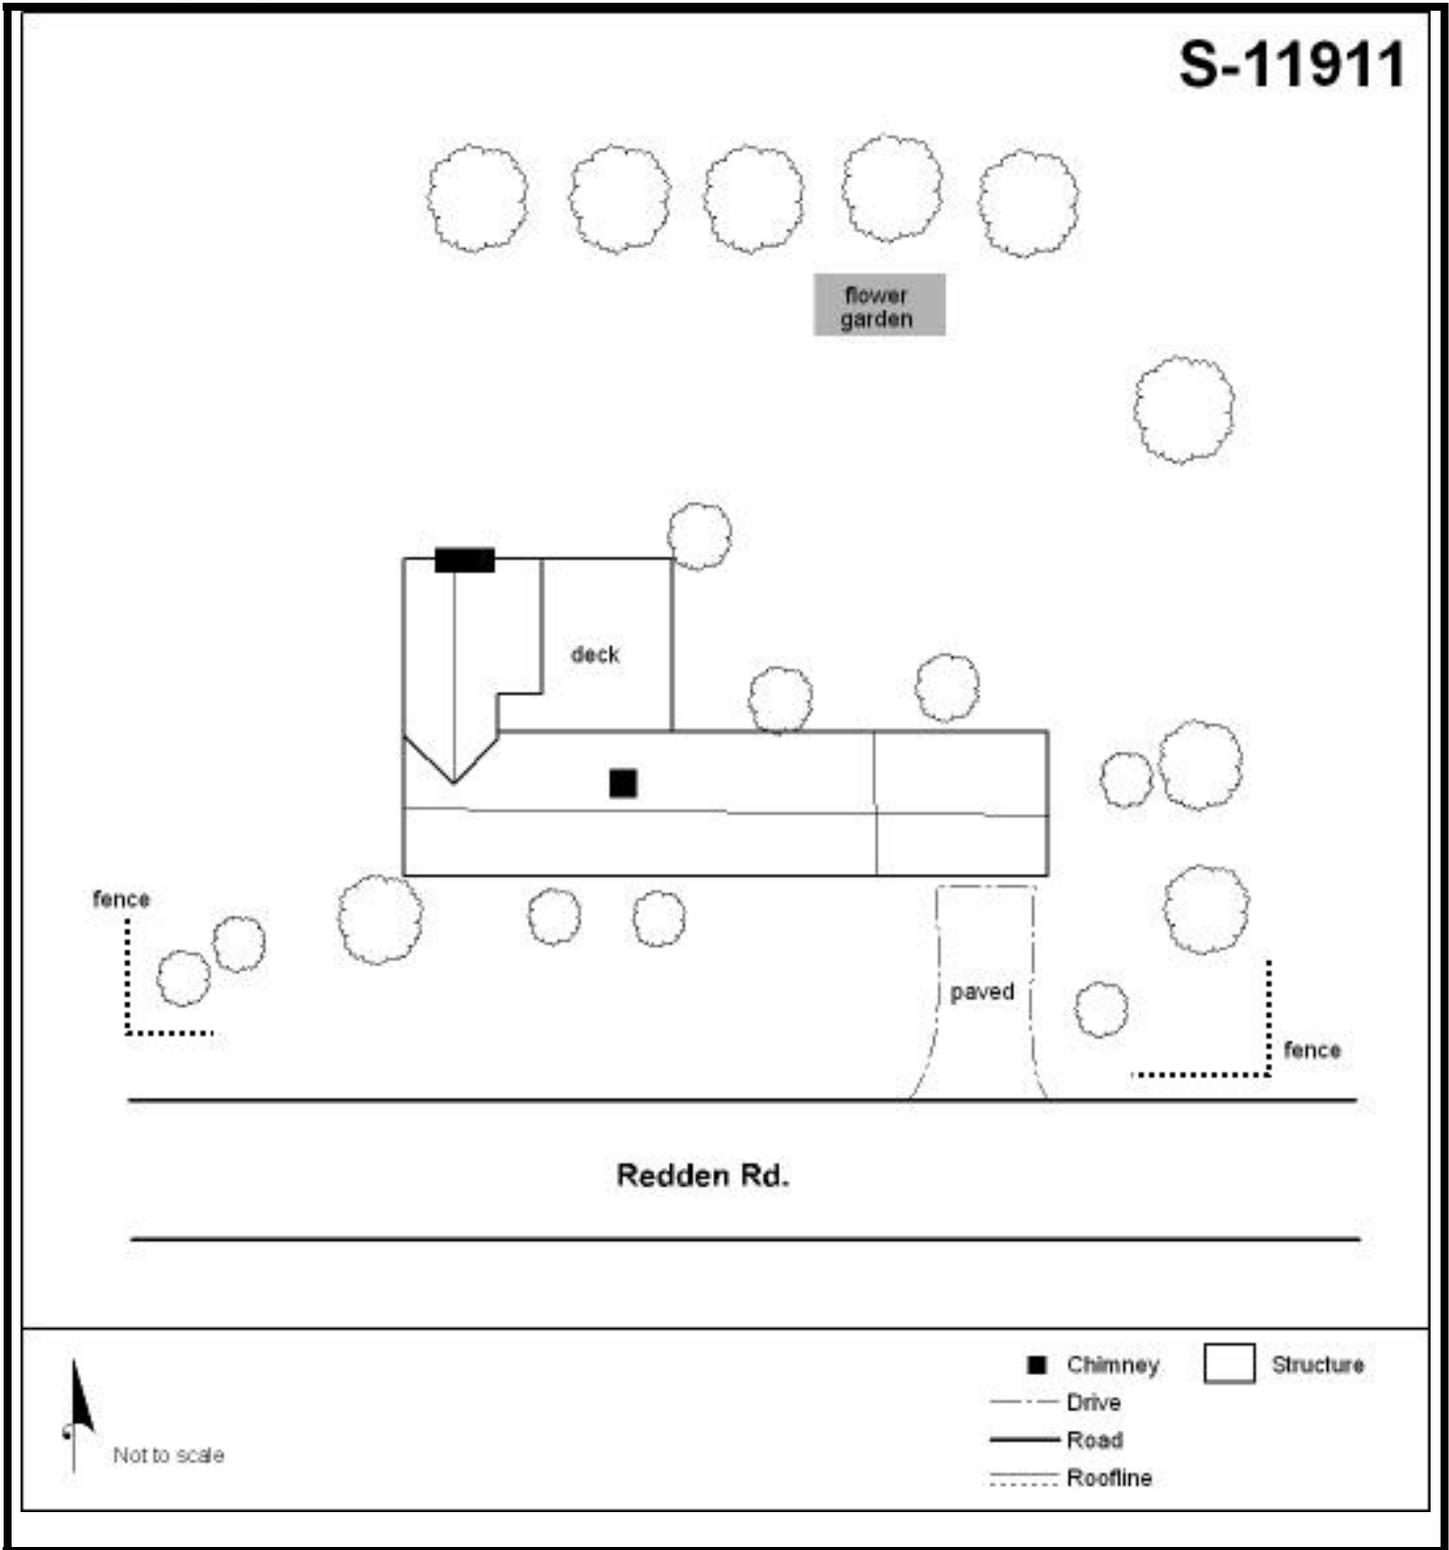
INDICATE NORTH ON PLAN

a. Overall shape: L-plan Stories: 1
Additions: original carport/garage enclosed; rear screened porch and deck added

e. Roof: shape: side gable
materials: asphalt
cornice: boxed
dormers:
chimney: location(s): ext. gable/center, brick - large chimney at rear

9.	INTERIOR:
10.	LANDSCAPING: open grassy yard with small trees and ornamental shrubs; paved driveway and sidewalk with brick curbing; medium setback; rear has modern deck and rock bordered flowerbeds; modern shed at NW rear corner; houses on either side; row of evergreens along rear of yard
11.	OTHER COMMENTS:

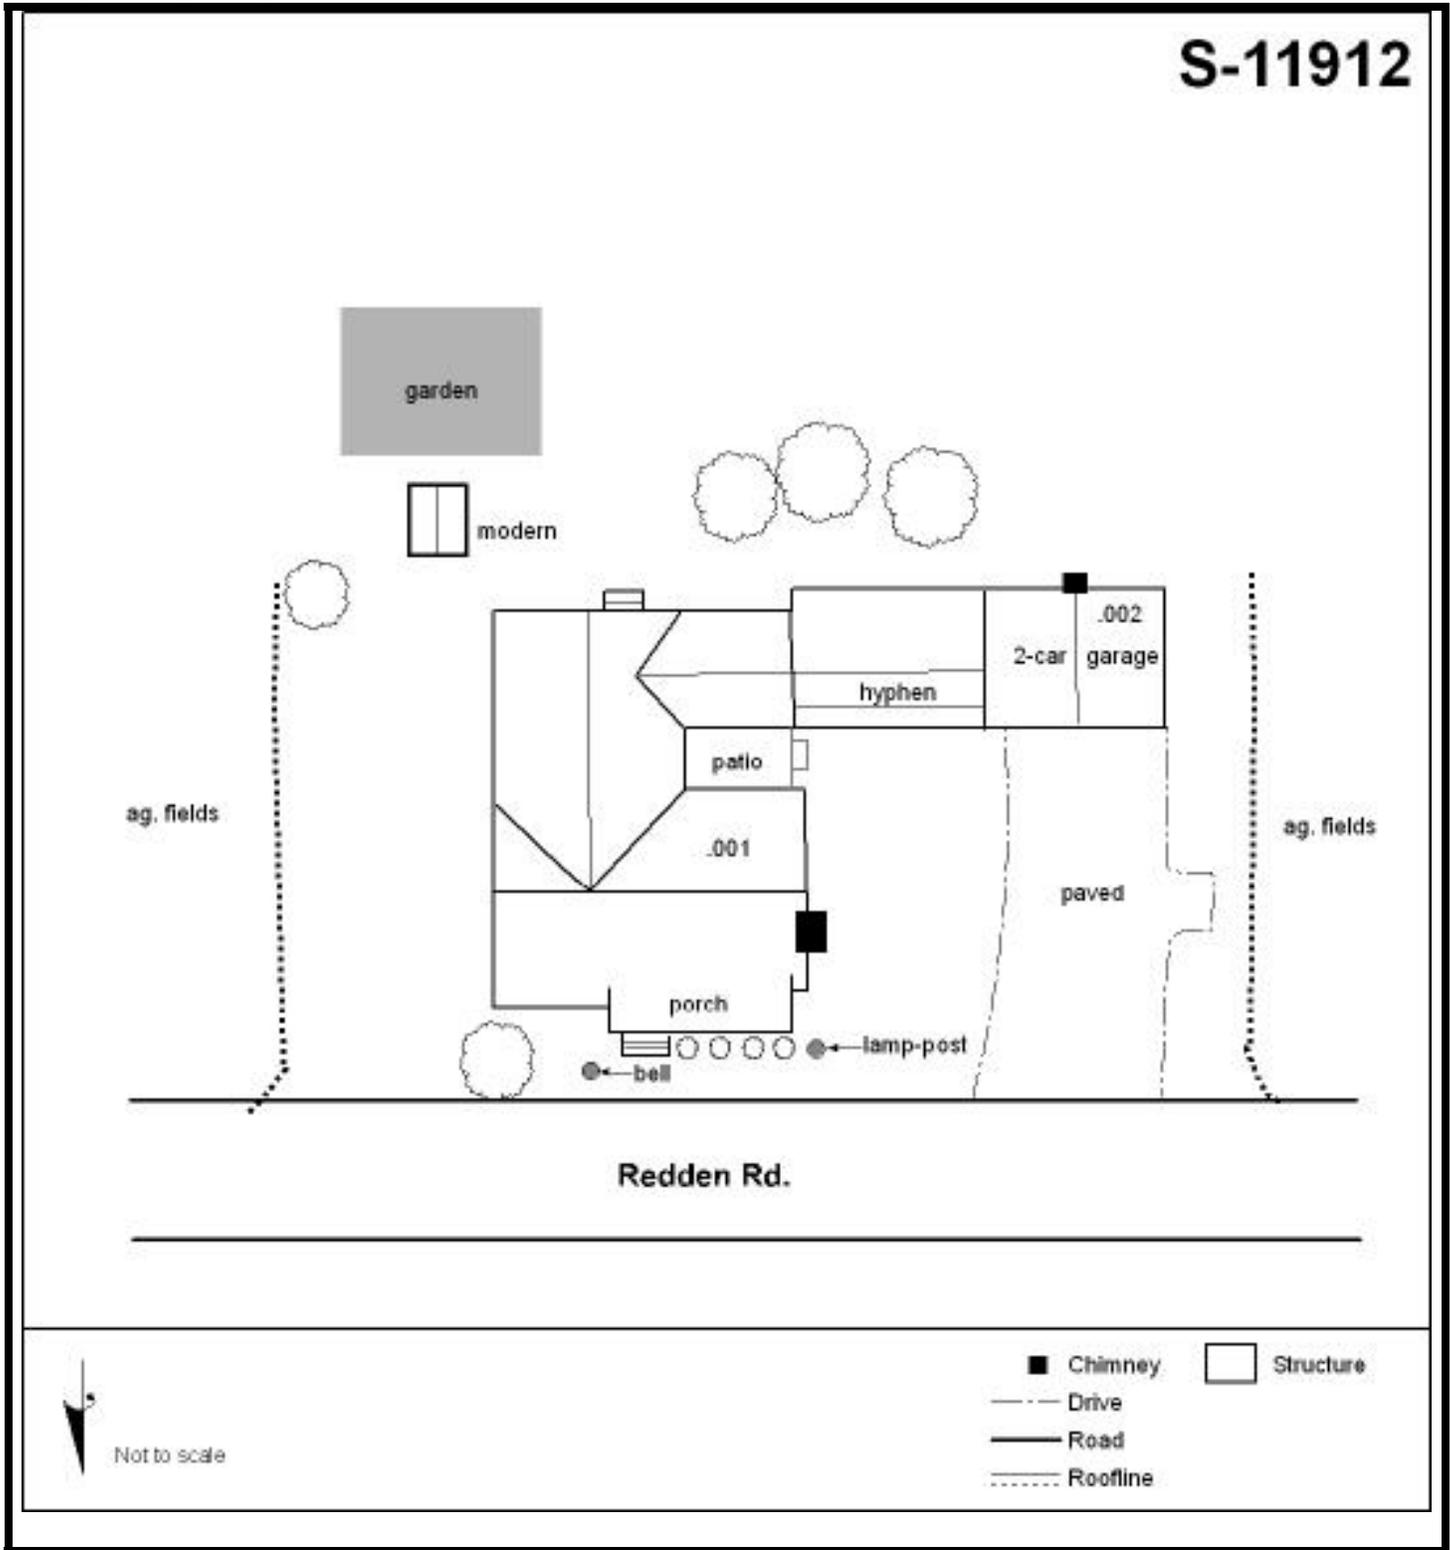
INDICATE NORTH ON PLAN

a. Overall shape: complex Stories: 1.5
Additions: _____

3)	Door(s)	2
	location	center
	type	wood and glass; 6-light, 2 panel and half-wheel, 4 panel
	trim	plain
4)	Porch(es)	carport – porte-cochere at rear beyond patio – connects house to garage; concrete floor and original wrought iron support columns

9.	INTERIOR:
10.	LANDSCAPING: open lot with a few small trees; agricultural fields on both sides and at rear; set back from road; wide paved driveway leads to double garage; paved sidewalk to front door; modern shed at rear SE corner of yard; fencing around sides and back
11.	OTHER COMMENTS:

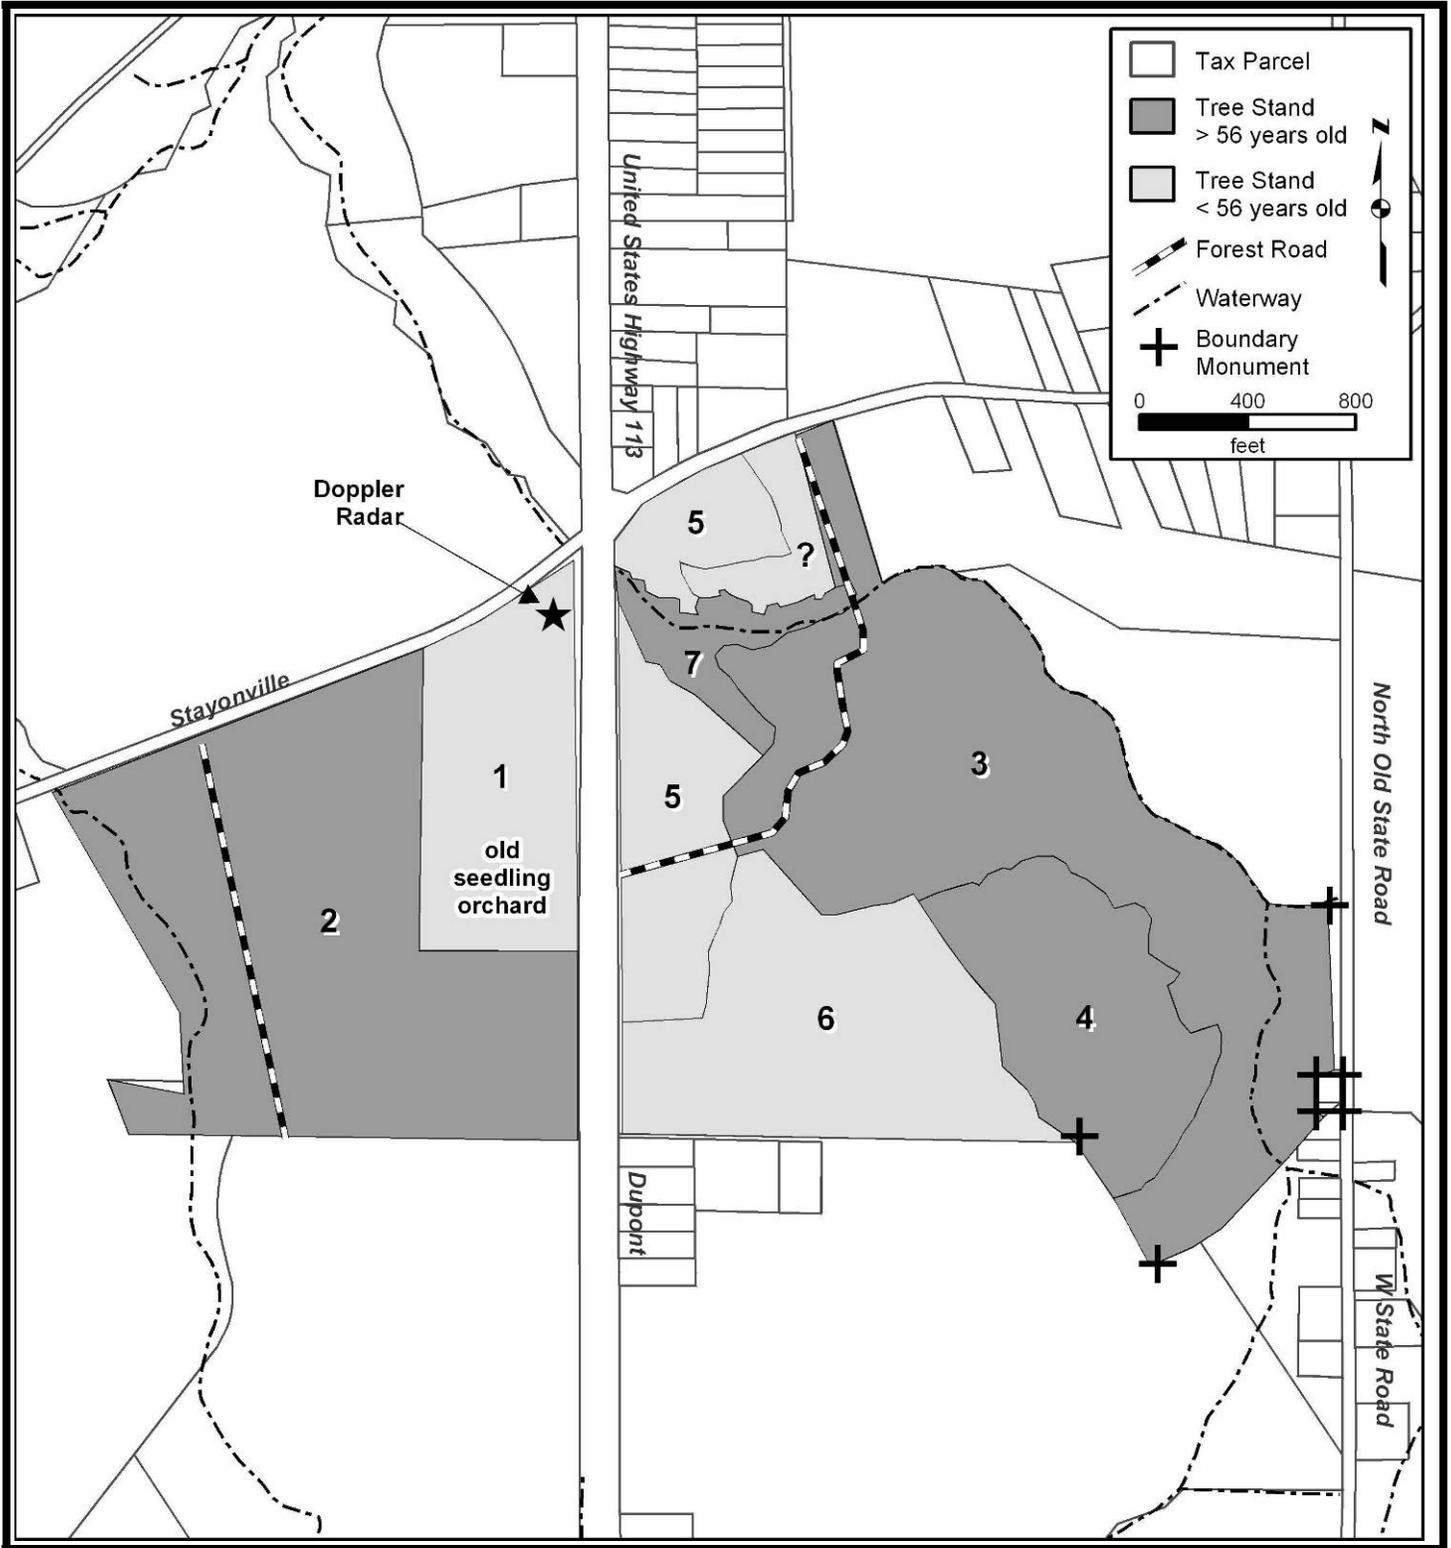
INDICATE NORTH ON PLAN

b) Circulation system: two unpaved forest roads extends into the tract on the east side of U.S. 113; one small drive provides access to a parking area at the north end of the tract on the west side of U.S. 113.

c) Spatial subdivisions: divided into 8 stands: 1) loblolly pine seed orchard and buffer; 2) mixed hardwoods; 3) pine and mixed hardwoods; 4) loblolly pine, Virginia pine and mixed hardwoods; 5) loblolly pine plantation; 6) loblolly pine plantation; 7) mixed hardwoods; 8) wildlife habitat area.

f) Water elements: tract located within the headwaters of the Cedar Creek watershed; one tributary of Hudson Pond is located along the western boundary of the tract and another tributary runs northwesterly through the east and northern portions of Stand #2.
