3. CULTURAL RESOURCE SURVEY FORMS

CULTURAL RESOURCE SURVEY
LOCUS IDENTIFICATION FORM

1. NAME OF LOCUS: "Hill Island Farm"
2. STREET LOCATION: 3379 Dupont Highway
3. OWNER'S NAME: _____ TEL. # _____
ADDRESS: _____
4. TYPE OF LOCUS: a) structure _____ b) district _____ c) archaeological site _____
d) other agricultural complex
5. SURROUNDINGS OF LOCUS: (check more than one if necessary)
a) fallow field _____ b) cultivated field x c) woodland _____
d) scattered buildings _____ e) densely built up _____ f) other _____
6. THREATS TO LOCUS: (check more than one if necessary) C
a) none known x b) zoning _____ c) roads _____ d) developers _____
e) deterioration _____ f) other _____
7. REPRESENTATION ON OTHER SURVEYS:
TITLE: _____ # _____
TITLE: _____ # _____
TITLE: _____ # _____
8. YOUR NAME: Carol A. Benenson/Mark A. Bower TEL. # 215-561-1050
YOUR ADDRESS: 1316 Arch Street, Philadelphia, PA 19107
ORGANIZATION (if any) KKFS, Inc. DATE: July 1986

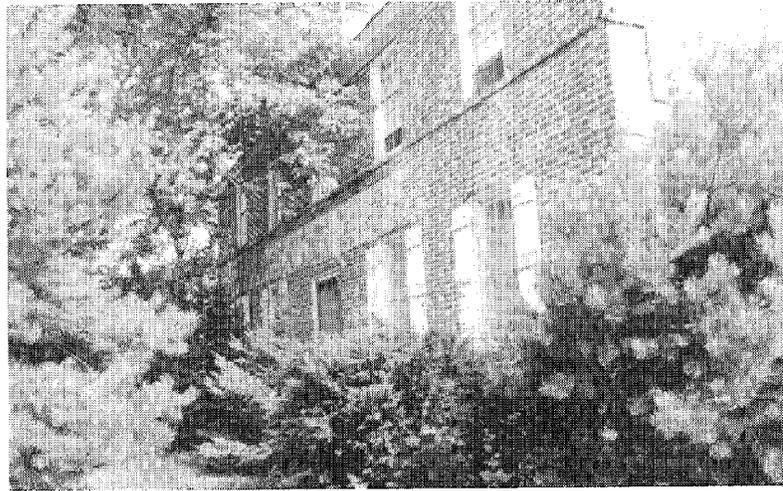
Fig. 3.1. Hill Island Farm (N-5898), Main elevation of house, looking northwest.

Surrounded by cultivated fields and bounded to the north by the Appoquinimink Creek, this 18th century farmhouse possesses an exceptional integrity of its historic agricultural setting, despite the fact that its outbuildings are of a later period and relatively minimal importance. The Flemish bond brick farmhouse, however, is a significant and unusual architectural landmark in this area. Its westerly gabled end wall features two small openings on either side of the chimney breast; since filled in, these closet windows are in keeping with the colonial Tidewater Virginia tradition. The brickwork, too, is distinctive. The main elevation is composed of Flemish bond brick with glazed headers while the rear is constructed of alternating header and stretcher bonds. Embellishing the brickwork is a belt course at the second floor that jogs at the gabled end walls and spans those elevations as well. The house warrants further investigation into its provenance and building sequence; this may have originally been a two-bay house with a three-bay addition.

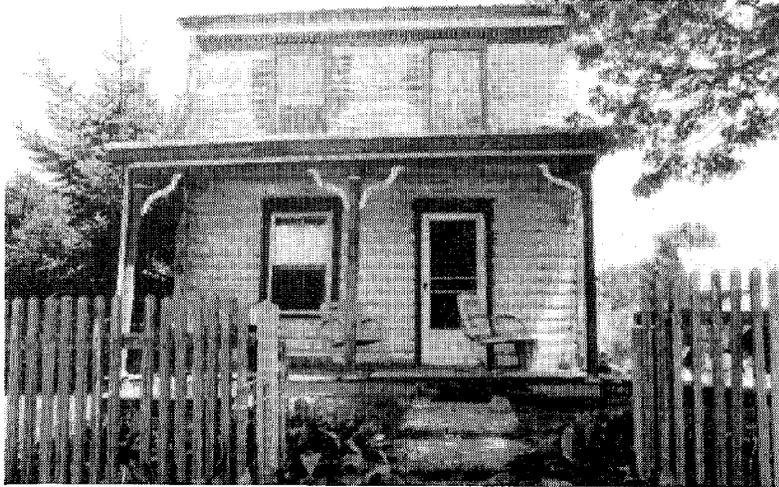
Fig. 3-3. J. W. Naudain Farm House (N-6270), Main elevation of house, looking east.

This vernacular late-Greek Revival farmhouse and its outbuildings are sited on their original road, although the area between Eagles Nest Landing Road and Dupont Highway has been altered for a weigh station. The frame dwelling and its surviving 19th and early 20th century outbuildings reflect the type of agricultural complex associated with the tenant or small landowner. This once common type has, as a result of continuously evolving farming practices, disappeared largely from the agricultural landscape. This rare survival retains its significant vernacular features, i.e. the setting of the house to the road, the random placement of outbuildings on a linear plan, and the absence of a planned landscape or ornamental plantings.

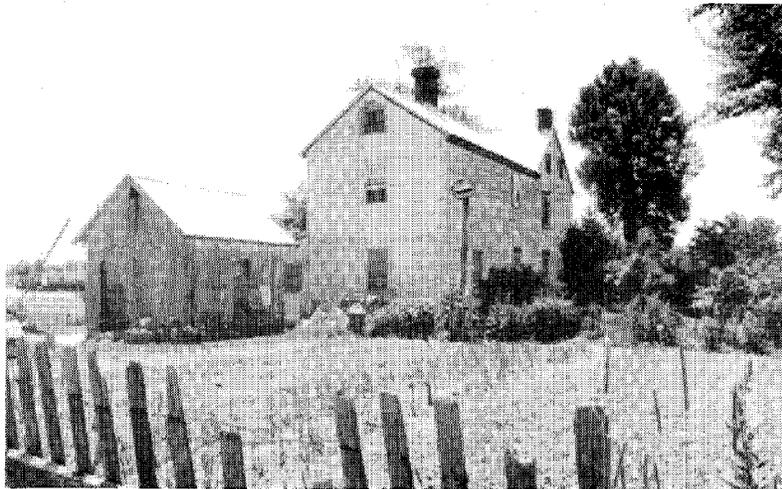
Fig. 3-4. J. W. Naudain Farm House (N-6270), Main house and pump house, rear elevation, looking west.

pump house - gabled roof, frame, cmu base, c. 1940;

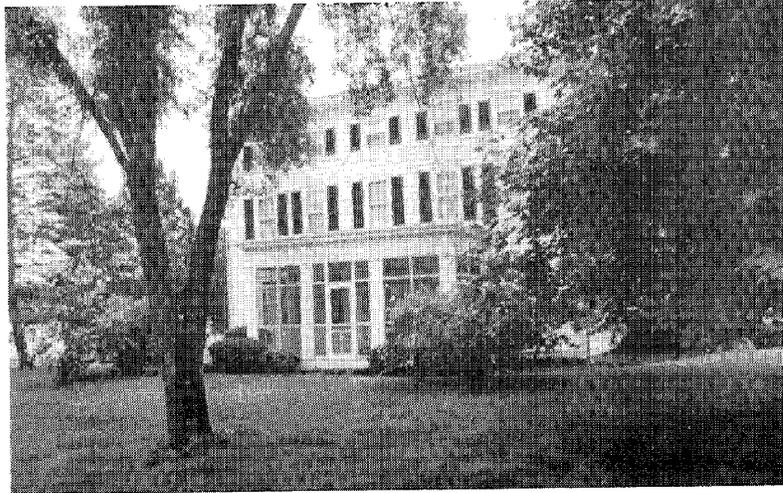
Fig. 3-5. Mt. Pleasant (N-6271), Main elevation of house, looking south.

This mid-19th century farmhouse has had its historic agricultural setting radically altered by a densely concentrated trailer park on former farm lands. However, several outbuildings and most importantly, the Italianate house, survive. The house stands as a representative house type of a form and style that was prevalent in Central Delaware during the state's mid-19th century era of agricultural prosperity.

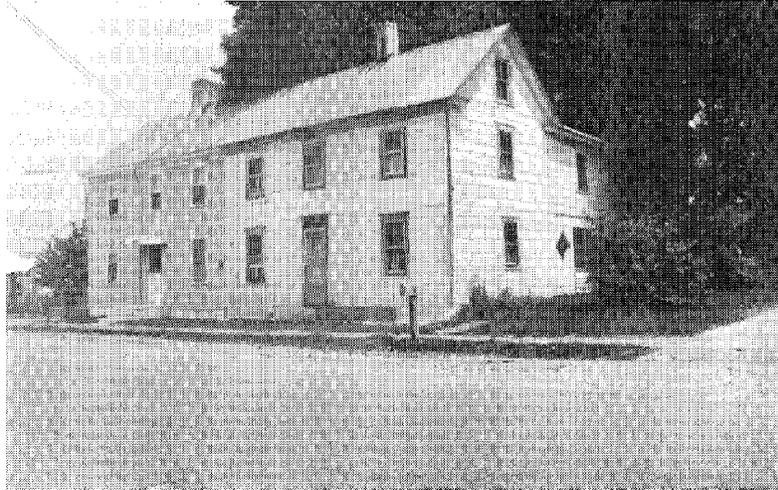
Fig. 3-7. Augustus Scout House (K-4014), Main elevation of house, looking southeast.

- a) Overall shape rectangular double house
 stories 2 1/2
 bays 6
 wings rear 2 story wing and 1 story
 addition on south half; rear 1 story add.
- b) Structural system frame on north.
- c) Foundation
 materials brick
 basement none
- d) Exterior walls
 materials asbestos; aluminum siding
 color(s) green; white
- e) Roof
 shape; materials gabled; asphalt
 cornice box, 4 small returns; cyma reversa molding; 1 side panned
 dormers none
 chimney location(s) interior along ridge
- f) Windows
 spacing regular
 type 2/2 double hung
 trim thin entablature lintels
 shutters none
- g) Door
 spacing central to each half
 type glazed and paneled
 trim thin entablature lintels
- h) Porches
 location(s) south rear, enclosed
 materials
 supports turned posts
 trim
- i) Interior details (if accessible)

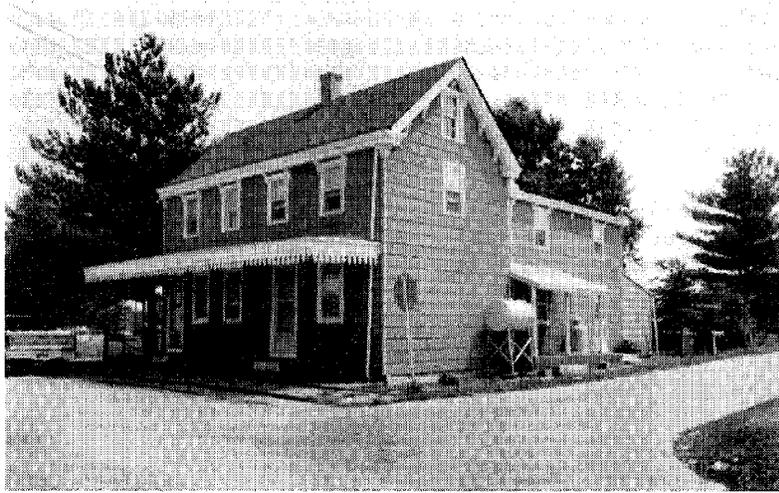
Fig. 3-9. Augustus Scout Store (K-4022), Main and northwest side elevations.

- a) Overall shape T
 stories 2 1/2
 bays 4
 wings rear addition
- b) Structural system frame
- c) Foundation
 materials stuccoed cmu
 basement none
- d) Exterior walls
 materials asbestos siding
 color(s) green
- e) Roof
 shape; materials gabled; asphalt
 cornice box with returns supported by brackets
 dormers none
 chimney location(s) center ridge line
- f) Windows
 spacing regular
 type 4/4 double hung
 trim simple surround
 shutters
- g) Door
 spacing 1 far left; 1 center right
 type paneled with transom
 trim simple entablature
- h) Porches
 location(s) pent eave across front
 materials
 supports
 trim Gothic Revival gingerbread
- i) Interior details (if accessible)

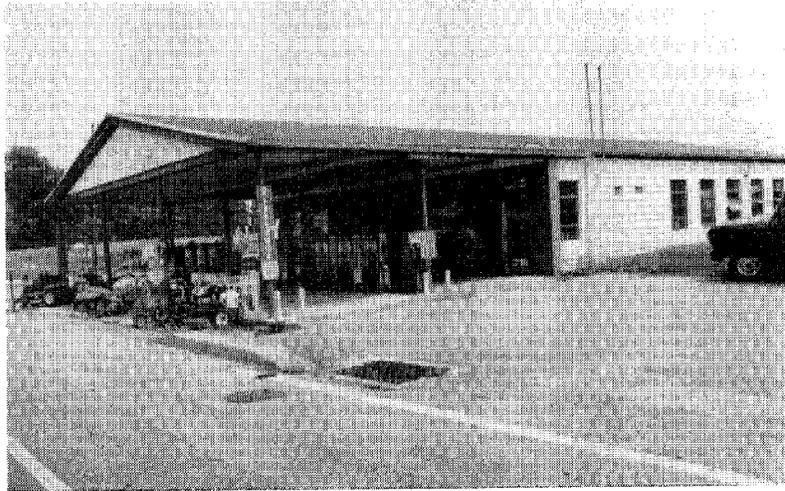
Fig. 3-11. Clarkie's Garage (K-3841), Main (west) and south elevations.

Located along the frontage of Dupont Highway in Smyrna, this 1920s service station is a representative cultural and architectural landmark of the automobile age. In part due to the widening of the highway in the 1930s, and in part due to subsequent development, most of the early roadside service stations along this corridor have been demolished. This particular example of rusticated cast stone construction not only survives from the 1920s era, but also depicts its adaptation to the 1930s' highway expansion with its open front bay and relocated pumps. As architecture, this resource marks a vanishing building type from the Delaware roadscape.

This rusticated cast stone structure was built as a service station in 1923 by the Holt Oil Company. It was later owned by the Tidewater Oil Company. The building continues to be used as a service station.

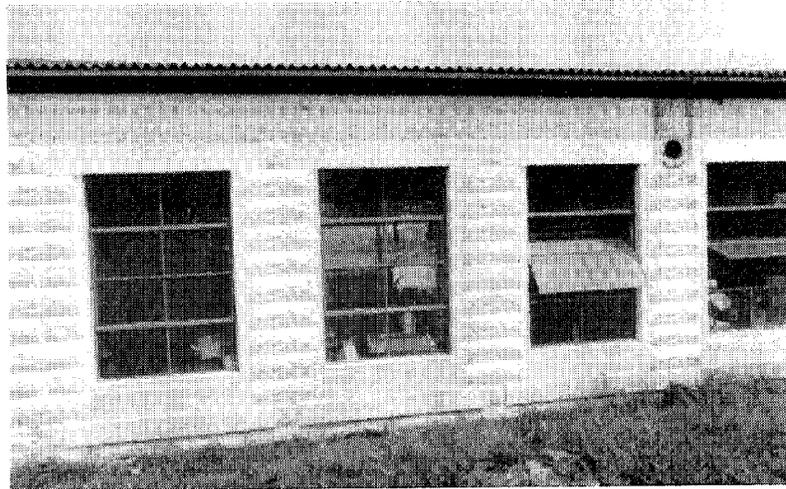
Fig. 3-12. Clarkie's Garage (K-3841), Detail of south facade.

d) Exterior walls
materials rusticated cast stone
color(s) white

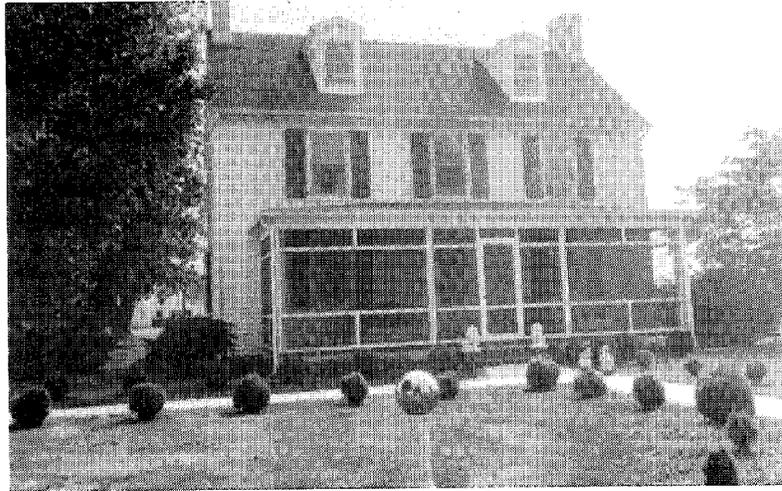
Fig. 3-13. Hoffecker Farm (K-3940), Main elevation of house, looking southwest.

The Hofferker Farm displays a common pattern in the development of farms in central Delaware. Typically, and as represented here, the original farmhouse remains, while the majority, if not all of the period outbuildings, has been demolished and/or replaced. On the Hofferker Farm, the frame Greek Revival house survives with some alterations and additions. However, the outbuildings that once supported the farm's orchards have been replaced with 20th century buildings relating to the dairying industry. This farm, historically associated with one hundred years of the Hofferker family, is located within an agricultural area rich in historic houses and farms: Belmont Hall, Glen Fern, and Ivy Dale, all of which are listed in the National Register. The Hofferker Farm would make a logical addition to a rural historic district composed of these 18th and 19th century agricultural properties.

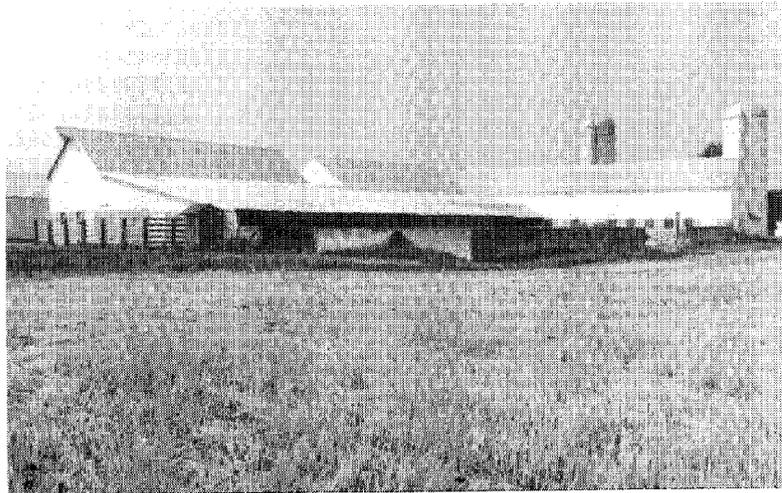
Fig. 3-14. Hoffecker Farm (K-3940), View of dairy barn complex from rear, looking north.

describe: shed- vertical board siding, cmu foundation, corrugated metal roof; cow barn - c. 1960, cmu foundation, vertical board siding; pump house - cmu with vertical board siding; dairy house - vertical board siding; cmu garage with asphalt roof; cmu equipment shed with metal roof; concrete silos; corrugated metal threshing shed; old cmu chicken house; grain barn.

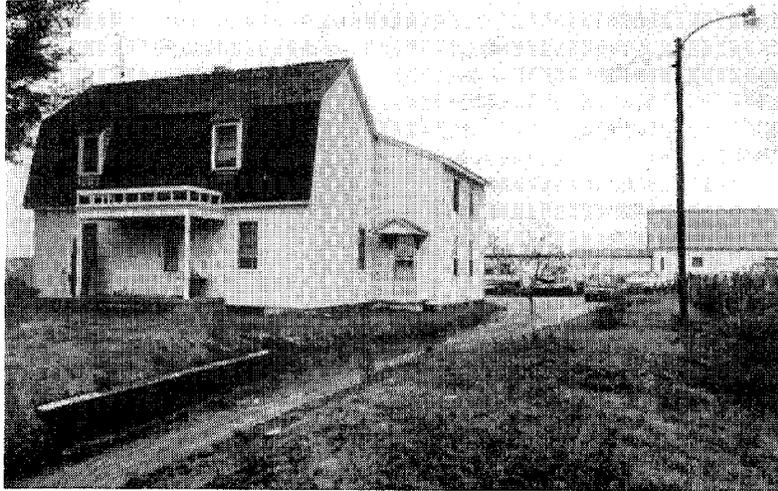
Fig. 3-15. Garrison/Hoffecker and Huffington Mill House (K-833), East and north elevations.

d) list major alterations and dates (if known) reclad with wood siding, windows and doors replaced, new chimney, rear addition, window openings altered

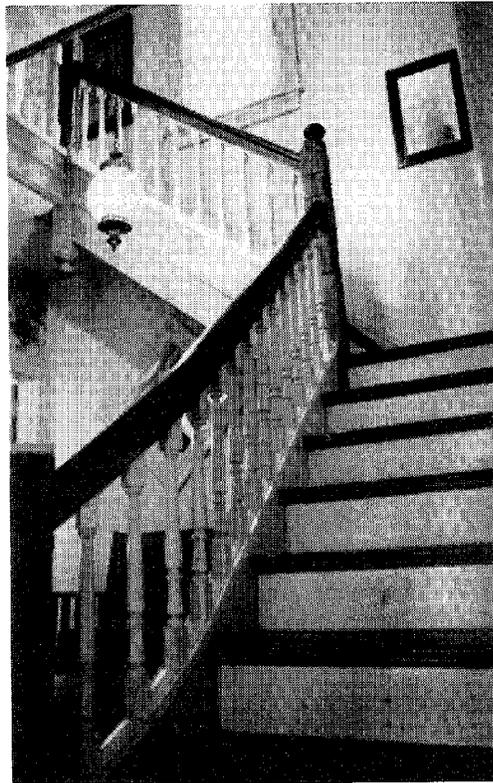
Fig. 3-18. S. J. Speal Residence (K-3772), Main Stairhall.

i) Interior details (if accessible)
largely unaltered; stained glass light in hall, handsome turned balustrade,
colonial revival mantel, grooved moldings with bosses

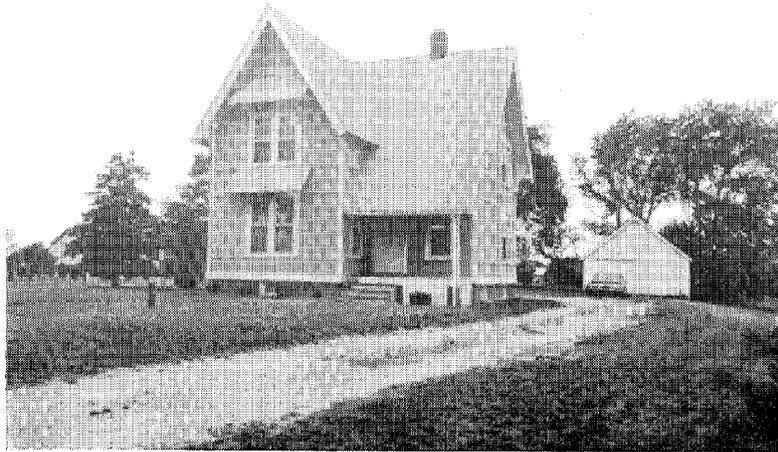
Fig. 3-19. Dwelling (K-3345), House and garage, looking northwest.

This house, now closely sited to Route 10, is a rare and good example of the Eastlake-inspired Neo-Grec style in the area. The massive sweep of the low hanging roof also suggests the influence of the late-19th century Shingle Style which is not commonly found in this area.

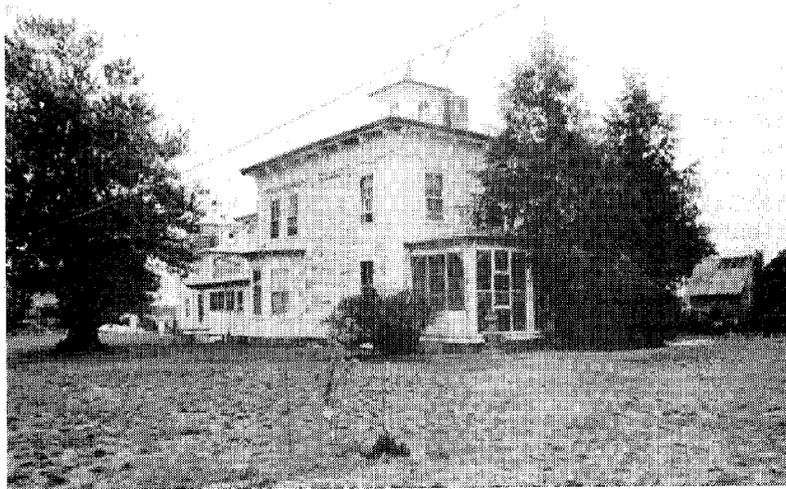
Fig. 3-21. Evergreen Farms (K-3351), Main house, looking southwest.

- a) Overall shape T
 stories 2
 bays 3
 wings rear wing and rear addition connected
 to main house by enclosed porch
- b) Structural system frame
- c) Foundation
 materials brick
 basement yes

- h) Porches
 location(s) front; wrap-around from side to rear to side
 materials wood
 supports square posts
 trim sinuous double height brackets; front porch screened in; wrap-around
 porch mostly enclosed with clapboarding
