**A Phase IB Archeological Survey  
and  
Historic Architectural Investigation  
of the  
U.S. Route 13/Delaware Route 404  
Intersection Improvement Project  
Bridgeville, Sussex County, Delaware**

**Delaware Department of Transportation  
Dover, Delaware**

**John Milner Associates, Inc.  
West Chester, Pennsylvania**

March 2006

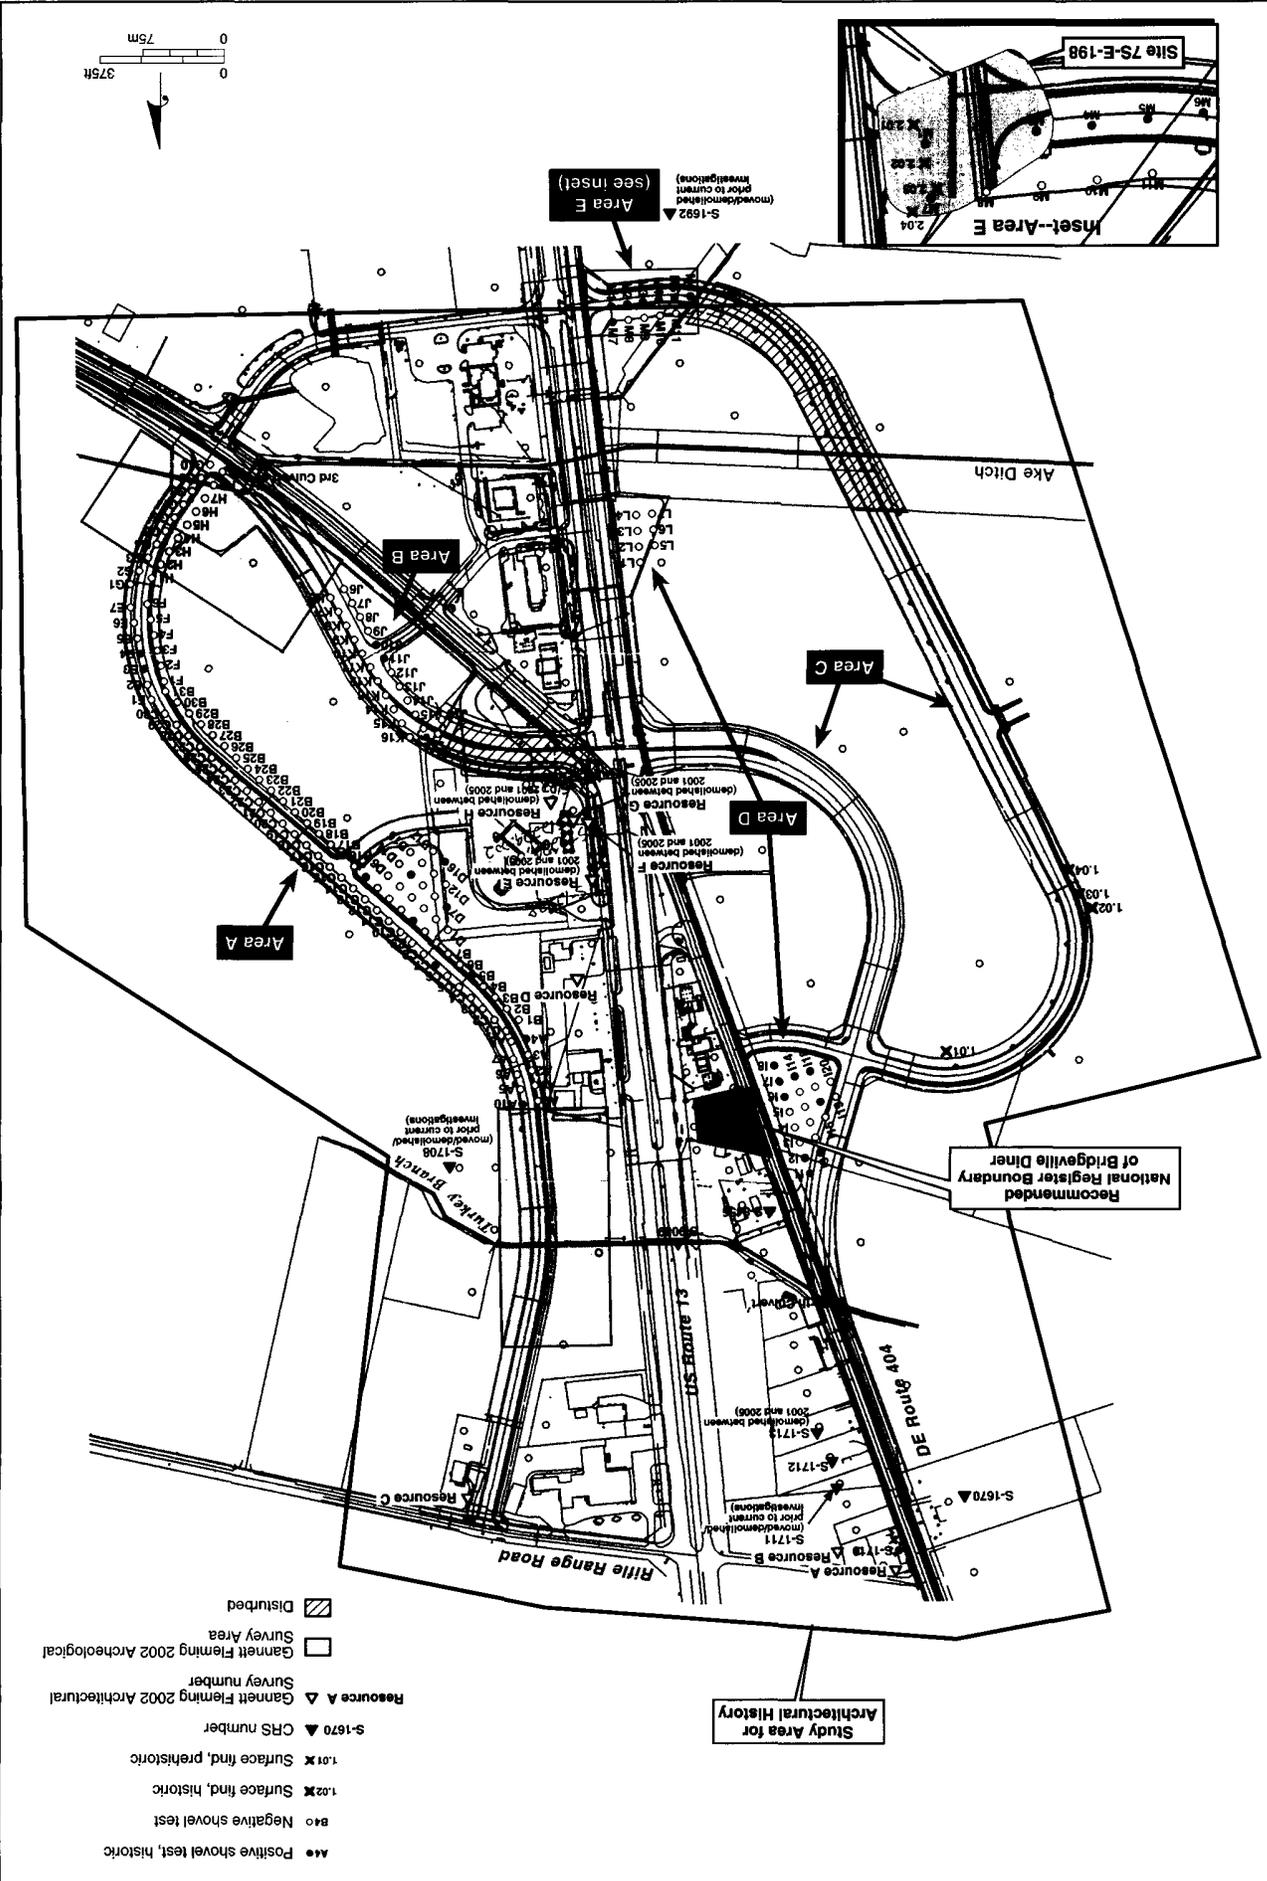
Figure 2. Project area, showing existing and proposed construction, historic properties, previously surveyed areas, current shovel test unit locations, and the boundaries of Site 75-E-198 and the Bridgeville Diner.

Phase IB archeological survey was also conducted. The APE was limited to a 100-m (328 ft.) wide corridor extending 200 m (656 ft.) on either side of Turkey Branch and Ake Ditch on the east side of Routes 13/404 (Figures 1-2). Subsurface testing was then restricted to within 100 m (328 ft.) of each water source and a total of 136 shovel tests were excavated (Martin et al. 2002). A light scatter of historic and modern debris was identified. No archeological features or sites were identified. No further archeological work was recommended for these two areas.

Area B denotes the proposed connector linking the intersection of Routes 13 and 404 to a planned intersection in the vicinity of Route 404 and Ake Ditch (Figure 2). An area of disturbance previously discussed and attributed to the Royal Farm construction was noted along the northern

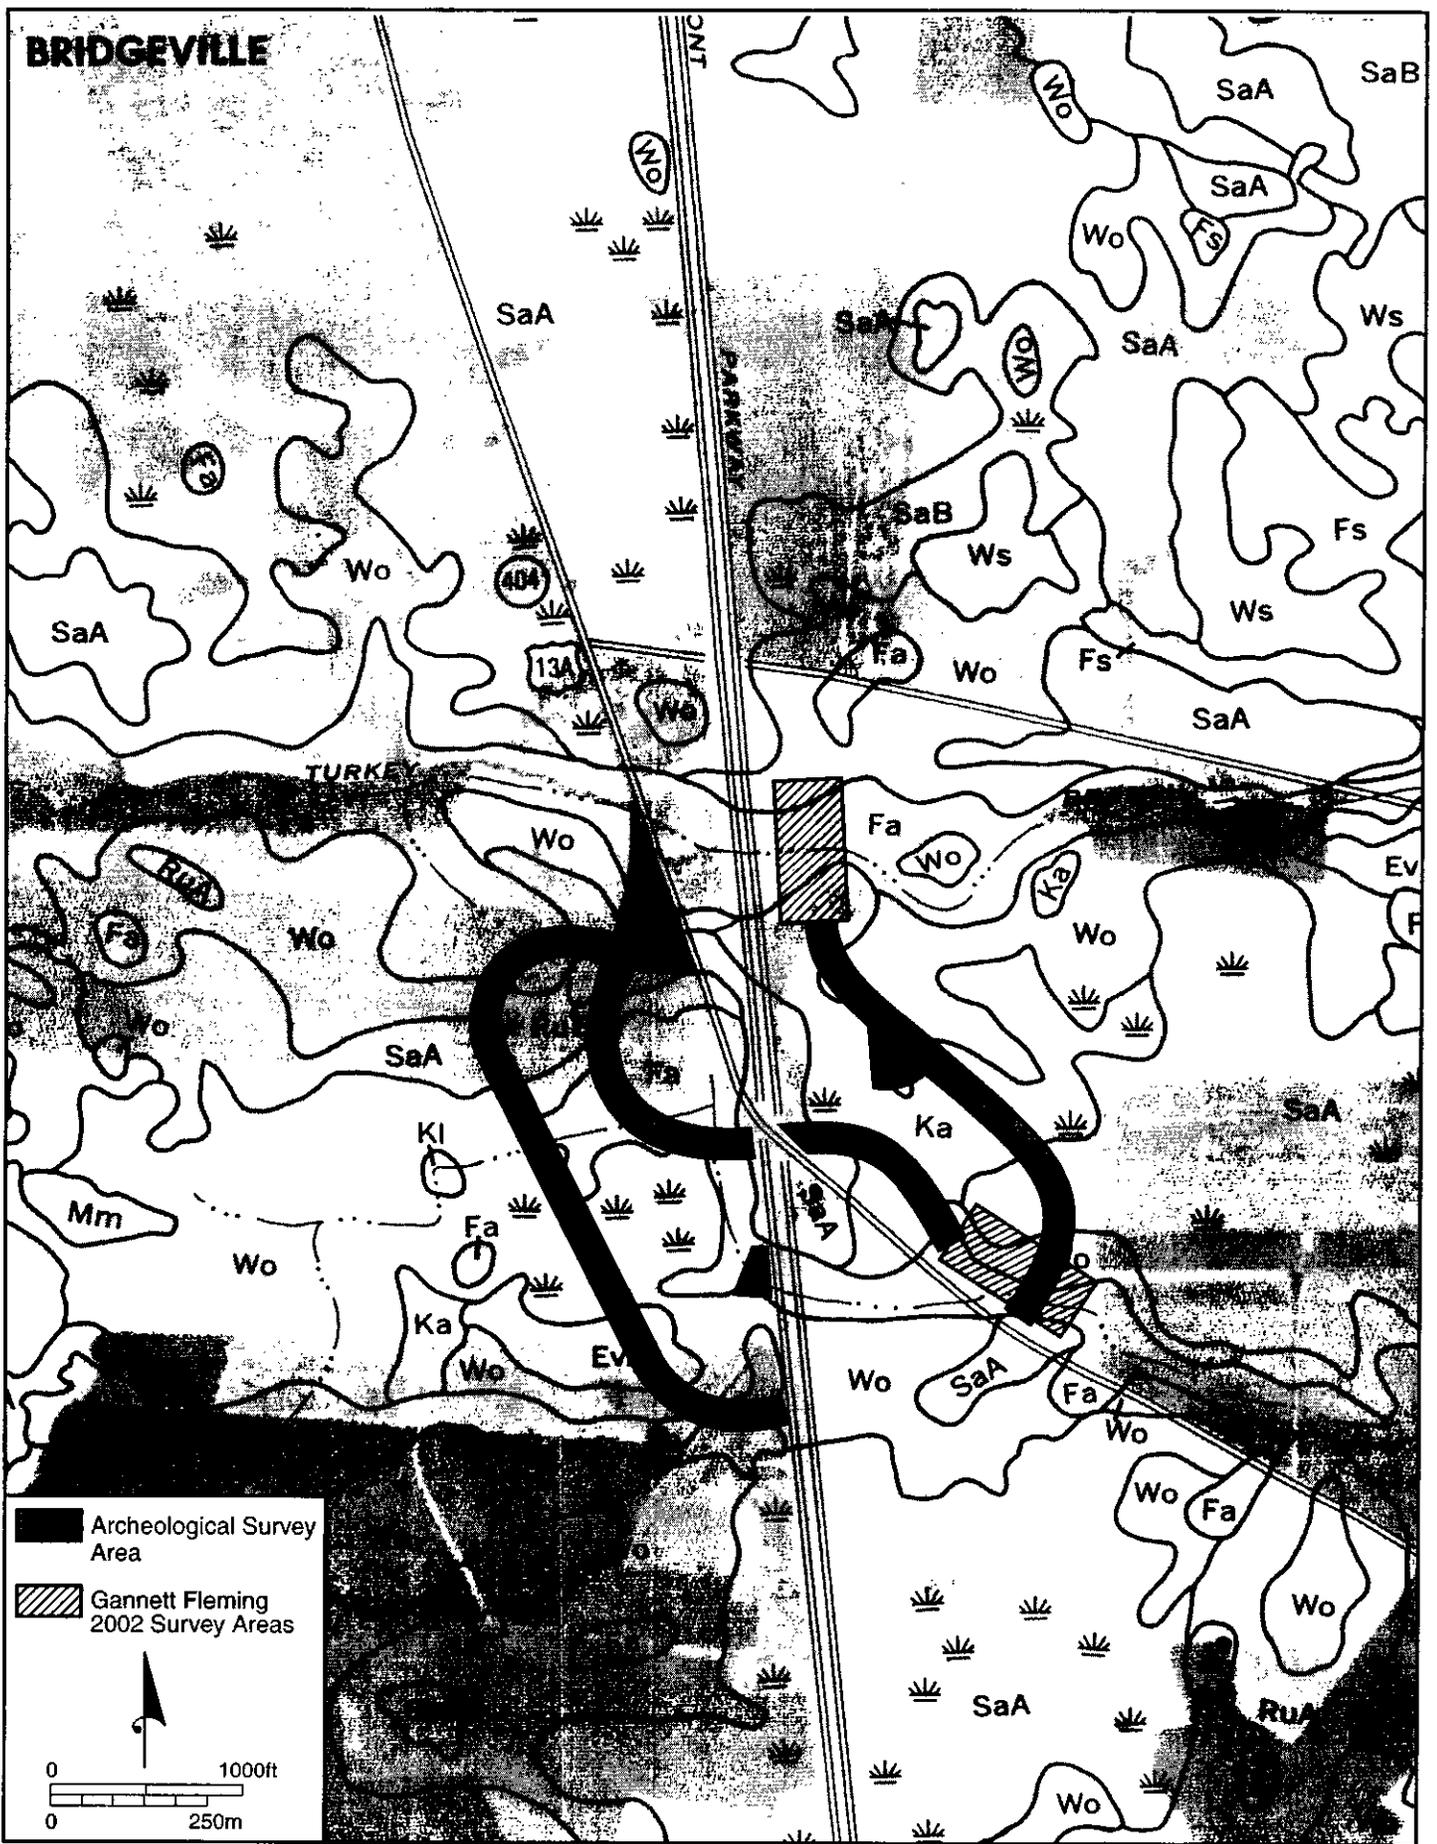
Figure 3. Detail of Soils Map (USDA 1974), showing project area.

The Kalmia sandy loam is the predominate soil situated within the higher elevations east of Route 13. This soil is easily worked and is described as being deep and well-drained. The surface horizon, as described by Ireland and Matthews, is a dark brown (10YR 4/3) sandy loam averaging 23 cm in thickness; a B horizon of yellowish brown (10YR 5/8) loamy sand underlies the plowzone (1974:19). Discrete pockets of Evesboro loamy sand, Rumford loamy sand, and Sassafras sandy loam also are mapped within the higher elevation areas adjacent to the APE. The

lower elevations within the project area, including the land adjacent to Turkey Branch and Ake Ditch, are occupied by the Fallsington sandy loam. This soil is described as having a surface horizon comprised of dark grayish brown (10YR 4/2) sandy loam with an average depth of 20 cm with an underlying argillic Bt horizon of gray (10YR 6/1) sandy clay loam with brownish yellow (10YR 6/8) mottles (Ireland and Matthews 1974:17). The later is described as poorly drained and can only be cultivated when artificial drainage is employed (Ireland and Matthews 1974:17).

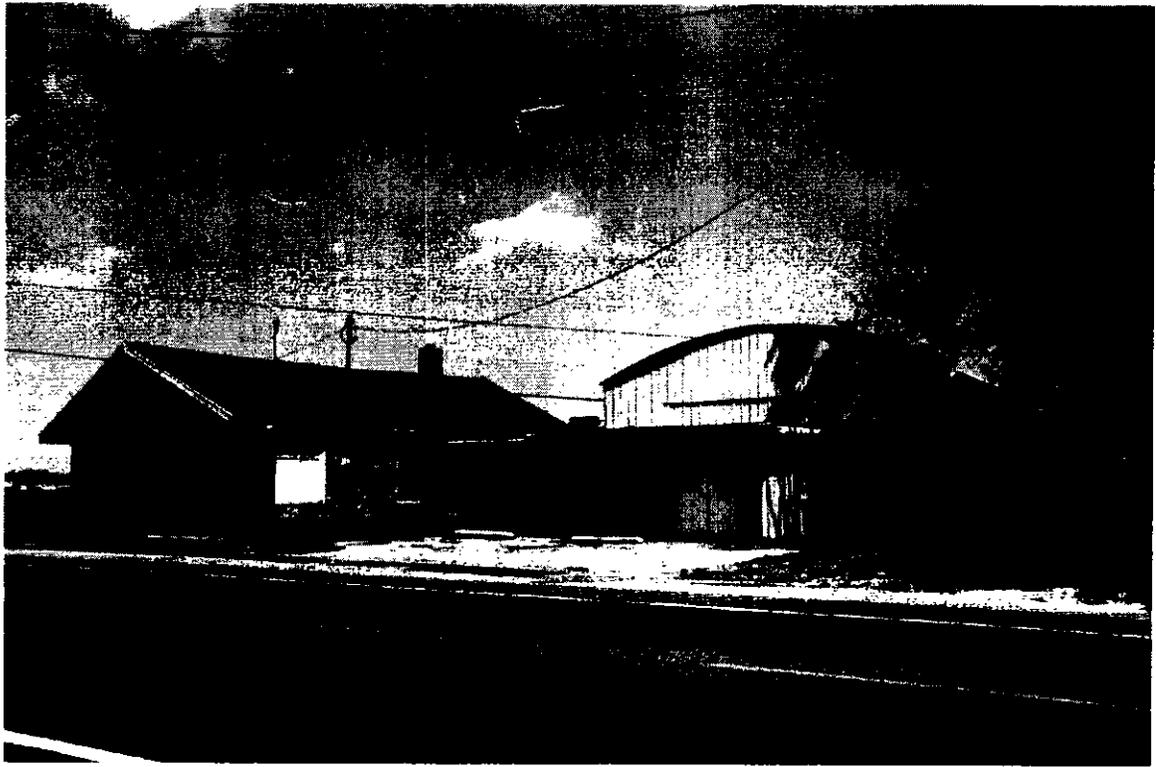
Plate 8. Buildings (S-11504), SE corner of Rifle Range Road and Route 13A. Southwest and southeast elevations toward northeast.

The building to the south (right in Plate 8) faces southwest towards Route 13A. The one-story paneled-faced concrete-block main block is rectangular in shape and measures approximately three bays wide by four bays deep. A wood-and-glass door pierces the south corner, and double-hung, six-over-six windows pierce the southeast façade. The gable-front roof is obscured by an arched-shaped parapet, which is attached across the upper roofline of the building. A skylight pierces the southeast side of the roofline, and a brick chimney rises from the rear interior. The northeast (rear) wall features two bays, a double-hung six-over-six window and a large wood-and-glass garage door. The gable end is sheathed in aluminum siding.

A flat-roofed, one-story addition projects from the southwest wall of the main block. The addition extends from the center of the building to the west corner, visually attaching itself to the adjacent building (left in Plate 8). Sheathed in vertical aluminum siding, the addition measures three bays wide by one bay deep. A double-door, wood-and-glass entrance pierces the south corner. Two double-hung, six-over-six window are located on the west side of the doors and at the southeast end of the addition.

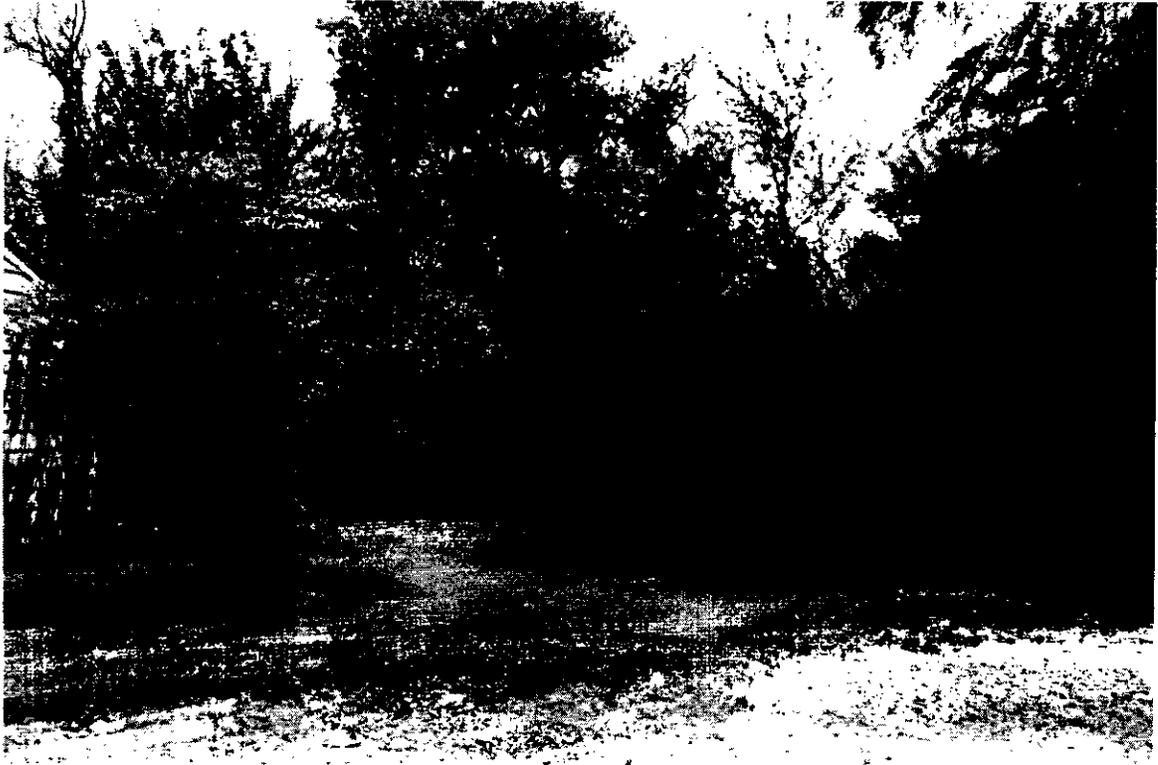
Plate 9. Outbuilding (S-11505), South side of Rifle Range Road between Route 13 and Route 13A.  
North elevation toward south.

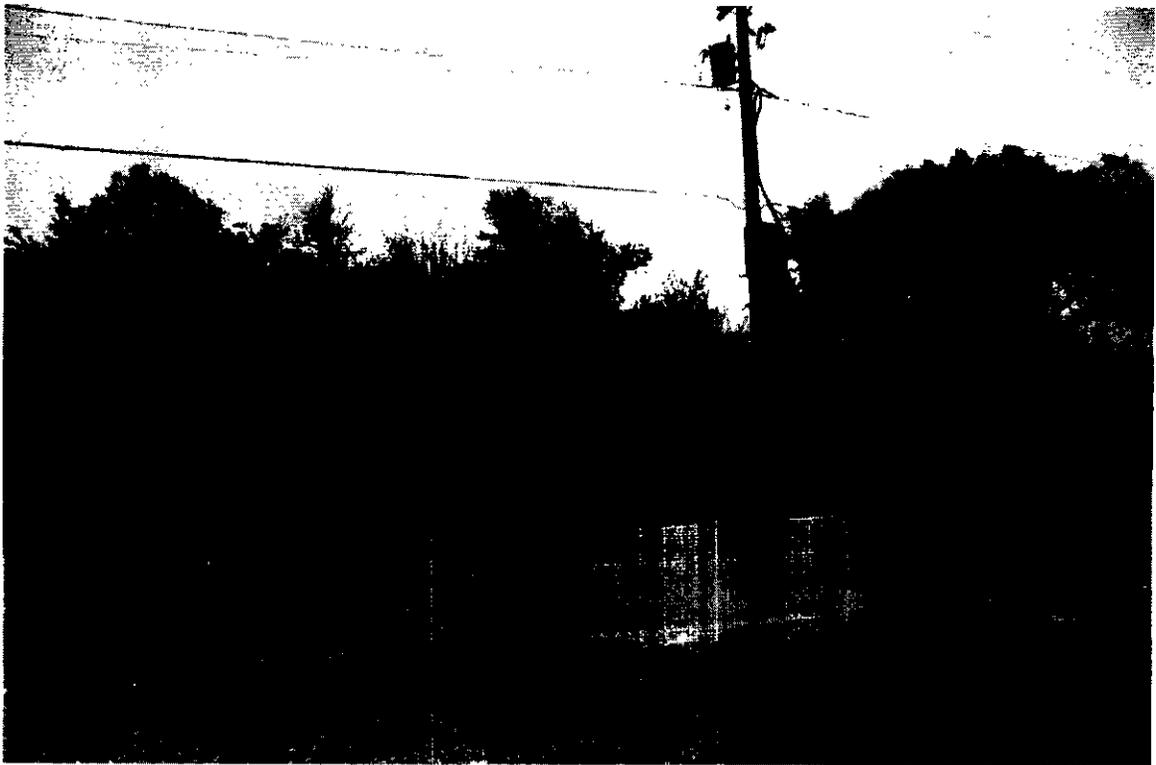
Plate 10. Outbuilding (S-11505), South side of Rifle Range Road between Route 13 and Route 13A.  
North and east elevations toward southwest.

The storage building (Plate 10), located southeast of the dwelling, faces north toward Rifle Range Road. This one-story frame building is rectangular in shape and measures two bays wide by one bay/room deep. Vertical wood paneling covers the exterior. Wood swing-hinge doors access the building from the southeast (front) façade. A modern double-hung, one-over-one aluminum-framed window is located to the west side of the entrance. The same type of window is featured on the east (side) elevation. The gable-front roof is wide, low-lying, and covered in standing-seam metal. The south (rear) elevation was obscured by overgrown vegetation.

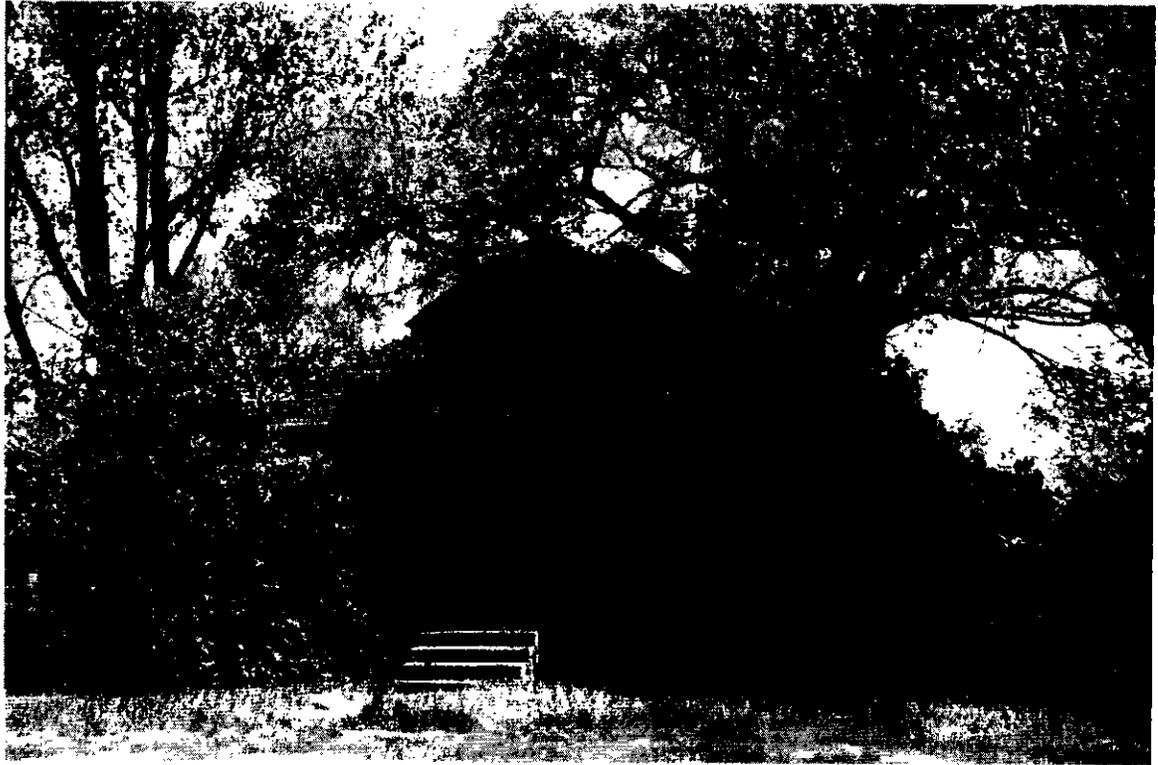
Plate 11. Dwelling (S-1710), East side of Route 13A, south of Rifle Range Road. Southwest elevation toward northeast.

The southwest façade measures three bays wide. Modern double-hung, one-over-one sash windows flank the centered entrance. The door is wood-and-glass, protected by a modern storm door. A clipped, gable-front dormer rises above the porch level of the façade and is pierced by a

triple window grouping, featuring a central, double-hung, one-over-one sash. A full-width inset porch shelters the entrance to the dwelling. Wood Doric-style columns on a wood deck with concrete-block piers support the porch. Concrete steps, centered along the front edge of the deck, provide access to the porch.

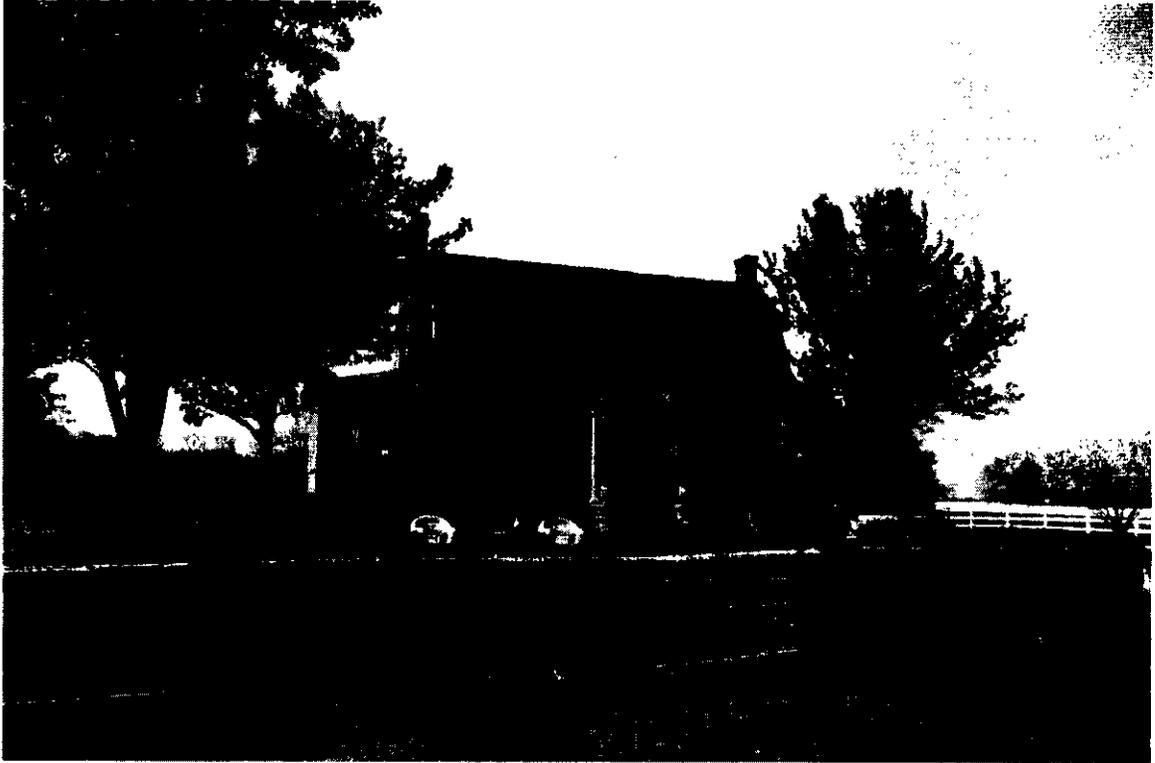
Plate 12. Julia A. Fleetwood Dwelling (S-1670), West side of Route 13A, south of Rifle Range Road. Northeast elevation toward west.

Situated on the west side of Route 13A, on an open, flat lot with scattered groups of trees, stands this Dutch Colonial-style dwelling (Plate 12). A post-rail fence lines the front (northeast) perimeter of the property. A driveway enters the south side of property and extends in a circle at the rear of the dwelling, between the rear outbuildings. The house faces northeast towards the roadway. The two-story, wood-framed, center-passage dwelling is rectangular in shape. A gabled rear ell extends from the center of the rear wall. The main block is sheathed in cement-

asbestos shingles and rests on a stone-and-brick foundation. A side gambrel roof, covered in asphalt, shelters the dwelling. Two half-engaged brick chimneys rise from either end. A third brick chimney rises from the center of the roof of the rear ell.

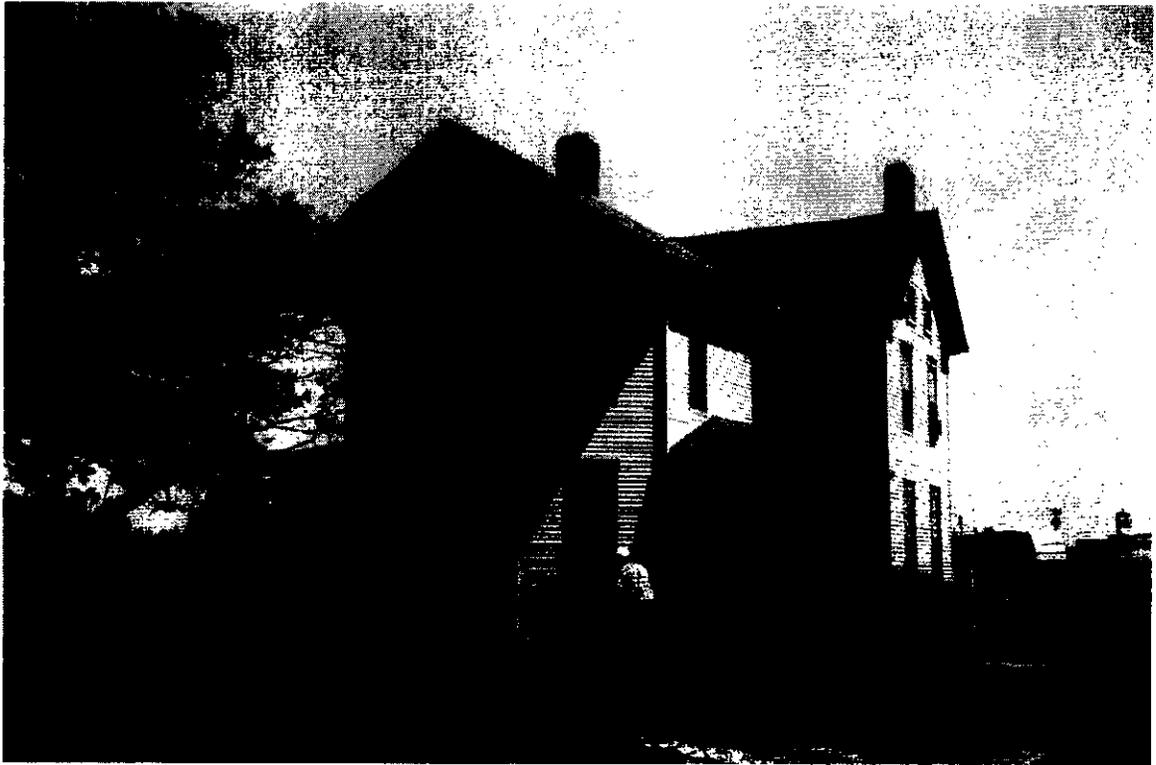
Plate 13. Lizzie Belle Richards Dwelling (S-1712), East side of Route 13A, south of Rifle Range Road. Southwest and southeast elevations toward northeast.

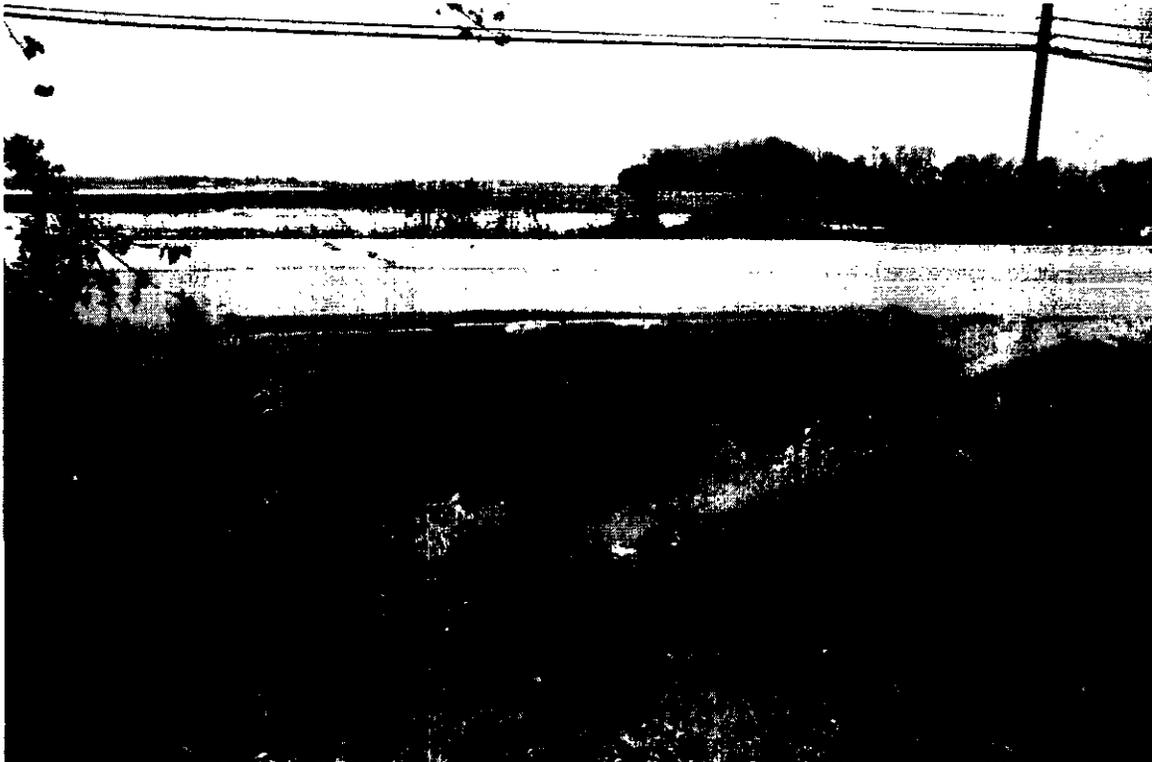
Plate 14. Culvert (S-11506), crosses Route 13A. East side.

The structure is a six-foot, box concrete culvert and consists only of abutments and a deck/roadway. Parapets, wing walls, or metal guardrails are not present on this structure. The

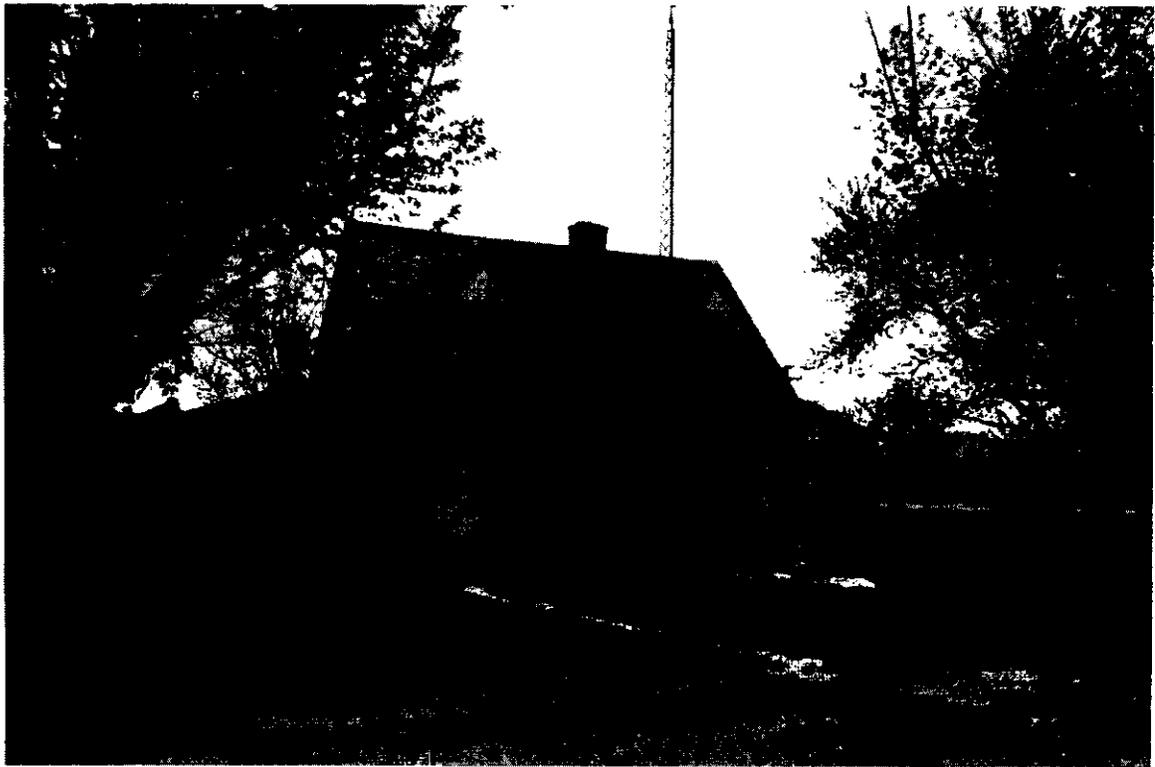
Plate 16. Dwelling (S-8456), East side of Route 13A, south of Rifle Range Road. Southwest and northwest elevations toward southeast.

The Cape Cod cottage had been a vernacular building type for over 200 years but was not adopted by the vernacular housing industry until the 1920s. When Cape Cod cottages were first introduced to the twentieth century homeowner, they were termed "colonial cottages." The Cape Cod cottage is a compact house featuring a small portico or pedimented entrance and a large interior central or wall-end chimney. Many models had a low gable rake on the façade, twin gabled dormers, or a cutaway porch. This style was produced and distributed in packages of integrated architectural elements. The cladding was typically clapboard or brick, and occasionally shingles. The chimney eventually disappeared from the plan, and the entrance developed into a projecting vestibule. The house was charming and cozy and was heavily marketed as a starter home (Gottfried and Jennings 1988: 192).

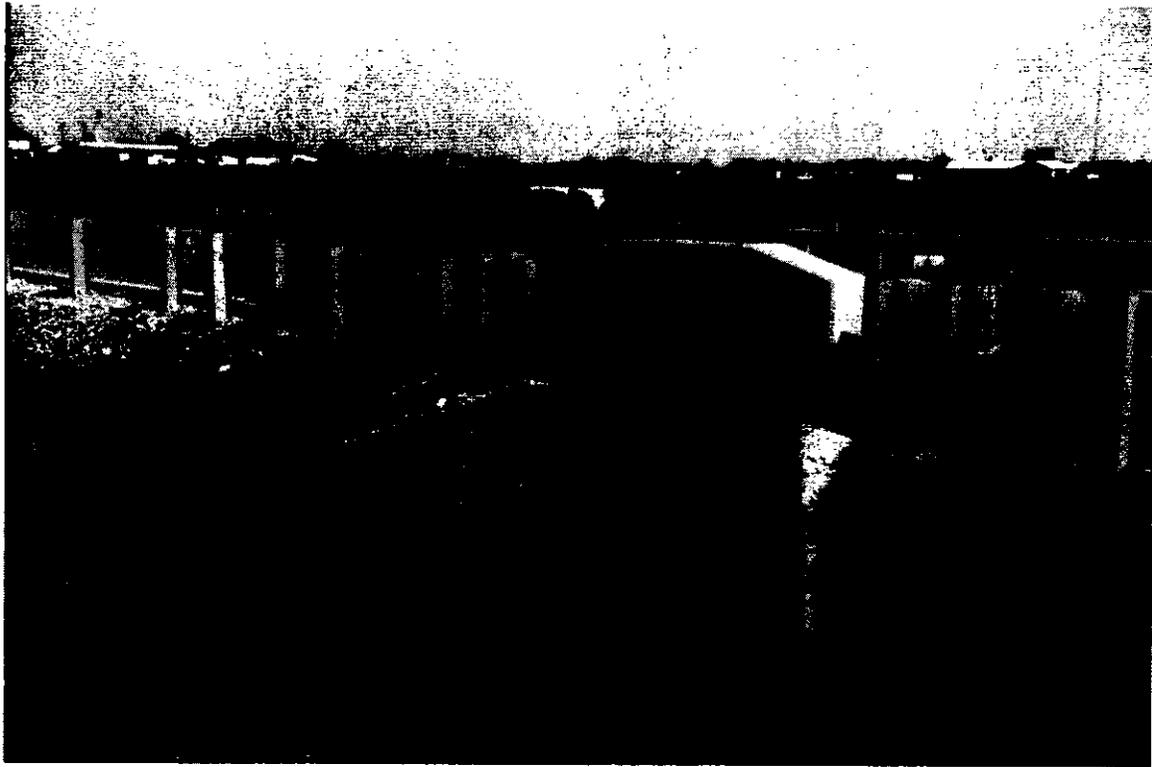
Plate 18. Third Culvert (S-11507), crosses Route 404. Southwest side.

The structure is a six-foot box concrete culvert and consists of abutments, wing walls, deck/roadway, and parapet. The single span structure measures approximately six feet in length, and has a curb-to-curb width of approximately twelve feet. Narrow shoulders run the length of the roadway along both sides of the road. The deck of the structure is concrete slab, topped by asphalt paving.
