**PHASE I ARCHAEOLOGICAL SURVEY OF
THE ARMSTRONG CORNER NEW
STORMWATER MANAGEMENT
FACILITY, NEW CASTLE COUNTY,
DELAWARE**

Parent Agreement 1534, Task 10, Subtask I

DOVETAIL
CULTURAL RESOURCE GROUP

September 2013

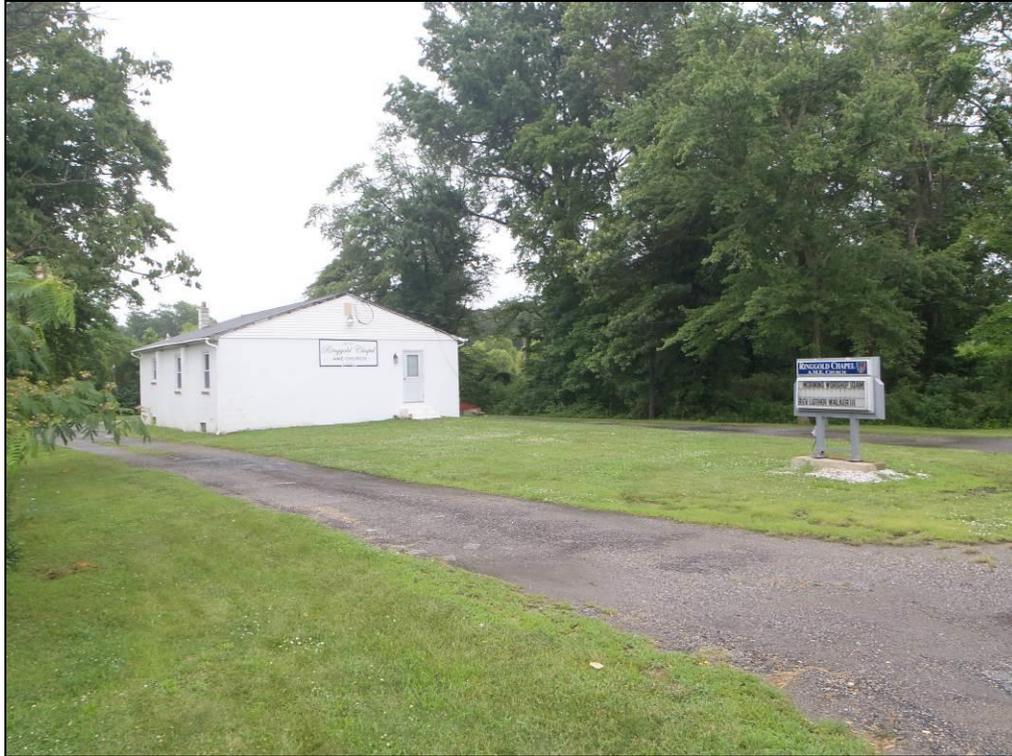
Photo 1: View of the Ringgold Chapel Driveway, Lawn, and Building, Looking East-Southeast.

A driveway, parking lot, lawn, and circa-1985 Ringgold Chapel building effectively divide the project area in half, creating approximately 1 acre (0.4 ha) northern and southern portions of the project area (Photo 1 and Photo 2, p. 5). Much of the northern portion is overgrown in young saplings (Photo 3, p. 6). South of the saplings, the vegetation changes to dense thickets of large bramble bushes, vines, and wetland grasses (Photo 4, p. 6). The southern portion is largely covered with older secondary growth trees surrounded by a dense understory of brambles and wetland vegetation with a large open area next to US Highway 301 (Photo 5 and Photo 6, p. 7). A flagged wetland is located directly north of the Ringgold

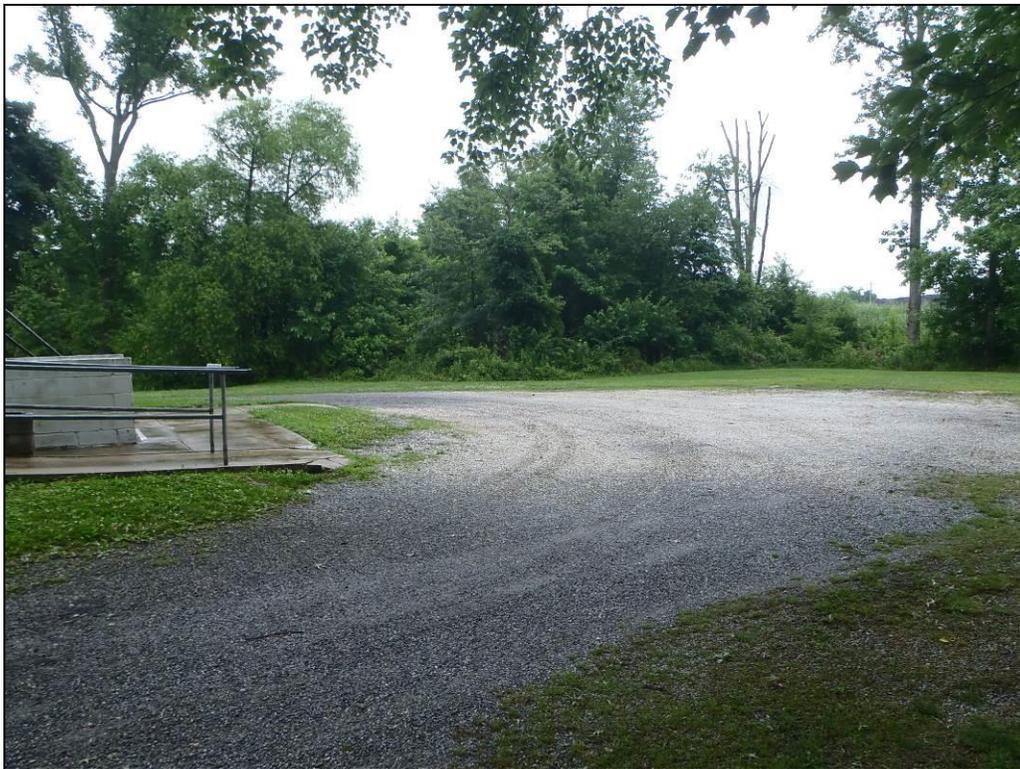
Photo 2: View of the Parking Lot Behind the Ringgold Chapel, Looking North-Northeast.

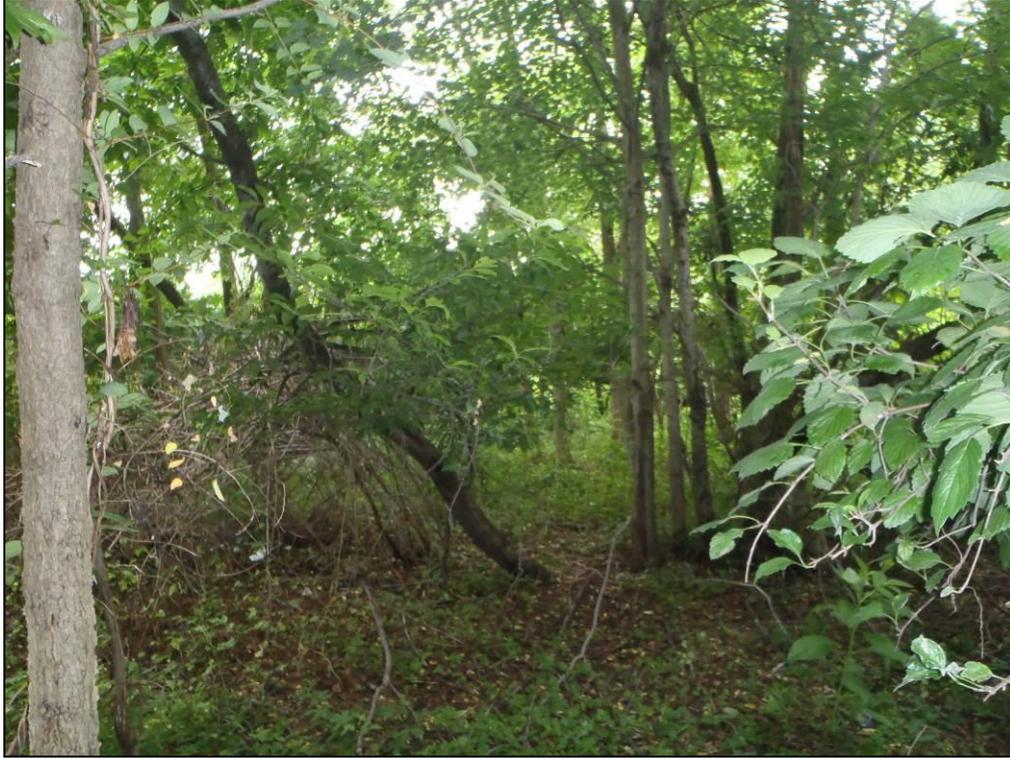
Photo 3: View of Growth in the Northern Portion of the Project Area, Looking West.

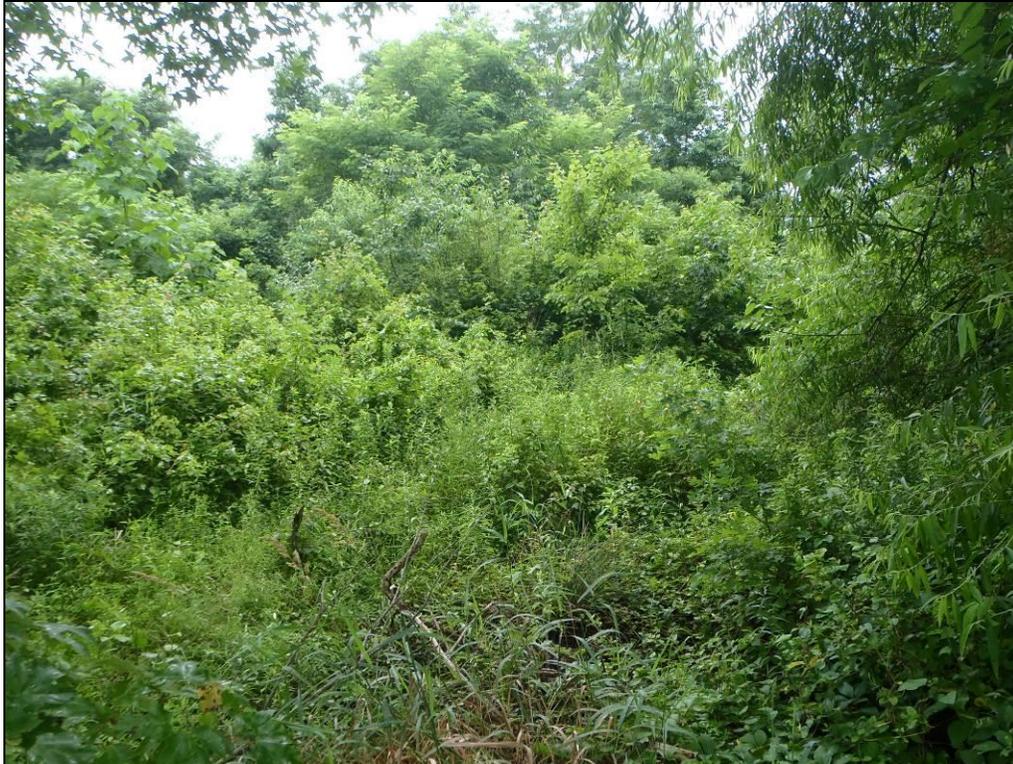
Photo 4: View of the Dense Thickets of Large Bramble Bushes, Vines, and Wetland Grasses South of the Saplings in the Northern Portion of the Project Area.

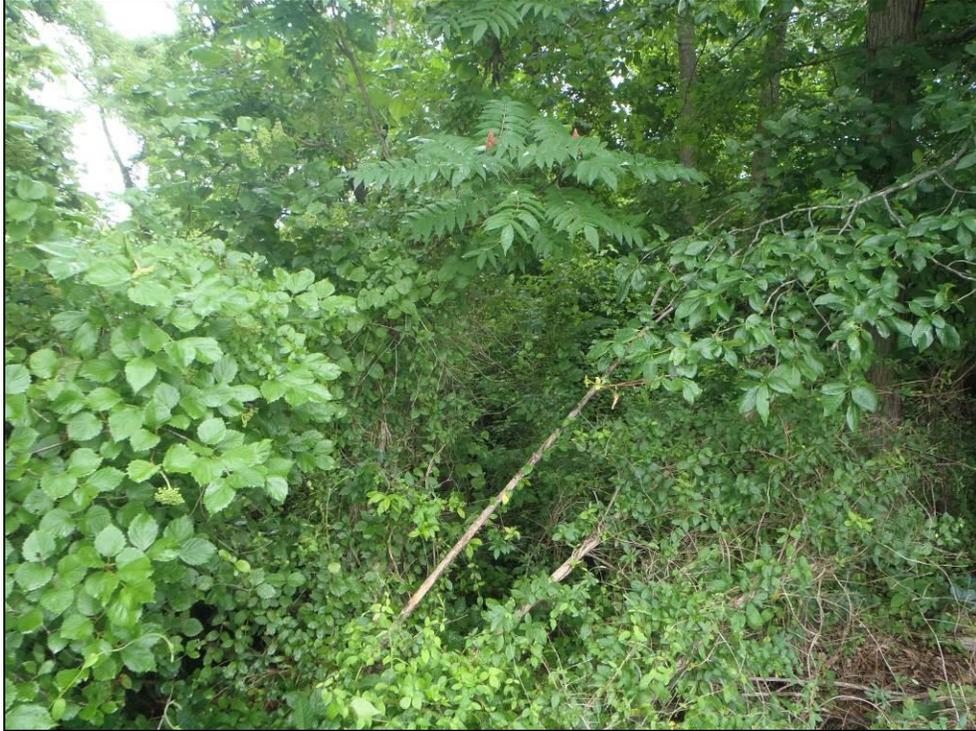
Photo 5: View of the Larger Secondary Growth Trees Surrounded by Dense Undergrowth in the Southern Portion of the Project Area, Looking North.

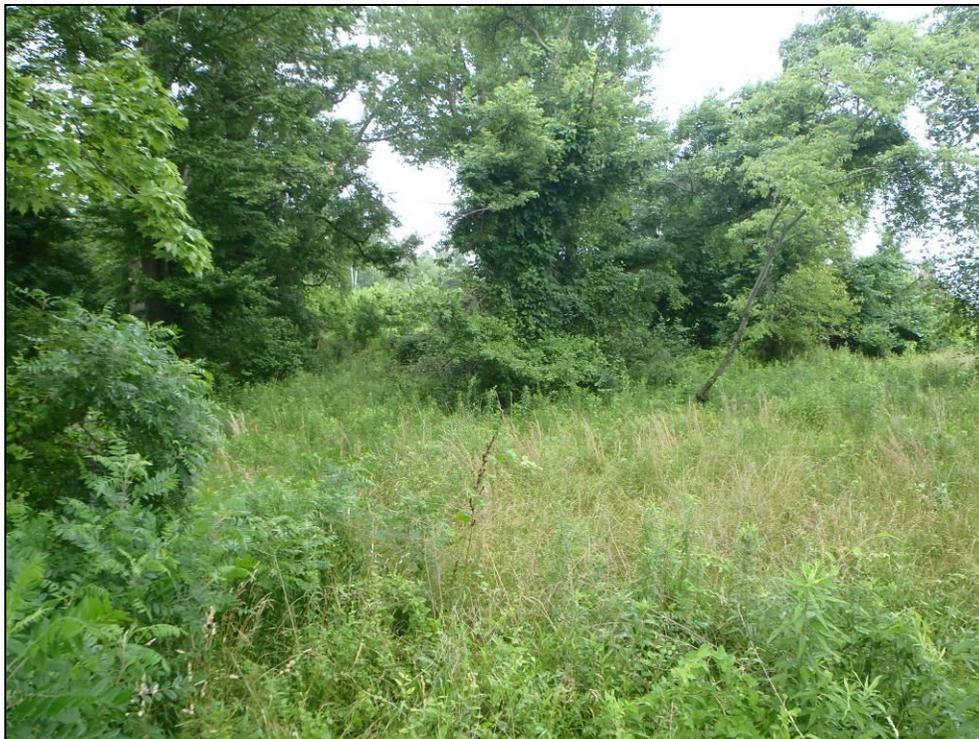
Photo 6: View of the Open Area next to US Highway 301 in the Southern Portion of the Project Area, Looking Southeast.

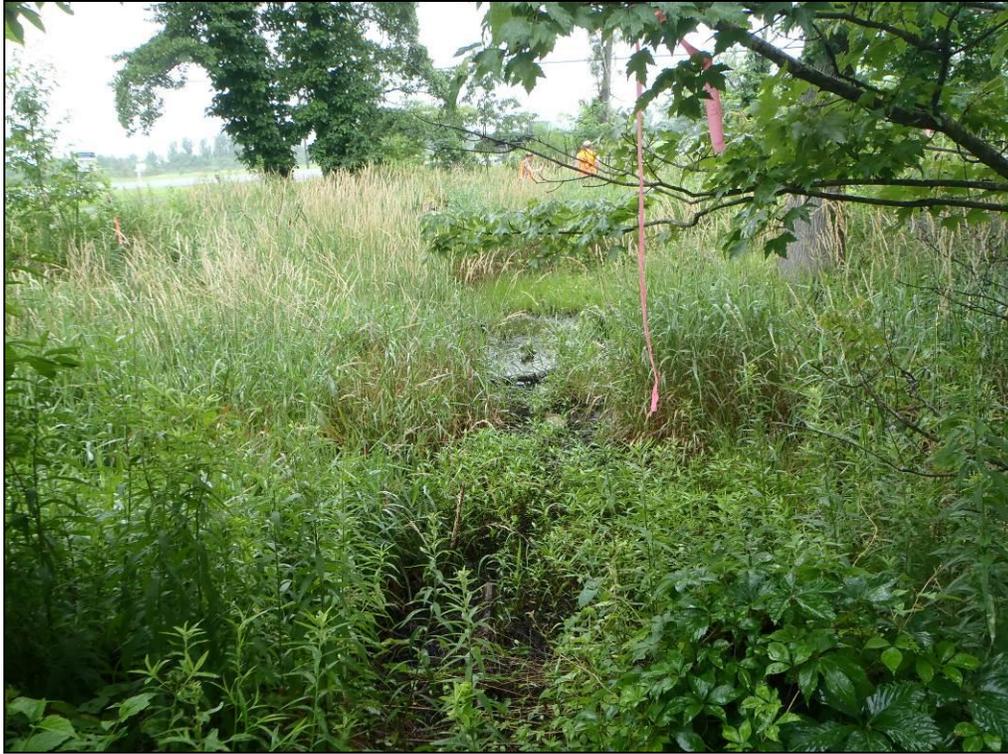
Photo 7: View of Flagged Wetlands in the Project Area, Looking Northwest.

Chapel grounds and another flagged wetland is located in the southeastern project area (Photo 7, p. 8).

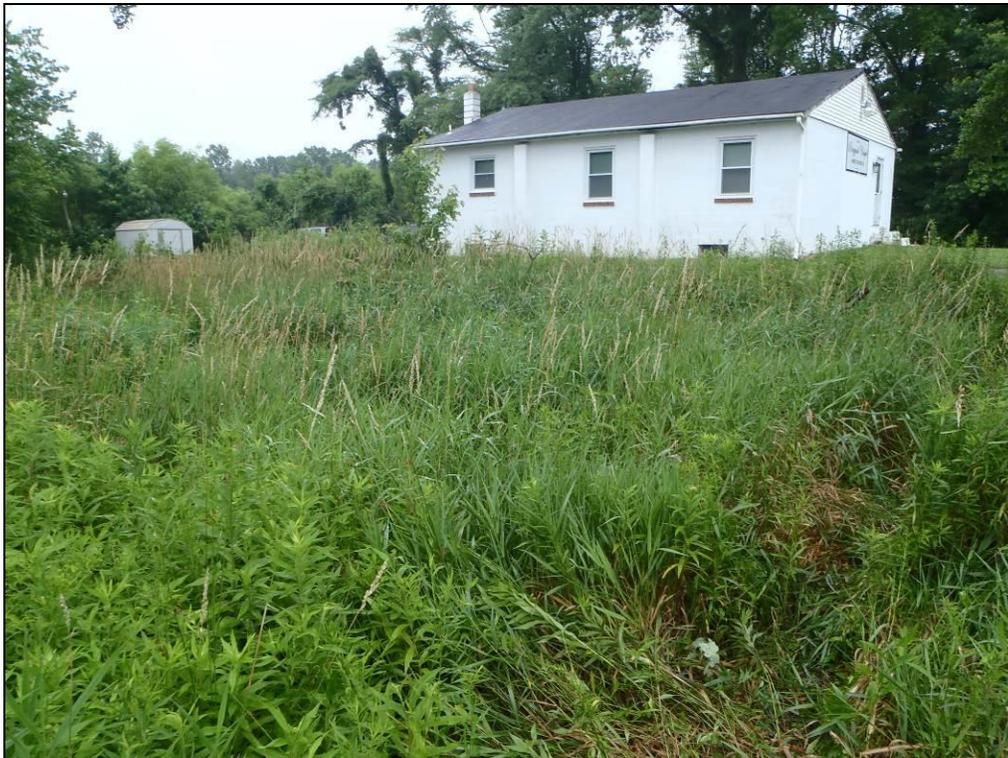
Photo 8: View of the Elevated Ringgold Chapel Grounds, Looking Southeast.

The Ringgold Chapel grounds are built up approximately 5 feet (1.5 m) above the current ground surfaces of the northern and southern portions of the project area (Photo 8, p. 8). There is also an artificial linear berm along the northern and eastern boundaries of the project area (Photo 9 and Photo 10, p. 9). The ground surface along the northern berm is significantly higher outside of the project area than inside (Photo 11, p. 10). Along the eastern boundary, the berm separates the project area from a large, intact wet area (Photo 12, p. 10). These two observations indicate that the berm was created from inside the project area by pushing soil towards the northern and eastern boundaries.

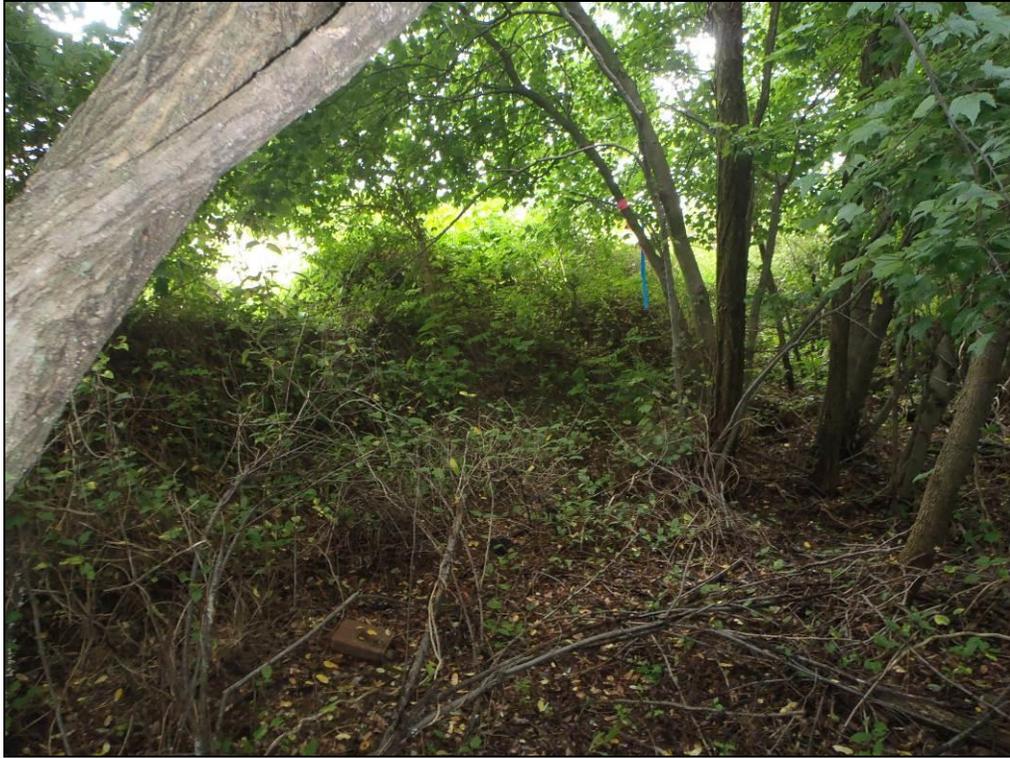
Photo 9: View of the Artificial Linear Berm along the Northern Project Area Boundary, Looking Northeast.

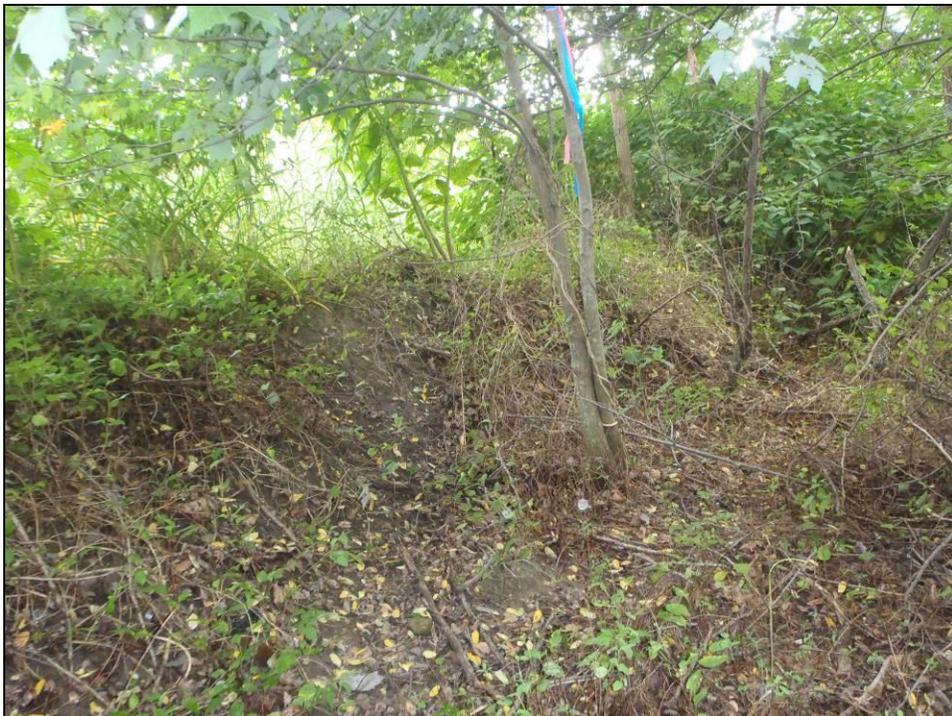
Photo 10: View of the Artificial Linear Berm along the Eastern Project Area Boundary, Looking Southeast. Wetland grasses are visible beyond the berm.

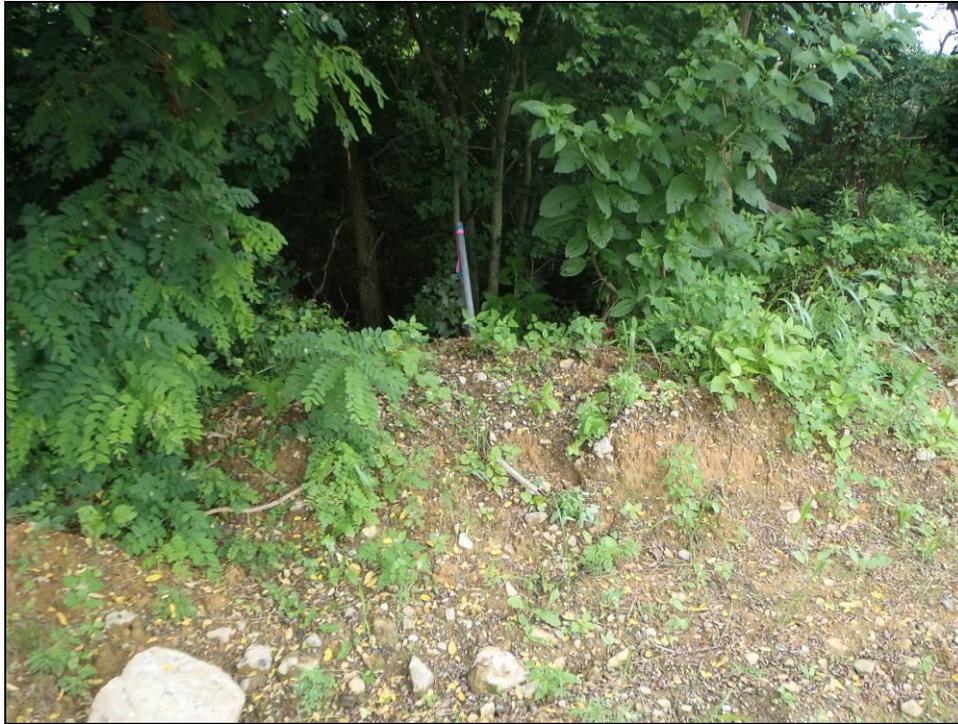
Photo 11: View of the Artificial Berm along the Northern Project Boundary from Outside of the Project Area, Looking Southwest. The significantly lower project area is visible beyond the berm.

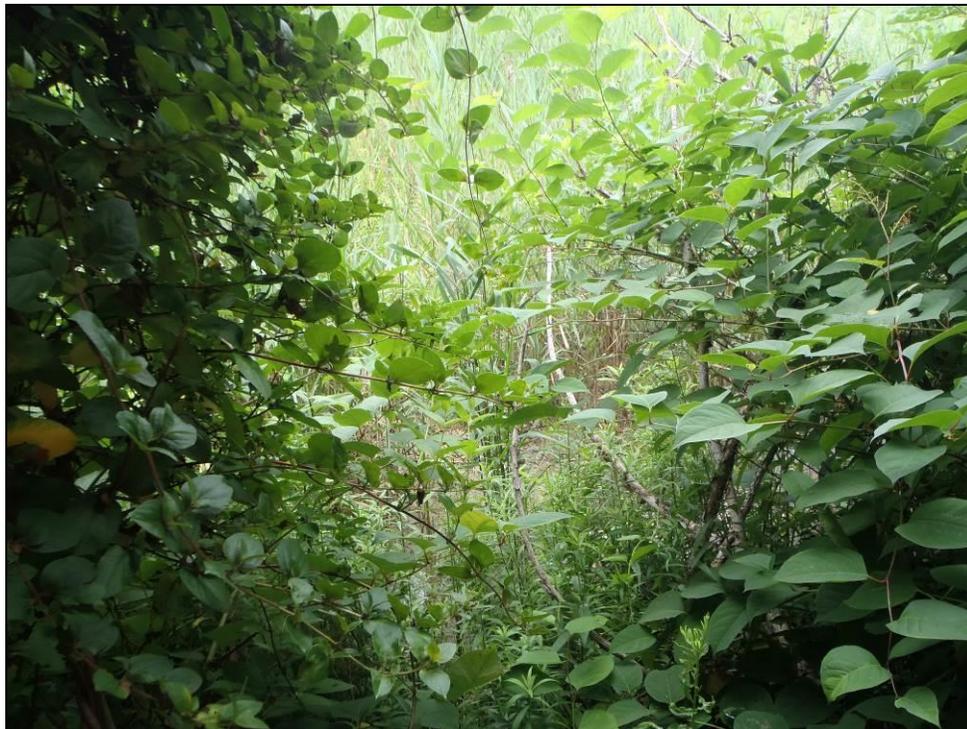
Photo 12: View of the Intact Wetland Beyond the Artificial Berm along the Eastern Boundary of the Project Area.

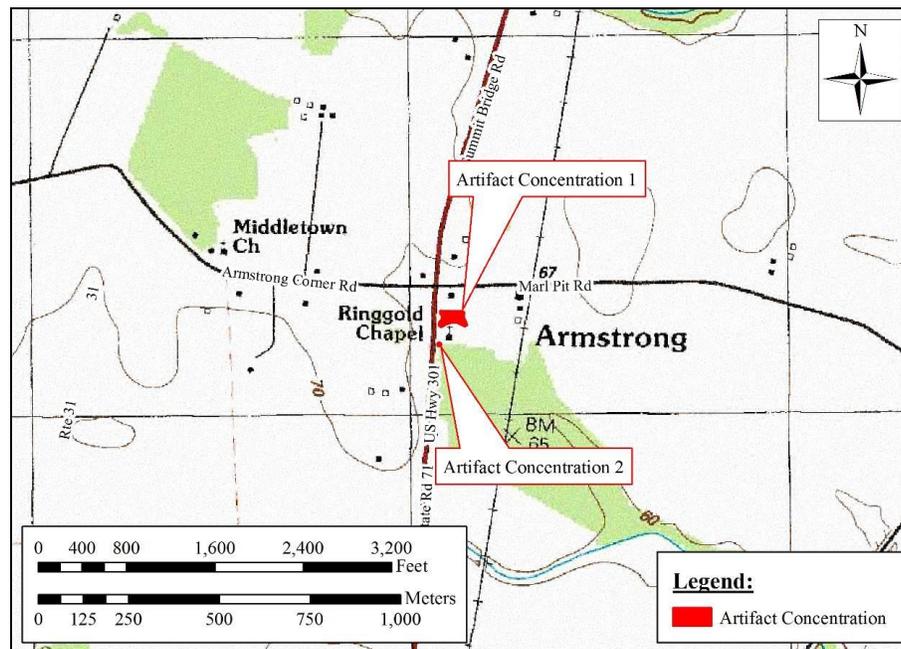
Figure 3: Location of Artifact Concentrations 1 and 2 on the 7.5-Minute Digital Raster Graphic Mosaic of New Castle County, Delaware (USDA 2001).

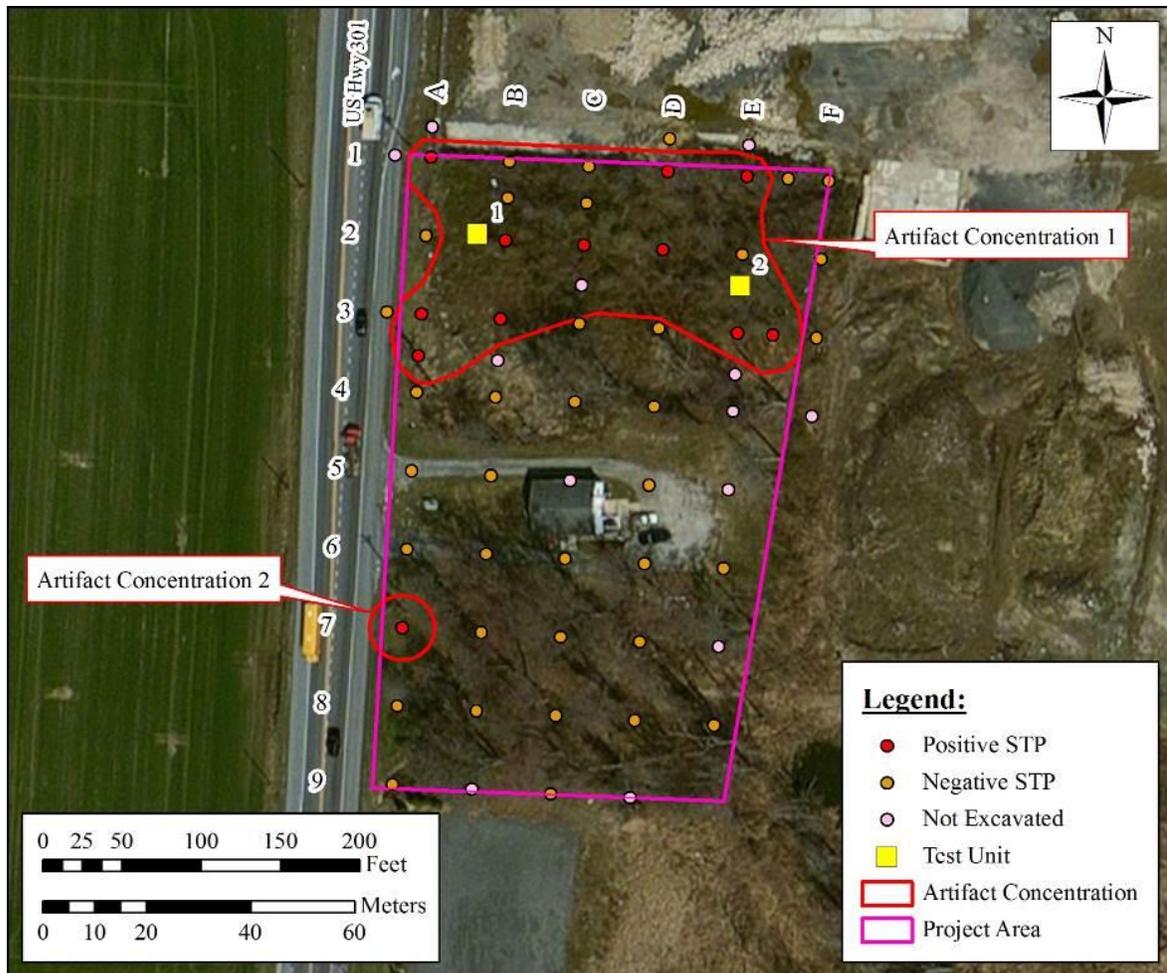
Figure 4: Location of STPs in the Project APE, NAIP (USDA 2011).

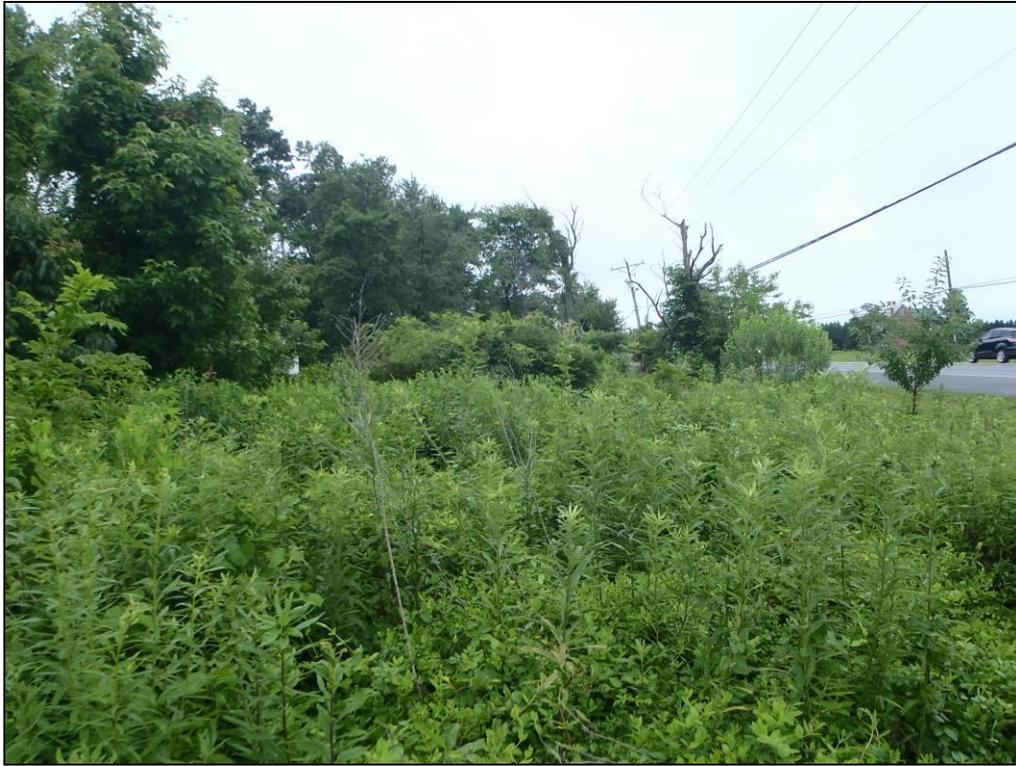
Photo 13: View of the Western Portion of Artifact Concentration 1, Looking South.

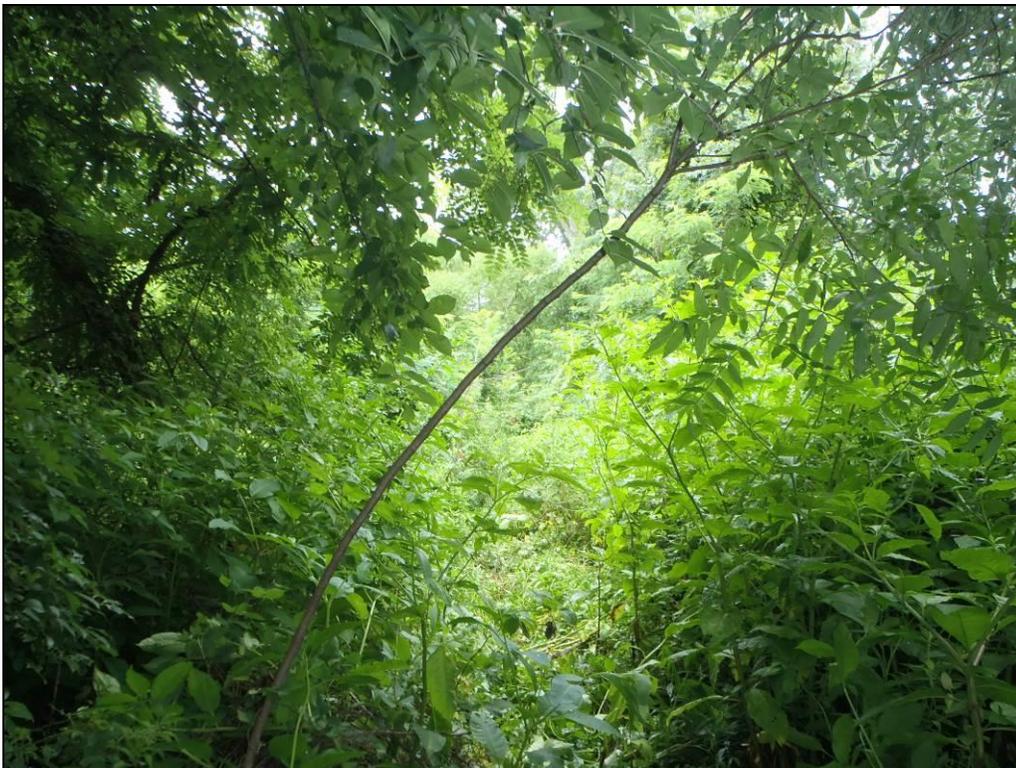
Photo 14: View of the Eastern Portion of Artifact Concentration 1, Looking South.

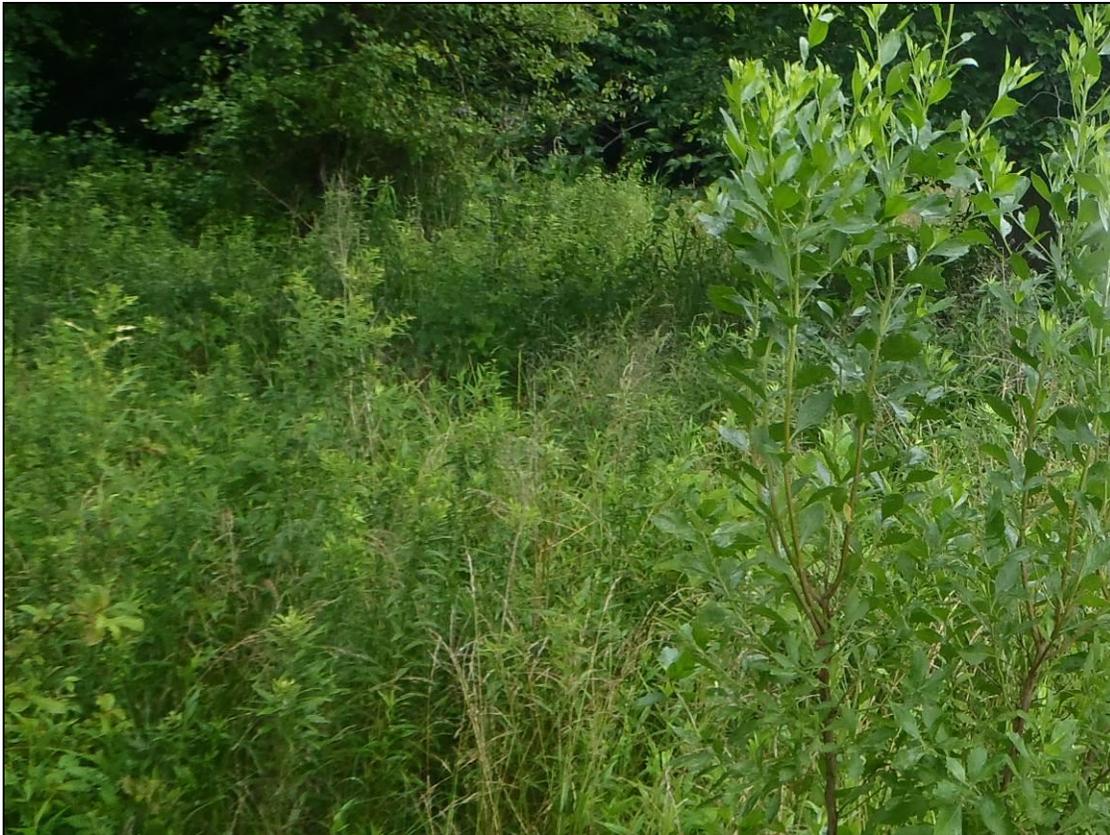
Photo 15: View of the Location of Artifact Concentration 2, Looking South.

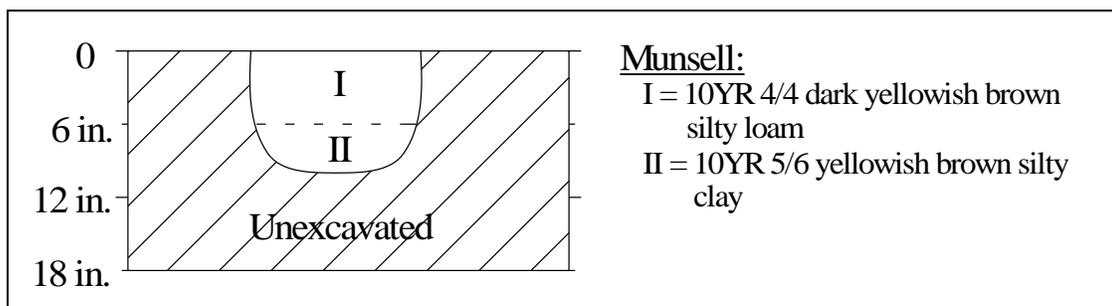
Figure 5: Representative STP Soil Profile From the Project Area.

STPs across the project area were fairly shallow. The average depth was 6.8 inches (17.3 cm) and the deepest STP was 14 inches (35.6 cm). The average depth of A-horizon soils was 3.8 inches (9.7 cm), with the deepest A-horizon at 12 inches (30.5 cm). These numbers speak to the fact that the thickness of A-horizons and the overall depth of STPs varied greatly from very shallow to much deeper. STP soil profile variability was dependent on the STPs' locations relative to marked wetlands, other areas of standing water at the time of the fieldwork, and areas of obvious disturbance. Gley soils were encountered in some STPs, some filled with water immediately, and some showed the mixed evidence of disturbance under the topsoil. However, a similar soil profile was encountered in just over half of the STPs consisting of a 10YR 4/4 dark yellowish brown silty loam covering 10YR 5/6 yellowish brown silty clay (Figure 5, p. 28).

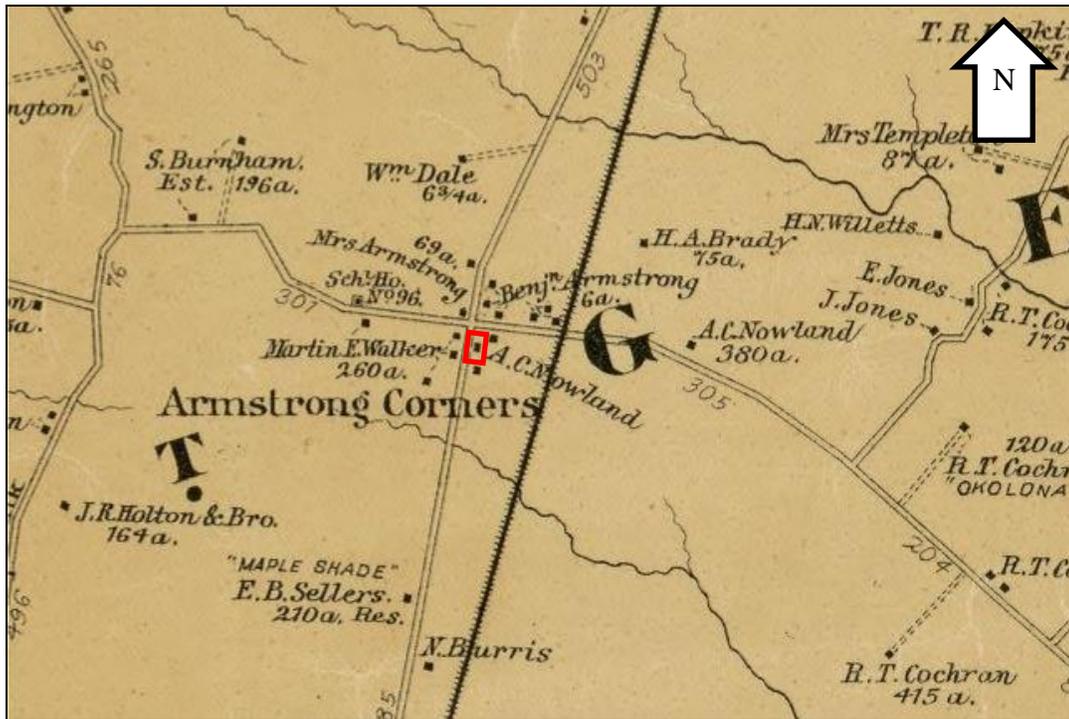
Figure 10: 1881 Hopkins Map (Copy on file at Delaware Public Archives). Project area highlighted in red.

The Nowland family continued to own property at the southeast corner of the Armstrong Corners crossroads into the last-quarter of the nineteenth century and is associated with buildings in the project area on the 1881 Hopkins and 1893 Baist maps (Figure 10 and Figure 11). Census records from 1850 to 1880 indicate that A.C. Nowland did not live at the farm, but resided in the town of New Castle (Ancestry 2009).

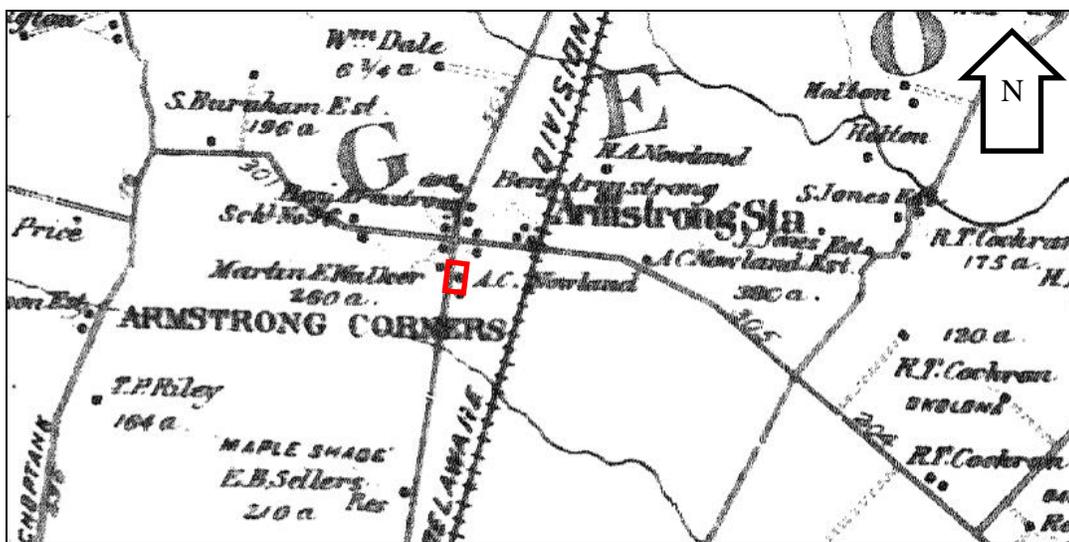
Figure 11: 1893 Baist Map (Copy on File at Delaware Public Archives). Project area highlighted in red.

The two dwellings noted along the east side of what is now Summit Bridge Road (SR 71/301) in 1893 are not depicted in a topographic map of 1899, but two barns or non-residential properties are recorded in another from 1957 (Figure 12 and Figure 13). These buildings are also visible in a circa-1961 aerial image of Armstrong Corners which reveals what appears to be a barn or farm building and what is likely the relocated Ringgold Chapel A.M.E. Church building (N-14330) situated within the project area (Figure 14, p. 34).

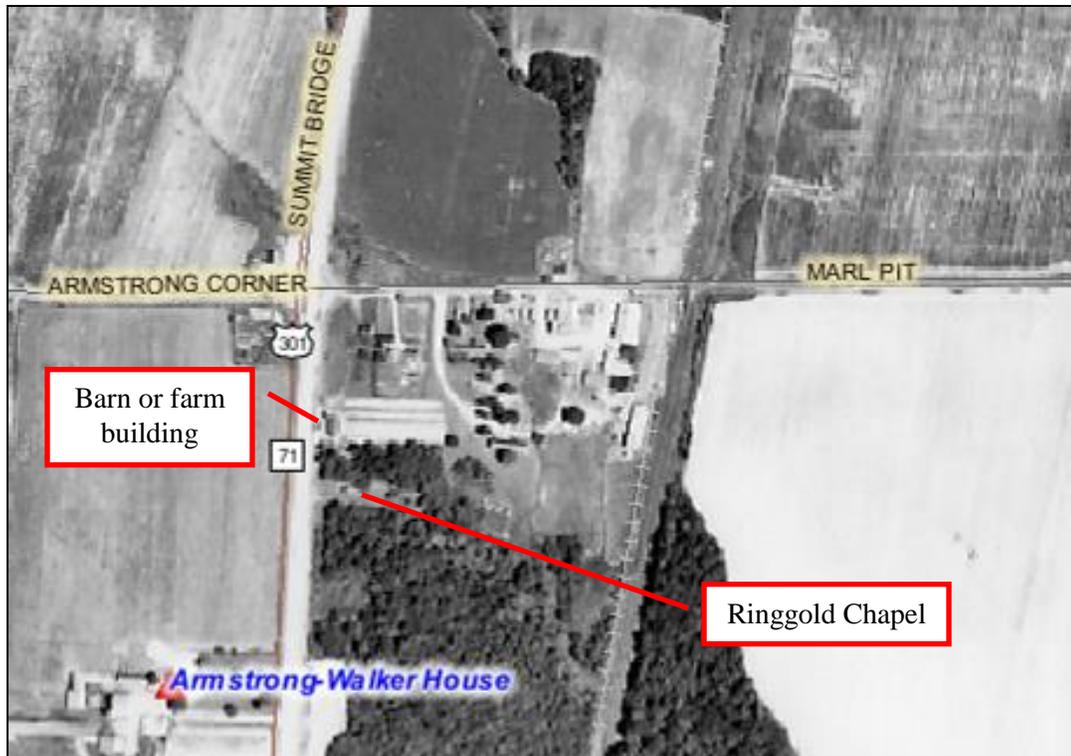
Figure 14: Circa-1961 Aerial Image of Armstrong Corners (CHRIS 2013). What is likely a barn, or farm building, and Ringgold Chapel (N-14330) are highlighted.

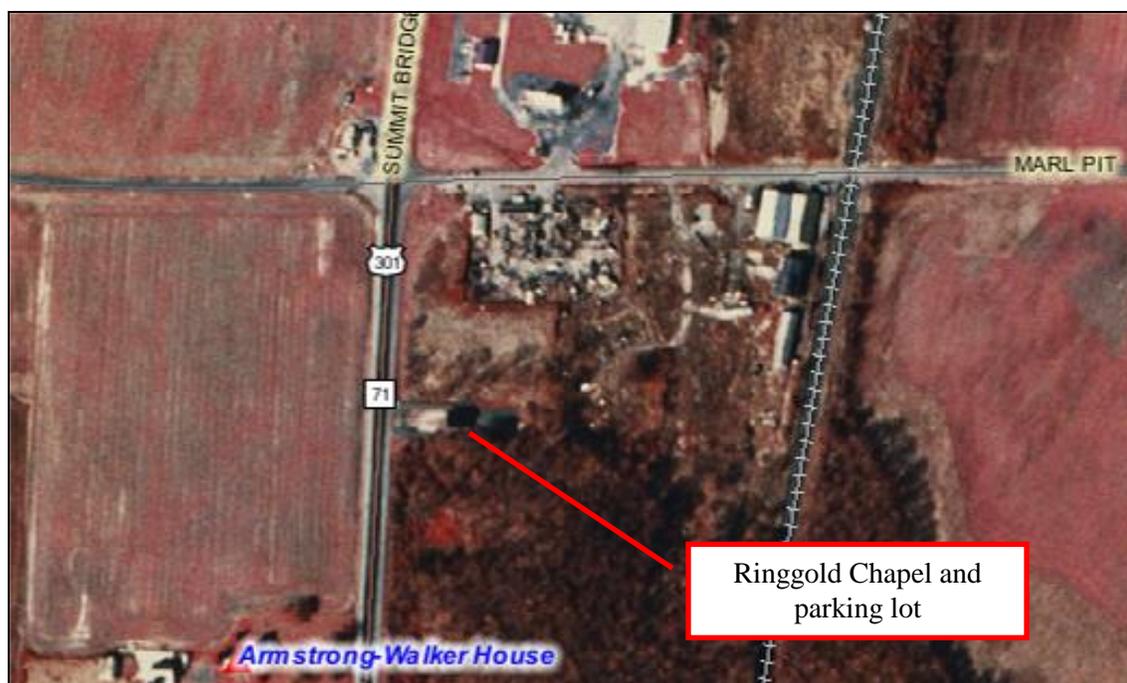
Figure 16: Circa-1992 Aerial Image of Armstrong Corners (CHRIS 2013).

By the early 1990s, the barn and other evidence of agricultural activities within the project area are no longer evident in topographic maps or aerial images (Figure 15 and Figure 16, p. 35).

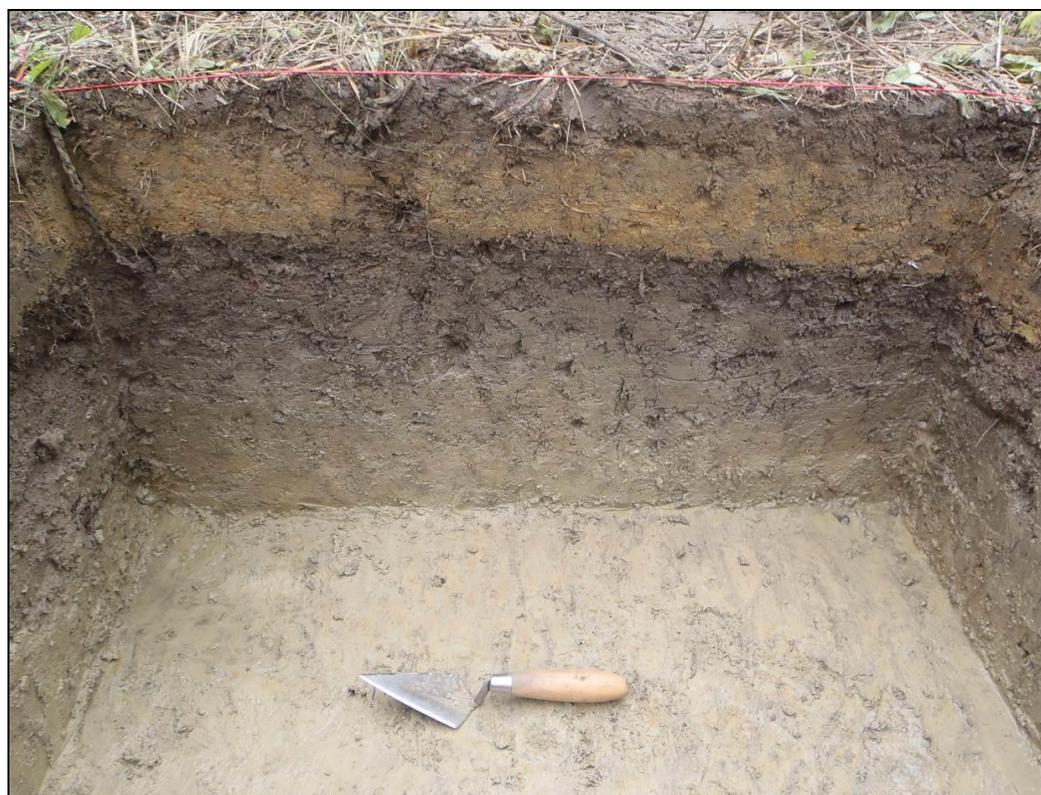
Photo 16: Test Unit 1 East Wall Profile.

Stratum IV represents a 2 to 3-inch (5.1 to 7.6-cm) thick possible transitional E-horizon above subsoil described as a 2.5Y 5/2 grayish brown silty clay. Twenty-four artifacts and one organic (coal) were present in this stratum. The artifacts include 11 glass fragments (10 vessel [eight clear, two solarized] and one brown bottle), nine architectural artifacts (eight nails [four unidentifiable and four cut] and one light aqua window glass), three ceramic fragments (one whiteware, one redware, and one refined stoneware), and the one piece of quartz lithic debitage. Finally, 4 to 6 inches (10.2 to 15.2 cm) of 2.5Y 5/6 light olive brown silty clay subsoil (Stratum V) was removed to ensure the bottom of the culture bearing strata had been reached. Water continued to seep in rapidly and excavation was terminated. No artifacts or organic materials were present in Stratum V (Photo 16 and Figure 17, p. 37).

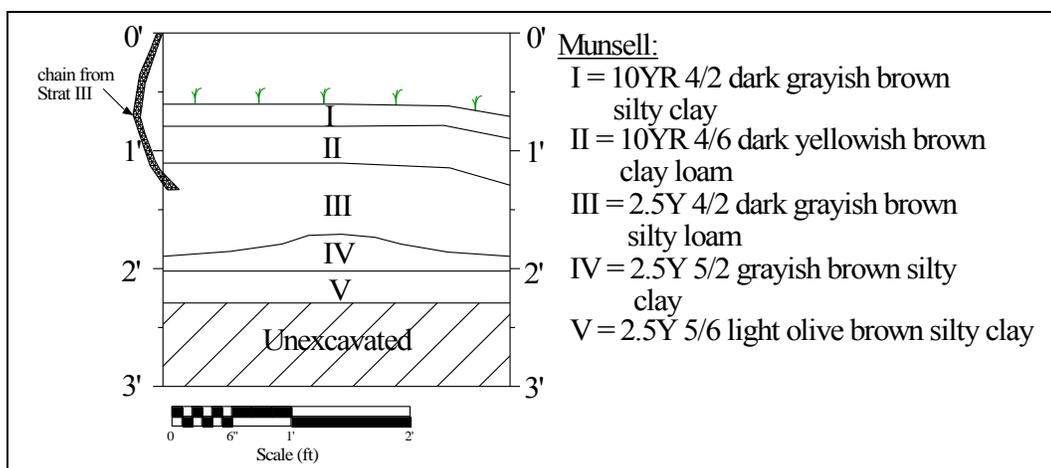
Figure 17: Test Unit 1 East Wall Profile.

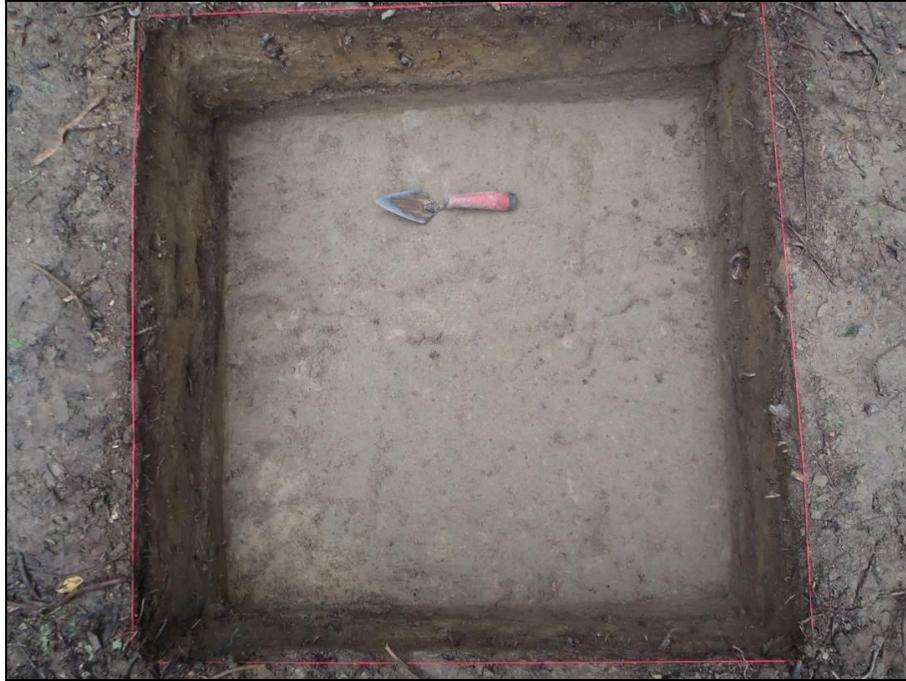
Photo 17: Test Unit 2 Plan View at Base of Excavation.

a soil change and at 4 inches (10.2 cm) across the rest of the unit. The soil was described as a very compact 10YR 6/3 silty loam and no cultural materials were present. Excavation of Test Unit 2 was terminated because two consecutive culturally sterile levels were encountered (Photo 17 and Photo 18; Figure 18, p. 40).

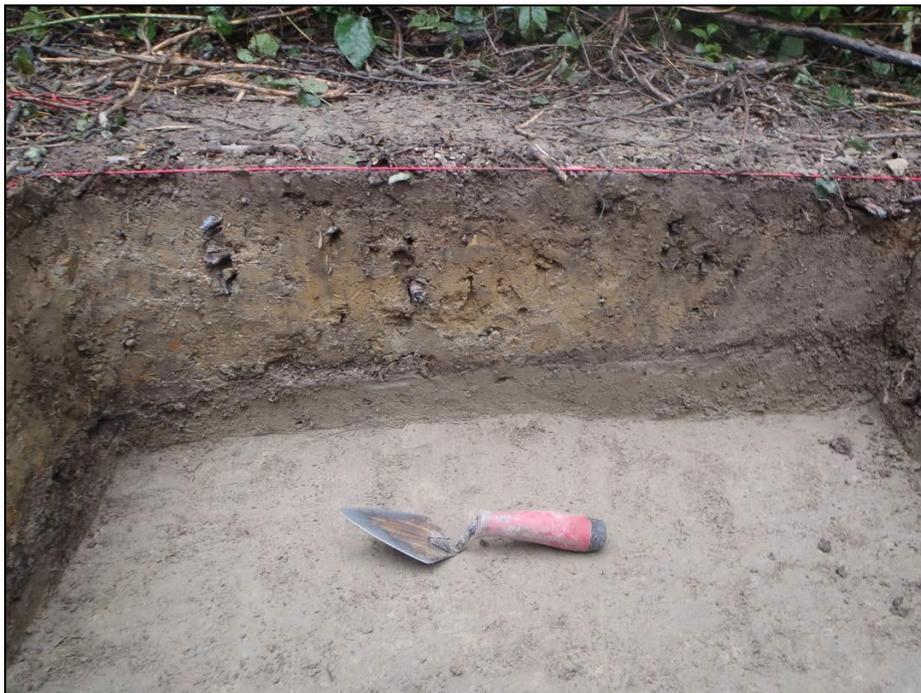
Photo 18: Test Unit 2 East Wall Profile.

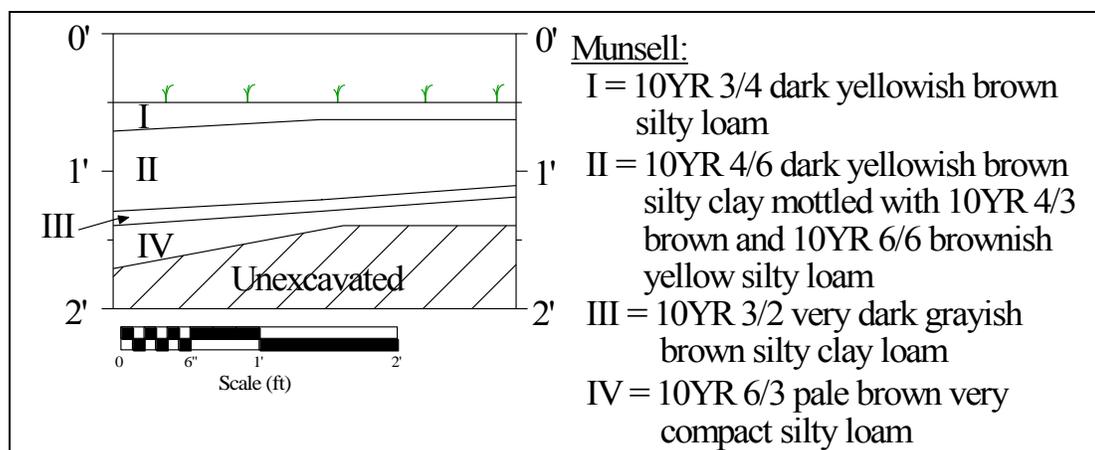
Figure 18. Test Unit 2 East Wall Profile.
