**CULTURAL RESOURCE SURVEY
SURVEY UPDATE FORM**

CRS # S03533

1. **HISTORIC NAME/FUNCTION:** Johnson/ Rust Dwelling

2. **ADDRESS/LOCATION:** 18672 Harbeson Road

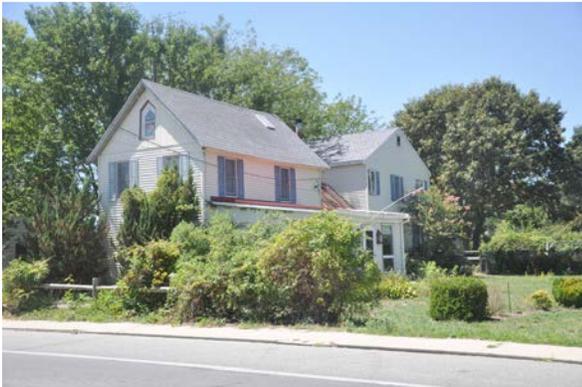
S03533: dwelling (.001) façade and north side, looking southwest.

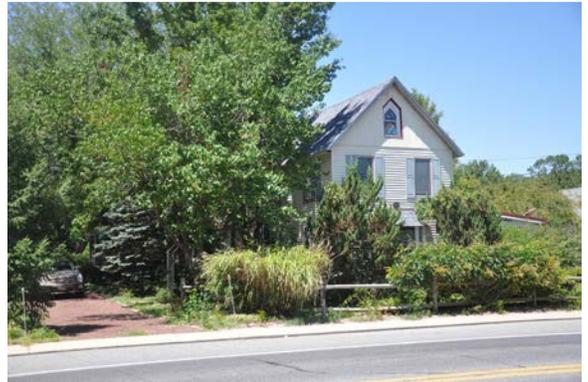
8. DESCRIPTION OF ELEVATIONS:
a. Facade: Direction: East
1) Bays: 4
2) Windows: 1, entrance level; 2, second floor; 1, attic level
fenestration : irregular
Type: modern 3-D bay; 1/1, double-hung; 1/1, double-hung stained-glass peaked
Trim: vinyl; wood
Shutters: paneled, vinyl, non-functional

S03533: dwelling (.001) façade, looking west.

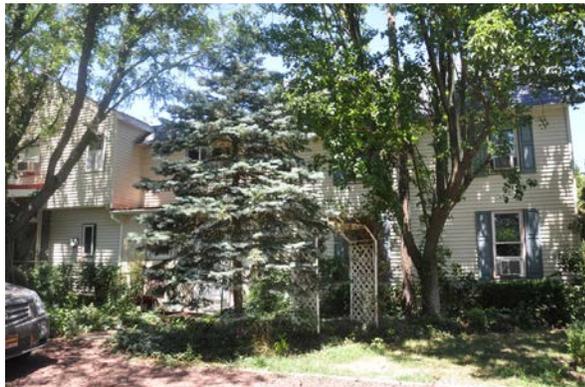
2) **Windows: 6**
 fenestration : irregular
 Type: 1/1, double-hung; casement
 Trim: vinyl
 Shutters: paneled, vinyl, non-functional

S03533: dwelling (.001) south side, looking northwest.

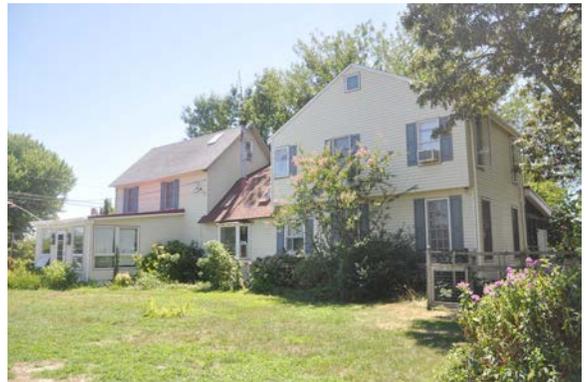
2) **Windows: 2, second floor of main block; 1, entrance level of rear ell**
 fenestration : irregular
 Type: 1/1, double-hung; modern 3-d bay
 Trim: vinyl
 Shutters: paneled, vinyl, non-functional

S03533: dwelling (.001) north side, looking south.

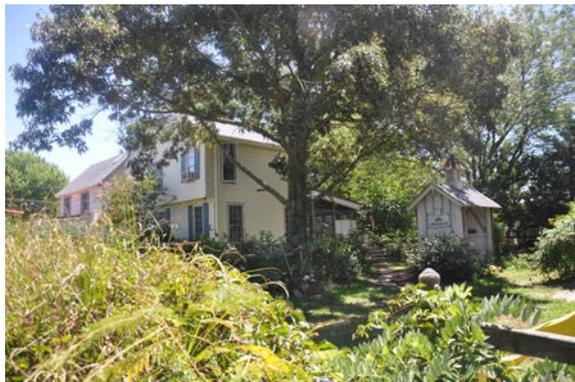
S03533: dwelling (.001) rear and north side and rear lawn structure (.002), looking southeast.

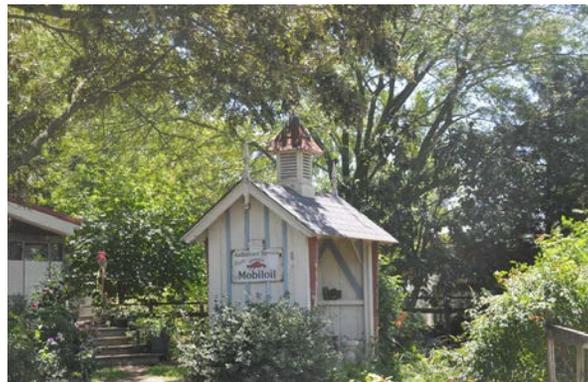
e. Roof: gabled w/ central ventilated cupola and pinnacles at each end
structural system
Coverings: asphalt
Openings:

S03533: rear lawn structure (.002), looking south.

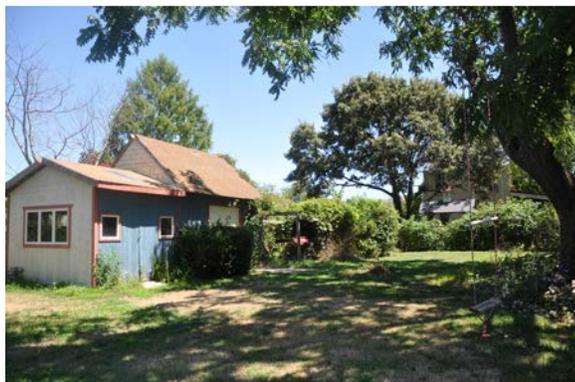
S03533: modern garage with attached shed, looking east.
