CULTURAL RESOURCE SURVEY
SURVEY UPDATE FORM

CRS # S03574

1. HISTORIC NAME/FUNCTION: Prettyman Complex/ Compass Point Associates

2. ADDRESS/LOCATION: 26373 Lewes-Georgetown Highway

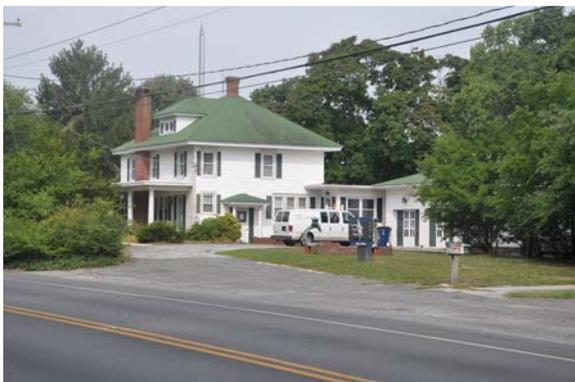
S03574: dwelling (.001), garage (.002) and water fountain (.003), looking northwest.

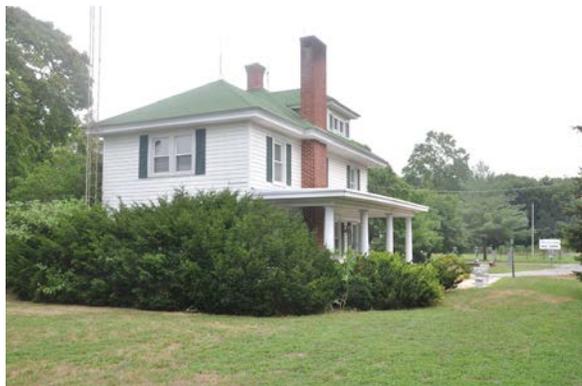
- a. Facade: Direction: South
 - 1) Bays: 6
 - 2) Windows: 2, entrance level; 3, second level
 - Fenestration: regular
 - Type: 1/1, double-hung
 - Trim: vinyl
 - Shutters: decorative, non-functional

- 1) **Bays: 1**
- 2) **Windows: 1, second level**
 - Fenestration: irregular
 - Type: 1/1, double-hung
 - Trim: vinyl
 - Shutters: decorative, non-functional
- 3) **Door(s): 0**
 - location
 - type
 - trim
- 4) **Porch(es)**

S03574: dwelling (.001) façade and west side, looking northeast.

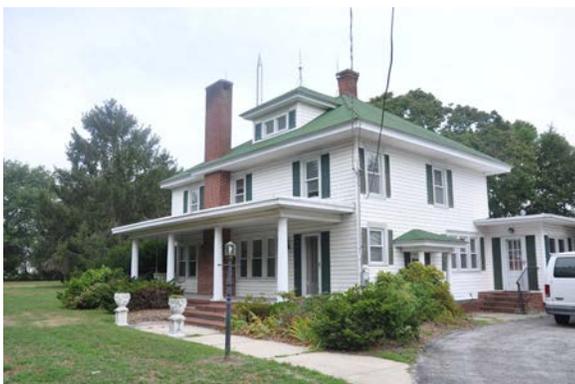
- 1) **Bays: 5**
- 2) **Windows: 2, entrance level; 2, second level**
 - Fenestration: regular
 - Type: 1/1, double-hung
 - Trim: vinyl
 - Shutters: decorative, non-functional
- 3) **Door(s): 1**
 - Location: center
 - Type: 1 pane/3 panel
 - Trim: wood
- 4) **Porch(es): hipped-roof portico w/ wood column supports, on brick flower bed wall**

S03574: dwelling (.001) façade and east side, looking northwest.

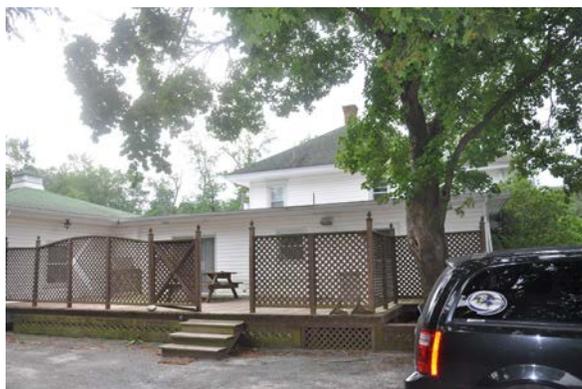
a. Overall shape: square Stories: 2.5
Additions: 1-story full-width L-shaped addition across rear wall w/ attached full-width wood deck; 1-window and 2-entrances pierce addition

d. Rear: Direction: North – partially obscured by rear addition

S03574: dwelling (.001) rear, south-southeast.

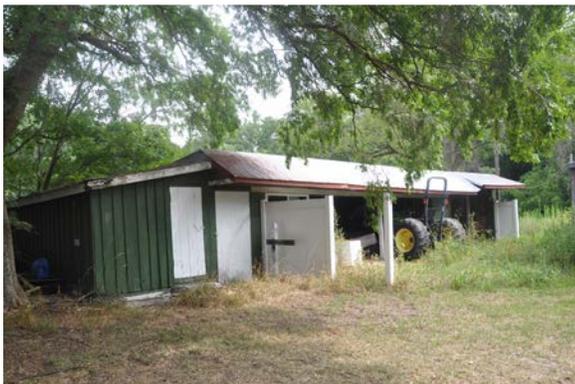
7. DESCRIPTION:
a. Structural system frame
b. Number of stories 1
c. Wall coverings board-and-batten
d. Foundation none
e. Roof: side-gabled
Structural system:
Coverings: corrugated metal
Openings:

8. DESCRIPTION OF ELEVATIONS:
a. Facade: direction: South
1) bays: 6
2) windows:
3) door(s): 2, wood-slat, hinge-swing doors
4) other: 4, open bays

S03574: outbuilding (.003), looking northeast.

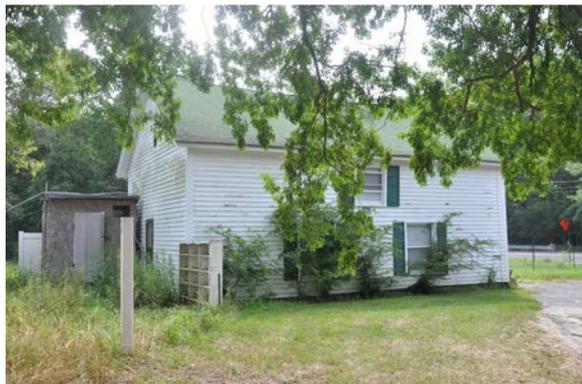
- 1) **bays:** 3
- 2) **windows:** 2, entrance level; 1, second level; all openings – 1/1, double-hung; vinyl-sash
- 3) **door(s):**
- 4) **other:**

S03574: outbuilding (.004) west side, looking east.

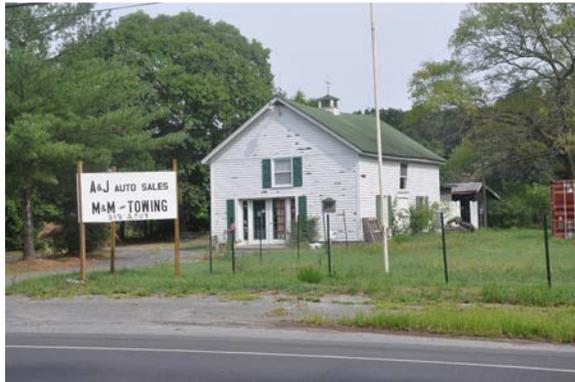
3) door(s): centralized double-door entry; fiberglass doors flanked by 5-light sidelights & decorative, non-functional shutters

- 1) **bays:** 4
- 2) **windows:** 3, 1/1 double-hung; vinyl-sash; opening flanked by decorative, non-functional shutters
- 3) **door(s):** 1, centralized, wood-slat barn-type opening
- 4) **other:**

S03574: outbuilding (.004) façade and east side, looking northwest.

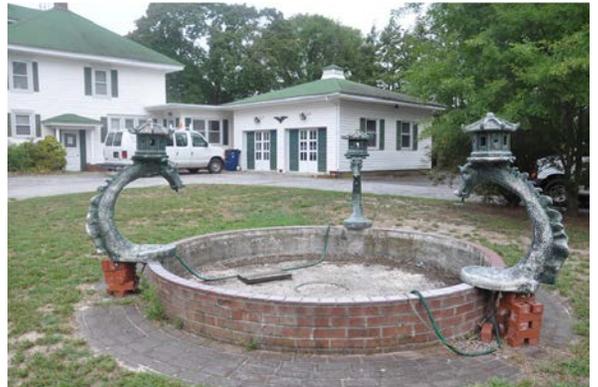
a. (3) Decorative, plastic dragon ornaments sit along edge of fountain wall

c) Retaining wall/lining material(s): interior of fountain parged in concrete; copper water faucets along interior wall

d) Other: size, approximately 6 feet in diameter

S03574: water fountain (.006), looking northwest.
