5.0 CRS PROPERTY EVALUATIONS

Figure 9: Historic Architectural Resources Surveyed for the US 9 Intersection Improvements Project

5.2 Evaluations

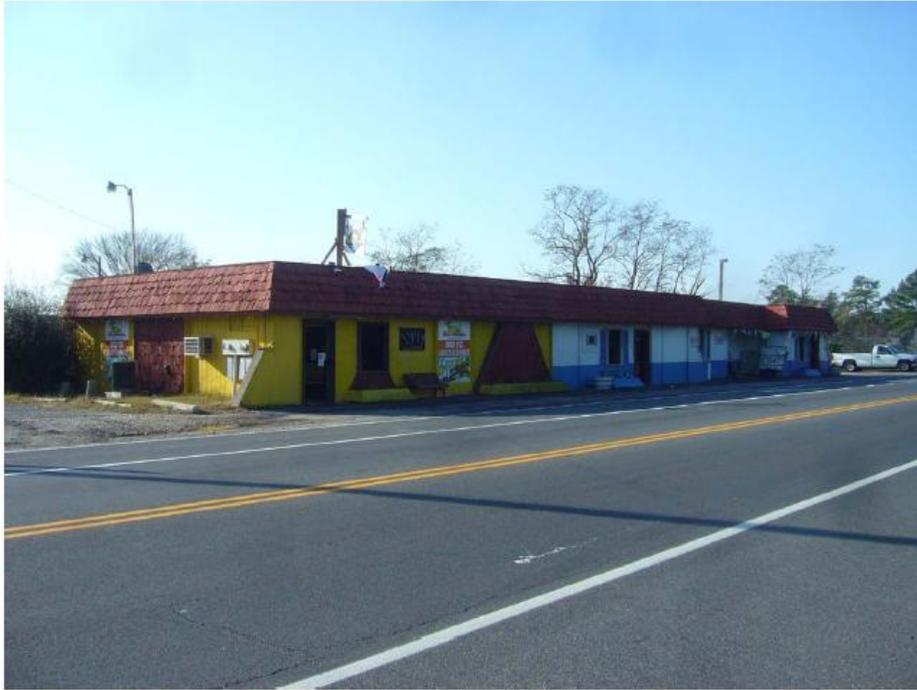
1. Gravel Hill Commercial Property (S-12232)

Photo 1: Façade (north) and east elevations, facing southwest. This structure, built in the 1940s as a gas station, has been highly altered through additions, changed fenestration, modern materials, and modern door and window units.

The one-story, vernacular, concrete-block commercial building is composed of multiple parts, which gives it an irregular footprint, and sits lengthwise fronting on US 9. According to a local source, the two end portions of the structure are the oldest (dating to the mid-20th century) and the section in between was built at a later date to connect the two. Currently, the eastern third of the structure houses a Mexican restaurant and the remaining two-thirds, a Mexican grocery. The façade (north) and two end elevations have been faced in a combination of brightly painted vertical and diagonal wood siding leaving the painted concrete-block rear (south) elevation visible. A false parapet roof, covered with irregular wooden shakes, is present on the three visible elevations (front and sides). Multiple doorways with modern glass commercial door units and large plate-glass windows with plastic shutters line the façade. The rear elevation features several metal doors and small two-pane windows situated at the top of the wall under the eave. The rear wall of the restaurant portion of the building projects beyond the wall of the rest of the structure and has a roof with a very shallow slope. Two interior concrete-block chimneys pierce the roof in this section. A third exterior concrete-block chimney is located at the southwest corner of the building.

National Register Evaluation: The Gravel Hill Commercial Property was evaluated as roadside commercial property. Originally constructed or reconstructed/remodeled as a gas station in the 1940s, this building has had many diverse uses and undergone considerable alterations over the years. The original garage was a smaller building that has been integrated into the current sprawling structure. The building's original fenestration has been altered, the exterior has been refaced with modern materials, and original doors and windows have been replaced with modern units. These alterations have resulted in a loss of integrity of design, materials, workmanship, feeling, and association. Only integrity of location and setting remains. Although this structure continues to function as a commercial property, it has been so completely altered that it no longer exhibits the physical characteristics from the time in which it originally functioned as a garage or corner market, so it is not eligible under Criterion A. Although a commercial store was first established by Gustav H. Koepfel at this same location, this is not significant for his association under Criteria B. The building has been rebuilt or reconstructed and badly altered. Additions have been made. The building in its current state is not reflective of Gustav's original crossroads store during his tenure. No other association between this property's building and any important persons could be made, so it is not eligible under Criterion B. Furthermore, the building no longer retain the characteristics of its original style, type, period or method of construction and it no longer conveys its historic commercial function, so it is not eligible under Criterion C. The property does not appear to possess the potential to yield information important in history or prehistory and is not eligible under Criterion D.

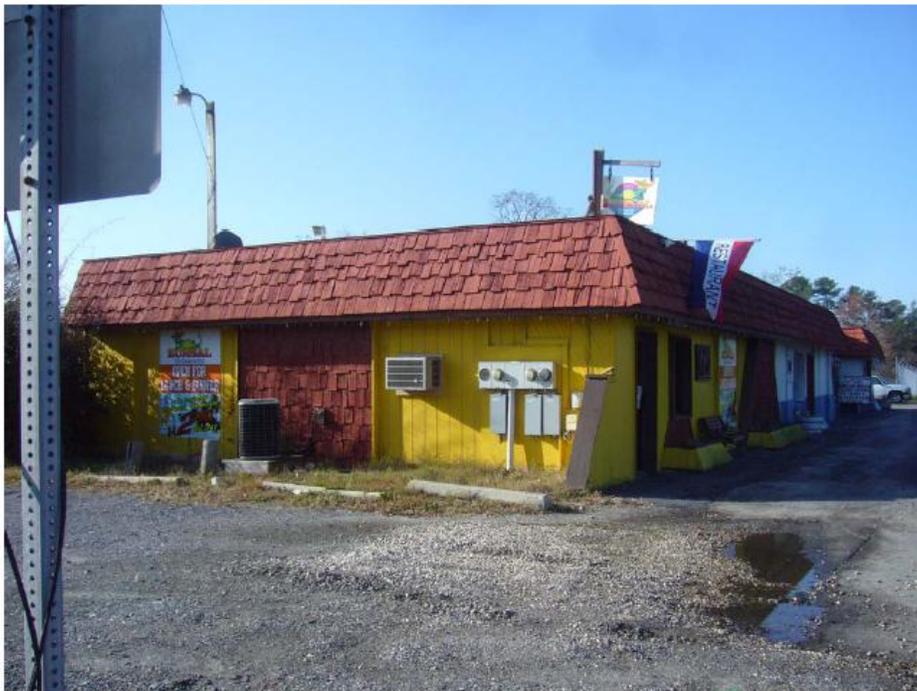
Photo 2: East elevation, facing southwest. This eastern portion of the structure was the earliest part of the building and was originally used as a gas station.

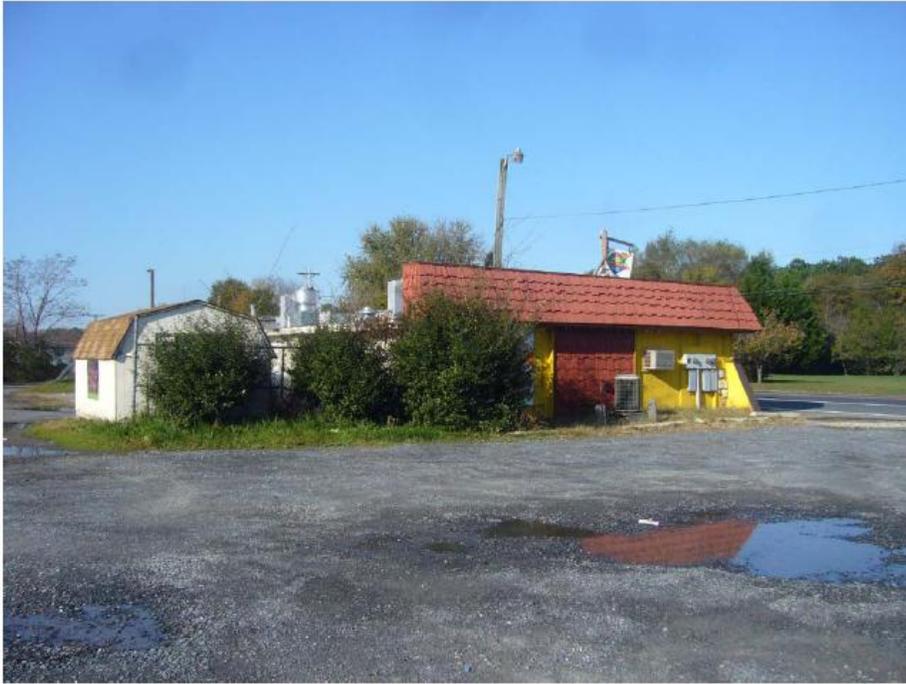
1. Gravel Hill Commercial Property (S-12232)

Photo 3: East elevation, facing west. The prefabricated shed sits off the building's southeast corner.

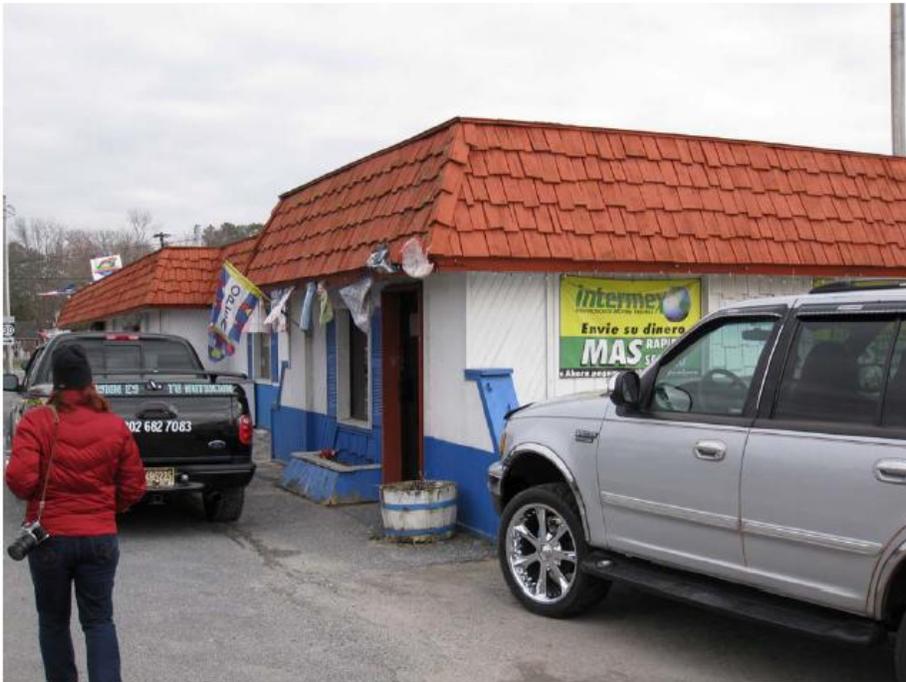
Photo 4: West elevation, facing east. This small western portion of the building was originally a barber shop.

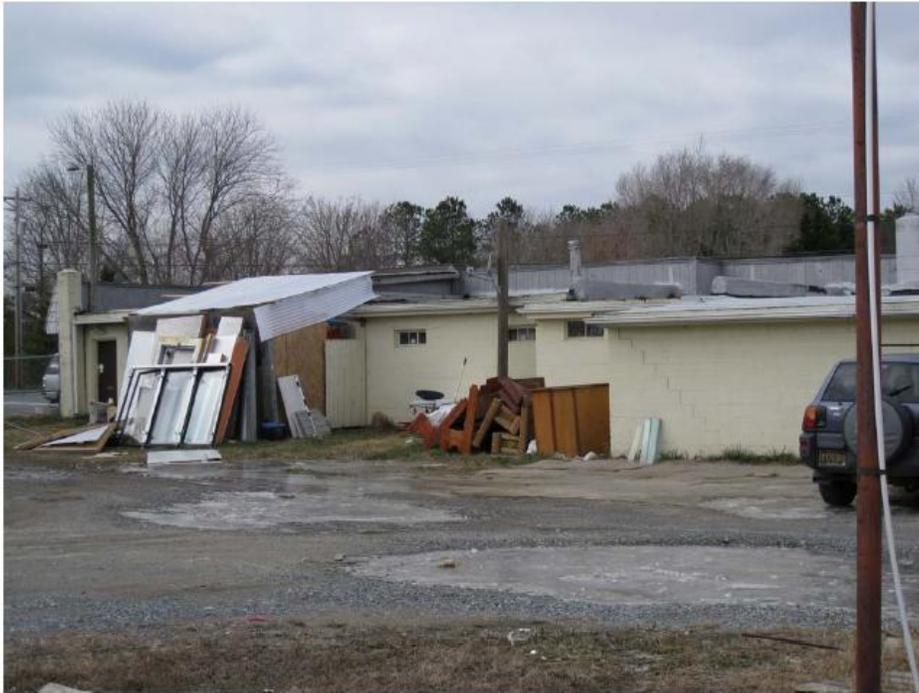
1. Gravel Hill Commercial Property (S- 12232)

Photo 5: Rear elevation at the west end of the building, facing northwest. Multiple additions have given this structure an irregular footprint.

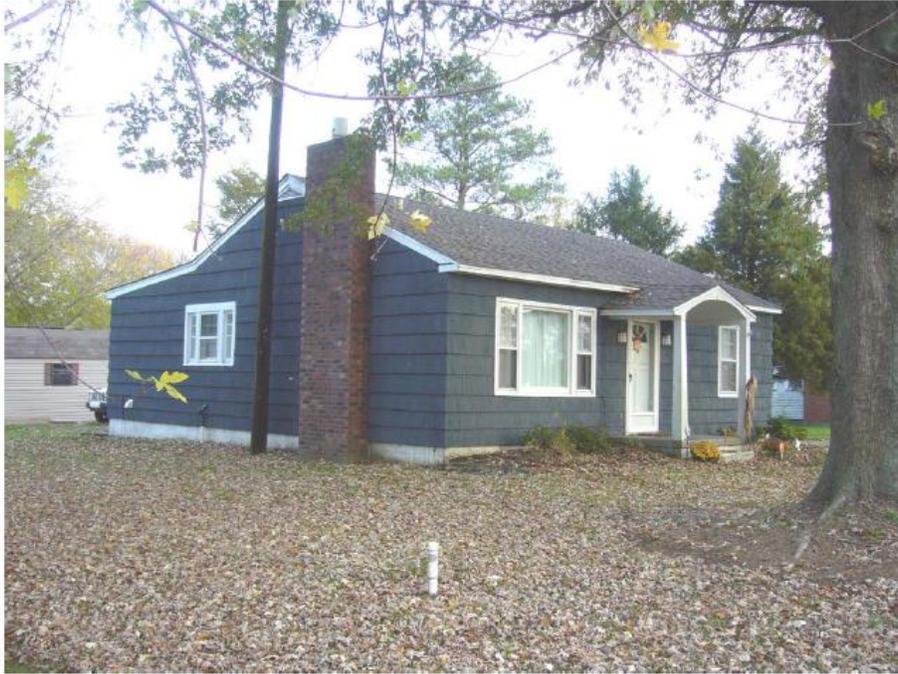
2. Henry Graves House (S-8496)

Photo 1: West façade and north gable end, looking southeast. This house was built circa 1951 as a double-pile cottage, a common house form in Sussex County.

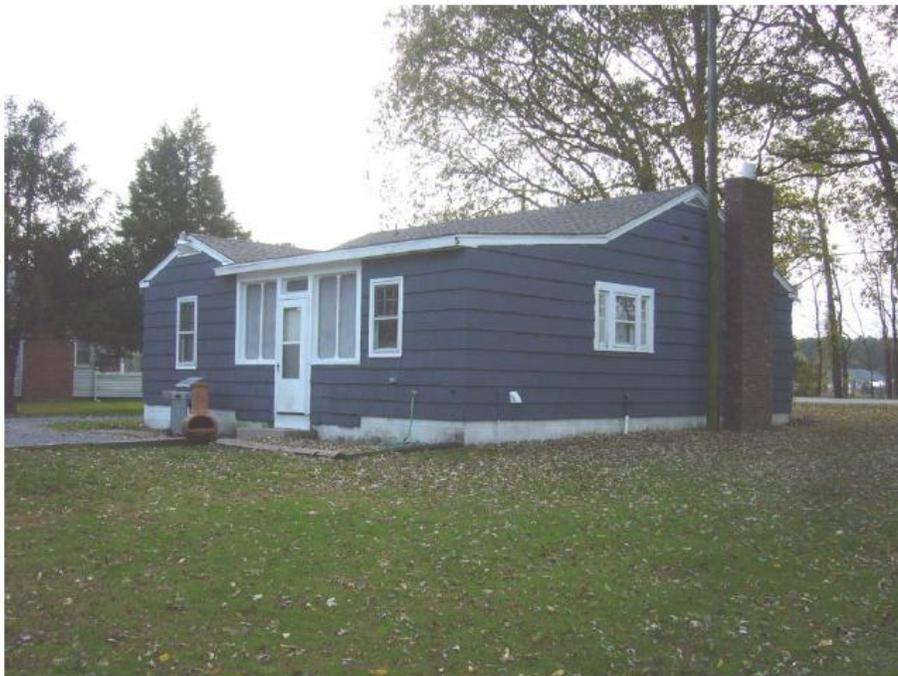
Photo 2: Rear (east) elevation and north gable end, looking southwest. In this example, the double-pile cottage design was adapted to include a rear extension for more living space.

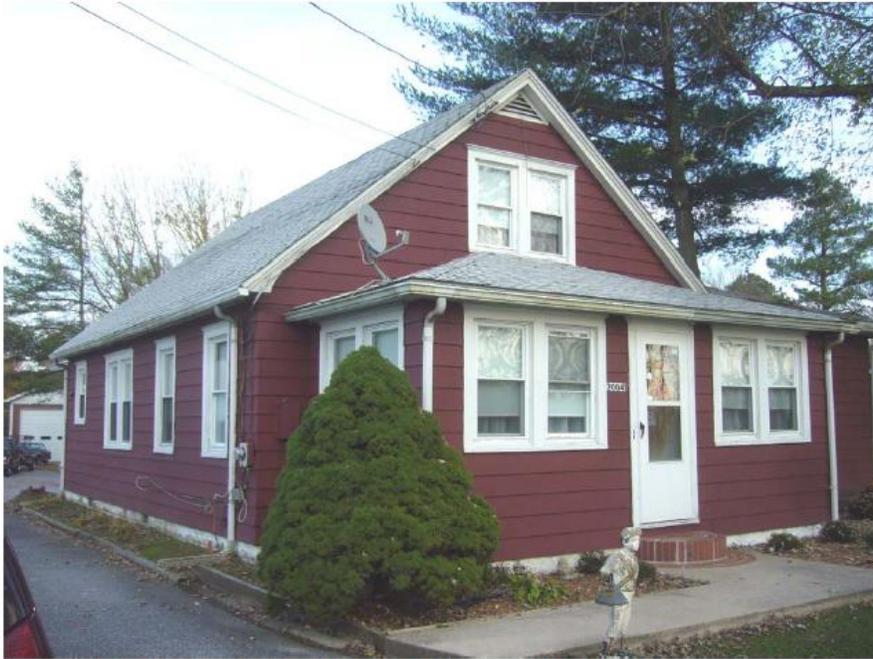
3. James Koeppel House (S-8495)

Photo 1: Façade (west) and north elevations, looking southeast.
The gable-front double-pile cottage is a common house type in Sussex County.

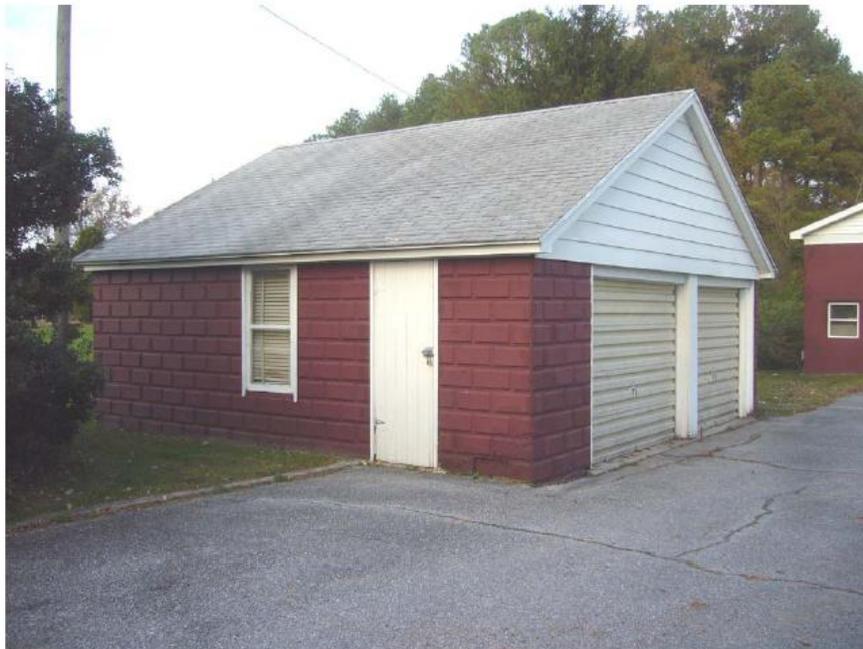
Photo 6: Garage, south west elevations, facing northeast.
This garage was built circa 1955.

Off the northeast corner of the dwelling is a front-gable, 2-bay garage that was built between 1937 and 1954. The garage is constructed of formed concrete-block and has an asphalt-shingle roof, aluminum siding in the gable ends, and two overhead bay doors on the south gable end.

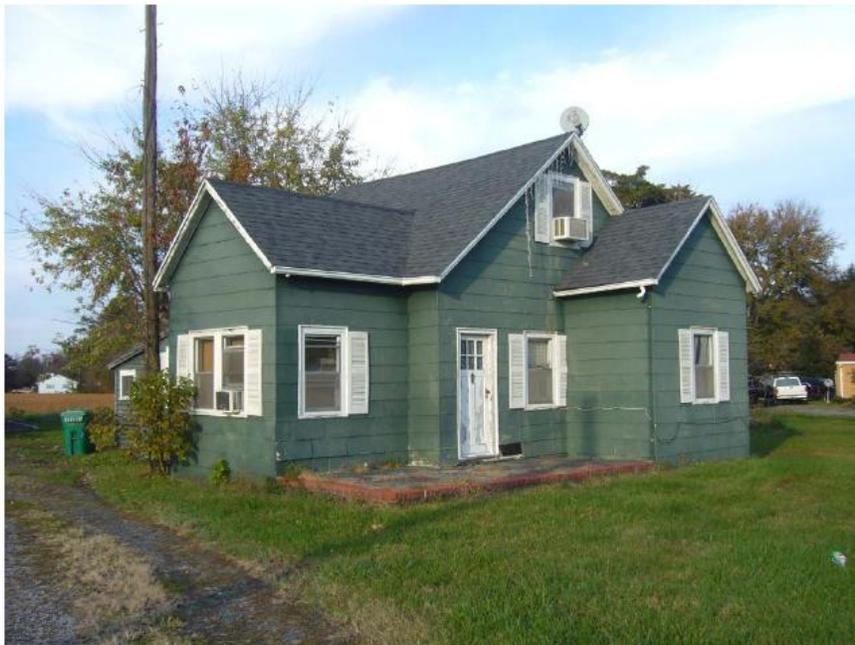
4. Howard Stewart House (S-8492)

Photo 1: Façade (south) and west elevations, facing northeast. This gable-front cottage has several projecting wings that give it an oddly proportioned, irregularly massed form.

The frame dwelling, which faces south toward US 9, is clad in asbestos siding and has an asphalt-shingled roof. Built in 1924, this 1½-story residence is asymmetrical in form consisting of a 3-bay, double-pile front-gabled main block with 1-story gable-roofed additions on the façade and west elevations and two successive shed-roof additions off the rear. Windows throughout are replacement 1/1, double-hung, wooden sash units, both single and paired sets, with aluminum storm windows and modern vinyl shutters. The front door is original and is wood paneled with six divided lights in the upper third. The successive rear additions are frame and are under one continuous metal-covered shed roof. The rearmost addition is clad in wooden clapboards and has jalousie windows in its side walls and a single wooden door in the rear wall. A tall interior brick chimney projects from the roof of this last addition.

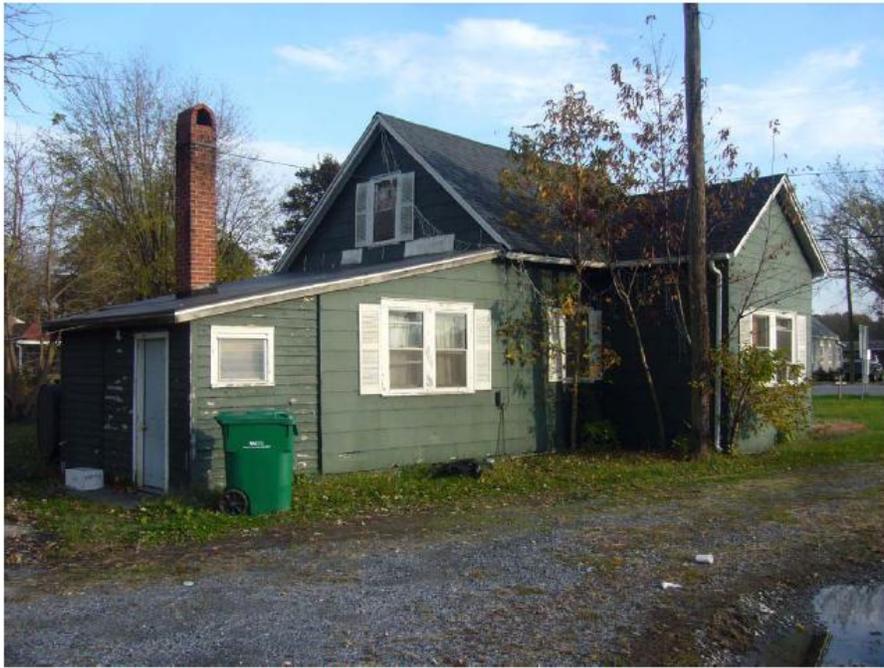
4. Howard Stewart House (S-8492)

Photo 2: Rear (north) and west elevations, facing southeast.
The additions on the rear gable end also date prior to 1962.

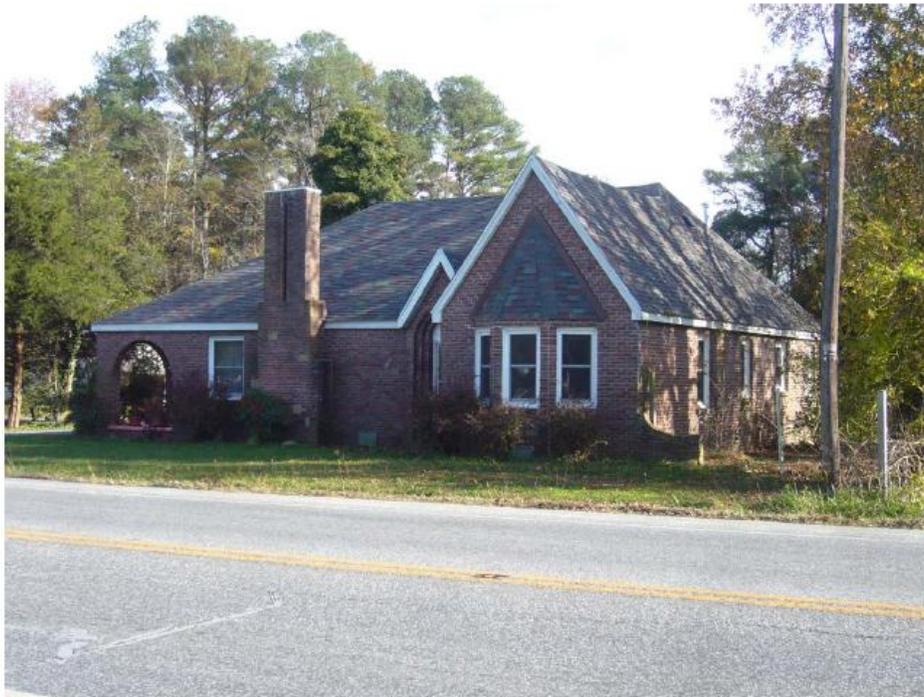
5. Alice Hancock House (S-12233)

Photo 1: Façade (north) and west elevations, facing southeast.
The use of differing European-inspired architectural details give this residence odd proportions and conflicting styles.

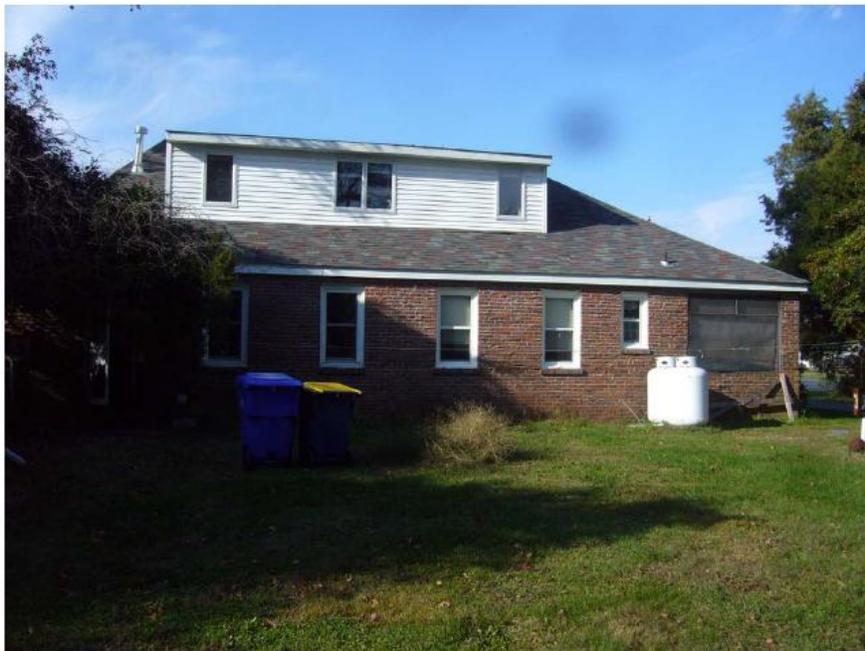
Photo 3: Rear (south) elevation, facing northwest. The shed-roof dormer is a more recent addition.

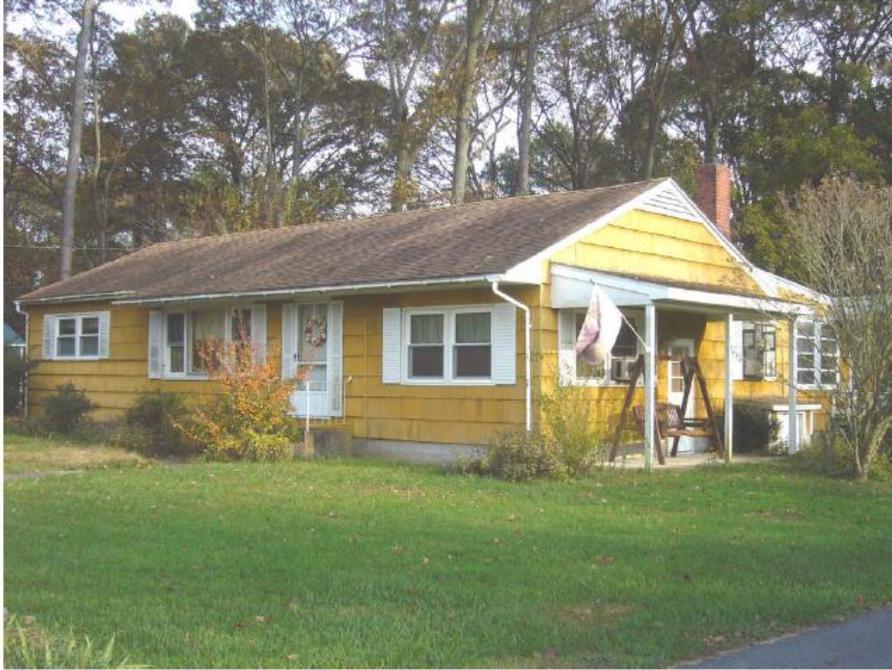
6. Joseph Clauser House (S-12234)

Photo 1: Façade (north) and west elevations, facing southeast.
The west bay of the dwelling is an enclosed carport.

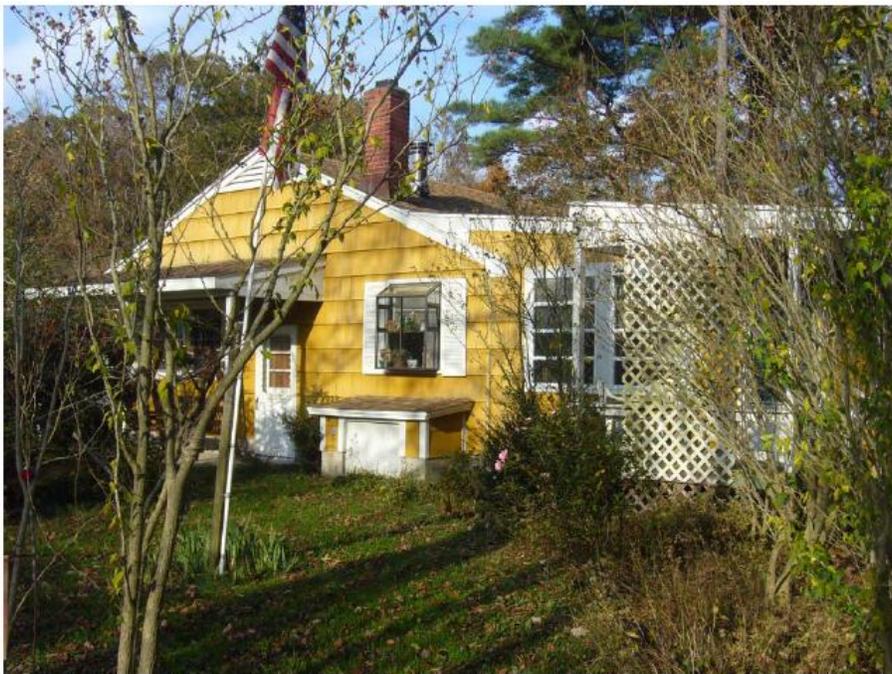
Photo 2: West gable end, facing northeast. This photo shows the enclosed carport
with its shed-roof porch as well as the modern sunroom added at the rear.

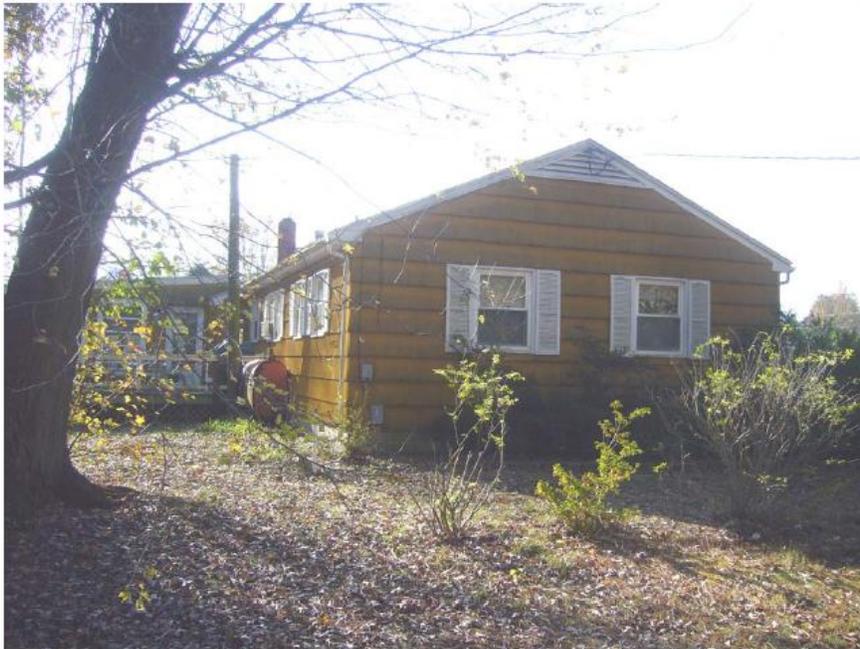
6. Joseph Clauser House (S-12234)

Photo 3: East gable end, facing west. This photo shows the sunroom and deck added to the rear of the structure.

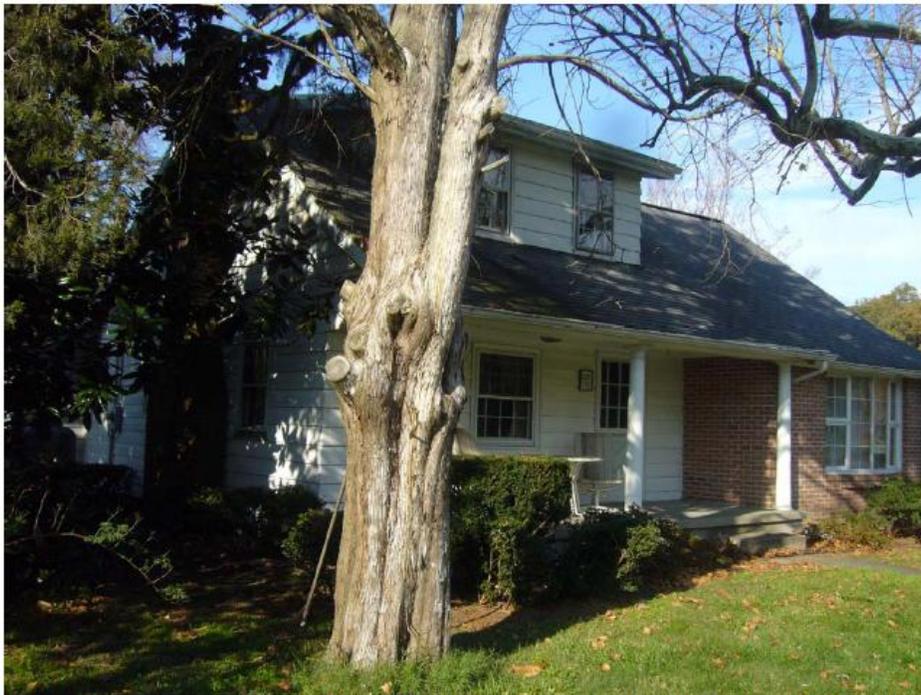
8. Samuel Burns Property (S-12236)

Photo 1: Façade (south) elevation, facing north. The aluminum-sided, dormered west half of the house was the original bungalow built by Arthur Rogers, circa 1922, and the brick east half was added by Samuel Burns, circa the 1960s.

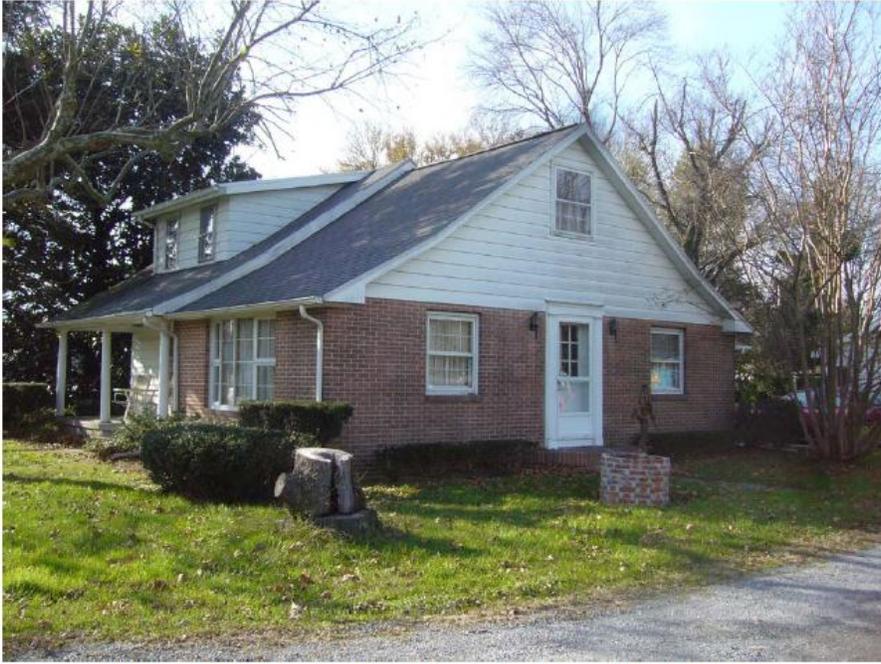
8. Samuel Burns Property (S-12236)

Photo 2: Façade (south) and east gable end, facing west.
This view shows Burns' 1960s brick addition to the original structure.

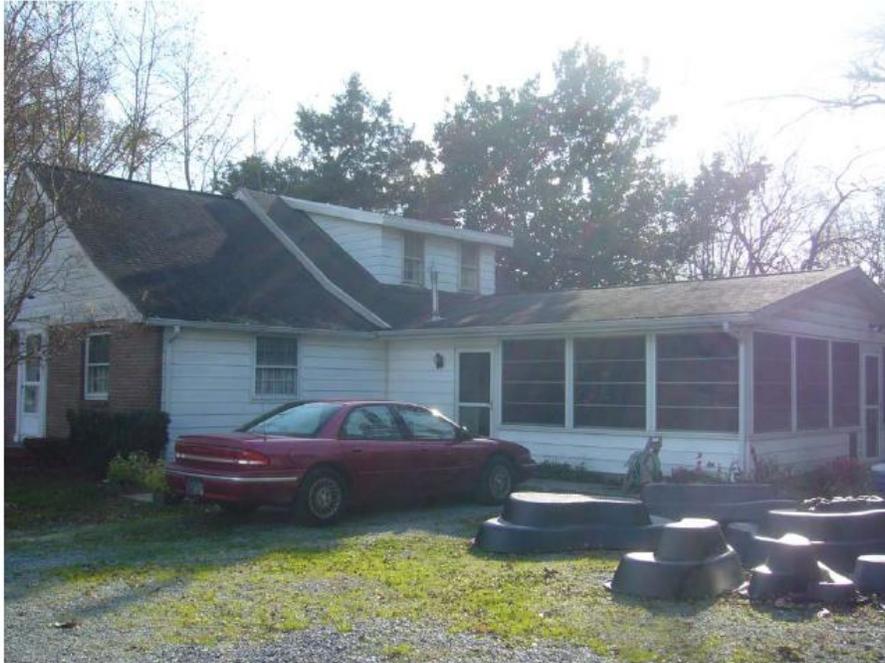
8. Samuel Burns Property (S-12236)

Photo 4: Rear (north) and east elevations, facing south.
The sunroom was added to the rear of the original bungalow after 1970.

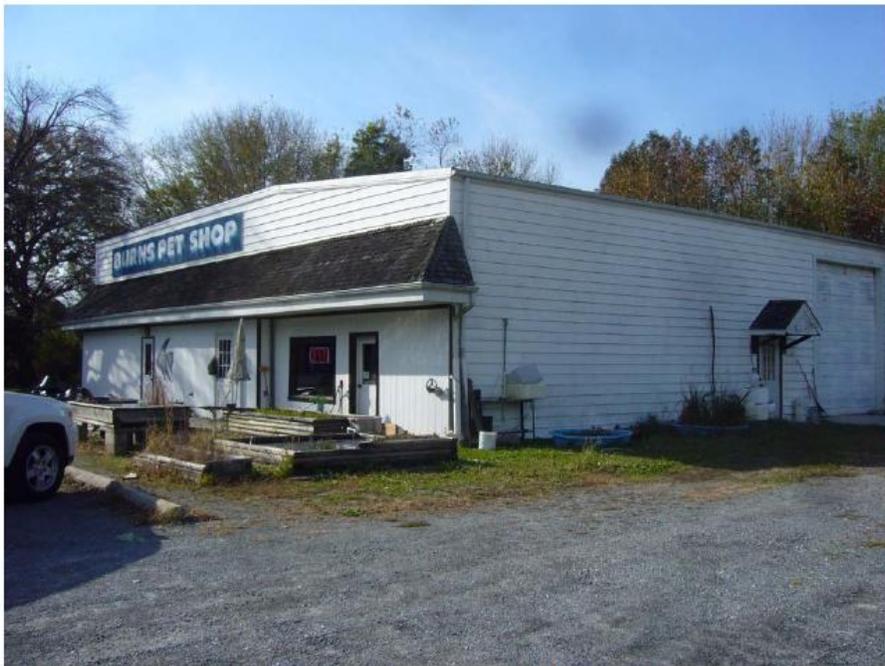
Photo 5: Façade (south) and east elevations of the Burns Pet Shop, facing west.
This east portion of this structure was originally built as a storage garage
for Burns' well-drilling equipment in the mid-1950s.

The store on the Samuel Burns Property was evaluated as commercial property. Originally constructed as a garage to house commercial well drilling equipment for a local contractor, this building has undergone considerable alterations since the 1970s to turn it into a pet store. The original 1950s garage was a much smaller building that has been completely integrated into the current much larger store, faced with modern materials, and its façade fenestration has been altered. These alterations have resulted in a loss of integrity of design, materials, workmanship,

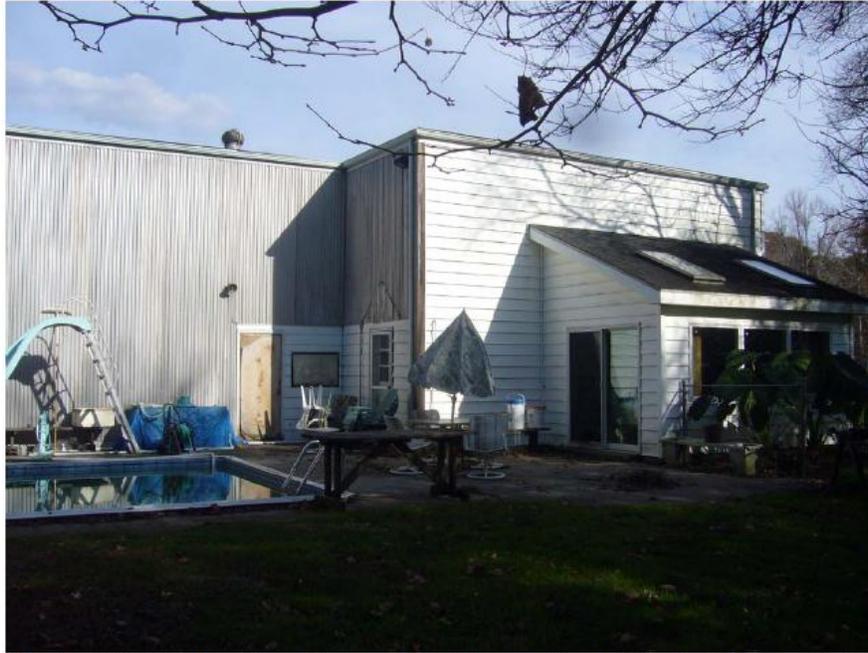
8. Samuel Burns Property (S-12236)

Photo 8: West elevation, facing east. This portion of the building with its 1-story shed-roof office was built by the current owner after 1965.

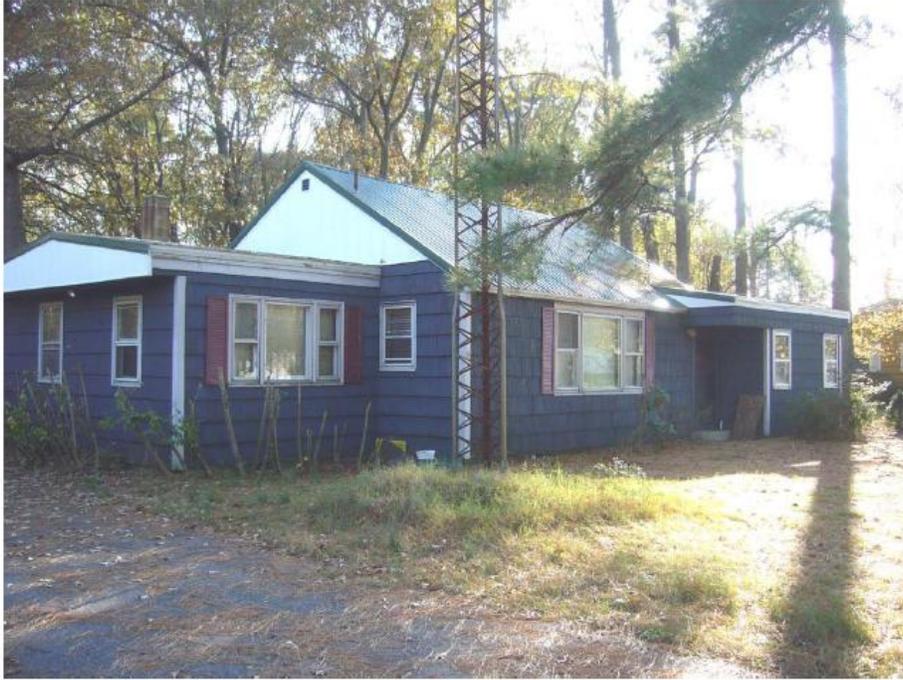
9. Harry Larson House (S-12237)

Photo 1: Façade (north) and east elevations, facing south.
The central double-pile cottage is encompassed by additions.

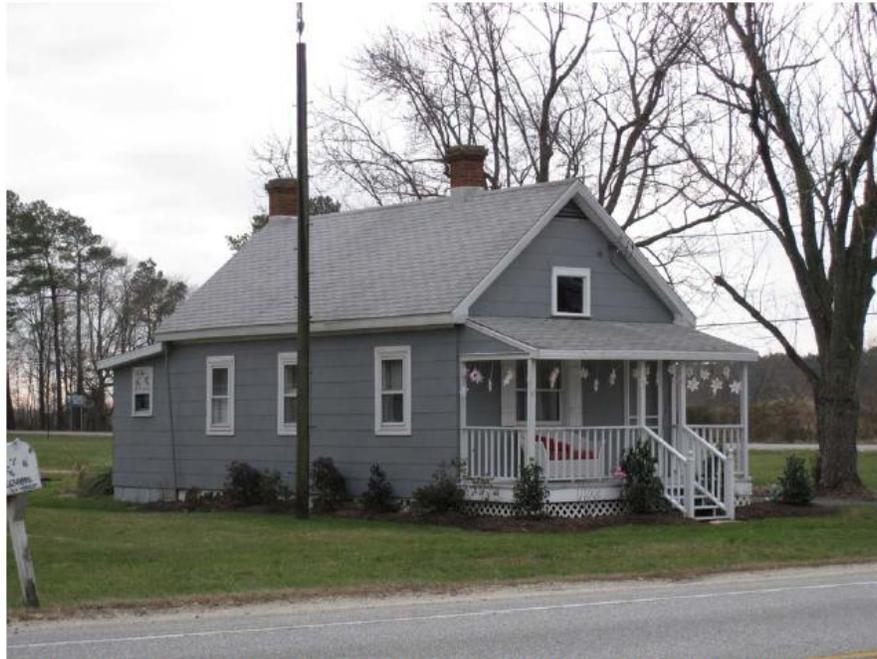
12a. Pearl Koeppel House (S-8493)

Photo 1: S-8493, façade (north) and east elevations, facing southwest. Alterations to this structure include the application of asbestos siding to the exterior and asphalt shingles to the roof, the replacement of original window sashes, and the reconstruction of the front porch with vinyl members.

S-8493. The earlier dwelling is a 1½-story, frame, front-gable shotgun cottage that sits with its gable end facing north toward the roadway. It is clad in asbestos siding with an asphalt-shingle roof that has two brick chimneys located along the ridge. The house sits on a contemporary painted concrete foundation, which is a good indication that it was moved from its original location. A full-width shed-roof porch is located on the façade and a partial-width shed-roof addition is on the rear. The front porch has vinyl supports and railings and shelters a single wood panel door and large one-over-one wood sash window with wood shutters. A square, fixed-sash window is located in the front end gable. The side walls of the dwelling have 1/1 double-hung wood sash windows. The rear addition has a single 1/1 double-hung wood sash window on each side elevation and a similar window and wood panel door on the rear. A wooden deck with vinyl railings extends the partial width of the addition.

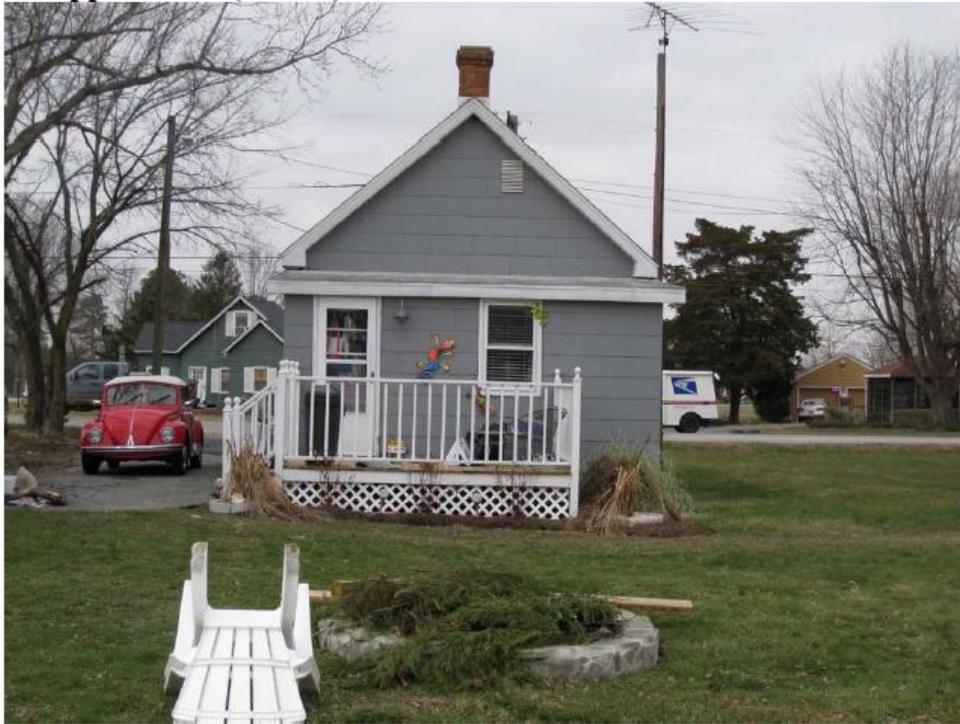
12a. Pearl Koeppl House (S-8493)

Photo 3: S-8493, rear (south) gable end, facing northwest. Alterations to this elevation include the shed-roof addition and the deck with vinyl members.

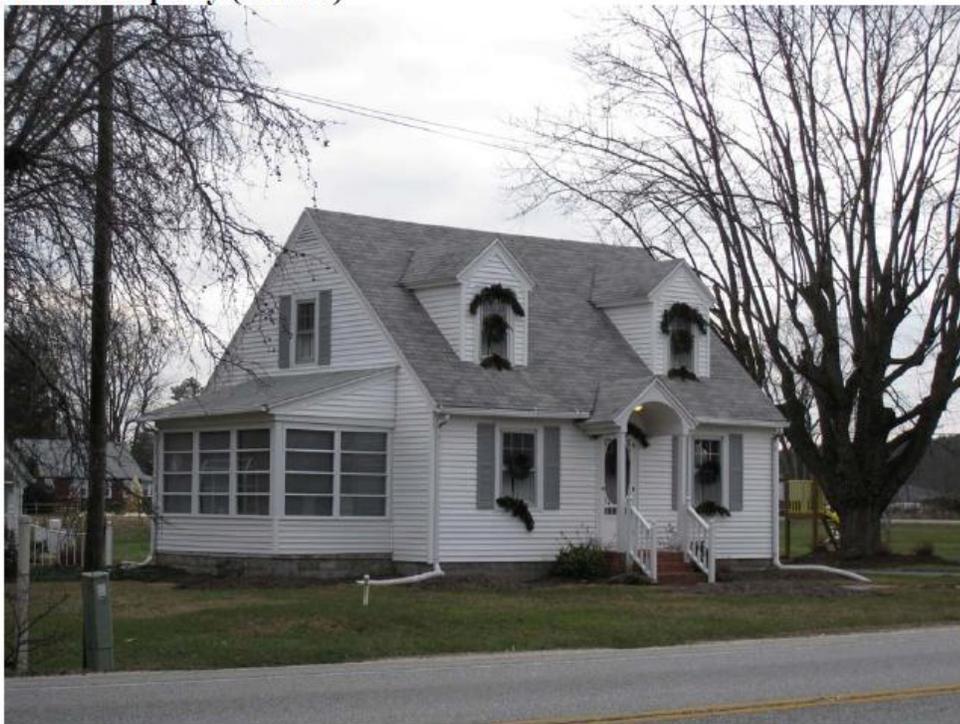
12b. Pearl Dodd Property (S-8494)

Photo 4: S-8494, façade (north) and east elevations, facing south. Alterations to this structure include the application of vinyl siding to the exterior, the replacement of original wood members with vinyl members on the front porch, and the addition of the sunroom to the east gable end.

S-8494. The later dwelling is a 1½-story, frame, Cape Cod that is clad in vinyl siding, sits on a painted molded concrete foundation, and has an asphalt-shingle roof. The symmetrical 3-bay façade consists of a central door flanked by 6/1 double-hung wood sash windows on the first story and two gable dormers with similar windows in the upper half story. A small entry porch consisting of a gabled roof with vinyl posts and railing is located at the door. The rear elevation has a shed-roof wall dormer with two 6/6 windows on the roof above a similar shed-roof wing that houses a mudroom. A door off the west side of the wing accesses a raised concrete porch with vinyl railings. A brick chimney rises from the roof of the rear wing along the outer wall of the shed dormer. A 1-story shed-roof sunroom lined with jalousie windows is located on the eastern gable end.

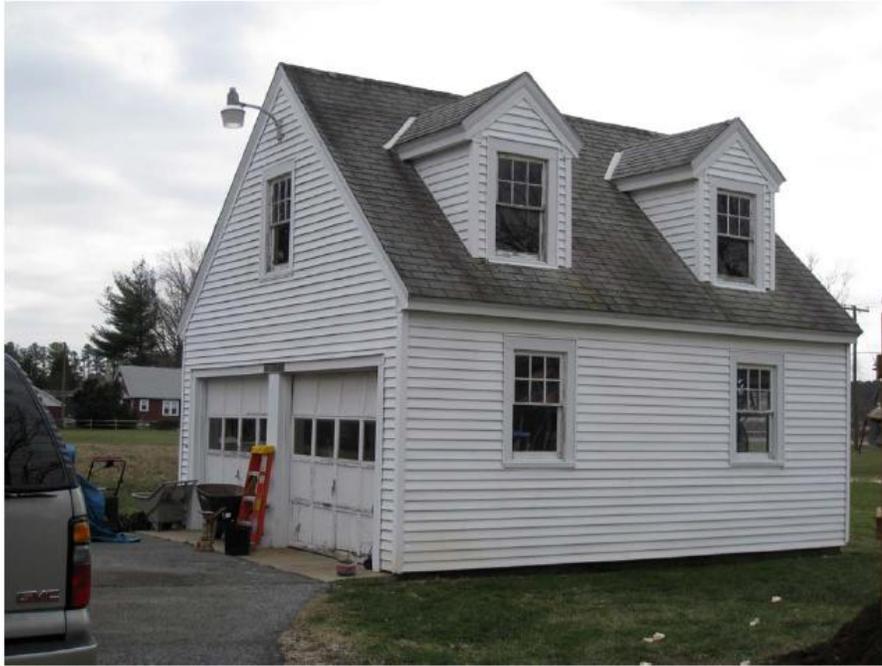
12b. Pearl Dodd Property (S-8494)

Photo 7: S-8494, garage, east and north (with dormers) elevations, facing southwest.
This 2-bay vinyl-clad garage was built at the same time and with the same features as the Cape Cod.

Sited approximately halfway between the two residences and to their rear (south) is 1½-story frame garage that was built at the same time as the Cape Cod. This front-gabled structure is clad in vinyl siding, sits on a concrete-block foundation, and has an asphalt-shingle roof. Two gabled dormers with 6/1 double-hung wood sash windows are located on the southern slope of the roof facing the highway. Two overhead garage bay doors are located in the eastern gable end facing the driveway between the two houses. Two 6/1 double-hung wood sash windows are in the northern side elevation and the western gable end. Similar windows are located in either end gable. The southern elevation has no openings.

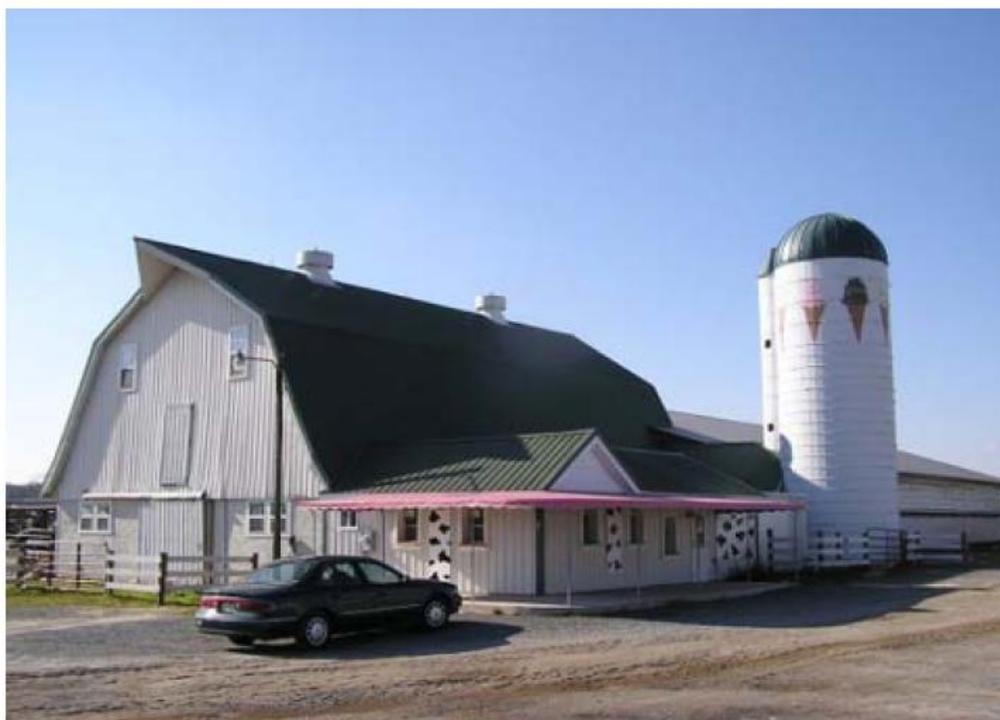
13. Hopkins Farm (S-861)

Photo 1: Dairy barn with modern ice stand and silo, east gambrel end and north elevation, facing southwest.

Upon close examination and oral interview, the building has been severely altered. The dairy barn building has new modern roofing sheathing that is standing seam metal. It is also a hunter green color. The roof is nice for contemporary needs, but not necessarily context sensitive or sympathetic for a barn built in the late 1940's. Originally, the roof sheathing system was cedar shake, but then replaced by asphalt shingle. Some of the asphalt singles in the roofing remain and can be seen from inside with remaining lathing. This is evident since there are additions that overhang and protect the original block and gambrel roof angles. However, the roof and sheathing support is contemporary.

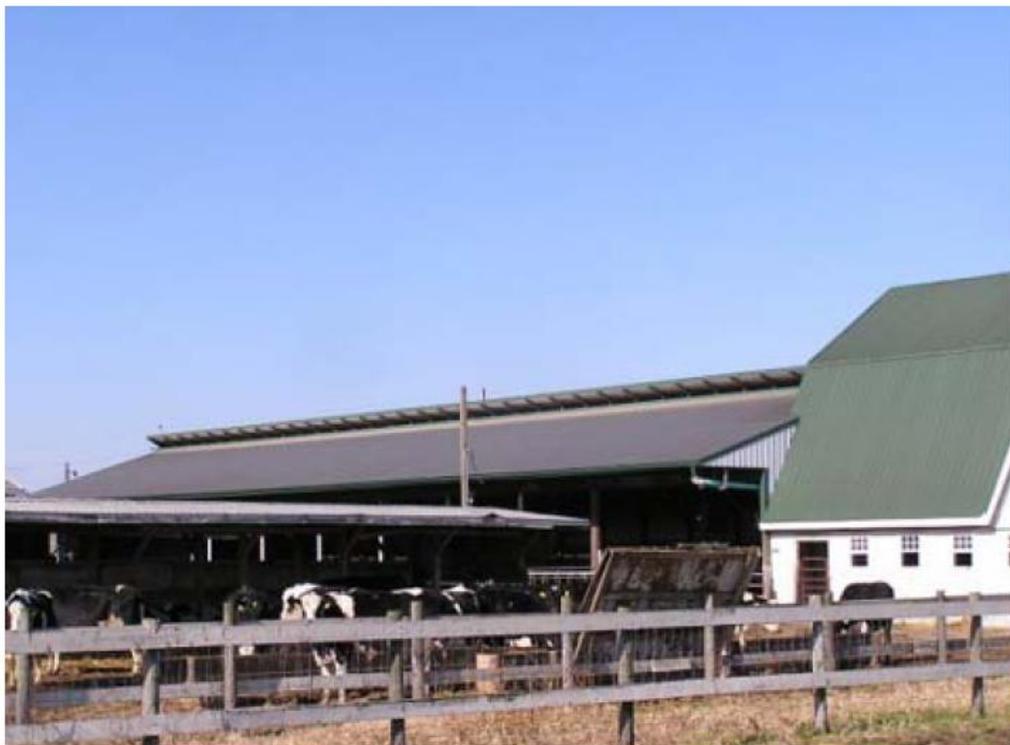
Photo 3: Modern loafing shed attached to the west gambrel end of the dairy barn, facing northwest.

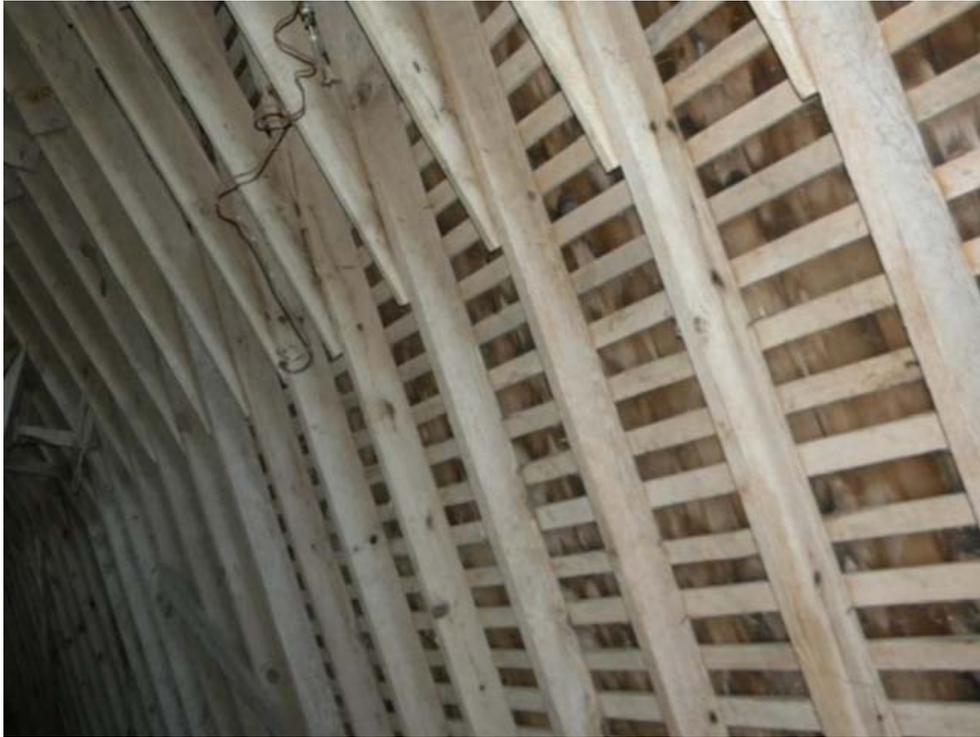
13. Hopkins Farm (S-861)

Photo 6: Interior of gambrel connection

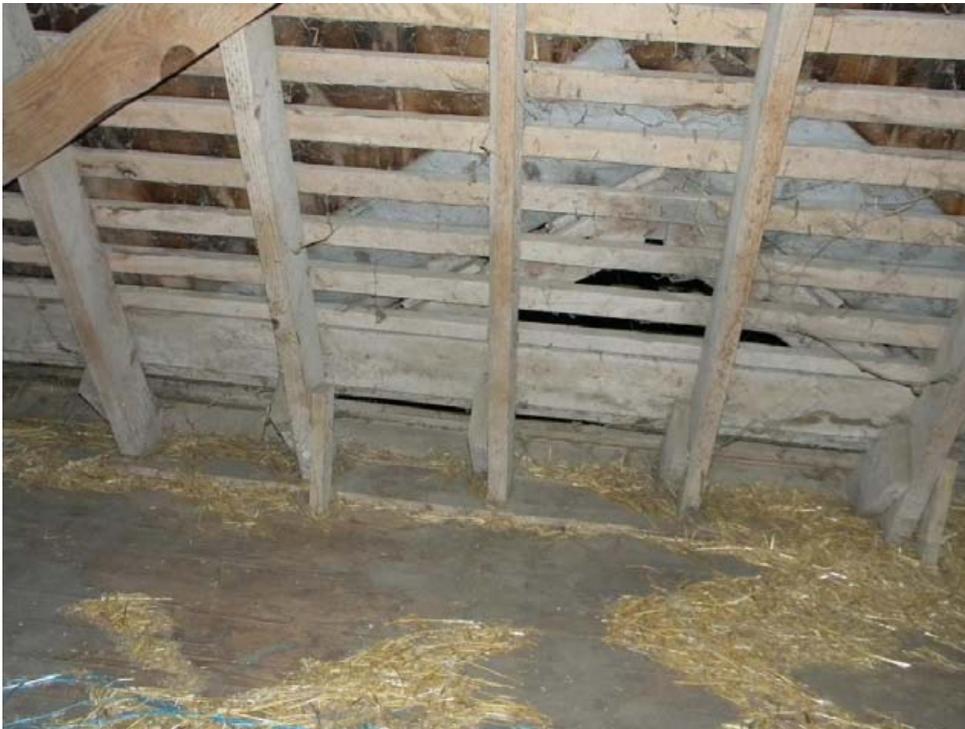
Photo 7: Interior with rafter on resting plate
