5.0 CRS PROPERTY EVALUATIONS

Figure 9: Historic Architectural Resources Surveyed for the US 9 Intersection Improvements Project

5.2 Evaluations

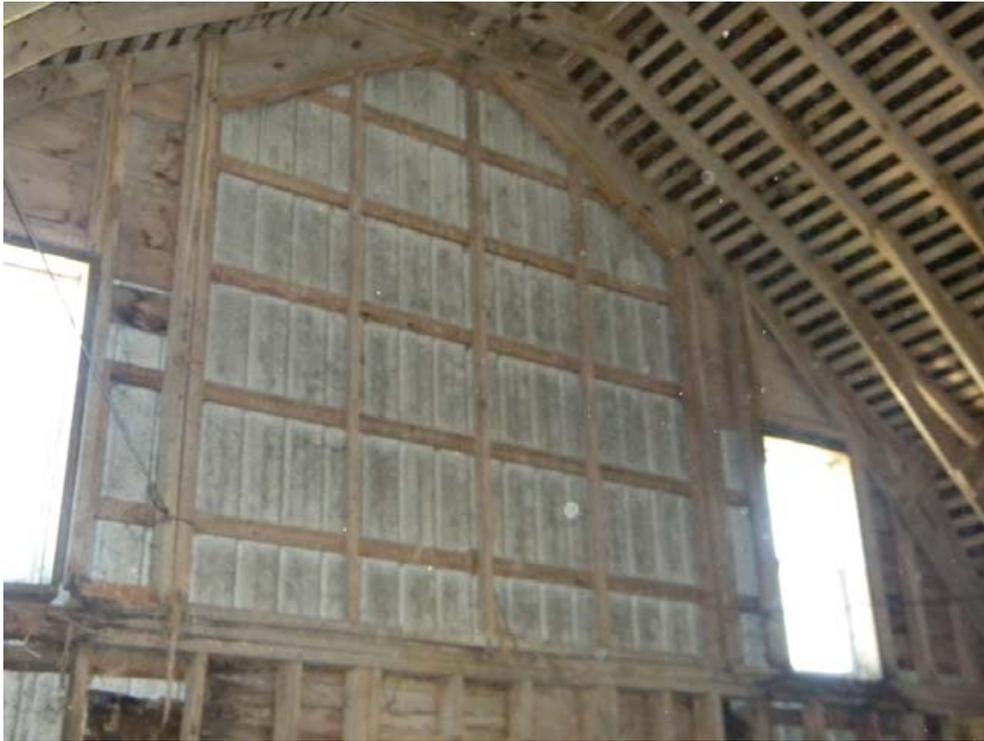
13. Hopkins Farm (S-861)

Photo 8: East gable end showing infill

All doors (sliding) and windows (now vinyl) have been replaced and are modern. In fact, the upper and original loft doors at both gable ends do not exist and have been filled in. The upper gable windows on the west end have been altered and shifted in position, size, and location. A covered canopy (loafing shed - contemporary) rests against the west gable end that has altered this end. The doors (all) are contemporary home-made that consist of a basic board. The boards are shaped in an outline and are simply sheathed over with the same seamless metal as a façade cover. No original swing, loft, Dutch door, or hardware remains from what was determined to be present on-site.

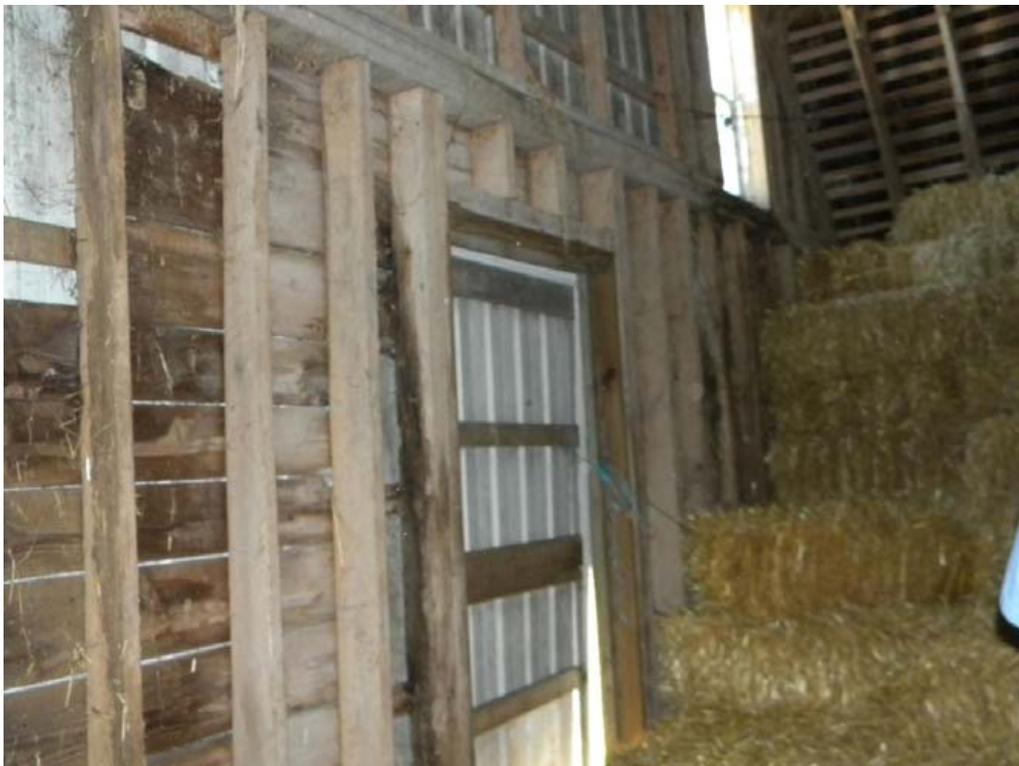
Photo 9: East gable end and what is now the hay loft door.

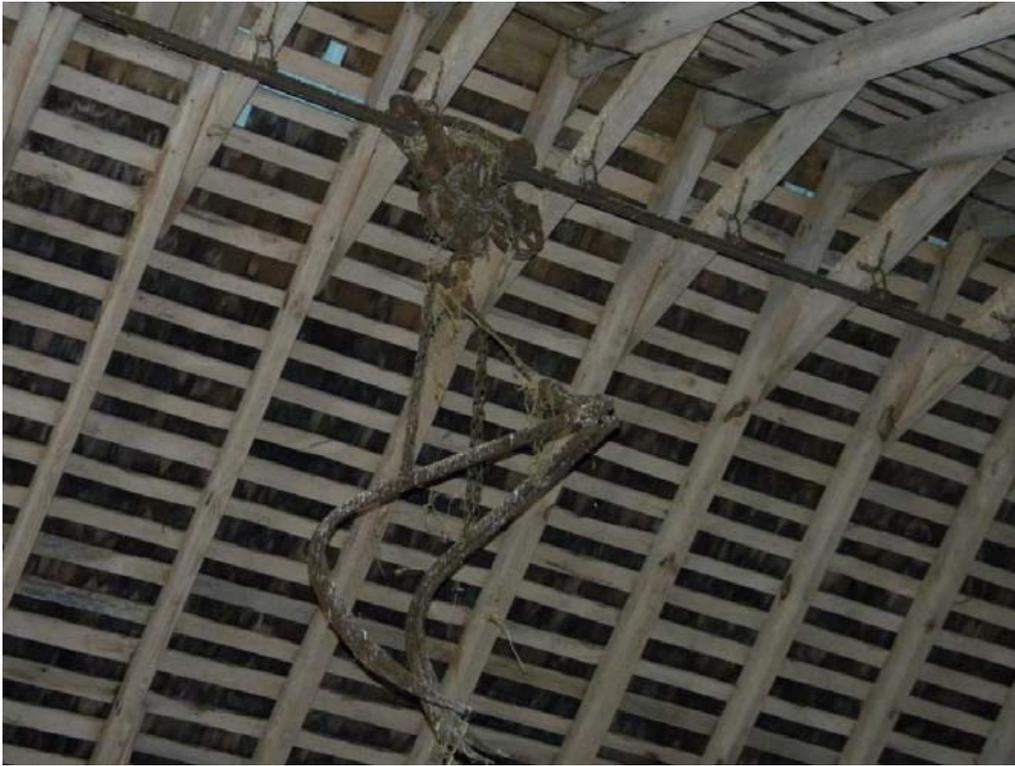
13. Hopkins Farm (S-861)

Photo 10: Peek of gable highlighting rafter connection, tie beams, lathing, and hay pick.

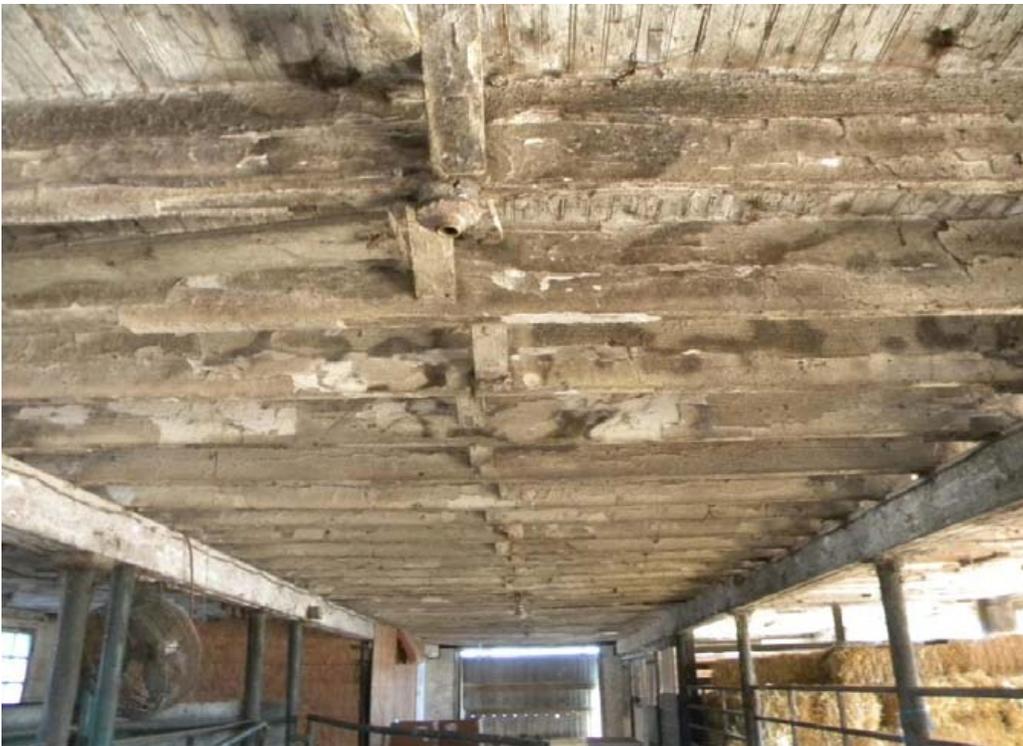
Photo 11: 1st floor center showing upper loft flooring, bracing, and beams. Note the end door.

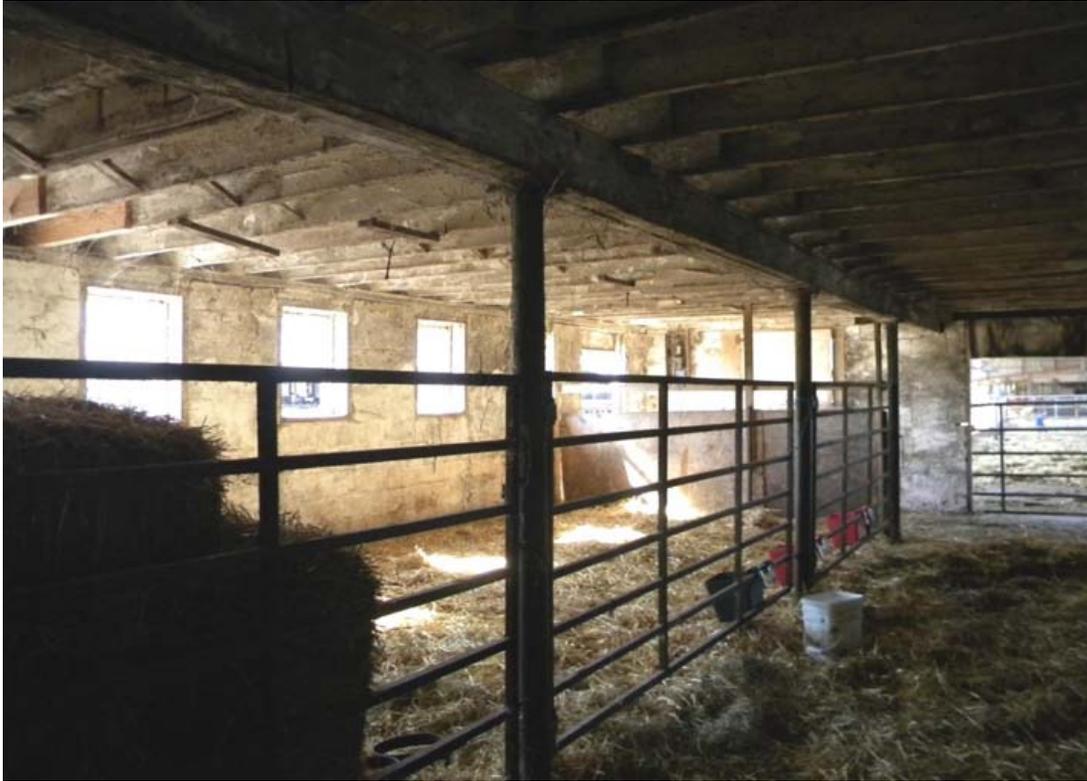
13. Hopkins Farm (S-861)

Photo 12: 1st floor looking southwest. Note the removal of milk stations and an open area.

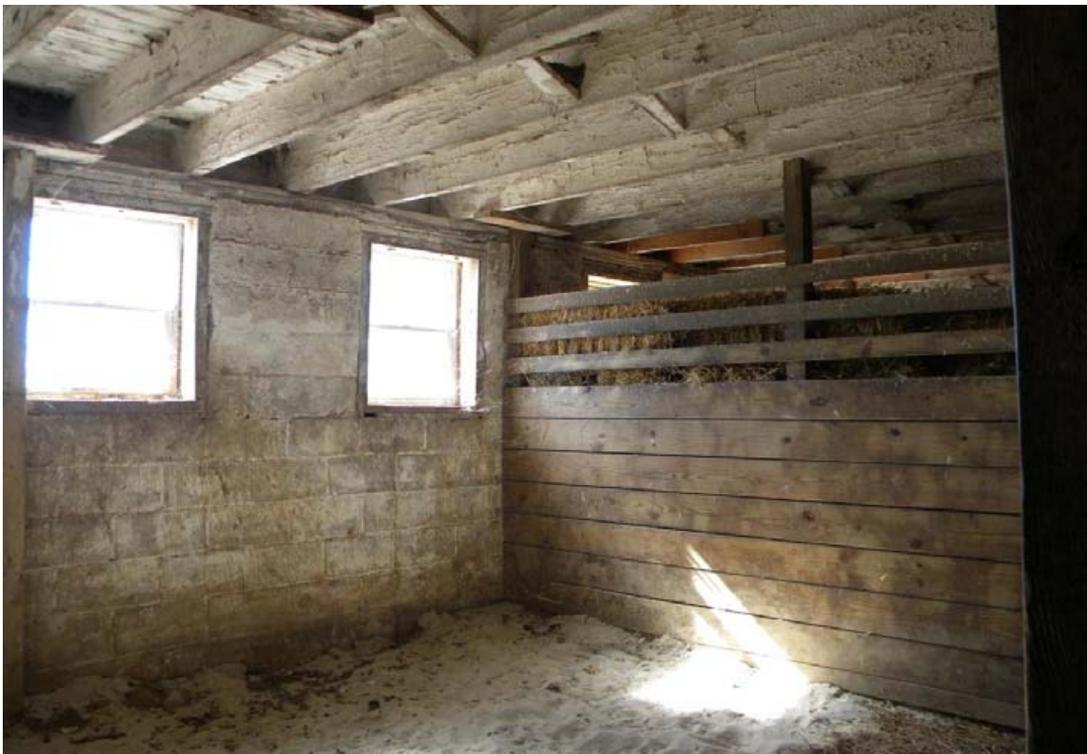
Photo 13: 1st floor modern partitions and windows. Note walls, flooring, and ceiling floorboards.

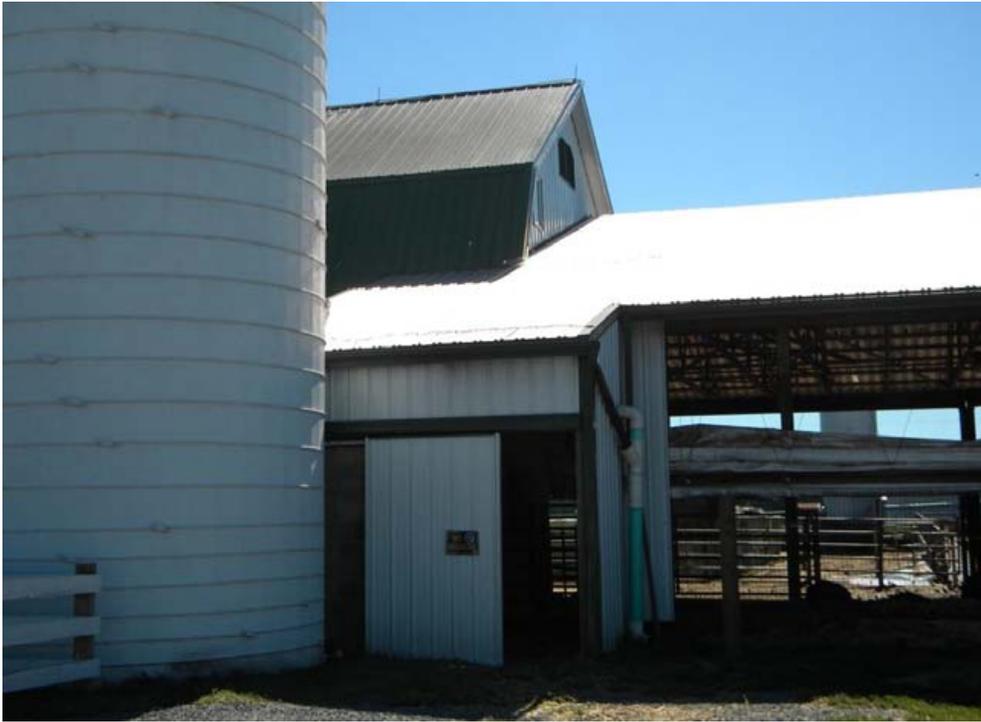
13. Hopkins Farm (S-861)

Photo 14: West gable end with loafing shed connection and addition.
