5.0 Field Results

5.1 Results of Previous Phase I Survey at 7K-C-73

Figure 4
Previous Phase I Results
 West Dover Connector
 Kent County, Delaware

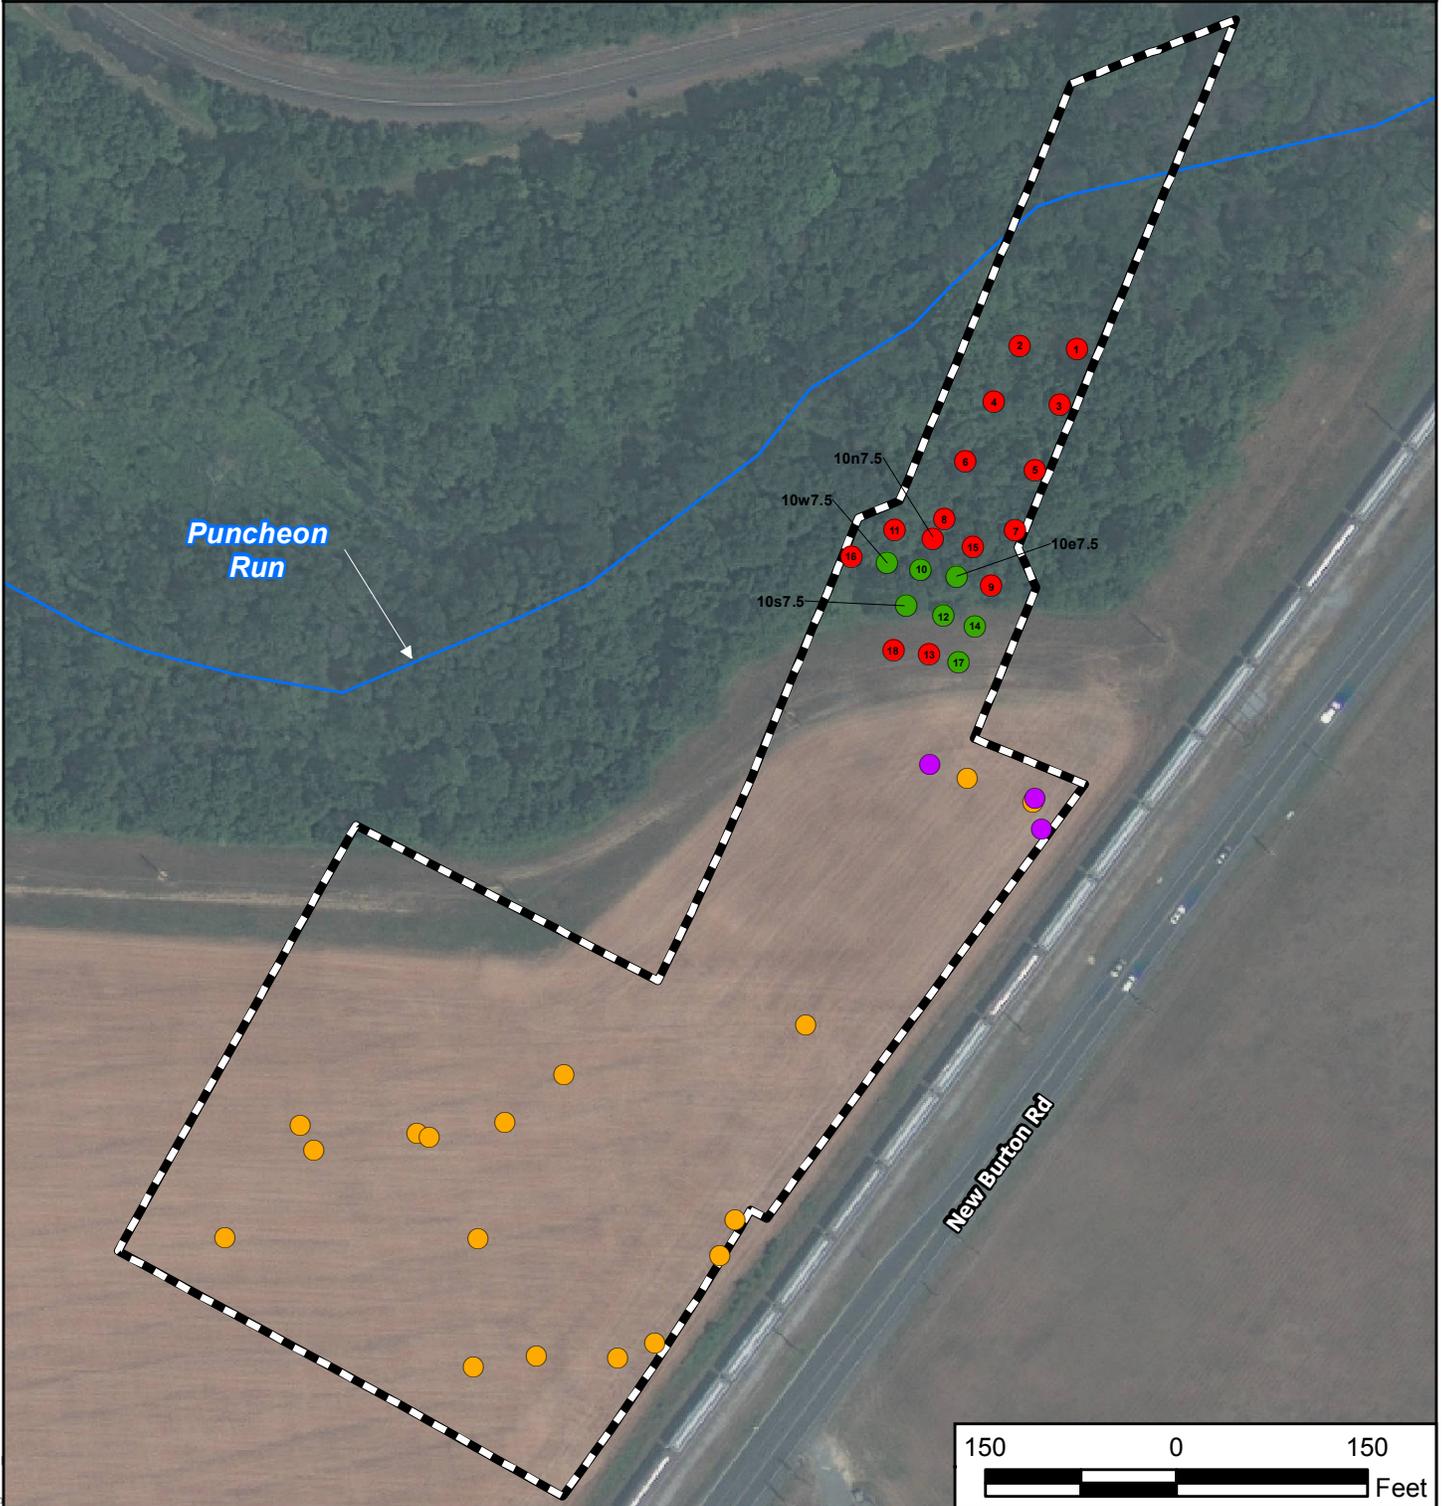
Previous Phase I survey in Test Area 1 of the West Dover Connector Project APE re-identified 7K-C-73 (Figure 4). Test Area 1 was a 5.5-acre area located in the southwest quadrant of the intersection of New Burton Road and Puncheon Run (A.D. Marble & Company 2012: Figure 2). The southern half of the test area is a relatively flat 3.5-acre portion of an agricultural field. The northern half of the test area is an approximately 2-acre portion of the wooded riparian buffer of Puncheon Run. This latter section of the test area slopes downhill northward toward the creek. The test area is located in the northeast corner of the Kesselring farm property (CRS K-1030). Background research had determined that the Woodland I-era site, 7K-C-73, is located on the south bank of Puncheon Run in the vicinity or inside Test Area 1. As anticipated, the field team re-identified the site in the north end of Test Area 1.

The previous (2012) Phase I survey in the test area consisted initially of laying in and excavating two transects of 50-foot interval STPs (STPs 1 through 10) in the wooded portion of the test area and pedestrian surveying the field portion of the test area. Additional STPs (N=12) were laid in and excavated following the recovery of three precontact artifacts in STP 10. A total of 22 STPs were excavated in the wooded portion of Test Area 1. The northern 150 feet of the wooded portion of the test area did not undergo shovel testing due its location within a low-lying wet area. An unmarked electrical utility was observed in the vicinity of STPs 12, 13, and 14. The profiles of these STPs confirmed disturbance at this location. STP 17, which was located southeast of the STP 12 through STP 14 cluster, was a low-lying wet and disturbed area that appeared to be filled with railroad ballast and soil, potentially used to level out an eroded gully.

Much of the artifact assemblage was collected from this approximately 1.5-mile stretch of the south edge of Puncheon Run during a surface collection that yielded thermally altered rock, quartz, jasper, and chalcedony debitage; an argillite biface fragment; and the base of a red jasper stemmed projectile point fragment. The field notes and aerial map show that eight 2-meter-by-2-meter TUs (Test Units 1 through 8) were excavated adjacent to one another on the western edge of the western portion of the expanded West Dover Connector APE, at the edge of the agricultural field adjacent to the wood line. The field notes also show that one test unit (Test Unit 9) was excavated inside the current APE, inside the woods close to the location of STP 5, which was excavated during the 2012 Phase I testing program (see Figure 4).

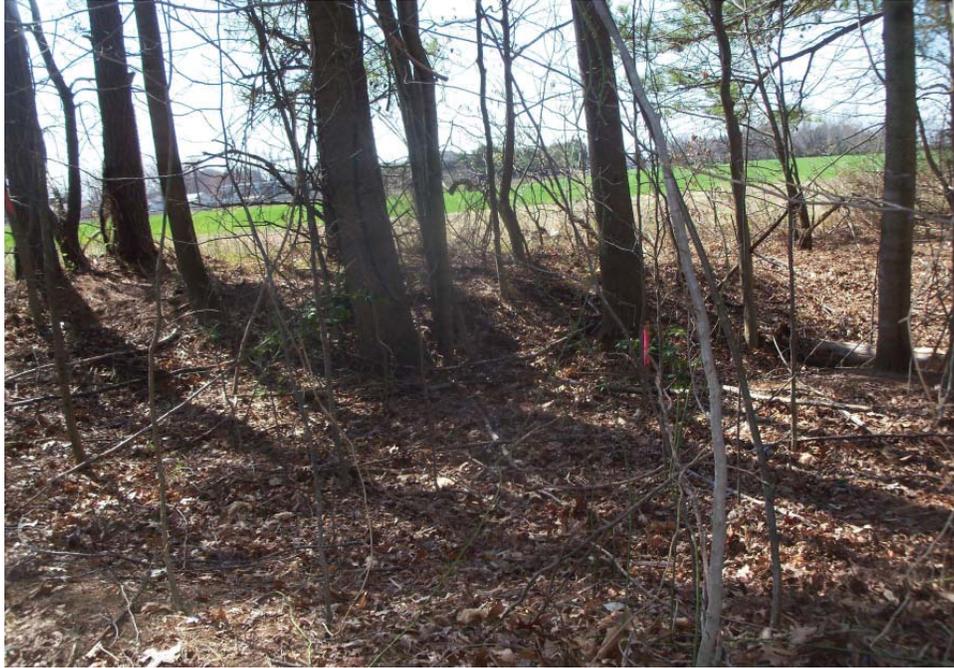
Photograph 5: General conditions in vicinity of STP 10

The stratigraphic sequence in STP 10, located near the top of the terrace overlooking Puncheon Run, consisted of an O-horizon, A-horizon, B-horizon, and B2-horizon. This sequence was the same basic sequence (with the occasional addition of an E-horizon between the A- and B-horizons) that was encountered during the Phase II evaluation program at the site. The field team recovered a total of 29 precontact artifacts in the wooded, shovel tested portion of Test Area 1. These artifacts consisted of jasper, chert, quartz, quartzite, and argillite debitage, as well as one jasper edge-modified flake (utilized flake) with a steep scraper-like edge and one Lamoka-like stemmed projectile point/knife fragment. Lamoka-type tools range in date from the Late Archaic to Woodland I periods (Custer 2001:63). This time period is consistent with diagnostics found previously in 1976 when the site was first discovered.

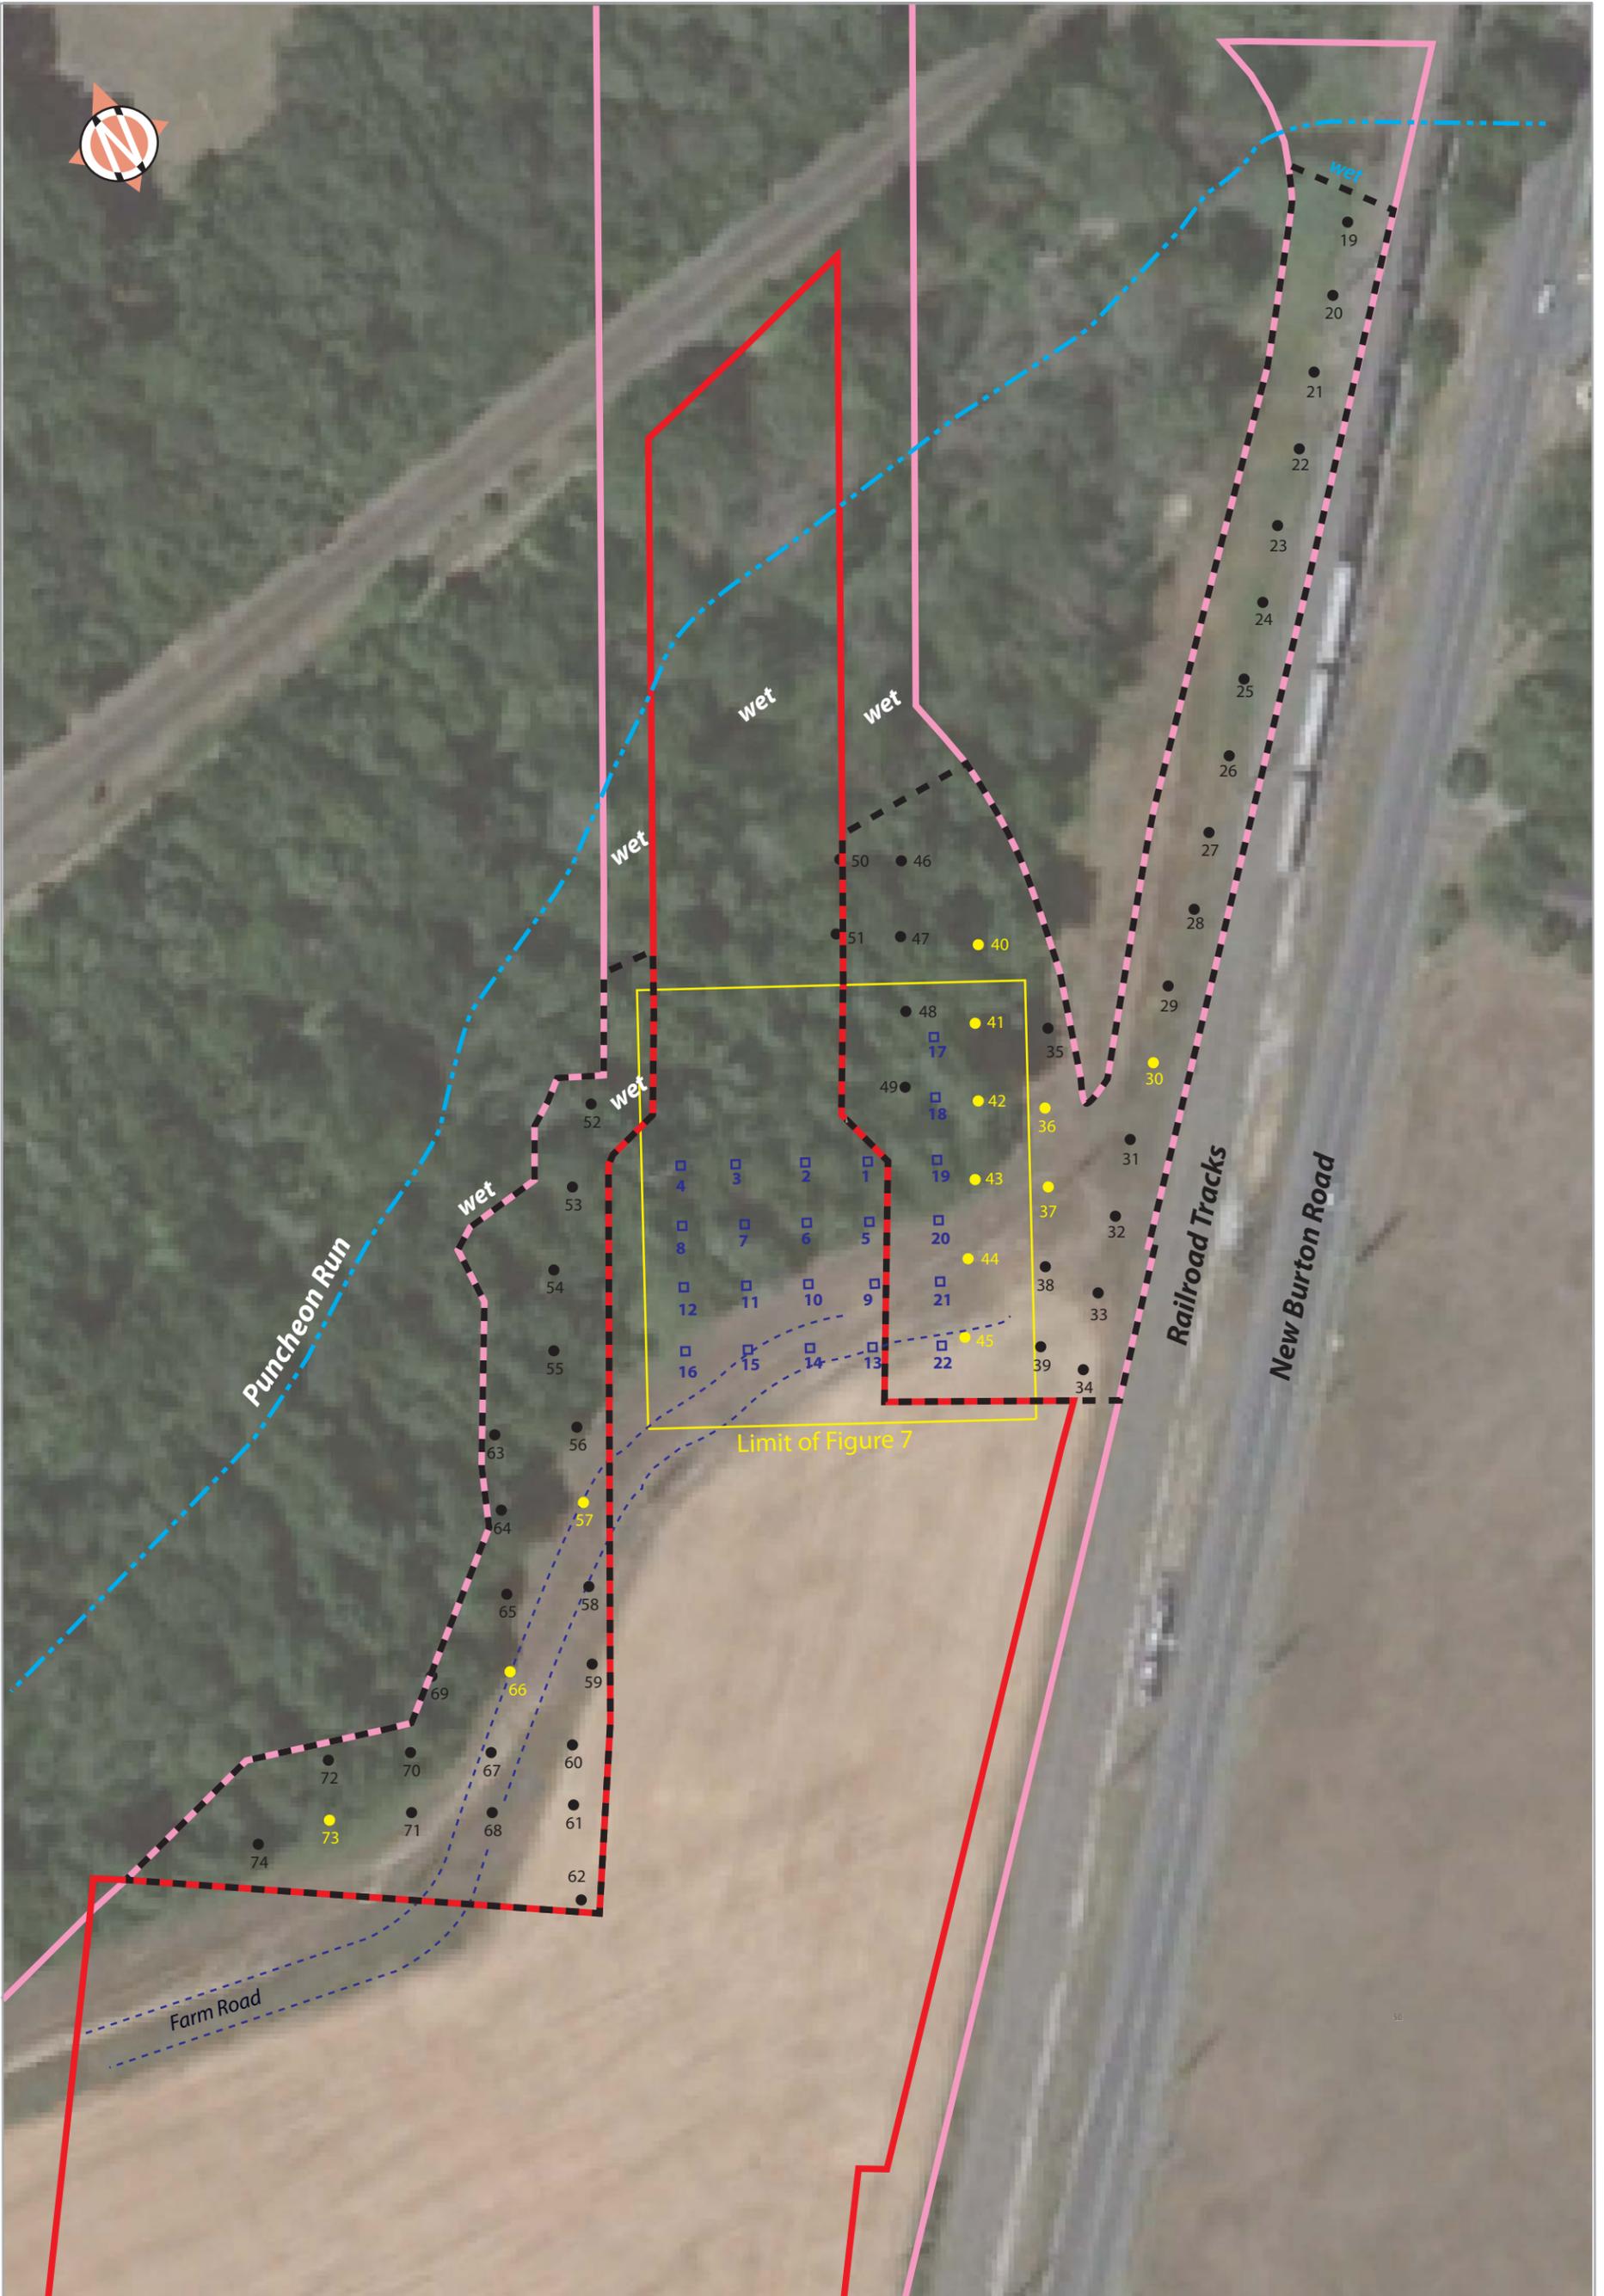
Figure 5
Shovel Test Pit and Test Unit Locations
 West Dover Connector
 Kent County, Delaware

team placed and excavated a total of 56 STPs during the additional Phase I survey program in April 2013 (Figure 5).

- TU Location
- STP Location
- Positive Precontact STP Location
- Former APE
- Revised APE
- - - Additional Tested Portions of APE

The field team then placed and excavated 23 STPs (STPs 52 to 74) at 50-foot intervals west of the previously tested area (Figure 5). Twelve of these STPs were placed in the woods and included STPs 52 to 56, 63 to 65, 69, 70, 72, and 74. STP 52 was placed near the north end of the test area, and its excavation was halted when the crew encountered the water table at approximately 10 centimeters below surface. STP 54 also exhibited a shallow water table at 15 centimeters below surface. The other STPs in the woods generally shared profiles characterized by an A-, E-, and B-horizon sequence (see STPs 56 and 70 on Figure 8). Historic aerial photographs show that this portion of the woods had never been plowed and thus seemed relatively intact. However, the STPs placed in the woods yielded no cultural materials or features.

The field team placed 22 1-meter-by-1-meter TUs in the artifact-dense core of 7K-C-73, as defined by the STP survey in 2012 and 2013 (Figure 5). The Phase II work plan had initially called for 16 TUs to be laid in four rows of four TUs on a 25ft-interval grid. However, the 2013 STP survey conducted adjacent to the east of the site core effectively expanded the site core to the east, and therefore an additional six TUs were placed east of the previously defined core.

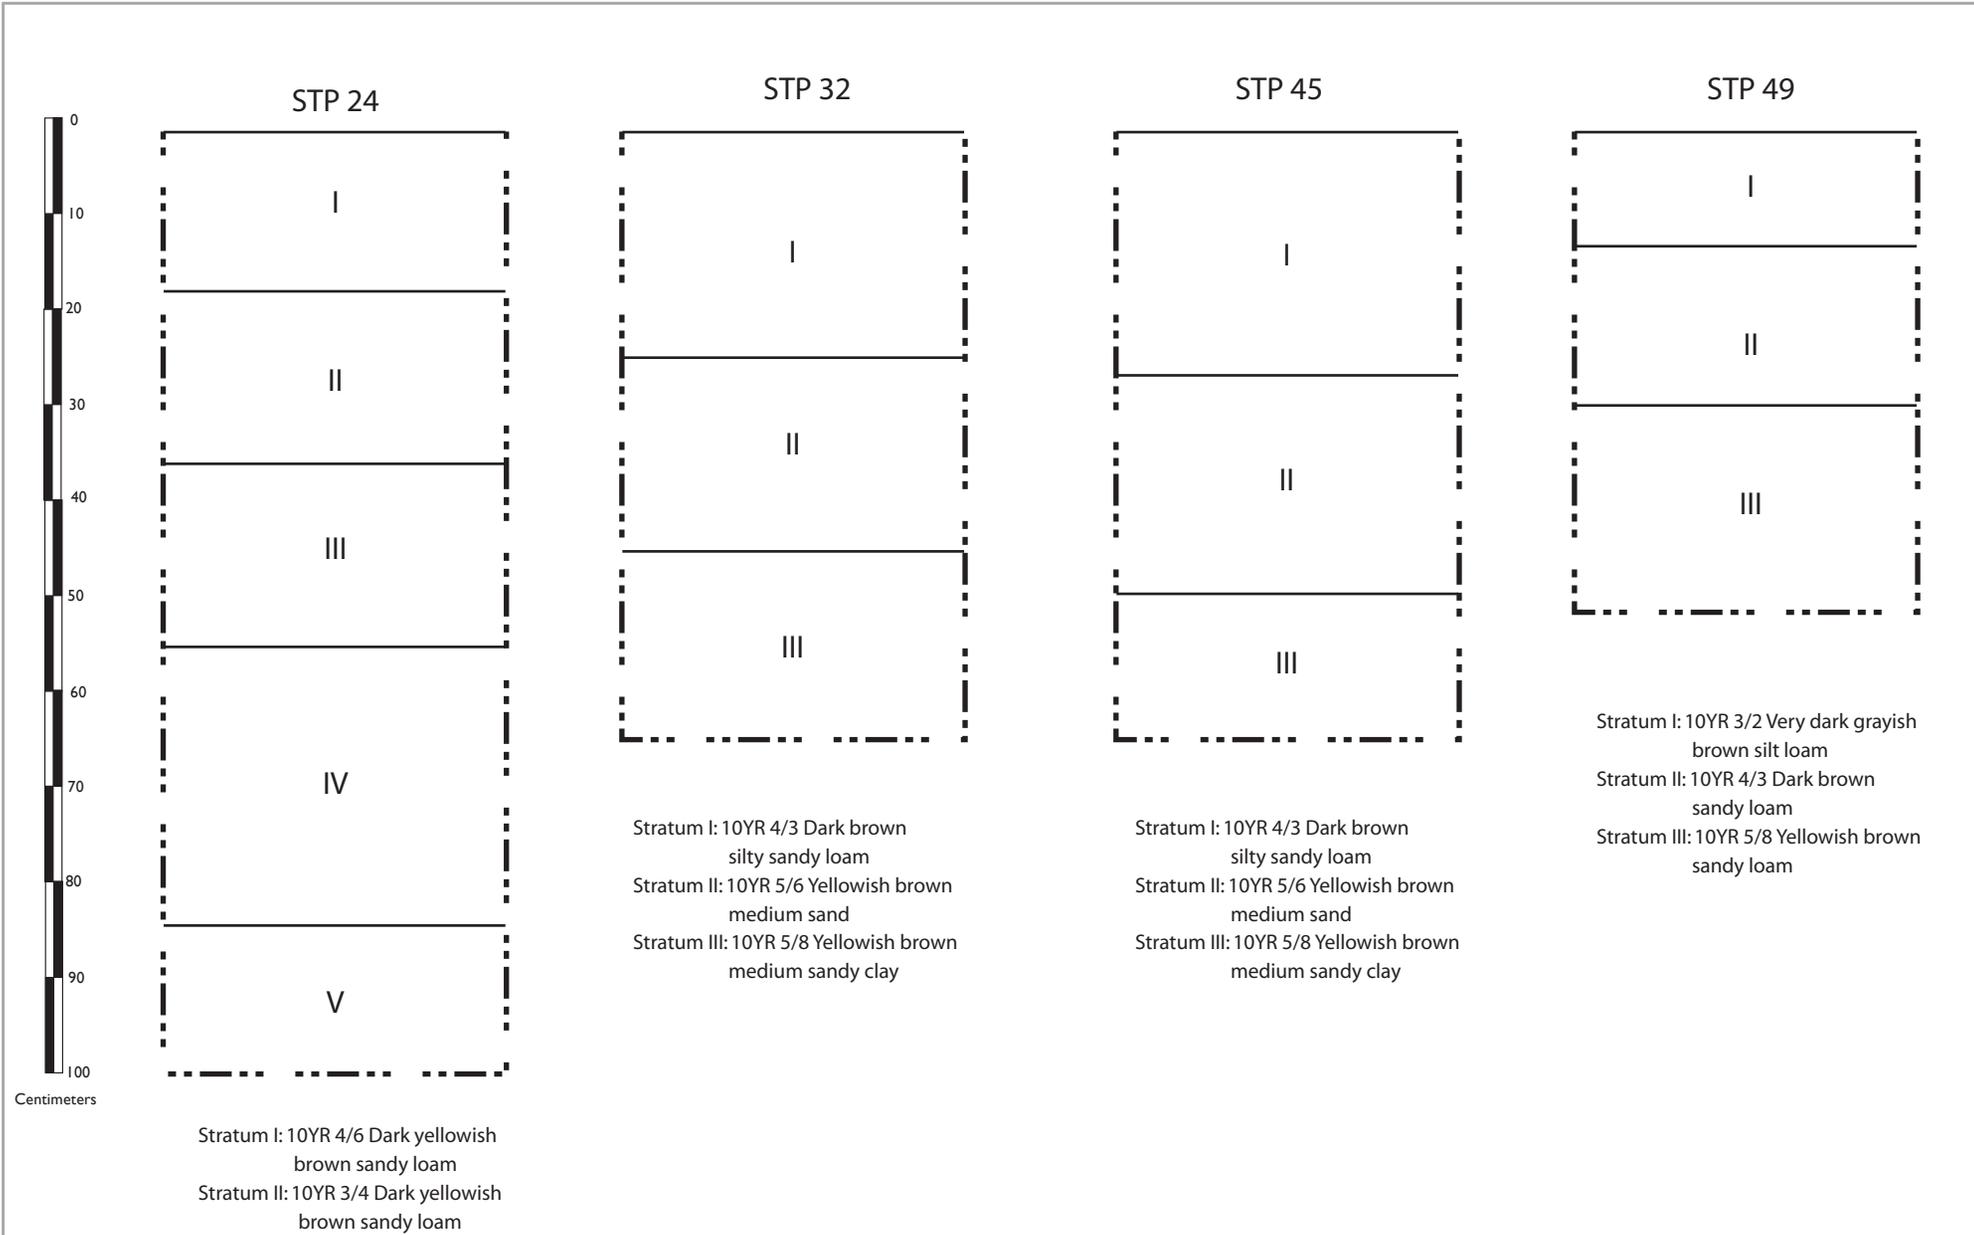
Figure 6
Representative Shovel Test Pit Profiles - East of Site Core
 West Dover Connector
 Kent County, Delaware

previously plowed and part of the agricultural field, and has been allowed to regrow into a lightly wooded forest (Delaware DataMIL, accessed May 2013). The profiles of the STPs in the woods exhibit a plowzone/A-horizon overlying B-horizon subsoil (see STP 49 on Figure 6). Some portions of this area exhibited a cut-and-fill landscape as well as sections with long linear depressed areas that appeared to be the former farm lane that skirted the edge of the woods when the field extended into the now-wooded/reforested area.

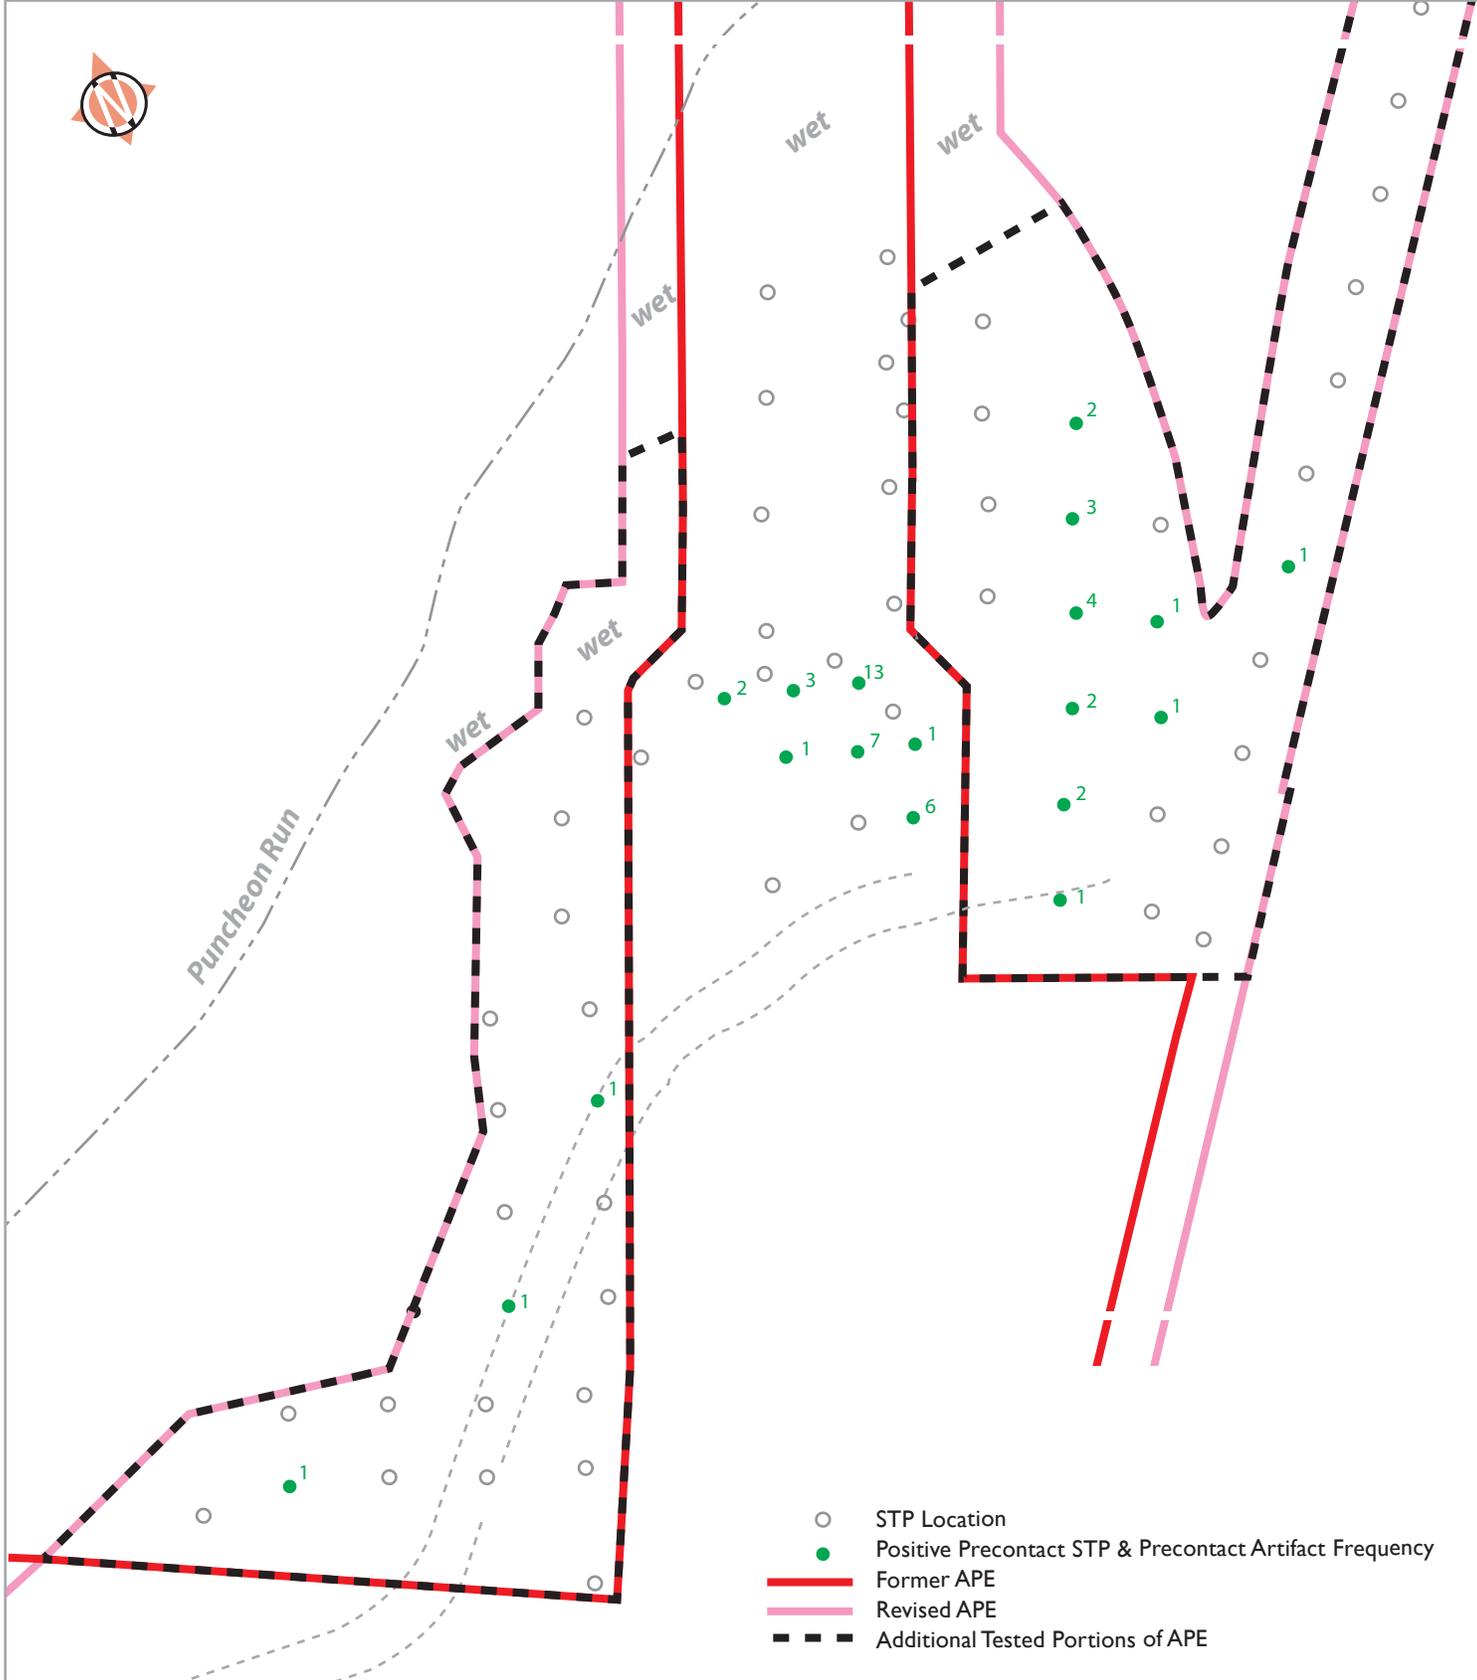
Figure 7
Shovel Test Pit Results: Precontact Artifact Frequencies
 West Dover Connector
 Kent County, Delaware

- STP Location
- Positive Precontact STP & Precontact Artifact Frequency
- Former APE
- Revised APE
- - - Additional Tested Portions of APE

TU 20 was placed in the grassy edge of the agricultural field (see Figure 7). It contained a trench in the southern third of the TU beneath the A-horizon (Photograph 19). The trench abuts an upcast/fill layer and cuts the B-horizon. The trench fill was generally similar to the trench fills encountered in TUs 7 and 12, but it was specifically characterized as a moderately compact, yellowish brown sandy loam with 0.5-inch diameter gravels. The field team removed the fill to an approximate depth of 45 centimeters below surface before halting the excavation. The field team recovered seven artifacts from the trench fill, which consisted of seven debitage (two secondary and five tertiary: four quartz and three jasper). The overlying A-horizon consisted of a 12-centimeter thick, compact, dark grayish brown sandy clay loam that contained nine debitage (two secondary, seven tertiary: one chalcedony, one quartzite, two chert, two quartz, and three jasper). The A-horizon overlay a 30-centimeter thick, compact, strong brown silt loam mottled with light gray containing a moderate amount of pea-sized gravels. It is hypothesized that this layer represents upcast soil that resulted from the excavation of the adjacent trench. It was then covered by a re-formed A-horizon. The layer contained 17 debitage (ten secondary, seven tertiary: two chert, 15 jasper). The B-horizon contained no cultural materials, and with the exception of the unmarked utility trench, no cultural features were encountered.

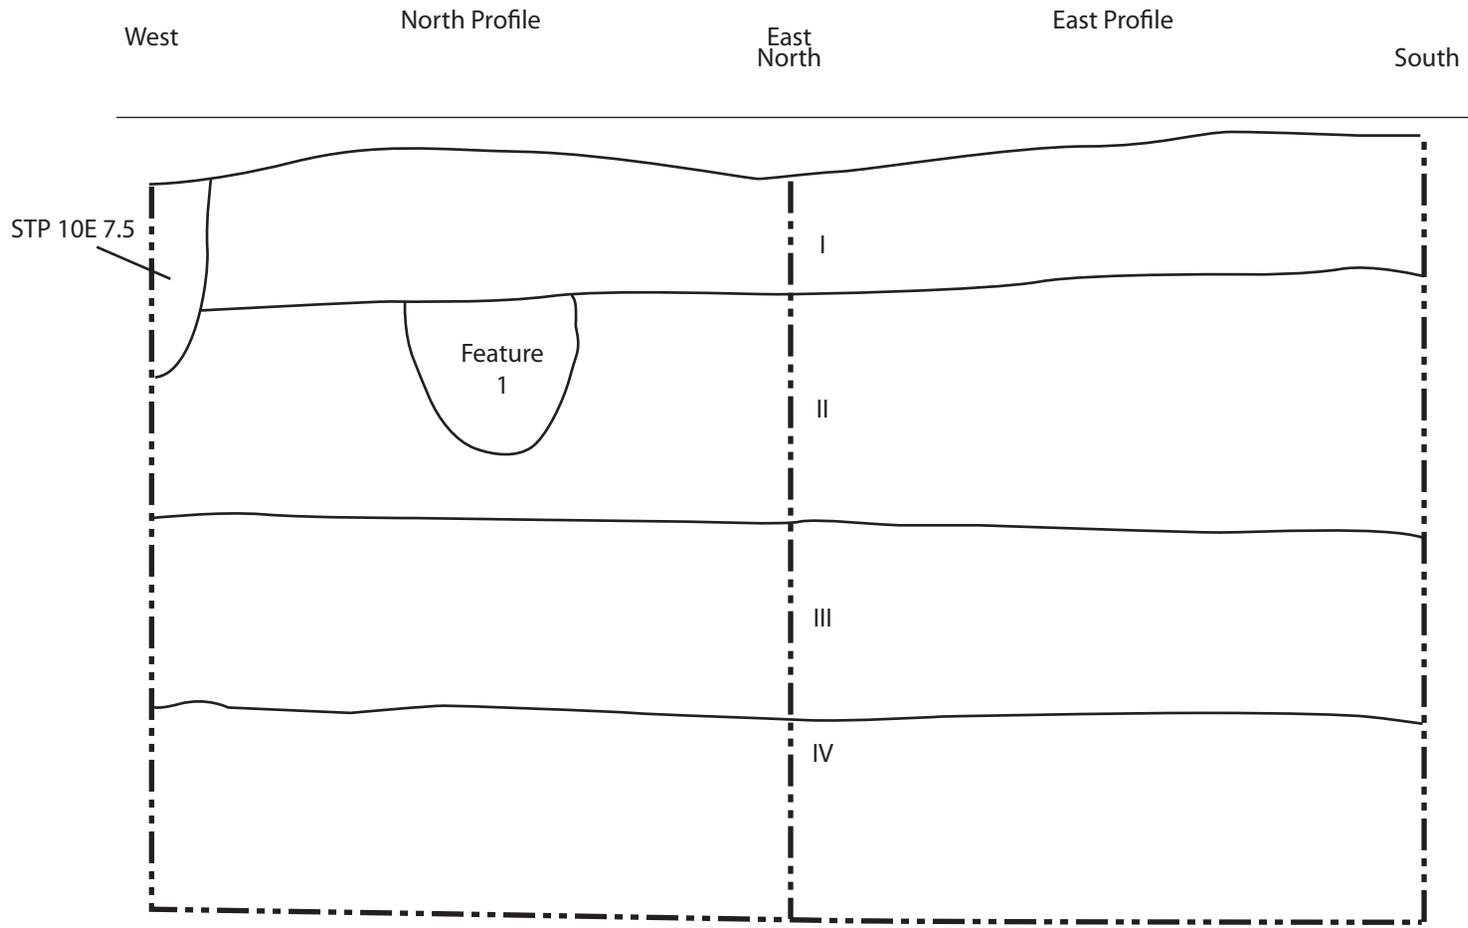
Figure 9
Test Unit 2 North and East Wall Profiles
 West Dover Connector
 Kent County, Delaware

TU 2 exhibited a 20-centimeter thick yellowish brown sandy loam A-horizon over a 35-centimeter thick sandy clay loam E-horizon overlying a 30-centimeter thick yellowish brown sandy clay B1-horizon atop a yellowish brown medium to coarse sand B2-horizon (Figure 9; Photograph 10). Note that the TU was excavated deeply to expose a soil profile for the geomorphological

- Stratum I: 10YR 5/4 Yellowish brown sandy loam
- Stratum II: 10YR 5/6 Yellowish brown sandy clay loam with pea gravel
- Stratum III: 7.5YR 5/6 Strong brown sandy clay with 10-15% pebble
- Stratum IV: 7.5YR 5/8 Strong brown medium to coarse sand
- Feature 1: 10YR 5/3 Brown silty sandy loam

study, which is reviewed later in this section. Excavators identified Feature 1 at the interface of the A- and E-horizons. The feature is a round, 30-centimeter wide and 20-centimeter deep basin-shaped pit. It contained no cultural materials, but based on its location near the edge of the field and its morphology, it is interpreted as a fencepost posthole. STP 10E 7.5 is present in the northwest corner of the TU. This STP was excavated by the field team during the 2012 Phase I study, and 13 artifacts that included 12 jasper, quartzite, and chert debitage and a chert Lamoka-like projectile point/knife were recovered. The A-horizon of TU 2 contained two aqua bottle glass fragments, a sandstone thermally altered rock, and 22 debitage (four secondary, 18 tertiary: five chert, two quartz, 15 jasper). Its E-horizon contained two thermally altered rocks and 33 debitage (one primary, six secondary, 26 tertiary: one chalcedony, two chert, 23 jasper, seven quartz; Photograph 11). Although the field team recovered 60 flakes in the unit, the team identified no precontact features.

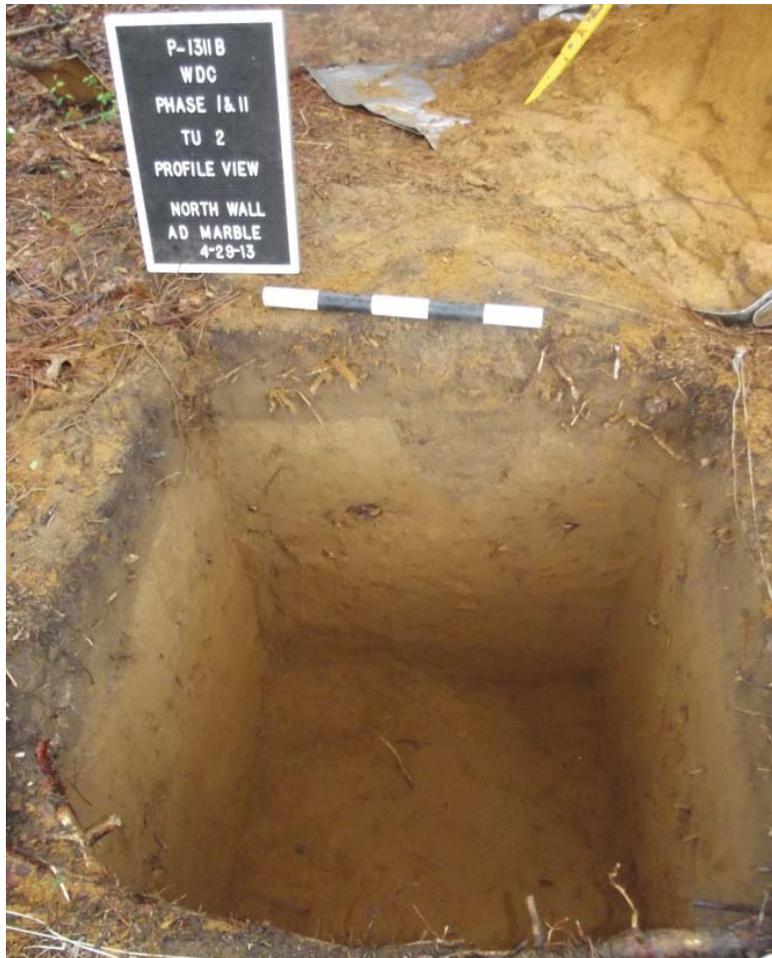
Photograph 10: TU 2, north wall profile, Feature 1 below plowzone in center of frame

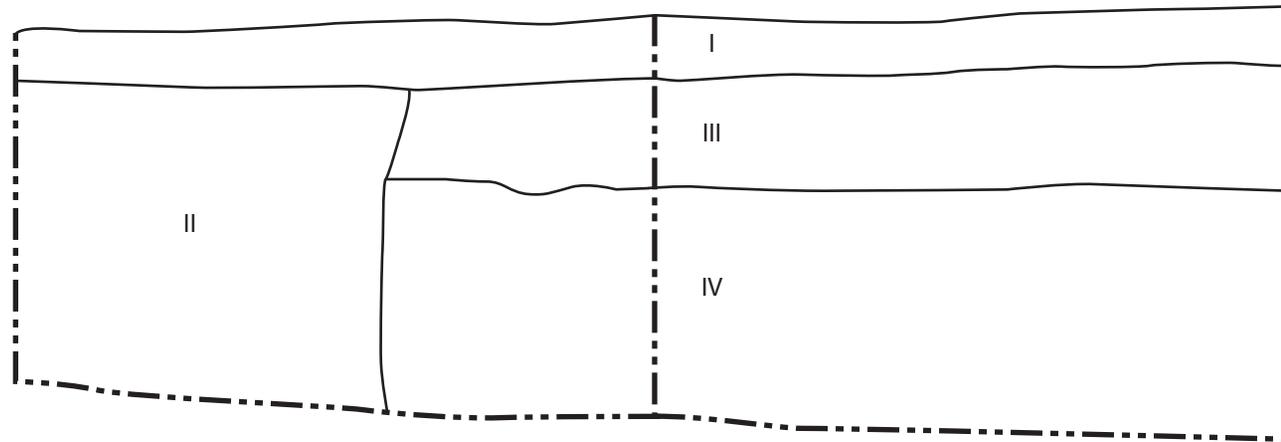
Figure 10
Test Unit 7 North and West Wall Profiles
 West Dover Connector
 Kent County, Delaware

TU 7 was placed on the edge of the tree line (see Figure 5). It exhibited an A-, E-, and B-horizon sequence, but was intersected by an unmarked utility trench in the southern part of the unit (Figure 10). The trench was identified at the interface of the plowzone/A-horizon and E-horizon and generally traverses the site in an east-west orientation, based on its location in the TU. The trench fill is composed of brown and yellowish brown sandy loam that extends at least approximately 45 centimeters below surface where pink flagging labeled “Caution – Buried Electric Line” was uncovered; excavation halted at this point. The trench cuts the E-horizon and B-horizon and contained 23 modern, historic, and precontact artifacts: seven pieces of plastic, an emerald green bottle glass fragment, and slag, as well as a thermally altered rock and 13 debitage (all tertiary: seven jasper, two quartzite, one quartz, and three chert). The overlying dark grayish brown sandy loam plowzone/A-horizon is approximately 12 centimeters thick and contained nine artifacts that included a piece of Bakelite shooting pigeon, two slag, an emerald green bottle glass fragment, and five debitage (one secondary, four tertiary: one quartz, four chert). The 20-centimeter thick dark brown sandy loam E-horizon was cut by the trench and overlain by the plowzone/A-horizon and contained 13 artifacts: eight pieces of black plastic bag, a piece of colorless bottle glass, and four debitage (one secondary, three tertiary: one quartz, three jasper). The uppermost level of the underlying dark grayish brown sandy loam B-horizon subsoil contained one secondary jasper flake. A total of 24 precontact lithics were recovered from TU 7, but no cultural features (other than the modern utility trench) were encountered.

- Stratum I: 10YR 4/4 Dark grayish brown sandy loam
- Stratum II: 10YR 4/3 Dark brown sandy loam mottled with 10YR 5/6 yellowish brown
- Stratum III: 10YR 4/3 Dark brown sandy loam
- Stratum IV: 10YR 4/4 Dark grayish brown sandy loam

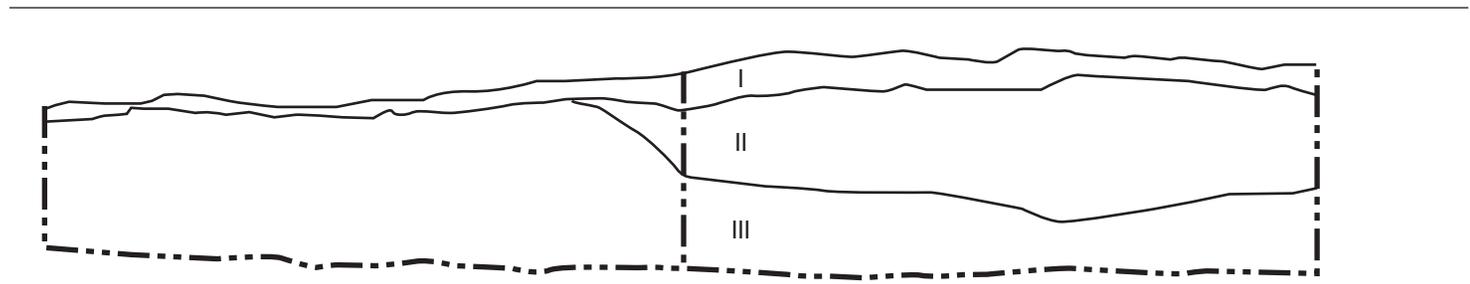
Figure I I
Test Unit 10 North and West Wall Profiles
 West Dover Connector
 Kent County, Delaware

TU 10 was also placed adjacent to the north of the farm lane. It contained a 7-centimeter thick vary dark grayish brown loamy and humic O-horizon overlying brownish yellow sandy loam B-horizon subsoil across most of the TU; however, it was overlying a dark yellowish brown sandy loam layer in the northern margin of the TU (Figure 11; Photograph 12). This layer apparently cuts into the B-horizon and reaches its greatest depth along the north wall. Given its proximity to the farm lane and the truncated natural profile evinced by the O-horizon that immediately overlies the B-horizon, it would appear that the descending fill layer is the edge of an infilled roadbed/farm lane. The fill layer was identified in the field as a trench and designated Feature 2. The field team recovered an aqua bottle glass fragment from the fill and an amber bottle glass

- Stratum I: 10YR 3/2 Very dark grayish brown humus/loam
- Stratum II: 10YR 4/4 Dark yellowish brown sandy loam; Feature 2
- Stratum III: 10YR 6/8 Brownish yellow sandy loam

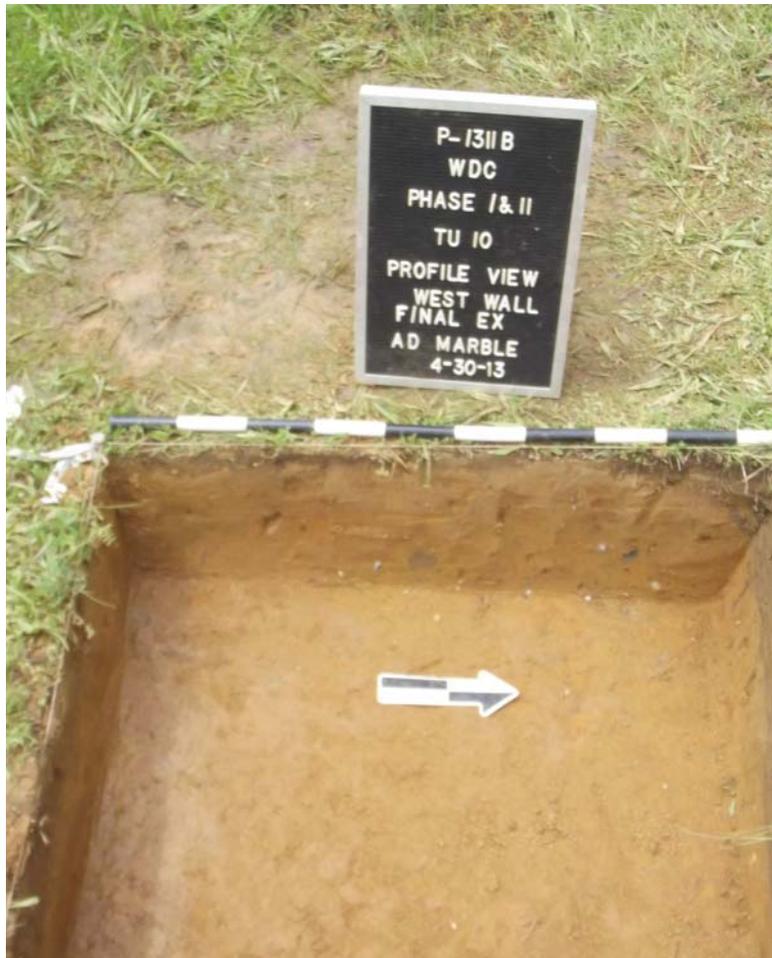
Photograph 12: TU 10, west wall profile, showing Feature 2

fragment and a piece of tertiary-stage jasper debitage from the uppermost level of the B-horizon. With the exception of the possible infilled road cut (i.e., Feature 2), no additional features were identified in TU 10.

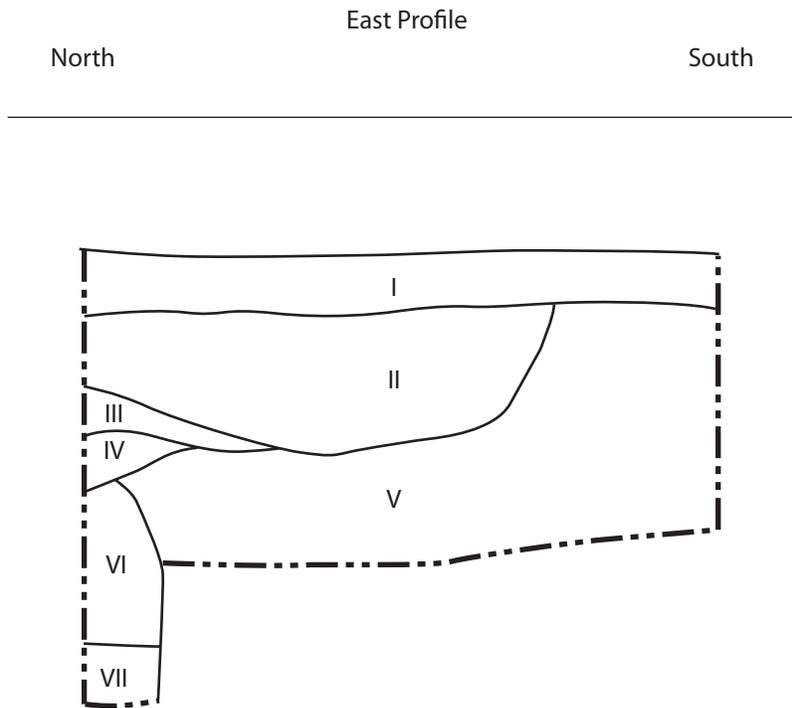
Figure 12
Test Unit 12 East Wall Profile
West Dover Connector
Kent County, Delaware

TU 12 contained a profile similar to that encountered in TU 7. Excavation of TU 12 revealed a 10-centimeter thick dark yellowish brown sandy loam plowzone/A-horizon atop an at least 40-centimeter thick mottled dark yellowish brown sandy loam with yellowish brown sandy loam and dark yellowish brown sandy loam lenses. The layer was defined as trench fill because the stratigraphic relationship showed that it overlay/cut the naturally occurring E-horizon, which slopes upward in the northern margin of the TU (Figure 12; Photographs 13 and 14). Excavation of the fill was halted because of its close similarity to the utility trench fill encountered in TU 7. The E-horizon was a 20-centimeter thick dark yellowish brown sandy loam overlying yellowish brown sandy loam B-horizon subsoil. The trench fill contained seven artifacts: a colorless bottle glass fragment, an eroded redware sherd, and five debitage (one secondary, four tertiary: one chert, one quartz, three jasper). No features other than the likely utility trench were encountered in TU 12.

- Stratum I: 10YR 4/4 Dark yellowish brown sandy loam
- Stratum II: 10YR 4/4 Dark yellowish brown sandy loam mottled with 10YR 4/6 Dark yellowish brown
- Stratum III: 10YR 4/4 Dark yellowish brown sandy loam mottled with 10YR 5/8 Yellowish brown
- Stratum IV: 10YR 4/3 Dark brown sandy loam
- Stratum V: 10YR 5/6 Yellowish brown sandy loam with pockets of 10YR 4/4 Dark yellowish brown and 10YR 3/2 Very dark grayish brown sandy loam
- Stratum VI: 10YR 4/6 Dark yellowish brown sandy loam
- Stratum VII: 10YR 5/8 Yellowish brown sandy loam

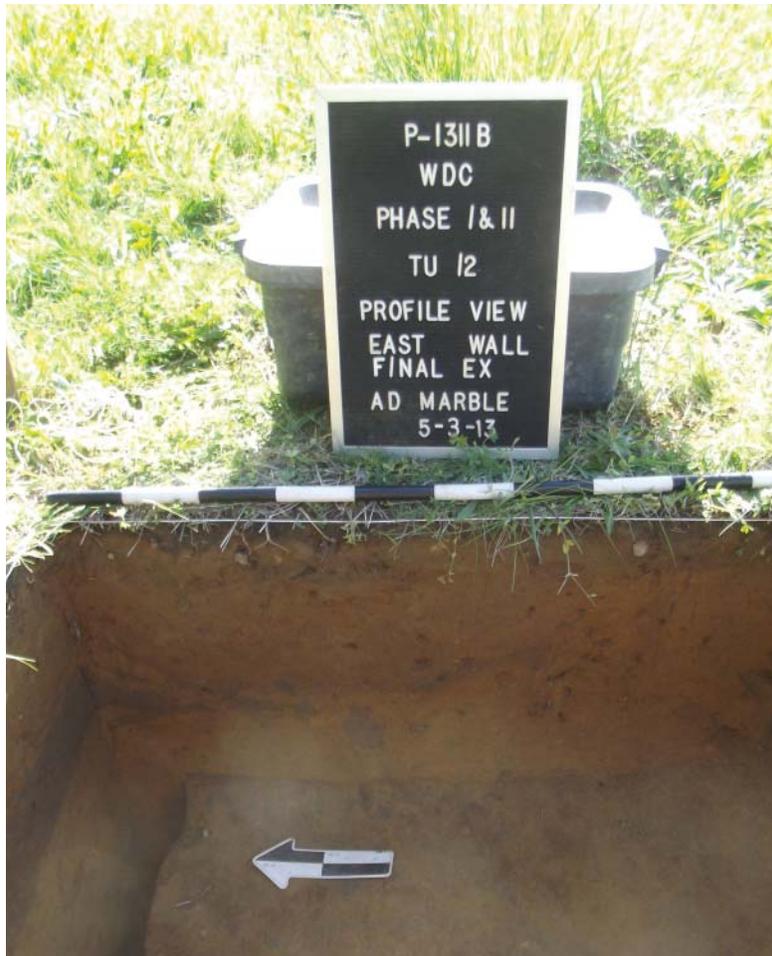
Photograph 13: TU 12, east wall profile, showing utility trench

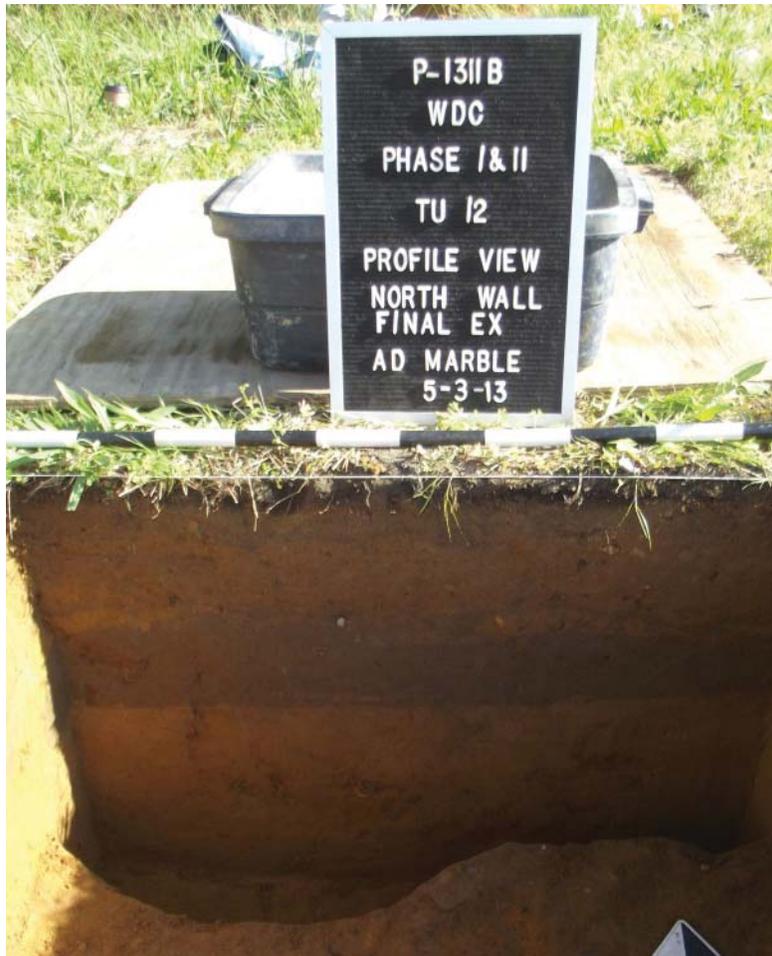
Photograph 14: TU 12, north wall profile, showing utility trench

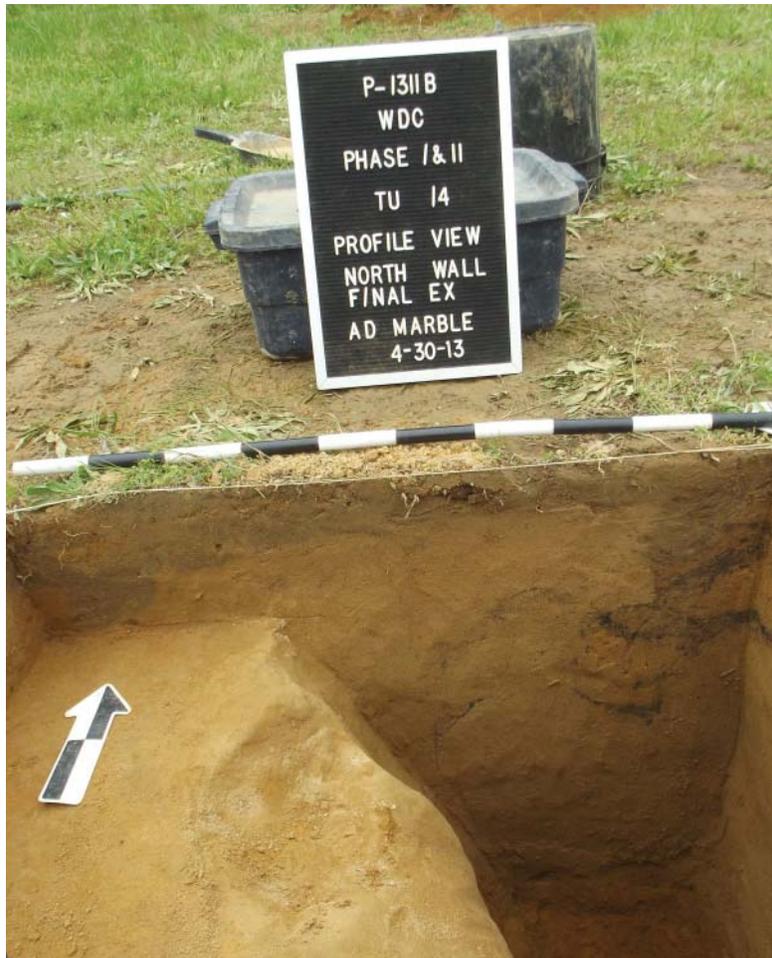
Photograph 15: TU 14, north wall profile, showing Feature 3

TU 14 was placed in the farm lane (see Figure 5). It contained a shallow (7-centimeter thick) dark yellowish brown sandy loam A-horizon overlying the very compact yellowish brown sandy loam B-horizon and Feature 3 in the northeast corner of the TU at the B-horizon surface (Photograph 15). Feature 3 extended out of the unit and to the north and east. It was excavated separately and discovered to be a burned tree root ball with root tunnels that spread out and into the B-horizon subsoil. The excavated portion of Feature 3 was 86 centimeters deep and contained four debitage (one primary, three tertiary: one chert, three jasper). The A-horizon contained 19 artifacts: a metal staple, two Bakelite shooting pigeon fragments, four amber bottle glass fragments, ten debitage (one primary, three secondary, six tertiary: one quartz, three chert, six jasper), a jasper core, and a Lamoka-like chert projectile point/knife fragment (Photograph 16). No additional features were observed in TU 14.
