5.0 Field Results

5.1 Results of Previous Phase I Survey at 7K-C-73

Figure 4
Previous Phase I Results
 West Dover Connector
 Kent County, Delaware

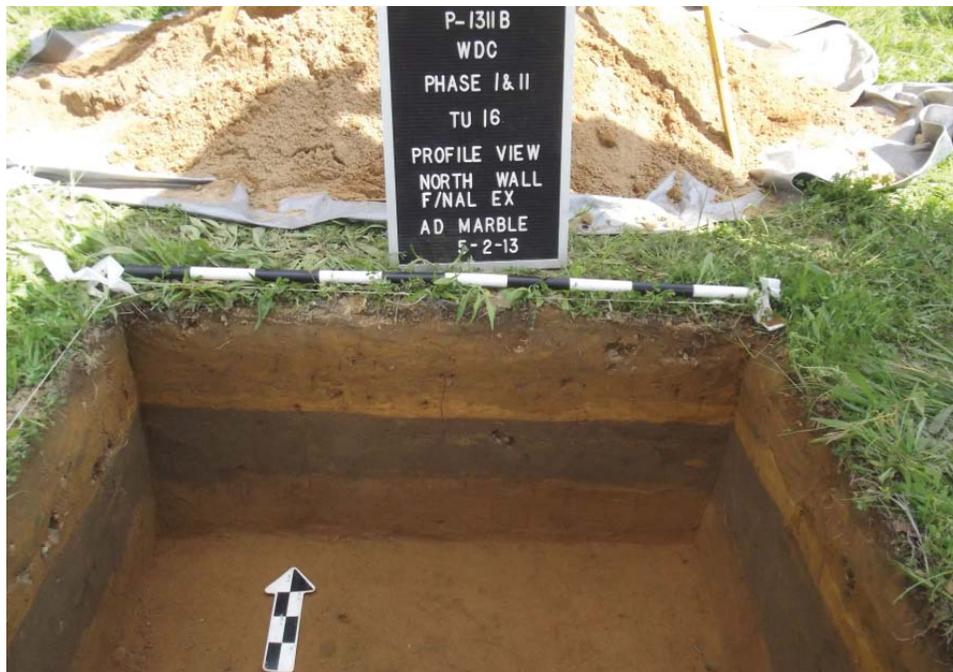
Photograph 17: TU 16, north wall profile, showing Feature 5

It would appear then that Feature 5, the compact lense, is related to a farm lane. The buried A-horizon/possible plowzone is a very compact, 17-centimeter thick, very dark grayish brown sandy loam overlying a compact yellowish brown loamy sand B-horizon subsoil. The field team recovered no cultural materials in TU 16.

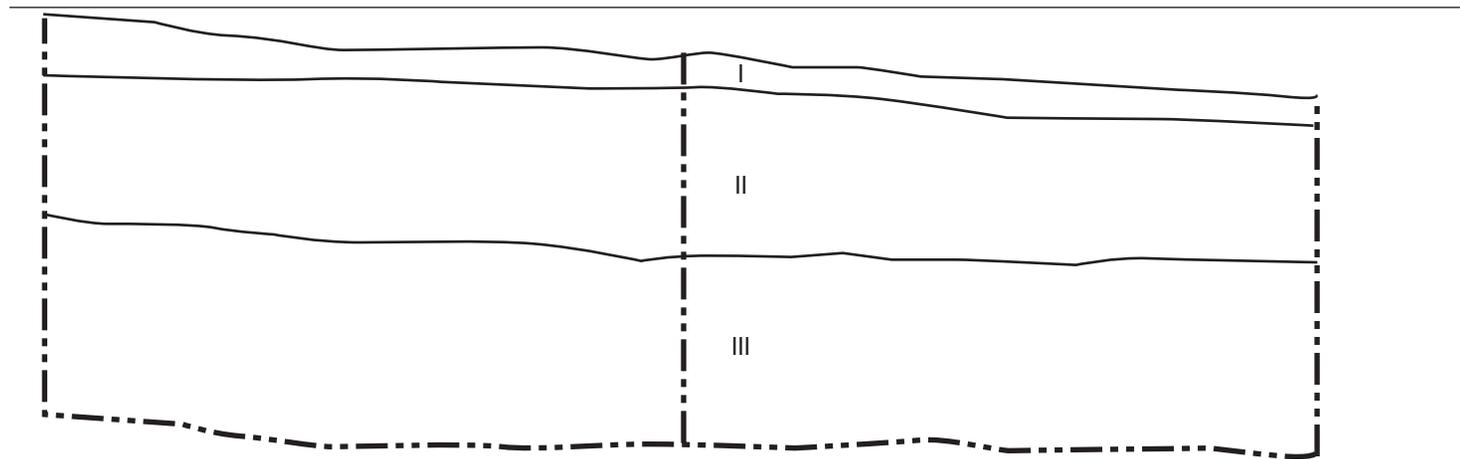
Figure 13
Test Unit 18 North and West Wall Profiles
West Dover Connector
Kent County, Delaware

TU 18 exhibited the same stratigraphy as TU 17: an O- horizon overlying an A-horizon overlying a B-horizon (Figure 13). The 5-centimeter thick O-horizon consisted of dark brown sandy loam and contained a plastic shotgun shell. The underlying 27-centimeter thick A-horizon consisted of dark yellowish brown sandy loam that contained 39 artifacts: a piece of a Bakelite shooting pigeon, a piece of amber bottle glass, a three-piece pull-tab Pepsi can with a steel bottom and bar code (Photograph 18), a thermally altered contracting stem jasper projectile point, and 35 debitage (one primary, five secondary, and 29 tertiary: four chert, three chalcedony, eight quartz, 20 jasper; Photograph 16). The uppermost level of the underlying yellowish brown B-horizon subsoil contained nine debitage (one primary, four secondary, and four tertiary: five chert and four jasper). Although 45 precontact artifacts (44 debitage and one projectile point/knife) were recovered, no features were identified in TU 18.

- Stratum I: 10YR 3/3 Dark brown sandy loam
- Stratum II: 10YR 4/4 Dark yellowish brown sandy loam
- Stratum III: 10YR 5/8 Yellowish brown coarse sand

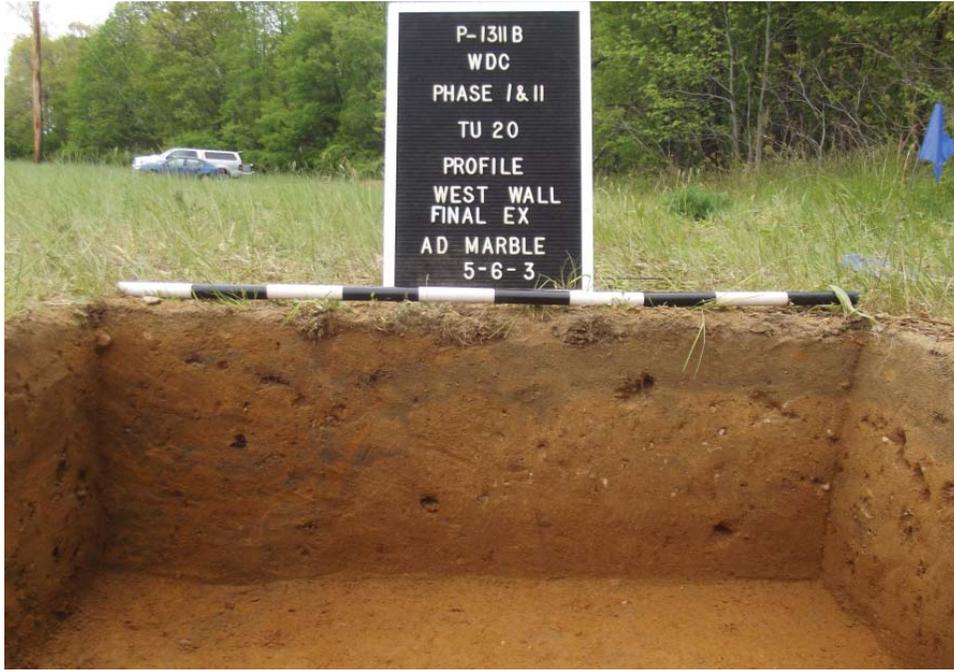
Photograph 19: TU 20, west wall profile

TU 20 was placed in the grassy edge of the agricultural field (see Figure 7). It contained a trench in the southern third of the TU beneath the A-horizon (Photograph 19). The trench abuts an upcast/fill layer and cuts the B-horizon. The trench fill was generally similar to the trench fills encountered in TUs 7 and 12, but it was specifically characterized as a moderately compact, yellowish brown sandy loam with 0.5-inch diameter gravels. The field team removed the fill to an approximate depth of 45 centimeters below surface before halting the excavation. The field team recovered seven artifacts from the trench fill, which consisted of seven debitage (two secondary and five tertiary: four quartz and three jasper). The overlying A-horizon consisted of a 12-centimeter thick, compact, dark grayish brown sandy clay loam that contained nine debitage (two secondary, seven tertiary: one chalcedony, one quartzite, two chert, two quartz, and three jasper). The A-horizon overlay a 30-centimeter thick, compact, strong brown silt loam mottled with light gray containing a moderate amount of pea-sized gravels. It is hypothesized that this layer represents upcast soil that resulted from the excavation of the adjacent trench. It was then covered by a re-formed A-horizon. The layer contained 17 debitage (ten secondary, seven tertiary: two chert, 15 jasper). The B-horizon contained no cultural materials, and with the exception of the unmarked utility trench, no cultural features were encountered.

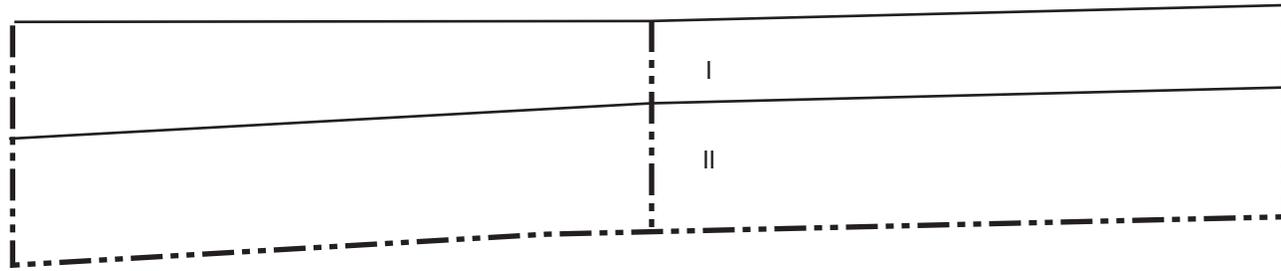
Figure 14
Test Unit 22 North and West Wall Profiles
West Dover Connector
Kent County, Delaware

TU 22 was located on the opposite edge of the farm lane across from TU 21 and exhibited the same A- and B-horizon sequence as TU 21 (Figure 14). An approximately 20-centimeter thick compact dark grayish brown medium sand overlay a compact strong brown medium sand. The field team recovered eight debitage from the A-horizon. These consisted of three secondary and five tertiary flakes derived from chert and jasper. The team observed no features in TU 22.

Stratum I: 10YR 4/2 Dark grayish brown medium sand
Stratum II: 7.5YR 5/6 Strong brown medium sand
