BLOCK 1191, KING TO FRENCH STREET: (Maps 2&9-11; Plates 2-5; Figures 3-18; Appendices 1-5)

Excavations

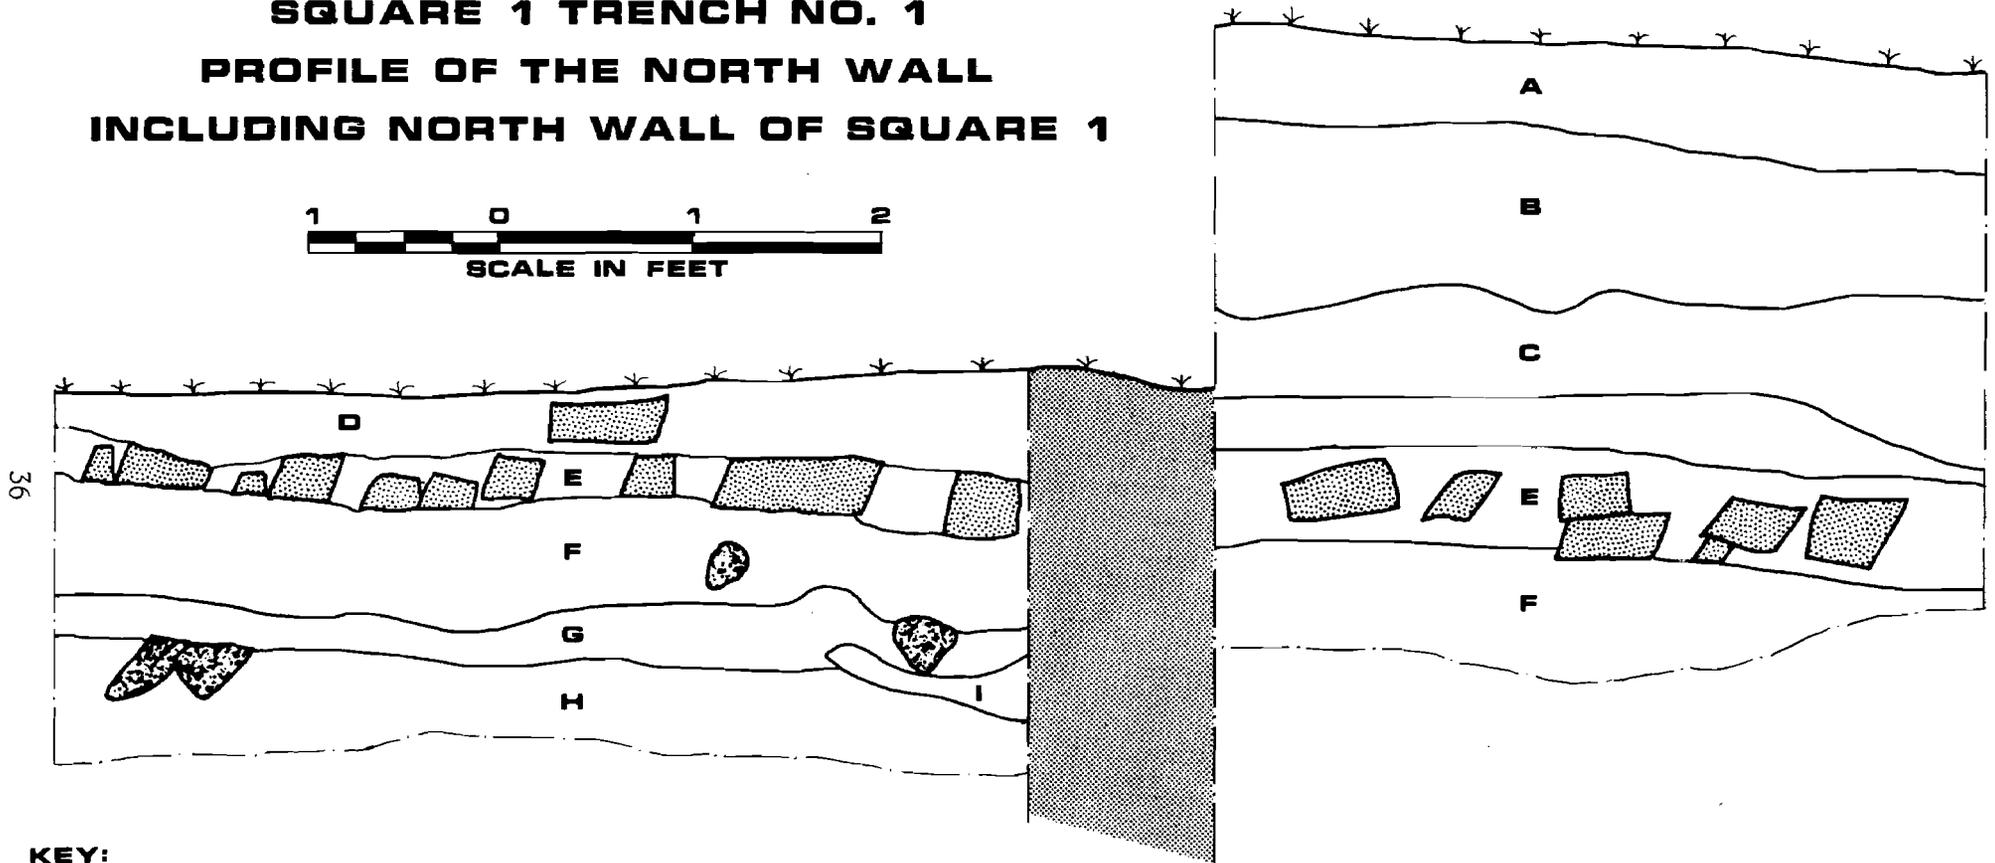
FIGURE 3

The stratigraphic profile of Trench #1 (Figure 3) exhibited complicated stratigraphy of demolition debris, fill layers, several dark, organic cultural levels, and a dense, wet, silty clay deposit ("gray muck") at the bottom. A square wooden post had been sunk into this level. Information provided by Cara Wise (pers. comm.) indicated this as being bog soil. Ms. Wise further stated that the area had a high water table and cellars often

SQUARE 1 TRENCH NO. 1 PROFILE OF THE NORTH WALL INCLUDING NORTH WALL OF SQUARE 1

filled with water; fill had to be deposited before rebuilding. Square #1 was placed in an area of the trench opened to the side and down to the oyster shell layer (Level D). Results of the controlled excavations in this unit (Figure 3) indicated 19th-century materials in Level C (Appendix 2, Provenience #007-001), and late 18th- and early 19th-century materials were recovered from Level E. The location of this trench corresponded to the rear of the stables fronting French Street in 1884 (Map 9).

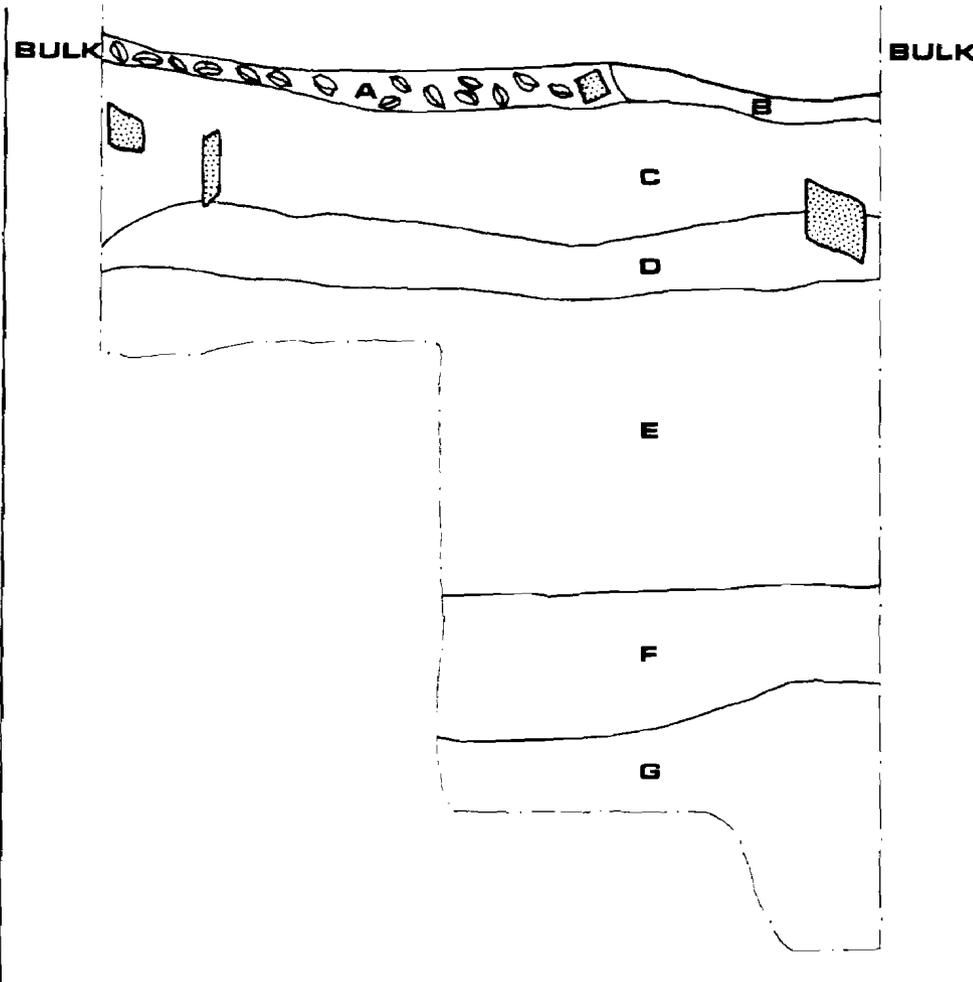
FIGURE 4

TRENCH NO. 1 PROFILE OF THE SOUTH WALL

NOTE: COLOR CHANGE IS GRADUAL
NO SHARP DIFFERENCES BETWEEN LEVELS E, F, & G

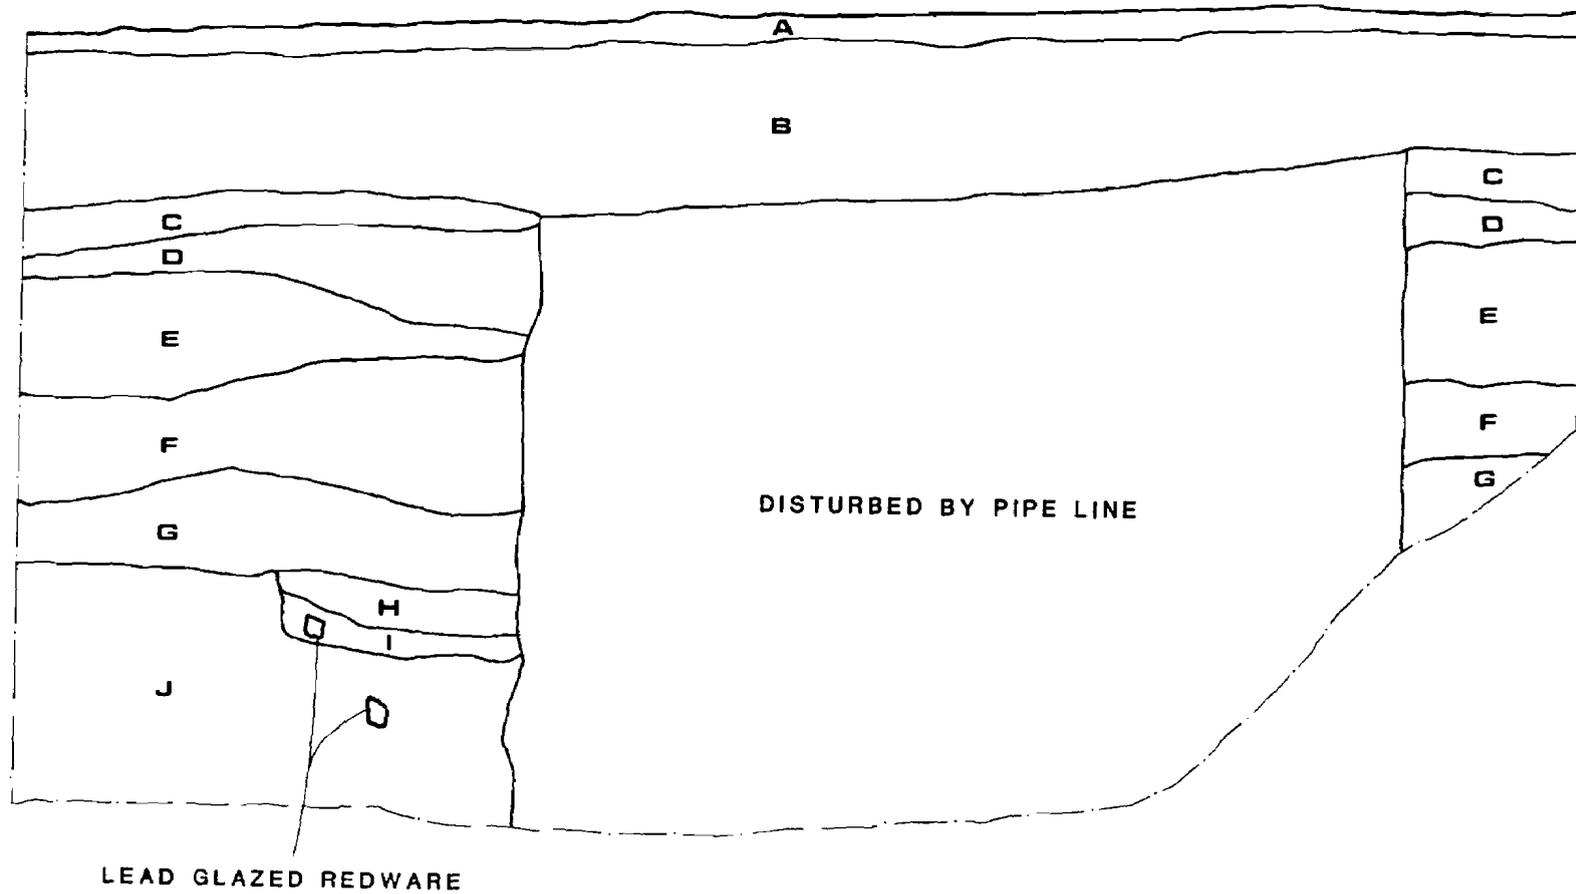
FIGURE 5
WILMINGTON BLVD. BLK. 1191
TRENCH NO. 2
PROFILE OF THE WEST WALL

Trench #2 provided information on stratigraphy beneath the bus station asphalt (Figure 5). Bus station design specifications called for a filling above original grade varying from 0.5' at the southern edge to 1.0' at the northern edge. This trench, and others through the asphalt, confirm this filling. A portion of the stratigraphic profile had been disturbed by utility pipe construction. Building demolition debris was deposited at various times during the block's history, perhaps to raise the ground surface above the damp, marshy conditions suggested by the "gray muck" level encountered at the bottom of most of the trenches (approximately 6' below current surface). Dark organic Levels H, I, and J (Figure 5) appear to be the most homogeneous of the levels and are interpreted as previous occupational ground surfaces. Artifacts (Appendix 2, Provenience #013-015) collected from the trench walls (levels G, I & J) include redware, a patent medicine bottle made after 1840, and a piece of pressed glass tableware dated after 1829. The location of Trench #2 corresponds to the interior of the southernmost Bush stable in 1884 (Map 9).

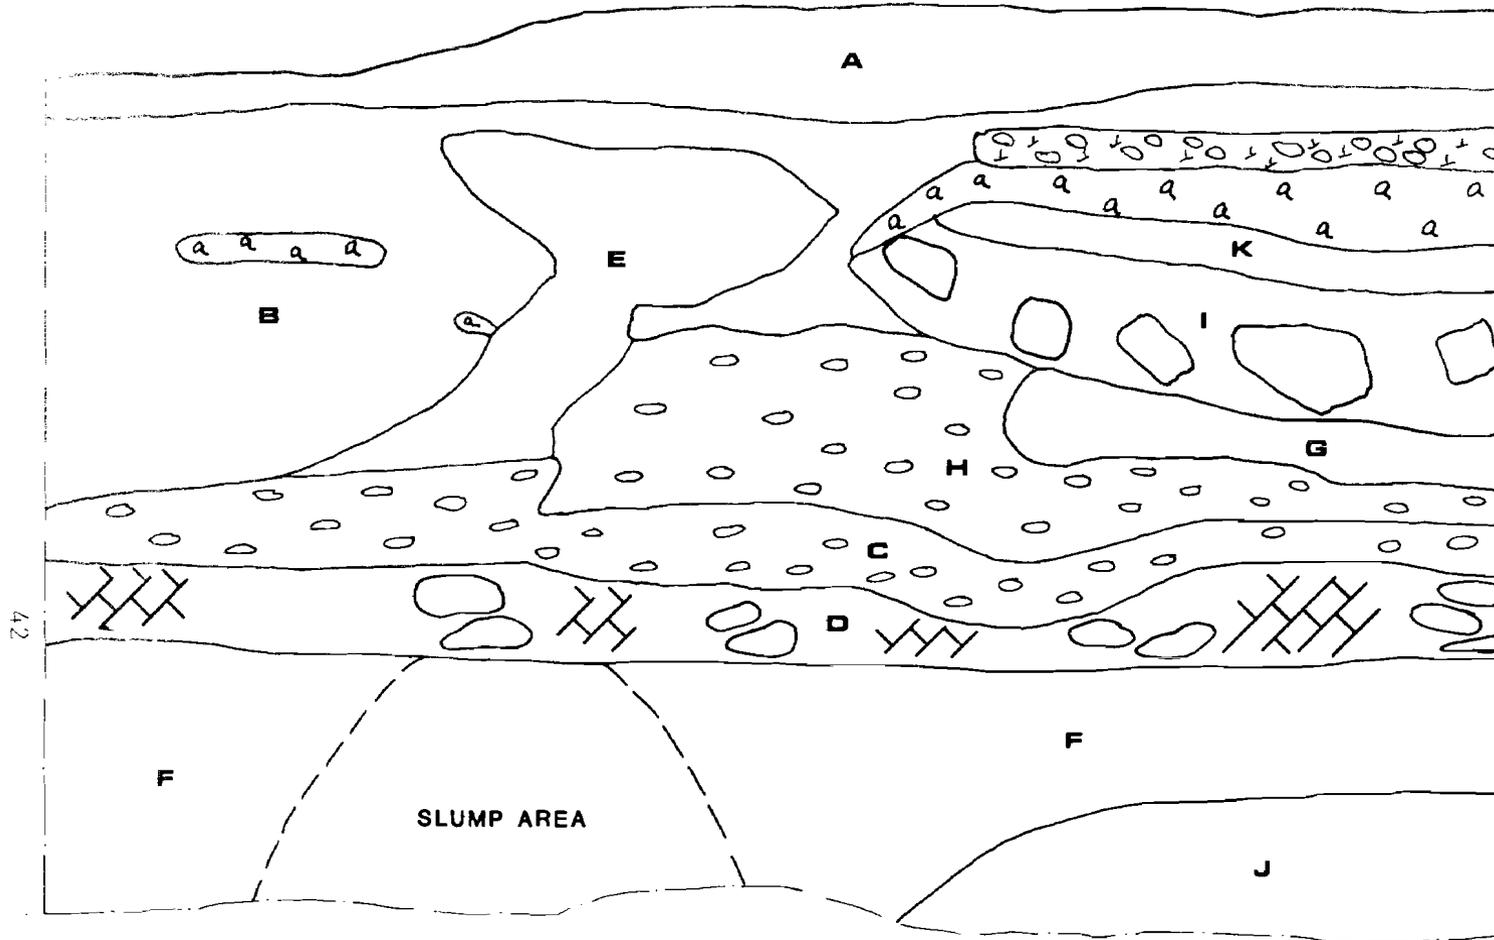
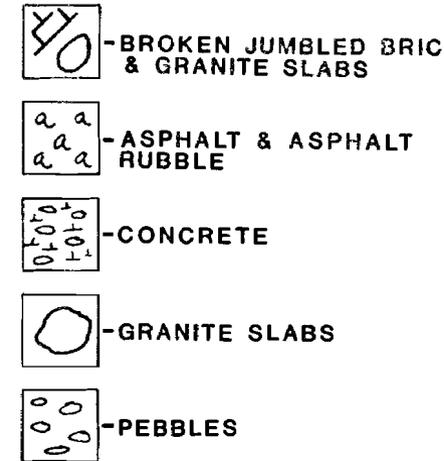
FIGURE 6

The southern profile of Trench #3 exhibited considerable stratigraphy, probably resulting from demolition of the bus station wing located in this area (Figure 6). Zone D in the profile may represent bus station flooring. The western profile (Figure 7) shows a layer of Belgian block paving. This paving is also visible to the southwest in Trench #12 and on the surface where soil has been eroded. The degree of mixing precludes accurate interpretation. The "gray muck" layer was encountered in a shovel test placed in the bottom of the trench. Results of the excavations of Square #1, placed in a shallow extension of the trench, are inconclusive due to disturbance of deposits. Artifacts recovered (Appendix 2, Provenience #016 & 017) were undiagnostic. The location of this trench corresponds to the 1884 yard area behind Lot 10 (Map 9).

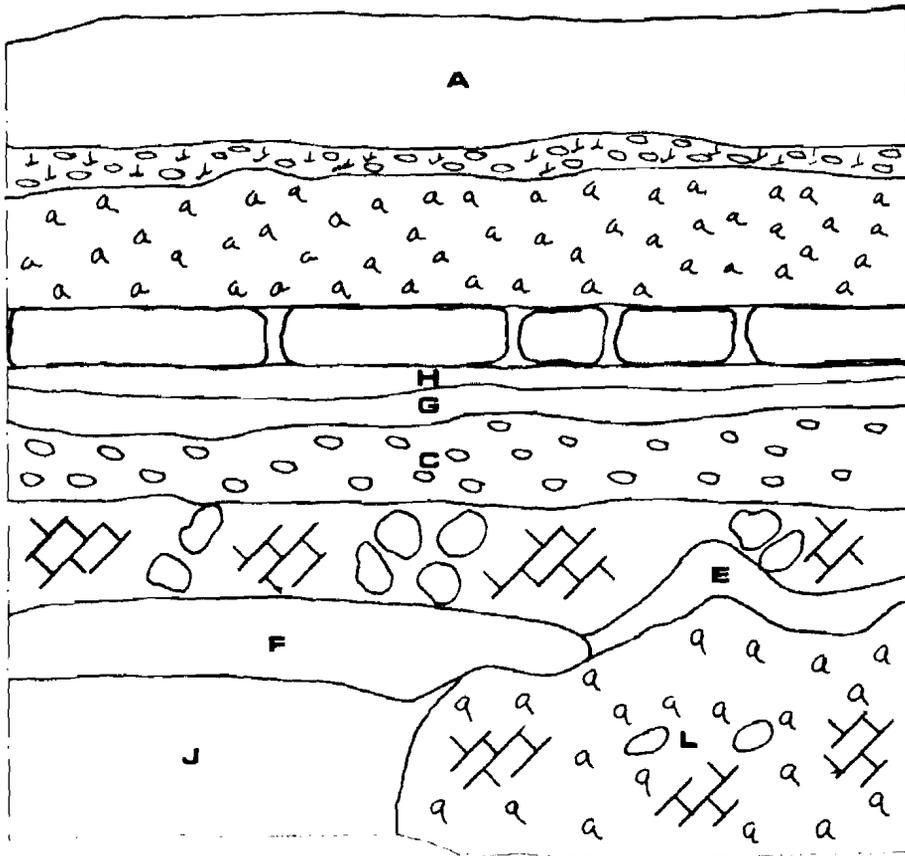
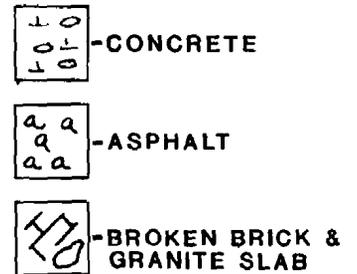
FIGURE 7

PROFILE OF THE WEST WALL

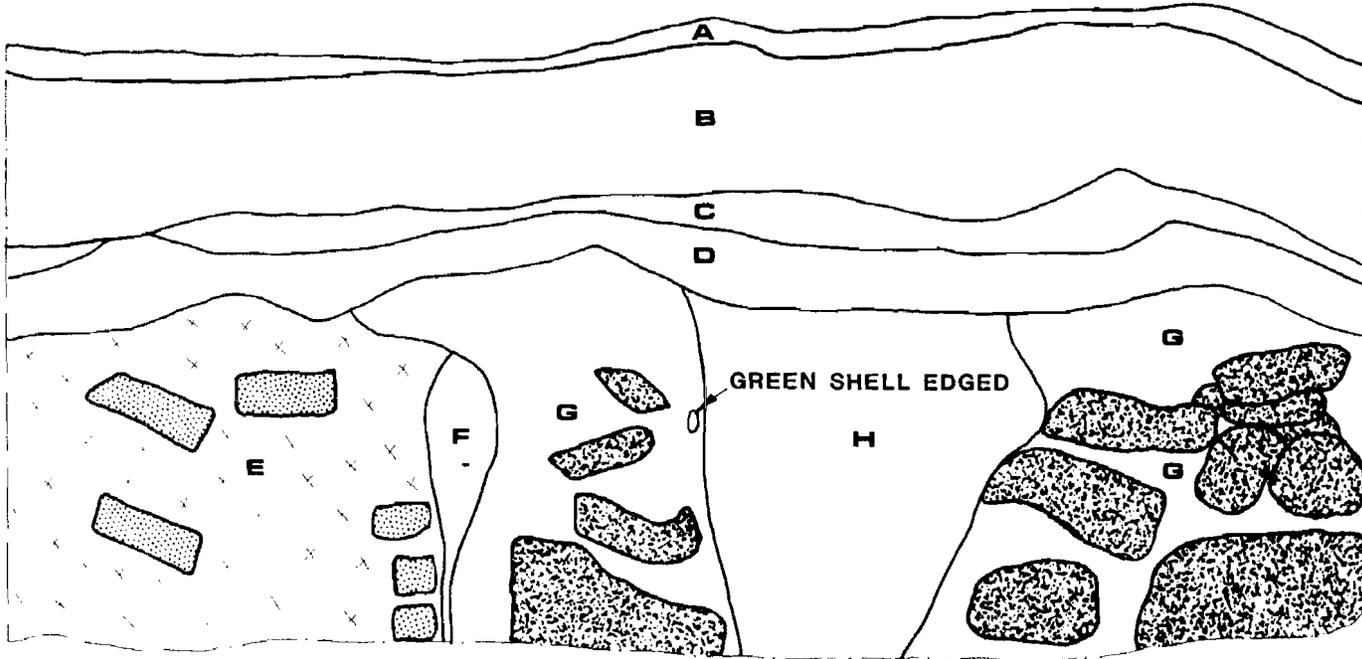
**TRENCH NO. 4
PROFILE OF THE EAST WALL**

Excavation of this trench revealed evidence of two brick foundations and demolition debris sealed by sand fill and asphalt paving (Figure 8). These two foundations correspond to the 1884 structures at Lot 10 (Map 9). Artifacts recovered (Appendix 2, Provenience #018) include 19th-century whiteware and yellowware.

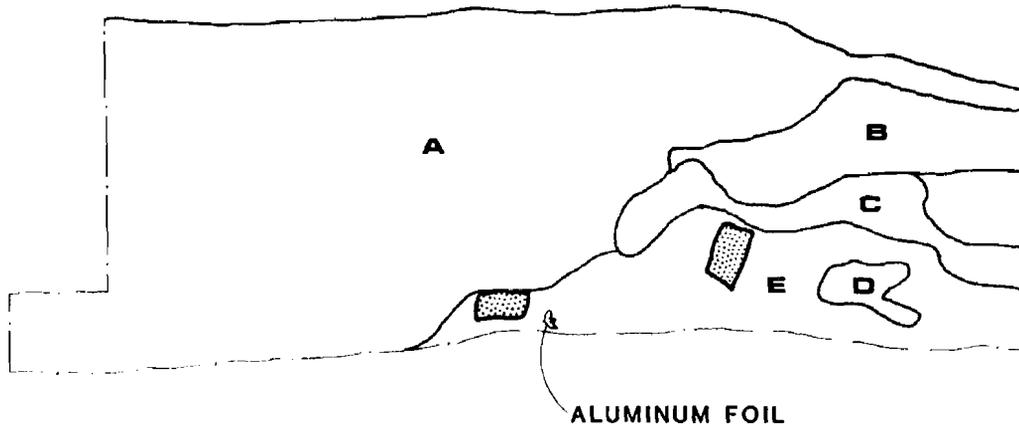
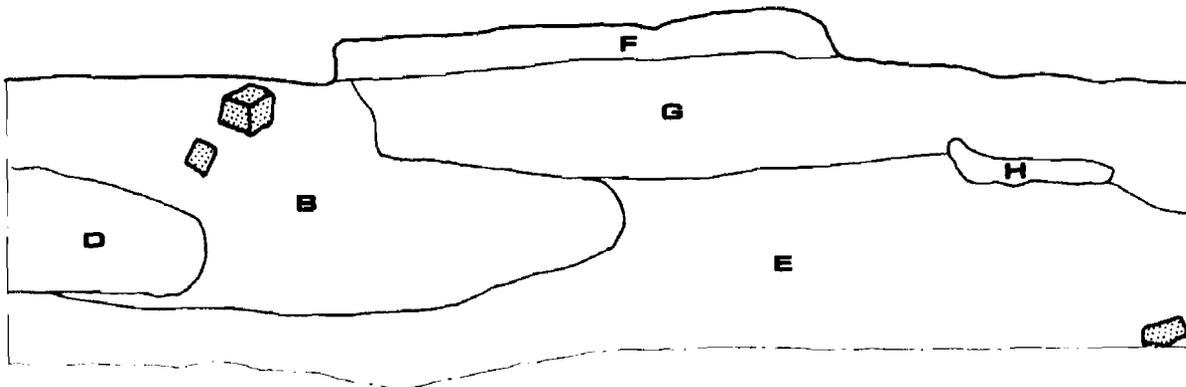
FIGURE 9

Trench #5 was a shallow excavation which exposed a brick flooring or walkway under select fill (Figure 9). The brick walkway was disturbed, probably due to structural demolition and/or looter activity. Looters excavated a brick-lined privy which had intruded into two earlier barrel privies (Map 10).

Materials collected from the backhoe dirt pile (Appendix 2, Provenience #001) are undiagnostic. The location of this trench corresponds to an area immediately behind the 1884 structures (Map 9).

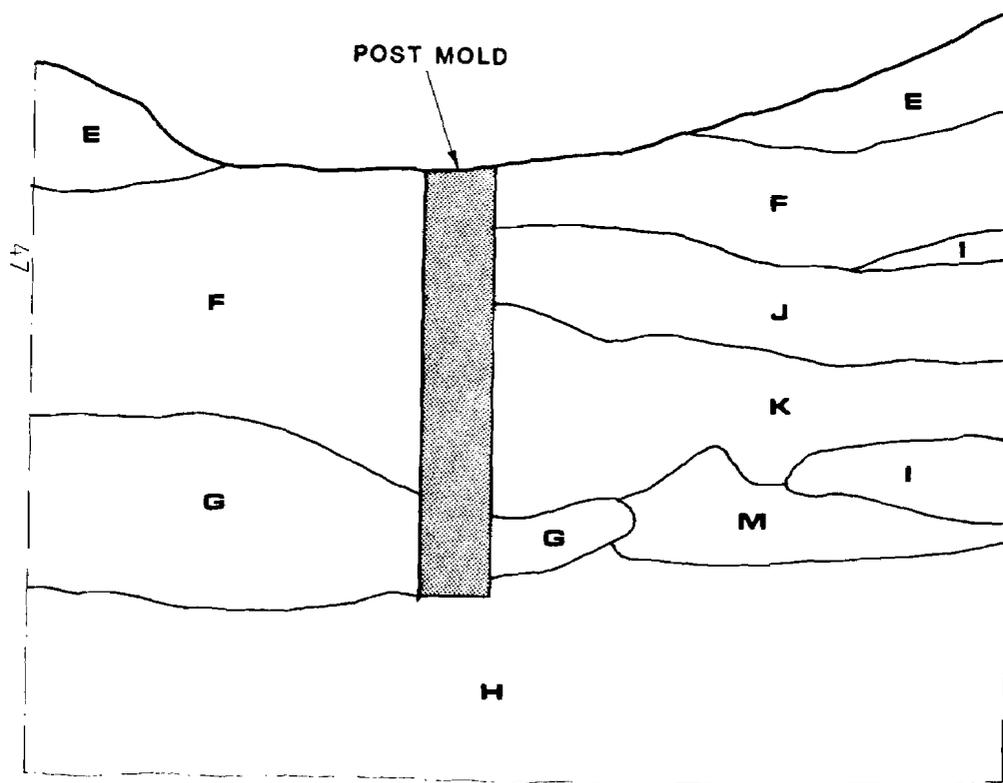
FIGURE 10

The stratigraphic profile of Trench #6 (Figures 10 and 11) shows numerous dark organic occupation layers, with the "gray muck" at the bottom. Excavation encountered a post mold with different depositional characteristics on either side of the post mold (Figure 10). This suggests that the post may have been part of a fence or frame wall along a rear property boundary, and different depositional activities occurred on either side. The location of the trench placed it in the middle of the 1884 hotel stable yard (Map 9). Artifacts collected from the backhoe back dirt pile (Appendix 2, Provenience #004) are attributable to the 19th century with the exception of a sherd from an 18th-century tin-glazed earthenware (delft) plate.

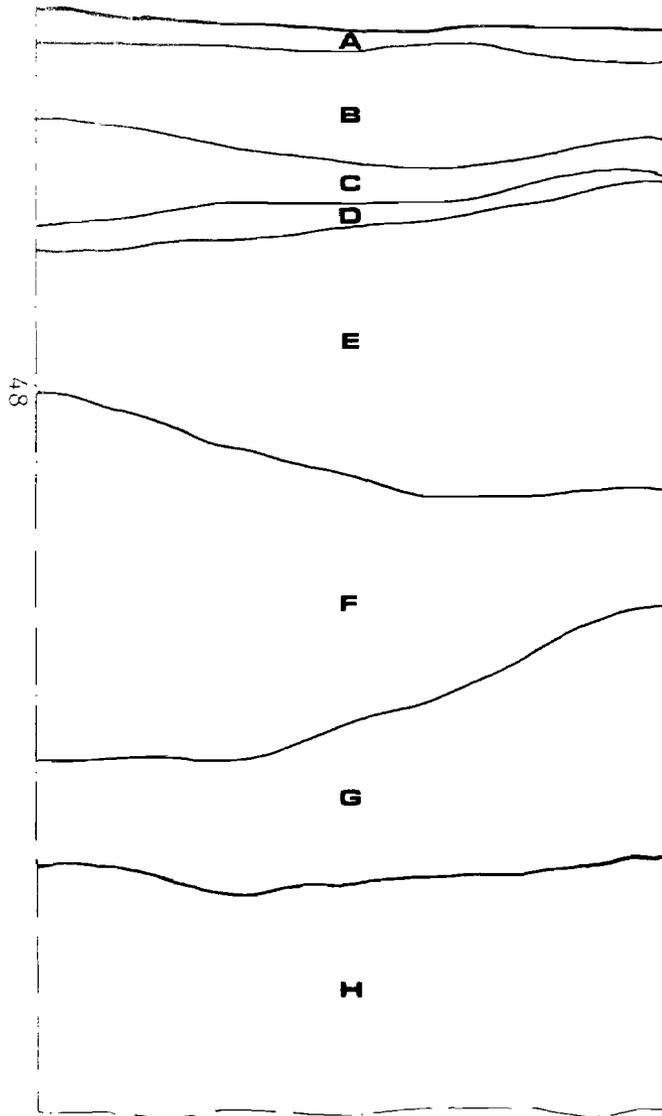
FIGURE 11 WILMINGTON BLVD. BLK. 1191

PROFILE OF THE WEST WALL

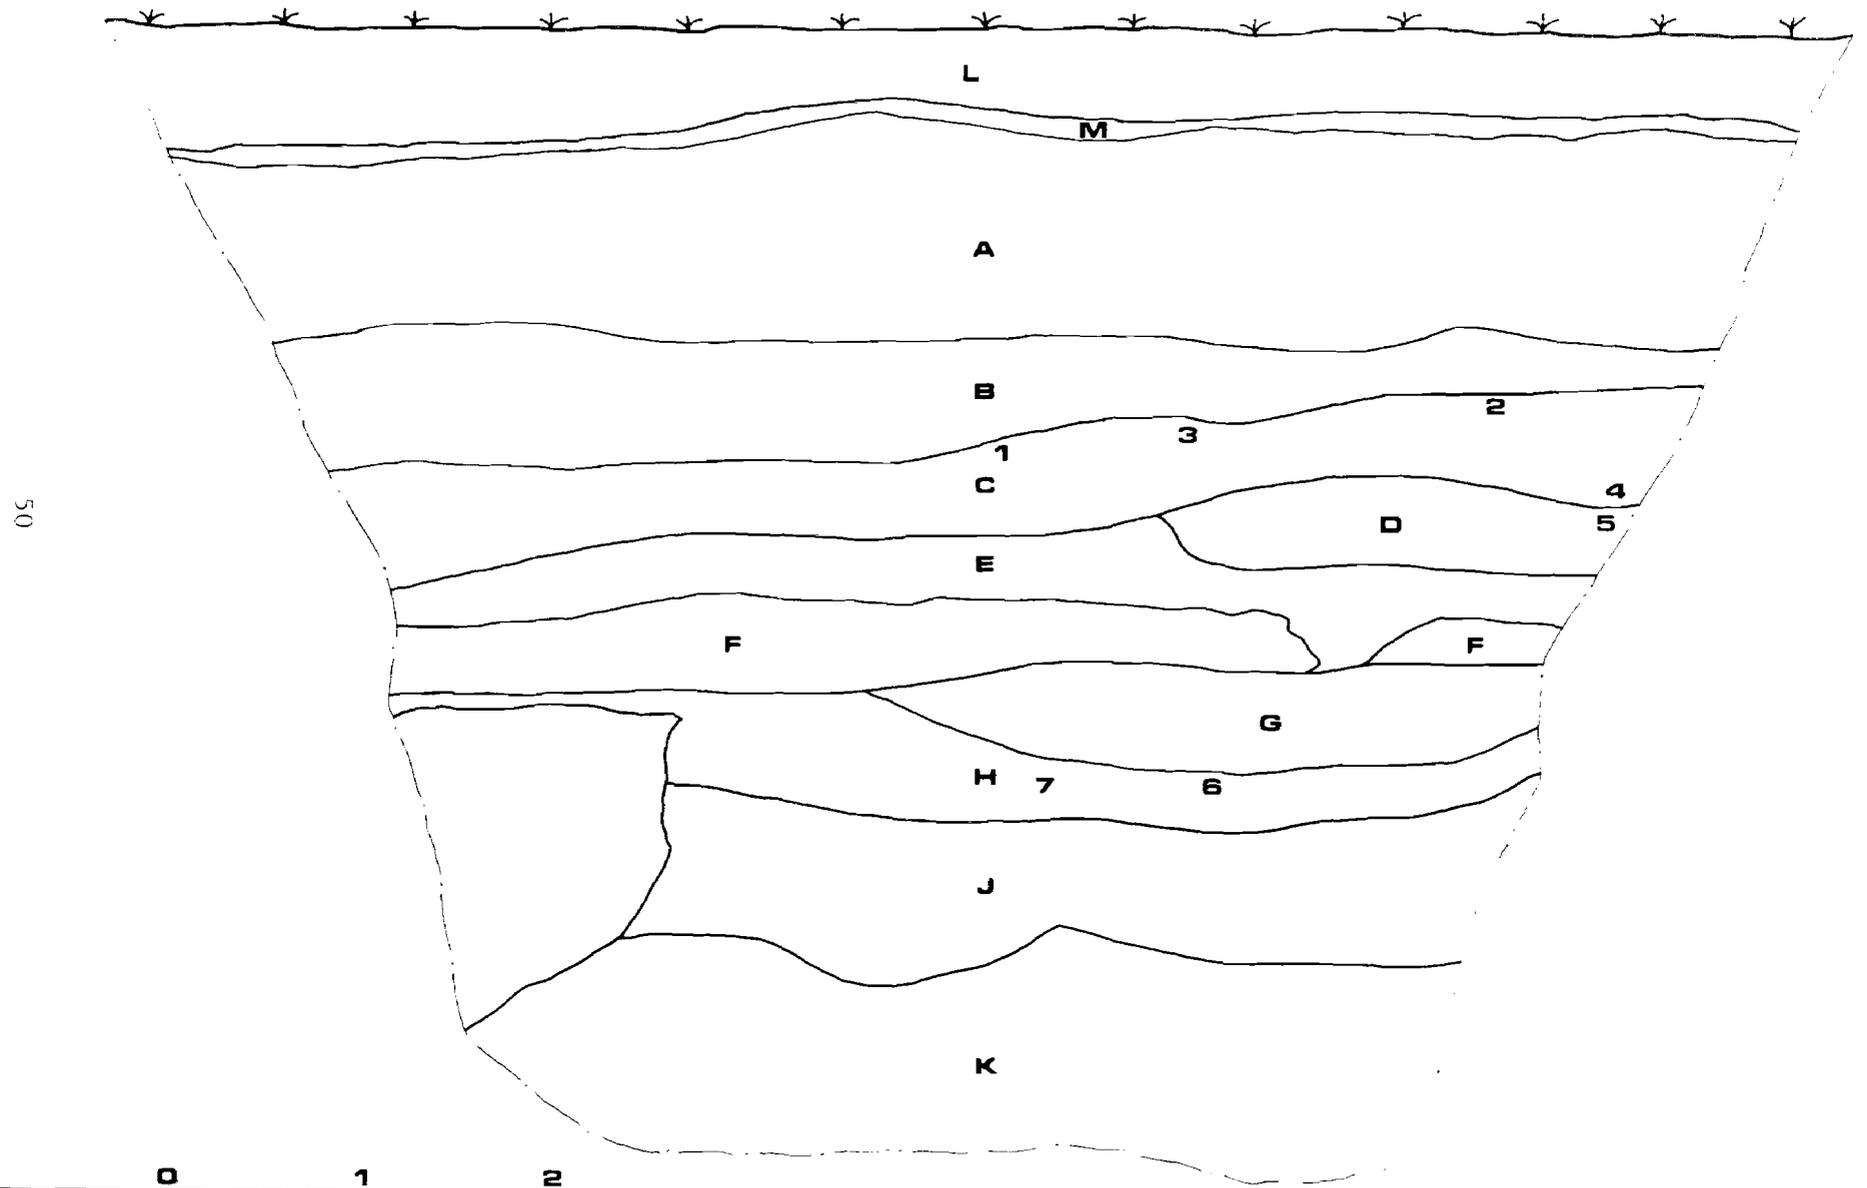
TRENCH NO. 8

Trench #8 is the southernmost of the 12 trenches (Map 11). The stratigraphic profile (Figure 12) exhibits little structural debris and probably represents several periods of filling alternating with several dark organic levels indicative of occupations. The southern profile exhibited layers of select fill, indicating that demolition south of this location was severe, causing the disturbance and/or removal of all cultural resources. The location of Trench #8 corresponds to the center of the 1884 hotel stable yard (Map 9).

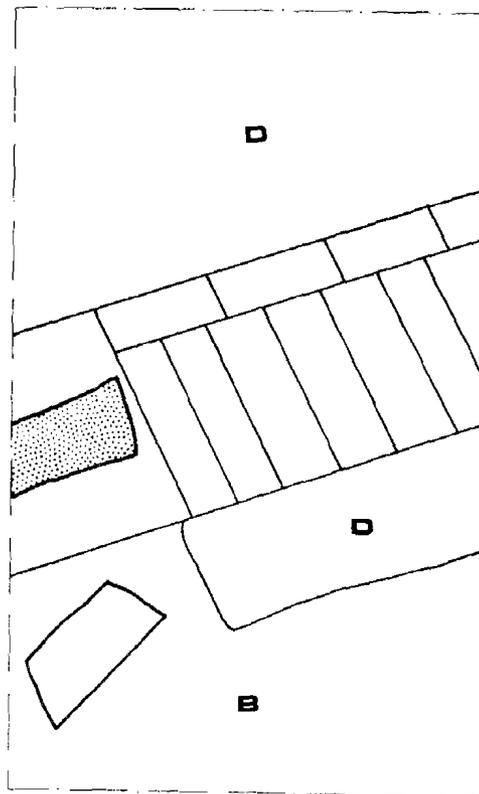
FIGURE 13 WILMINGTON BLVD. BLK. 1191

Trench #9 encountered a brick foundation (Figure 13), with a north-south axis (parallel to French Street). The stratigraphic profile (Figure 14), indicated differential deposition on either side of the foundation. Cultural horizons were intact. No artifacts were present. The location of this foundation corresponds to the western wall of the 1884 Bush stable to the rear and slightly north of Lot 2 French Street (Map 9).

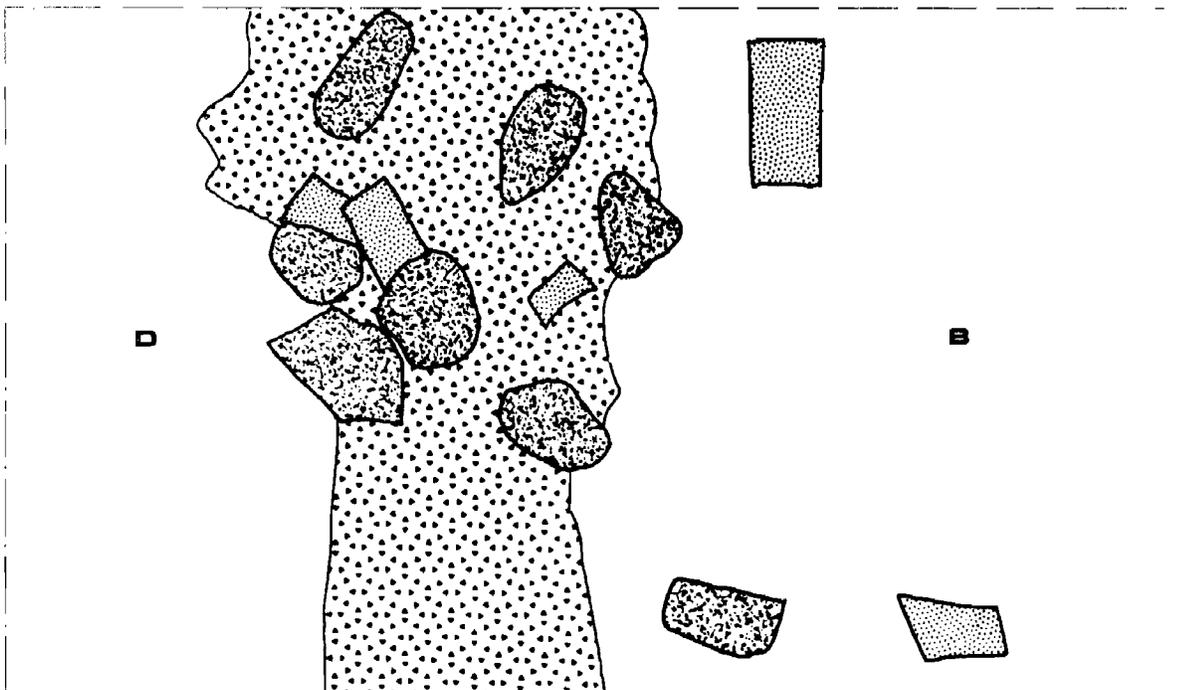
FIGURE 15

Situated just south of Trench #9, Trench 10 likewise encountered a north-south trending brick foundation (Figure 15), perhaps another segment of the foundation located in Trench #9. Cultural deposits were intact (Figure 16); though no artifacts were present. This foundation corresponded to the party wall between the 1884 hotel stable and the other structure behind Lot 10 French Street (Map 9).

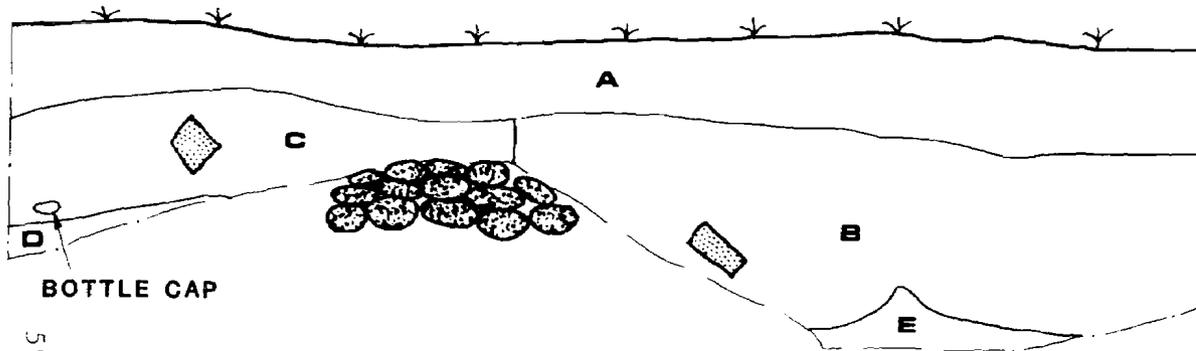
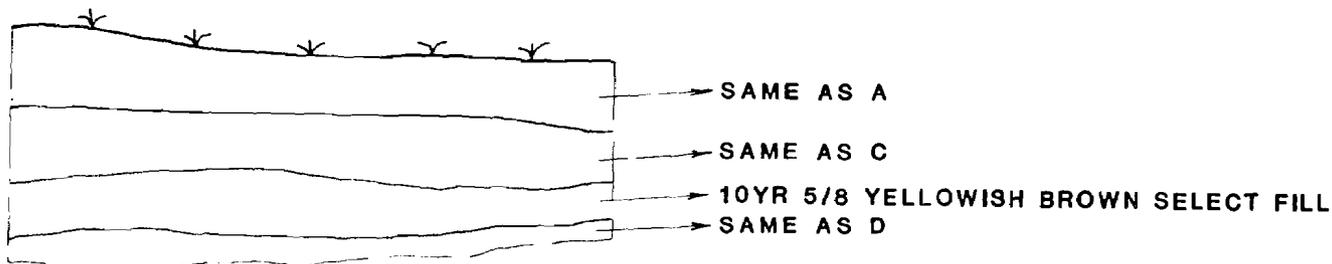
FIGURE 16

TRENCH NO. 10 NORTH PROFILE

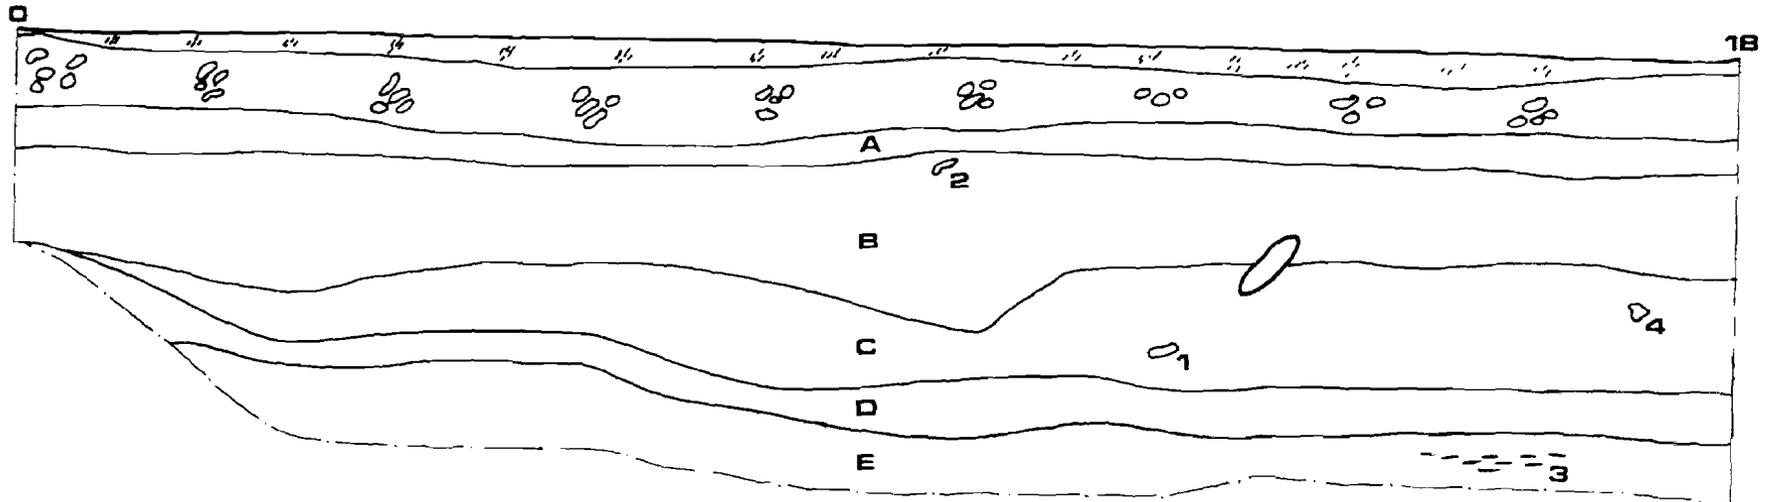
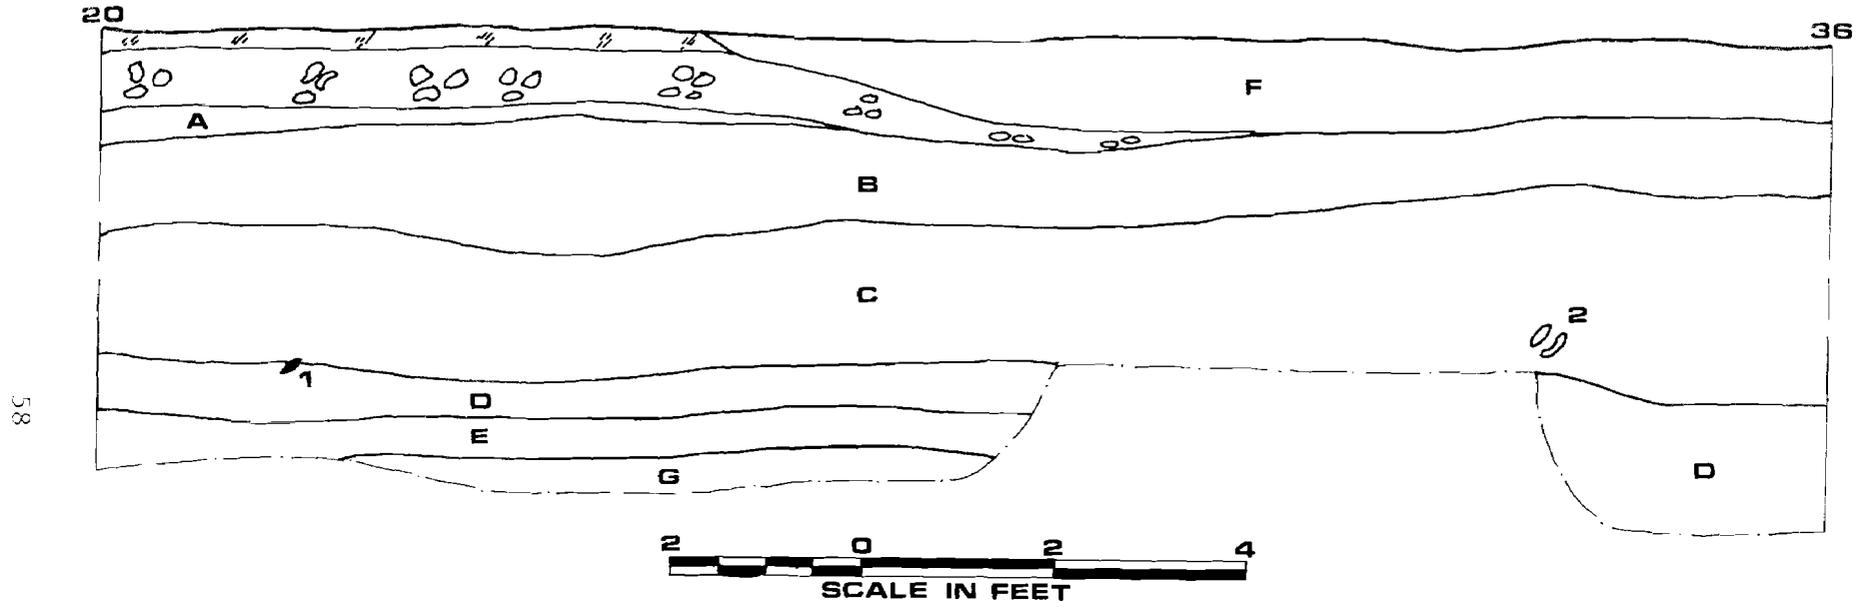
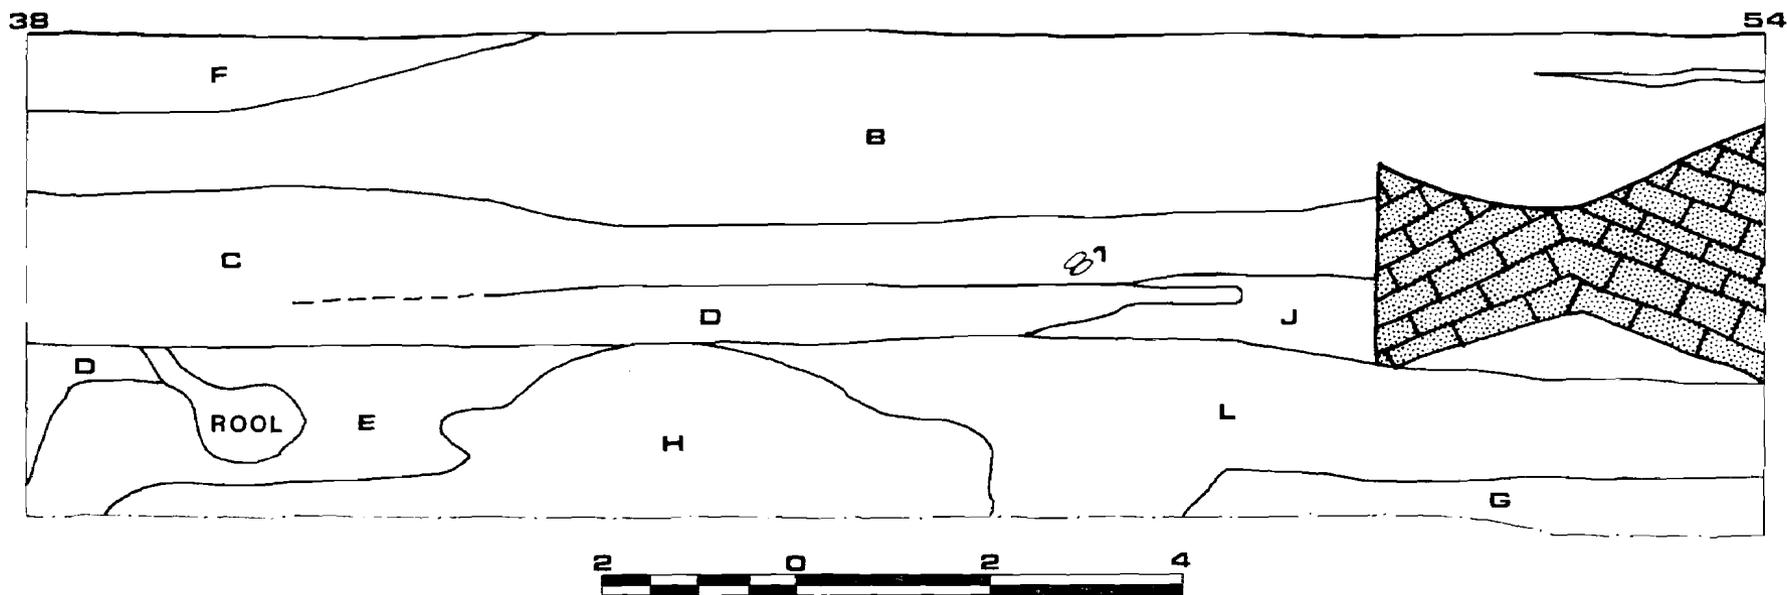
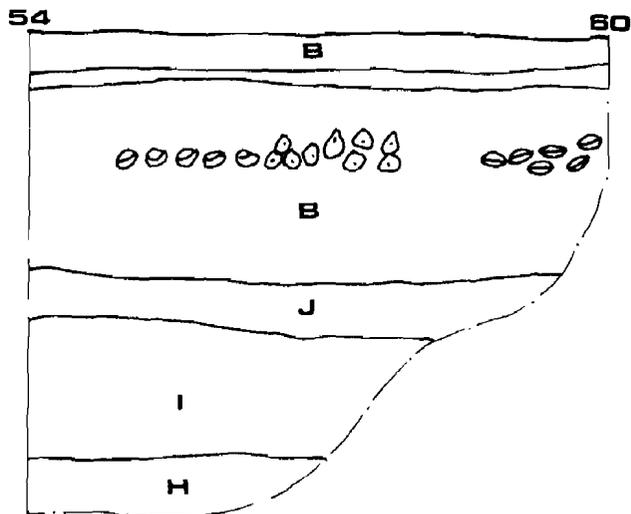
FIGURE 17

Approximately 60' long and averaging 4'-5' deep, Trench #11 provided information on stratigraphy and features in the northern portion of Lot 10. The stratigraphic profile (Figure 17) indicated structural demolition debris and the subsequent asphalt paving. Levels below the structural debris represent occupation layers and, at the bottom, the "gray muck" bog soil. A corner of a brick foundation and an intact barrel privy were encountered and are associated with the pre-1940s property lot east of Lot 347 in 1884 (Map 9). Considerable amounts of brick demolition debris were located at the northern end of the trench in Lot 347 (not included in the profile drawing). Artifacts within the barrel privy were left in place for future research and no other artifacts were present in the remainder of the trench.
