BLOCK 1191, KING TO FRENCH STREET: (Maps 2&9-11; Plates 2-5; Figures 3-18; Appendices 1-5)

Excavations

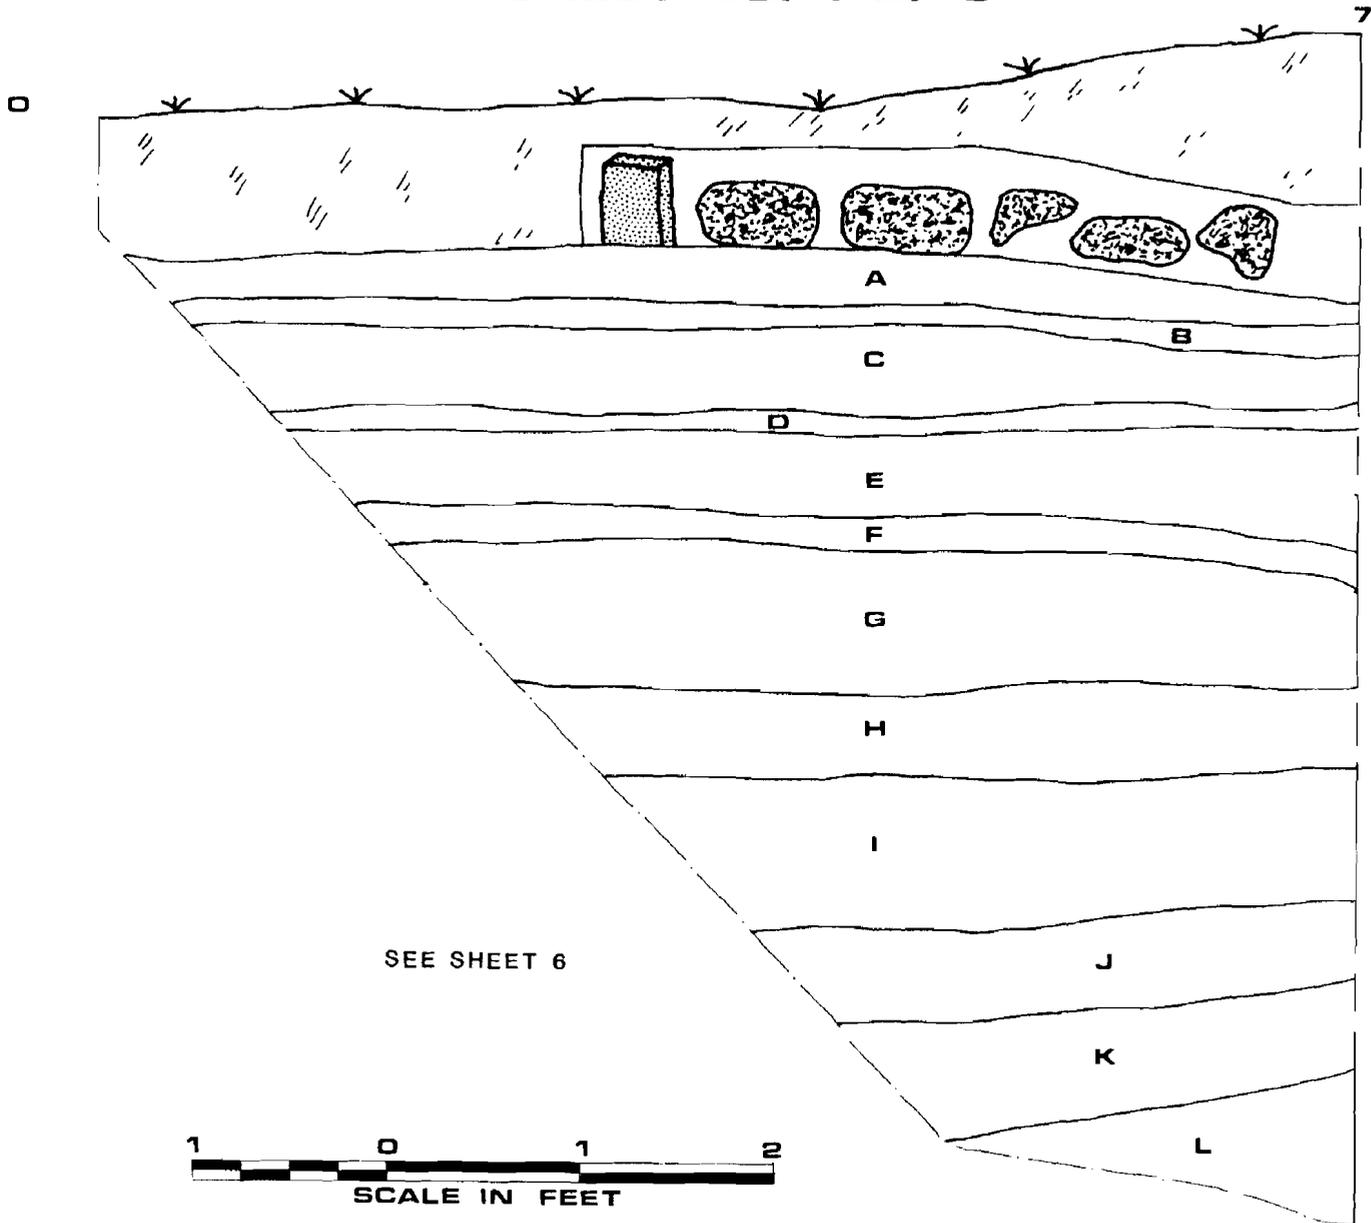
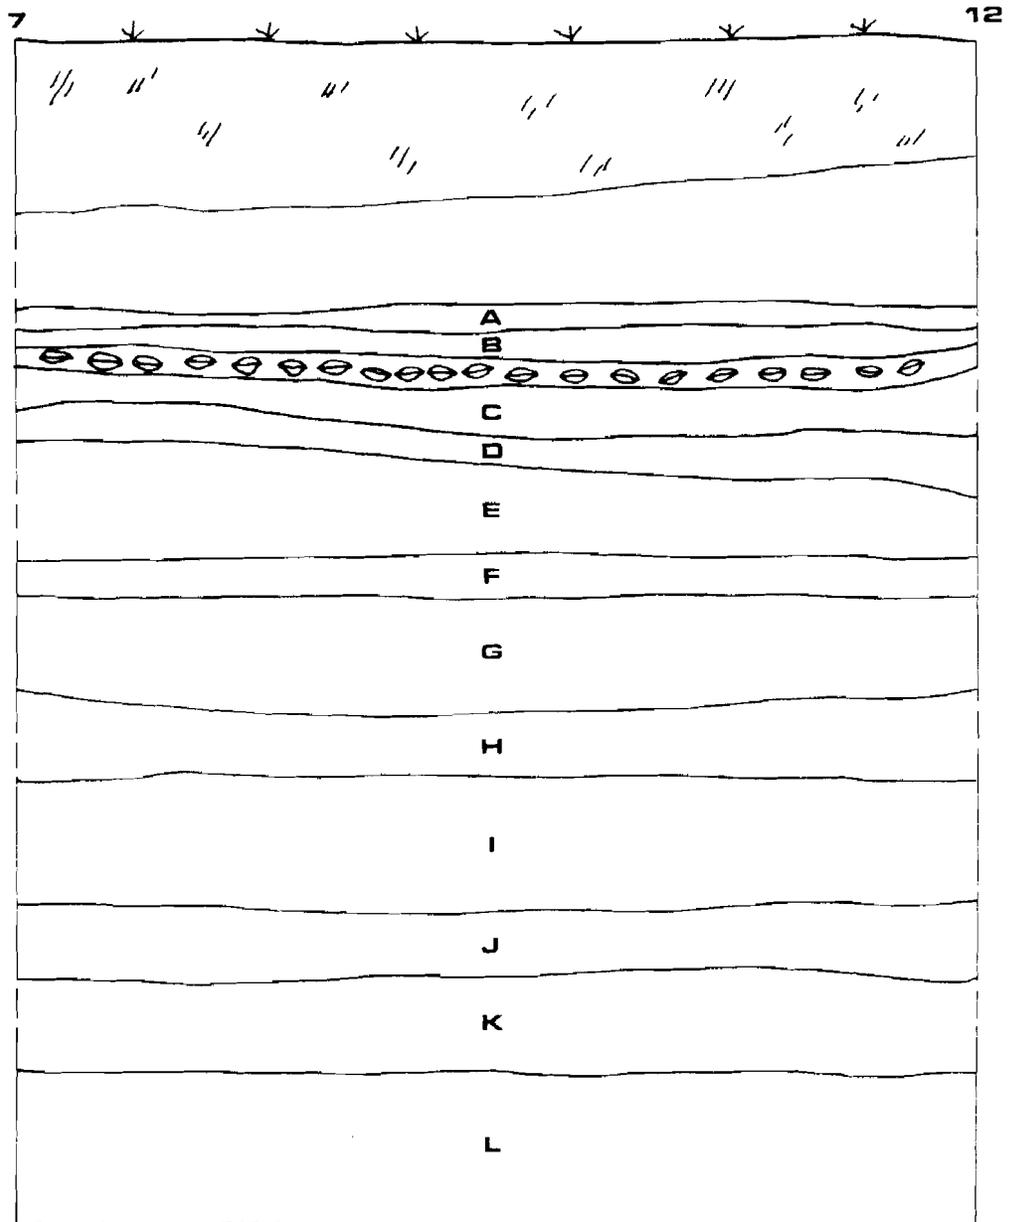
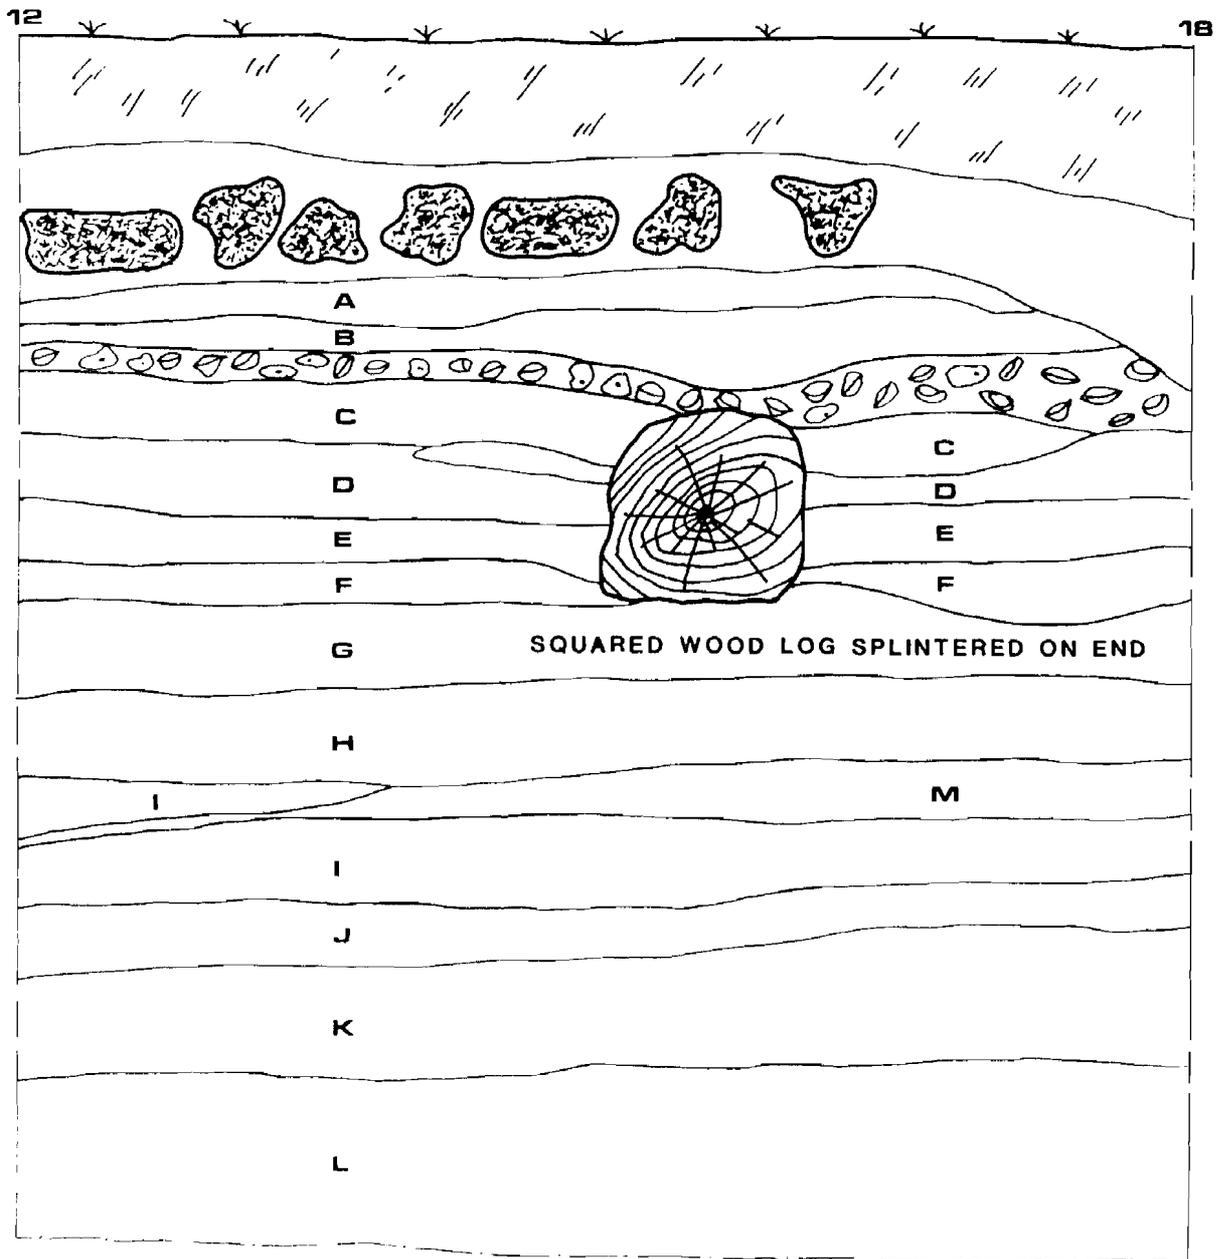
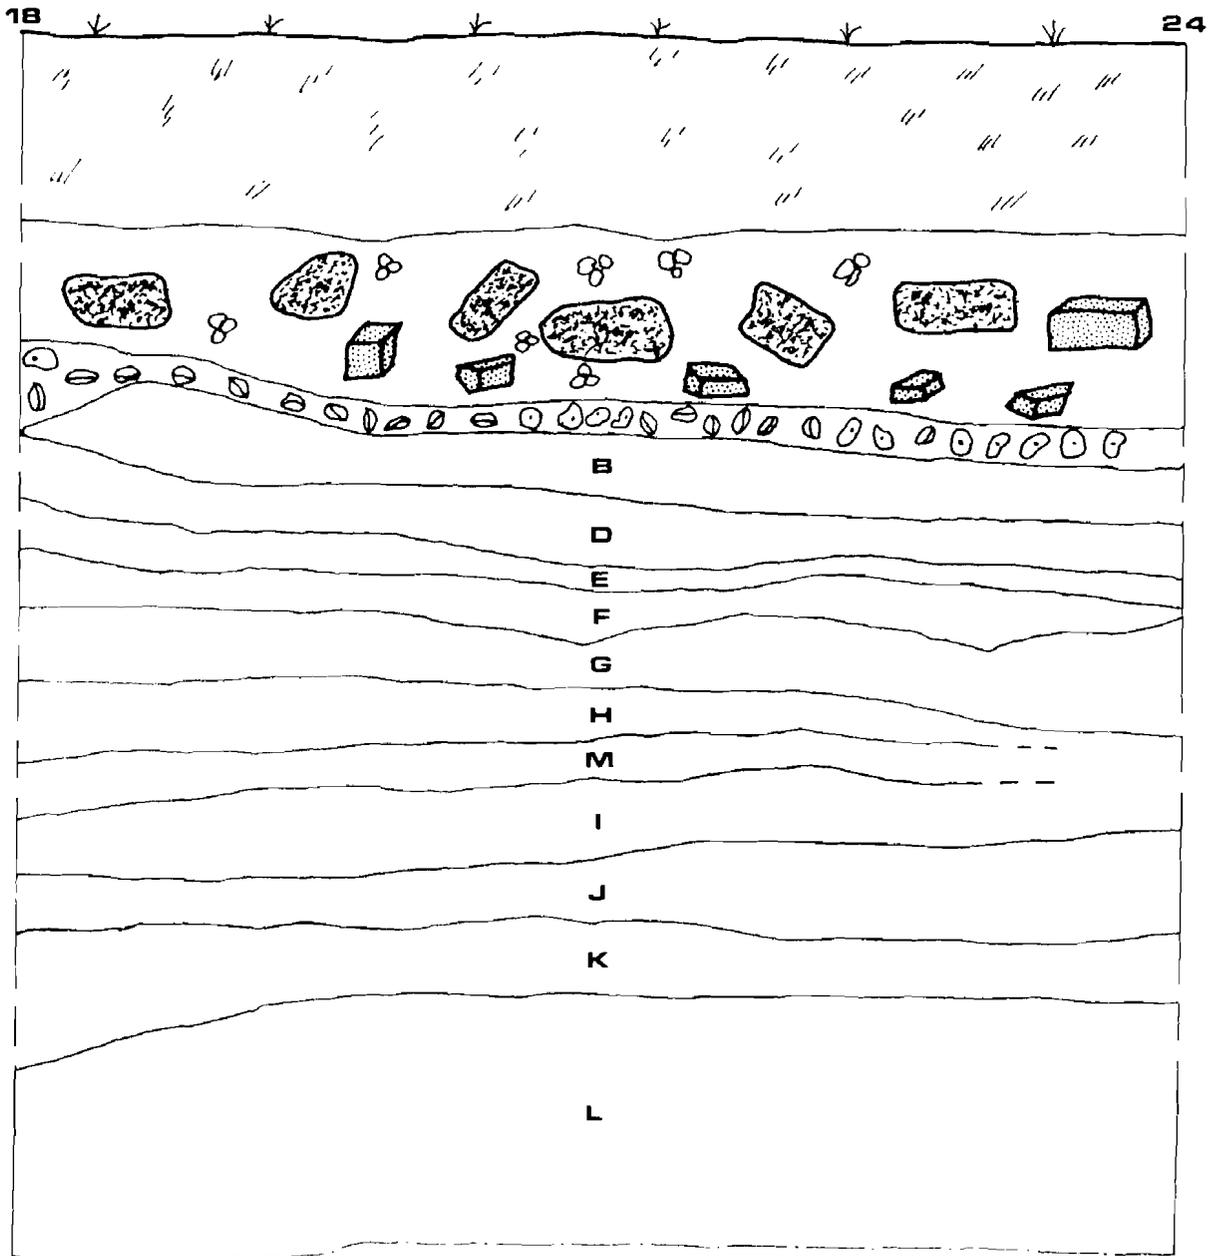
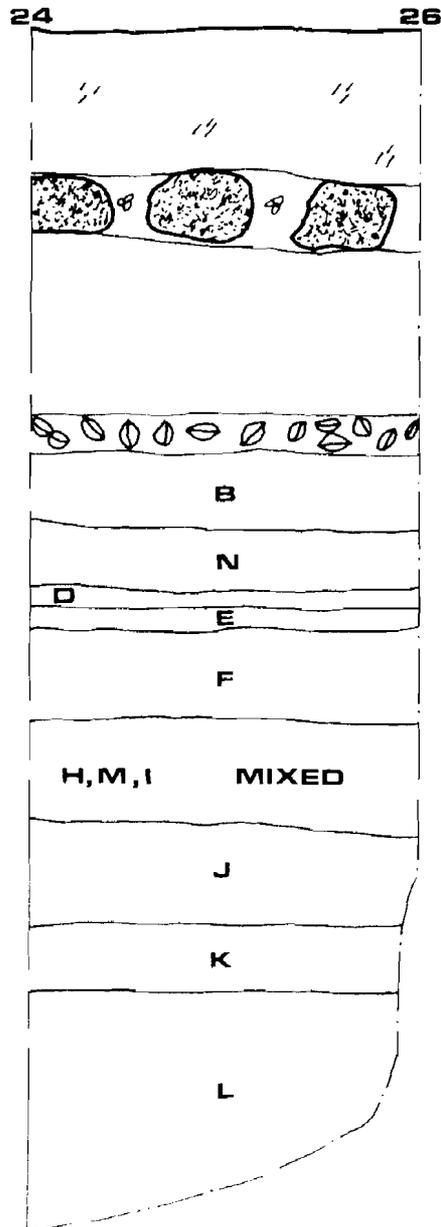
FIGURE 18
WILMINGTON BLVD. BLK. 1191
SHEET NO. 1
TRENCH NO. 12
PROFILE OF THE WEST WALL
SHEET NO. 1 OF 6

The stratigraphy exhibited in Trench #12 (Figure 18) is similar to that in other trenches on the block, with the exception of a lesser amount of structural debris. This suggests that the area was a yard. Belgian block paving is evident immediately under the asphalt, and may be a continuation of that located in Trench #3 (Figure 7). The location of this trench, in fact, corresponds to the 1884 yard area behind Lot 10, French Street (Map 9). No artifacts were present.
