CHAPTER IV

NATIONAL REGISTER ELIGIBLE RESOURCES

COMPLEX #5
THE PULLMAN PALACE CAR REPAIR SHOPS

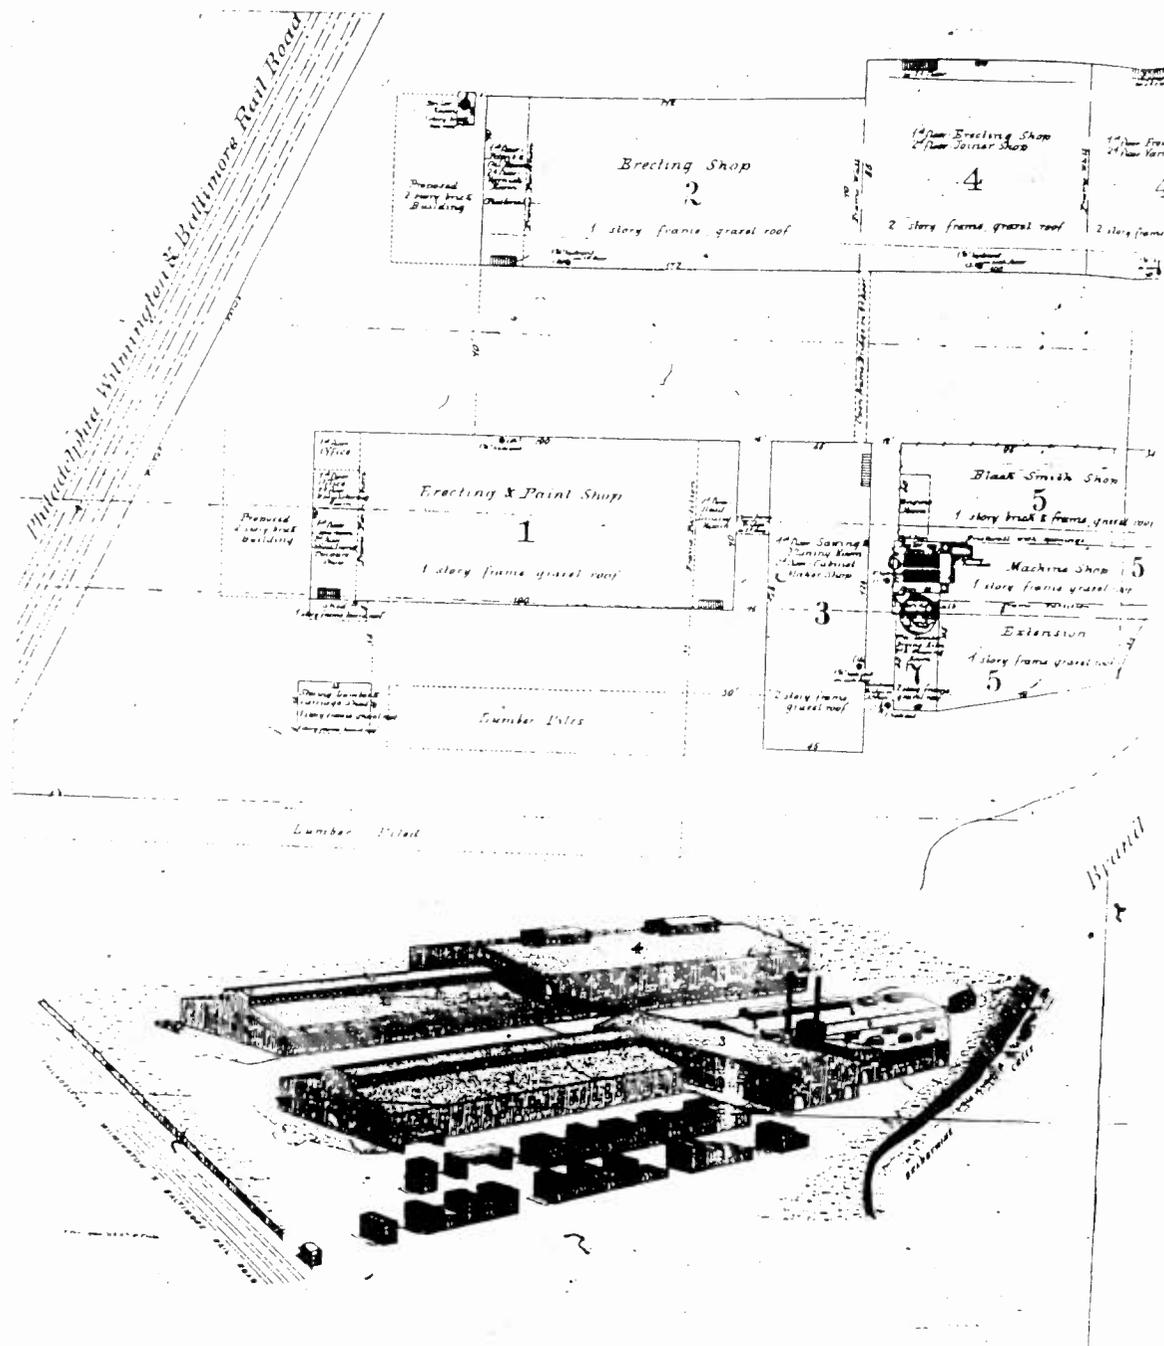
Figure 13: Detail of Bowers, Dure & Co.
 from Hexamer General Survey #1711
 (Reprinted courtesy of the Eleutherian Mills Historical Library)

A Hexamer General Survey of the Wilmington Car Works undertaken in November of 1882 reveals the expansion of the Bowers, Dure & Co. plant (see Figure 13, p. 61). A one-story, frame machine shop with a one-story, frame extension had been added to the earlier brick blacksmith shop present in 1872. The 1872 putting-up shop and paint shop were now labeled erecting shops. A new large, two-story, frame building attached to the east end of the earlier paint shop contained an erecting shop, a joiner shop, a freight shop and a varnish shop. A wooden bridge connected the second floor of the new joiner shop to the second story of the 1872 cabinetmakers shop.

South of the earlier putting-up shop stood a small combination lumber and carriage shed. Woodworking machinery in the planing mill and cabinetmakers shop included seven planers, six circular saws, two band saws, three shapers, six moulders, two boring machines, four mortising machines, 1 blind slat mortiser, three turning lathes and two gig saws. Two of the three buildings that Bowers and Dure expected to erect by the end of 1872 were not present in 1882. In 1886 the Pullman Palace Car Co. purchased the plant from Dure who had become sole proprietor of the car factory when Bowers retired a few years earlier.⁵⁰

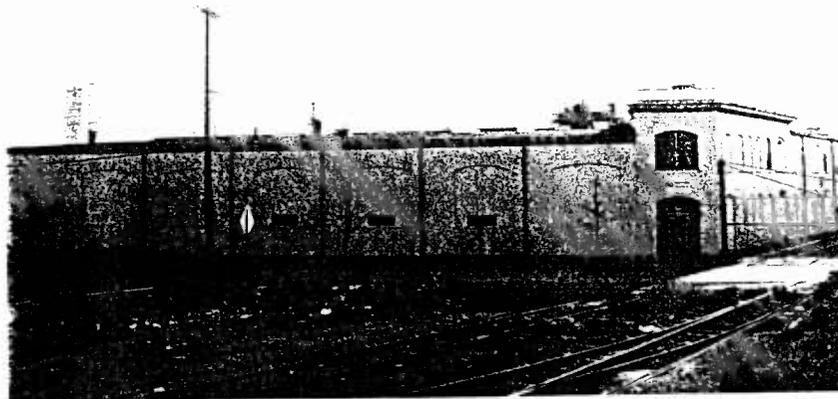
Plate 1: Northwest and northeast elevations of the
Pullman Palace Car Building No. 1 (N-3648.01) looking south
(Photograph by Stuart Dixon)

Identified as Building 1 (N-3648.01) on insurance surveys, the painted-white brick building with stone foundation southeast of the AMTRAK Viaduct's bridge over East Twelfth Street stands two-stories high with a flat roof and a large rectangular one-story wing (see Plate 1, p. 67). The northwest elevation parallels the rail siding to the northwest instead of being perpendicular to the northeast and southwest elevation. The two-story section currently contains offices.

Eleven bays stretch across the building's northeast elevation facing East Twelfth Street. Eight bays penetrate the one-story eastern portion while three bays puncture the upper floor of the two-story portion. Most windows, crowned by triple rowlock segmental arch lintels, contain concrete block infill. The three second-story windows possess pairs of hoppers. The first story of the two-story section contains a large steel door on its western end. A corbeled string course separates the two stories. A tin cornice wraps around the two story-section and continues along the length of the northwestern elevation.

The building's northwest elevation contains six bays on the second story and eight on the first story. The southern portion of the elevation is not as tall as the north corner. Triple rowlock segmental arch lintels top window openings, most infilled with brick. A steel door and entry similar to the northeast elevation pierces the northwest elevation's north end. Seven former windows, now filled with concrete block, extend along the one-story wing's southeast elevation.

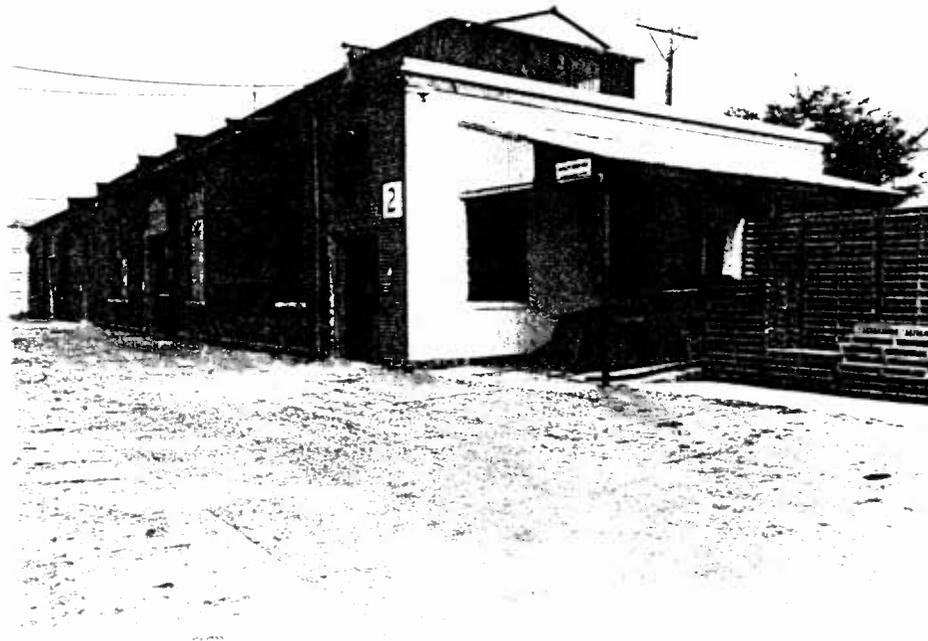
Plate 2: Southwest and southeast elevations of the Pullman Palace Car Building No. 2 (N-3648.02) looking north (Photograph by D. Gula)

Southeast of the Building 1 along East Twelfth Street stands Building 2 (N-3648.02; see Plate 2, p. 68). White paint covers the small, rectangular building on three sides. Only the southwestern elevation exhibits its natural red brick facade. One-story tall with a corrugated tin-roofed monitor, Building 2 displays ten bays along its southwestern elevation. The southwest elevation's bays all appear to have been former windows although four of the bays have been enlarged and now contain large loading doorways. The remaining windows possess sixteen-over-six sash with arched wooden heads, triple rowlock segmental arch lintels and sandstone sills.

Brick parapets capped by a terra cotta coping slice the roof and monitors indicating the placement of walls separating interior space. Monitor glazing consists of 12-light and four-light fixed sash composed of wireglass. Concrete block fills all seven northeast elevation windows and one of the southeast elevation's three bays.

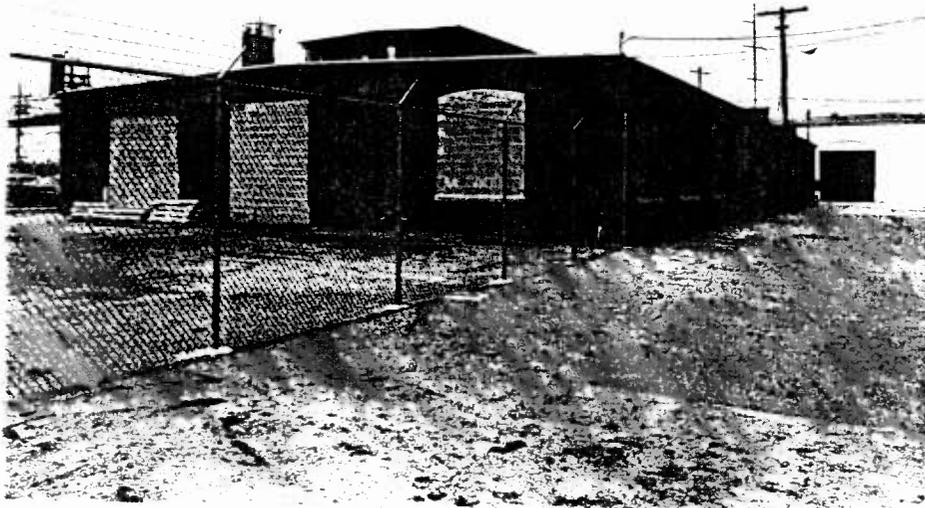
Plate 3: Southeast and northeast elevations of the
Pullman Palace Car Building No. 2A (N-3648.03) looking west
(Photograph by D. Gula)

The northwestern end of Building 2A (N-3648.03; see Plate 3, p. 70), directly southwest of Building 2, served as a wash room during Pullman's ownership. Two small monitors with shallowly-sloped gable roofs sit atop the northwestern half of the one-story building, perpendicular to the southeastern half's monitor with a similarly sloped roof. The two northwestern monitors possess three nine-light casements along their southwest and northeast faces and four casements along the southeast and northwest. Each monitor lights interior rooms three bays wide along the southwest and northeast. Brick walls separate the rooms and penetrate the roof forming parapets with terra cotta copings. The southeastern monitor contains 12 windows along its southwest and northeast and four windows on its southeast elevation. A brick parapet forms the northwest end of the southeastern monitor.

The southwestern elevation's 11 bays exhibit triple rowlock segmental arch lintels over concrete block. An entry door penetrates the concrete block of the eastern-most bay. Four brick piers divide the southeast elevation into three bays. All former openings along this elevation are currently closed with concrete block.

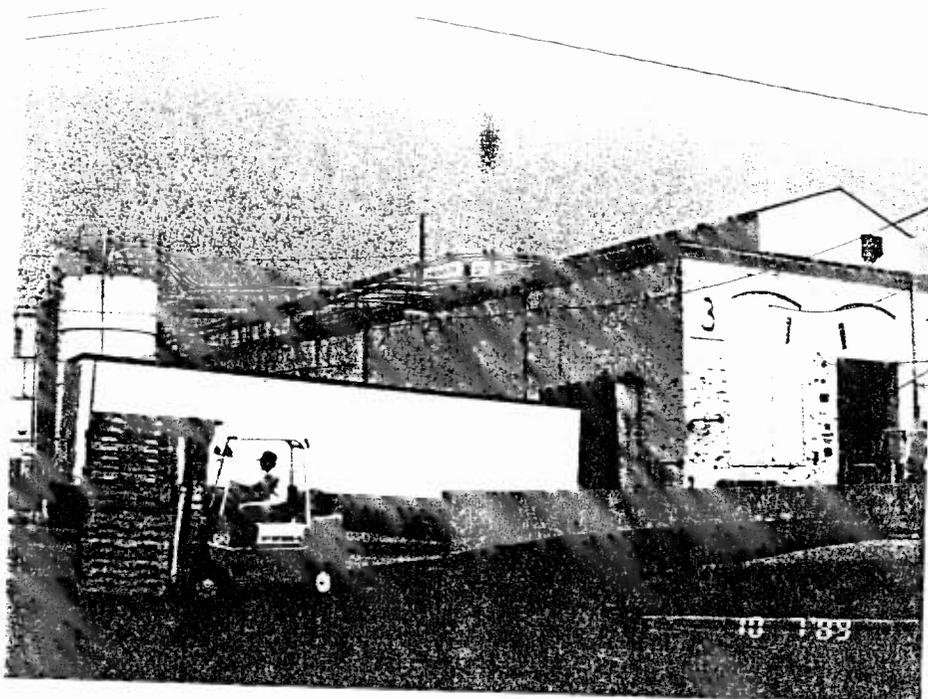
Plate 4: Southwest and southeast elevations of the Pullman Palace Car Building No. 3 (N-3648.04) looking north (Photograph by D. Gula)

Building 3 (N-3648.04), a large one-story building with two gable-roofed monitors sheathed with aluminum on its roof (see Plate 4, p. 71), stretches southwest of Building 2A and Building 1. A third monitor once penetrated the northeastern portion of the roof. Currently painted white, Building 3 possesses 20 bays along its southwestern elevation and 15 bays along its southeastern elevation. Most southwest elevation bays, now filled with concrete block, once possessed large openings for the movement of railcars in and out of the building. Triple rowlock segmental arch lintels and concrete sills ornament most visible wall openings. The southeast elevation contains a large loading bay, an entry door and a four-light hopper window. Three silos for chemical storage stand southwest of the southeast corner of the building. Two additional silos stand southeast of the building's southwest corner. Rail sidings and a vacuum-powered loading and unloading pump apparatus sits northwest of the building. Remnants of a transfer table that once moved railcars between Building 3 and Building 4 to the southwest have been covered with concrete and macadam.

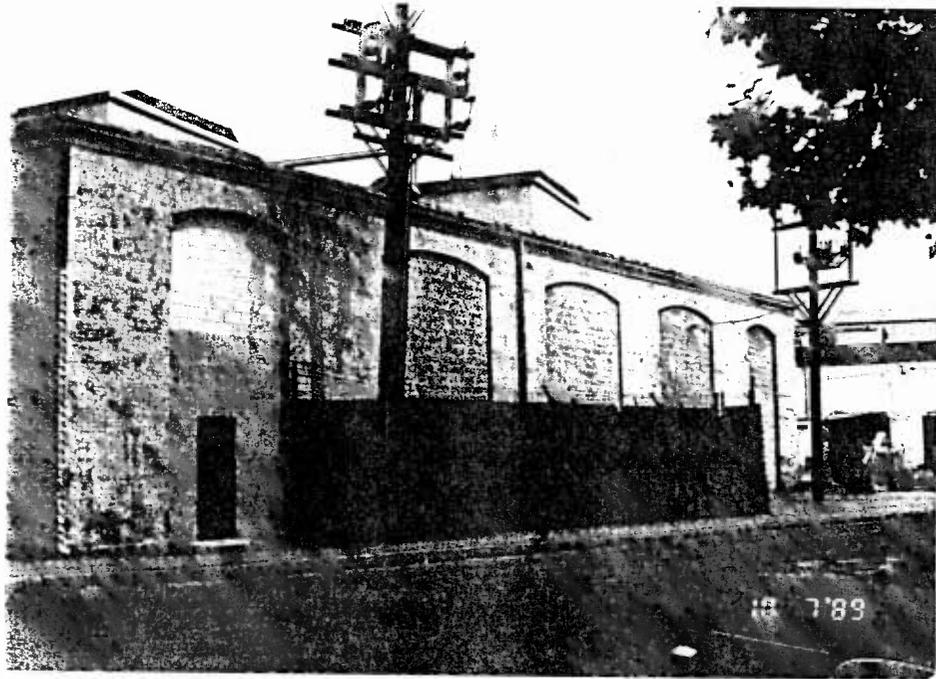
Plate 5: Southwest and southeast elevations of the Pullman Palace Car Building No. 4 (N-3648.05) looking north (Photograph by D. Gula)

Building 4 (N-3648.05), an elongated rectangular, one-story building with two monitors (see Plate 5, p. 72), stands southwest of Building 3 across the concrete and macadam lot. A stone foundation supports the six-to-one common bond brick construction.

A reinforced poured-concrete loading dock extends across the northeast elevation's 22 bays. The two eastern and four western bays formerly contained windows. The rest of the bays possessed large openings for railcars utilizing the former transfer table. Concrete sills and triple rowlock segmental arch lintels ornament each bay. Three wooden horizontal roll doors and one steel entry door currently penetrate the northeast elevation. Other openings now exhibit concrete block infill. A parapet with a terra cotta coping tops the central portion of the elevation.

The northwestern elevation of Building 4 contains five bays currently plugged by concrete block. Segmental arch lintels imitate the lintels on other buildings of the Pullman Complex. The center three bays once contained windows while the other two enclosed doors. A concrete block wall connects the northwest elevations of Building 4 and Building 5 (N-3648.06), approximately 15 feet to the southwest. Train rails protrude from under the concrete wall. The southeastern elevation's five bays displays treatment similar to the northwest elevation.

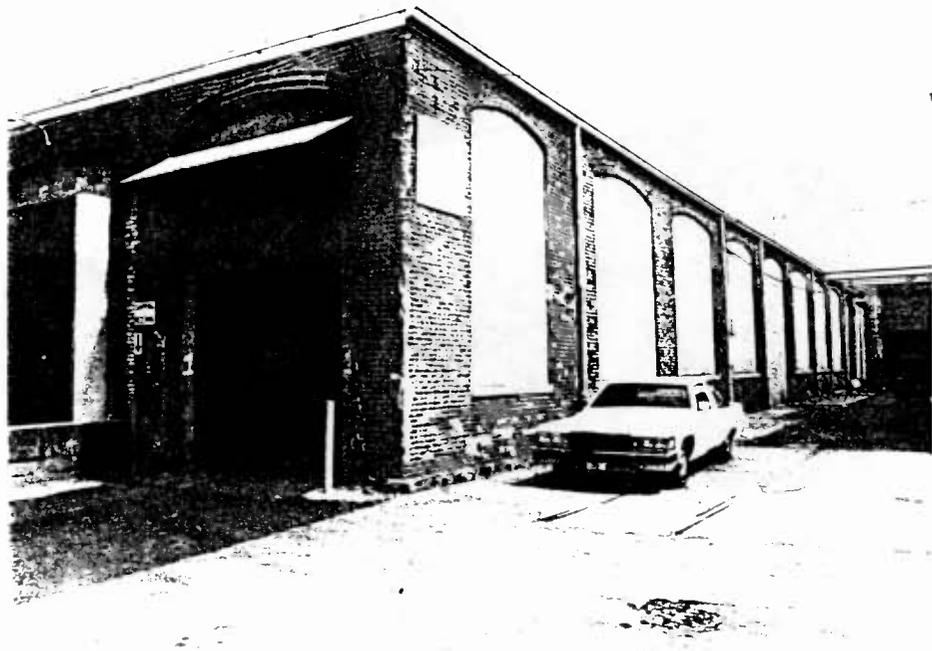
Plate 6: Southwest and southeast elevations of the Pullman Palace Car Building No. 5 (N-3648.06) looking north (Photograph by D. Gula)

Building 5 (N-3648.06) stands one-story high (see Plate 6, p. 74). Constructed of six-to-one common bond brick and a stone foundation, a new shallowly-sloped gable roof has replaced the building's original roof possessing four monitors. Nine bays stretch along the northwest and southeast elevations while eight bays extend along the southwest. The northwest elevation's two north and two south bays formerly served as railcar entrances. The other bays probably functioned as doors for pedestrian traffic since they are thinner than the other railcar entrances. Concrete block fills all of the openings.

A macadam driveway and concrete loading dock projects southwest of the southwest elevation. The driveway slopes approximately three feet below grade at the building's foundation allowing trucks to unload directly into the building. Concrete block walls extend southwestward forming bulkhead walls on the northwest and southeast side of the macadam driveway. Five loading bays have been enlarged from the building's original openings. The fifth loading dock located on the southeast end of the southwest elevation lays at grade level instead of below grade.

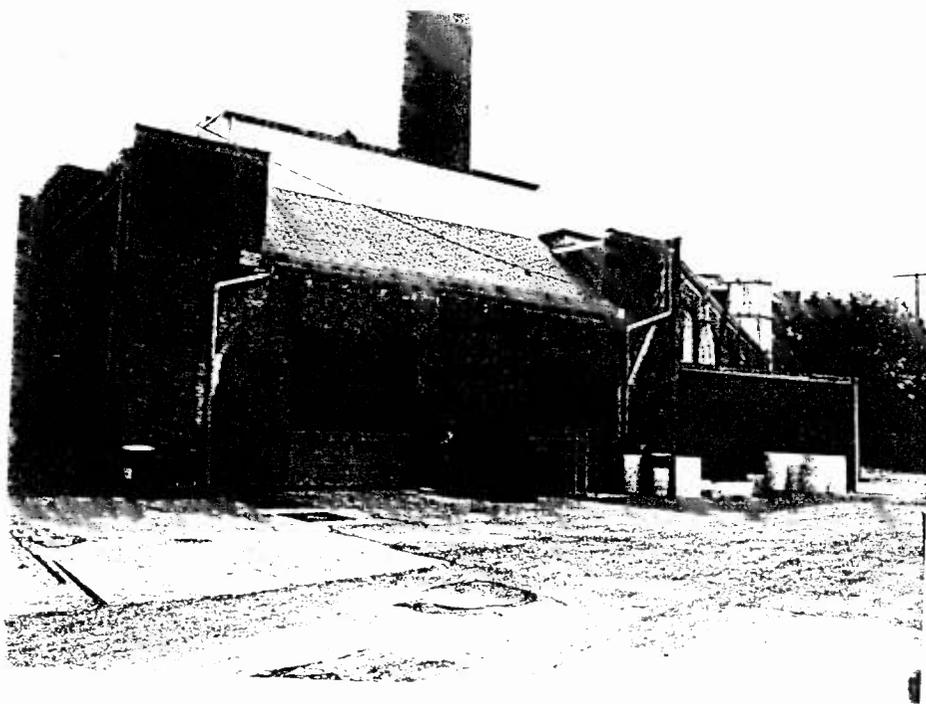
Plate 7: Northwest and southwest elevations of the
Pullman Palace Car Building No. 6 (N-3648.07) looking east
(Photograph by D. Gula)

Directly southeast of Building 5 stands Building 6 (N-3648.07), a one-story five-sided brick building with two roof monitors and a stone foundation (see Plate 7, p. 75). Eleven bays extend along the northwest elevation. Concrete block fills the six former window openings and five railcar entries of the northwest elevation. The southwest elevation possesses two windows featuring pairs of 15-light industrial sash with six-light hoppers. A small door penetrates the east end of the southwest elevation.

Building 6's south elevation contains six bays overlooking Rosemont Avenue and the Brandywine River. The eastern ends of the two roof monitors match the angled southern elevation. A small concrete block addition with a tin roof adjoins the building along the south elevation. The southeast elevation contains four bays filled with concrete block. Four silos stand southeast of the elevation.
