## AREA OF POTENTIAL EFFECT

### **RESULTS OF FIELD TESTING**

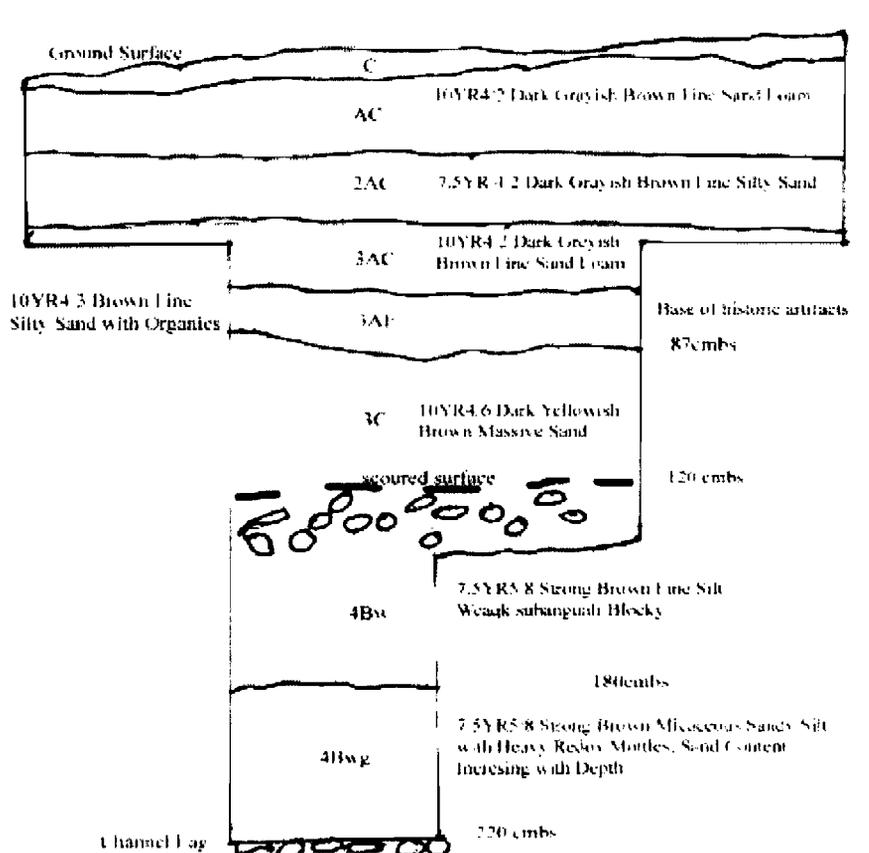
Figure 7: Profile Drawing of Deep Test 1

**Deep Test 1** was located 5m SW of STP 4 astride the natural levee of Red Clay Creek. Due to the steep construction slope leading to the lower terrace, heavy equipment access was restricted in this area. Thus the deep test was hand excavated. Following OSHA guidelines for benched excavations, a 2x2 meter block was excavated to a depth of 50 cmbs. A 1x 1 meter excavation was then placed in the center of the 2 x 2 meter block and excavated to a depth of 150 cmbs. At 150 cmbs a 0.50x0.50 meter block was excavated to channel lag. Approximately 1/3 (33%) of the excavated soil was screened through ¼ inch hardware cloth. The stratigraphic sequence was recorded and mapped (**Figure 7 and Plate 3**).

Recent flood deposits consisting of 10YR6/2 light brownish gray fine to medium grained massive sands laminated with organics extended from 0-10 cmbs (C horizon).

This horizon, in turn, was underlain by three discrete stacked AC horizons; the upper extending from 10-35 cmbs composed of a 10YR4/6 dark grayish brown fine sand loam lightly flecked with organics. The intermediate designated 2AC horizon extended from 35-55 cmbs and was composed of 7.5YR4/2 dark grayish brown fine silty sand with light organic flecking. The lower AC horizon (3AC) extended from 55-70 cmbs and was composed of a 10YR4/3 brown fine silty sand with light organic flecking. Coal slag and thin plastic (possibly from fertilizer packaging) were present in the 3AC horizon. From 70-87 cmbs a 3AE horizon containing organics leached from the overlying 3AC horizon was present. No artifacts were recovered from this horizon.

A thick C horizon (3C) with a layer of water-rounded cobbles at the base was present from 87 – 130 cmbs. This deposit represents a disconformity in the profile associated with a high discharge event and lateral migration of the stream channel, with the cobbles at the base indicating a channel position north of the existing channel. No artifacts were recovered from this deposit.

A cambic B-horizon (Bw) composed of a 7.5YR 5/6 strong brown fine micaceous sandy silt, with weak subrounded to subangular blocky structure, extends to channel lag at 220 cmbs. The Bw horizon begins just below the disconformity marked by the cobble layer at 130 cmbs. At 180 cmbs the sand content of the 4Bw horizon increases, along with pronounced redox mottling, leading to the designation 4Bwg.

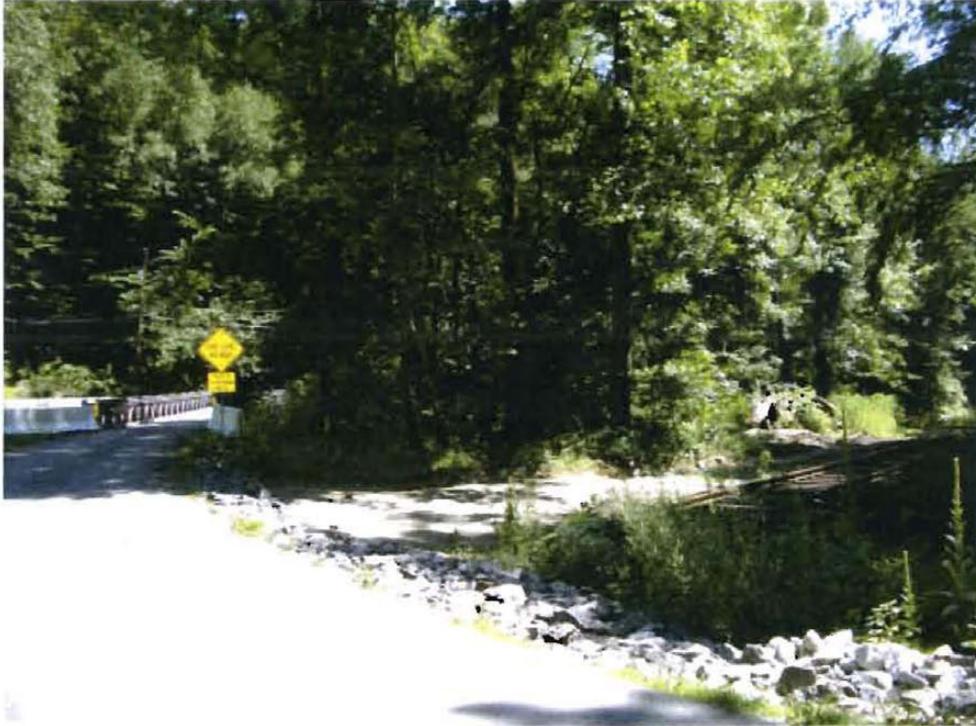
**Plate 4:** Possible Location of Former Train Station.  
(Note: see Plate 2 for comparison to historic photograph.)

Based on comparisons with historic maps and existing conditions, it appears the former train station location is currently under the existing roadway leading to the temporary bridge disturbance directly adjacent to the roadway (**Plate 4**). No archaeological remains of the train station were found.
