WATER QUALITY IMPROVEMENT PROGRAM

2015 WINTER WORKSHOP

Water Quality Improvement Plan (WQIP)

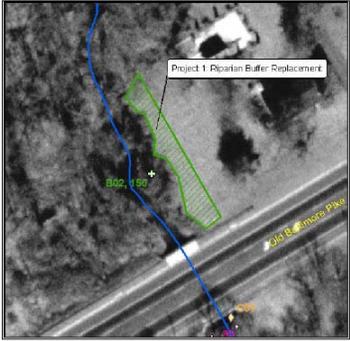
Proposed Project *Leatherman's Run*

Project Location: Immediately upstream of the crossing of Old Baltimore Pike.

Project Description: The riparian buffer on the left bank (facing downstream) has been generally reduced to less than 10 feet, and less than 5 feet in localized areas upstream of the Old Baltimore Pike crossing. The above photo shows the view of the buffer facing downstream towards Old Baltimore Pike. The project would entail planting of native trees and shrubs to widen the existing buffer. Some landscape style plantings have been installed in the very southern corner of the site however more natural vegetation with a developed understory will provide the most benefit.

Stabilization	Additional trees and shrubs will help stabilize the stream bank.
Water Quality	A more established buffer will provide shading effects to reduce water temperature and will trap runoff and pollutants such as fertilizers from the adjacent property.

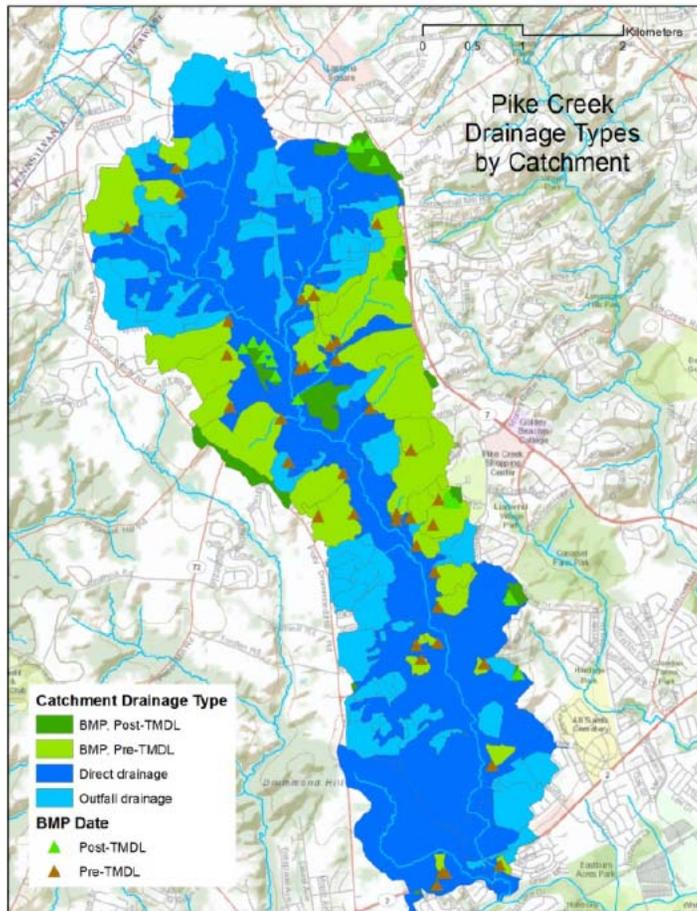
GIS Analysis - BMP Treatment

Figure 2 -- Categorized stormwater catchments in the Pike Creek watershed. BMPs and their catchments are differentiated by date to indicate pre- v. post-TMDL implementation.

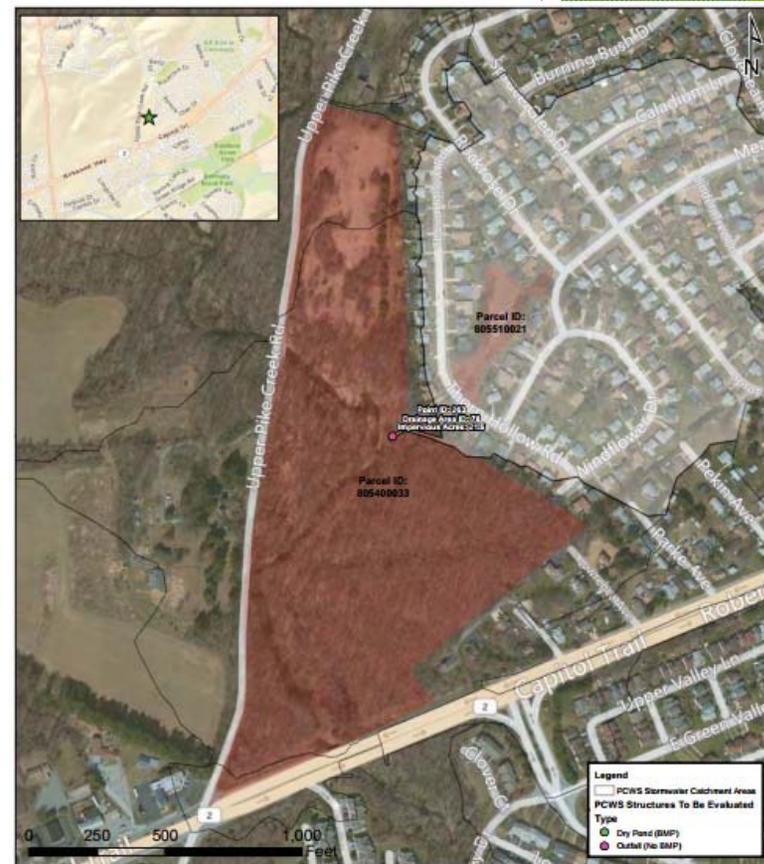
DATE: 7/1/2012	Drainage Area ID: 78	CREATED BY: DAI	 5400 LIMESTONE RD WILMINGTON, DE 19808 OFFICES IN DELAWARE, PENNSYLVANIA, MARYLAND, & NEW JERSEY
SCALE: 1 inch = 350 feet	PCWS Pilot Water Quality Improvement Plan	BASEMAP: ArcGIS Online: Bing Hybrid Basemap	
SHEET: Page 14 of 52	Now Castle County-Delaware	FILE: 8054VC_CatchAreas.MXD

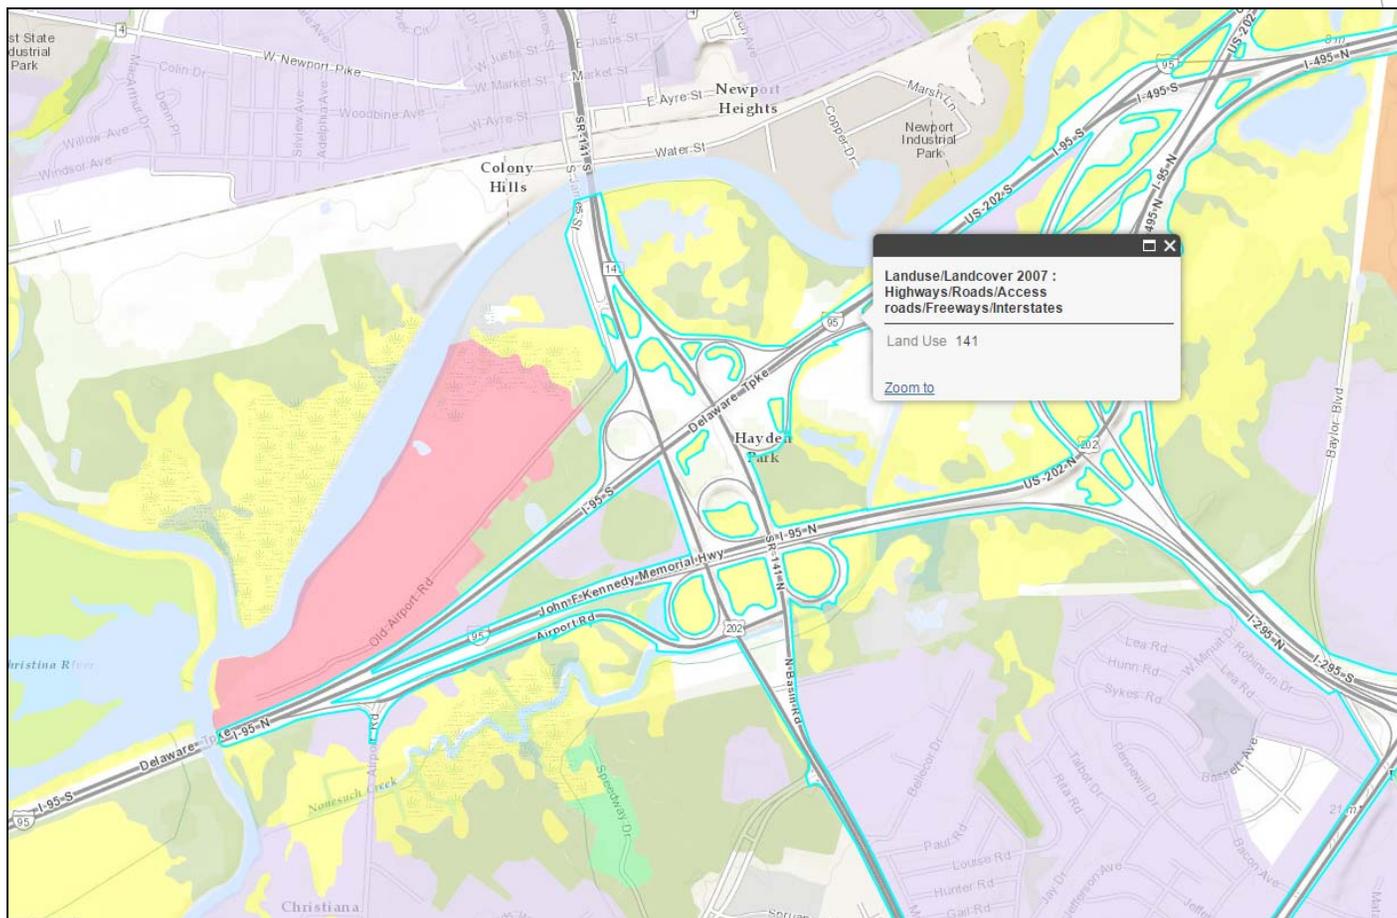
Effective Impervious Area

- ▶ 2007 NCC Land Use/Land Cover Layer

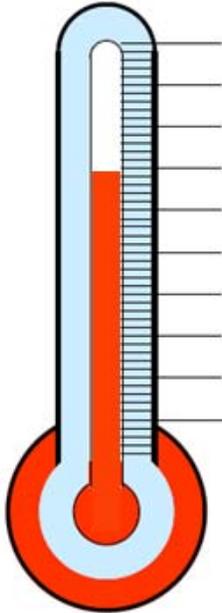
CHRISTINA RIVER EFFECTIVE IMPERVIOUS AREA REDUCTION

383.00 ACRES *8.8.14 Goal*

278.33 Acres treated to date by DelDOT

CHS Stormwater Retrofit – 2.89 Acres

I-95 Toll Plaza – 10.763 Acres

BMPs Constructed After 1996 – 264.67 Acres
