3.0 Existing Conditions

3.1 Site Characteristics

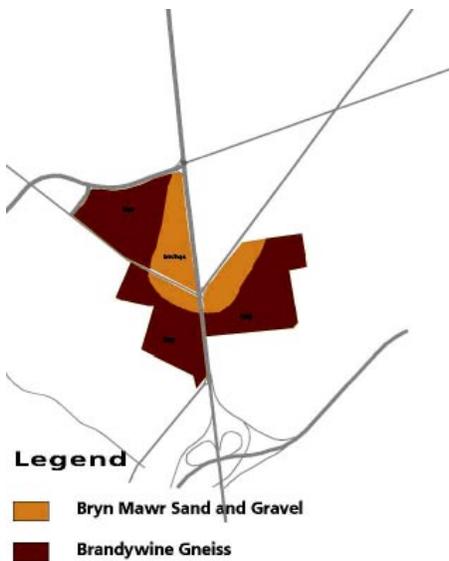
Existing Conditions- Geology

The Blue Ball properties lie in the Piedmont physiographic province of Delaware – a transition zone between the Appalachian province to the northwest and the Coastal Plain province to the south. The Piedmont province is an eroded and dissected area of uplands developed on metamorphic crystalline bedrock. The site itself is underlain by Precambrian rock of the Wilmington Complex (predominantly gneiss) with a patchy veneer of Tertiary conglomerates of the Bryn Mawr formation. Both gneiss and conglomerate rocks crop out at the surface of the site.

The majority of the site consists of Brandywine Gneiss, which is characterized as variable with typical depths to bedrock of up to approximately 20 feet. This was confirmed by geotechnical testing which encountered gneiss in many locations at considerably less than 20 feet deep. The very hard and dense rock has irregular fractures with large boulders ranging in size from 1 to 10 feet in diameter. This rock necessitates specialized excavation techniques and foundation engineering for structures.

Bryn Mawr Sand and Gravel are located at the higher elevations of the site in a band parallel to and south of Rockland Road and Foulk Road. These sands and gravels are poorly sorted and erratically distributed in this portion of the site. They typically overlay the gneiss at depths of up to 5 or 10 feet.

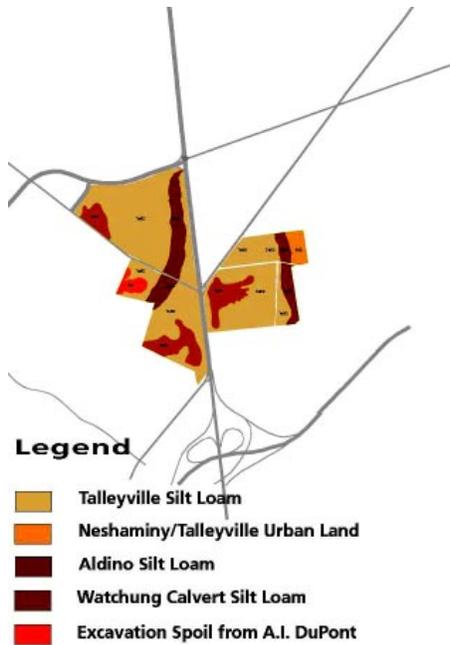
Existing Conditons- Soils

Soils in the site generally fall into either the Neshaminy-Aldino-Watchung or Neshaminy-Talleyville-Urban Associations. The majority of the site is covered by Talleyville Silt Loam which tends to be deep and well drained, presenting few limitations to development. Aldino Silt Loam covers areas to the east and west of Route 202. It is less well drained with seasonal wetness and shallow depth to bedrock. The Alapocas and Matson Run stream corridors are characterized by Watchung Calvert Silt Loam which is poorly drained with high water tables. An area containing excavation spoil from the construction of the A.I. DuPont Institute occupies a large area on the west of the site, adjacent to the Institute's property.

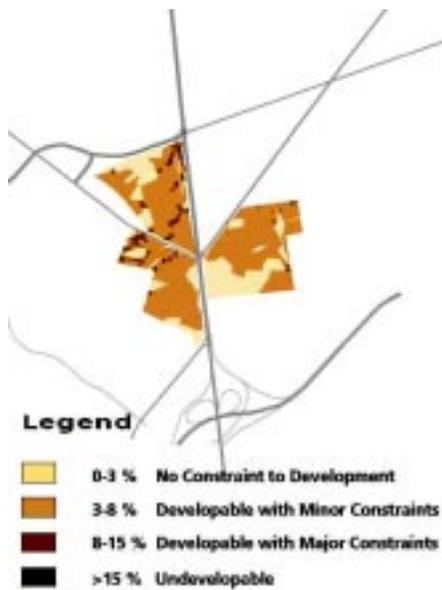
Existing Conditons- Slopes

Route 202 is located on the ridgeline separating the east and west portions of the Blue Ball properties. The Weldin parcel is characterized by gentle slopes of less than 10% falling to the east and southeast toward Matson Run. These slopes do not present a constraint to development except near the stream corridor.

The Alapocas parcel on the west consists of farm fields sloping, typically less than 8 %, west and south toward Alapocas Creek. Steeper slopes of over 15 % are located adjacent to the stream corridor. The greatest slopes in the site are west of the stream. The land rises dramatically at over 15 % to meet the A.I. DuPont Institute parking lot. The steepest slopes are those around the Institute's construction spoil site. This feature was created by constructing a dike and filling its interior with rock and soil excavated during hospital site preparation.

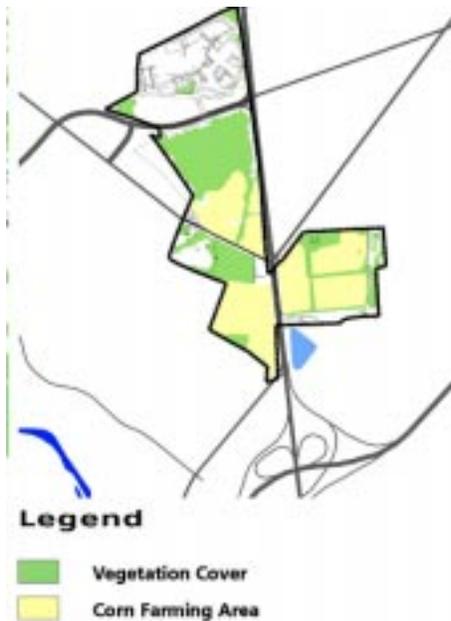
Existing Conditions- Vegetation

The majority of the site, on both sides of Route 202, is characterized by agricultural fields. In the Weldin parcel there are also hedgerows originally planted to protect fields from wind. They consist of trees and shrubs. The hedgerows are approximately 1,400 feet long and 100 feet wide in the north/south direction and 1,100 feet long by 50 feet wide in the east/west direction. While the hedgerows are generally diverse, offering wildlife habitat, the greatest diversity exists in the north where they mingle with the woods surrounding the Weldin Plantation ruins.

The eastern portion of the Weldin parcel contains woodlands that grade from shrubs and modest secondary growth to more mature trees on the extreme east, including numbers of large oaks, beech and yellow poplar. Wetland vegetation characterizes the Matson Run stream corridor with sweet gums, maples and ash trees in evidence.

Approximately half the Alapocas parcel is covered by agricultural fields. A small scrub shrub and young woodland area is located on its south border adjacent to the Alapocas residential developments. Woodlands predominate from the eastern side of the Alapocas stream corridor to the west of the parcel. Wetland species characterize the stream corridor itself with upland species in a small stand east of the stream and the majority of the west side. A three to four acre area of mown lawn is located next to the A.I. DuPont Institute parking lot.

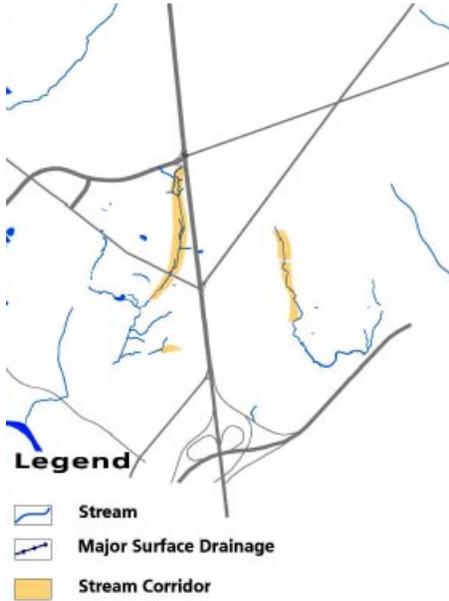
Existing Conditions- Hydrology

The site consists of two major drainage areas, one east and one west of Route 202. The Weldin parcel on the east drains through overland flow and a series of swales to Matson Run along its eastern border. Matson Run is one of the three subwatersheds of the Shellpot Creek watershed, which drains an area of approximately 5,300 acres. Most of that area, as well as the watershed of Matson Run, was developed prior to the State of Delaware's institution of stormwater management for new development. Consequently, the Matson Run watershed is subject to increased storm flows due to high coverage by impervious surfaces. Additionally, significant disturbance to the natural stream system (including relocation, channelization and lining, flood-

plain/riparian buffer encroachment) has occurred. The combination of increased flows and stream disturbance has caused the system to exceed its natural capacity resulting in flooding, erosion and other flood-related problems.

The Alapocas parcel drainage is carried by Alapocas Creek which flows to the Brandywine. Stormwater flows from the agricultural fields by sheet flow and along a number of swales to the Creek. The Alapocas Run itself shows signs of severe erosion caused by upstream conditions similar to those described for Matson Run above. A temporary detention basin designed to accommodate Route 202 runoff is located to the southwest of the intersection of Route 202 and Rockland Road.

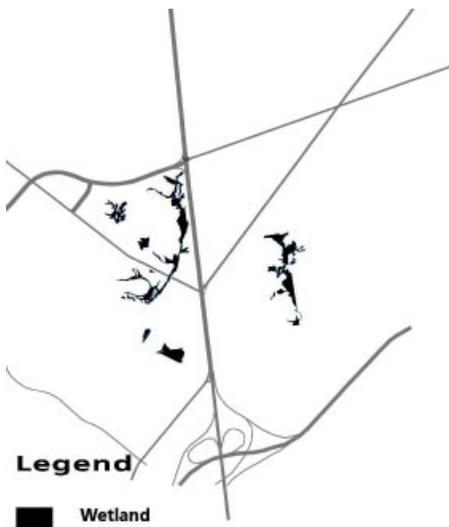
Existing Conditions- Wetlands

Wetlands have been mapped along the length of Matson Run in the Weldin parcel, along the southern border of the parcel adjacent to the Alapocas residential developments, along the Alapocas stream corridor itself and at the base of the construction spoil fill area located on the western border of the parcel.

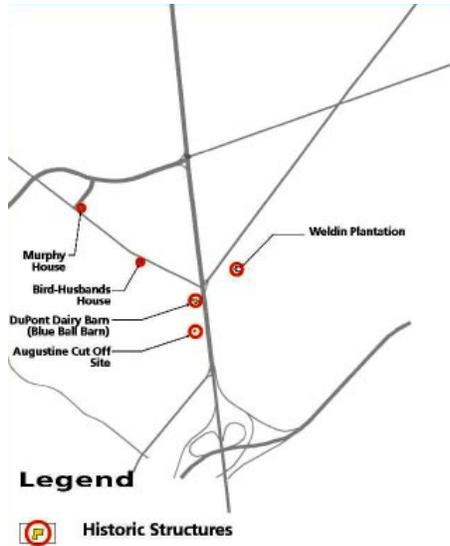
Existing Conditions- Historic Structures

A complete documentation of the cultural resources on the Blue Ball properties was conducted for the Master Plan and has been published in a separate document as noted in the Introduction. The most visible among the extant historic resources associated with the site are the Bird-Husbands House, DuPont Dairy Barn, Weldin Plantation site, and the William Murphy House.

The Bird-Husbands House is located in the western portion of the Alapocas parcel, approximately 100' south of Rockland Road. It is listed as a contributing cultural resource in the Nemours National Register Historic District. It is a small vernacular-style, wood frame farmhouse originally constructed between 1808 and 1816 and is representative of nineteenth century vernacular farmhouse design.

The DuPont Dairy Barn, often called the Blue Ball Dairy Barn, is located to the southwest of the intersection of Route 202 and Rockland Road. The building is listed as a contributing resource to the Nemours National Register Historic District. The barn is a large, stone wall/stucco coated building constructed in 1914 as part of the A.I. DuPont estate. It is an example of the American Country House Movement and reflects the changing agricultural practices of the time.

The Weldin Plantation site is located in the Weldin parcel approximately 400 feet east of the intersection of Foulk and Weldin Roads. The site consists of the stone foundations of at least five structures, only some of whose uses have been determined. It was likely constructed in the latter part of the 18th century.

An historic archaeological site (7NC-B-49/N-13717) identified as the Augustine Cut-Off site is located west of Route 202, approximately 500 feet north of the Augustine Cut-Off intersection with Route 202. The site consists of brick-lined cistern dating from the late nineteenth to early twentieth centuries.
