SR 141 Pedestrian Safety Study

SR 273 (Frenchtown Road/Delaware Street) to SR 37 (Commons Boulevard)

2019 Hazard Elimination Program – Site U-2

June 2023

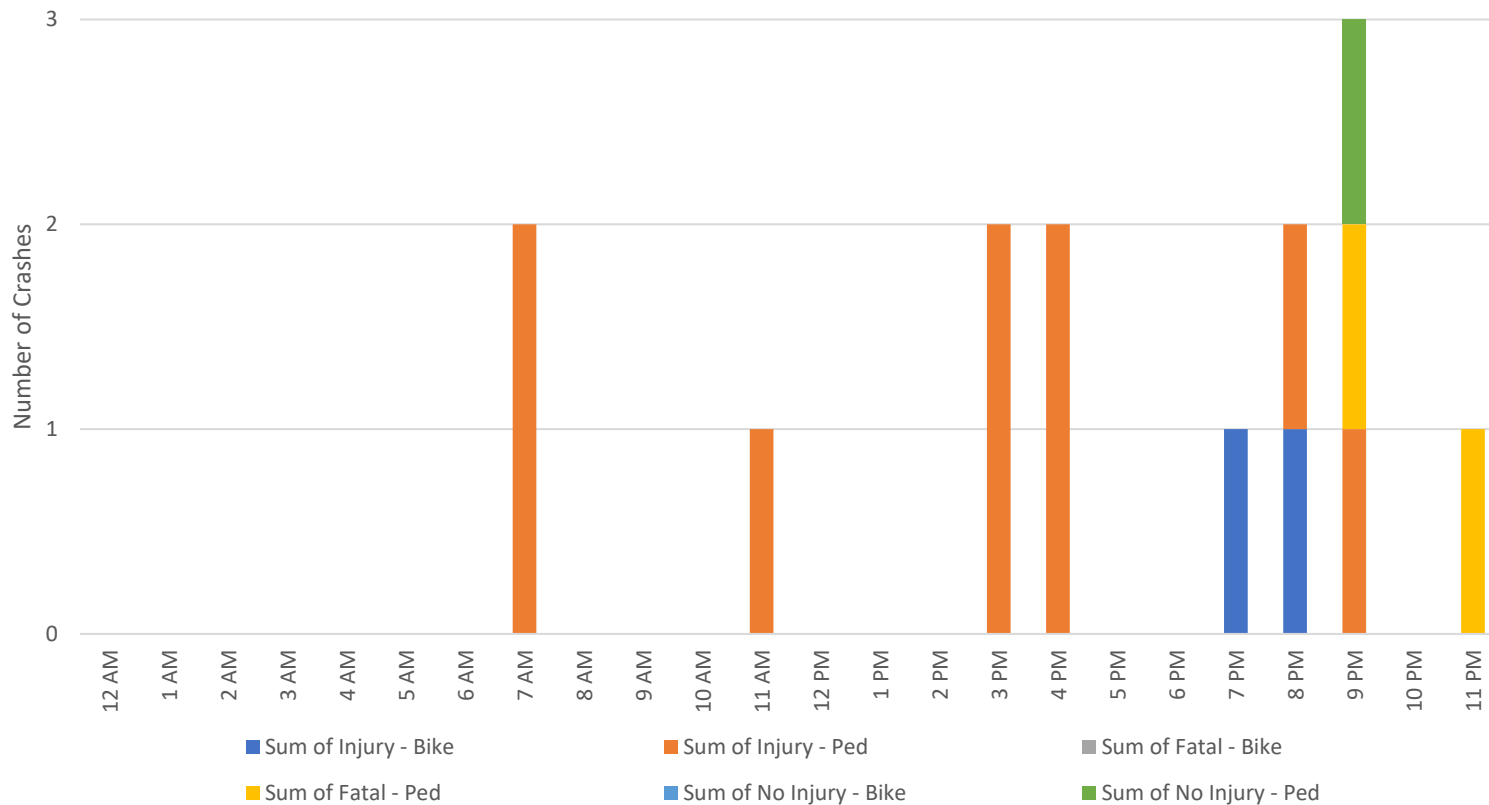
SR 141, Commons Blvd to SR 273 Ped / Bike Crashes by Time of Day (January 2012 to May 2023)

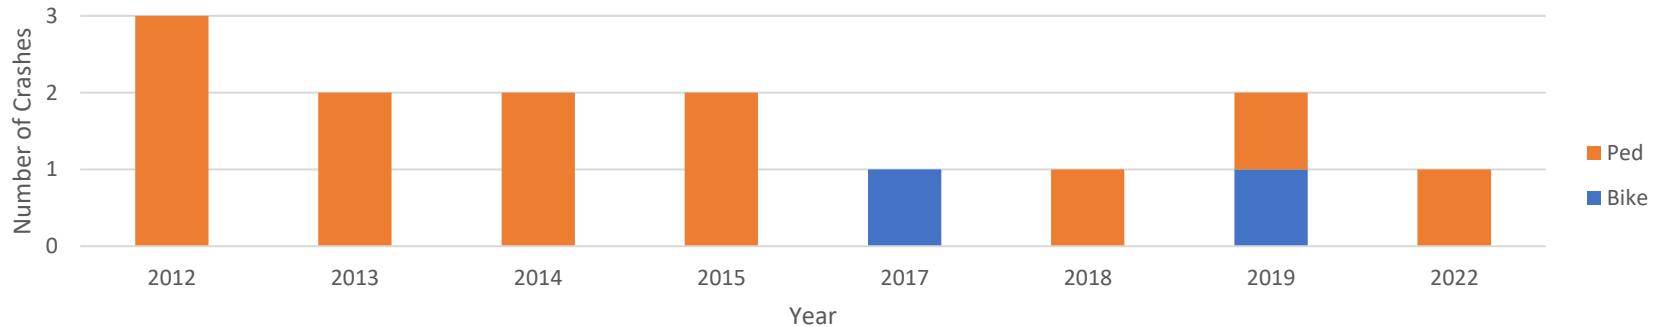
SR 141, Commons Blvd to SR 273 Ped / Bike Crashes by Year (January 2012 to May 2023)

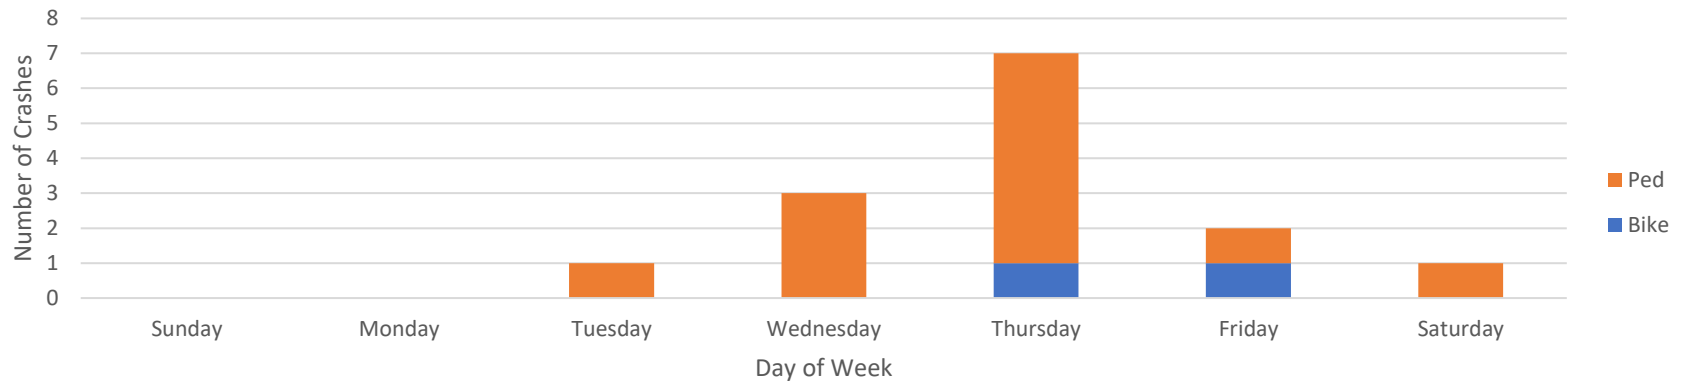
SR 141, Commons Blvd to SR 273 Ped / Bike Crashes by Day of Week (January 2012 to May 2023)

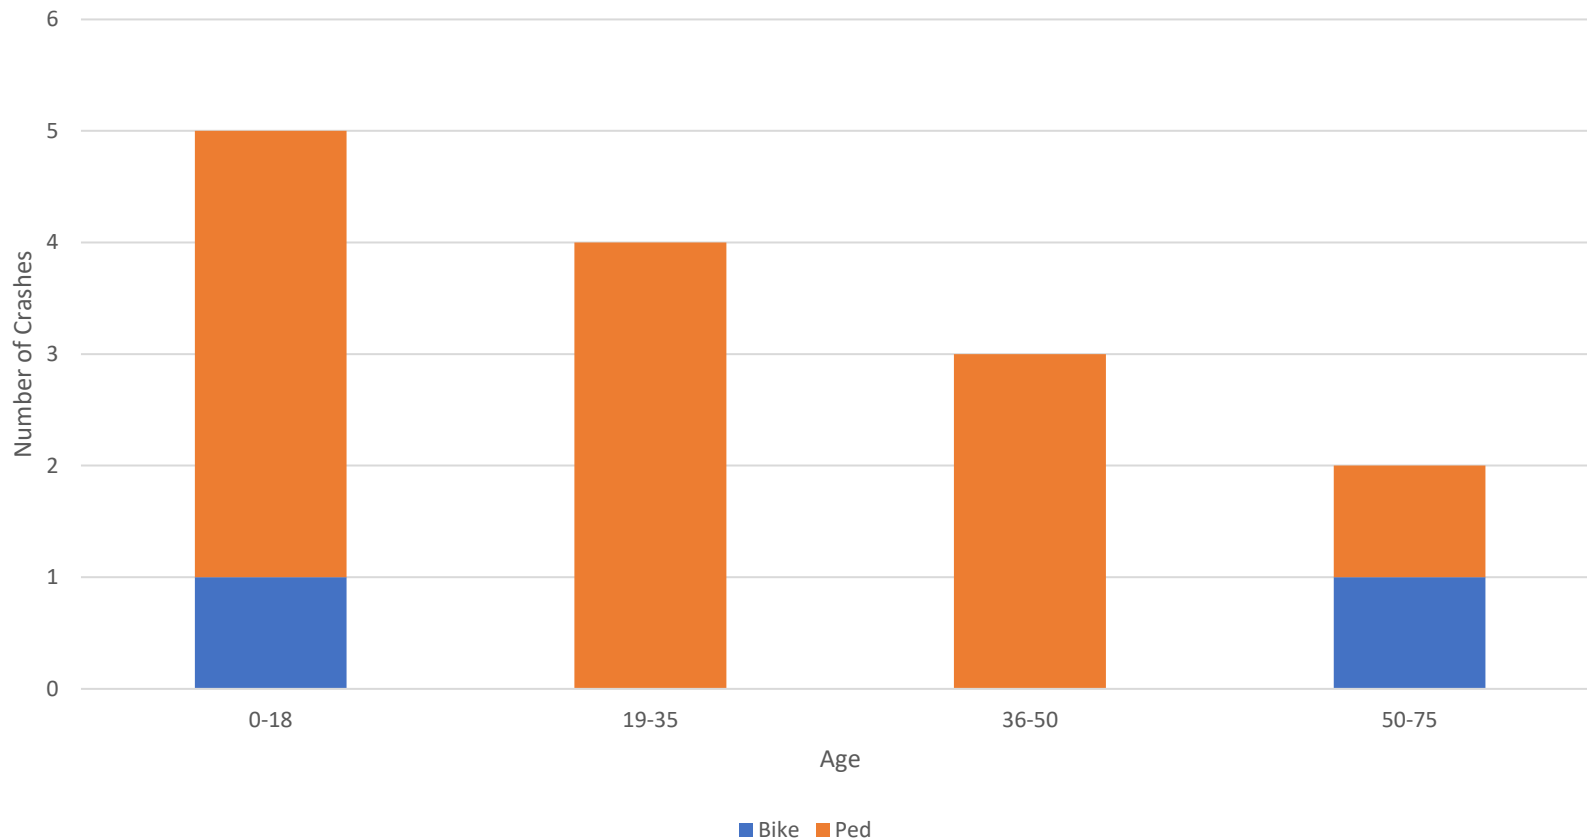
SR 141, Commons Blvd to SR 273 Ped / Bike Crashes by Age (January 2012 to May 2023)

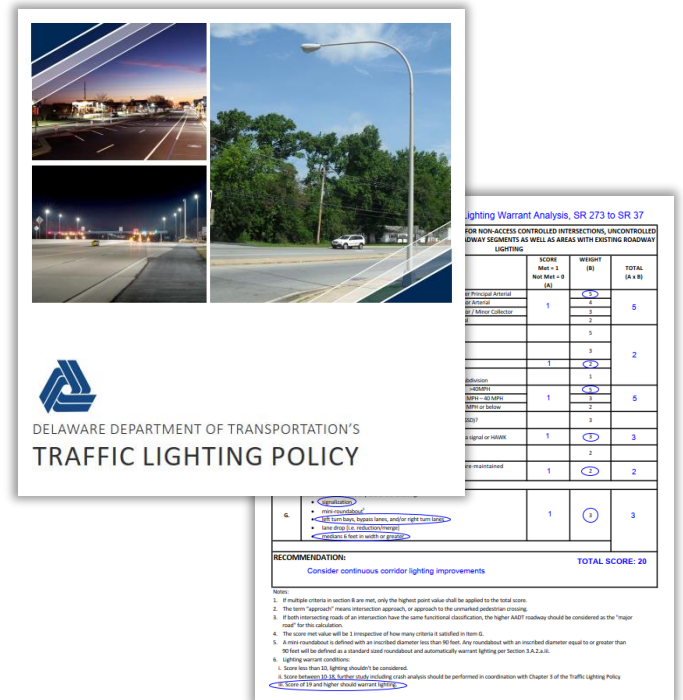
- Continuous corridor lighting is warranted per *Form A* of the *DelDOT Lighting Policy*
 - Score of 20 (19+ warrants lighting)
- Preliminary photometrics conducted for potential lighting improvements:
 - Installation of luminaires on existing utility poles provides adequate lighting levels from SR 273 to the US 13 interchange
 - Consider installation of DelDOT lighting system from Washington Avenue to Paul Road
 - Prioritize Jay Drive intersection due to nighttime crash rate
 - No aerial utilities between Washington Avenue and Jay Drive
 - Existing utility pole spacing between Jay Drive and Paul Road does not provide adequate lighting levels
 - Coordination required with DRBA/FAA to place light poles along SR 141 SB
 - Approximate \$300K construction cost

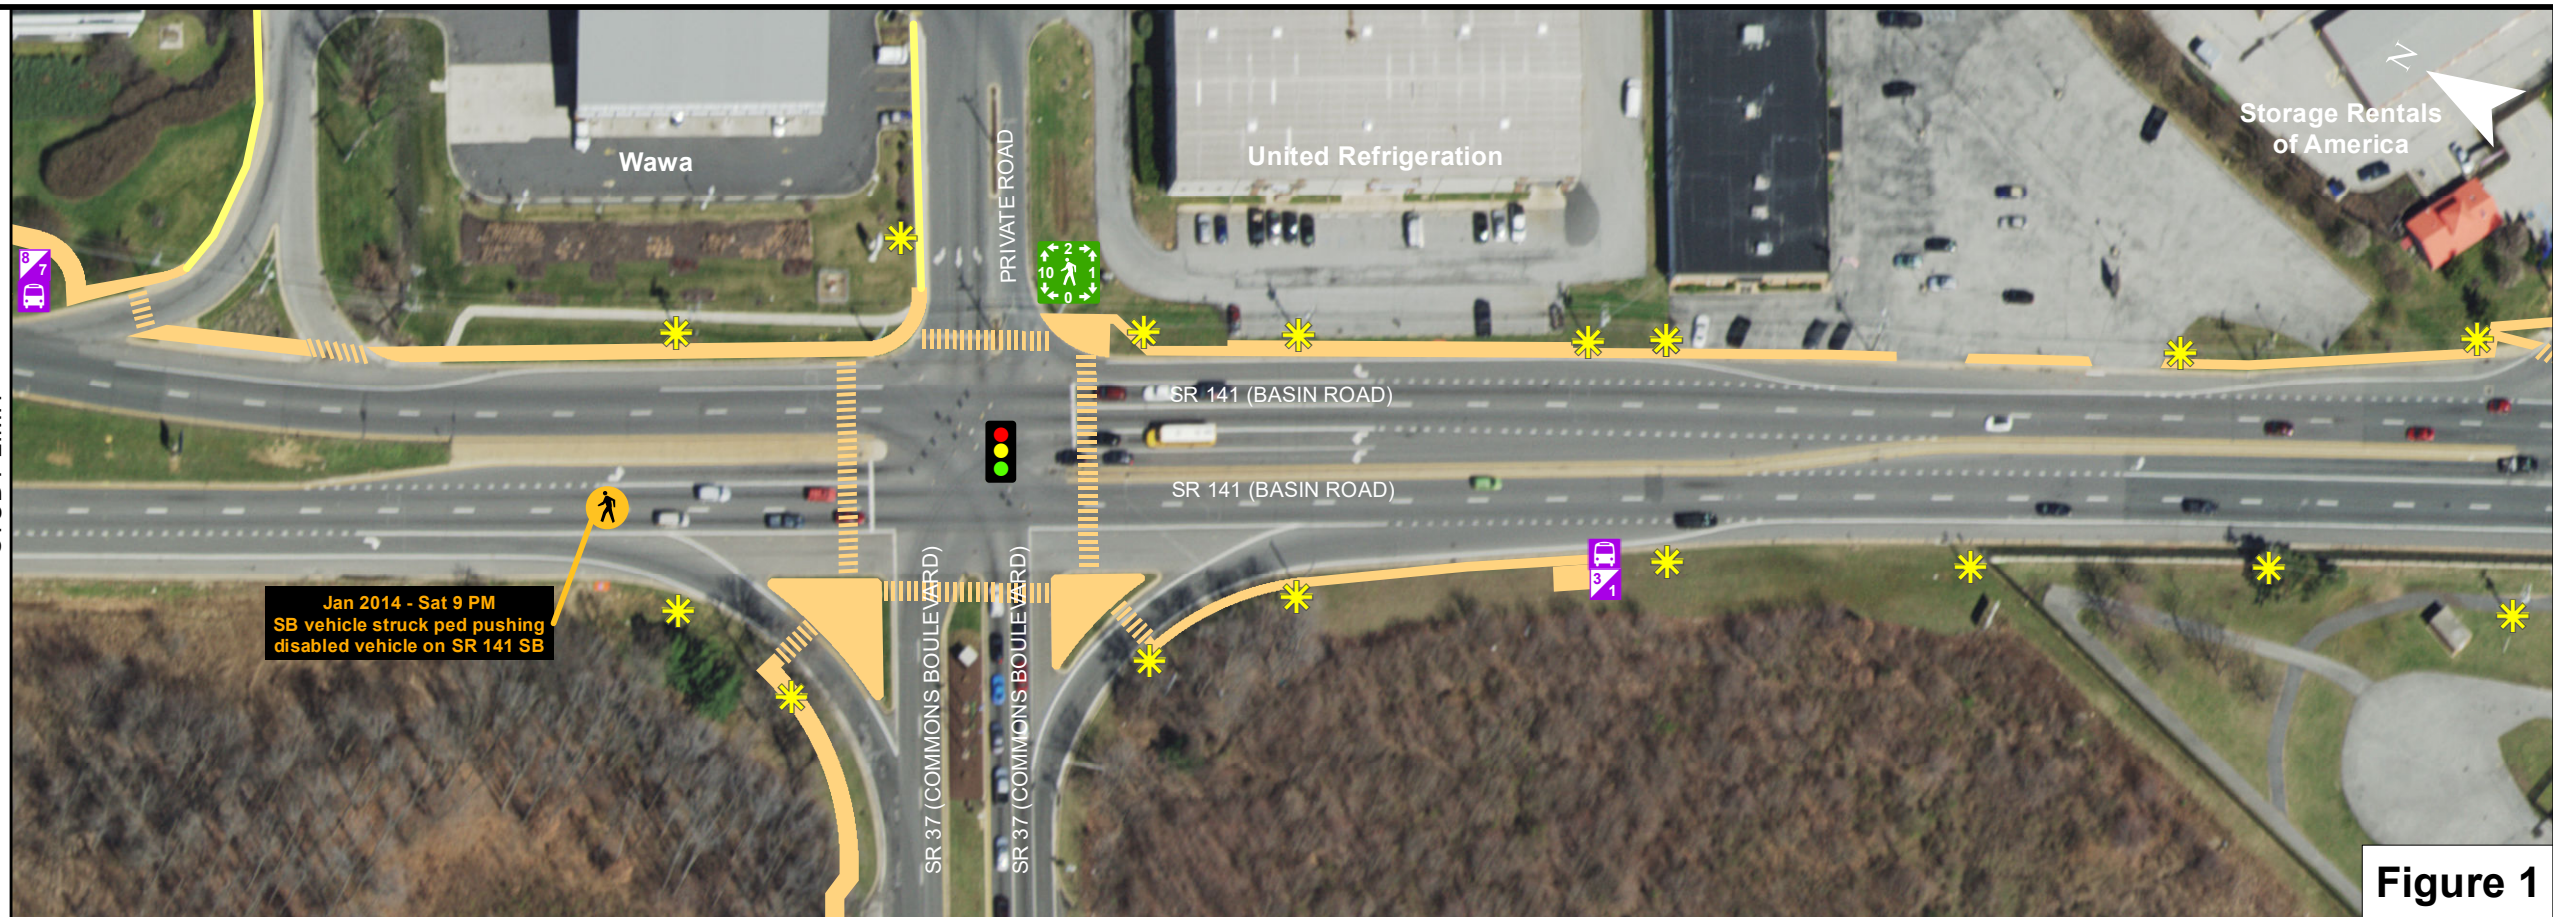
Figure 1

Existing Conditions

Crash study period - January 2012 through August 2022

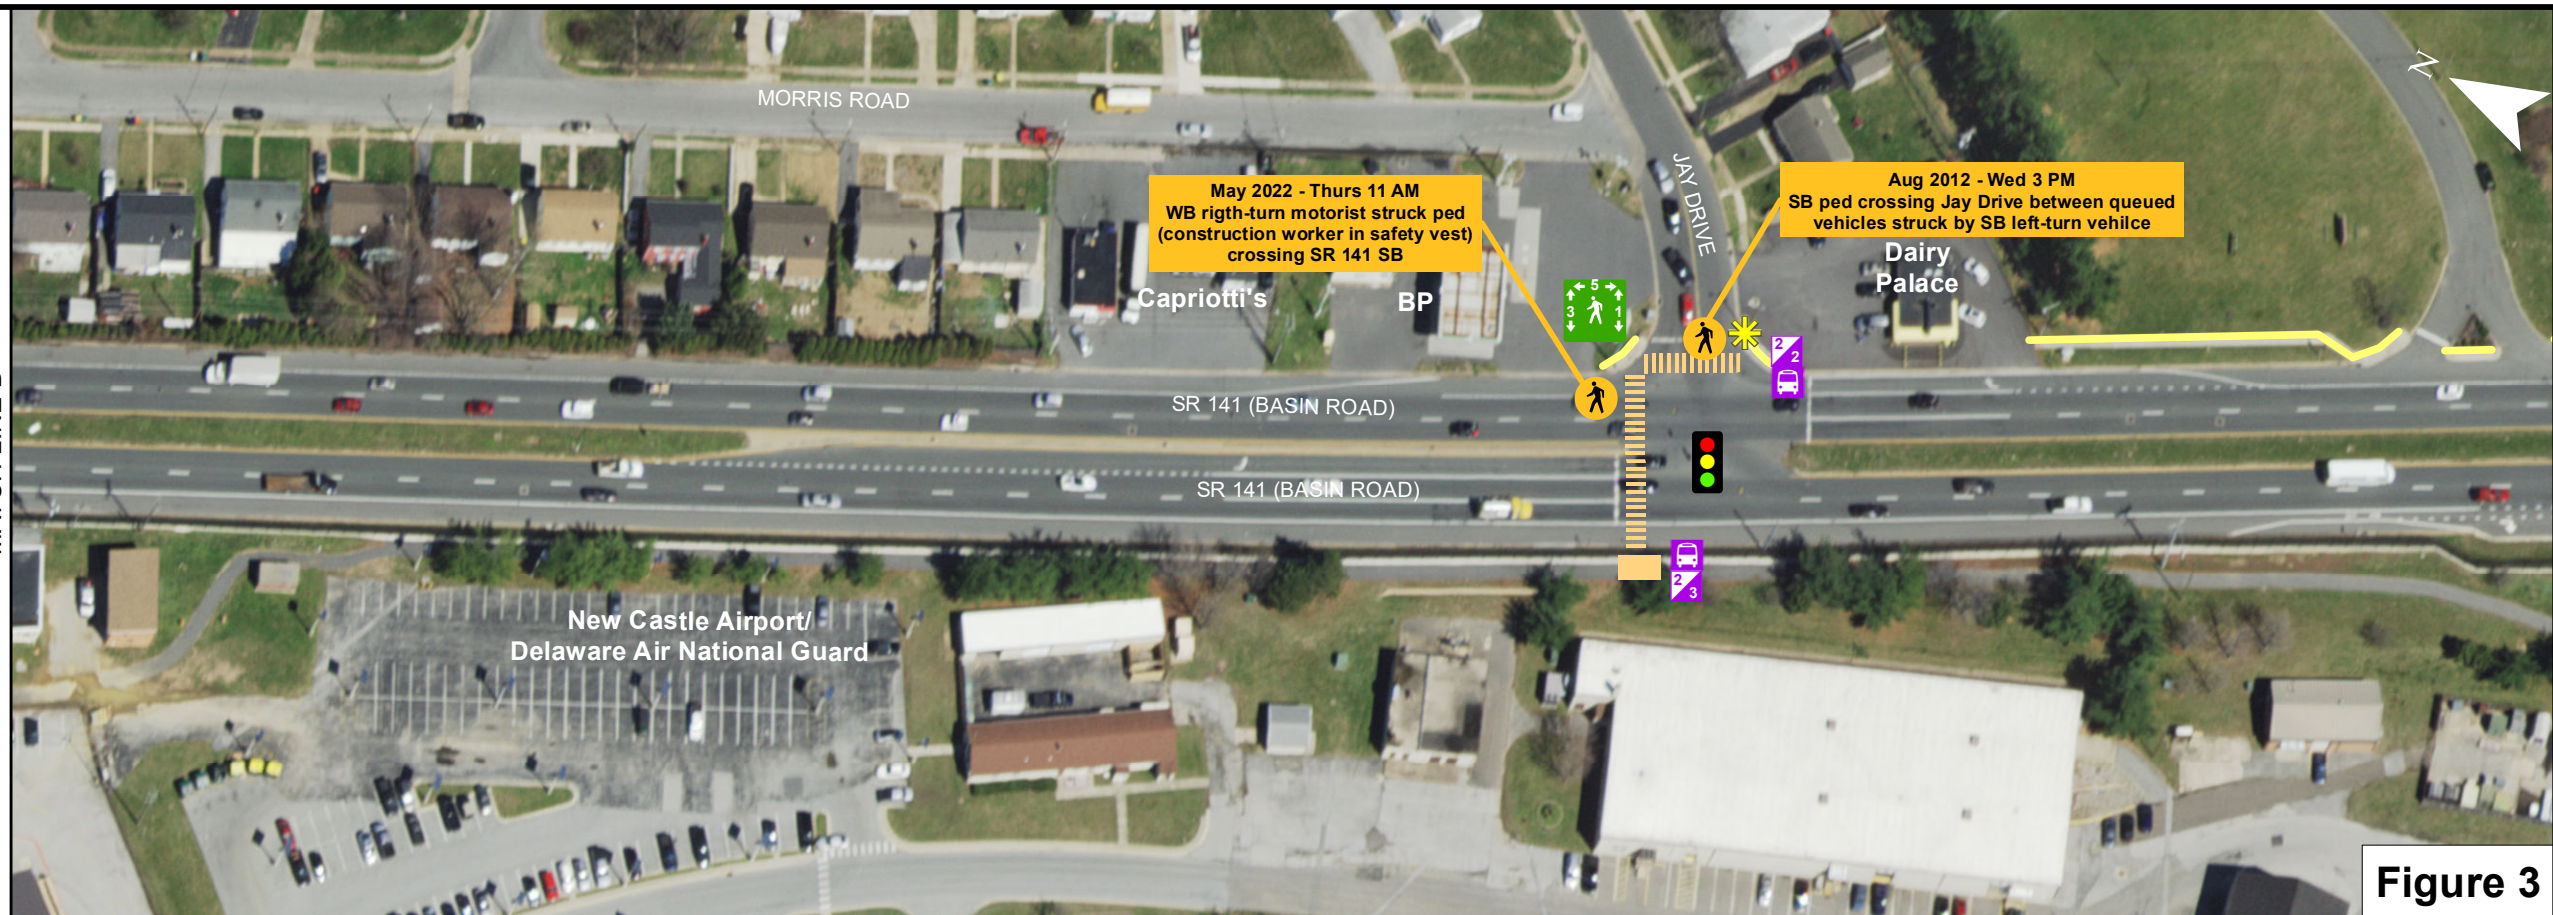
Figure 3

Existing Conditions

Crash study period - January 2012 through August 2022

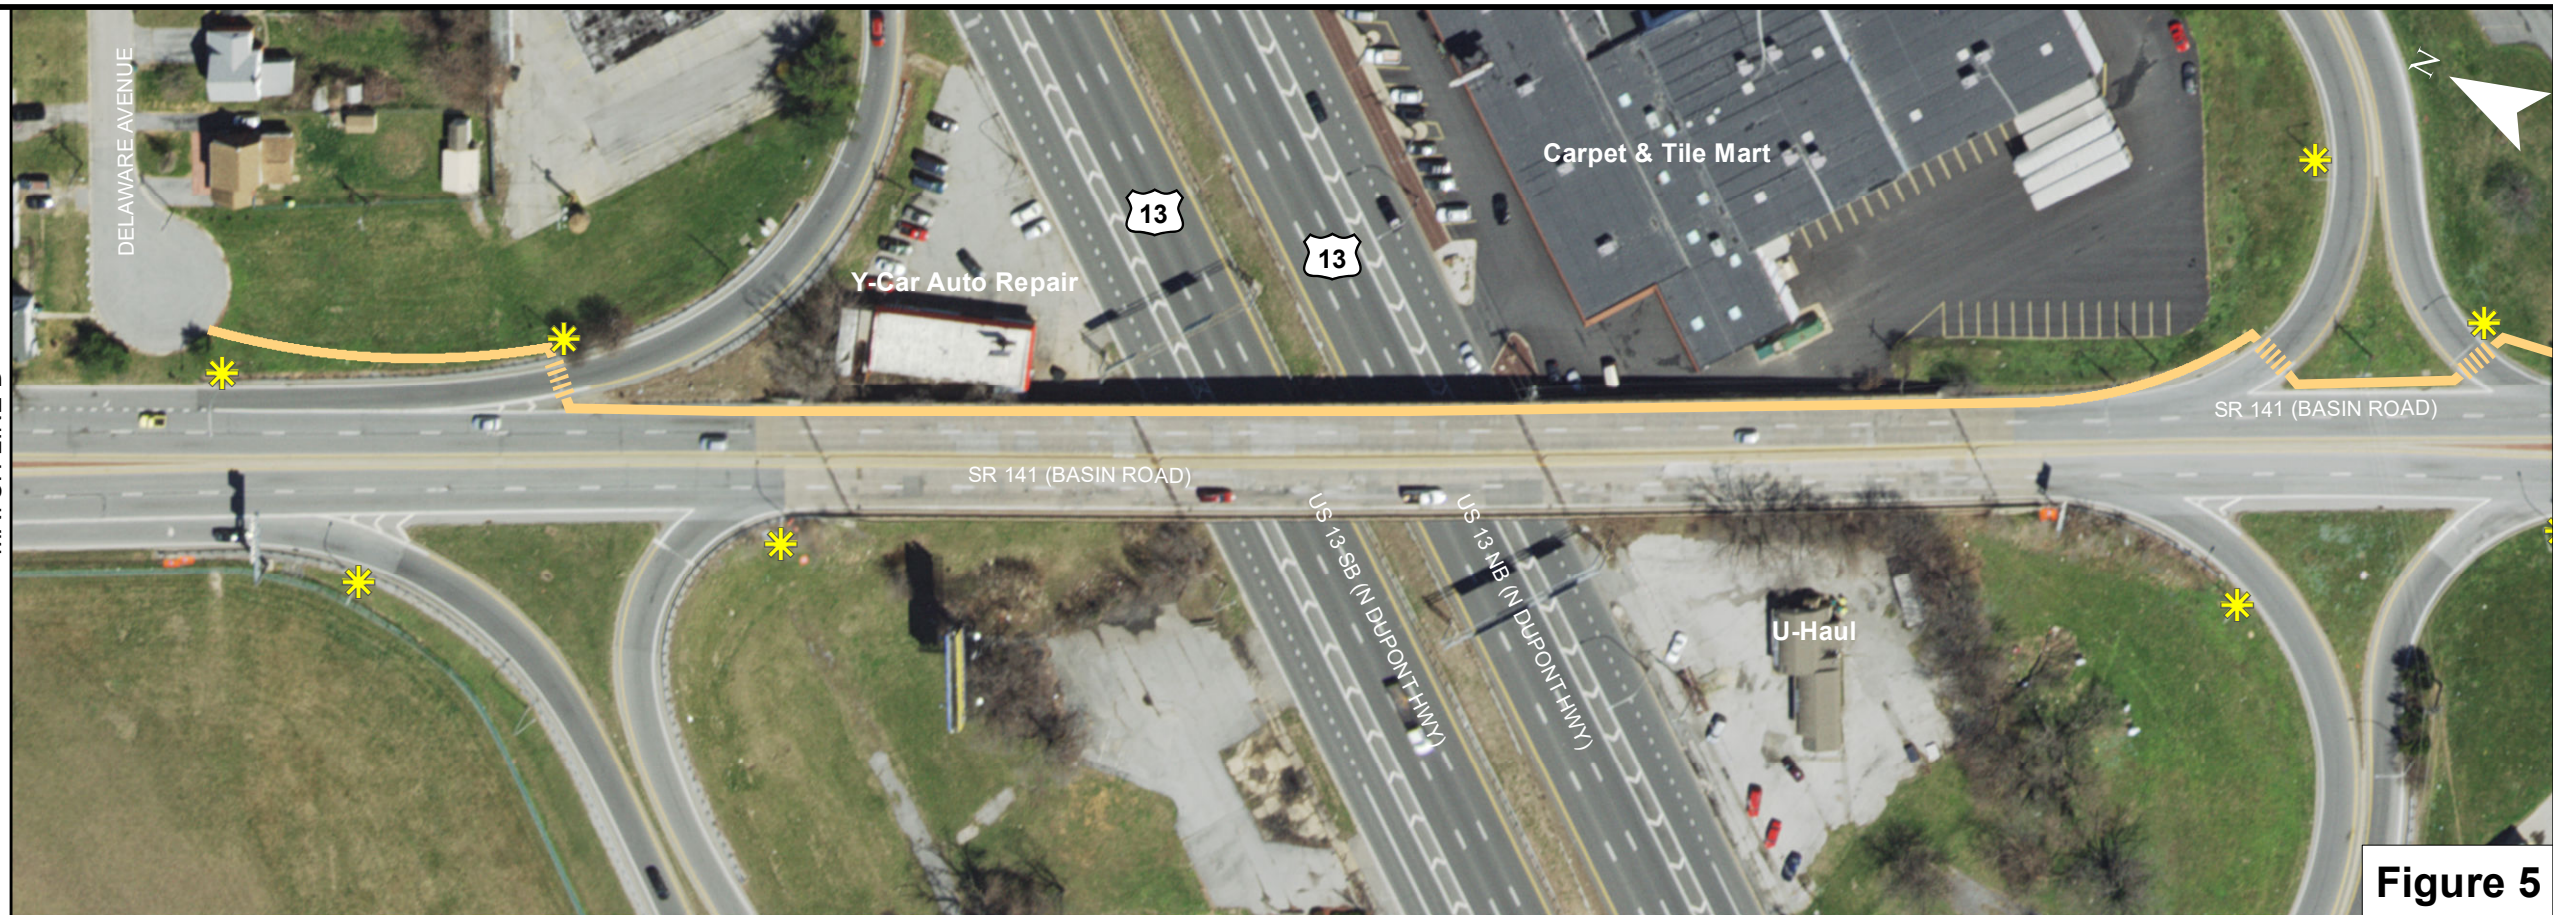
Figure 5

Existing Conditions

Crash study period - January 2012 through August 2022

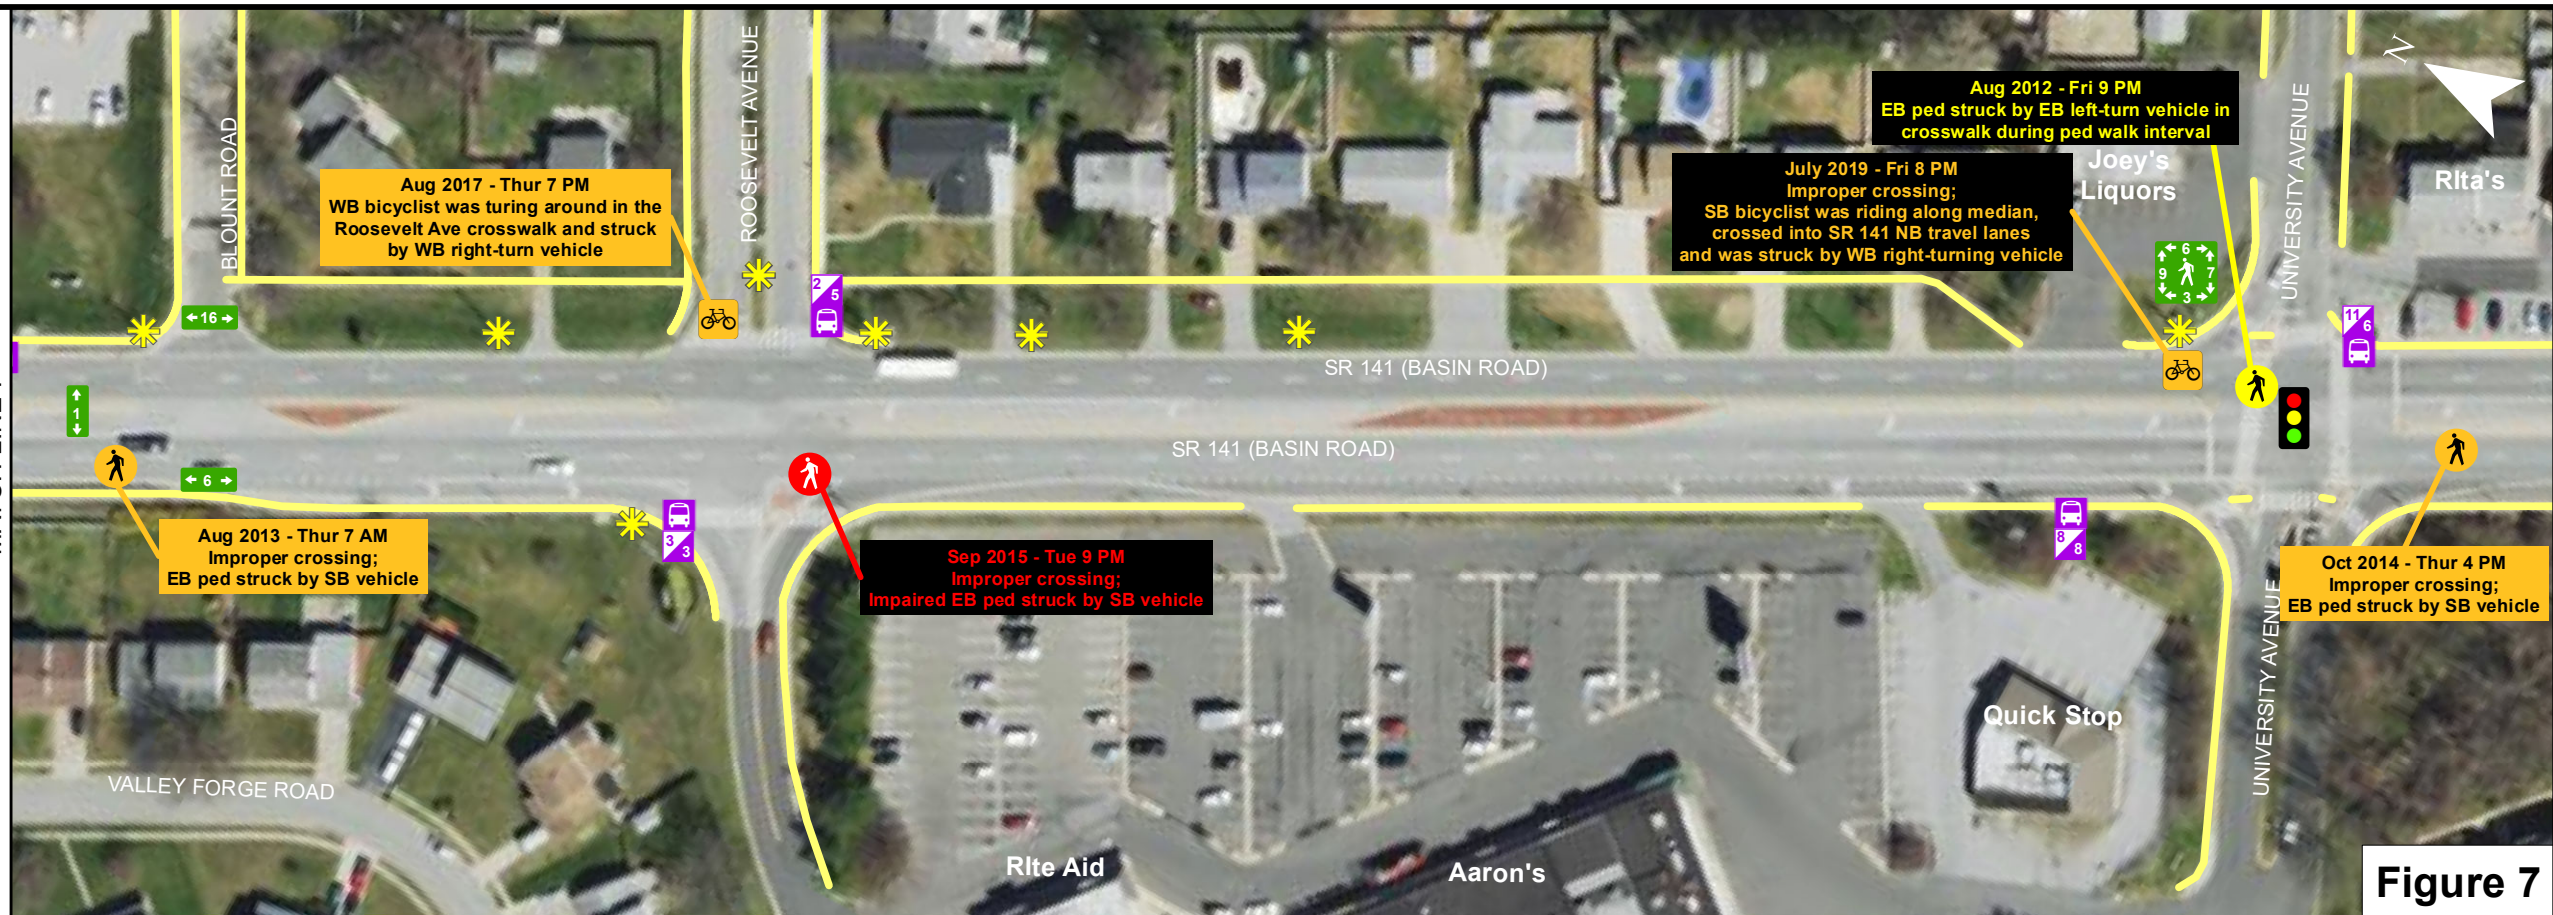
Figure 7

Existing Conditions

Crash study period - January 2012 through August 2022

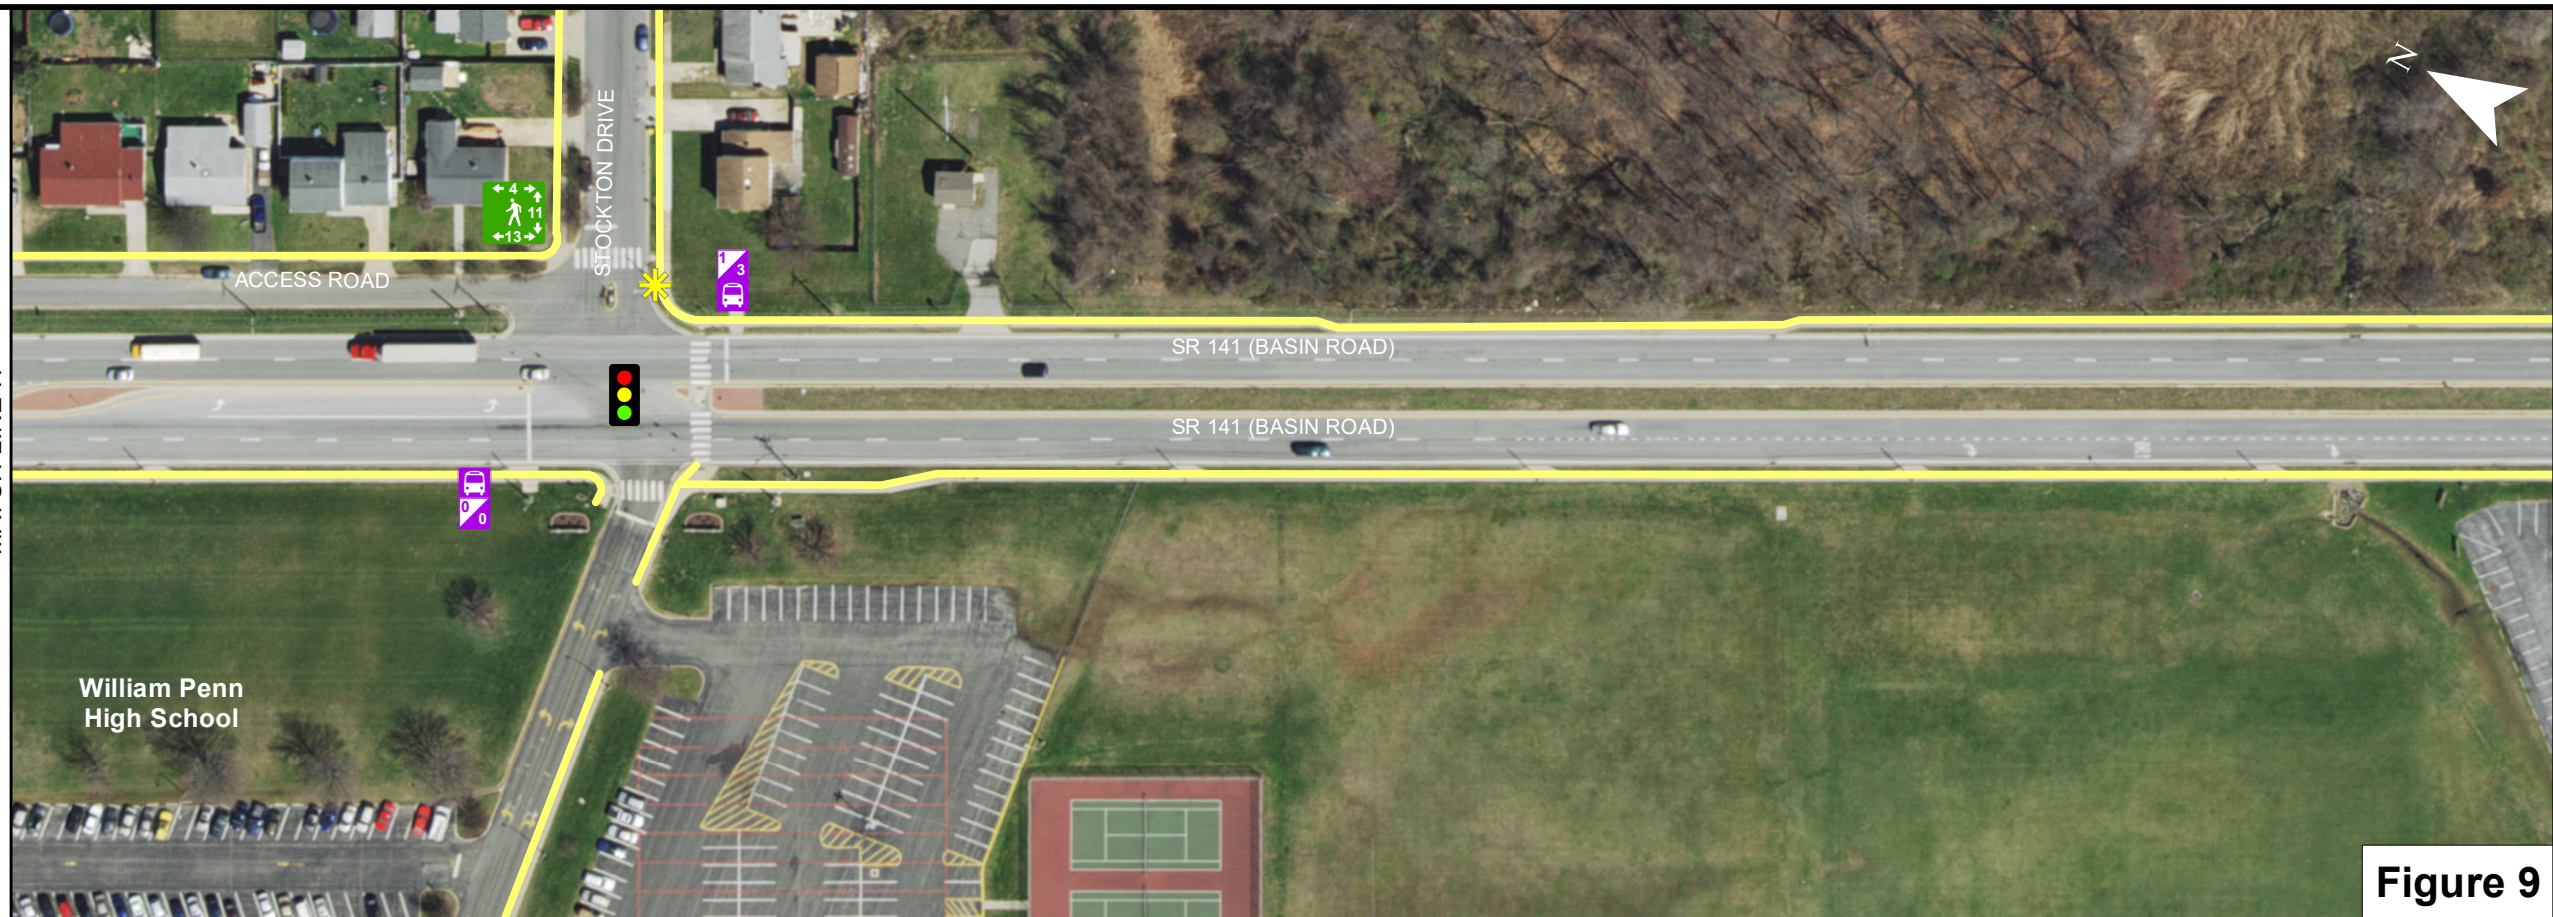
Figure 9

Existing Conditions

Crash study period - January 2012 through August 2022
